King Street Tile Drain Inspections

Inspection Report for Observation:
AgriculturalFlooding1

CLIENT	Saginaw County Public Works Commissioner

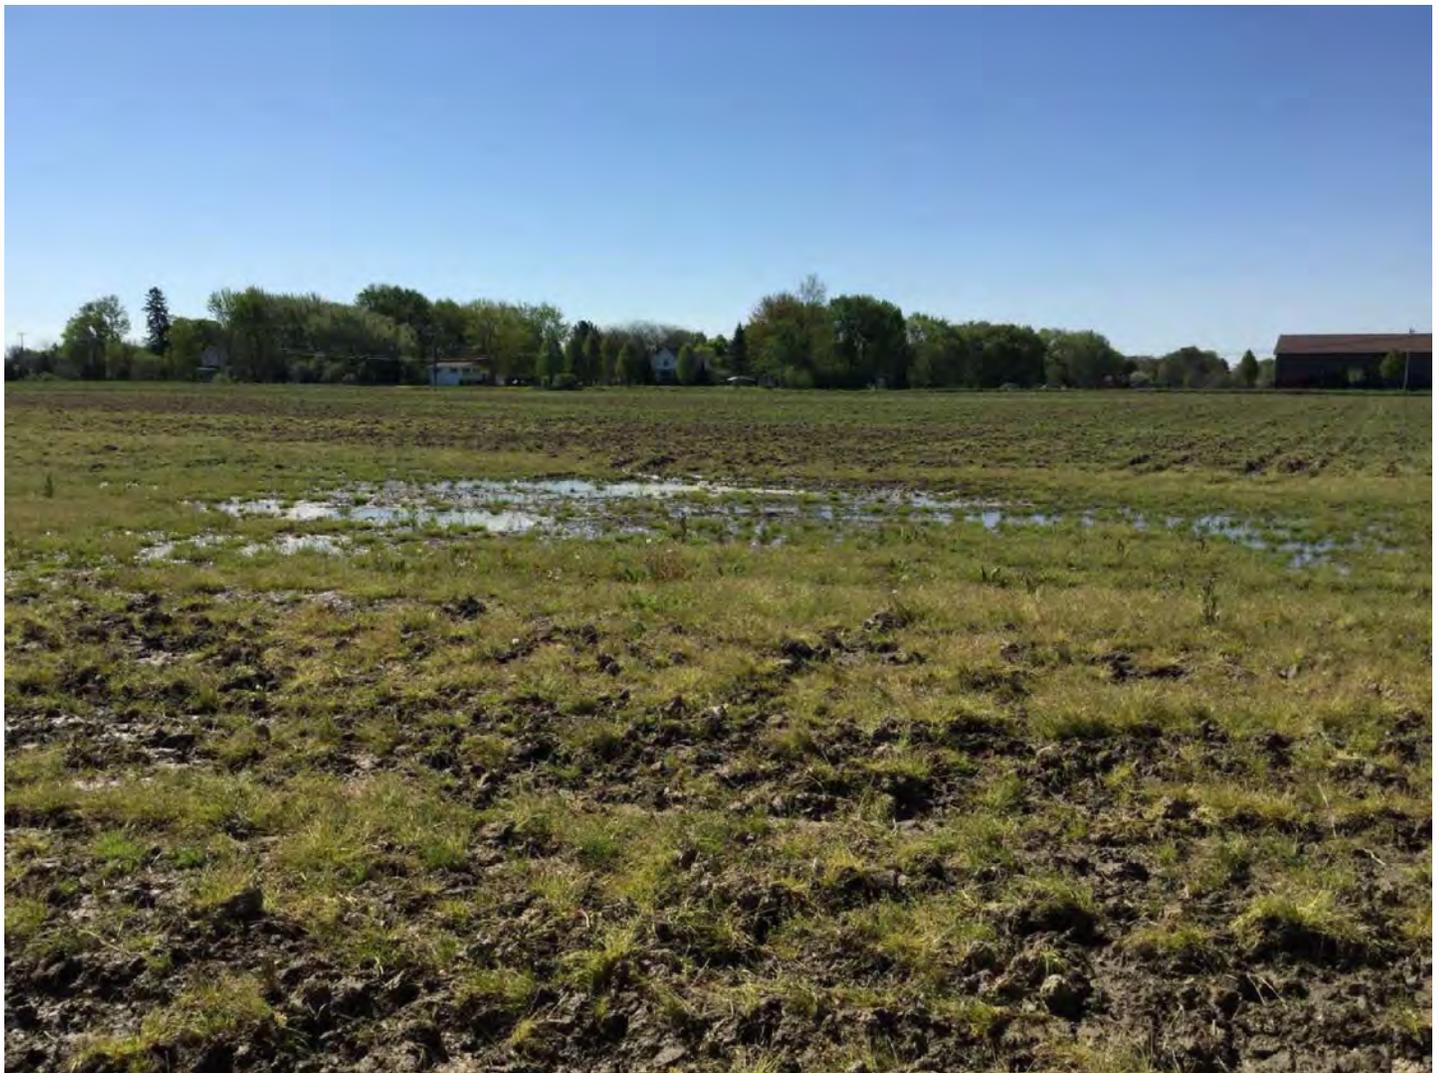
Photo 1

Existing flooding in farm field right side of the drain. Picture facing South.

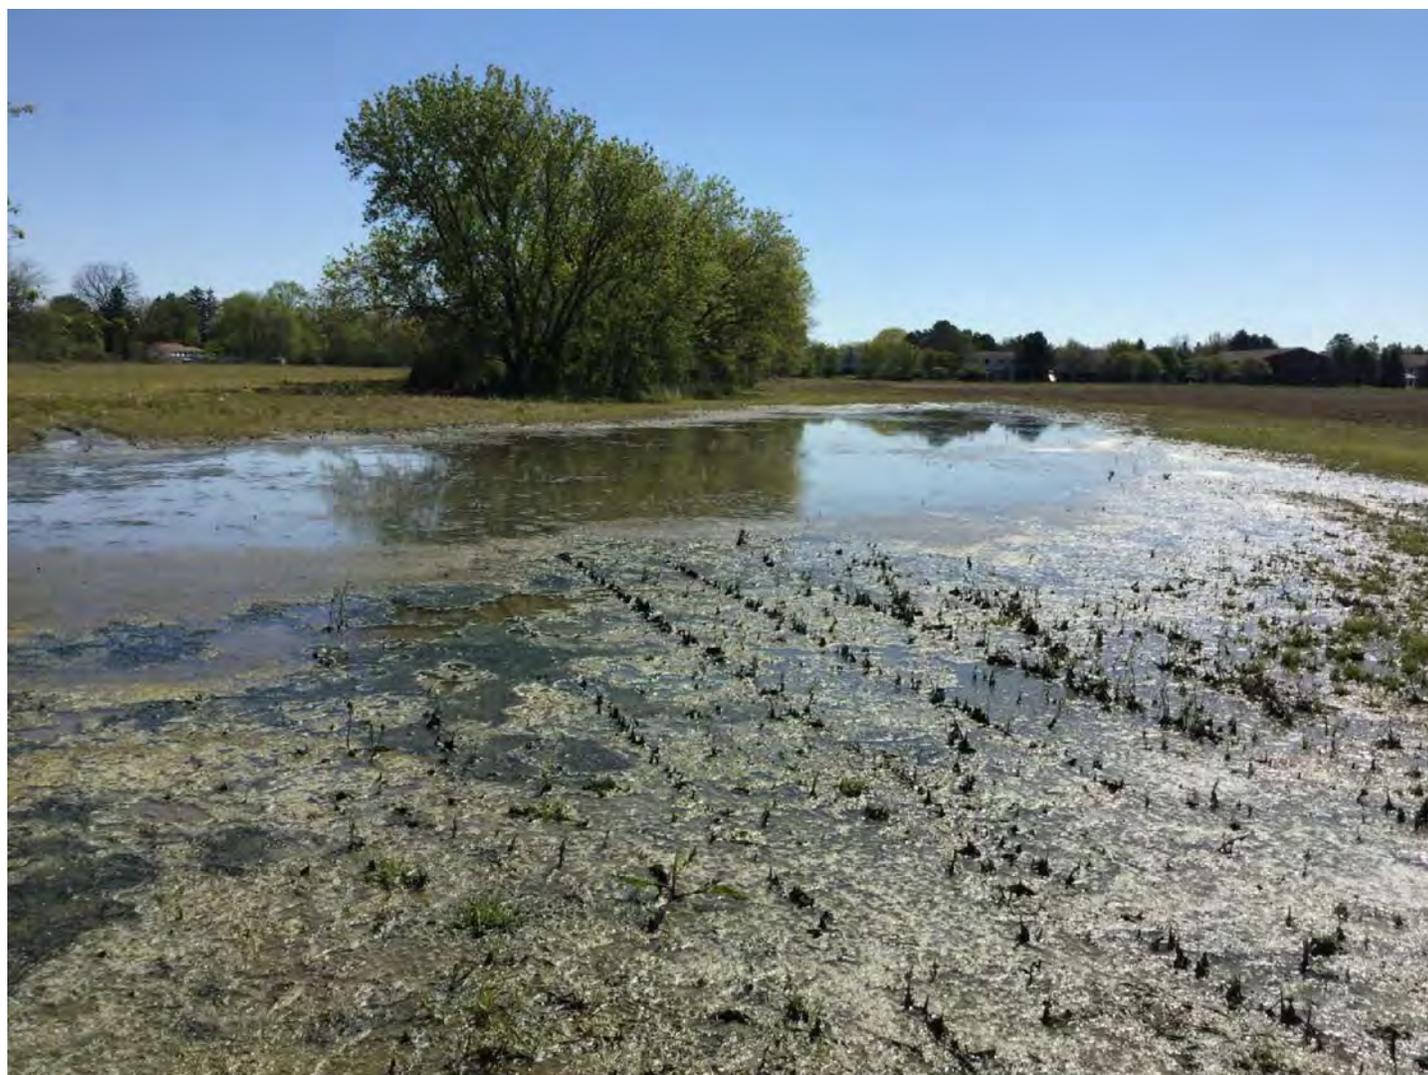
Photo 1

Considerable flooding in farm field right side of the drain. Picture facing East

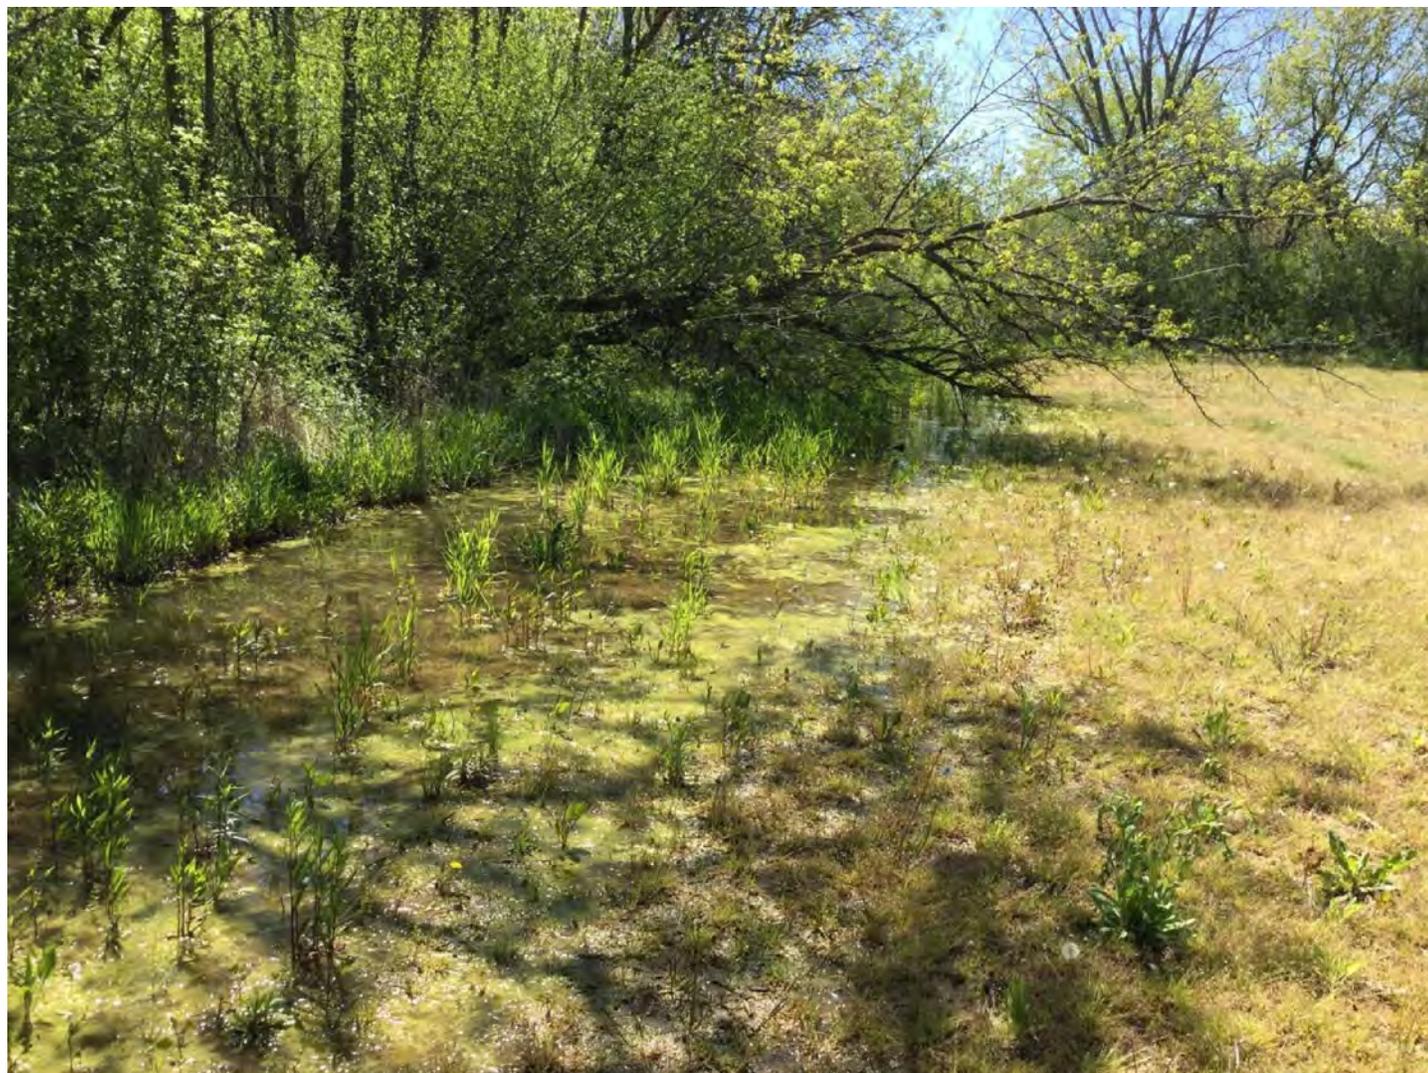
Photo 1

Flooding on edge of farm field right side of the drain . Picture facing Southeast

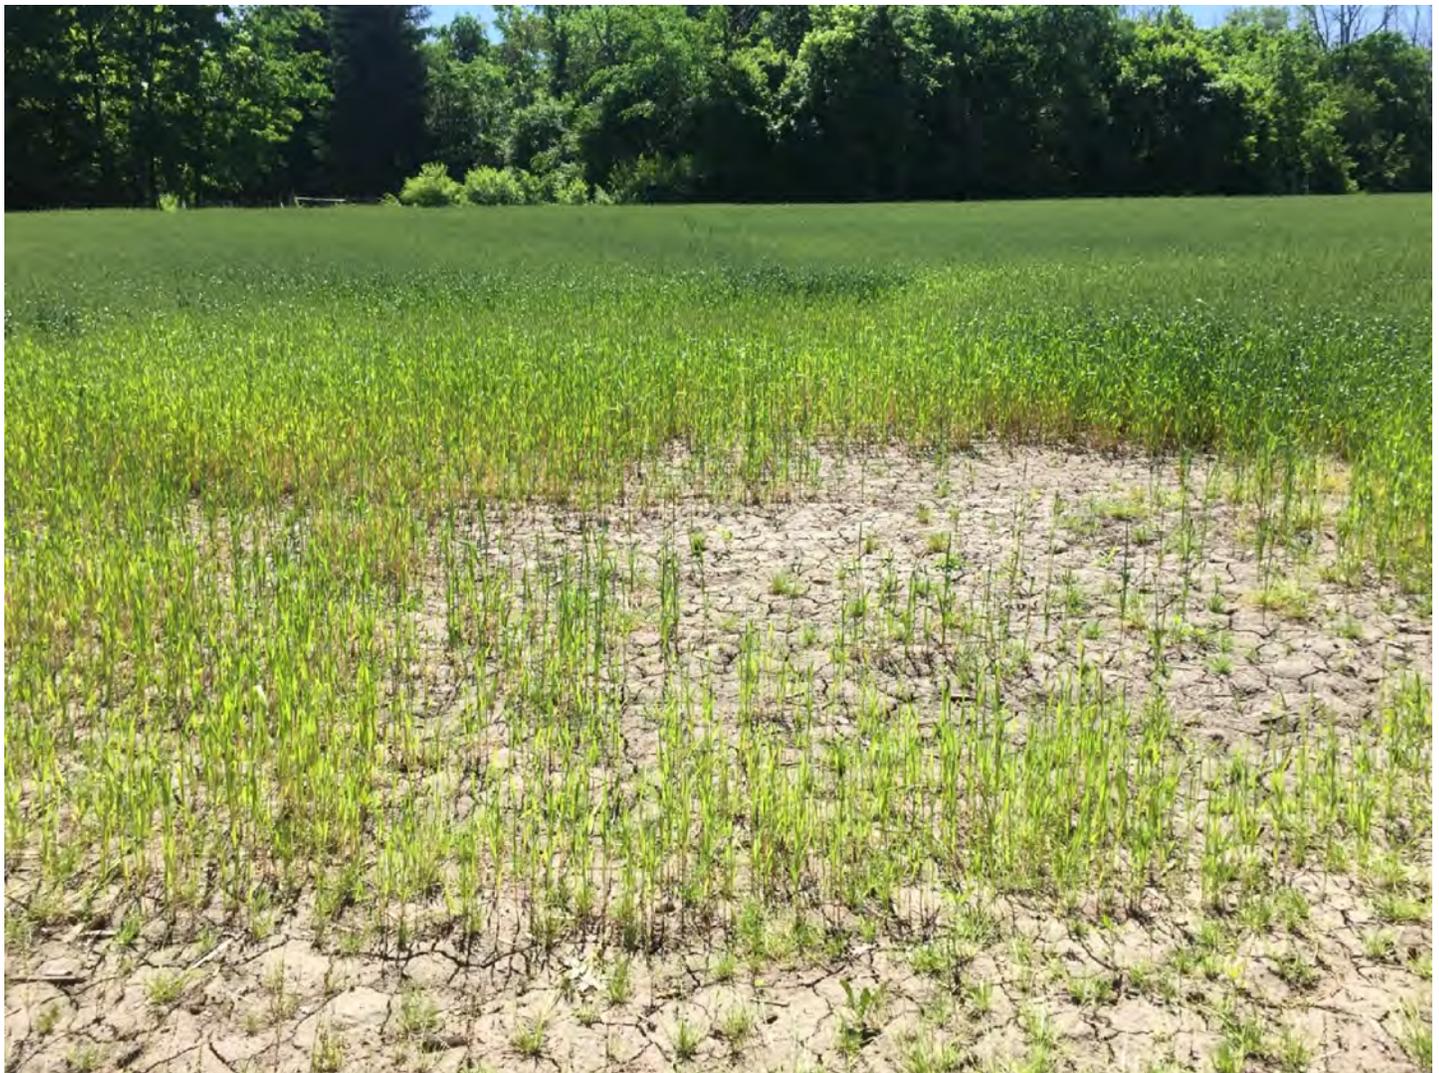
Photo 1

Agricultural flooding on the east side of the drain can be seen in dry conditions where farmland isn't growing. Picture facing east from outside of drain.

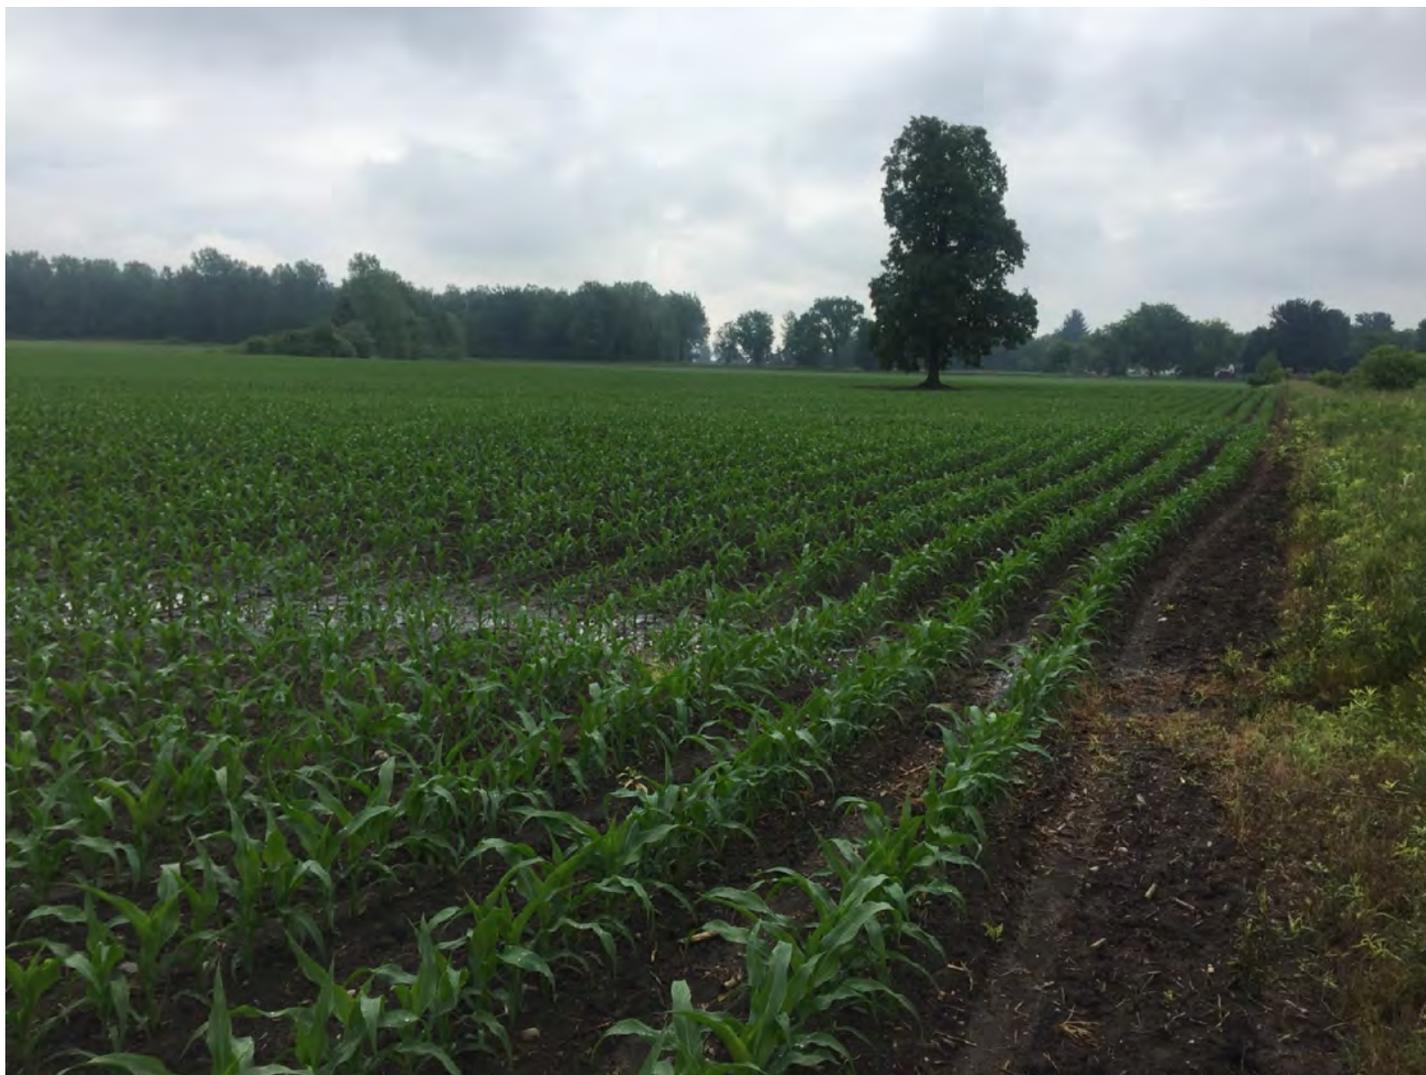
Photo 1

Some agricultural flooding on left side of drain facing upstream. Picture facing east.

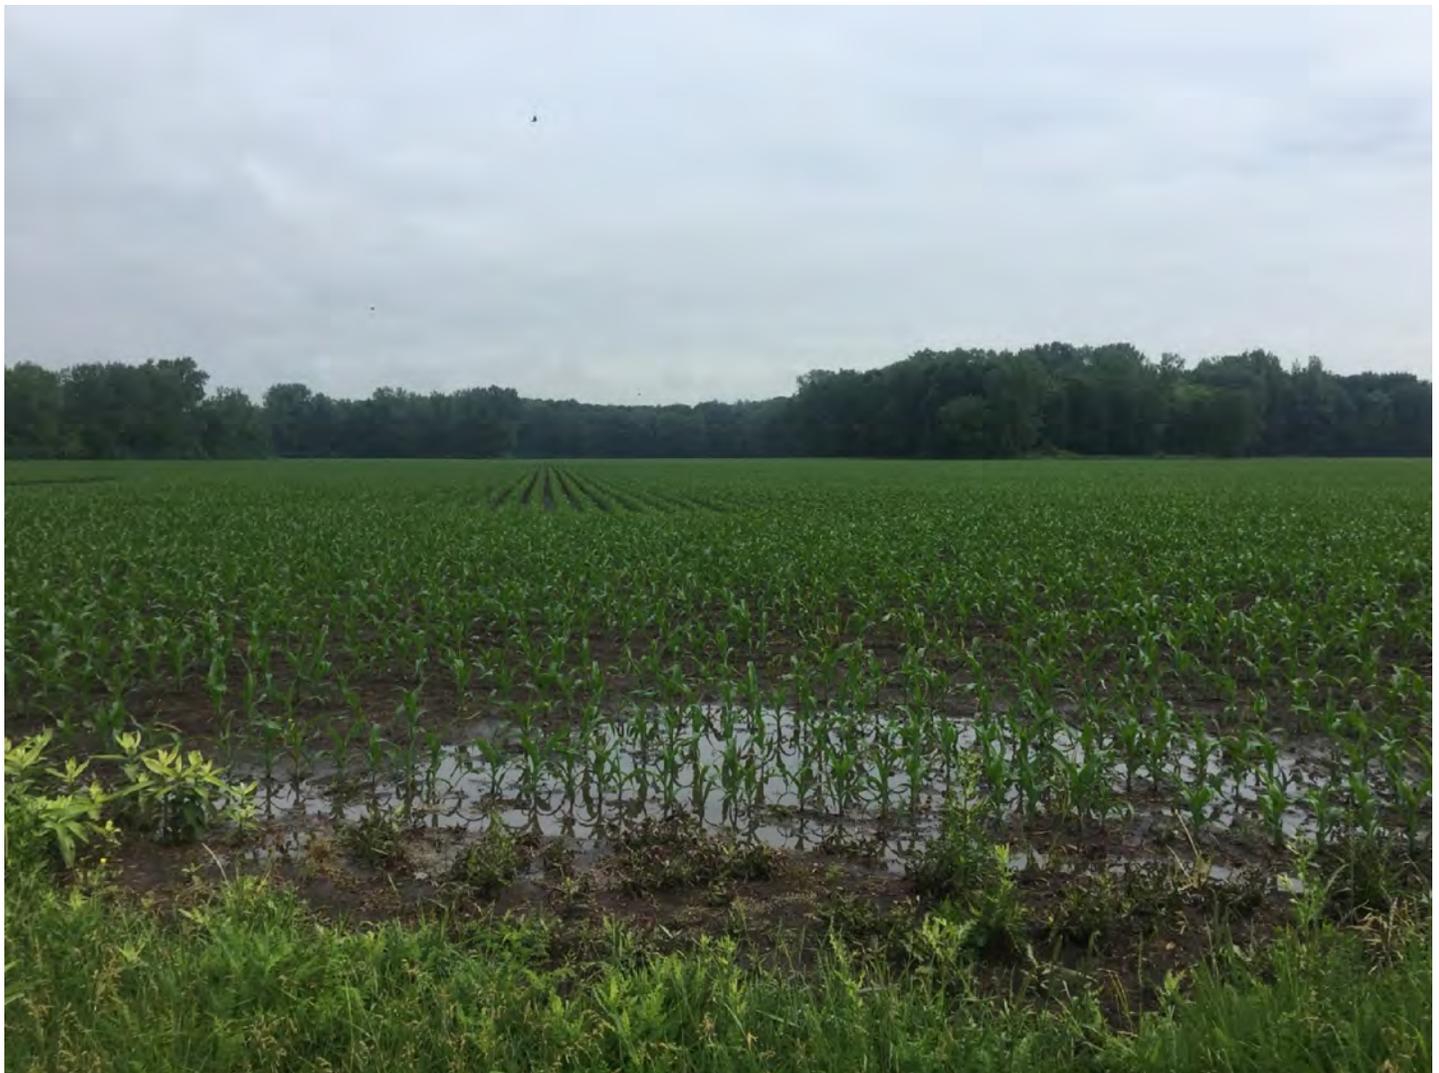
Photo 1

Agricultural flooding on left side of drain facing upstream. It spans about 100' out and 50' wide. Picture facing north from atop the drain crossing.

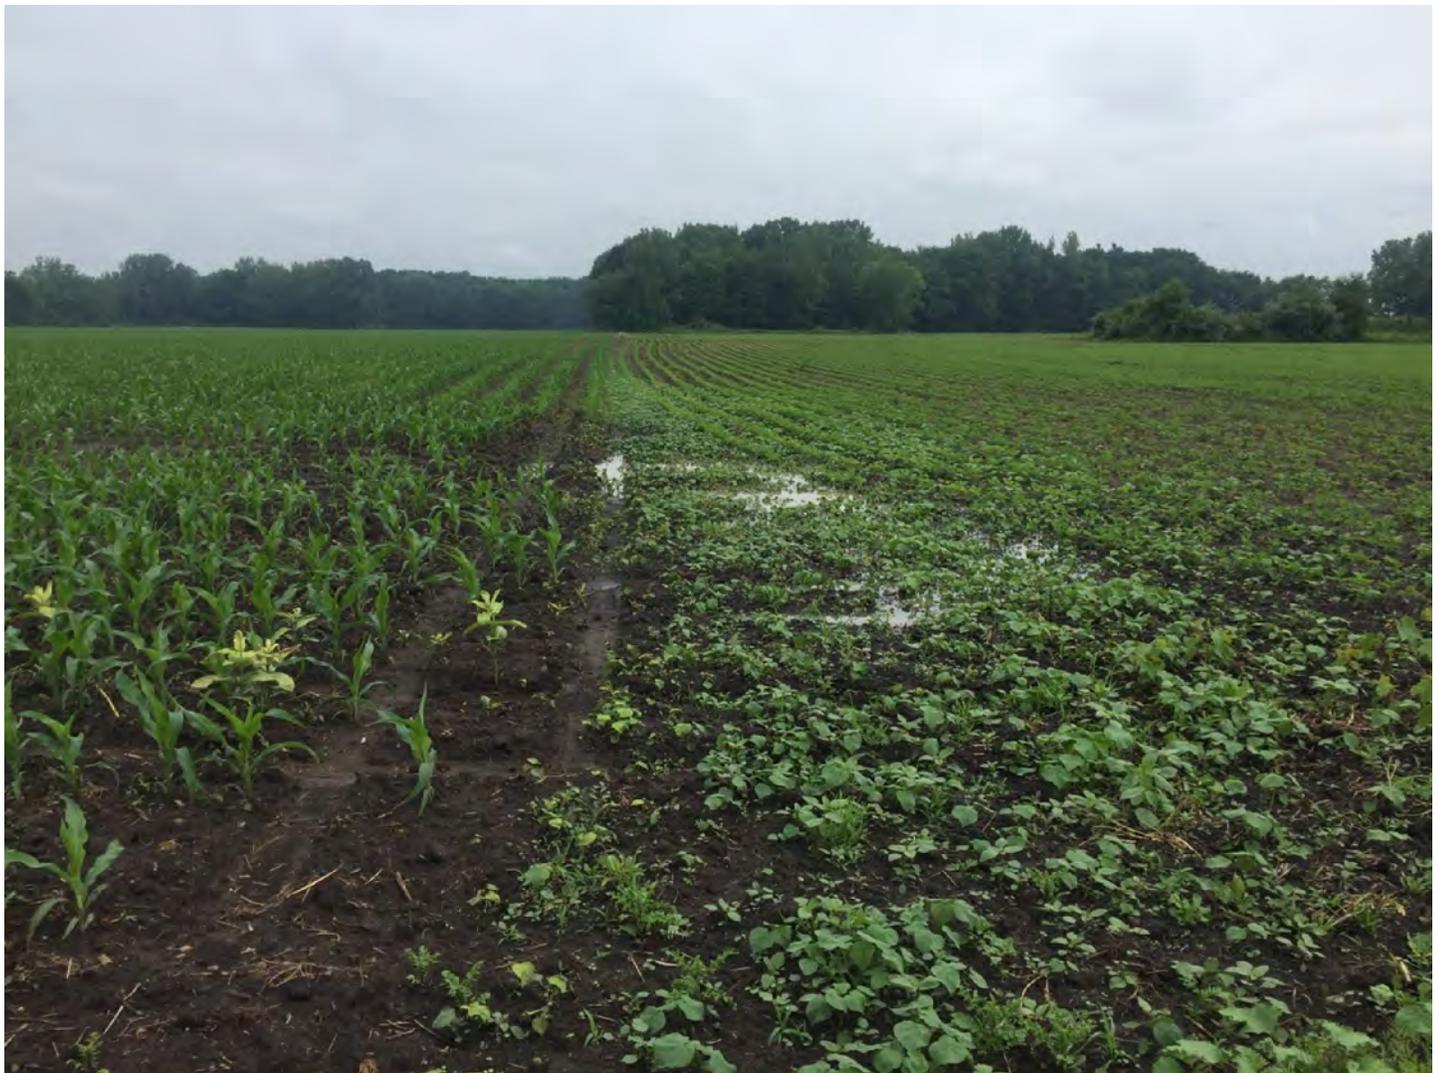
Photo 1

Agricultural flooding on left side of drain facing upstream. It extends from drain approximately 50' and is 15' wide. Picture facing north from drain.

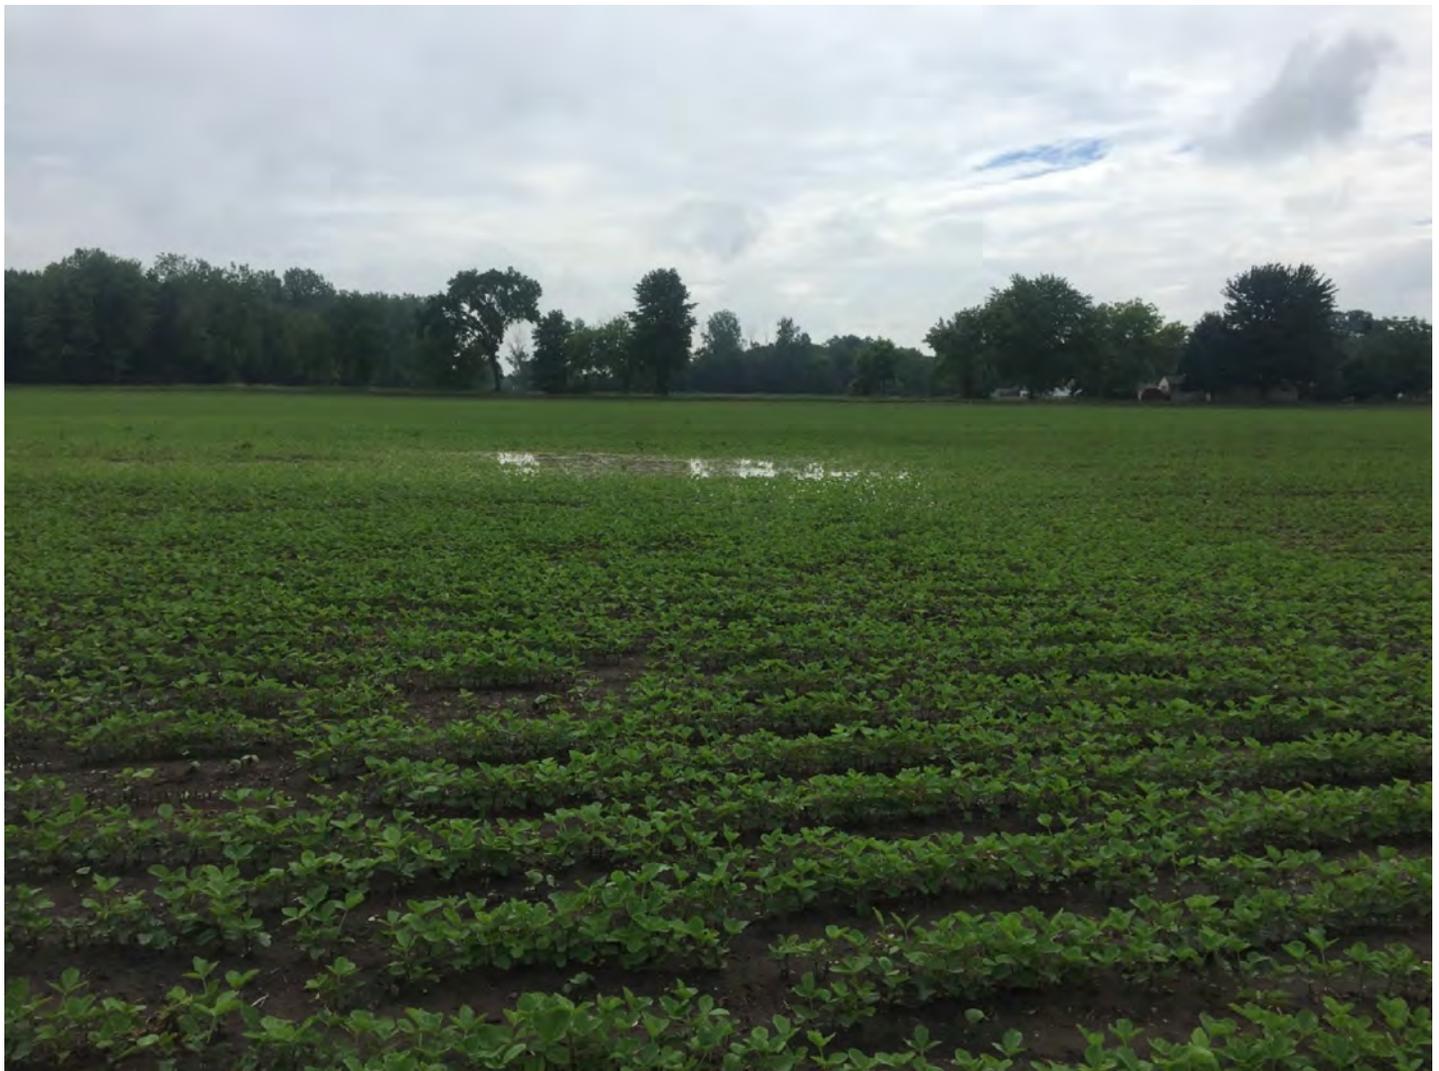
Photo 1

Agricultural flooding on left side of drain facing upstream. Water is about 100' east of the drain and area is 40'x40'. Picture facing east from bend in drain.

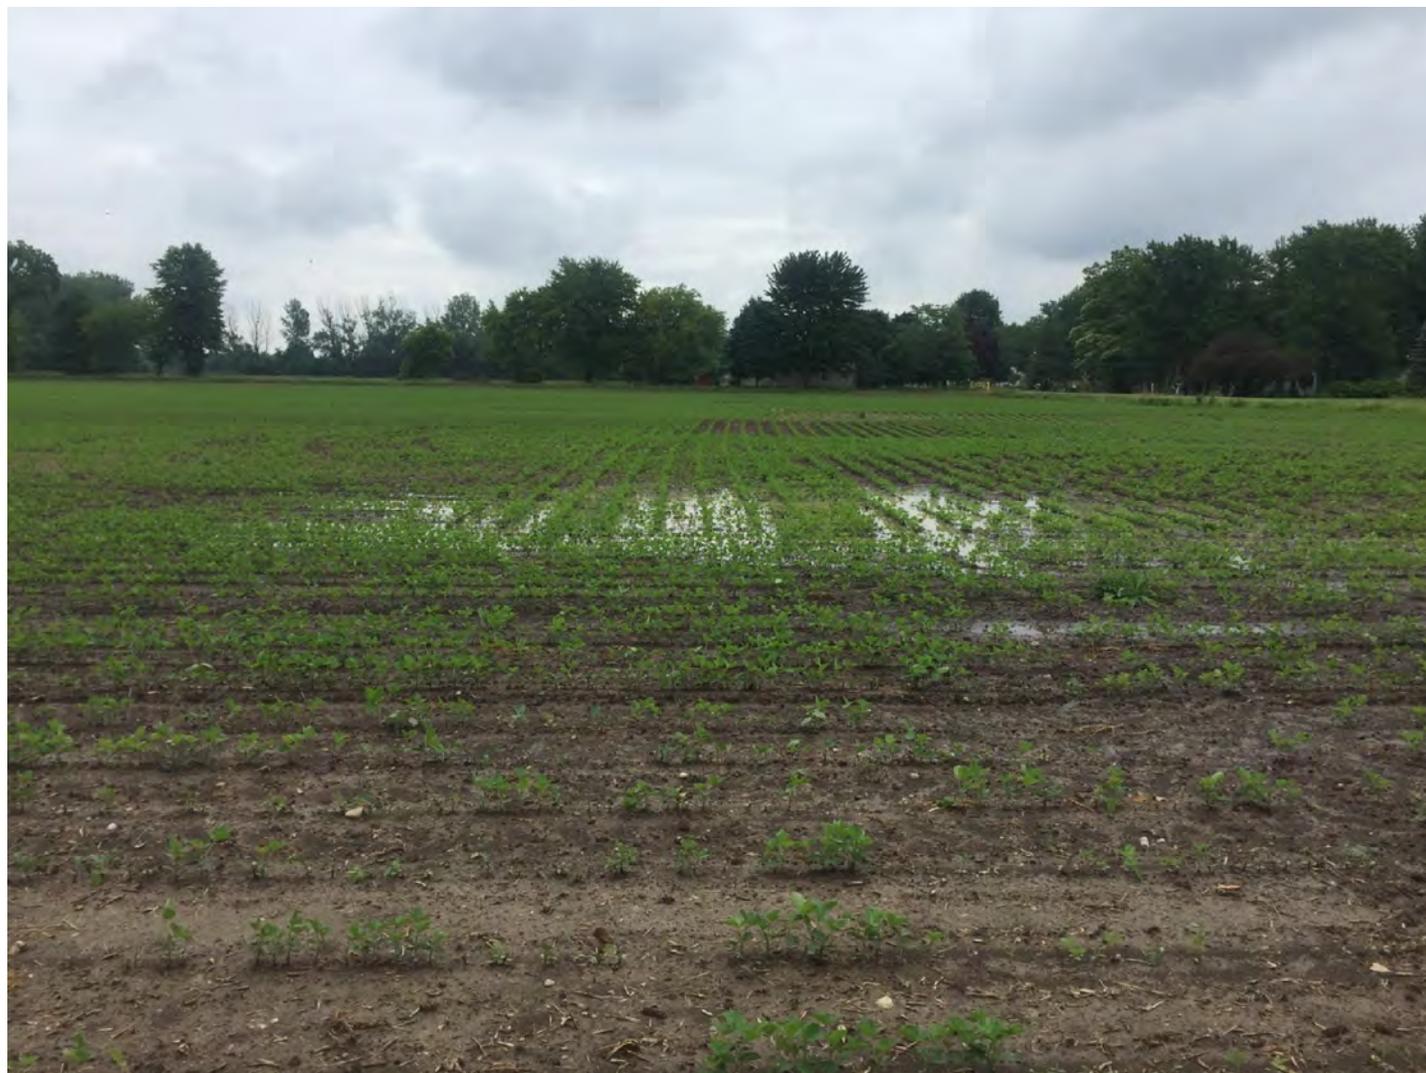
Photo 1

Agricultural flooding on left side of drain facing upstream. Water is approximately 50' east of drain and is 60'x25' in size. Picture facing east from drain.

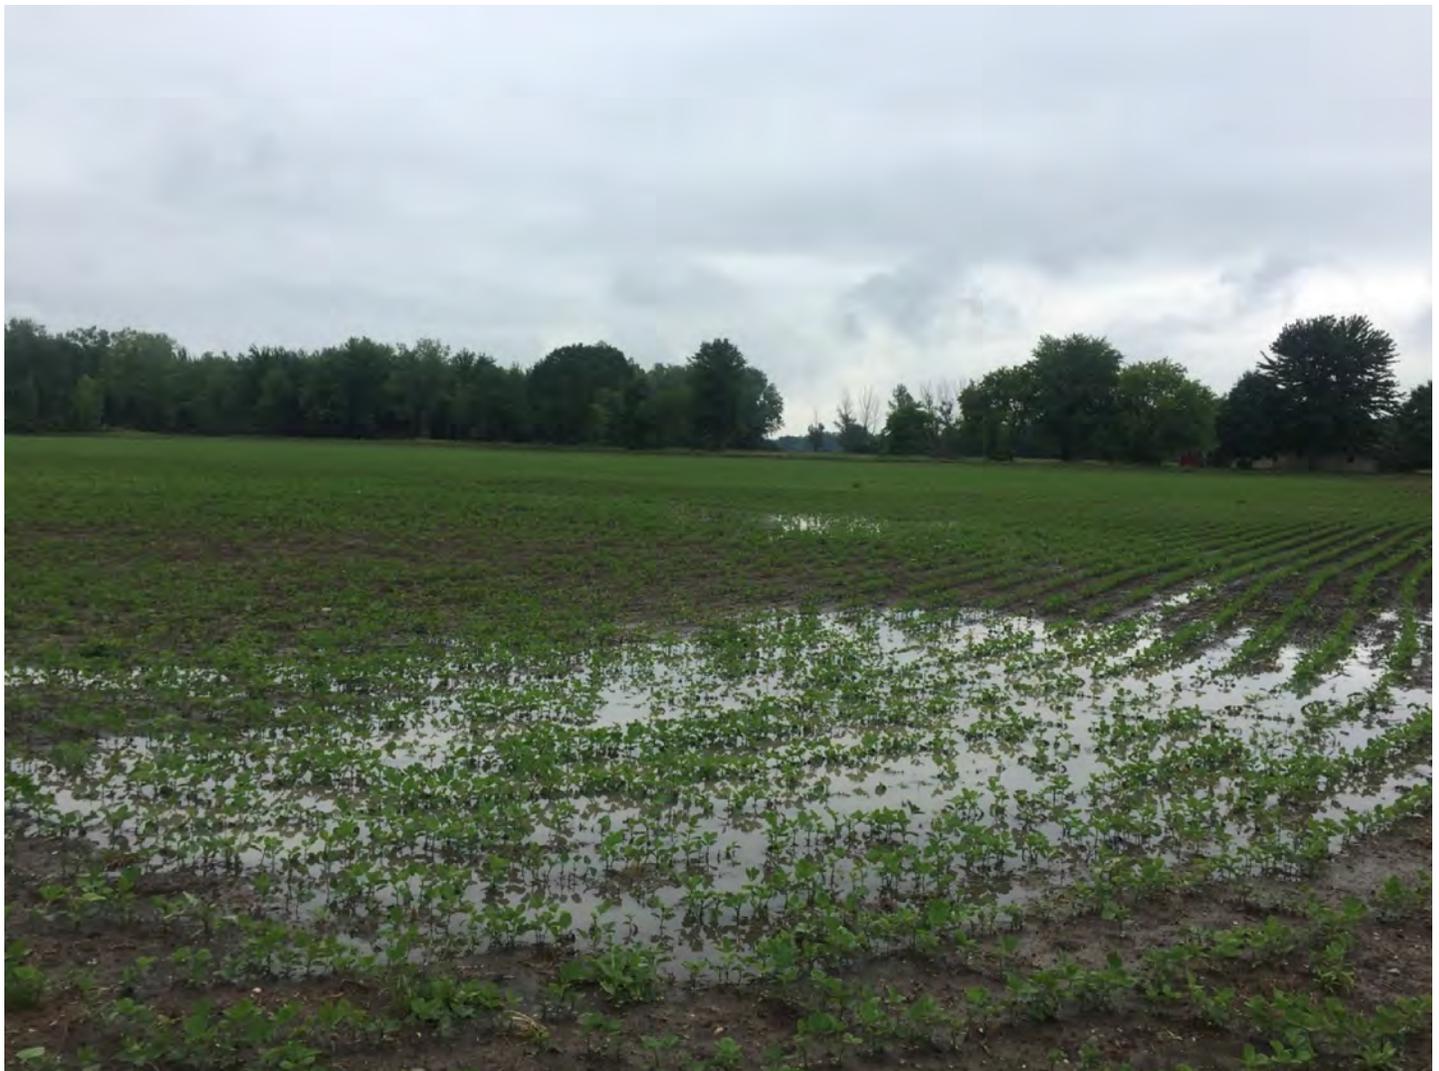
Photo 1

Two agricultural flooding ponds to the northeast of the drain. Near one is 35' away and far one is 50' past it. Near one is 20'x40' and far one is 20'x20'. Picture facing northeast away from drain.
