King Street Tile Drain Inspections

Inspection Report for Observation:
BankErosion1

| CLIENT | Saginaw County Public Works Commissioner | HUBBELL, ROTH & CLARK, INC CONSULTING ENGINEERS SINCE 1915 | 555 Hulet Drive P.O. Box 824 Bloomfield Hills, MI 48303-0824 (248) 454-6300 http://www.hrc-engr.com | DATE: | 08/16/2016 |

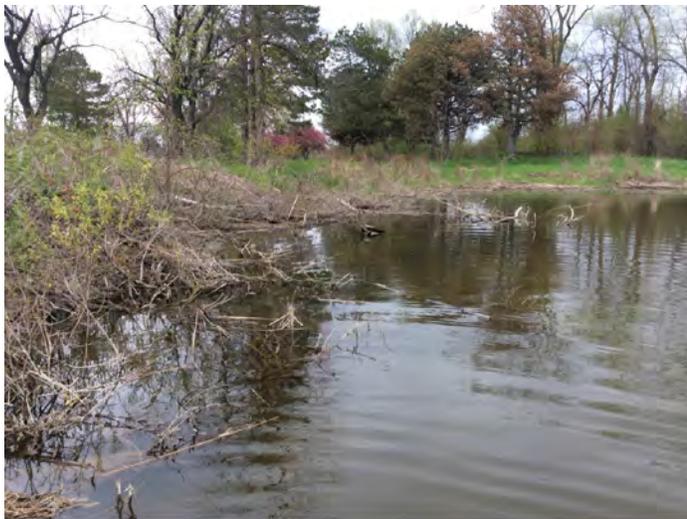
Photo 1

Left side. 60 ft. Picture facing upstream. Bank erosion.

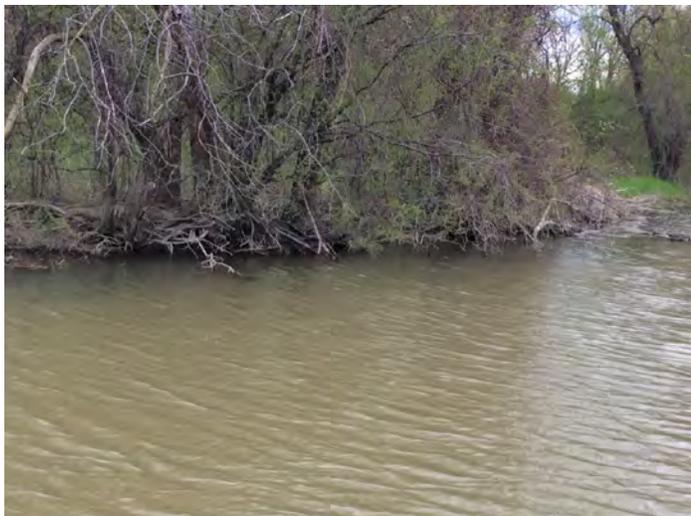
Photo 1

Erosion left side. Photo facing upstream.

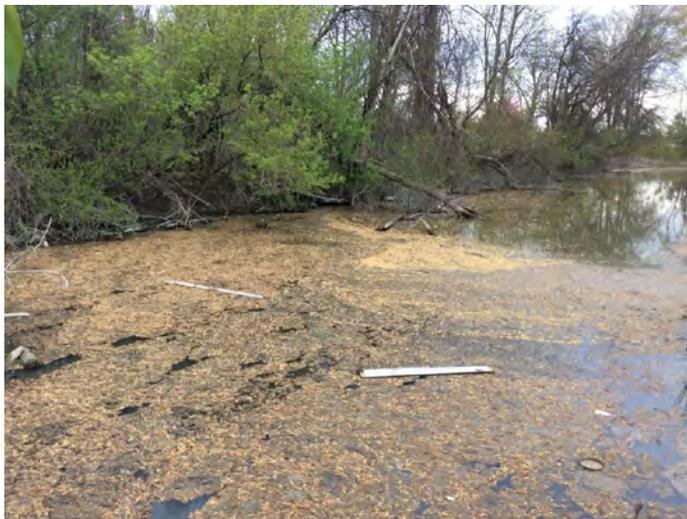
Photo 1

Photo facing upstream. Bank erosion on left side exposing roots and causing trees to lean over drain. Potential future concern.

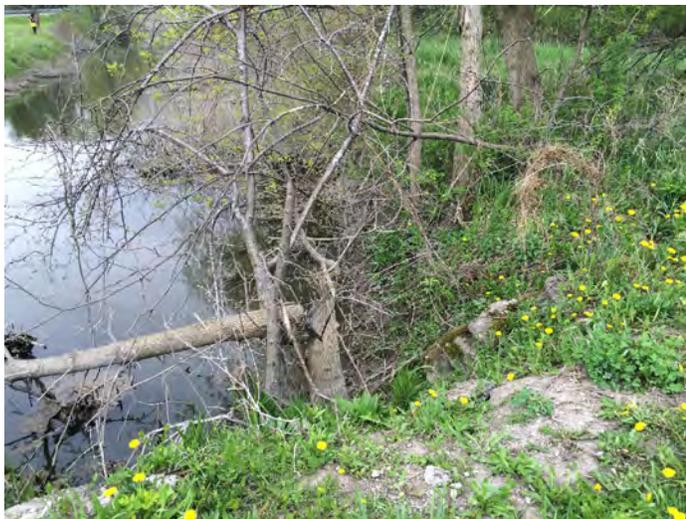
Photo 1

Right side, upstream of farm crossing for 20 ft. Photo facing upstream.

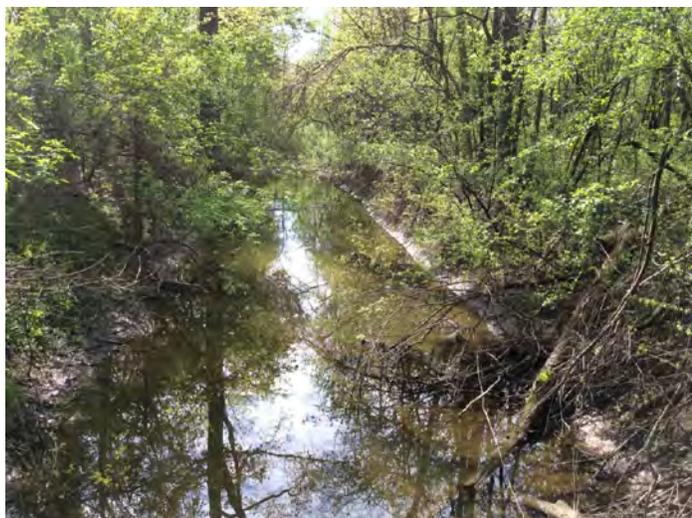
Photo 1

Bank erosion on both sides for next 200 ft. Photo facing upstream. Up to banner rd.

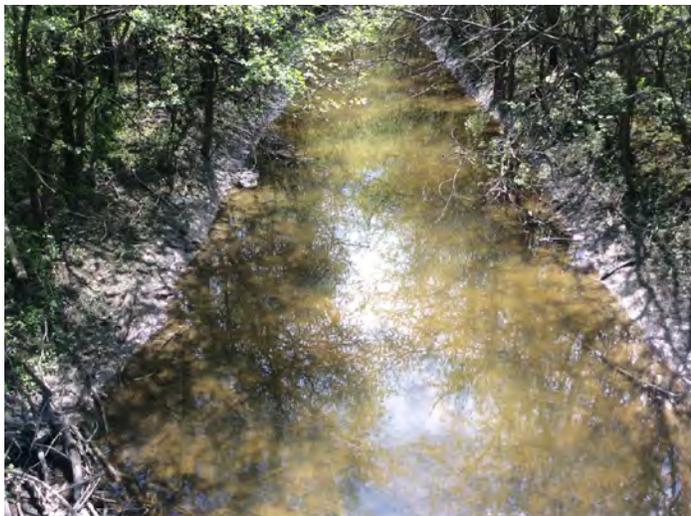
Photo 1

Bank erosion both sides for 500 ft. Photo facing upstream.

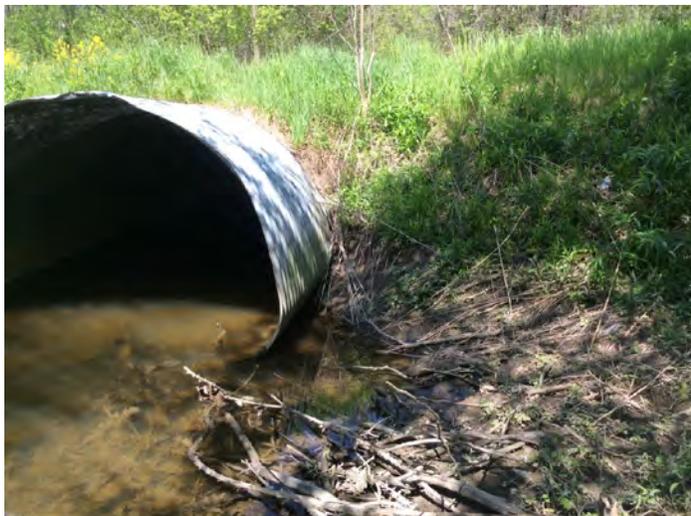
Photo 1

Bank erosion on both sides of headwall at banner rd crossing. Photo facing downstream.

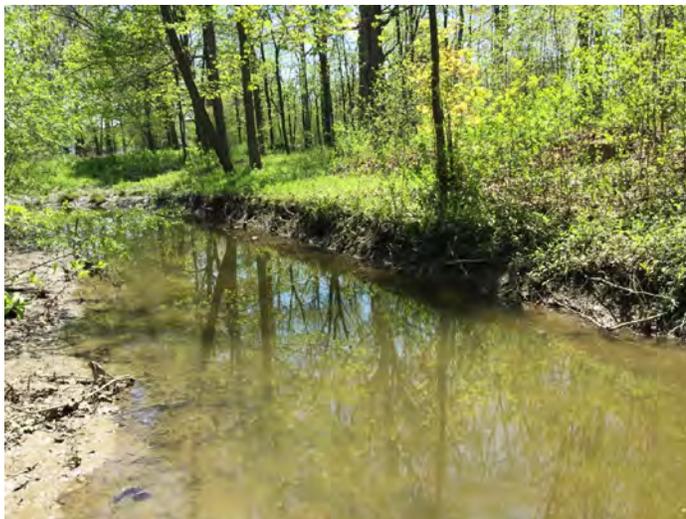
Photo 1

Bank erosion on right side around bend for 80 ft. Photo facing upstream.

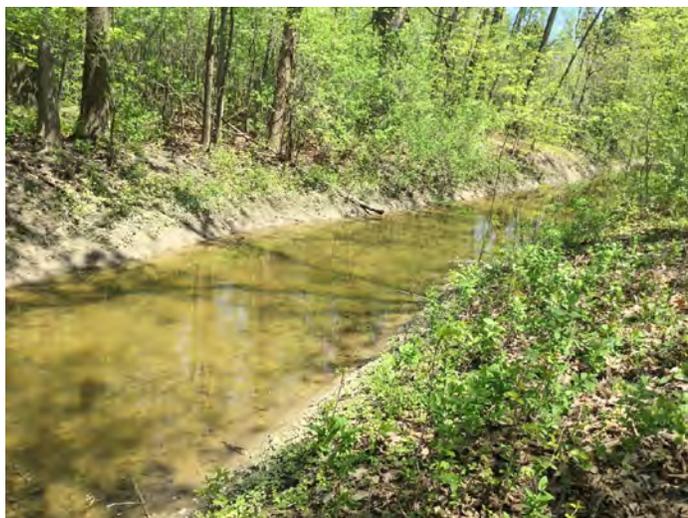
Photo 1

Bank erosion left side next 150 ft. Photo facing upstream.

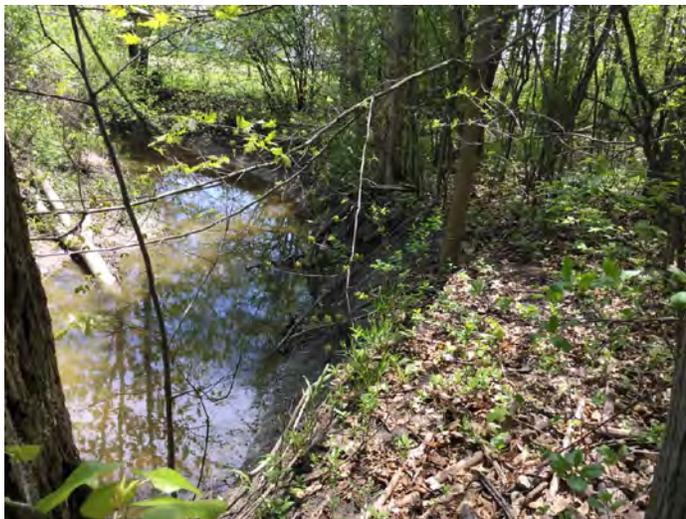
Photo 1

Bank erosion on right next 200 ft. Photo facing upstream. Around the bend. Exposed tree roots.

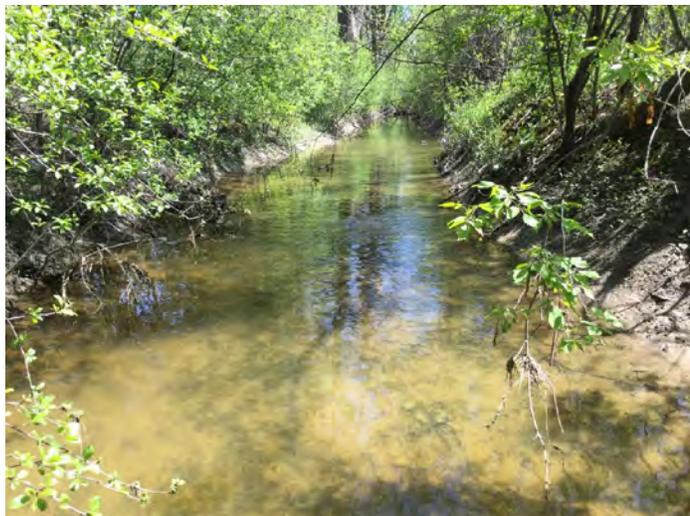
Photo 1

Bank erosion both sides next 400ft. Photo facing upstream.

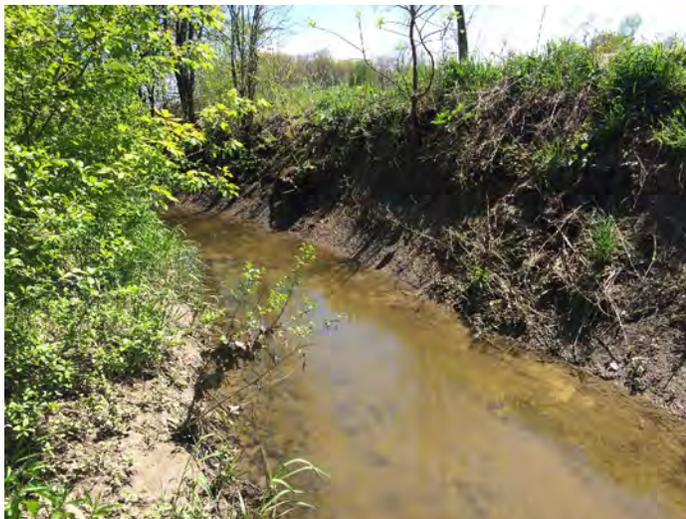
Photo 1

Bank erosion around bend next 100 ft. Right side is significantly higher than left side. Photo facing upstream.

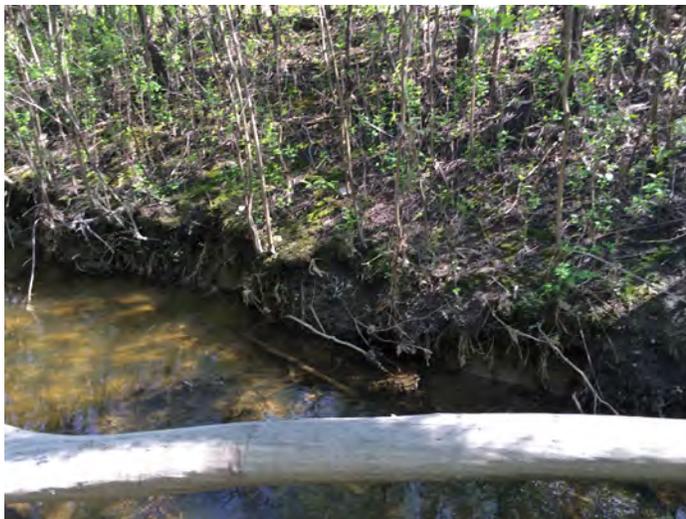
Photo 1

Significant bank erosion on right side leading to sediment buildup on right side. Photo facing south.

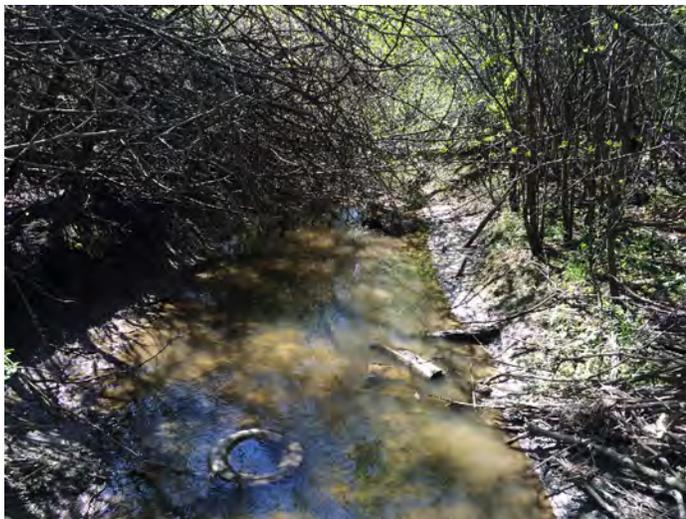
Photo 1

Bank erosion both sides next 50 ft up to crossing. Photo facing downstream. Need to move

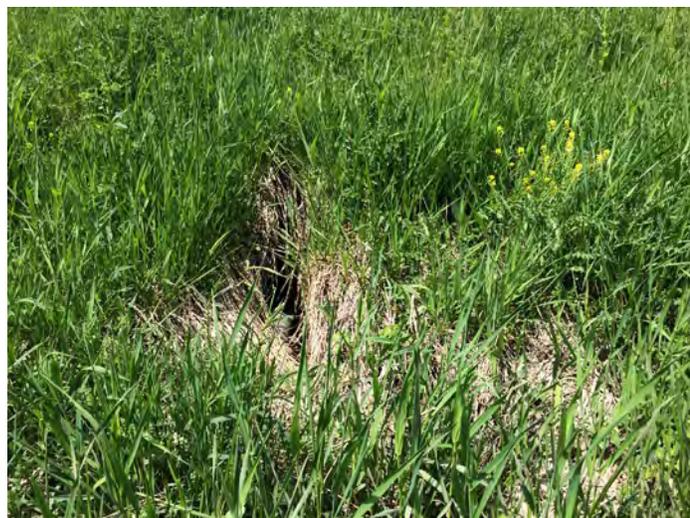
Photo 1

Bank erosion on left side at failed field tile outlet. Photo facing northwest.
