King Street Tile Drain Inspections

Inspection Report for Observation:
Barrier1

CLIENT	Saginaw County Public Works Commissioner

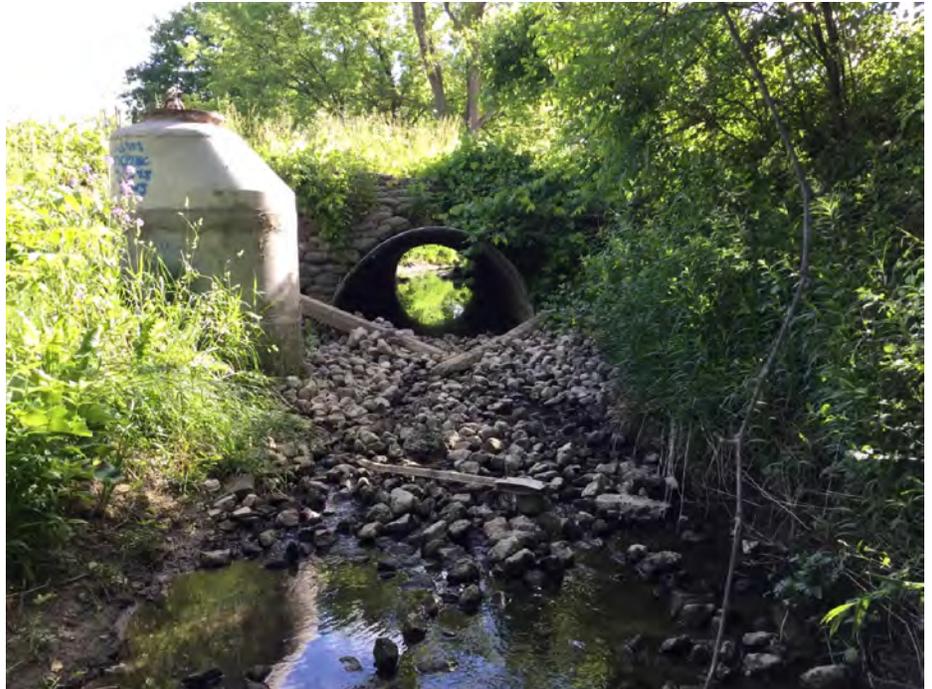
Material: Riprap

Length (feet): 25

Photo 1 Direction: Facing Upstream

On south side of Kansas st crossing. Could be intentional as a flow control device. 25 ft long. Water is dammed up behind it into culvert. Rip rap as well as two pieces of curb.

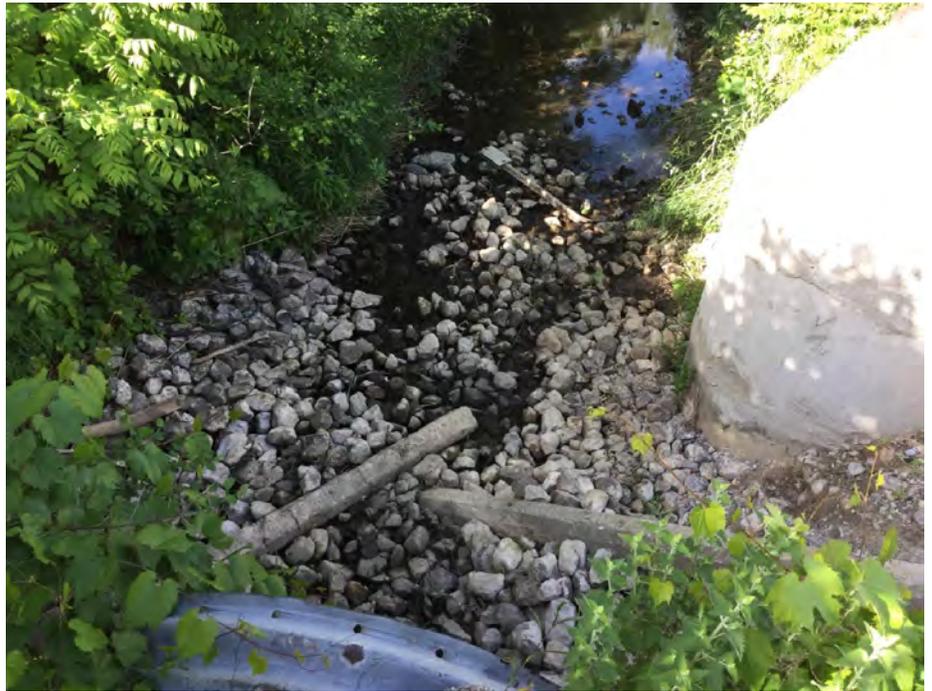
Photo 2 Direction: Facing Downstream
