# King Street Tile Drain Inspections

Inspection Report for Observation:  
**BridgeCrossing1**

CLIENT	Saginaw County Public Works Commissioner

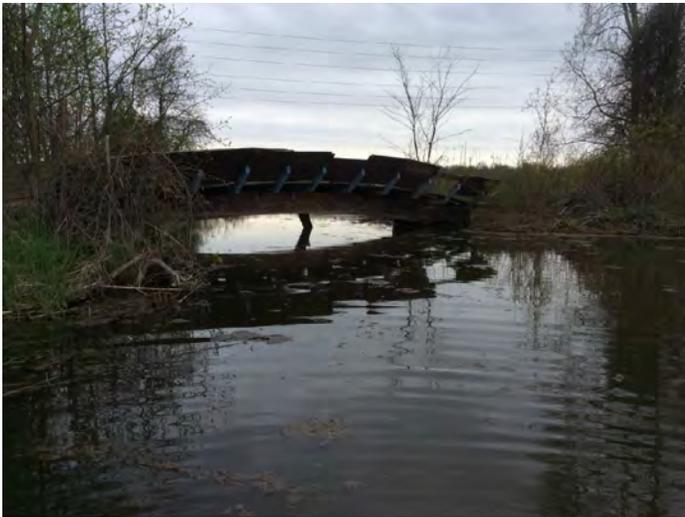
**Photo 1**

Photo 1 Right side wood bridge with steel support, photo 3 missing plank on bridge

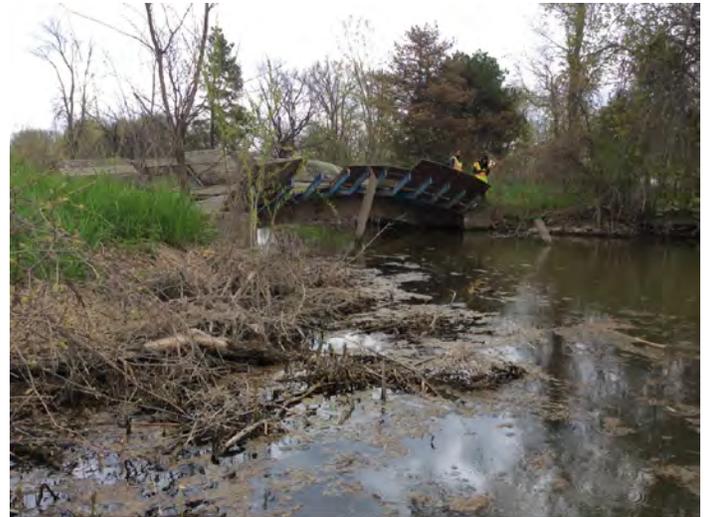
**Photo 2**

(Footbridge) Photo 2 ds 30 ft bridge right side

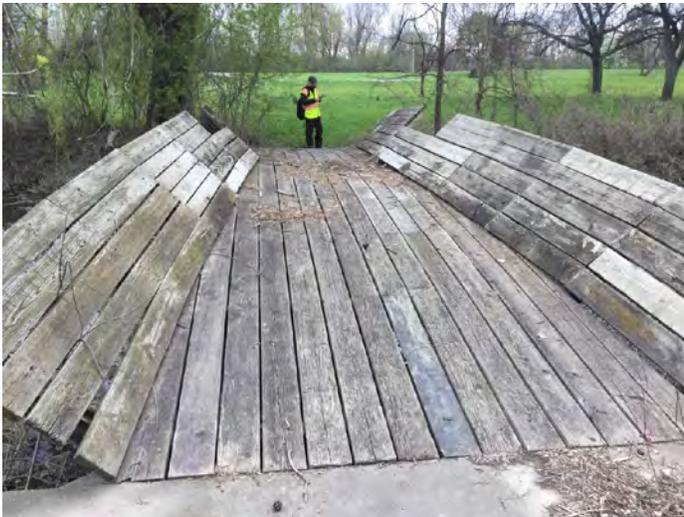
**Photo 1**

Wood bridge with holes. Photo 1 taken facing north. Photo 2 taken facing upstream.

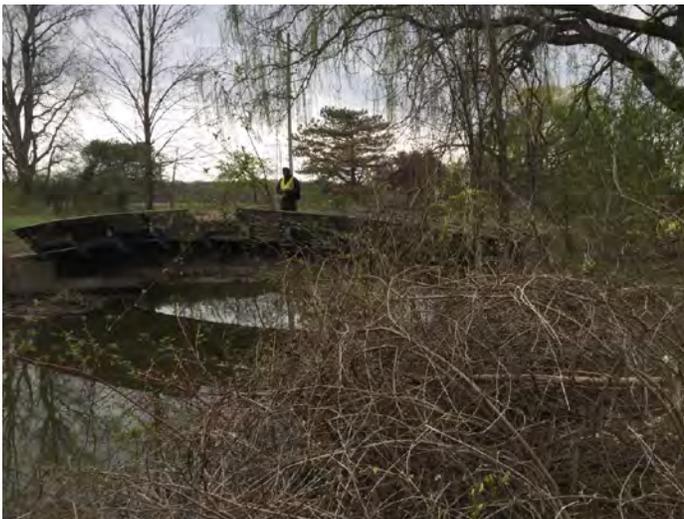
**Photo 3**

(Footbridge) Photo 3 taken facing downstream from other side of bridge.

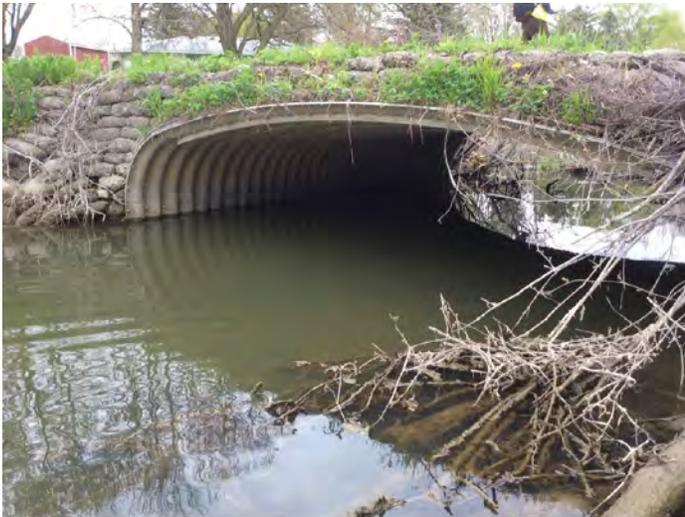
**Photo 1**

**Upstream Comments:**  
 Upstream right side photo 1, half CMPA

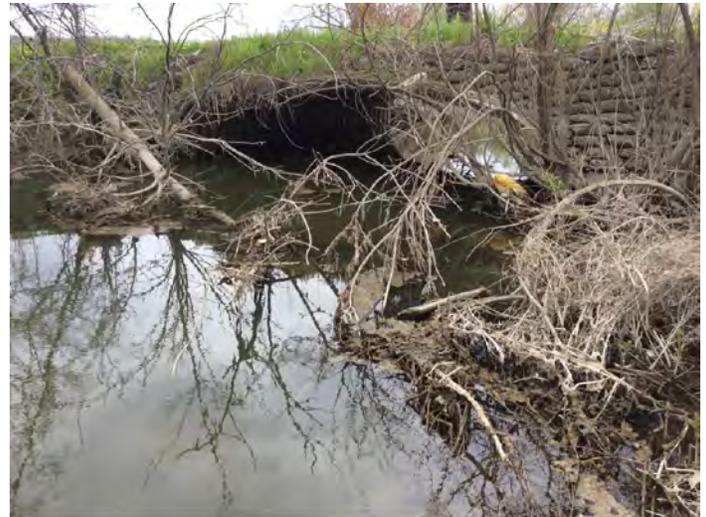
**Photo 2**

**Structure Type:** CMPA  
**Structure Condition:** Good  
**Entrance/Exit Type:** Other  
**Photo 1 Direction:**  
**Downstream Comments:**  
 Downstream left side photo 2

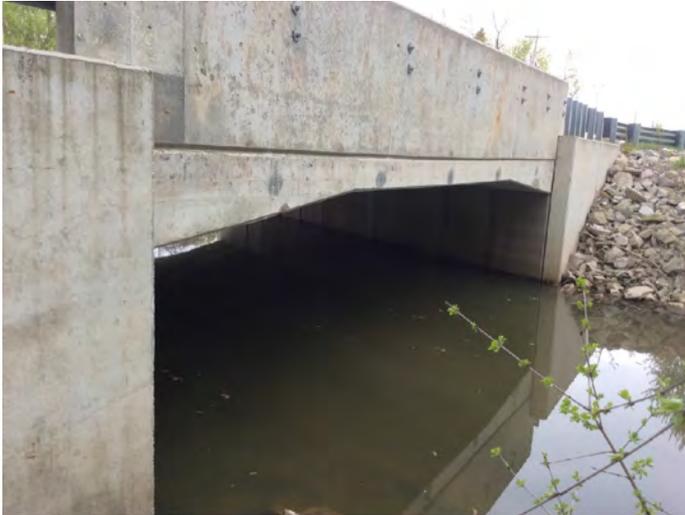
**Photo 1**

Photo taken on west side of m-13 facing east photo 1.

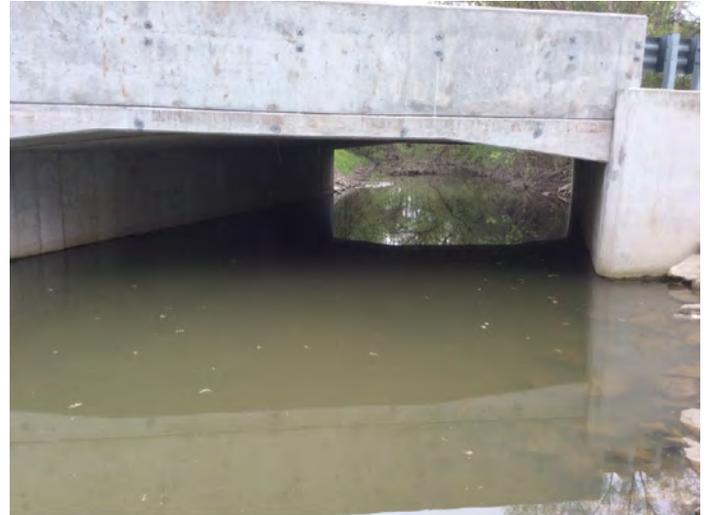
**Photo 2**

(M-13 Bridge) Photo taken on east side of m-13 facing west photo 2

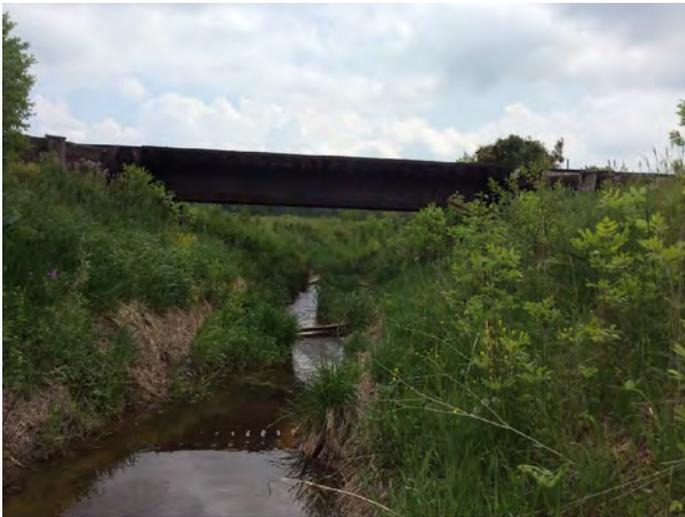
**Photo 1**

Railroad bridge. Vegetation, woody debris, bank erosion, and sediment. Photo1

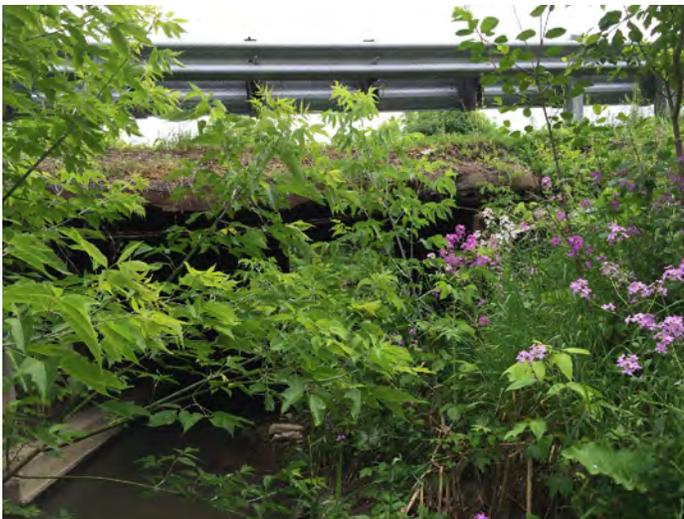
**Photo 1**

**Downstream Comments:**  
 (Williamson Road Bridge) Bridge crossing under williamson rd. Erosion at both banks and headwall. Bridge in poor condition. Rusted out. Sediment deposits downstream of sop. Sop enters from right side under the bridge.

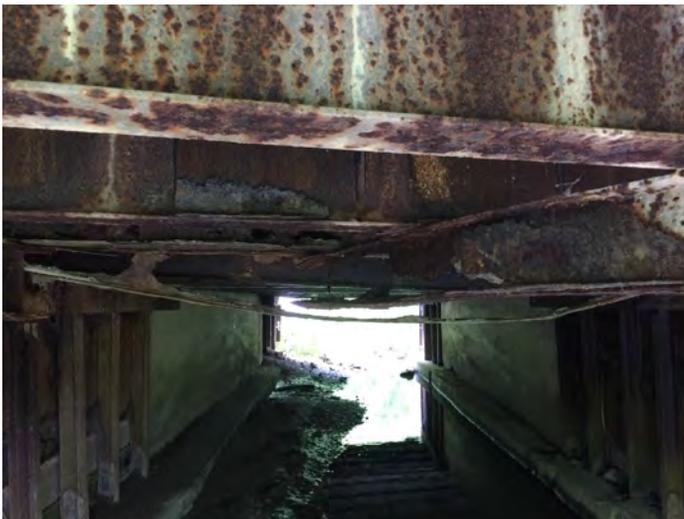
**Photo 3**

**Upstream Comments:**  
 Rusted underneath. See photo3. Erosion on both banks and headwall. Rocks and debris in bottom. Enters crossing at 45 deg angle. Excessive vegetation.

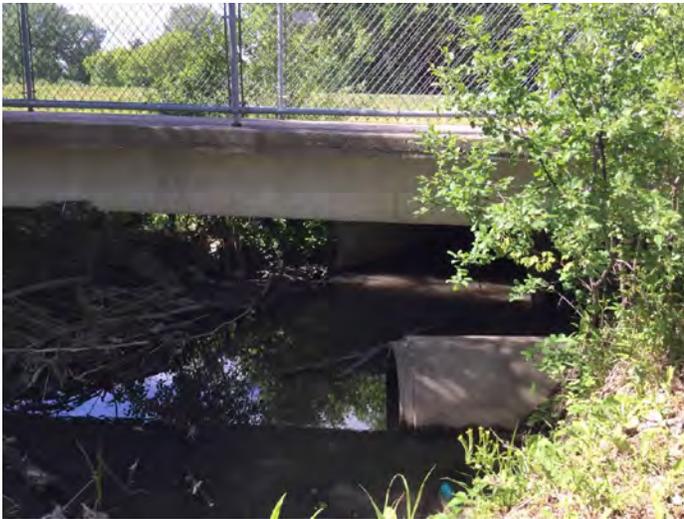
**Photo 1**

(Footbridge) Small amounts of crumbling at bottom of bridge. Spoke to homeowner. Flooding in grass, sometimes over tops the bridge. Photo1. Foot path on south side of King st. Fence on both sides.

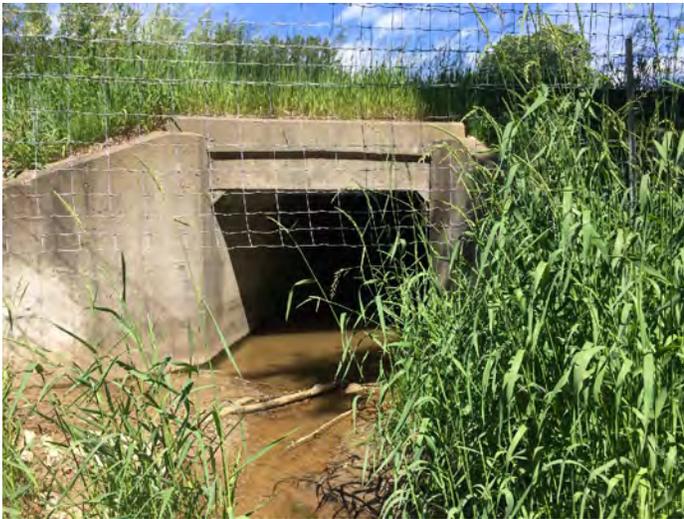
**Photo 1**

**Downstream Comments:**  
 (I-75 Bridge) Headwalls in fair condition. Fence just downstream. Sops enter on each side from I75. Heavy vegetation, sediment, and woody debris just downstream of crossing.

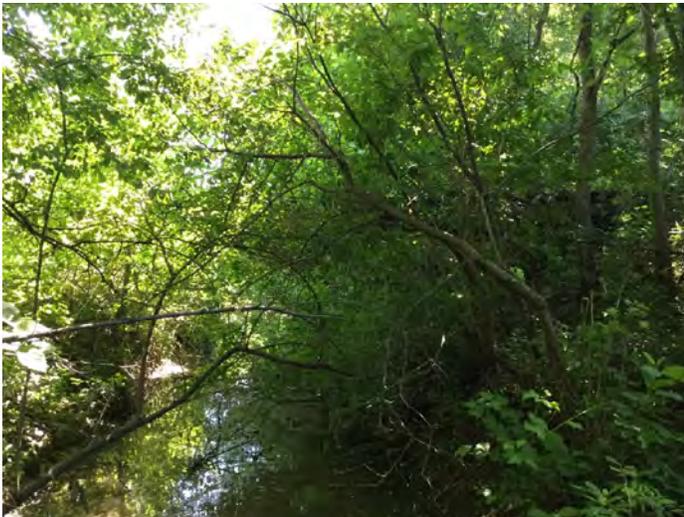
**Photo 1**

(Footbridge north of drain) Woody debris and excessive vegetation overhanging drain. Wood bridge in fair shape. Entrance/exit type wood and concrete blocks. About 32 ft long across drain.

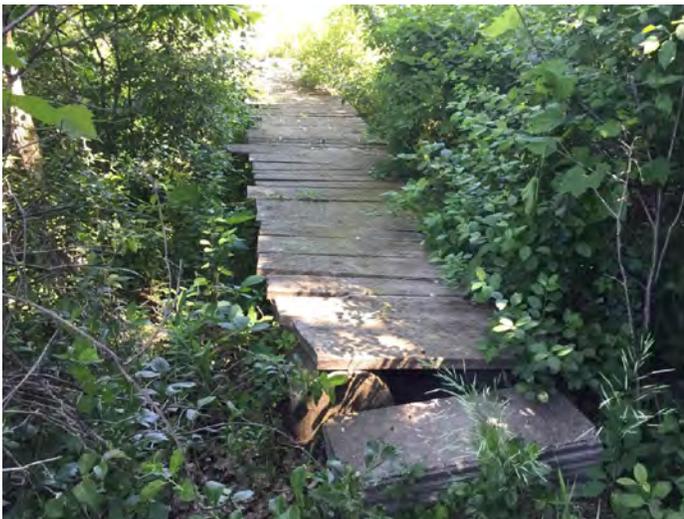
**Photo 3**

Excessive woods debris on upstream end. Erosion on both sides of bank. Photo 3 taken facing north showing entire wood bridge.
