# King Street Tile Drain Inspections

Inspection Report for Observation:  
**ConstructedBank1**

CLIENT	Saginaw County Public Works Commissioner

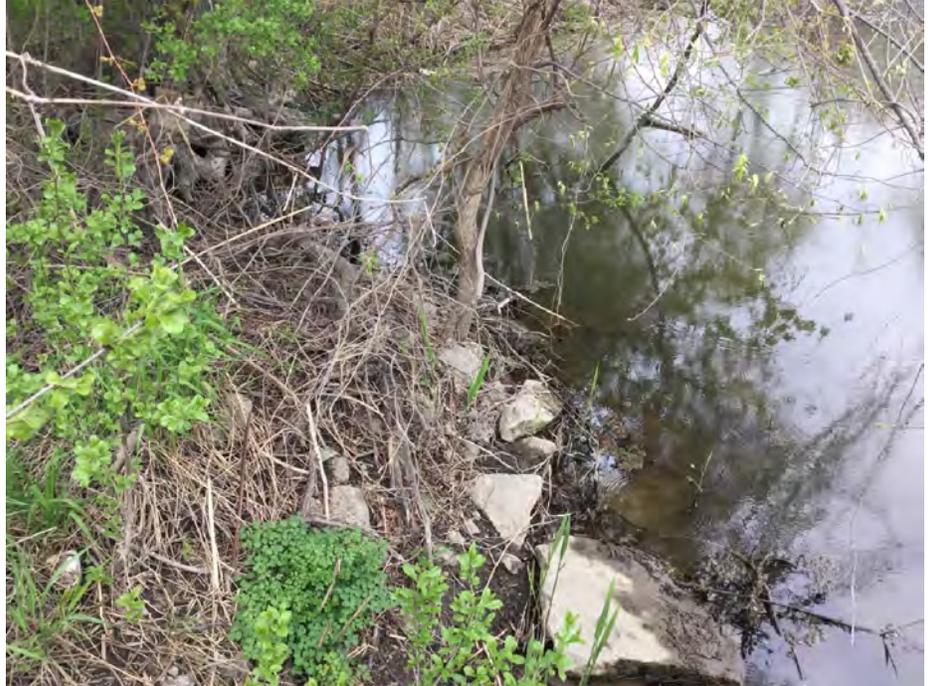
**Photo 1**

**Material:** Broken concrete. Also rocks.

**Length (feet):** 20

**Location:** Left Side Facing Upstream

Left side. 20 ft. Photo upstream.

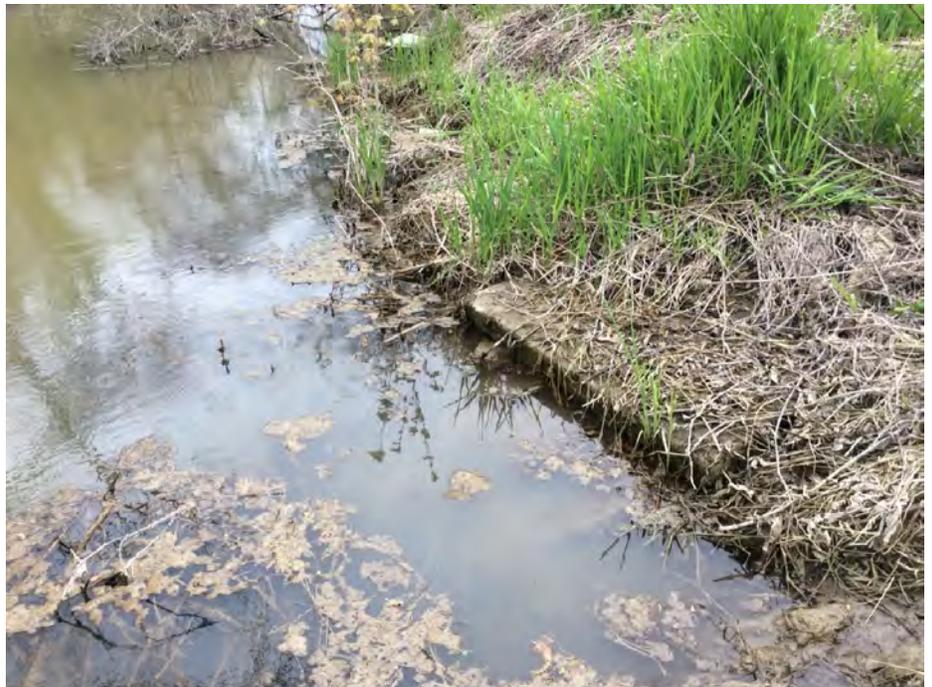
**Photo 1**

**Material:** Concrete

**Length (feet):** 40

**Location:** Right Side Facing Upstream

Cnnstructed bank with pieces of broken concrete bank on right side for 40 ft. Photo facing upstream.

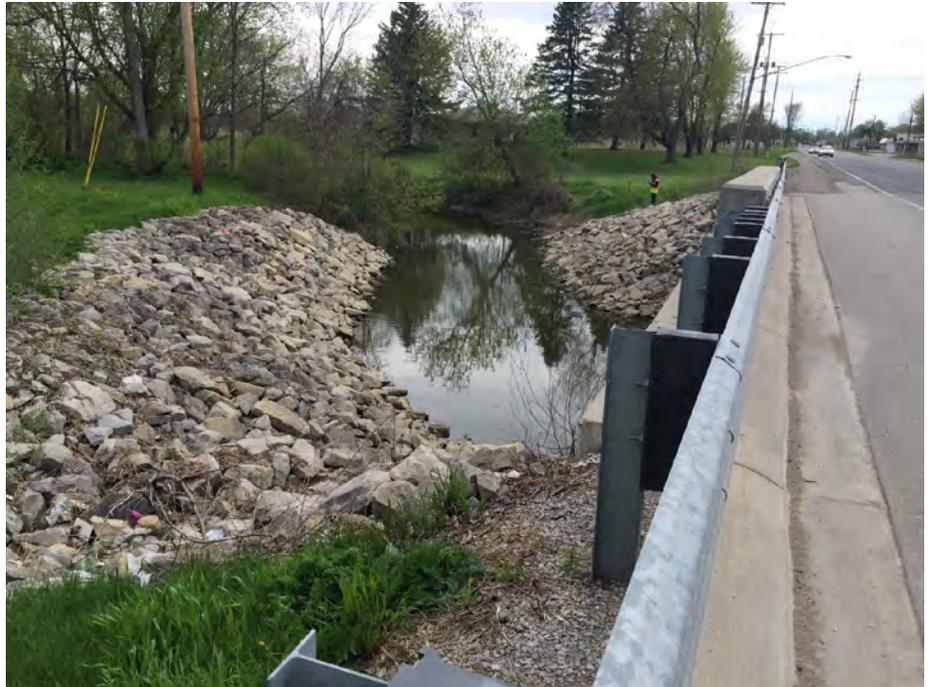
**Photo 1**

**Material:** Rocks, rip rap

Constructed bank on both sides of drain, downstream of M13 crossing for 40 ft. Photo facing downstream.

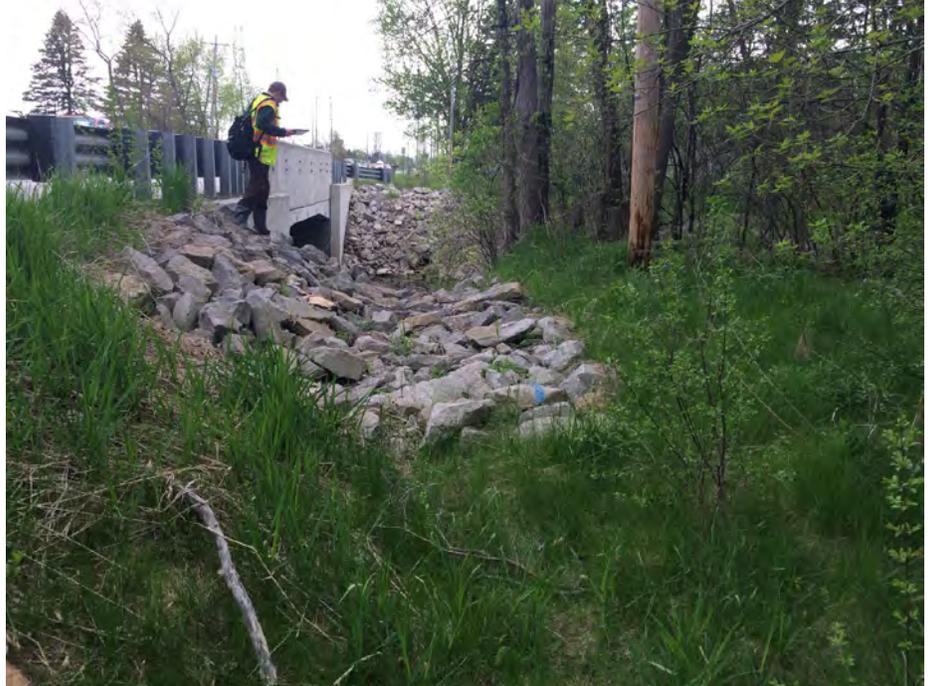
**Photo 1**

**Material:** Rocks, rip rap

**Length (feet):** 10

Constructed banks on both sides for 10 ft, just upstream of M13 crossing. Photo facing north.

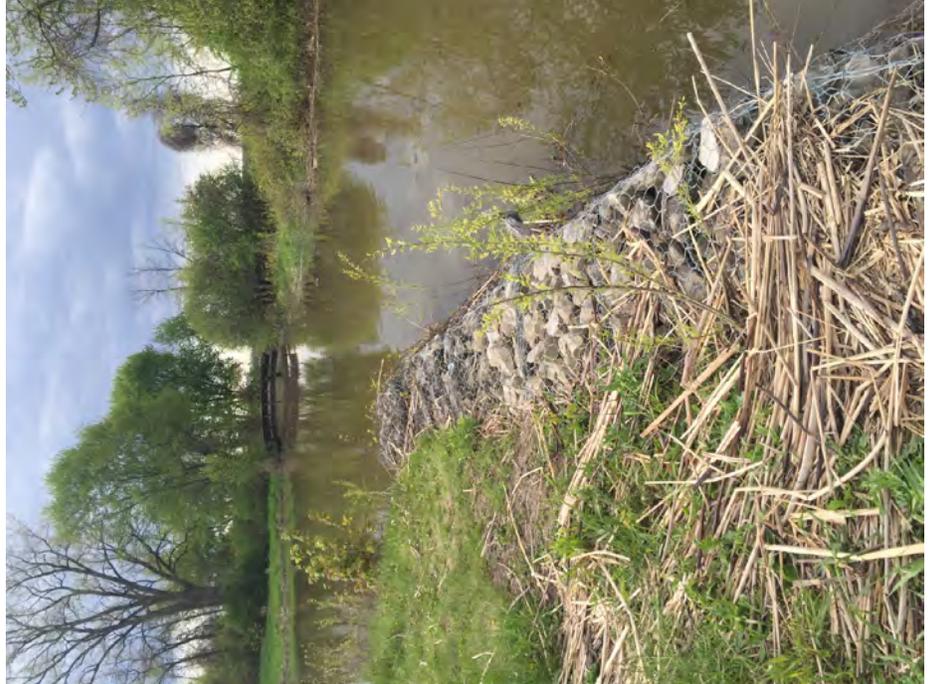
**Photo 1**

**Material:** Gabion baskets with rip rap

**Location:** Left Side Facing Upstream

Left side of the drain at the outlet to the Saginaw River . Picture facing upstream

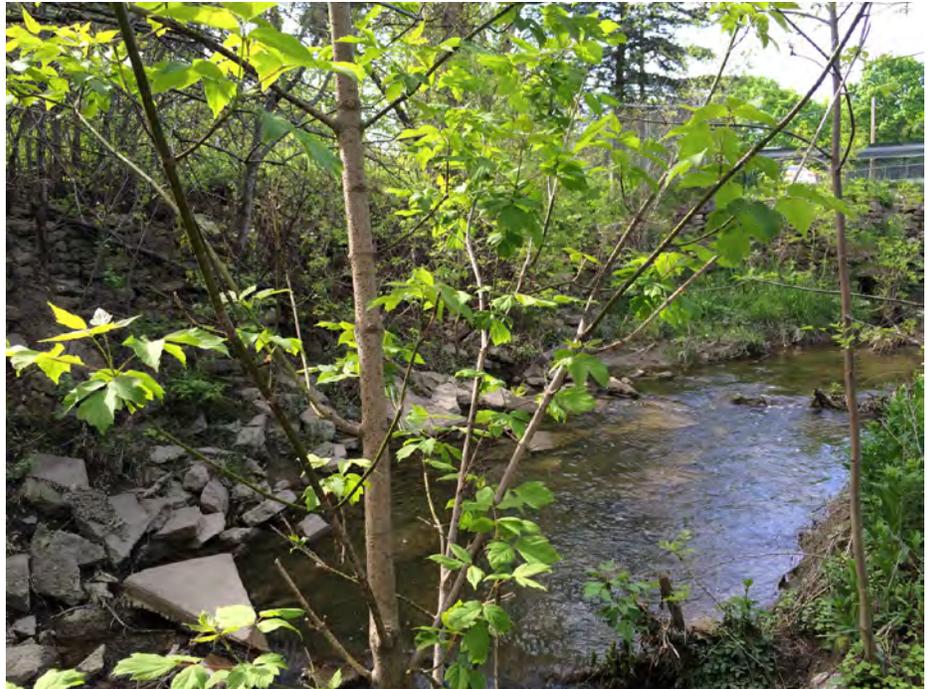
**Photo 1**

**Material:** Broken concrete

**Length (feet):** 40

**Location:** Left Side Facing Upstream

Constructed bank with broken concrete. 40 ft up to washington rd. In poor condition. Falling apart and leaving debris in the drain. Causing riffle. Photo facing upstream.contains surface outlet pipe at washington rd.

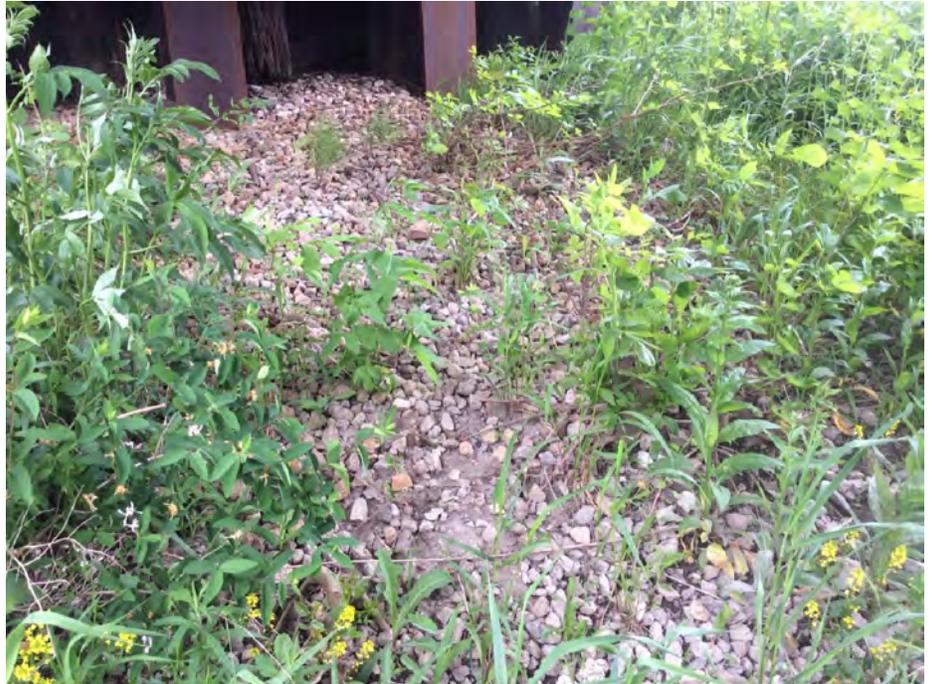
**Photo 1**

**Material:** Small stones.

**Length (feet):** 30

Constructed banks on both sides under railroad bridge. Small stones. Photo facing north.

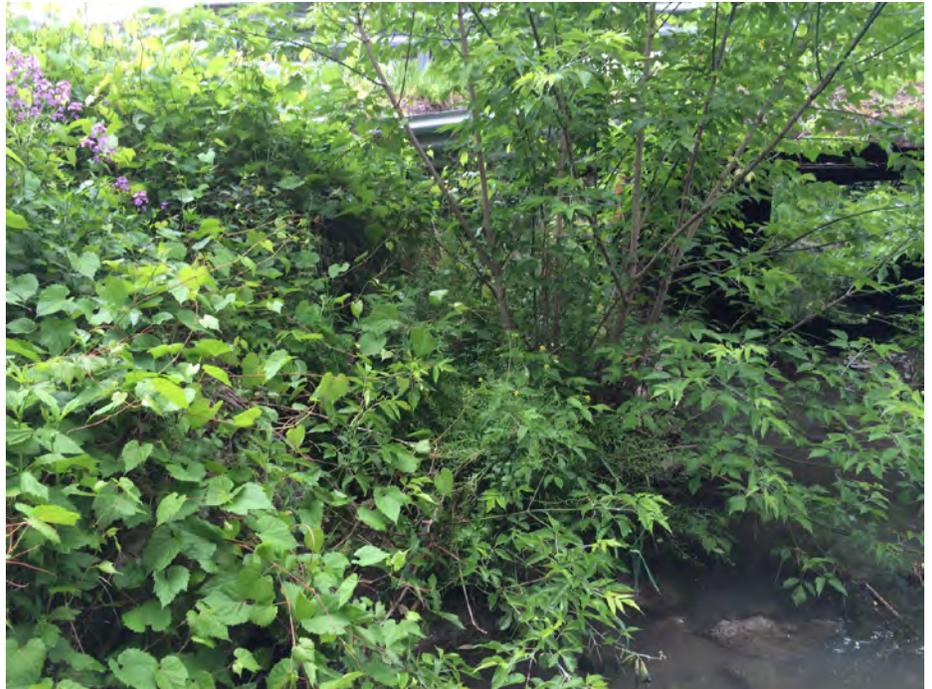
**Photo 1**

**Material:** Bag riprap

**Length (feet):** 20

**Location:** Left Side Facing Upstream

Bag riprap constructed bank. Serves as headwall for 19" sop on left side and extends to crossing at williamson rd.

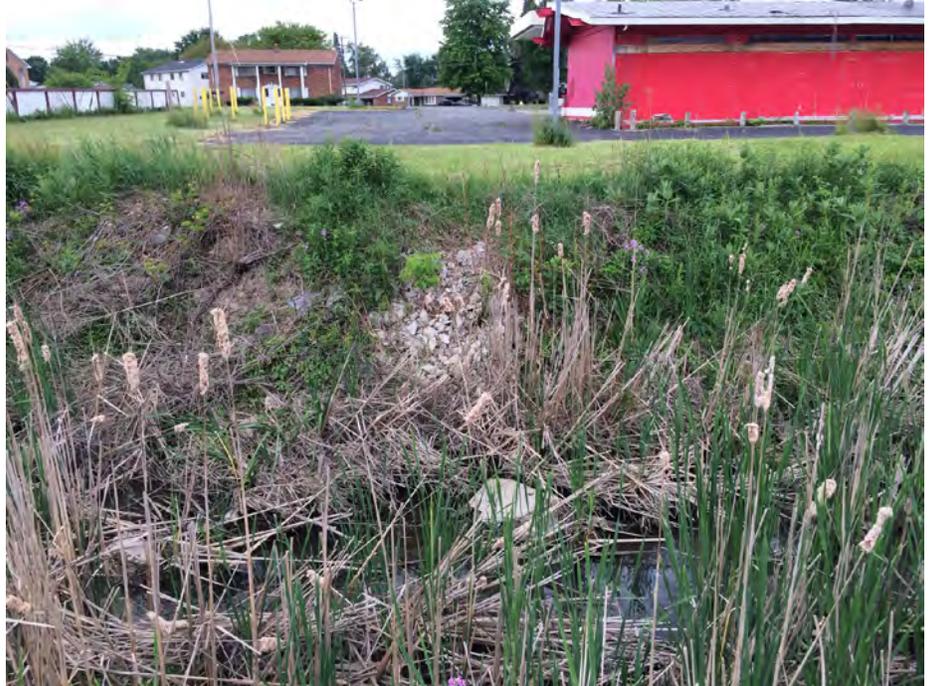
**Photo 1**

**Material:** Stone

**Length (feet):** 6

**Location:** Right Side Facing Upstream

Stone used for erosion protection on right side of drain.

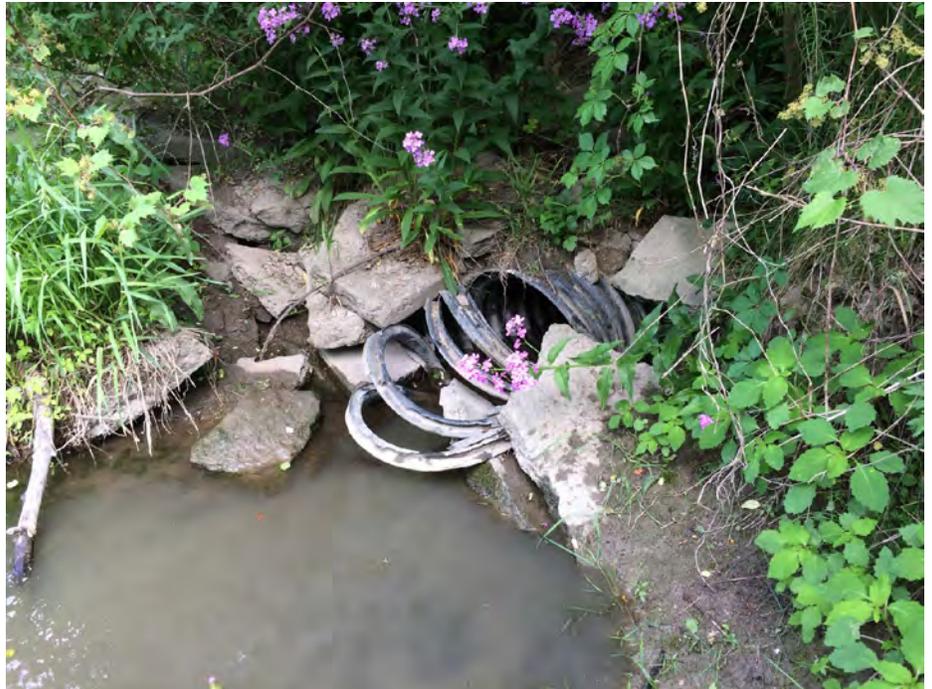
**Photo 1**

**Material:** Broken concrete

**Length (feet):** 10

**Location:** Right Side Facing Upstream

Constructed bank is headwall for 18" hdpe sop. In failed condition.

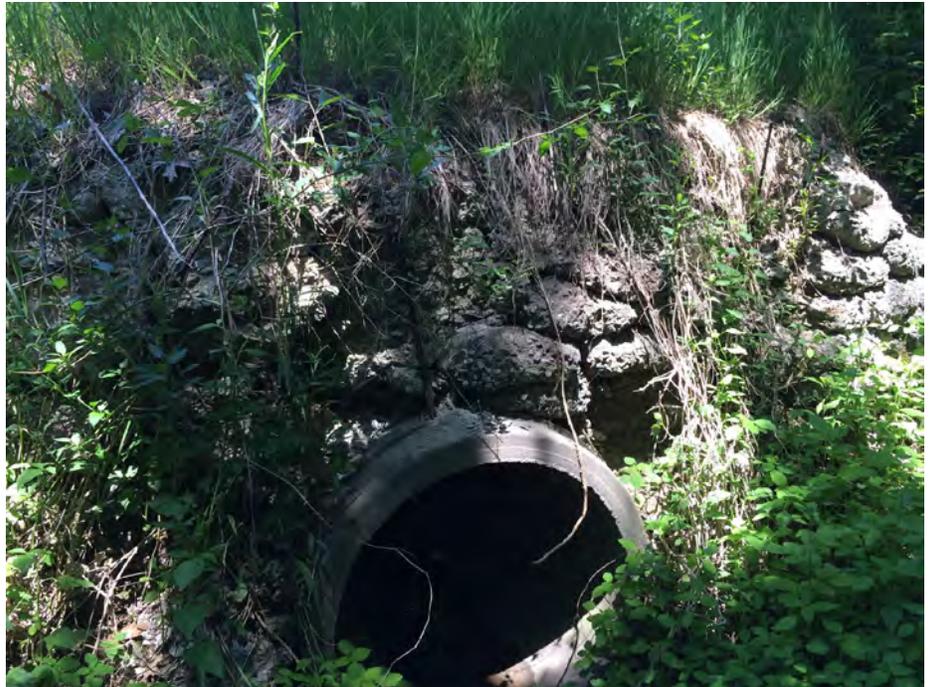
**Photo 1**

**Material:** Bag riprap

**Length (feet):** 10

**Location:** Left Side Facing Upstream

Bag riprap headwall around 30" concrete sop. In fair condition. Some erosion is visible. Just upstream of mack crossing.

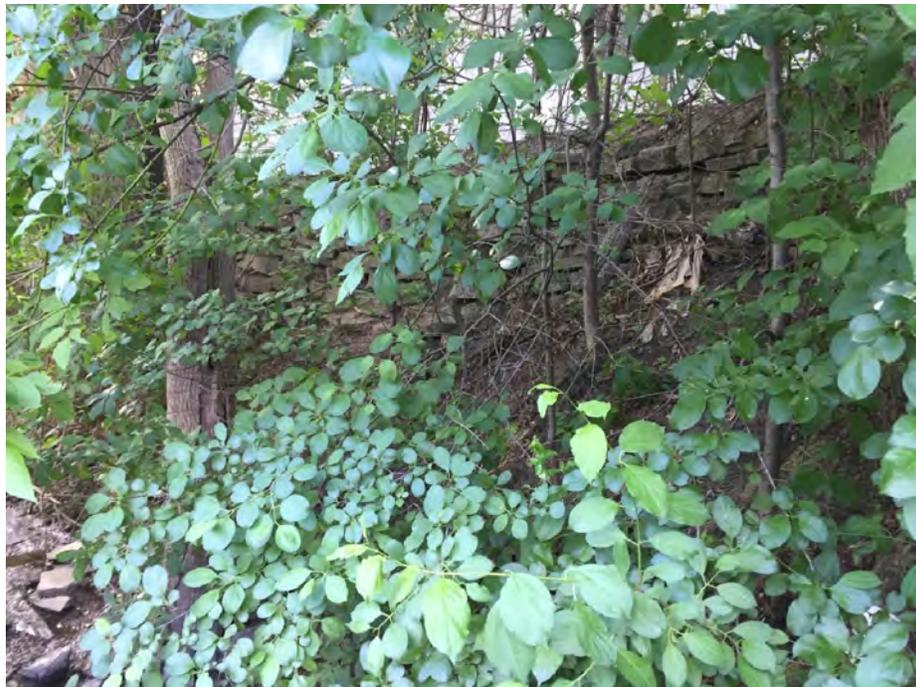
**Photo 1**

**Material:** Crushed concrete bricks.

**Length (feet):** 50

**Location:** Right Side Facing Upstream

5' wall on right side of drain facing upstream made of concrete bricks. Picture facing upstream.

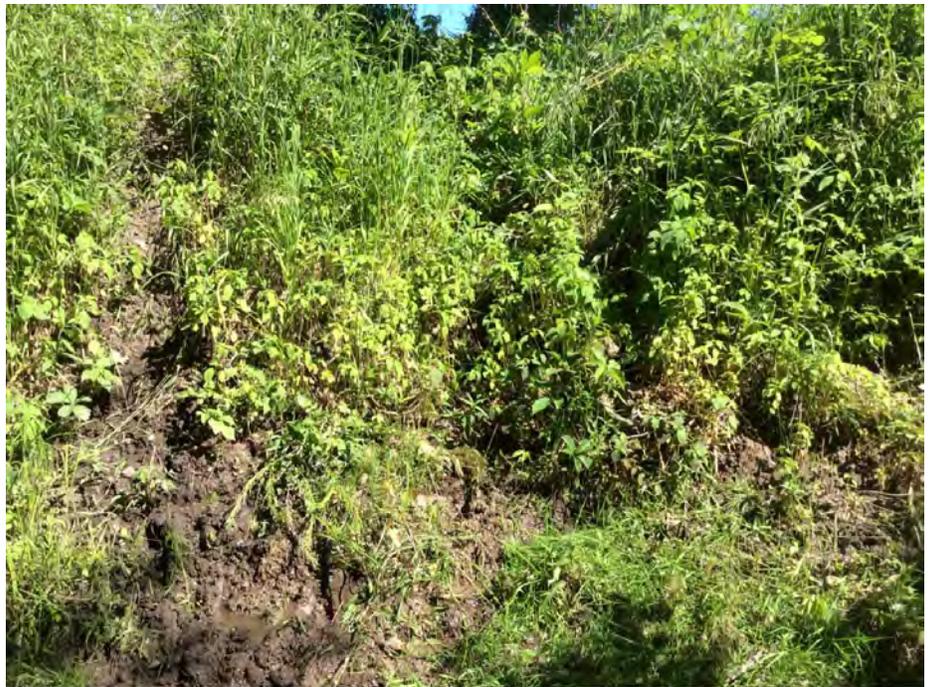
**Photo 1**

**Material:** Stones.

**Length (feet):** 6

**Location:** Left Side Facing Upstream

Concrete blocks on left bank. Sediment deposit as well. Looks like a location of a field tile outlet, but could not be located.

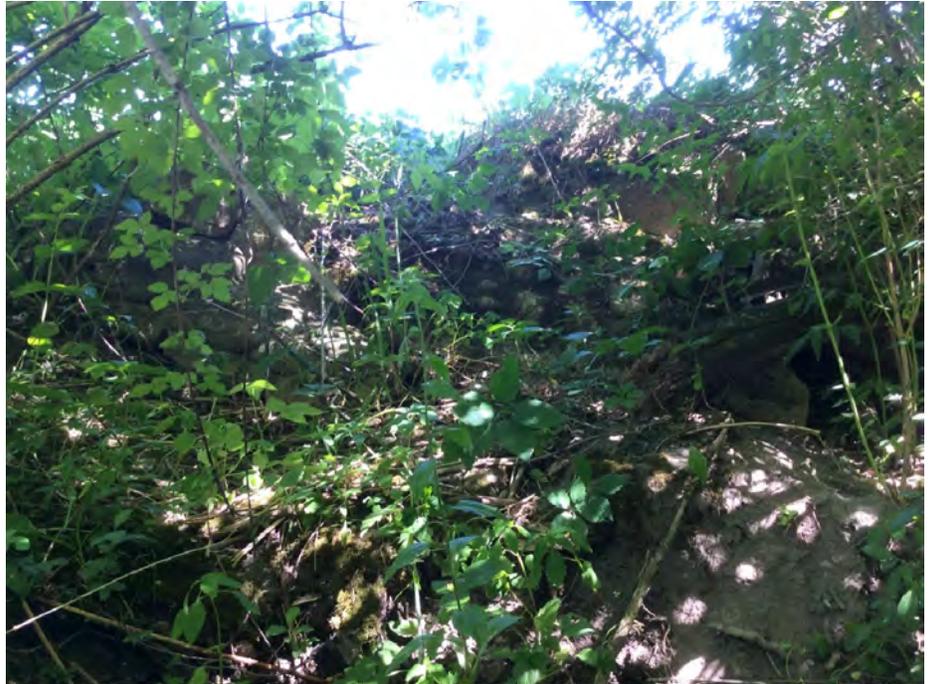
**Photo 1**

**Material:** Bag rip rap

**Length (feet):** 25

**Location:** Left Side Facing Upstream

Bag rip rap constructed bank. Possibly a headwall for ag field surface drainage. Most likely for a field tile outlet, but could not locate. Erosion.

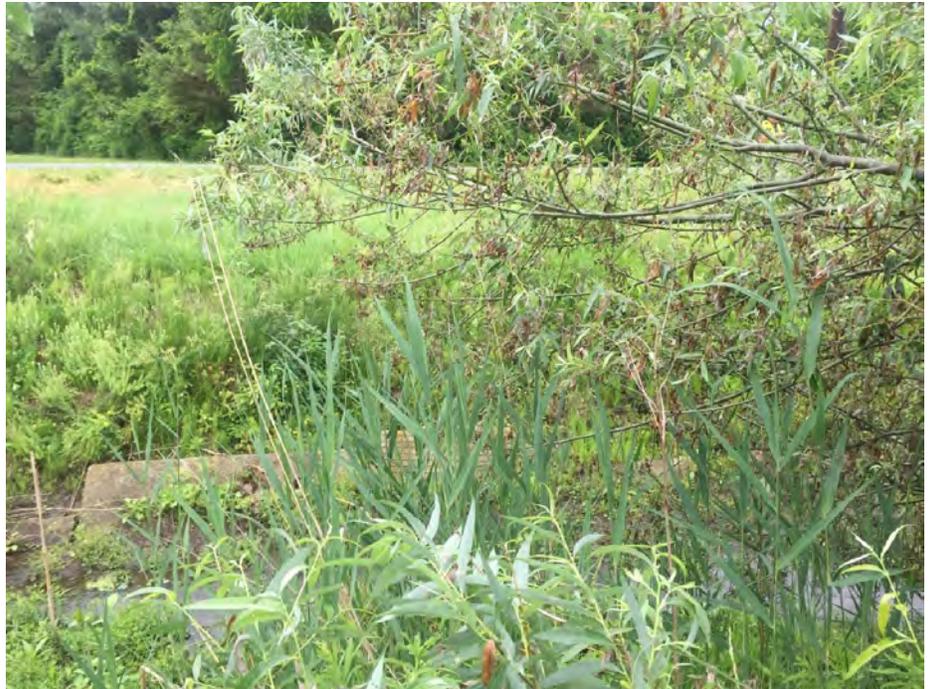
**Photo 1**

**Material:** Stamped concrete walls

**Length (feet):** 20

**Location:** Right Side Facing Upstream

Concrete walls on right side of drain facing upstream for 20' and approximately 5' high. Falling into drain. Picture facing southwest across drain.

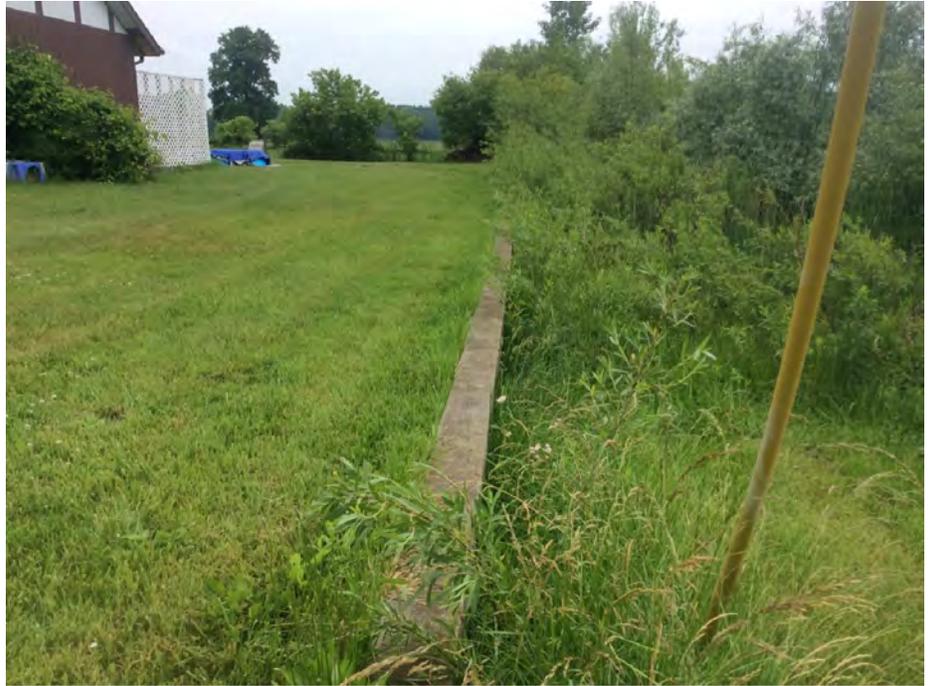
**Photo 1**

**Material:** 8" poured wall

**Length (feet):** 200

**Location:** Right Side Facing Upstream

8" poured conc wall approximately 25' right of drain centerline from this location approximately 200' downstream to end. Picture facing downstream

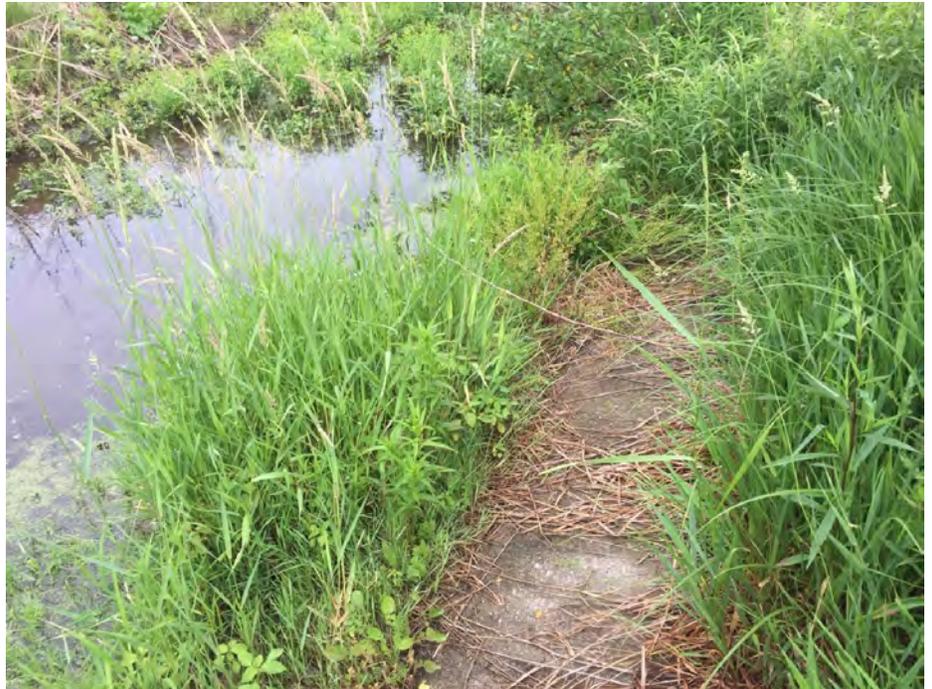
**Photo 1**

**Material:** Concrete

**Length (feet):** 15

**Location:** Left Side Facing Upstream

Approximately 20' long concrete wall sloping into drain and approximately 5' high. Picture facing downstream.
