King Street Tile Drain Inspections

Inspection Report for Observation:
CulvertCrossing1

CLIENT	Saginaw County Public Works Commissioner

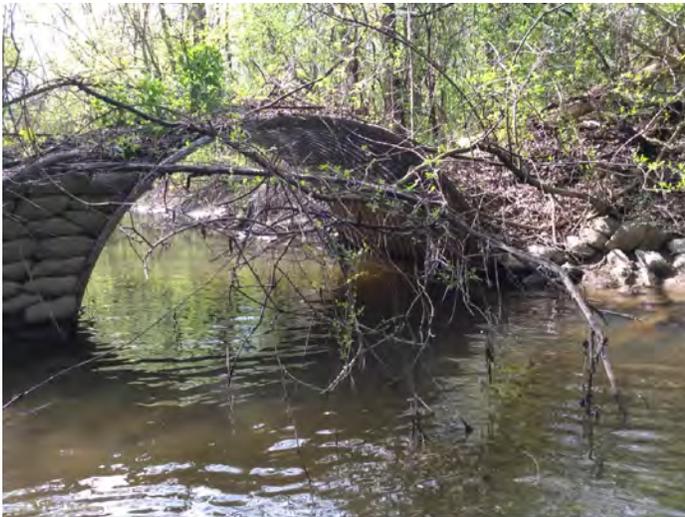
Photo 1

(Old Farm Crossing) Photo1. Head wall on right side is failing. Minimal cover. Erosion at headwall.

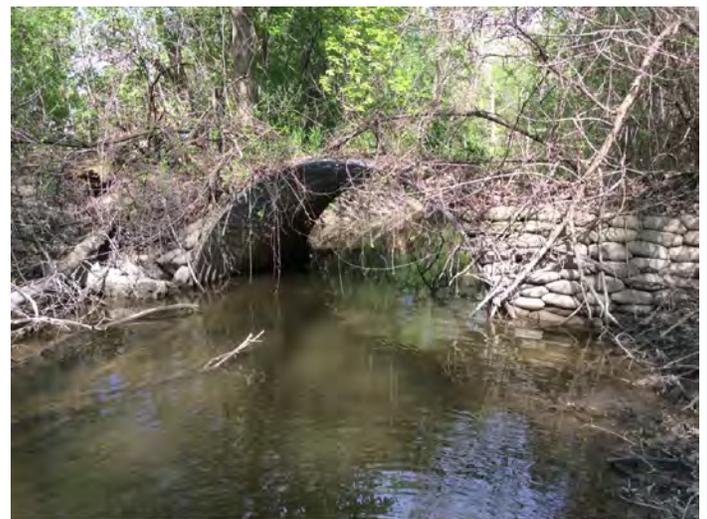
Photo 4

Photo4. Erosion on both sides. Woody debris.

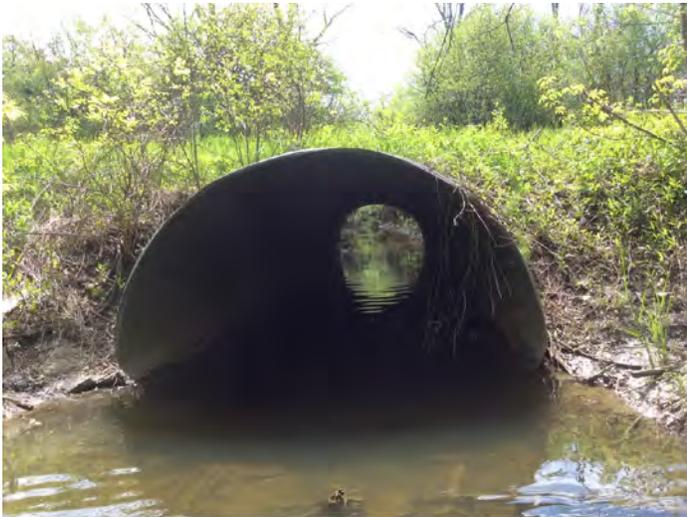
Photo 1

(Banner Road Crossing) Erosion at headwall, but vegetation growing so might be okay. Photo 1. Debris and side drain on left side.

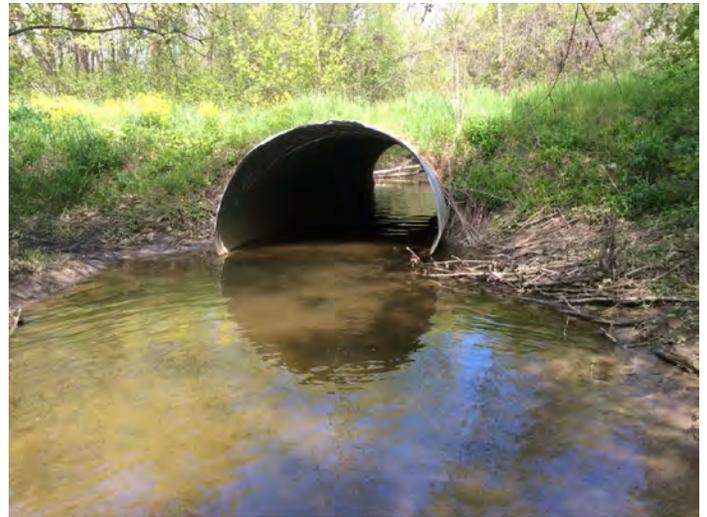
Photo 2

Erosion at headwall. Worse on left side. Photo2. Side drain enters on right. Culvert under banner rd.

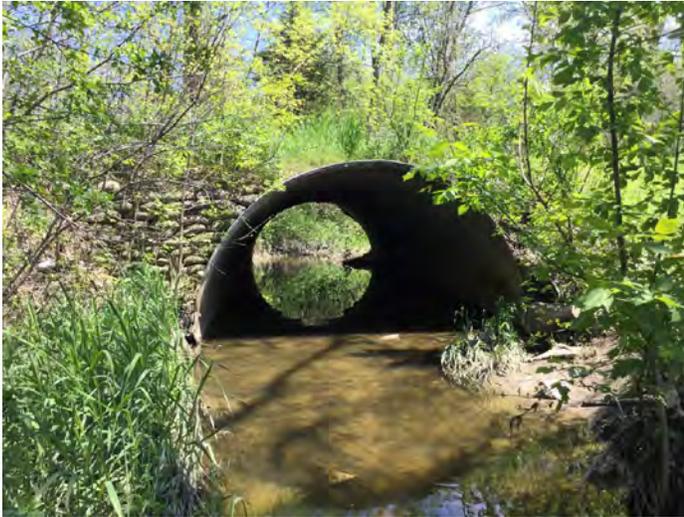
Photo 1

Downstream Comments:
(Casey Drive Crossing) Under Casey dr. Surface outlet pipes on both sides of drain. Erosion on left side. Deep decline. Could use guard rail.
Photo1

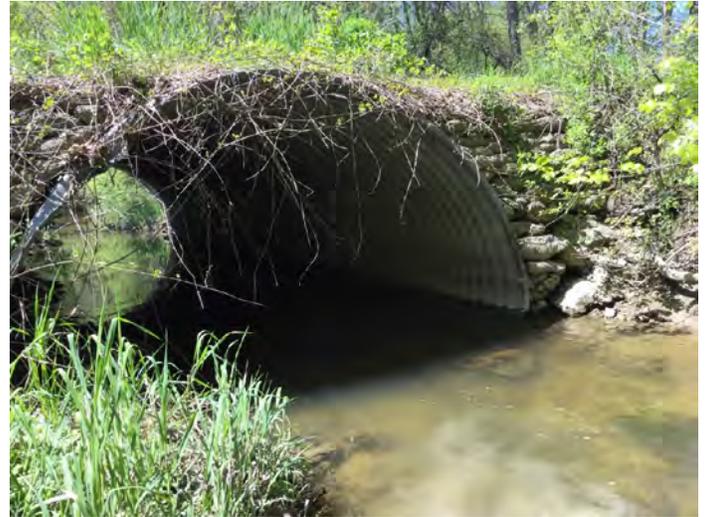
Photo 2

Upstream Comments:
Under Casey dr. Side drain from right. Entrance to culvert is at an angle.
Photo2

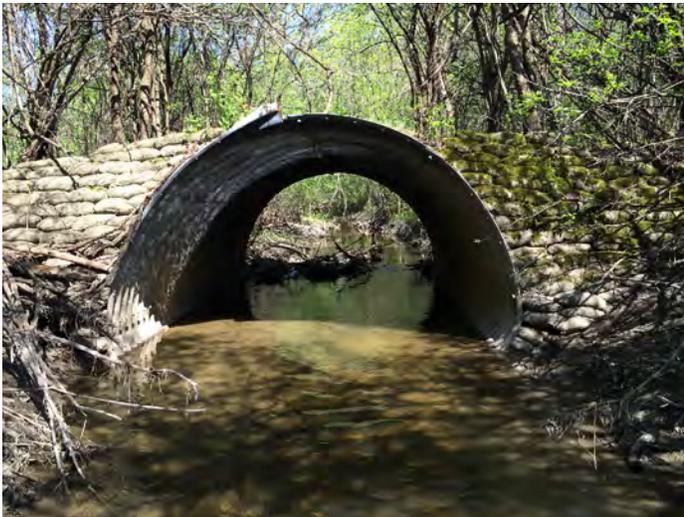
Photo 1

(Farm Crossing) Photo1. Headwall in good condition. Bank erosion on right side especially. Minor erosion behind headwall on right side. Cover is minimal and is in poor shape.

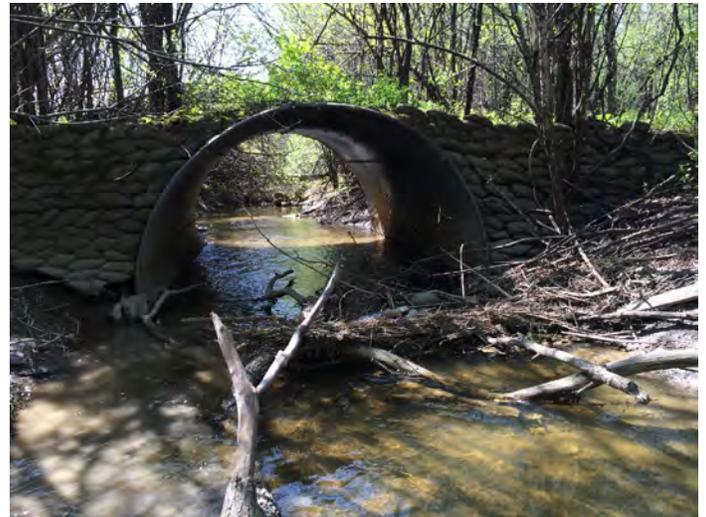
Photo 2

Photo2. Significant erosion behind headwall. However, headwall still structure seems fine. Woody debris blockage. Significant erosion at field tile outlet on right. Small bend in top of culvert.

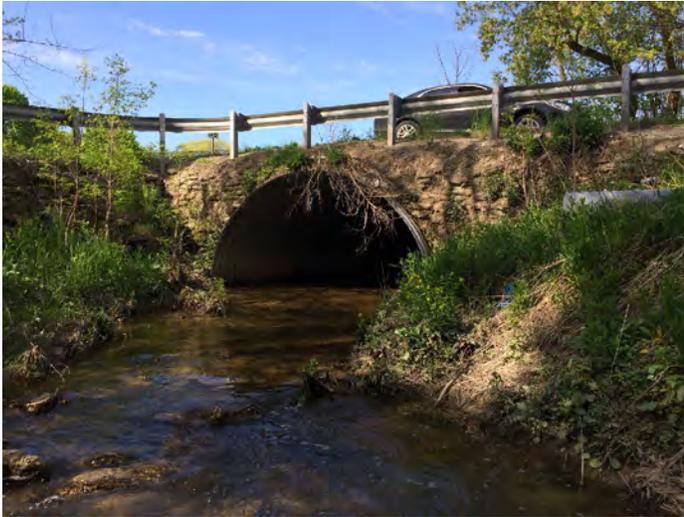
Photo 1

Downstream Comments:
(Washington Road Crossing) Surface outlet pipes on both sides. Exposed resteel. Minimal vegetation at top of headwall. Trash on right side. Photo 1. Drain exits at an angle.

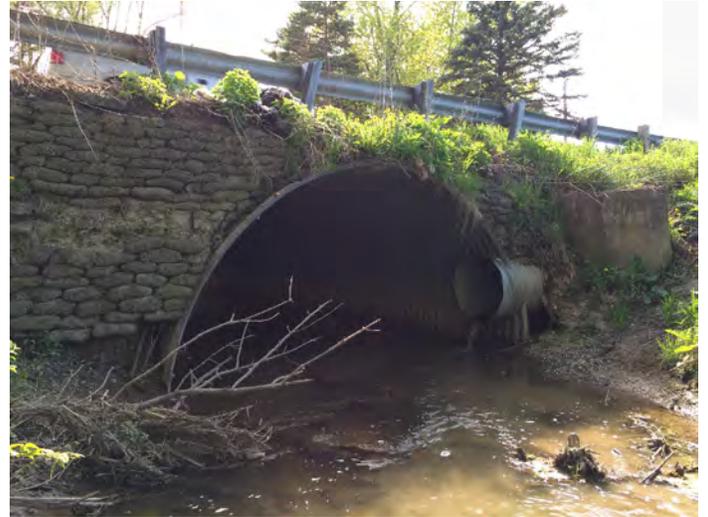
Photo 2

Upstream Comments:
Surface outlet pipes on both sides. Sop on left cuts into culvert. Concrete headwall support on left around sop. Debris in drain. Trash all over. Photo 2. Drain angles to right.

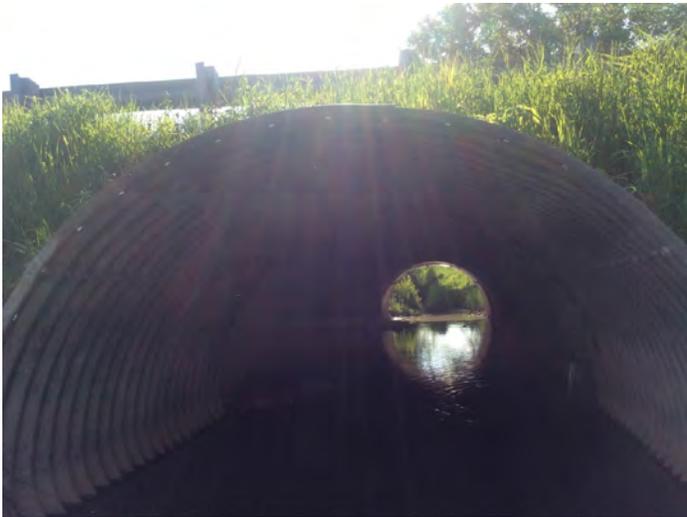
Photo 1

(Sheridan Road Crossing) Downstream crossing excessive vegetation. Riprap head wall in good condition. Roadside ditches enter on both sides.

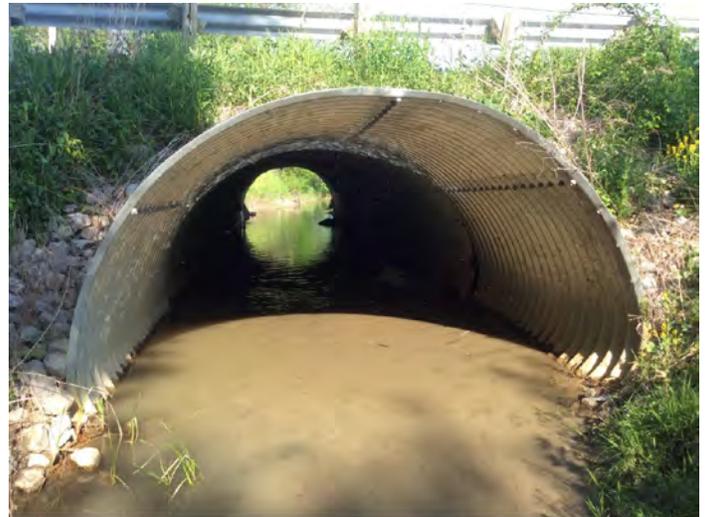
Broken concrete around headwall because of erosion. 1 upside ditch entering on right side of culvert and 1 for surface outlet pipe on left side. Photo 1 facing downstream. Photo 2 facing upstream.

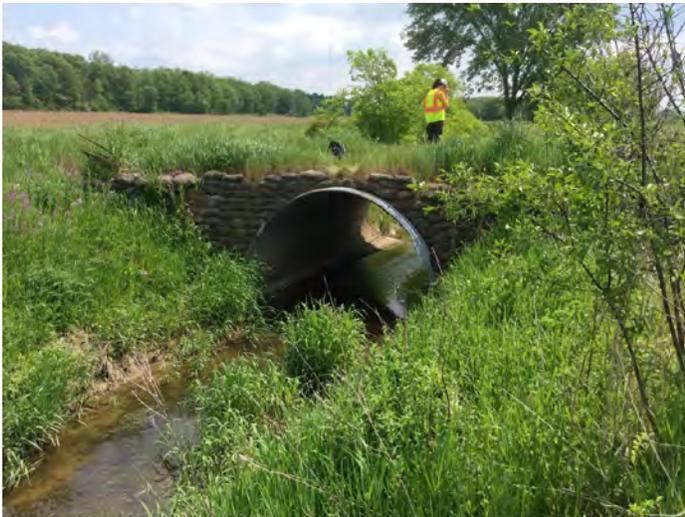
Photo 1

(Farm Crossing) Vegetation and sediment deposits on downstream side. Consistent with this stretch of drain. Sediment cave in at top of right bank. Bag rip rap headwall. Photo1

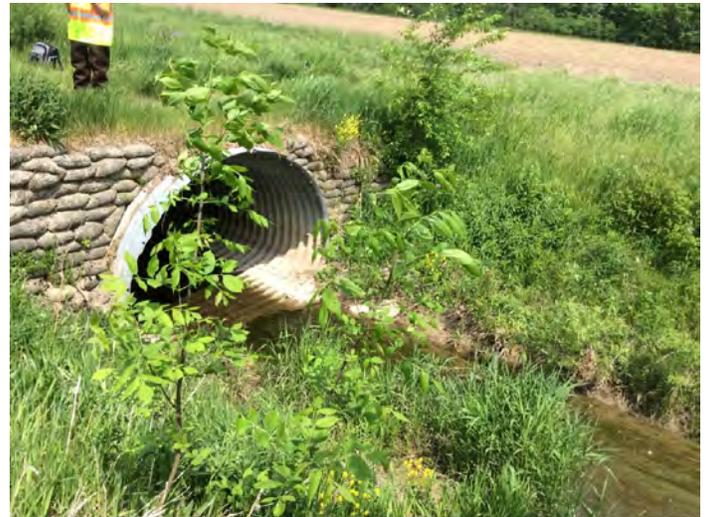
Photo 2

Erosion at banks around headwall. Just downstream of field tile outlet. Shiny substance on right side. Photo2.

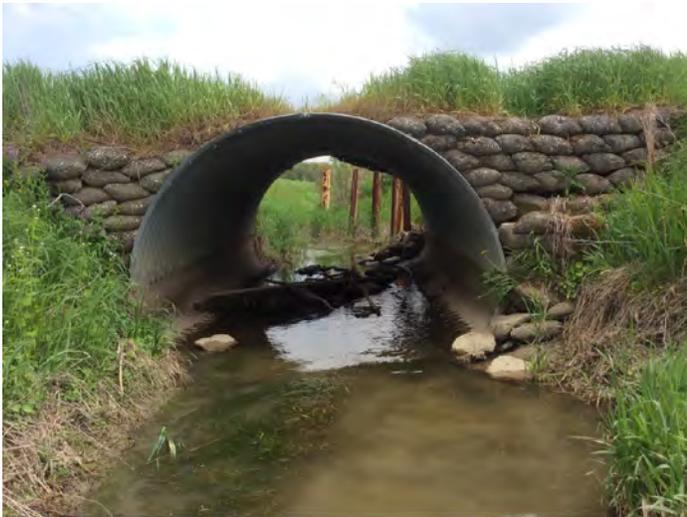
Photo 1

Downstream Comments:
(Farm Crossing) Vegetation. Farm crossing. Debris inside culvert. Photo1

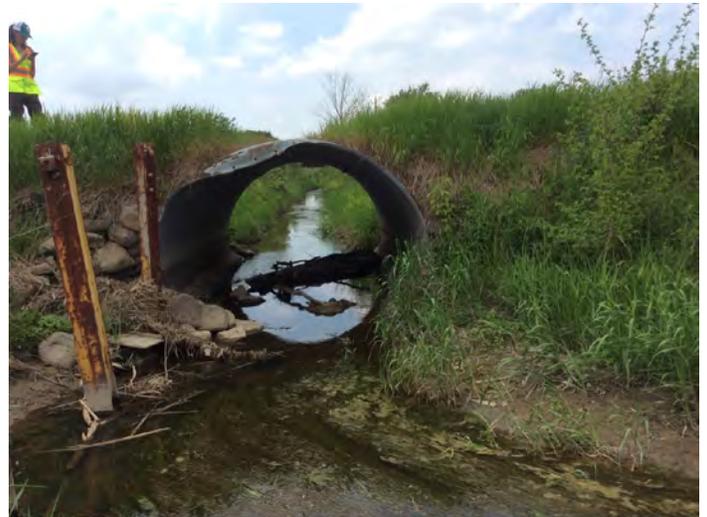
Photo 2

Upstream Comments:
Headwall on right side is starting to fail due to erosion. Just downstream of bend in drain and side drain. Photo2

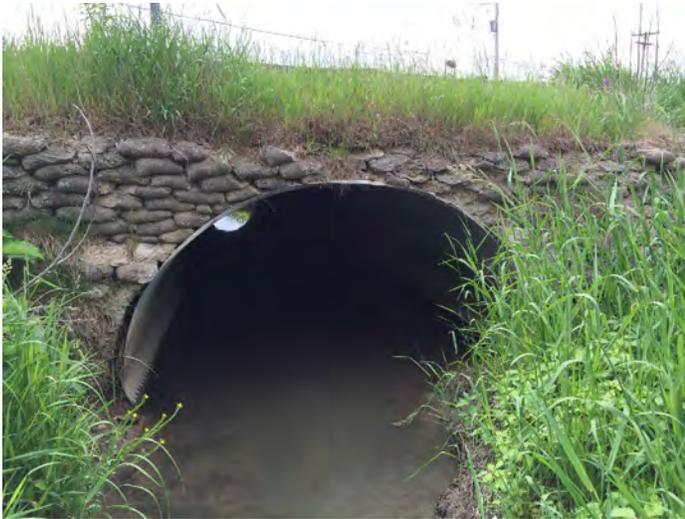
Photo 1

(King Street Crossing) Crossing under King St. Erosion behind headwall and at side drain outlet on right side. See photo2. Water level is about 24" inside culvert, which much greater than upstream and downstream sides. Two cmp sops enter culvert under King St.

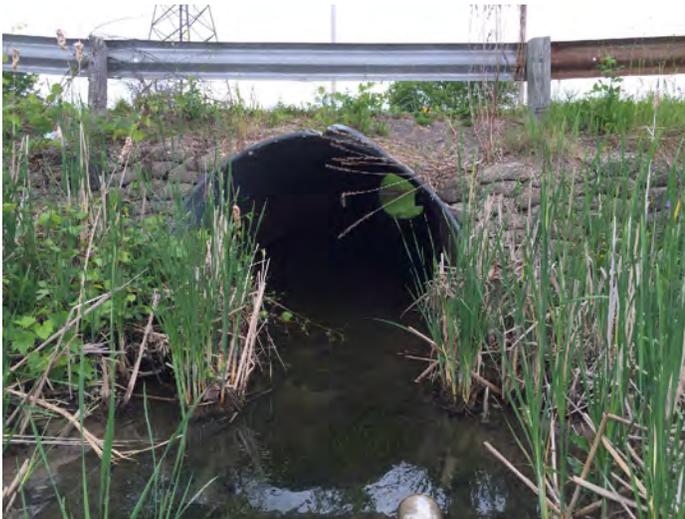
Photo 3

Erosion at headwall. Two 6" hdpe sops enter. Excessive vegetation and non vegetative debris. Lots of trash on banks and in drain channel. Photo3.

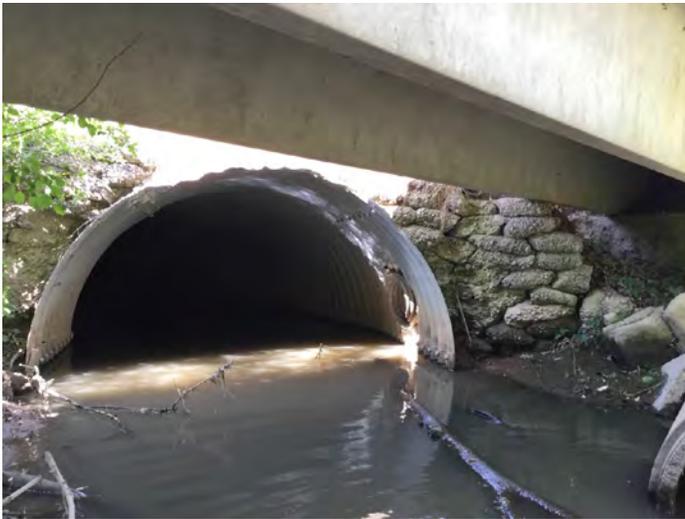
Photo 1

Crossing Type: City **Structure Condition:** Good
Structure Type: CMPA **Photo 1 Direction:** Facing Upstream
Downstream Comments:
 (King Street Crossing) Erosion at head wall. Flow backs up and floods neighboring lawn area. No guardrail. Sop cuts on right.

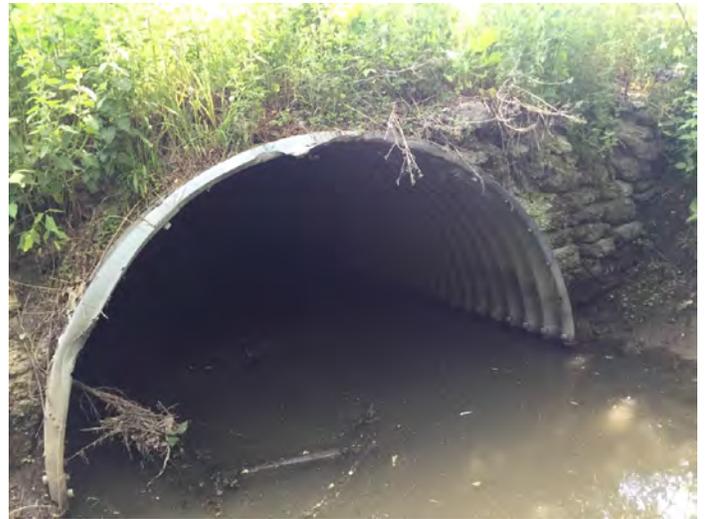
Photo 2

Upstream Comments:
 Exposed resteel at head wall. Erosion on head wall. Deep, loose sediment. Local resident says this side backs up considerably during high flows. Photo2.

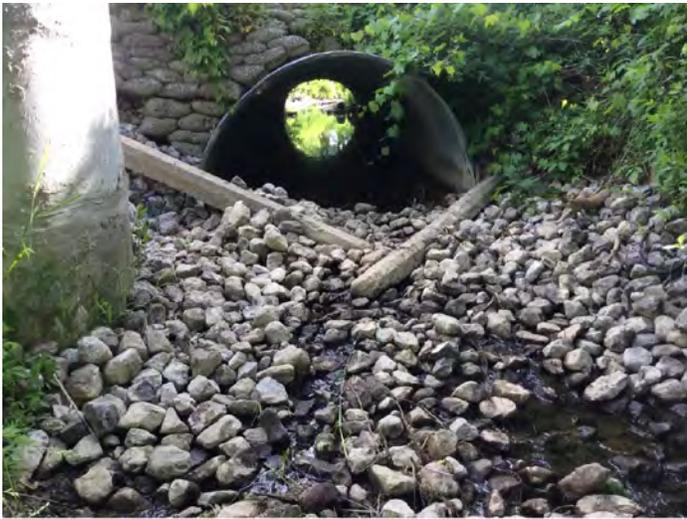
Photo 1

(Kansas Street Crossing) Riprap with curbs thrown in making riffle. Water elevation under culvert is significantly higher than drain water elevation. Huge manhole on left side of drain before culvert about 10 ft tall. Bag riprap headwall is in poor condition. Holes in headwall. Doesn't cover whole culvert CMP. Crossing under Kansas St.

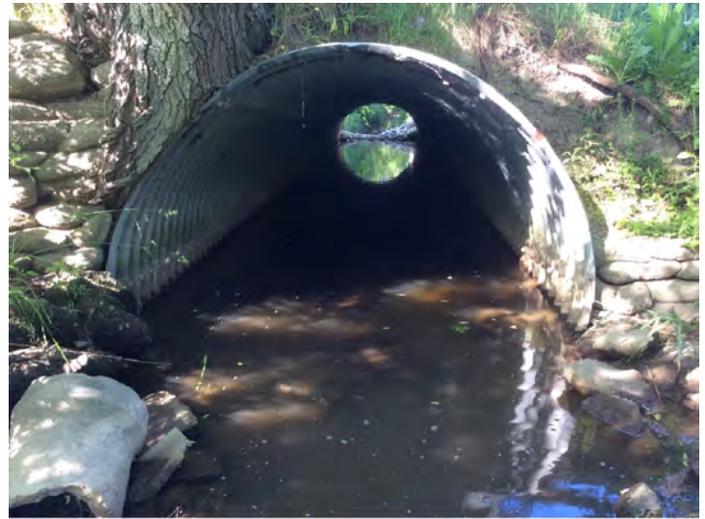
Photo 2

Bag riprap headwall on left side- right side only by bottom of culvert. Poor condition. Large tree growing on left side on top of culvert. Broken concrete and bag riprap laying on either side of drain.

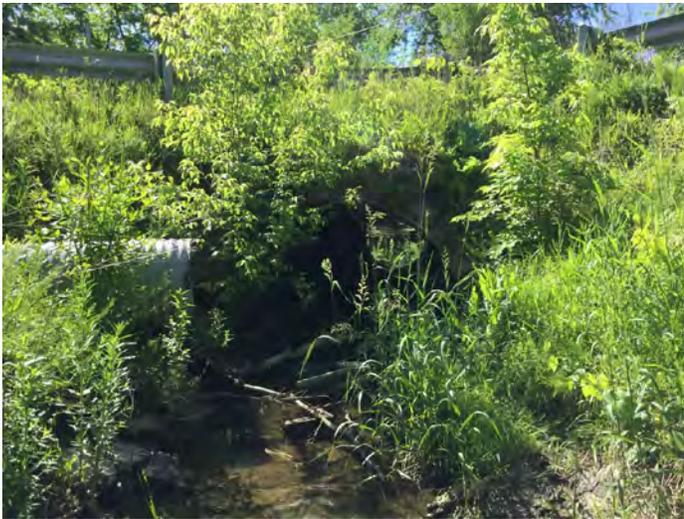
Photo 1

(Kansas Street Crossing) Log jam with non vegetative debris is obstruction. 24" sop from left. Enters at an angle. Under intersection of Kansas and Broadway. Sediment bar on right side.

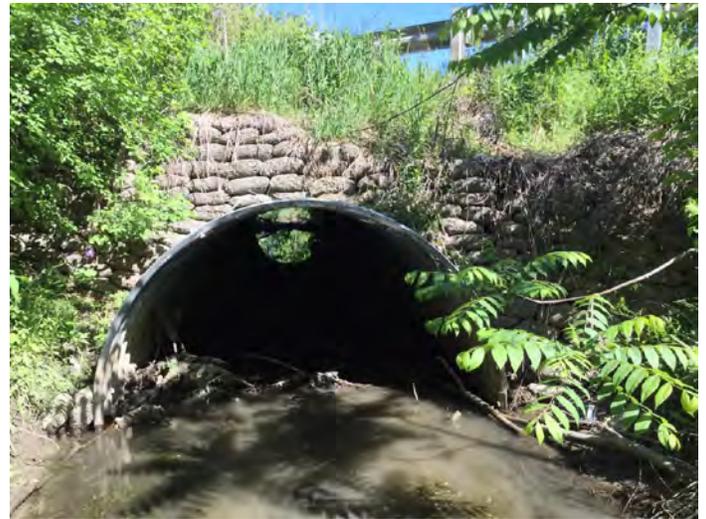
Photo 2

Head wall in fair condition. Erosion on right side. Sop on rights is blocked off. Woods debris and excessive vegetation upstream. Sanitary manhole on left side.

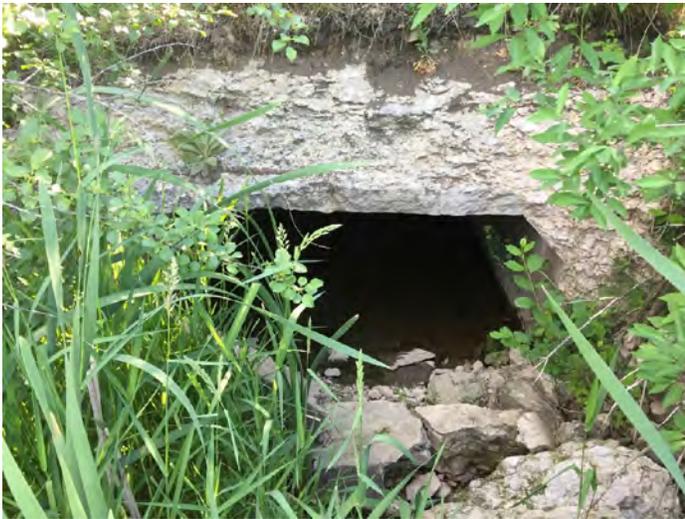
Photo 1

(Railroad Crossing) Downstream comments, downstream head wall has failed and is blocking the drain. Crossing going under railroad tracks. The drain is not flowing through crossing and instead is flowing through bypass to the south.

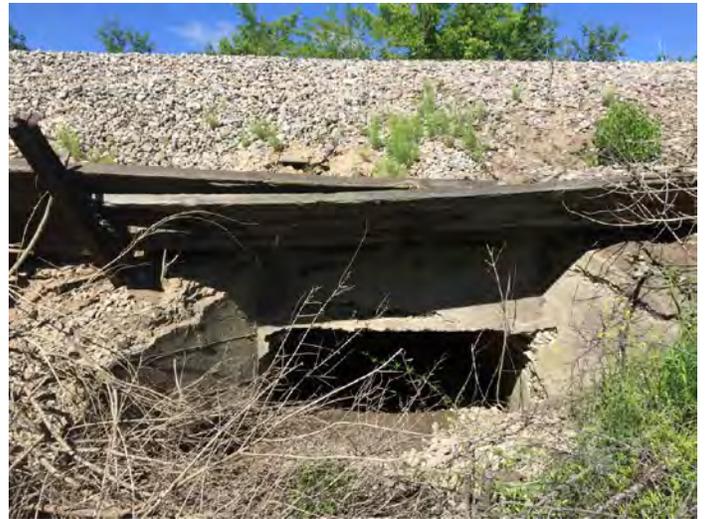
Photo 2

Upstream comments for railroad concrete box culvert crossing. Wooden head wall failed and stone falling into drain.

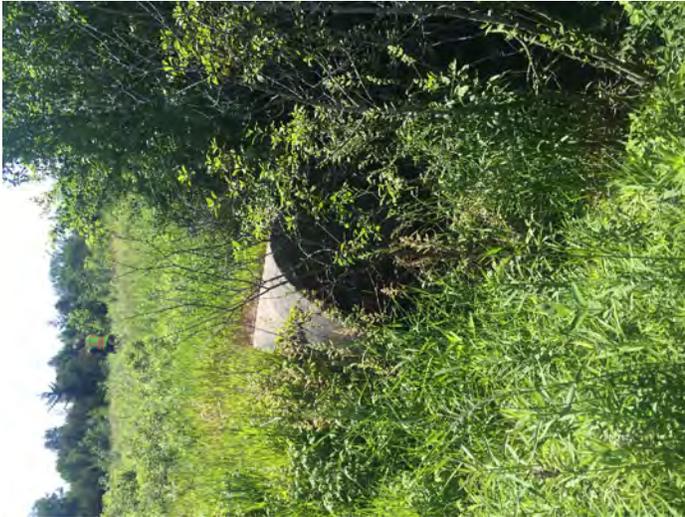
Photo 1

Crossing Type: Farm **Structure Condition:** Failed
Structure Type: Other **Photo 1 Direction:** Facing Upstream
Downstream Comments:
 (Farm Crossing) Photo1 downstream end of 72" rcp farm crossing with holes in the top. Picture facing upstream.

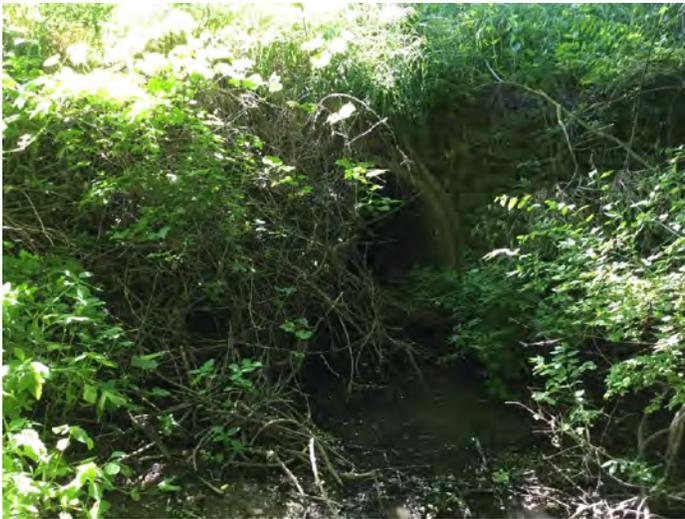
Photo 1

(Farm Crossing) Culvert structure seems in decent condition. Bag riprap head wall on right side is decent, but on left side is covered in Woody debris blocking most of culvert hole. Major erosion on both sides of bank. Woody debris all around.

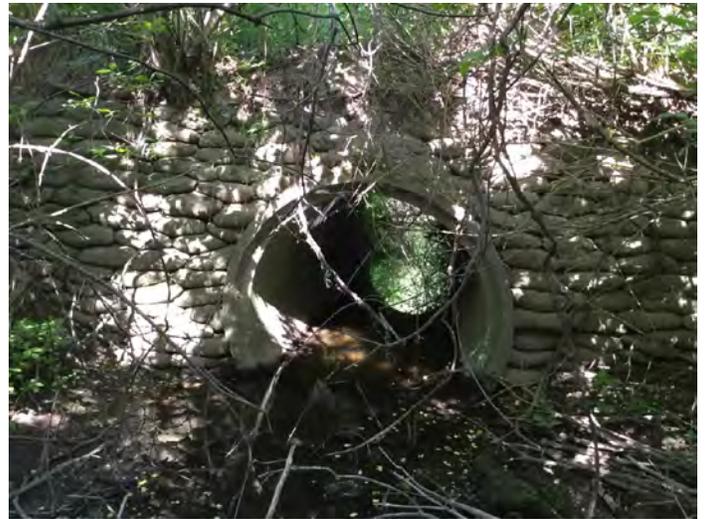
Photo 2

Concrete culvert in good shape. Bag riprap headwall is in good shape. Woody debris and erosion on both sides. Water depth only 7 inches deep. Concrete blocks upstream.

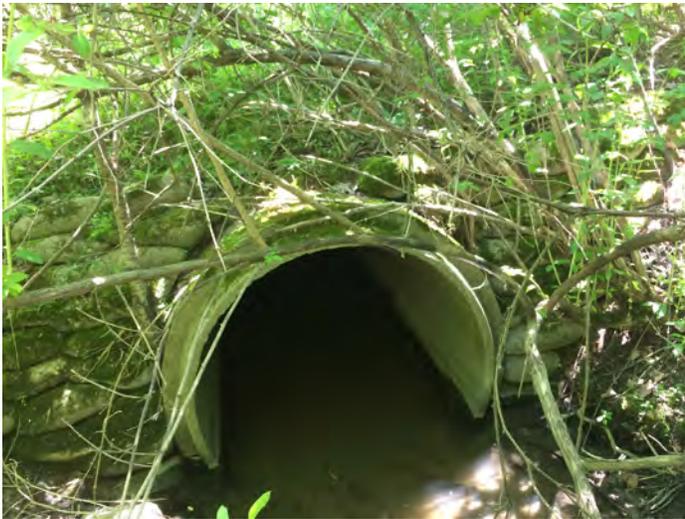
Photo 1

Crossing Type: Farm **Structure Condition:** Fair
Structure Type: RCP **Photo 1 Direction:** Facing Upstream
Downstream Comments:
 (Farm Crossing) Erosion behind headwall. The tree on right side.
 Excessive veg and bank erosion.

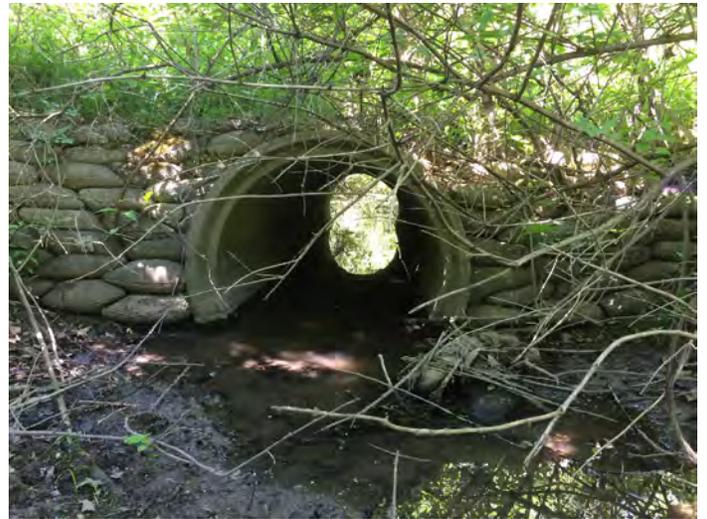
Photo 2

Upstream Comments:
 Erosion behind headwall. Debris is center of drain. Erosion on left bank.
 Heavily wooded. More a footpath.

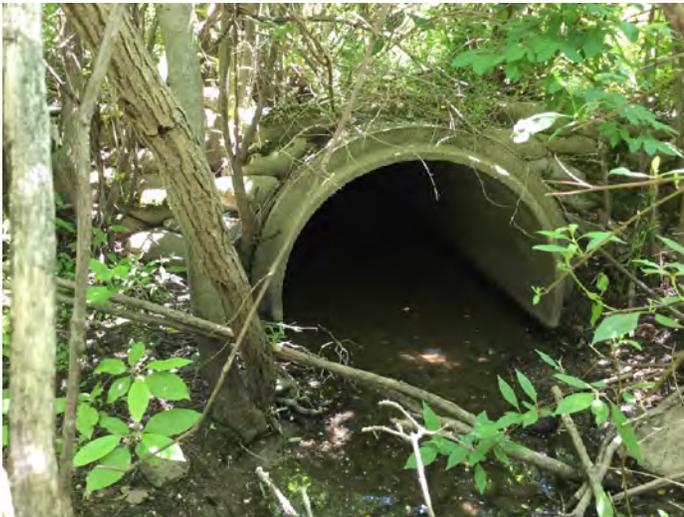
Photo 1

(Farm Crossing) Bag riprap headwall. Debris on right side facing upstream- some metal/steel item. Erosion and excessive overhanging vegetation on both sides of crossing. Excessive vegetation growing on bag riprap headwall.

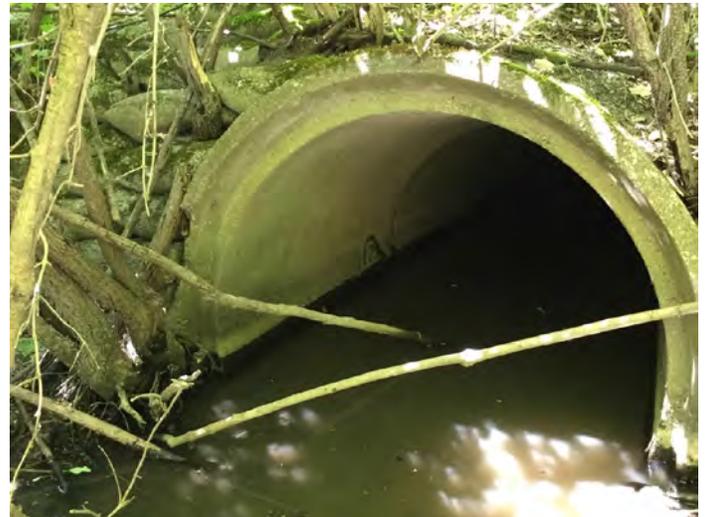
Photo 2

Massive amount of woody debris/overhanging vegetation to get to upstream end. Excessive woody debris on right side facing upstream. Bag riprap headwall on right side facing downstream is half gone. Excessive vegetation on headwall. RCP structure is in good shape, but has excessive vegetation growing on top. Picture 3 is facing downstream showing woody debris.

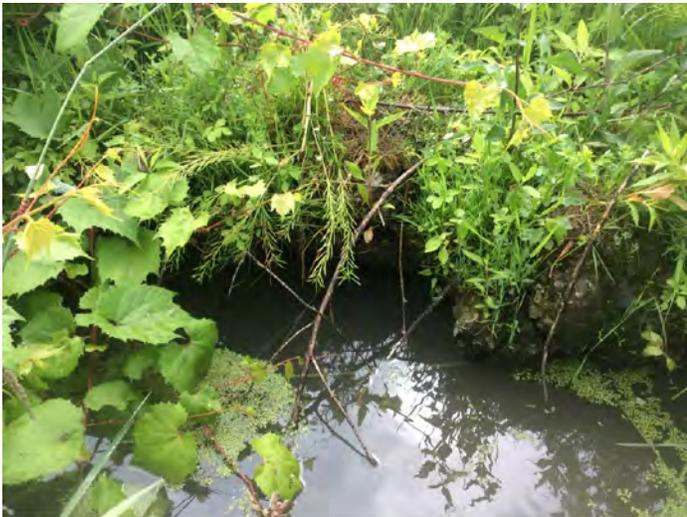
Crossing Type: Farm **Structure Condition:** Failed
Structure Type: RCP **Photo 1 Direction:** Facing Upstream
Downstream Comments:
 (Farm Crossing) Photo 1 downstream end of 30" rcp farm crossing (failed) . Full of water. Picture facing upstream

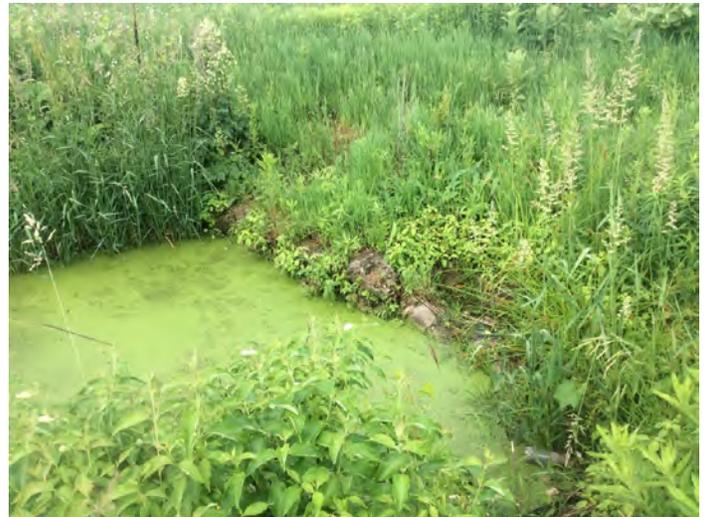
Upstream Comments:
 Photo 2 upstream end of failed 24" rcp at farm crossing full of stagnant non moving water. Picture facing downstream.
