# King Street Tile Drain Inspections

CLIENT	Saginaw County Public Works Commissioner

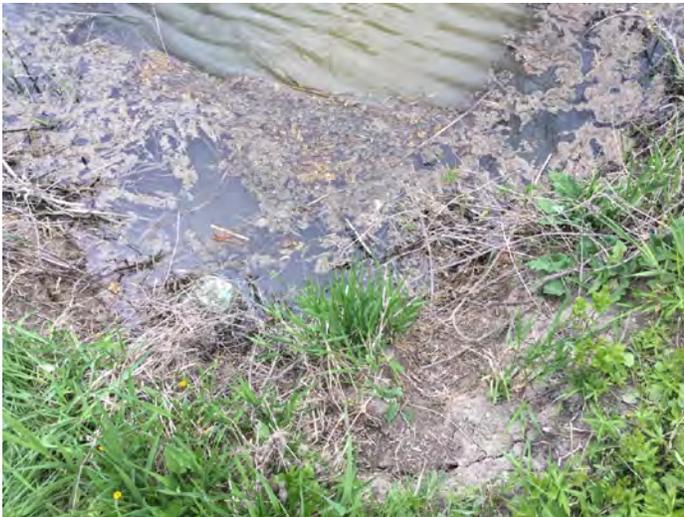
**Photo 1**

**Condition:** Fair

Plastic tile on right side upstream. Erosion at outlet. Photo taken facing north.

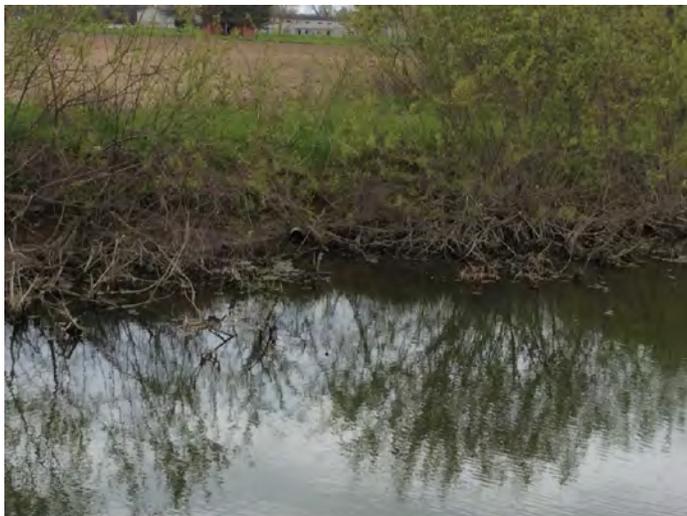
**Photo 1**

**Condition:** Good

Left side of drain, PVC 6" diam, photo facing north.

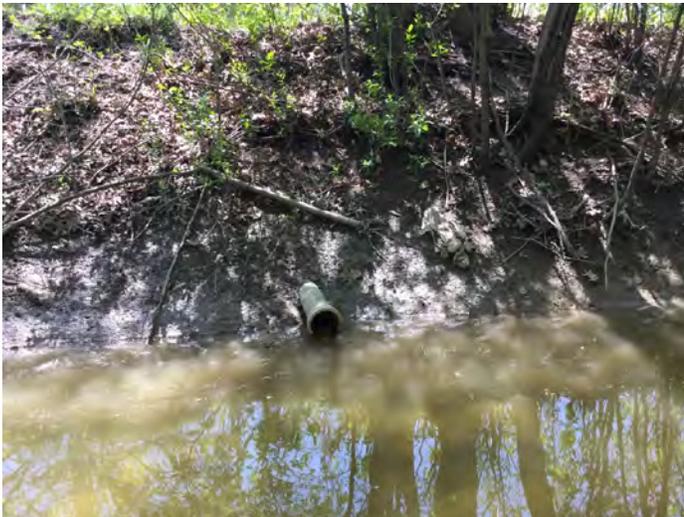
**Photo 1**

**Condition:** Fair

3" clay field tile. Enters drain on right. Photo facing north.

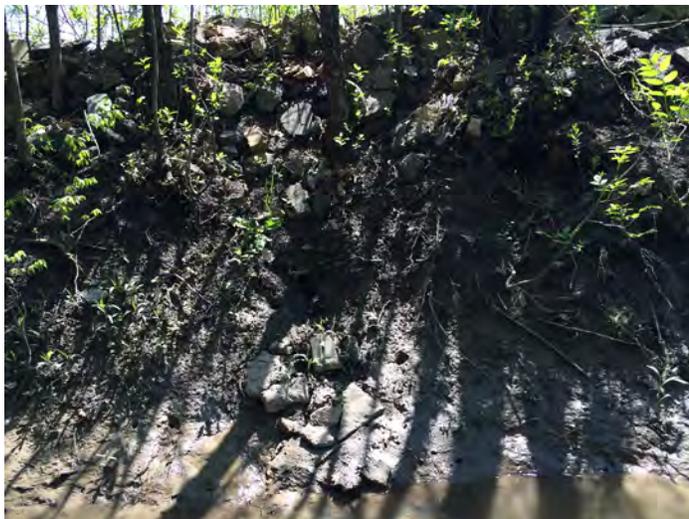
**Photo 1**

**Condition:** Fair

2" clay field tile enters drain from right. Photo facing northeast.

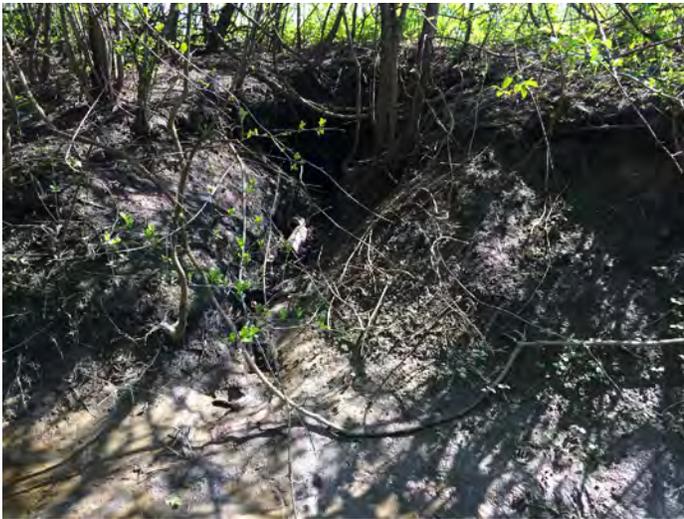
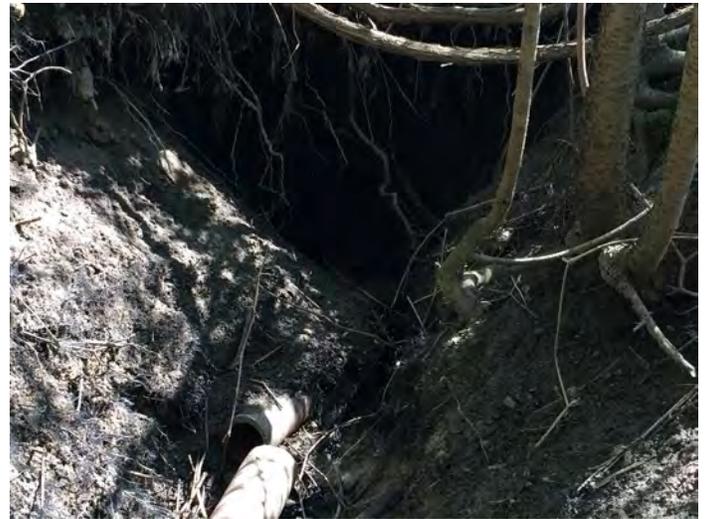
**Condition:** Poor

2.5" diam field tile outlet. Broken at outlet to drain. Significant erosion. Photo facing northeast. Loose sediment at outlet. Excessive vegetation clump downstream.

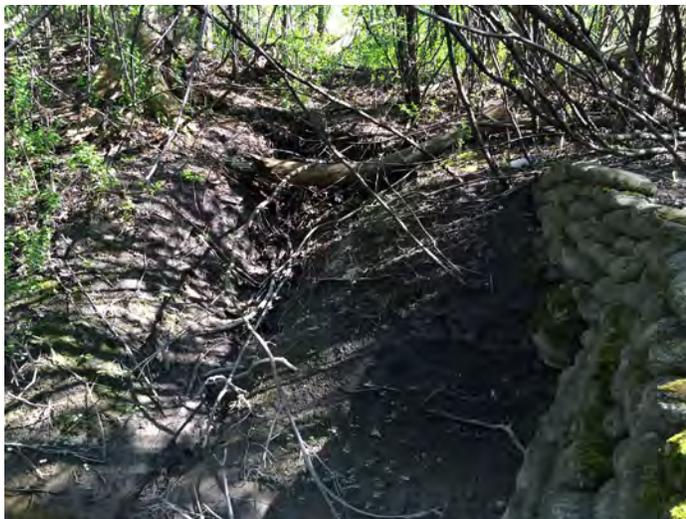
**Photo 1**

**Condition:** Poor

Field tile outlet enters drain on right. Clay, 2.5" diam. Significant erosion at outlet. Photo facing south.

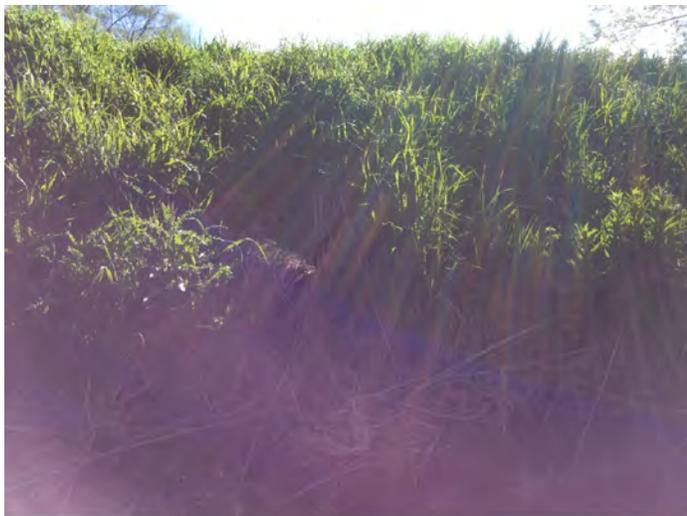
**Photo 1**

**Condition:** Fair

Photo facing northeast. 6" metal field tile outlet. Enters drain on left.

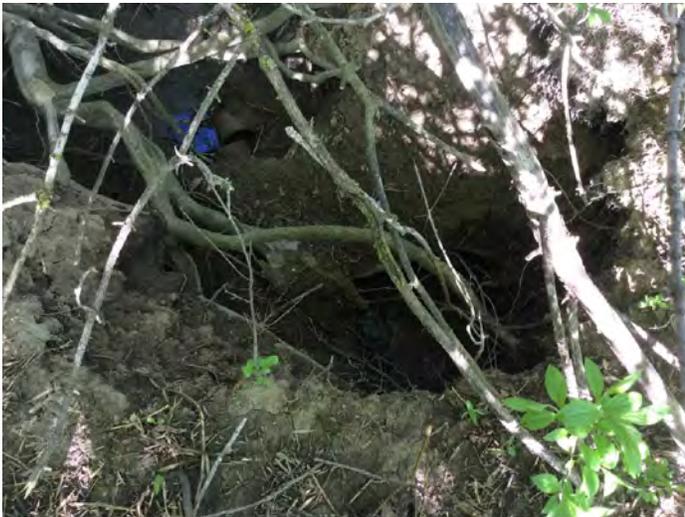
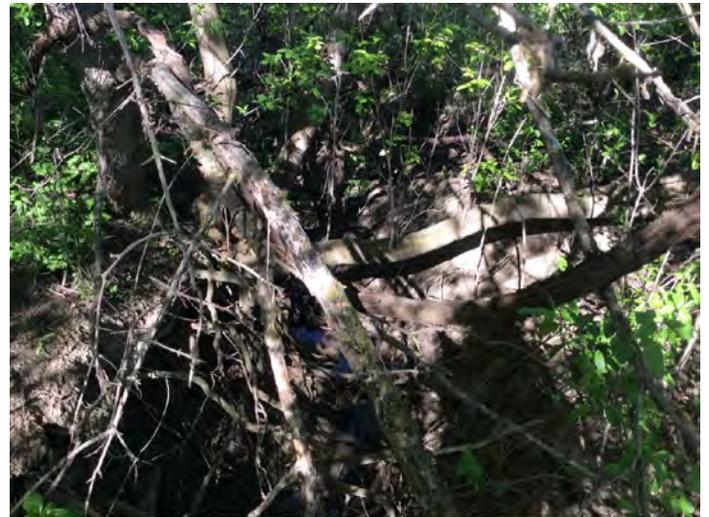
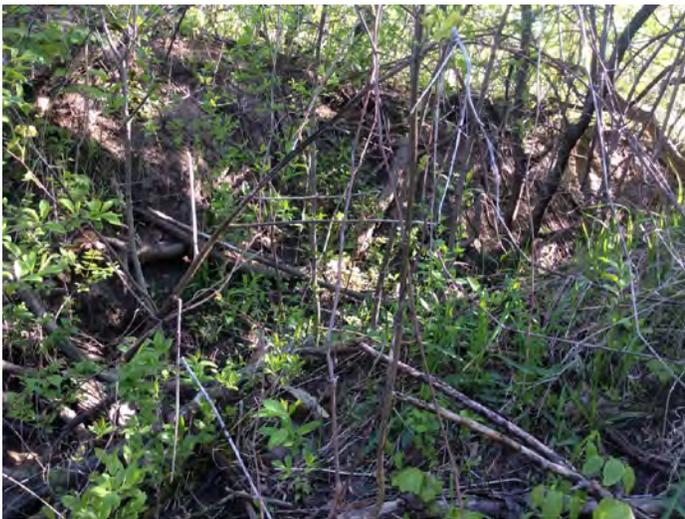
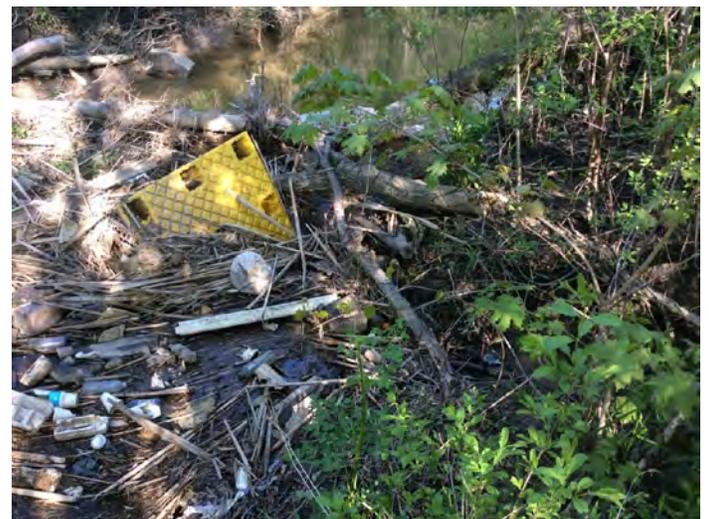
**Condition:** Failed

Broken field tile. Significant erosion 30 ft inland.

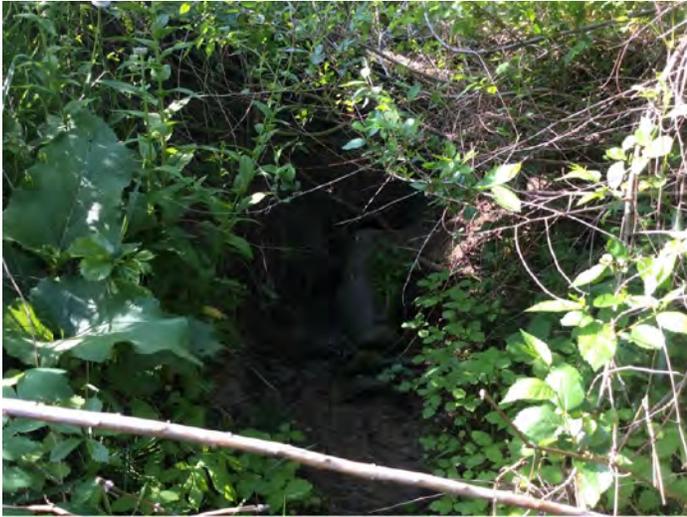
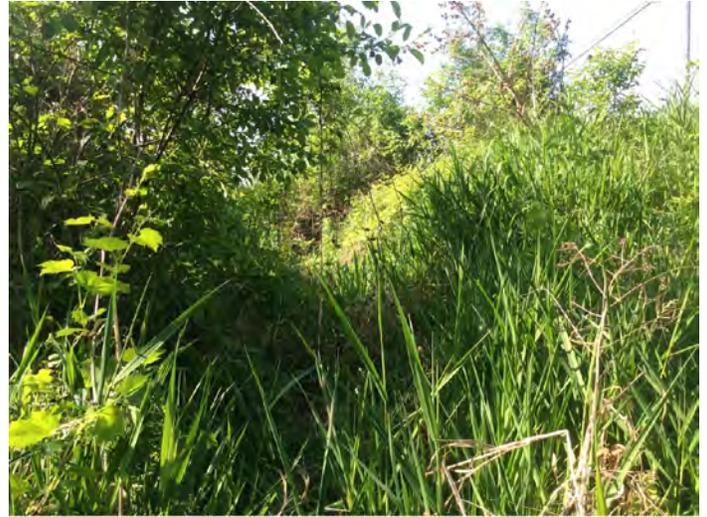
**Condition:** Poor

Field tile outlet on right side is broken 30 ft south of drain. Side drain formed. Photo1 facing south.

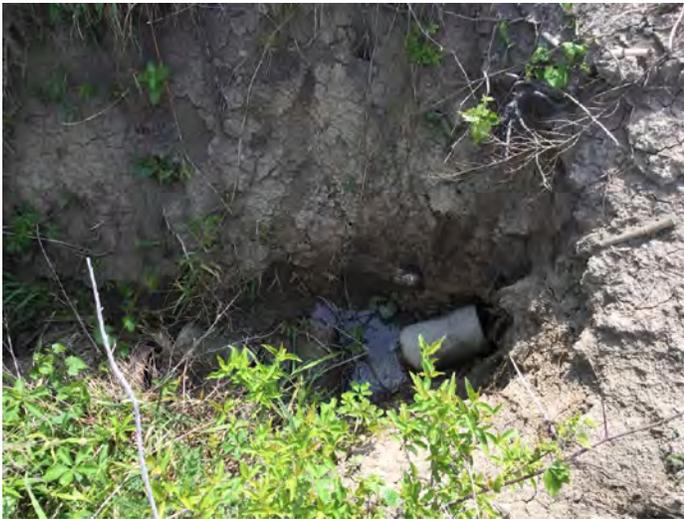
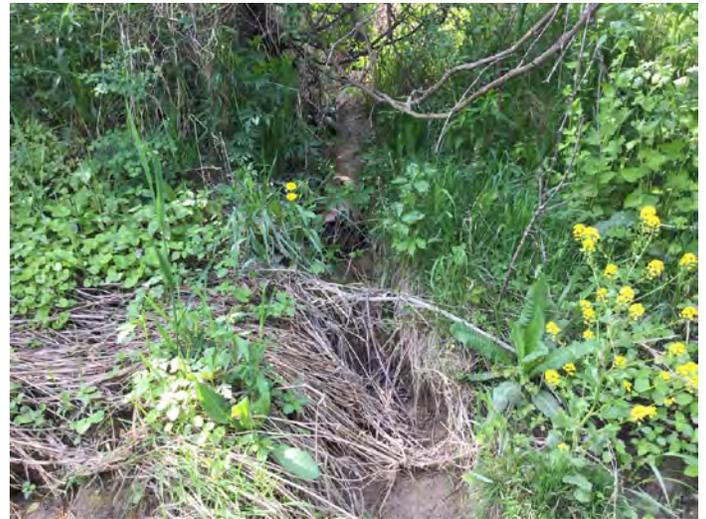
**Condition:** Failed

Clay field tile on right side facing upstream. Broken apart in failed condition. CMP extending 20 ft from field. Rusting. Photo 1 taken facing looking down at field tile. Photo 2 facing south.

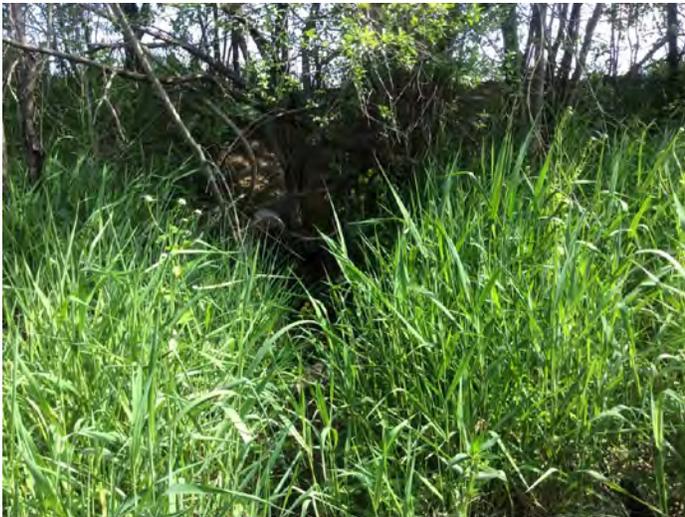
**Photo 1**

**Condition:** Fair

8" diam cmp field tile outlet enters drain on left side. Photo facing north.  
Erosion at the outlet. Stretches inland 8 ft.

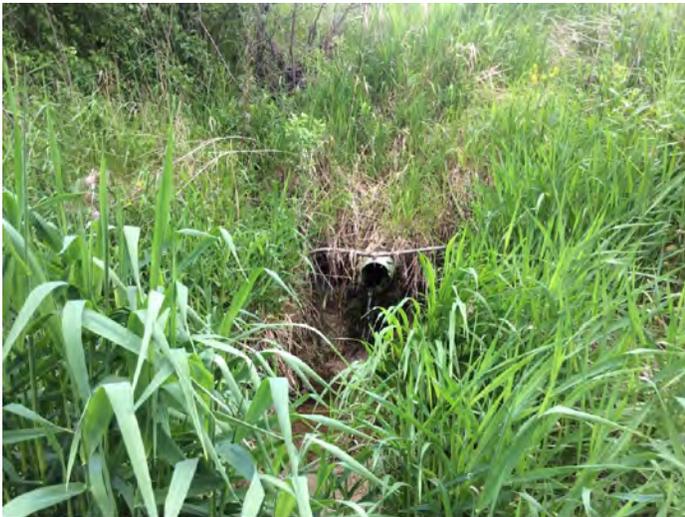
**Photo 1**

**Condition:** Fair

6" green plastic field tile outlet enters drain on right side. Erosion at outlet. Photo facing south.

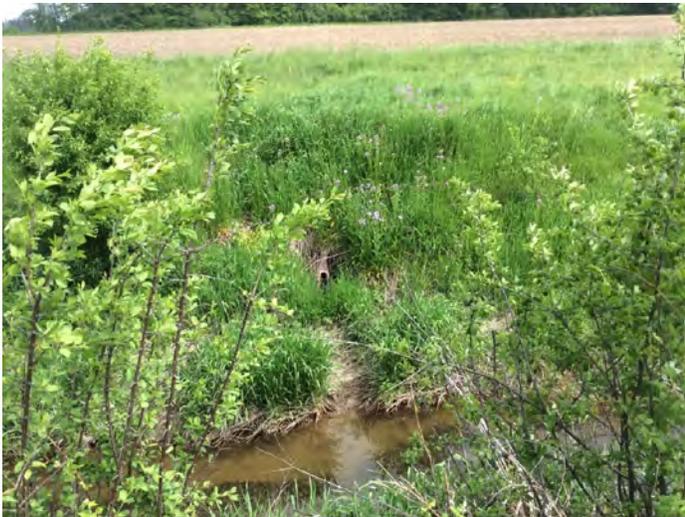
**Photo 1**

**Condition:** Fair

4" PVC field tile outlet enters drain on left. Photo1 facing north.

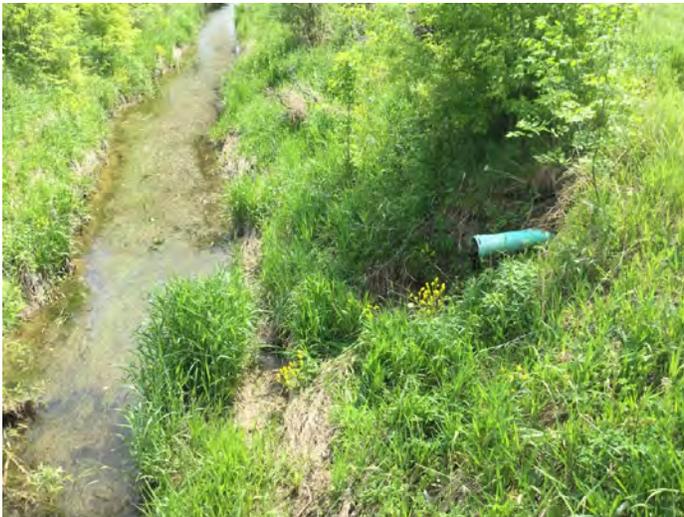
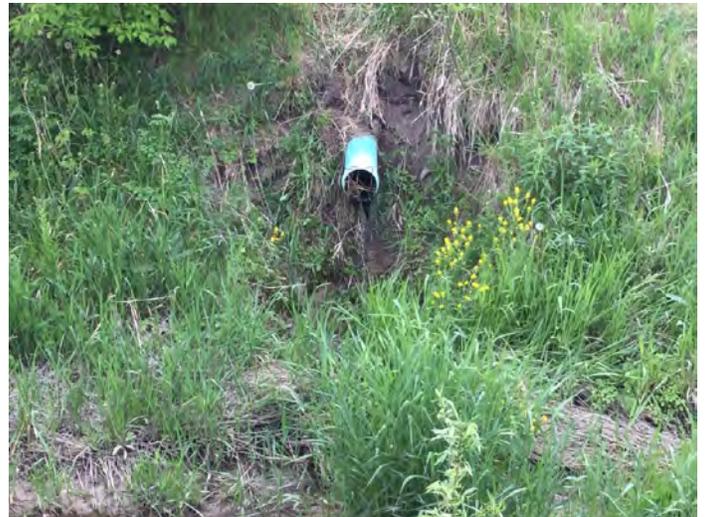
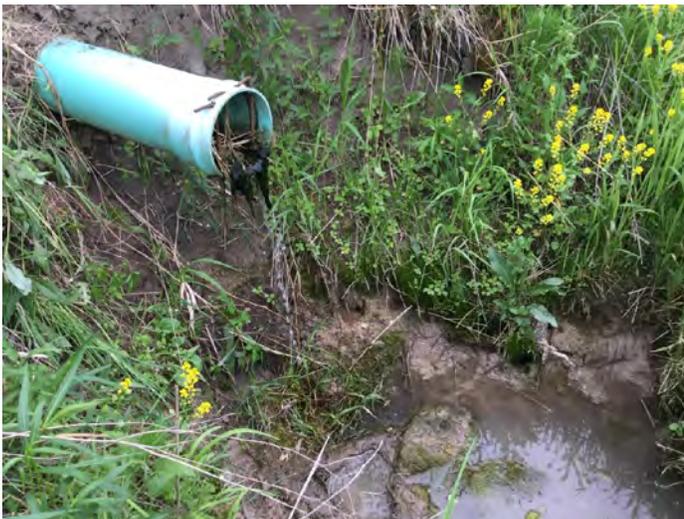
**Condition:** Fair

Field tile outlet on right side of drain facing upstream. Plastic material. About 10" diameter. Fair condition, little rusty, but no direction to flow into drain. Photo 1 taken facing upstream. Photo 2 taken facing south. Photo 3 taken facing southwest.

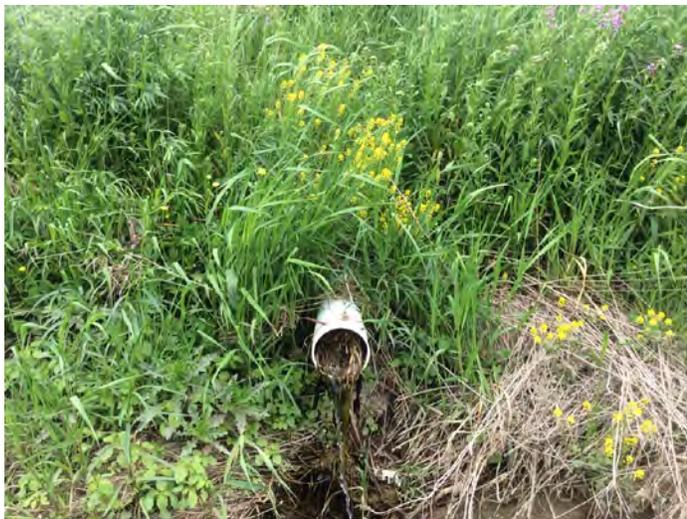
**Photo 1**

**Condition:** Good

6" field tile outlet enters drain on left. Grate is plugged. Opposite of additional field tile. Photo facing north.

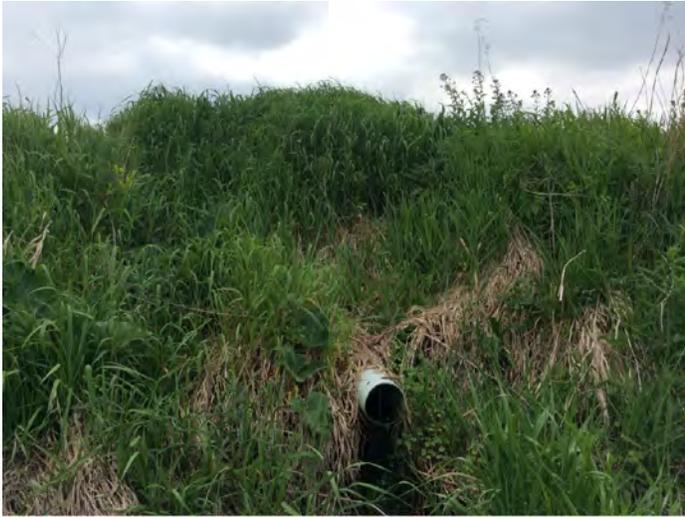
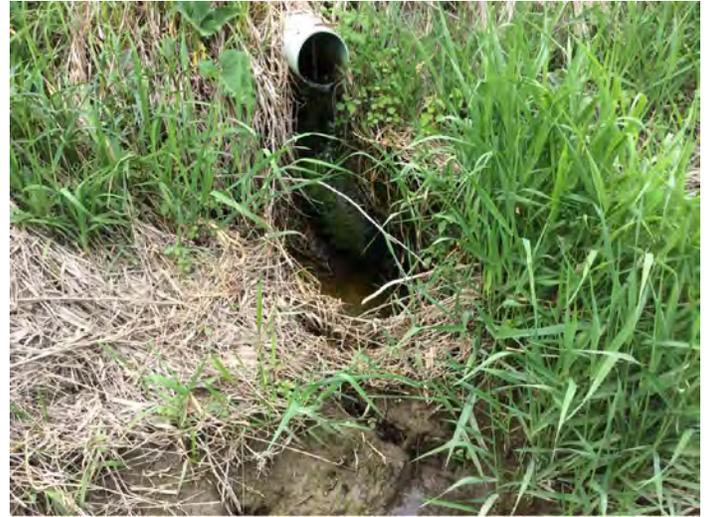
**Condition:** Good

6" field tile enters drain on right side. Splash pad present but in poor shape. Opposite of additional field tile outlet. Photo facing south.

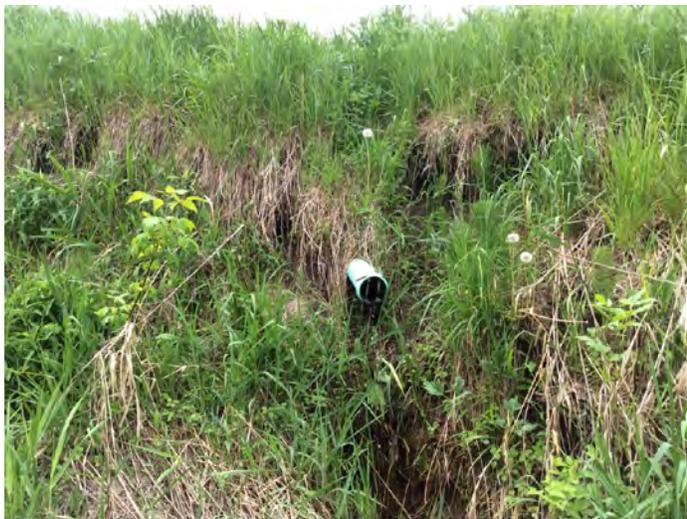
**Photo 1**

**Condition:** Good

4" field tile outlet enters drain on right side. No splash pad. Erosion at outlet. Photo facing south.

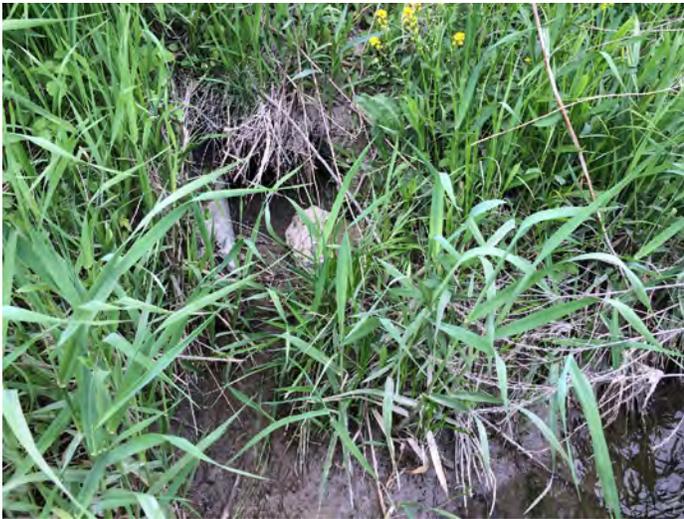
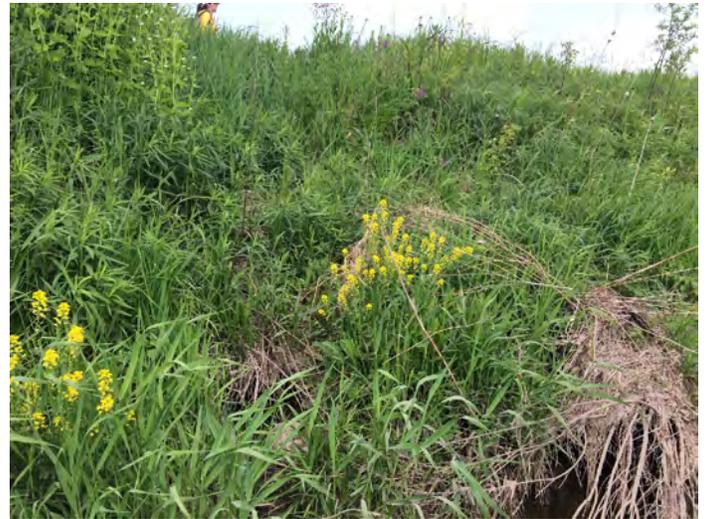
**Condition:** Failed

Failed metal field tile outlet enters drain on left. Erosion around it. Sediment cave in on left side of bank. Photo1 facing northwest.

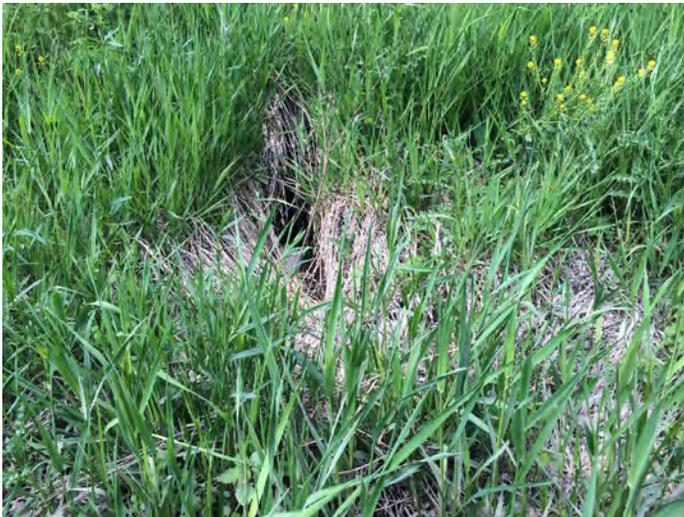
**Photo 1**

4" diam failed metal field tile outlet enters drain on left side. Erosion around it. Broken piece 6 ft from drain channel. Photo facing northwest.

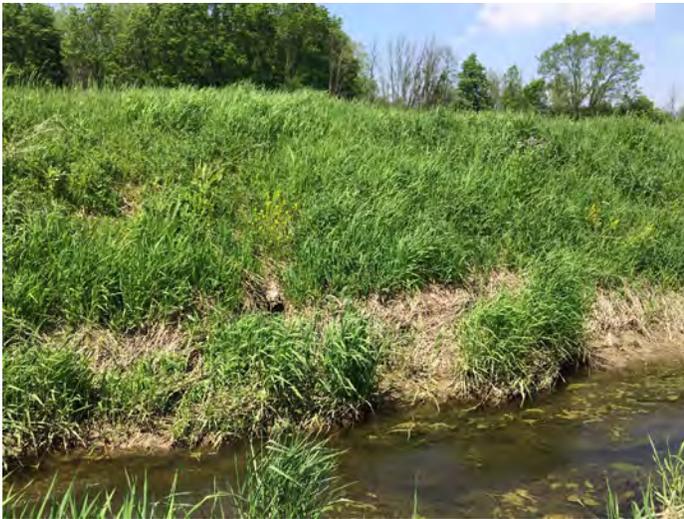
**Photo 1**

Failed 3" diam metal field tile outlet on left side of drain. Photo facing northwest.

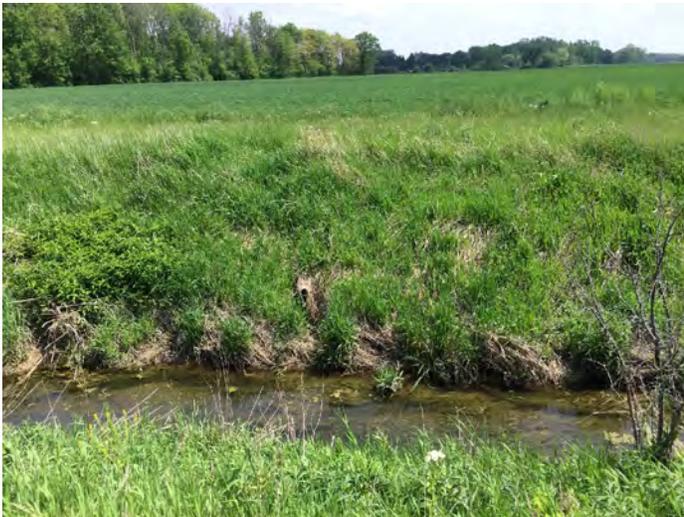
**Photo 1**

**Condition:** Fair

4" pvc field tile outlet enters drain on right side. Photo facing southeast.

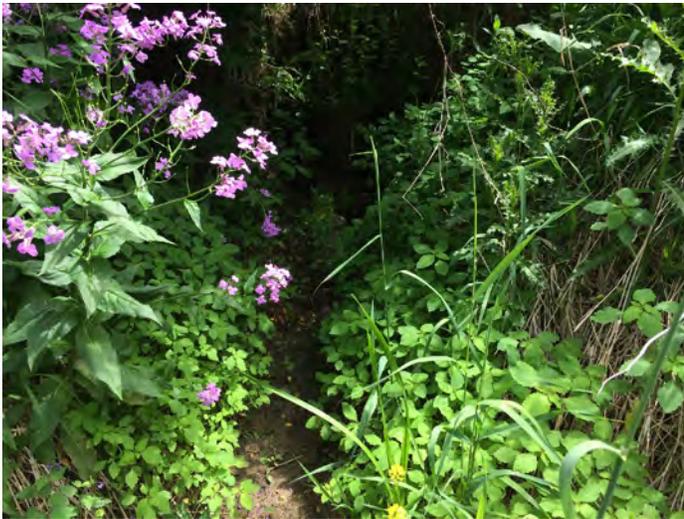
**Photo 1**

**Condition:** Failed

Could not determine pipe material. 6" field tile outlet enters drain on right. Broken segments. Bank erosion inland 20 ft.

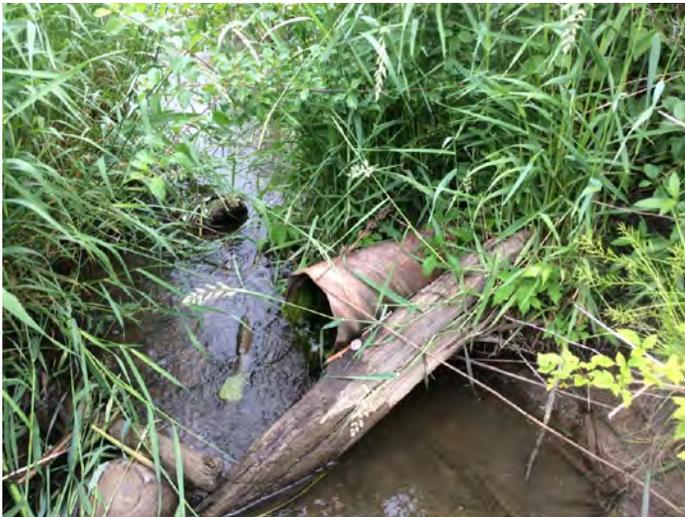
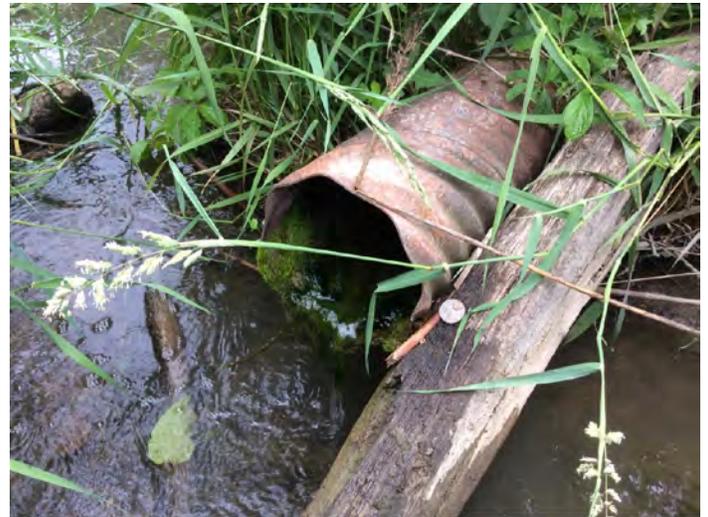
**Condition:** Poor

Field tile on left side of drain. Rusted with vegetation growing inside. About 8" diameter. Layered with excessive vegetation around drain.

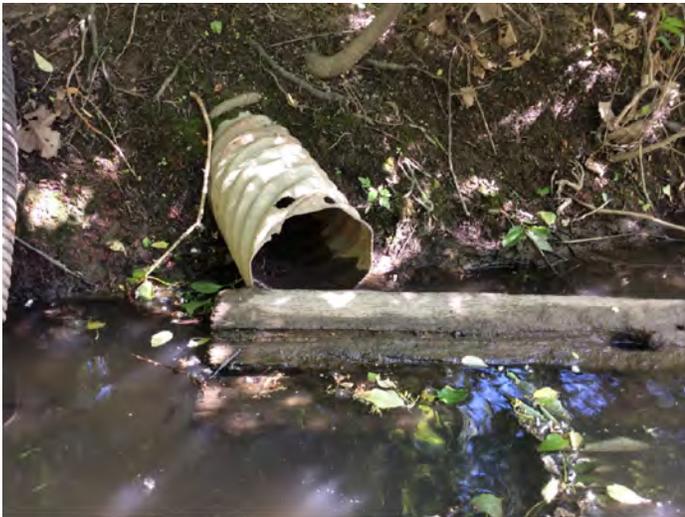
**Photo 1**

**Condition:** Fair

Clay field tile on right side of drain. Fair condition about 20" diameter. Holes on top. Not sure if field or surface outlet because of soccer field.

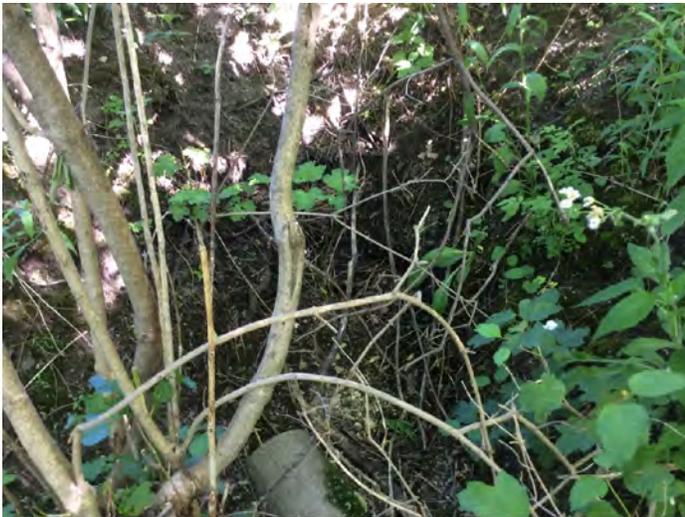
**Photo 1**

**Condition:** Failed

Buried field tile outlet enters drain left side. Broken end segment. Erosion at outlet.

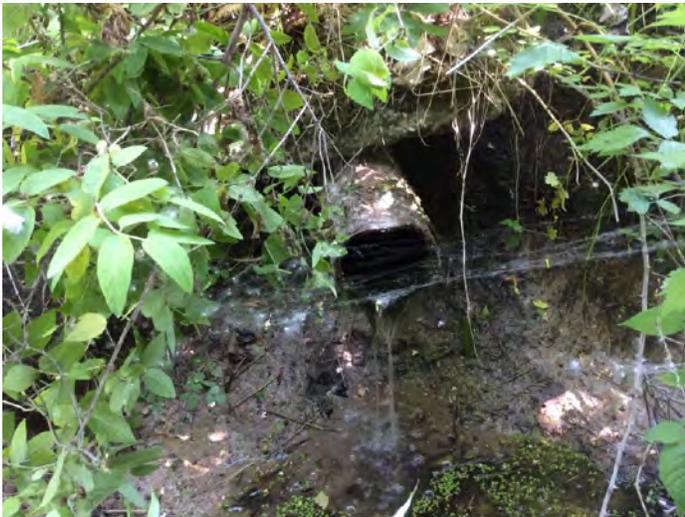
**Photo 1**

**Condition:** Poor

6" field tile outlet enters drain on left. Loose sediment downstream. Concrete block head wall.

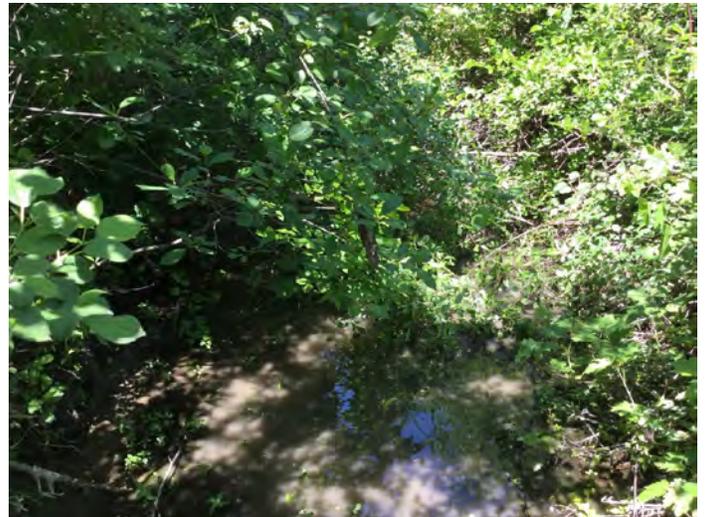
**Condition:** Fair

Field tile on left side of drain. Hidden under excessive overhanging vegetation. 4 in. in fair shape, little rusty. Hard to get picture. Can see an attempt at a splash pad, but is not in use right now.

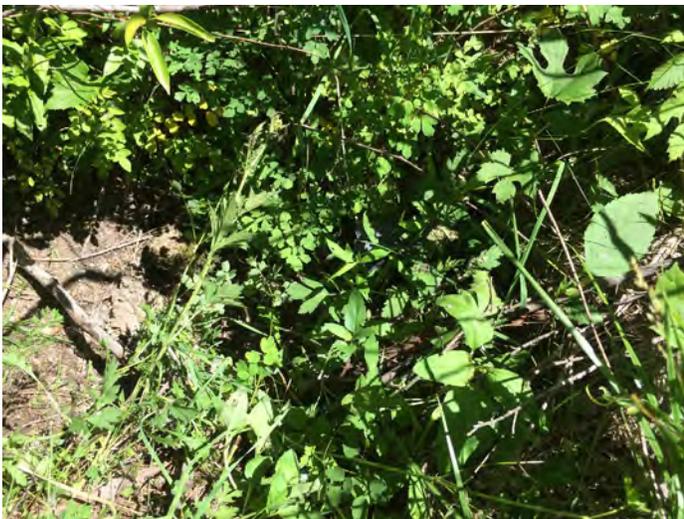
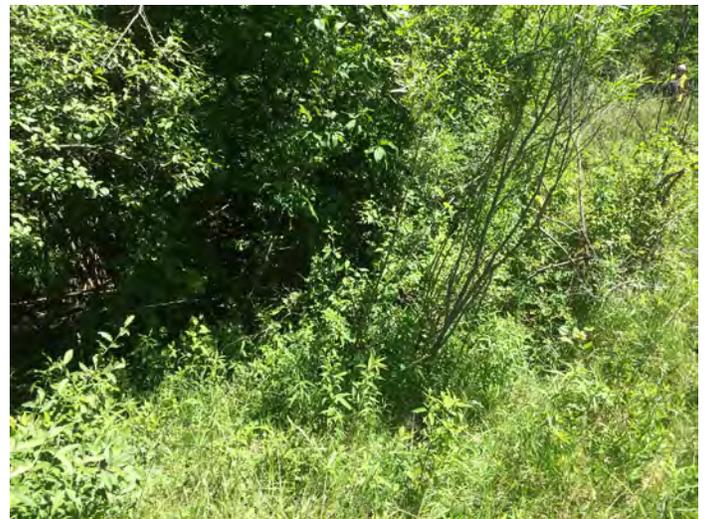
**Condition:** Poor

4" diam hdpe field tile outlet enters drain on right. 15 ft right of drain. End piece is cracked. Erosion at outlet. On downstream side of farm crossing.
