King Street Tile Drain Inspections

Inspection Report for Observation:
GeneralConditionPhoto1

CLIENT	Saginaw County Public Works Commissioner

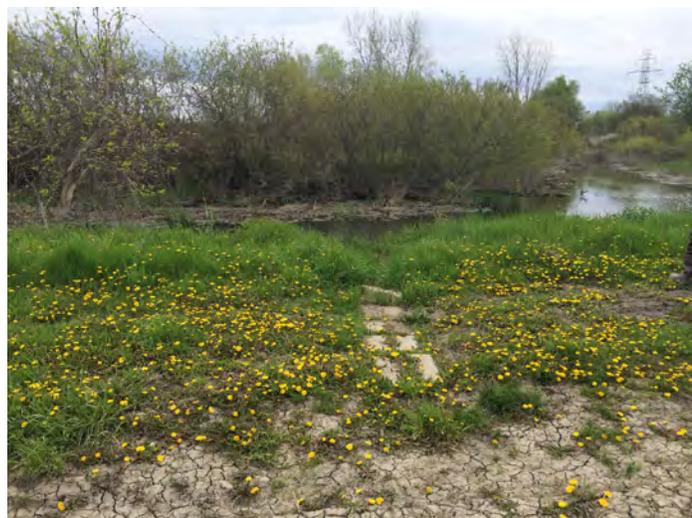
Seems like a field tile marker, but field tile outlet not visible.

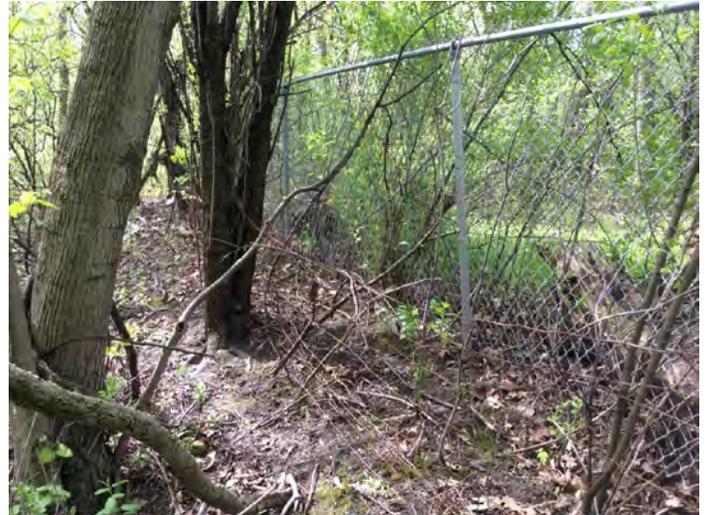
Fence at top of bank runs along the drain on right side for 80 ft. Photo1 facing southwest. Photo 2 facing southeast. Two fences.

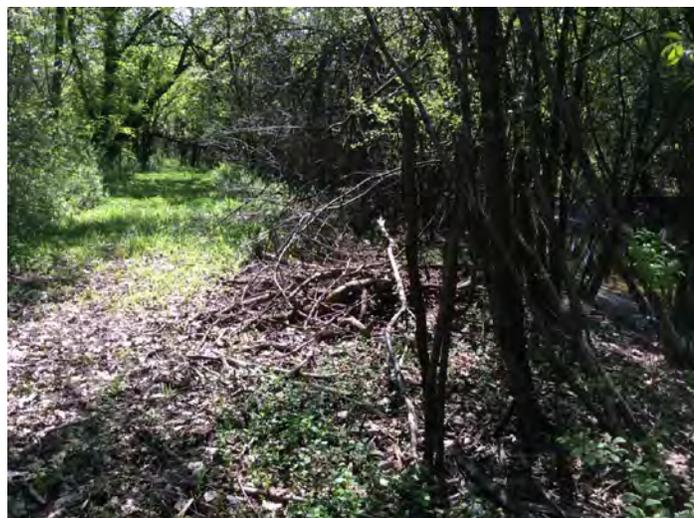
Facing upstream. Access path on left side of drain over next 650 ft.

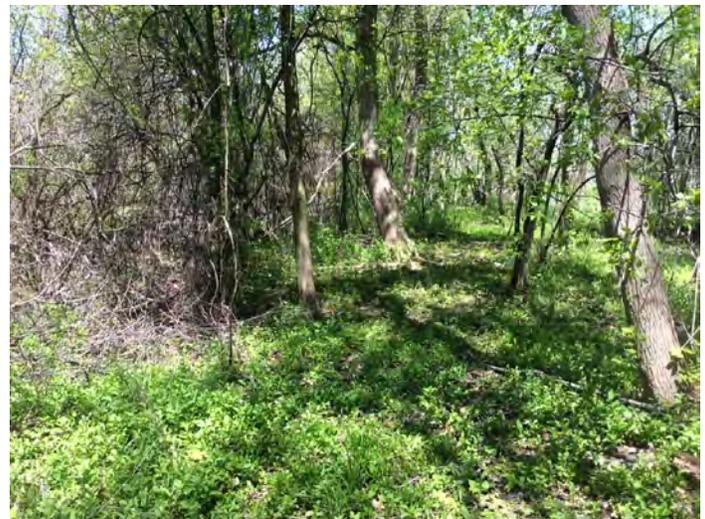
Photo1 upstream. Photo2 downstream. Access path continues on left side of drain. On north side of drain. Next 300 ft.

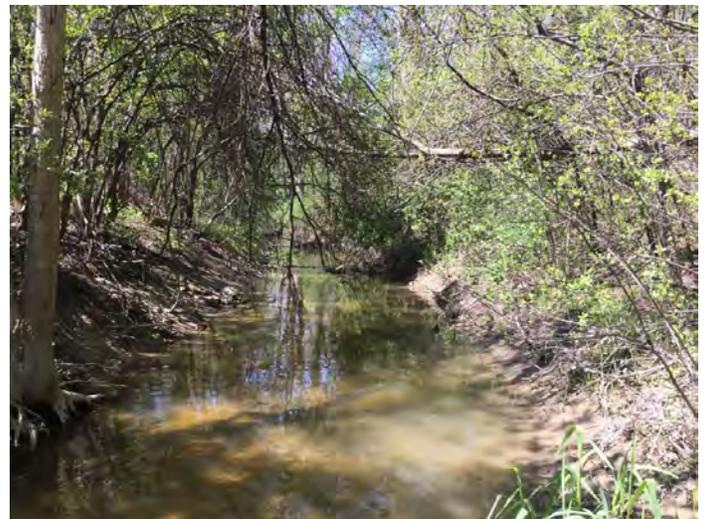
Significant change in channel width. 6 ft upstream. 12 ft downstream.
 Photo1 upstream. Photo2 downstream.

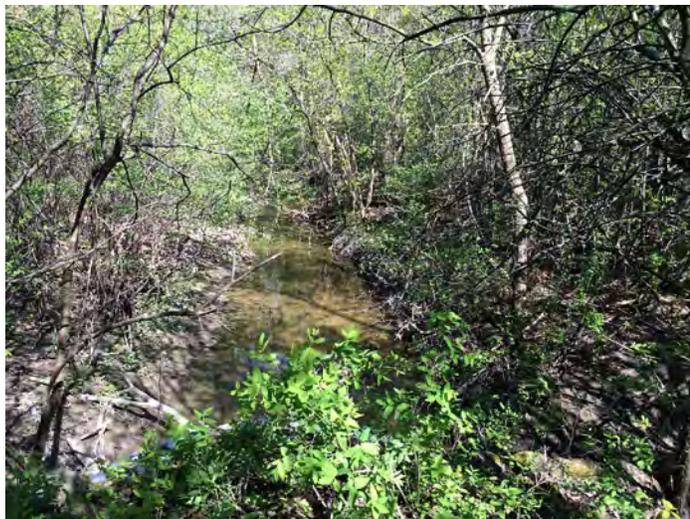
Photo1 upstream. Photo2 downstream. From culvert crossing.

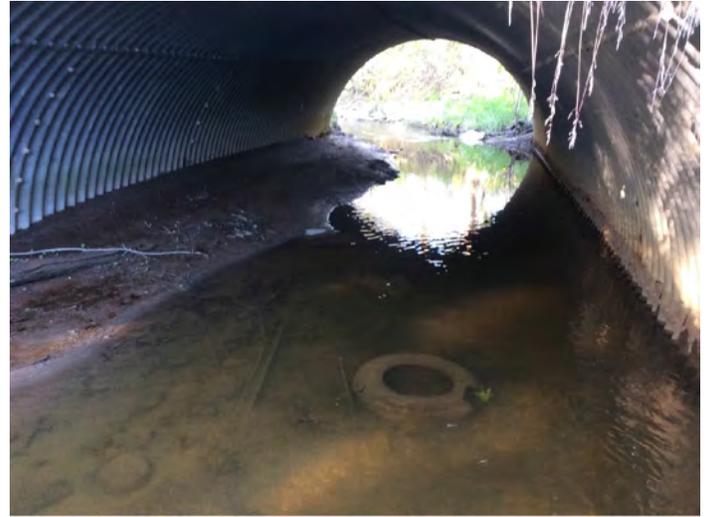
Photo1 upstream. Photo2 downstream through culvert under Washington rd. Debris and sediment inside culvert.

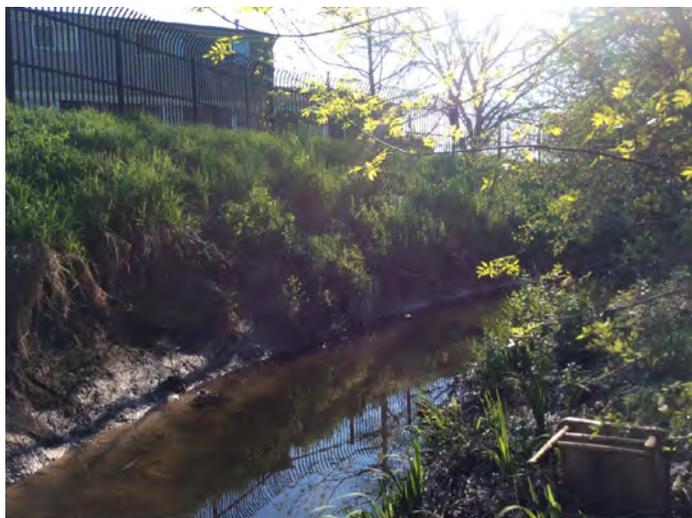
Steep side slope on left side of drain.

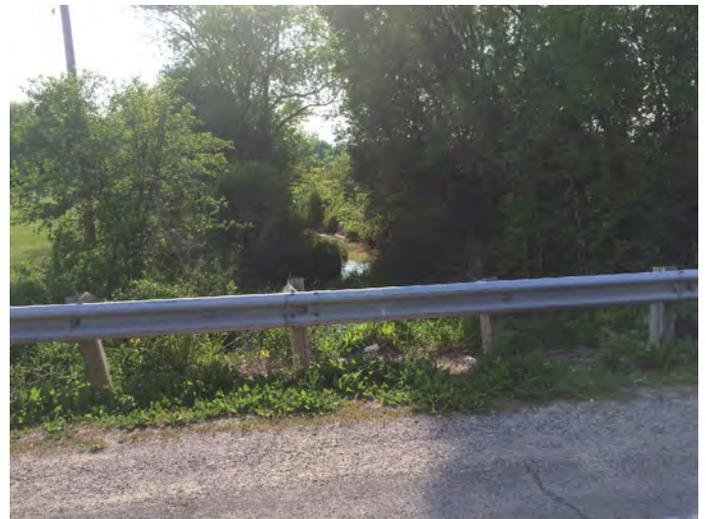
Photo1 facing upstream. Photo2 facing downstream. Guardrails on both sides. From sheridan rd.

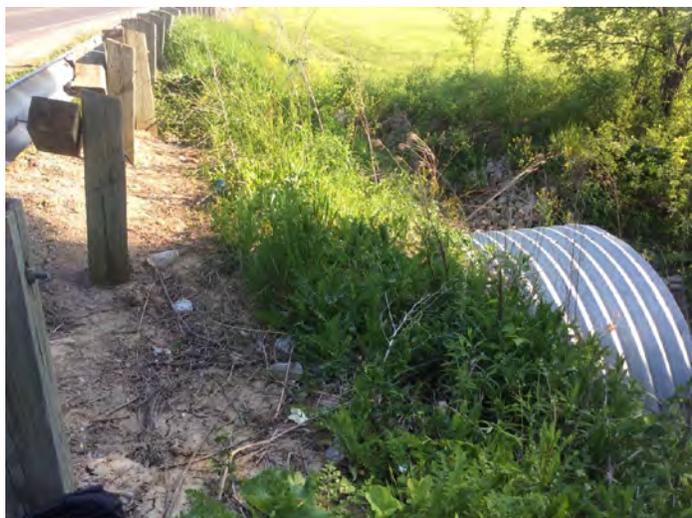
Trash on both sides of culvert crossing. Photo taken facing south.

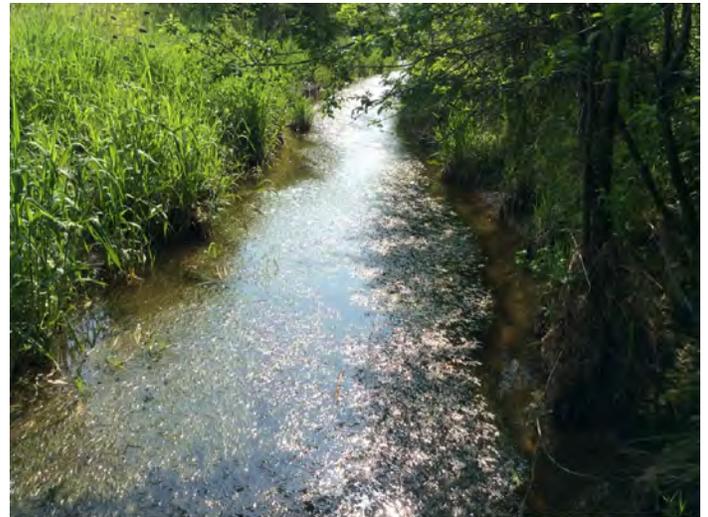
Heavy vegetation growing in the bottom of the drain channel is essentially restricting width to 1.5 ft. Vegetated area is soft sinking sediment. Channel part is hard and easy to walk on.

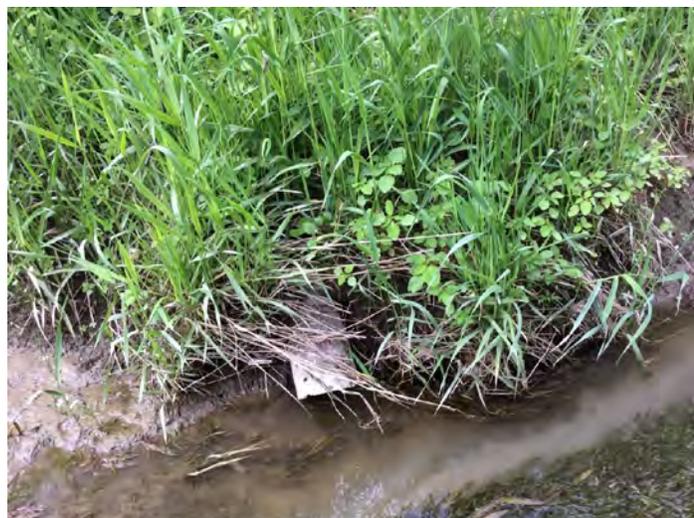
Broken piece of field tile on right side, but could not find an outlet.

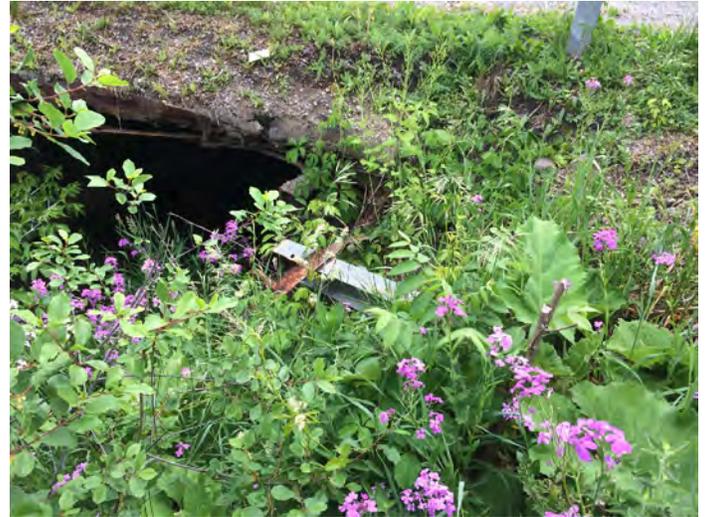
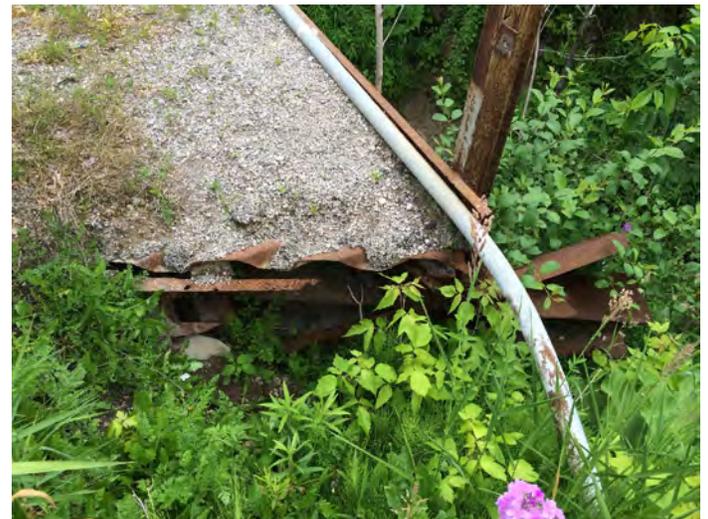
Bridge crossing at williamson rd in poor condition. Photo1 facing southeast on downstream side. Photo2 facing upstream on downstream side. Photo3 downstream side. Photo4 upstream side.

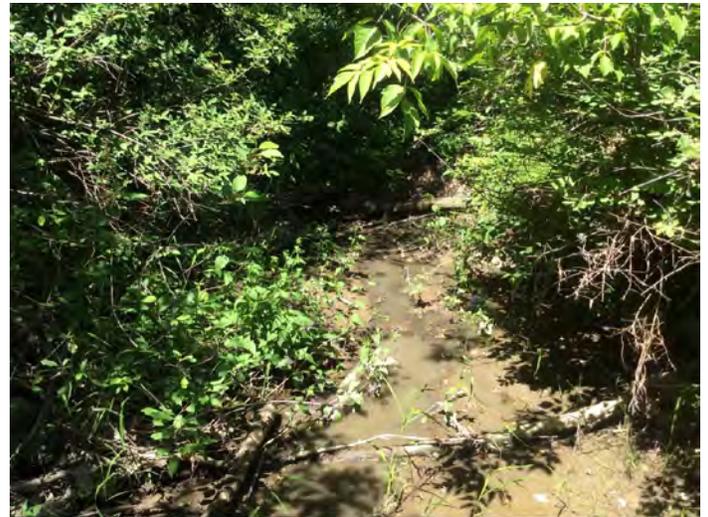
Taken at bend in drain. Upstream seems manageable. Downstream along ag field is loose sediment, heavy vegetation, and very difficult to walk through.
