# King Street Tile Drain Inspections

Inspection Report for Observation:  
**SideDrain1**

CLIENT	Saginaw County Public Works Commissioner

<b>HUBBELL, ROTH &amp; CLARK, INC</b> CONSULTING ENGINEERS SINCE 1915	555 Hulet Drive P.O. Box 824 Bloomfield Hills, MI 48303-0824 (248) 454-6300 <a href="http://www.hrc-engr.com">http://www.hrc-engr.com</a>	DATE:	08/16/2016
				SCALE:	
NOTE				SHEET #:	
				JOB #:	20160331

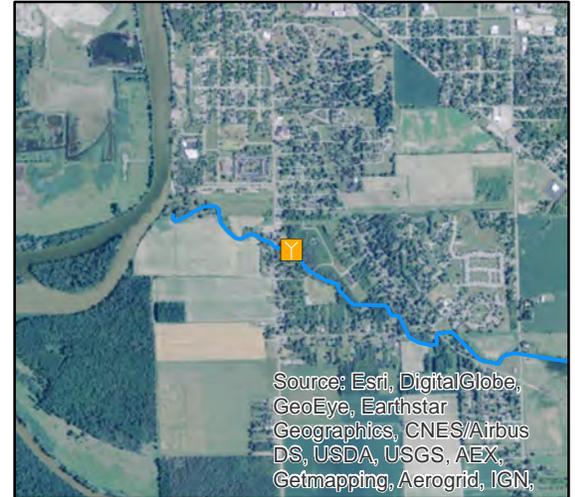
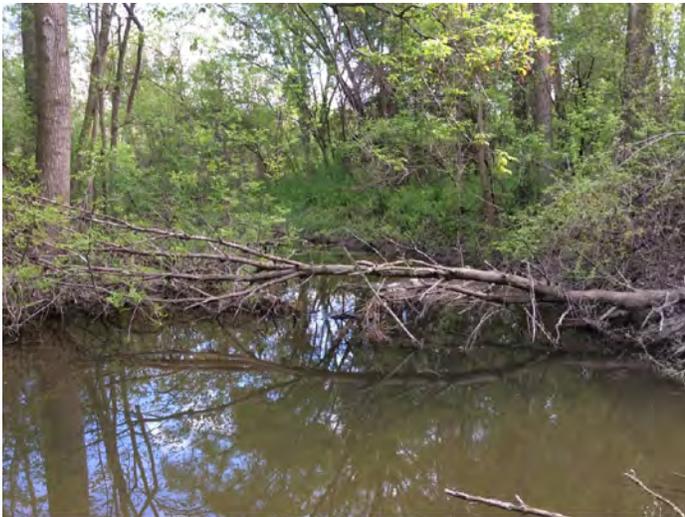
12 ft wide side drain enters drain on left side. Flows south. Drain increases in width downstream of side drain. Photo facing north.

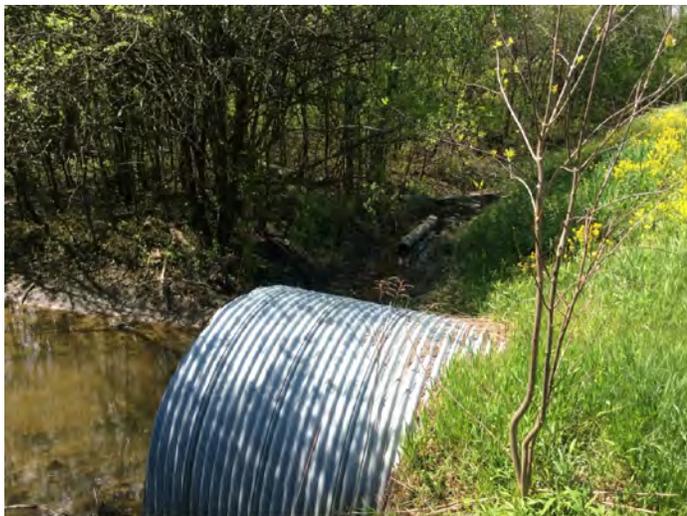
Inspection Report for Observation:  
**SideDrain2**

Side drain flows northeast. Enters drain on right side. 5 ft wide. Photo facing southwest.

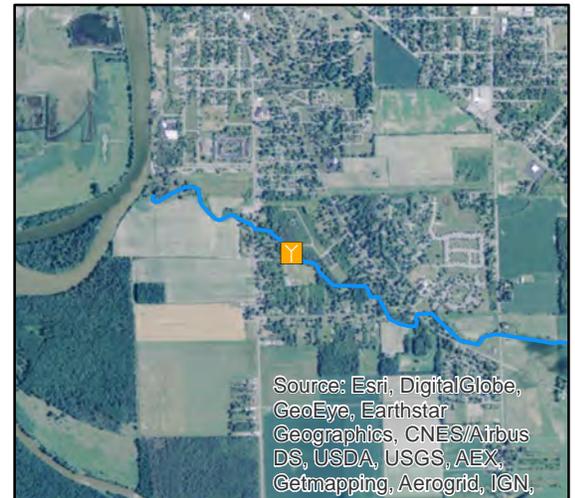
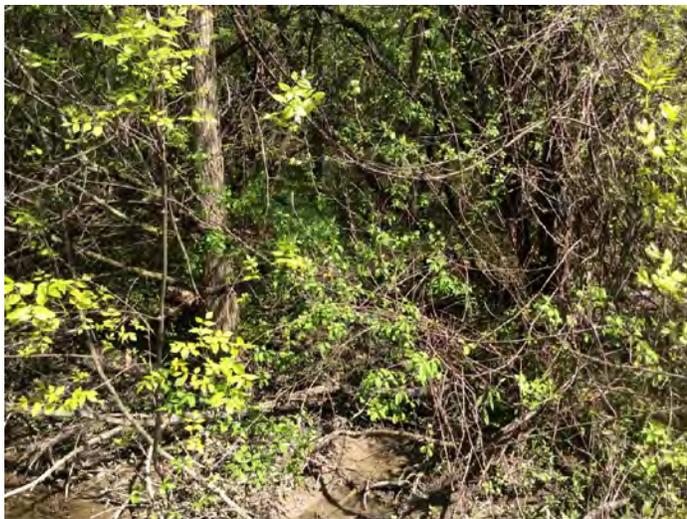
Inspection Report for Observation:  
**SideDrain3**

2ft wide side drain enters on left. Photo facing northeast. Flows southwest.

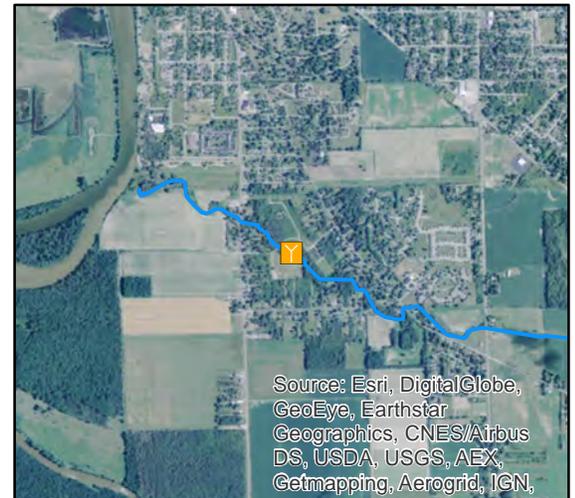
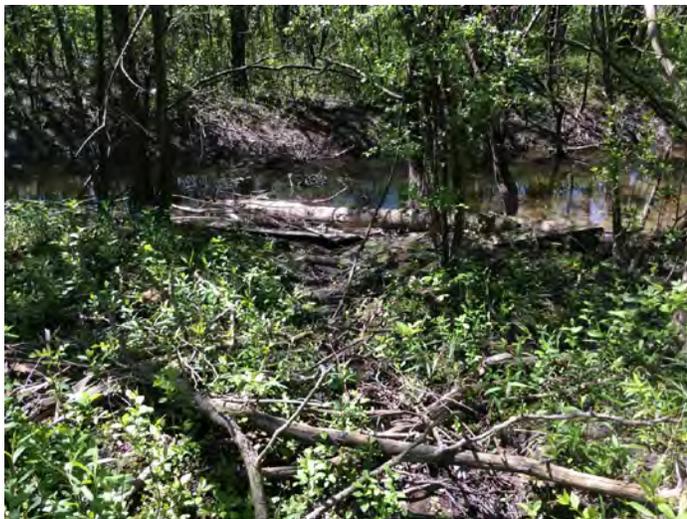
Inspection Report for Observation:  
**SideDrain4**

1.5 ft wide side drain flows south. Enters drain on left side. Photo facing southwest.

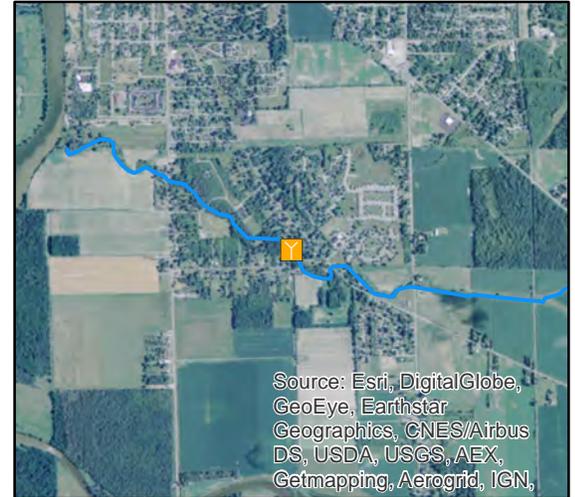
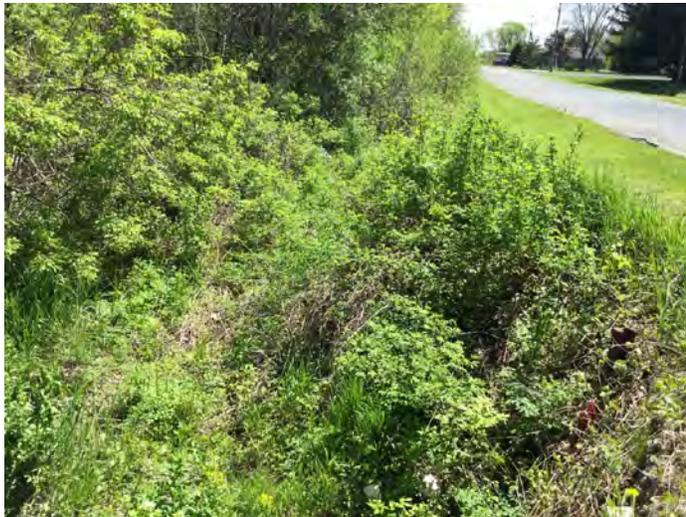
Inspection Report for Observation:  
**SideDrain5**

2 ft wide side drain flows north along Casey dr. Photo facing south.

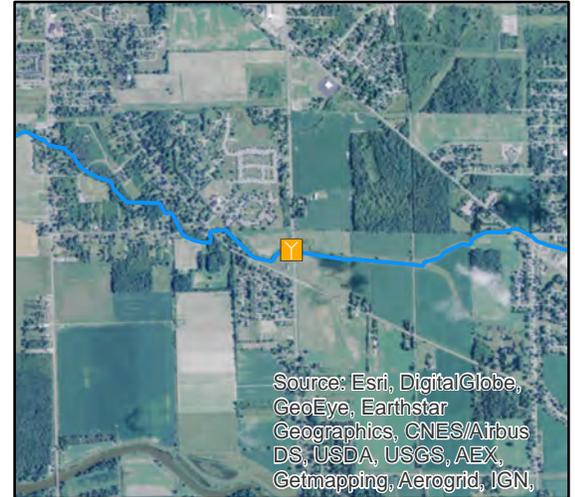
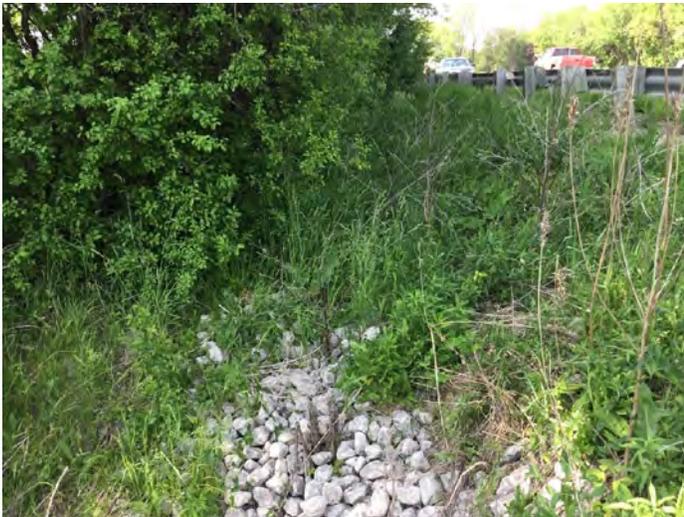
Inspection Report for Observation:  
**SideDrain6**

Roadside ditch along west side of Sheridan rd flows south into drain. Enters drain on left. Photo facing north. Heavy vegetation in it.

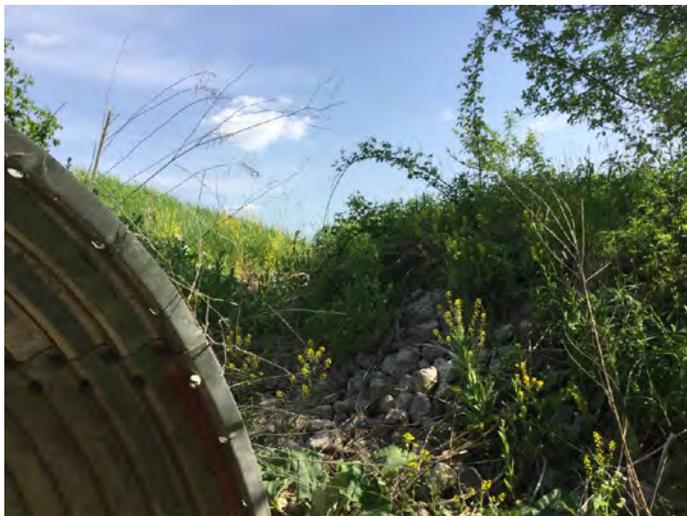
Inspection Report for Observation:  
**SideDrain7**

Roadside ditch on west side of Sheridan rd enters drain on right side. 3 ft wide. Heavy vegetation. Photo facing south.

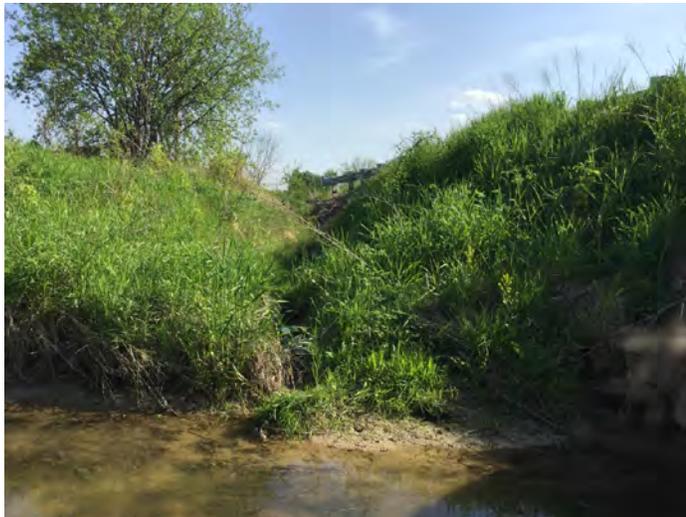
Inspection Report for Observation:  
**SideDrain8**

Roadside ditch on east side of Sheridan rd flows north and enters drain on right. 3 ft wide. Photo facing south.

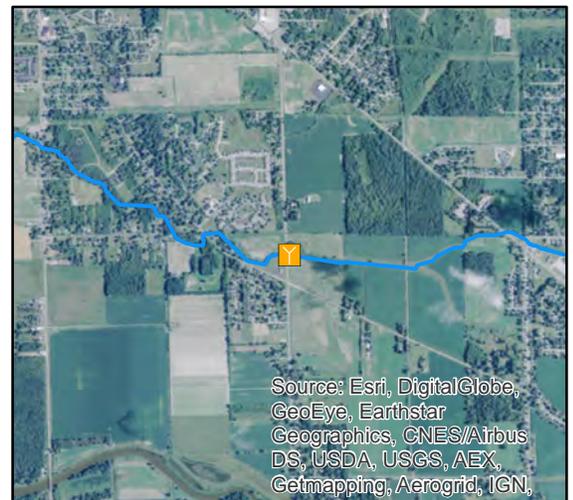
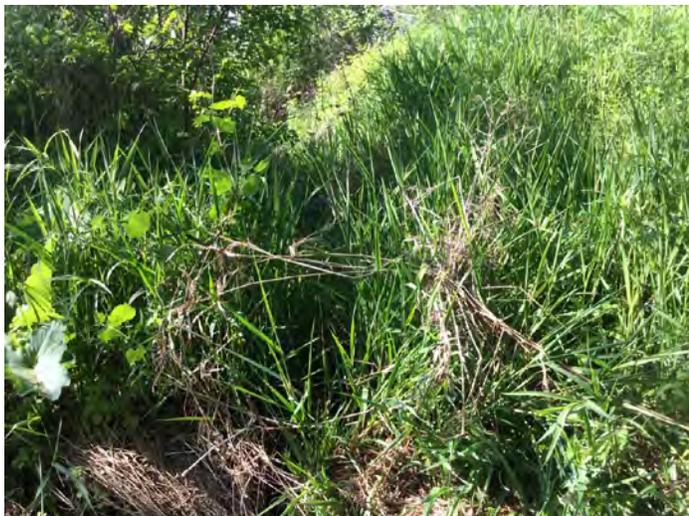
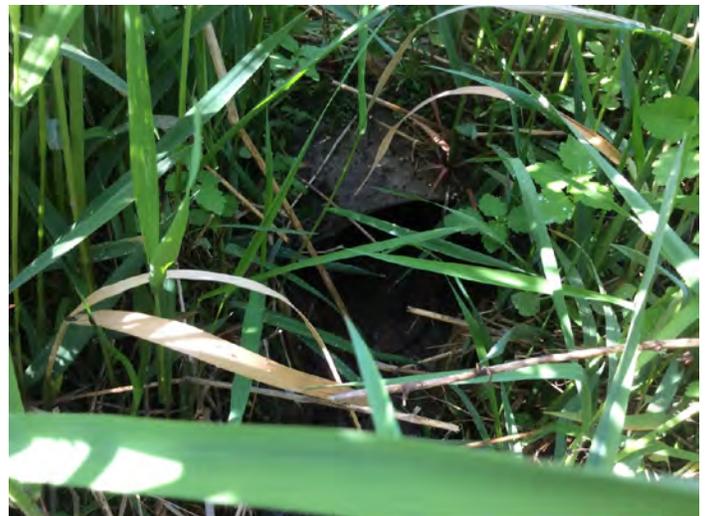
Inspection Report for Observation:  
**SideDrain9**

Side drain enters drain on right side. 2 ft wide. Carries drainage from field tile outlet. Includes a failed 6" diam cmp that is rusted and broken. Photos facing south.

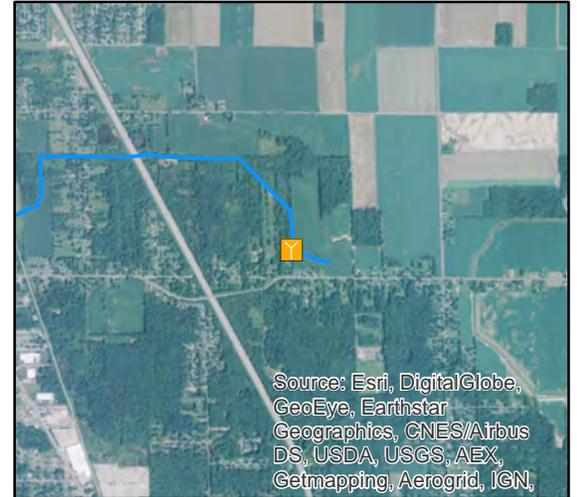
Inspection Report for Observation:  
**SideDrain10**

2ft side drain right side of drain. Picture facing west

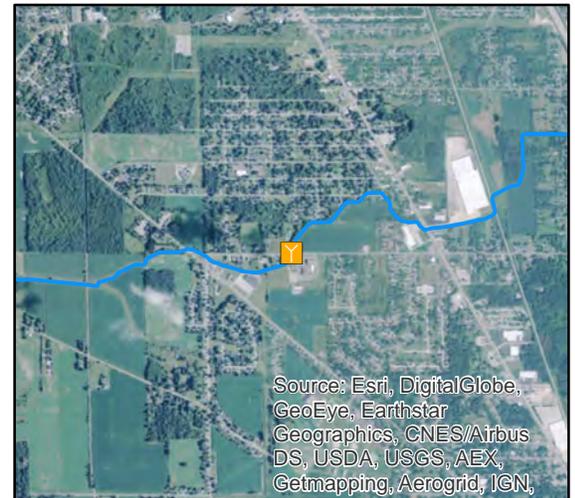
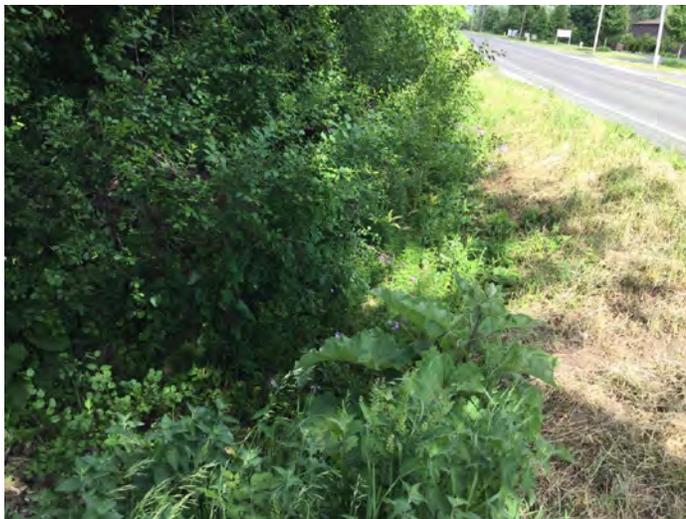
Inspection Report for Observation:  
**SideDrain12**

Roadside ditch on north side of King st flows west and enters drain on right. Heavy vegetation in it.

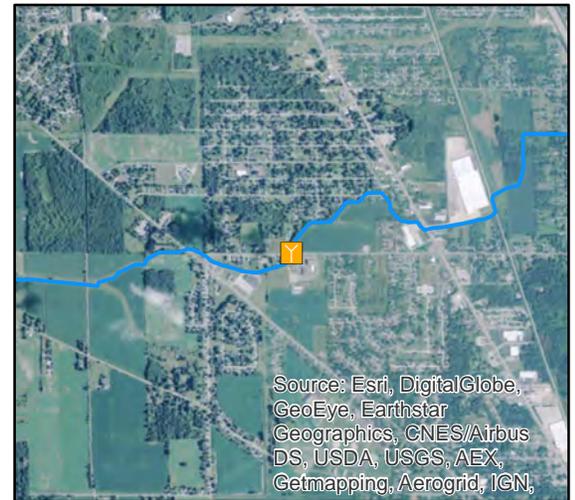
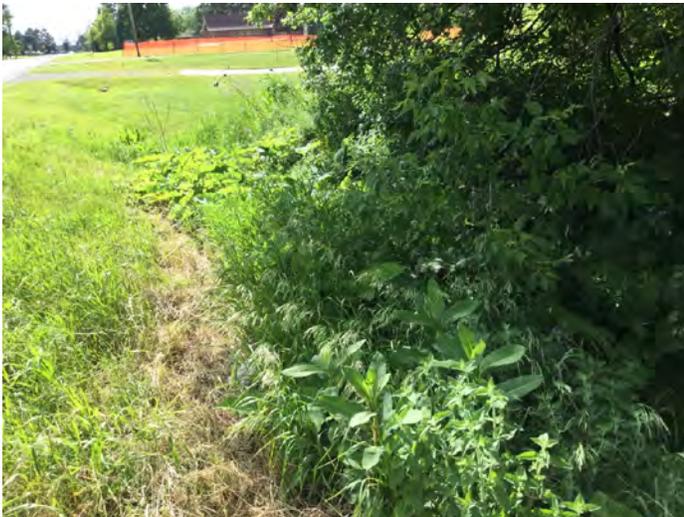
Inspection Report for Observation:  
**SideDrain13**

Roadside ditch on north side of King st flows east and enters drain on left. Heavy vegetation in it.

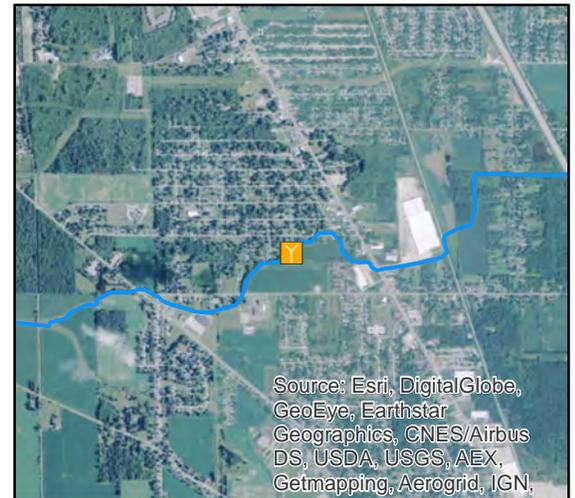
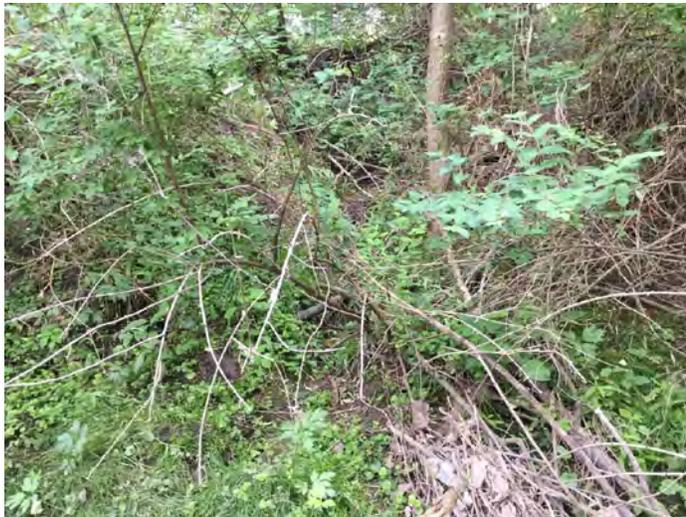
Inspection Report for Observation:  
**SideDrain14**

**Comments:**  
Side drain enters from tight. Flows northwest.

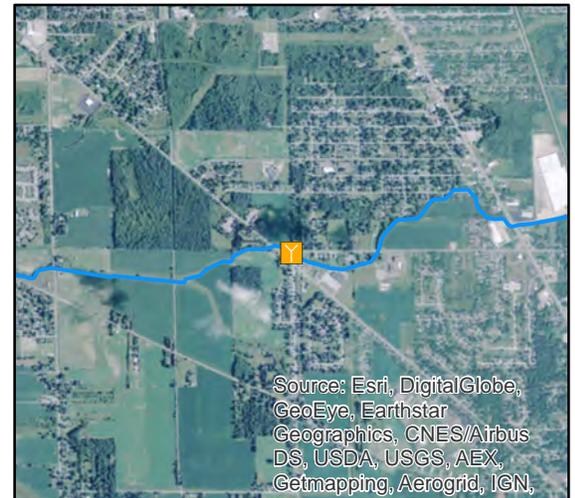
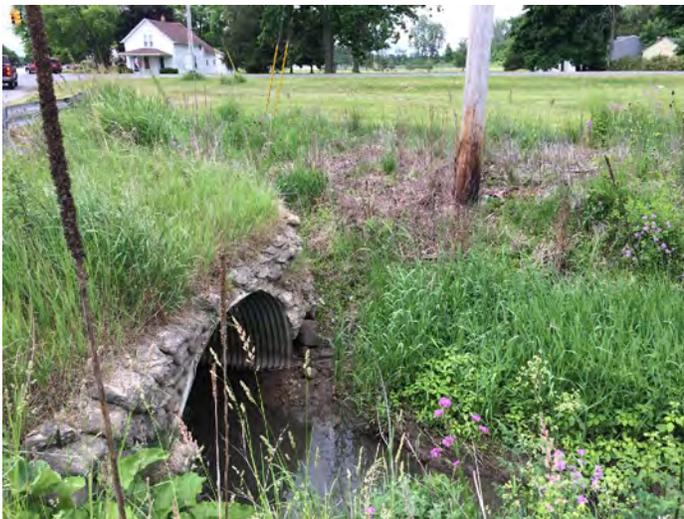
Inspection Report for Observation:  
**SideDrain15**

Side drain flows south and enters drain on right. Photo facing north.

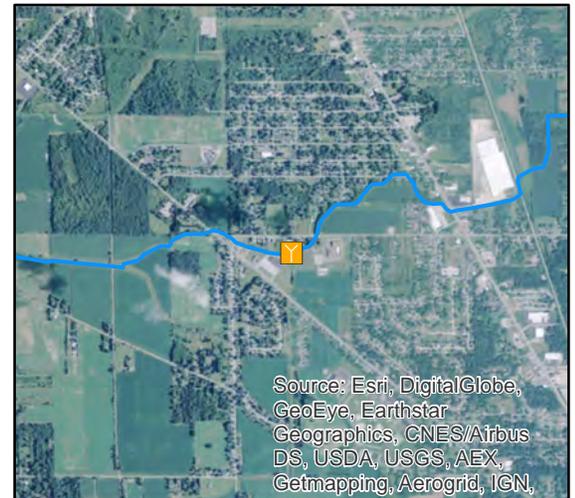
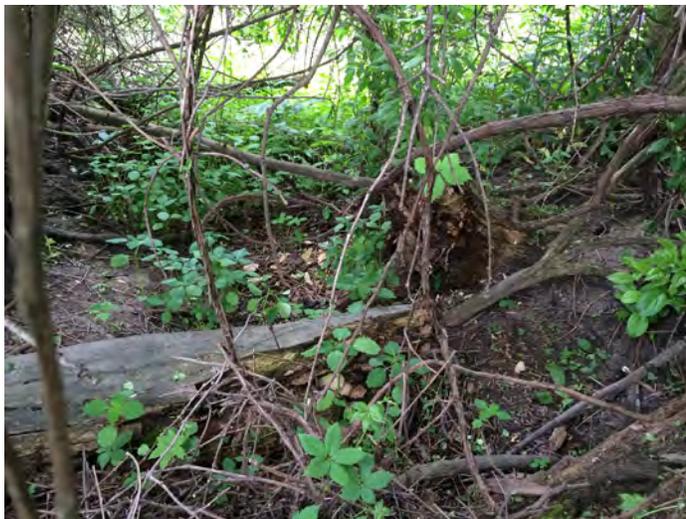
Inspection Report for Observation:  
**SideDrain16**

Side drain enters on right. Flows north.

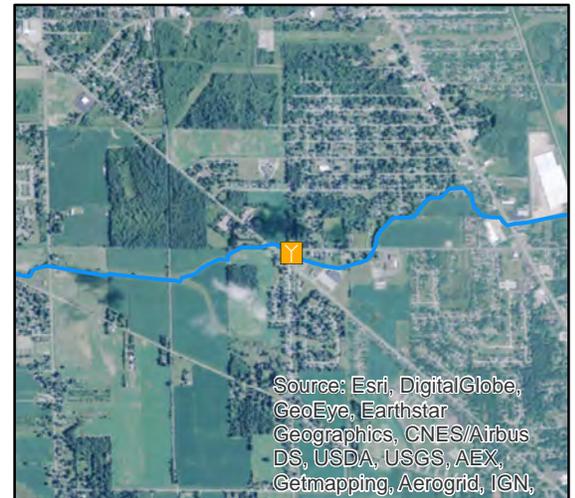
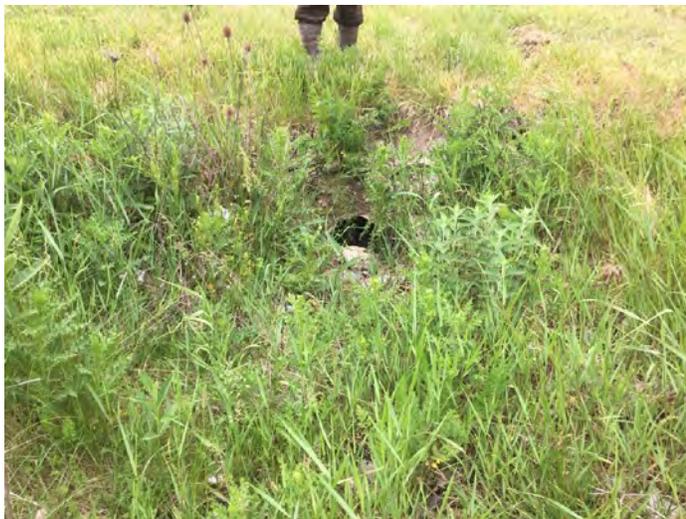
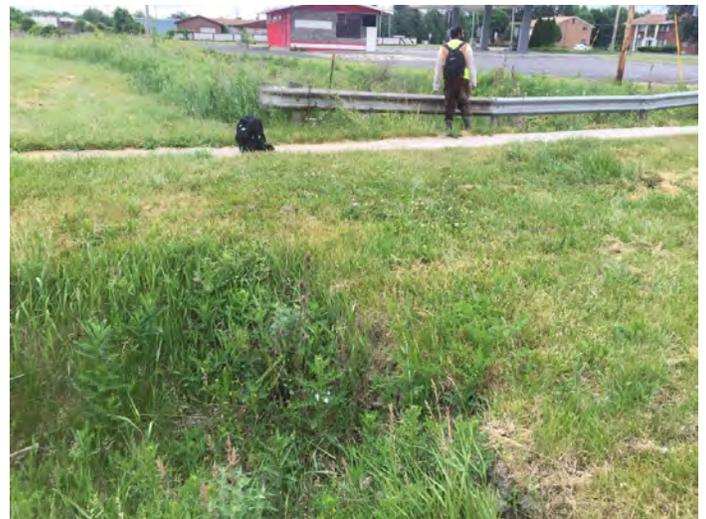
Inspection Report for Observation:  
**SideDrain17**

Side drain going across drain. 12" CMP

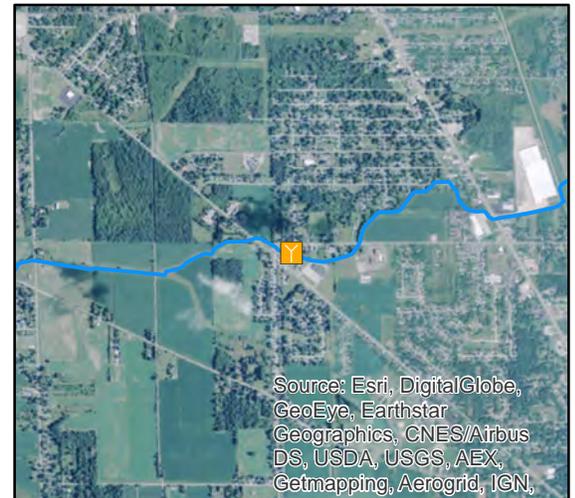
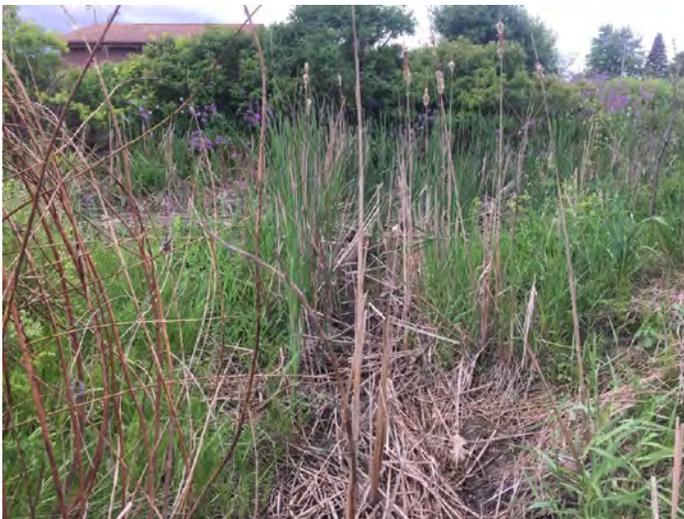
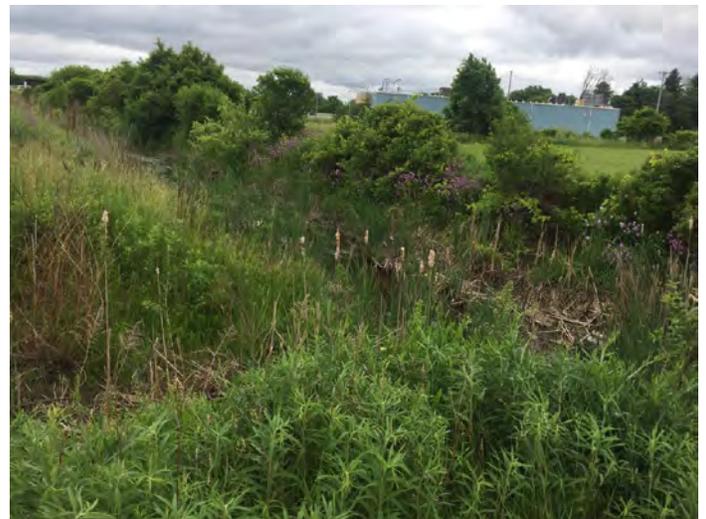
Inspection Report for Observation:  
**SideDrain18**

Side drain on left side of drain facing upstream approximately 6' wide and 8' deep.

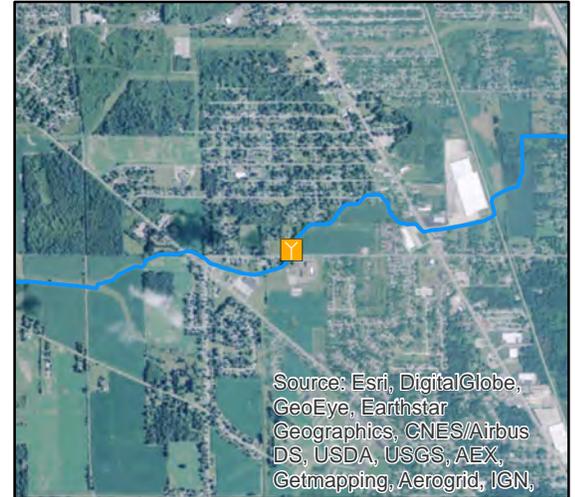
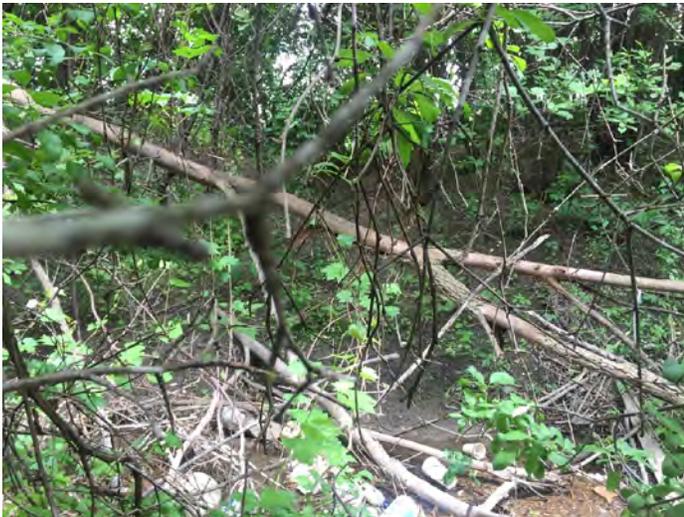
Inspection Report for Observation:  
**SideDrain19**

Side drainage ditch dumping a lot is sediment into this area. Picture facing east across the drain.

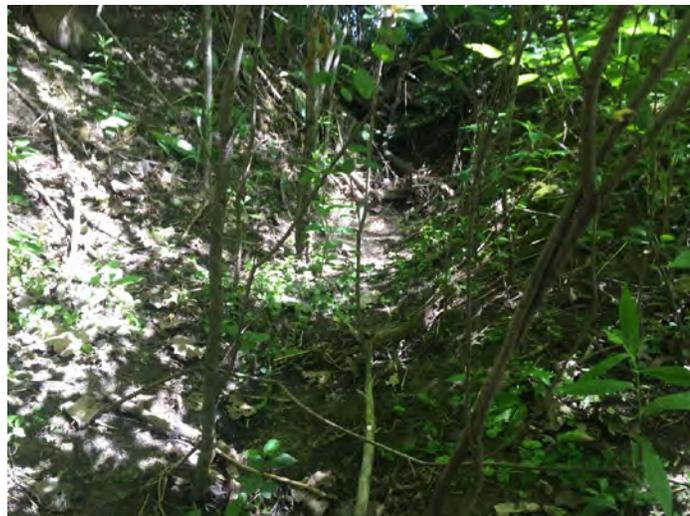
Inspection Report for Observation:  
**SideDrain20**

4' wide drain coming in the east side of drain.

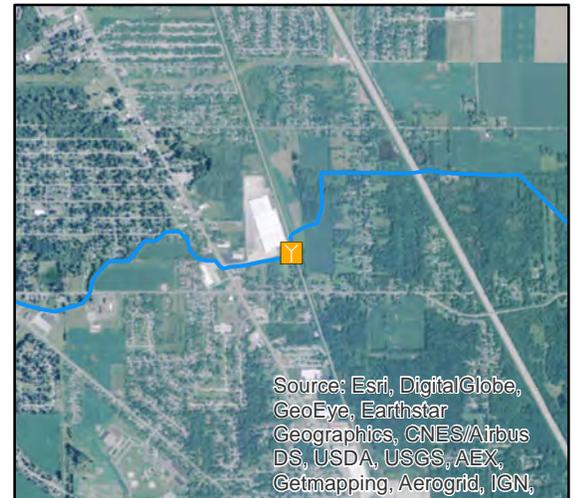
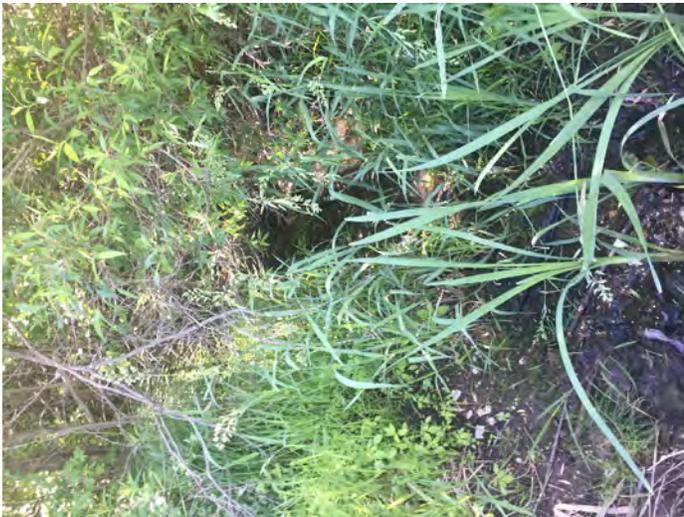
Inspection Report for Observation:  
**SideDrain21**

**Comments:**  
2' side drain right side of the drain. Picture facing Southeast

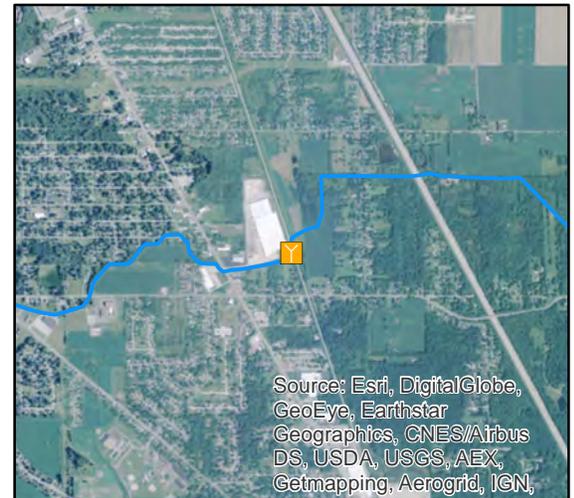
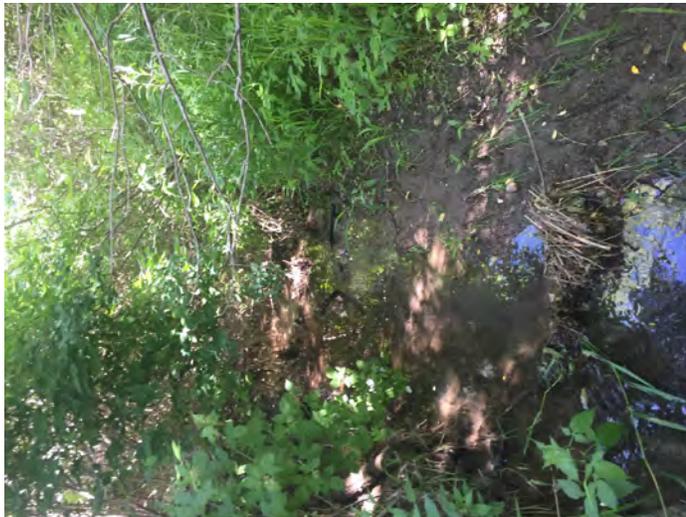
Inspection Report for Observation:  
**SideDrain22**

Side drain taking flow of the county drain due to bi pass of blocked culvert at railroad . Picture facing upstream .

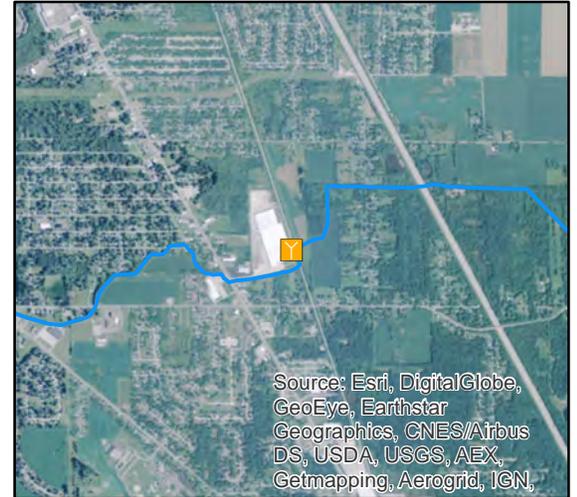
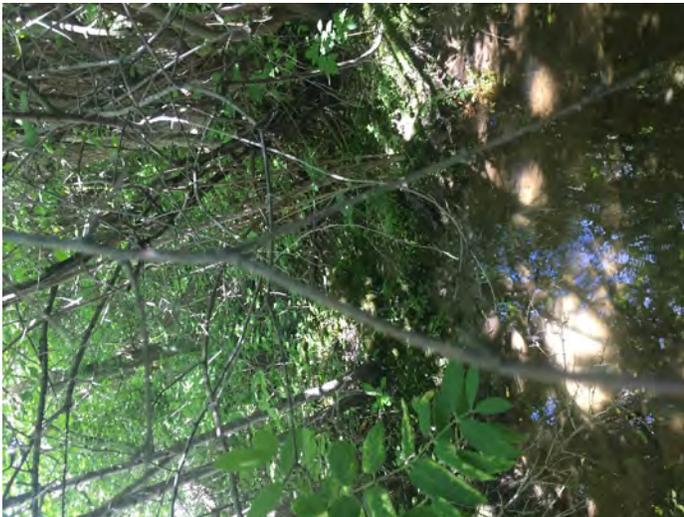
Inspection Report for Observation:  
**SideDrain23**

**Comments:**  
2' side drain left side. Picture facing North

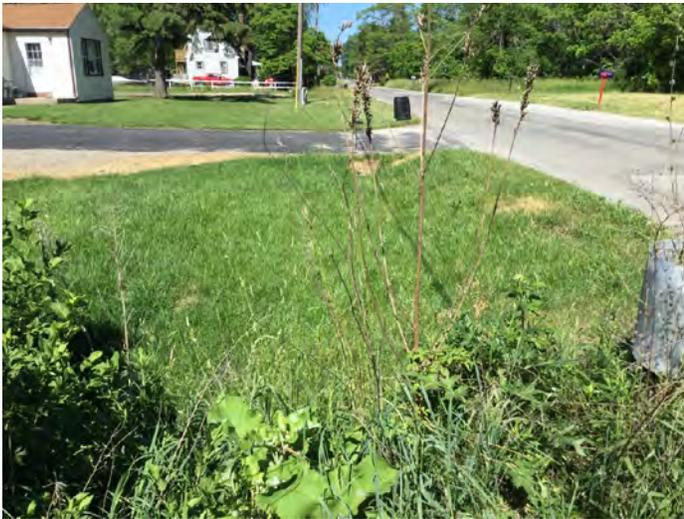
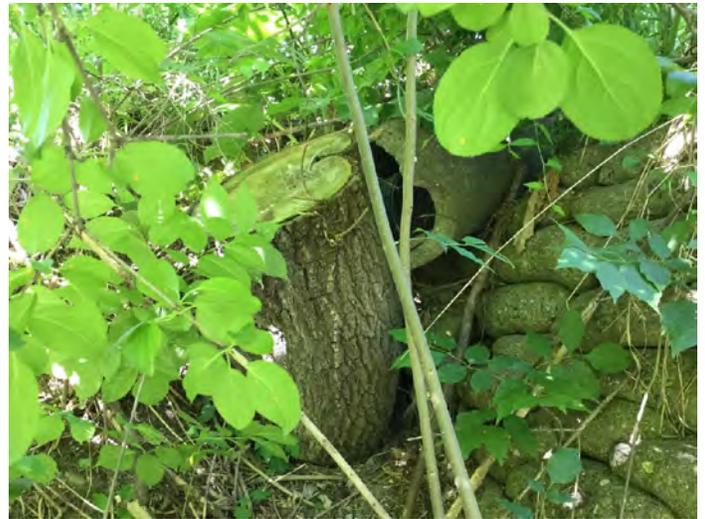
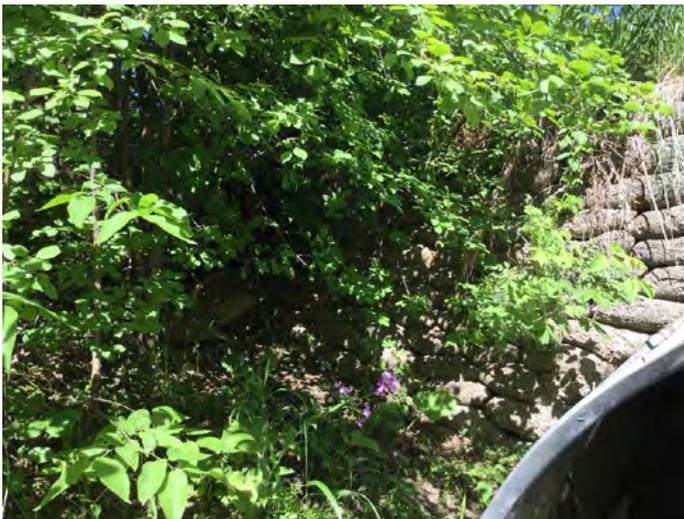
Inspection Report for Observation:  
**SideDrain24**

Roadside ditch on south side of Kansas street enters drain from right. 12" diam concrete pipe segment is located at top of hill and is supported by tree stump. Assumption is this serves as a conduit. Might also be random debris. Unable to clearly determine flow direction on south side of Kansas st. Possibly flows west and enters drain at downstream crossing.

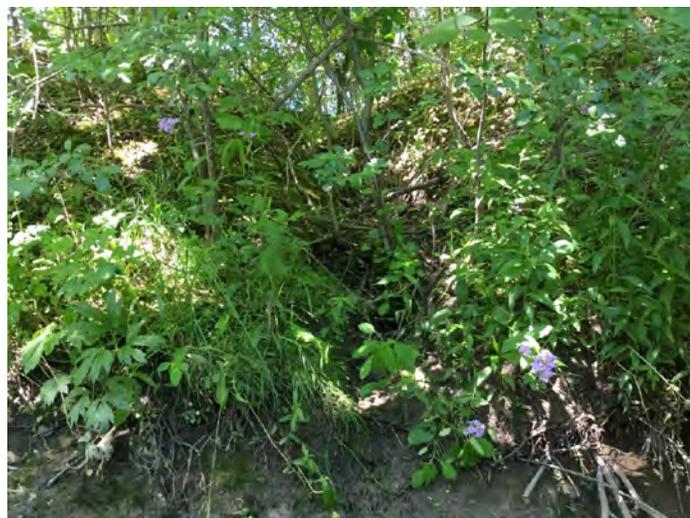
Inspection Report for Observation:  
**SideDrain25**

Side drain flows west and enters drain on right.

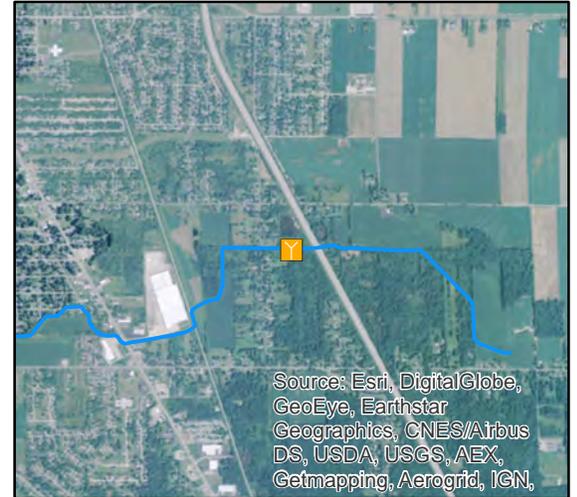
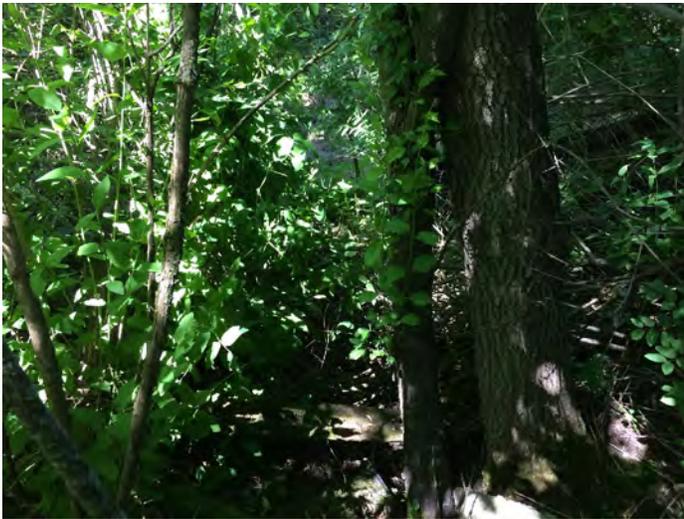
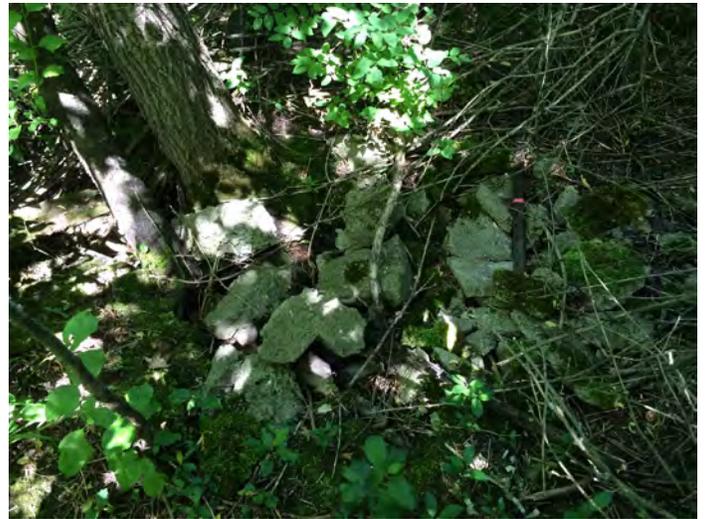
Inspection Report for Observation:  
**SideDrain26**

Side drain 3 ft enters drain on right. Flows north. Undercutting tree roots. Potentially an outlet pipe but cannot tell under rubble.

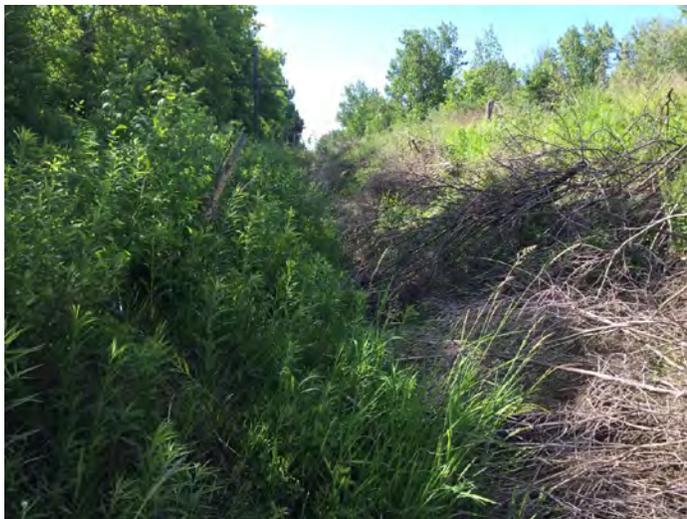
Inspection Report for Observation:  
**SideDrain27**

Side drain coming due north from the south side of drain at the bend.  
Picture facing south.

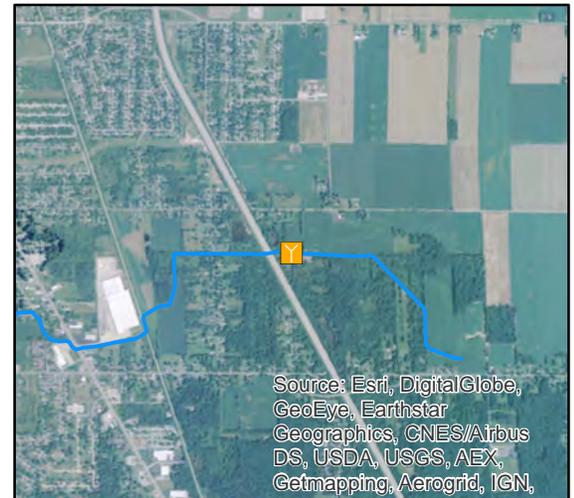
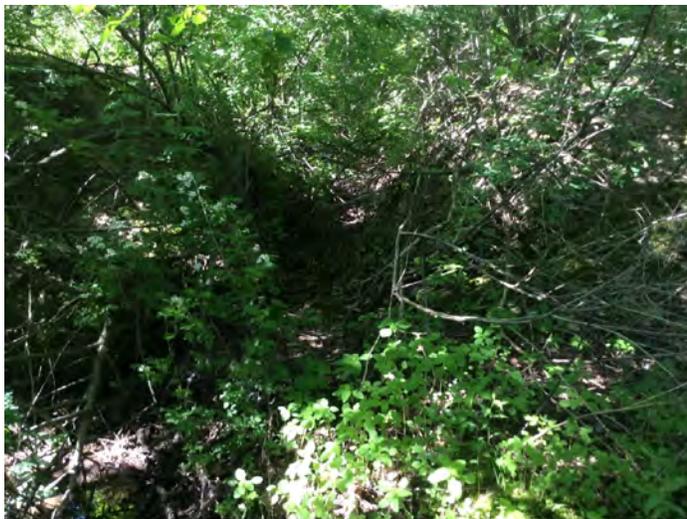
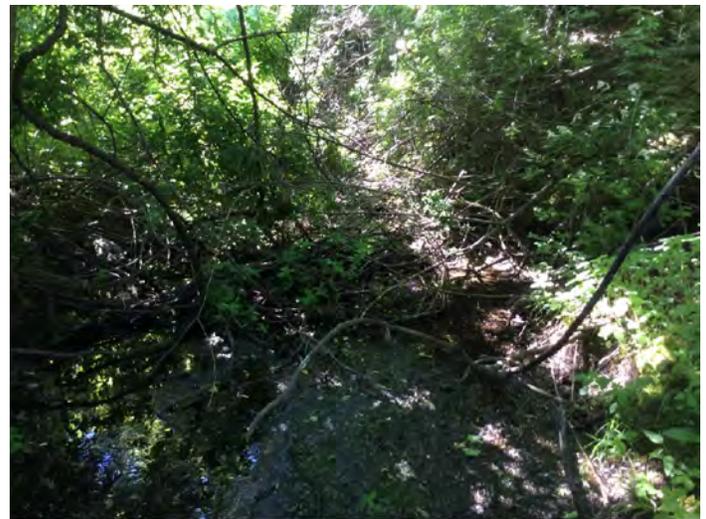
Inspection Report for Observation:  
**SideDrain28**

Side drain enters drain from right side. 5 ft wide. Flows north.

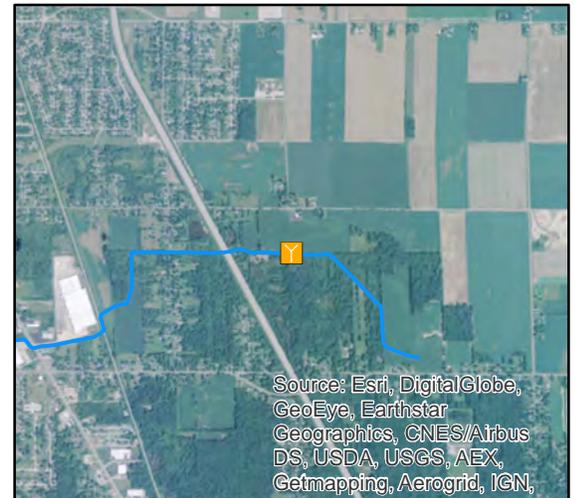
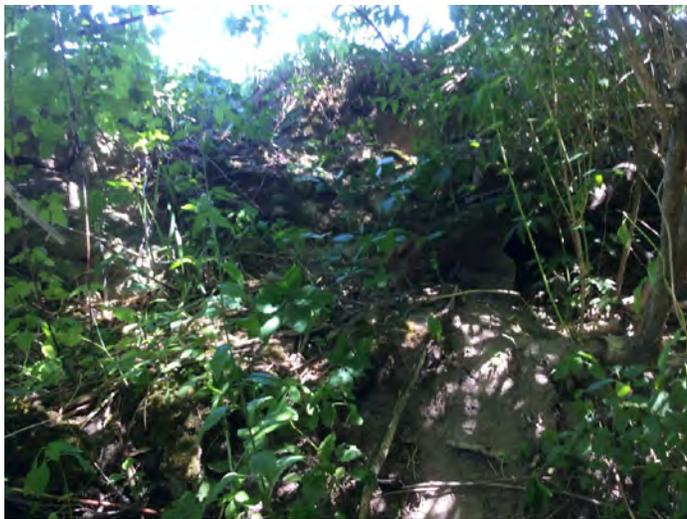
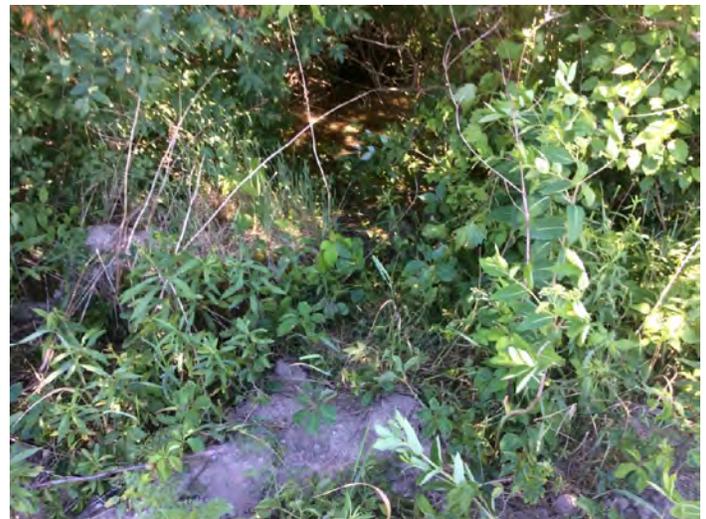
Surface drain for ag field. Assume collapsed field tile outlet but could not locate. Collapsed headwall and erosion. Left side of drain.

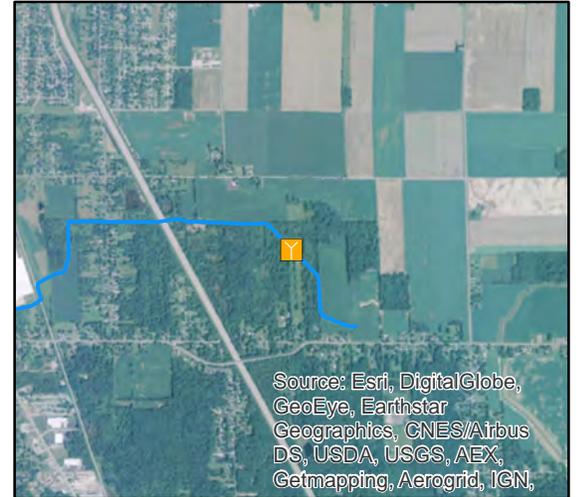
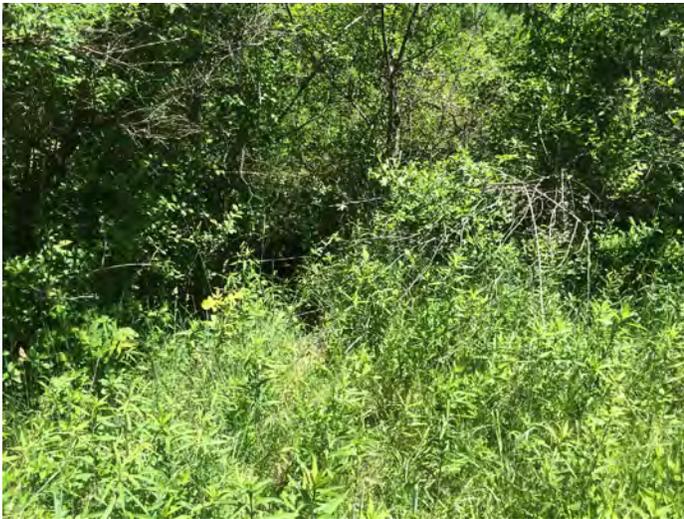
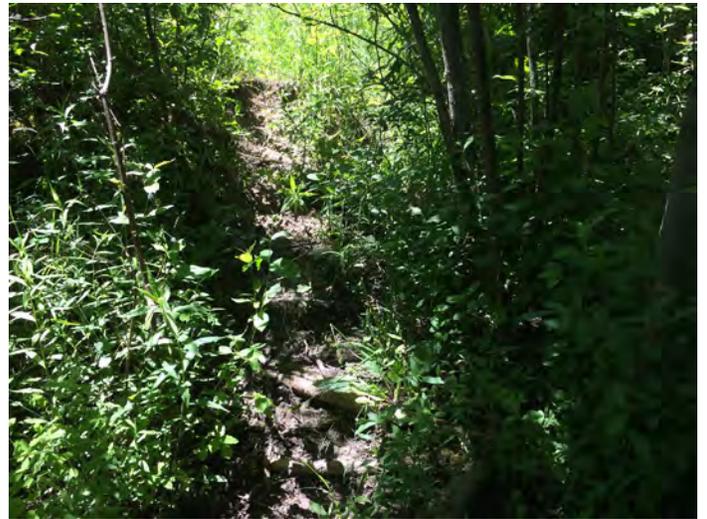
Side drain 2 ft wide enters drain on right. Looks like it is difficult draining grassy field, but might just be a deer run.

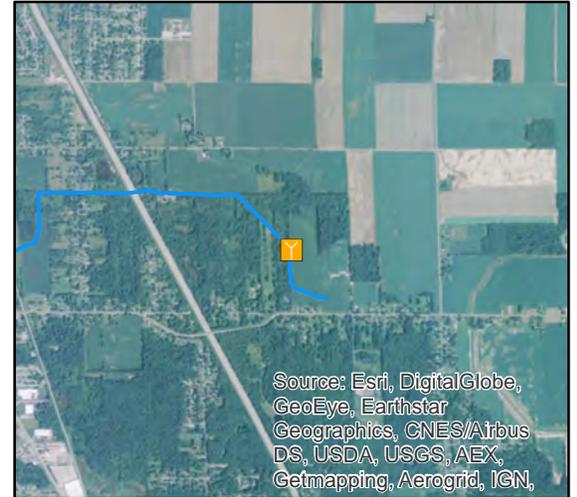
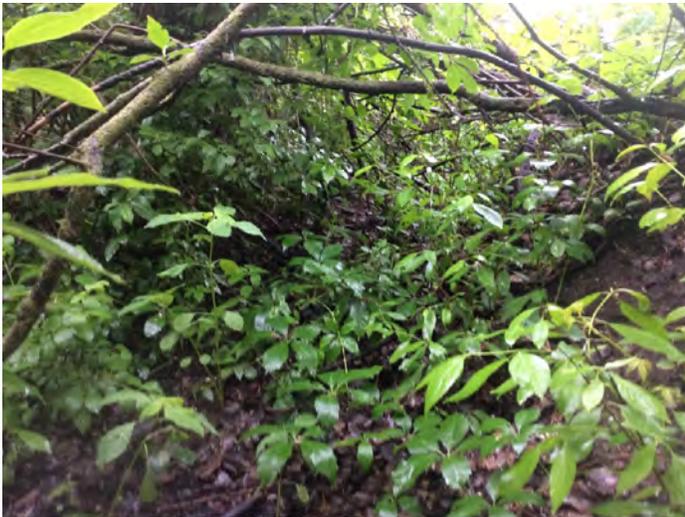
**Comments:**  
2' side drain left side. Picture facing North

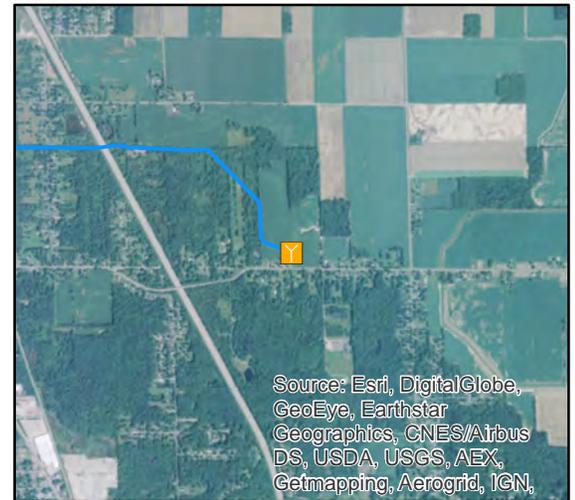
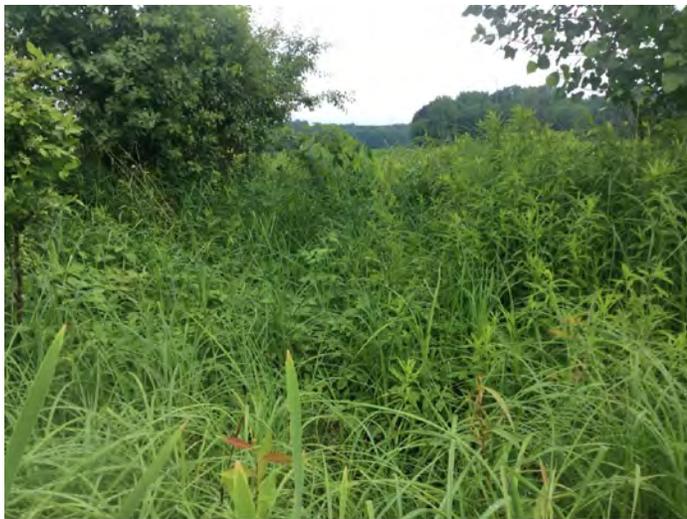
3' side drain left side at bend draining low point in agricultural field.  
Picture facing North

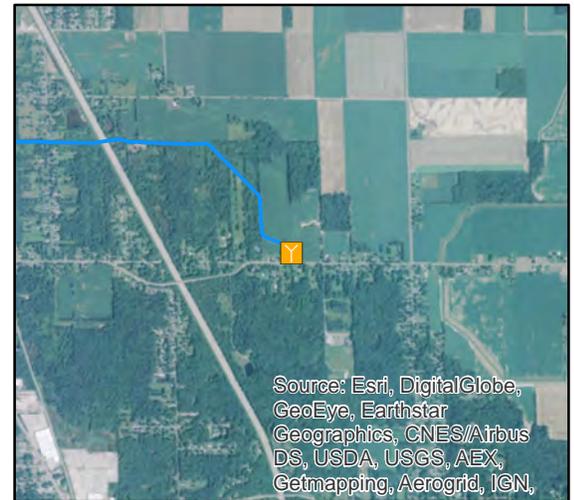
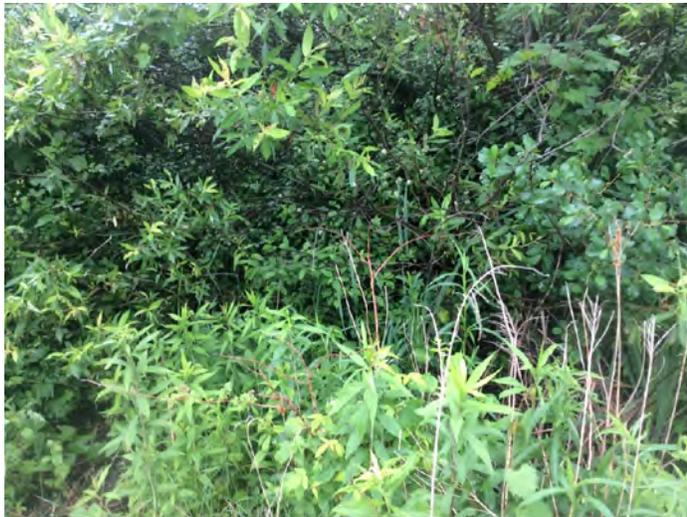
**Comments:**  
2' side drain right side. Picture facing East.
