# King Street Tile Drain Inspections

Inspection Report for Observation:  
**SideDrain1**

CLIENT	Saginaw County Public Works Commissioner

<b>HUBBELL, ROTH &amp; CLARK, INC</b> CONSULTING ENGINEERS SINCE 1915	555 Hulet Drive P.O. Box 824 Bloomfield Hills, MI 48303-0824 (248) 454-6300 <a href="http://www.hrc-engr.com">http://www.hrc-engr.com</a>	DATE:	08/16/2016
				SCALE:	
NOTE				SHEET #:	
				JOB #:	20160331

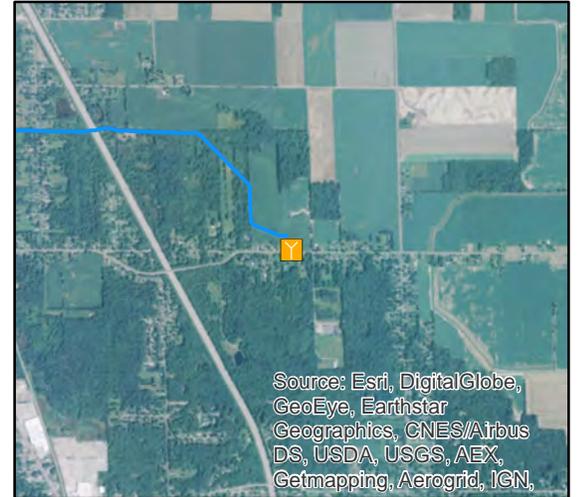
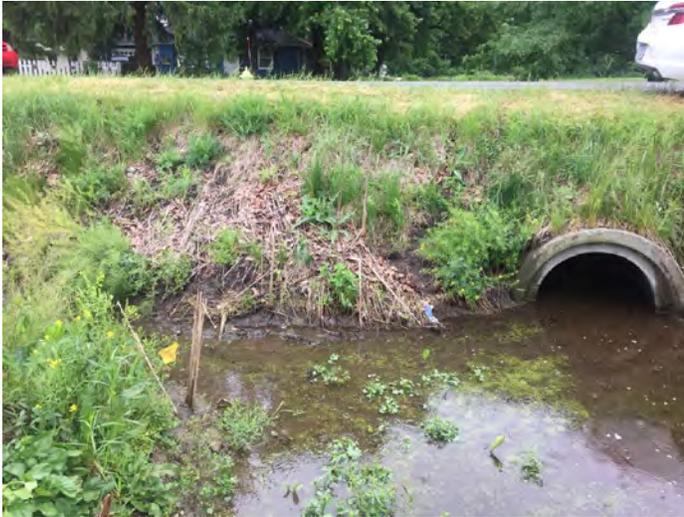
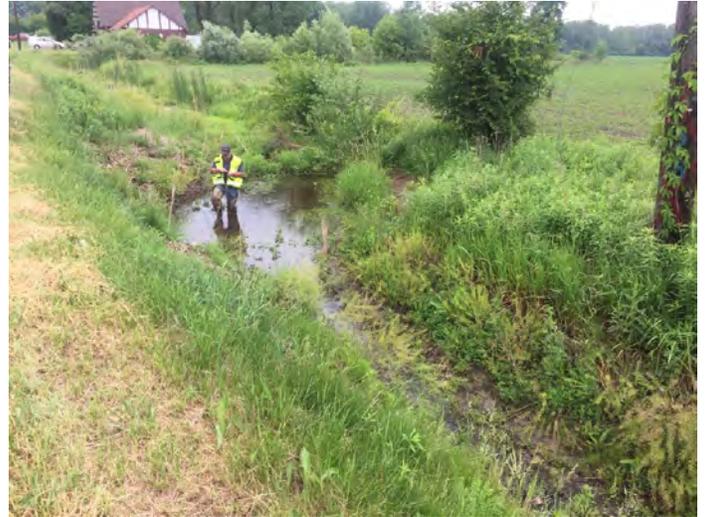
4' wide side drain (county road ditch) coming in the left side of drain facing upstream from the east. Picture one facing upstream. Picture two facing west toward drain.
