King Street Tile Drain Inspections

Inspection Report for Observation:
SurfaceOutletPipe1

CLIENT	Saginaw County Public Works Commissioner

HUBBELL, ROTH & CLARK, INC CONSULTING ENGINEERS SINCE 1915	555 Hulet Drive P.O. Box 824 Bloomfield Hills, MI 48303-0824 (248) 454-6300 http://www.hrc-engr.com	DATE:	08/16/2016
				SCALE:	
NOTE				SHEET #:	
				JOB #:	20160331

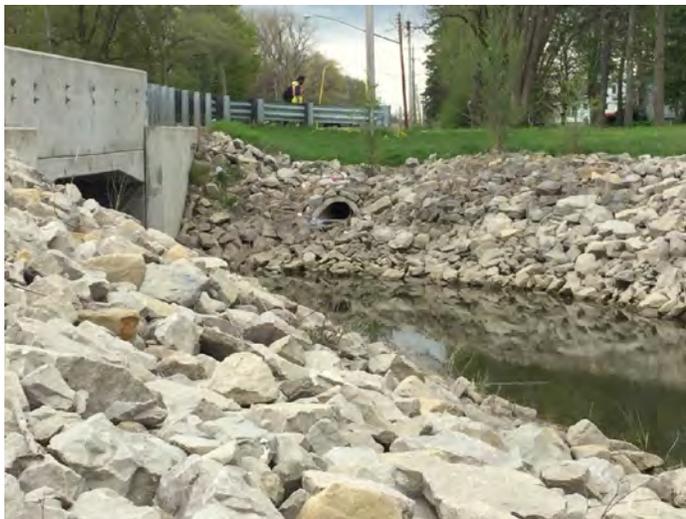
Photo 1

Condition: Good

FES type. On right side of drain facing upstream. Photo taken facing south.

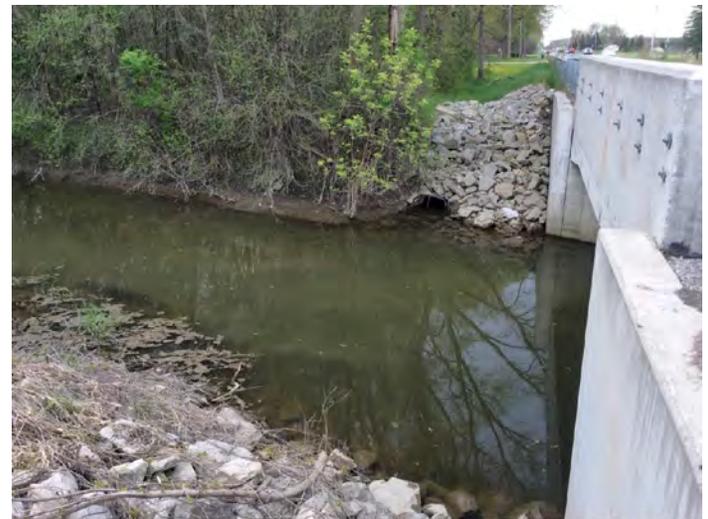
Photo 2

Condition: Good

Upstream right side 18" diameter east side of m-13 photo taken facing south, flows north

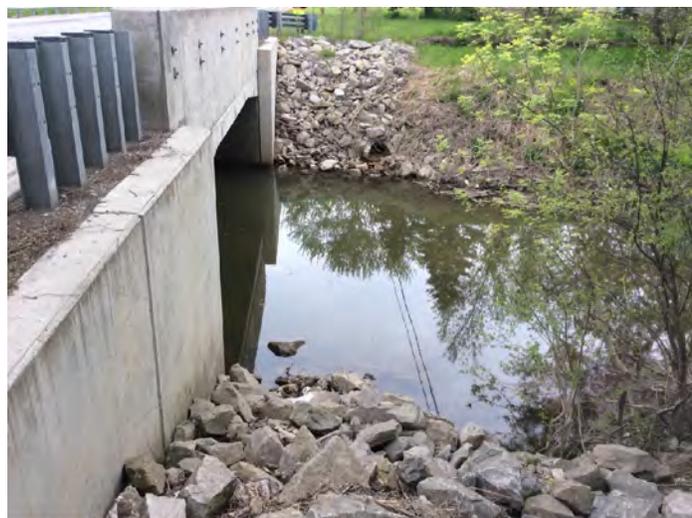
Photo 1

Condition: Good

FES outlet 18", left side of drain, east side of m-13, photo taken facing north, flows south

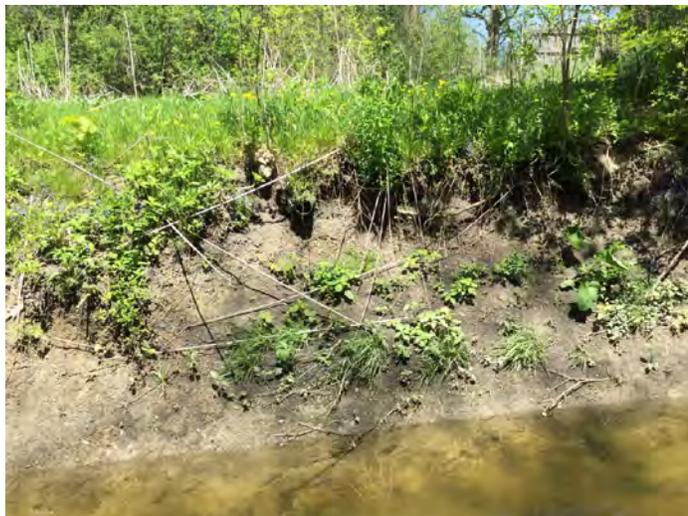
Photo 1

Condition: Good

Photo facing northeast. Enters drain on left. 4" hdpe.

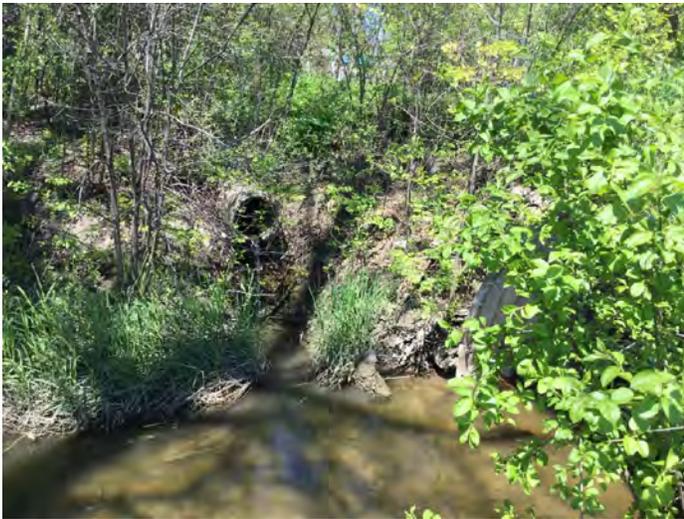
Photo 2

Condition: Good

18" concrete pipe enters drain from left. Photo facing north. Significant erosion at outlet and loose sediment. Elevated above drain about 3 ft. No splash pad present.

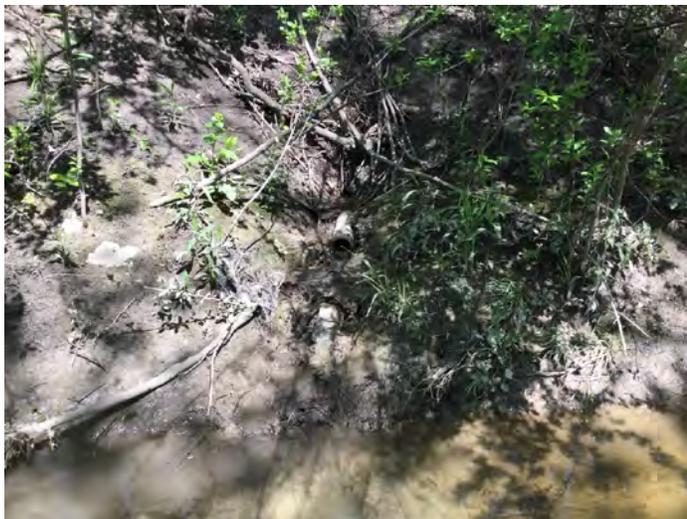
Photo 2

Condition: Poor

Surface outlet pipe is broken. 2" clay on left side of drain. Erosion at outlet. Photo facing north.n

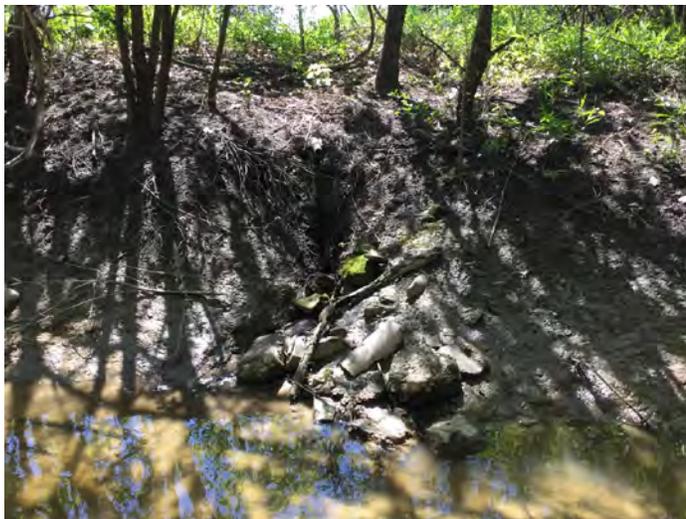
Photo 2

Condition: Good

1.5" pic pipe enters drain on right. Probably from sump pump. Erosion at outlet. Photo facing west.

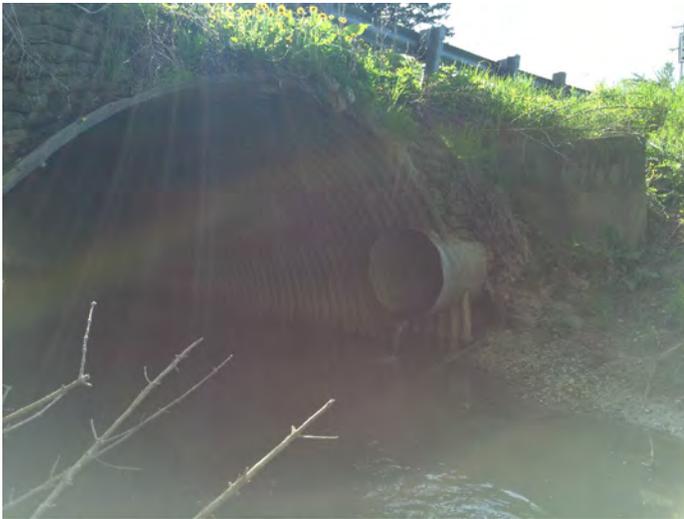
Photo 2

Condition: Good

Enters drain from left. Upstream of Washington rd. Cut into the side of the drain. Additional concrete headwall support. Flows southwest. Photo facing downstream.

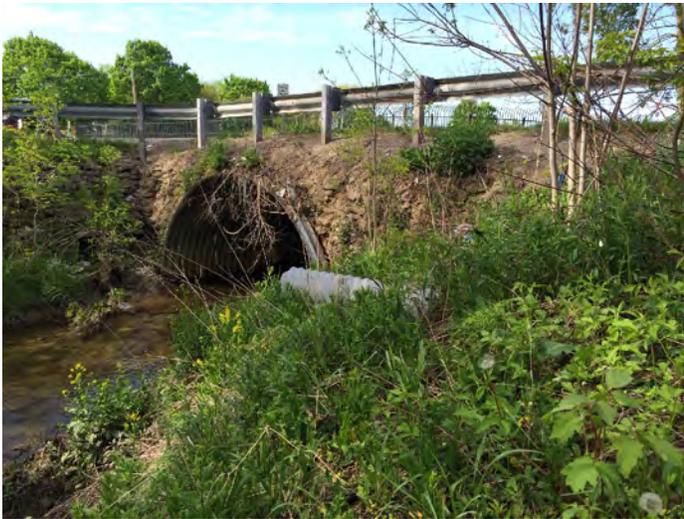
Photo 2

Condition: Good

20 ft cmp connecting roadside ditch on southwest side of washington rd. Flows northwest. Photo facing northwest. Enters drain on right. 12" diam

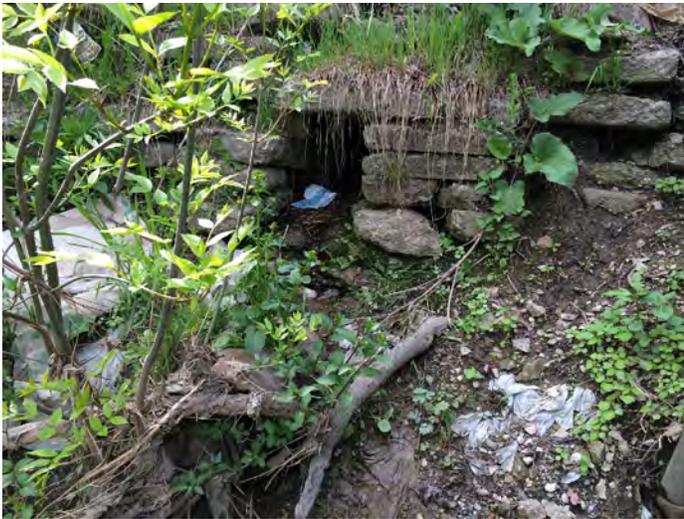
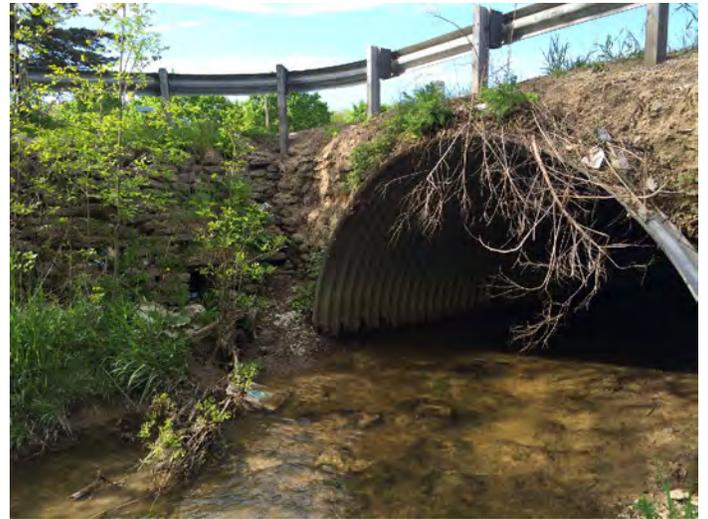
Condition: Failed

12" surface outlet pipe enters drain from left side downstream of Washington Rd. Broken at end. Within headwall and constructed bank. Flows southeast. Photo facing northwest.

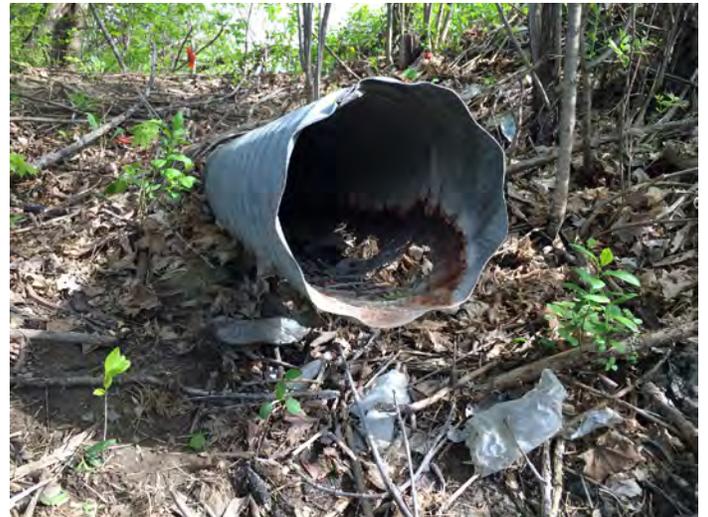
Photo 3

Condition: Poor

12" cmp enters drain on right side. Rusted out in bottom. Photo1 facing upstream. Rusted out in bottom. 20 ft culvert carrying roadside ditch on southeast side of Washington rd. flows northwest.

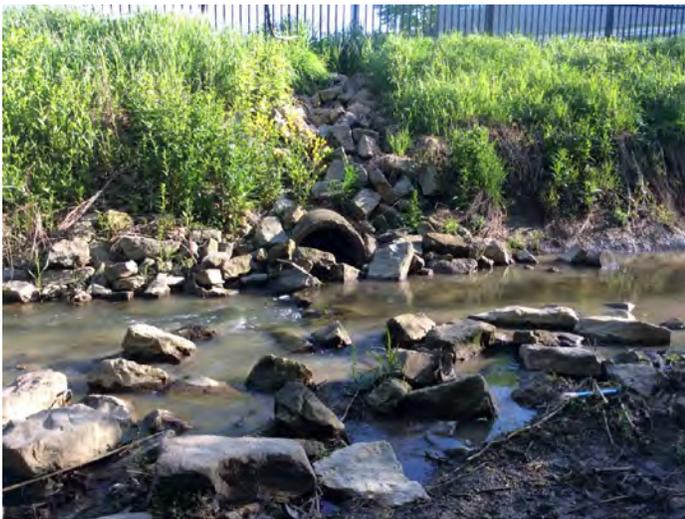
Condition: Fair

24" diam concrete surface outlet pipe. Head wall structure is falling and possibly depositing large rocks in drain. Photo1 facing south. Photo2 facing north.

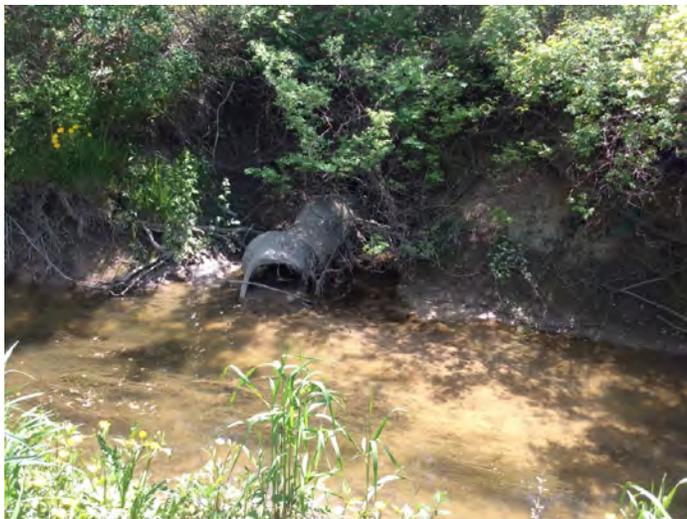
Photo 2

Condition: Failed

18" concrete surface outlet pipe enters drain on right side. Failed. Broken into multiple pieces with significant erosion around it. Photo facing south.

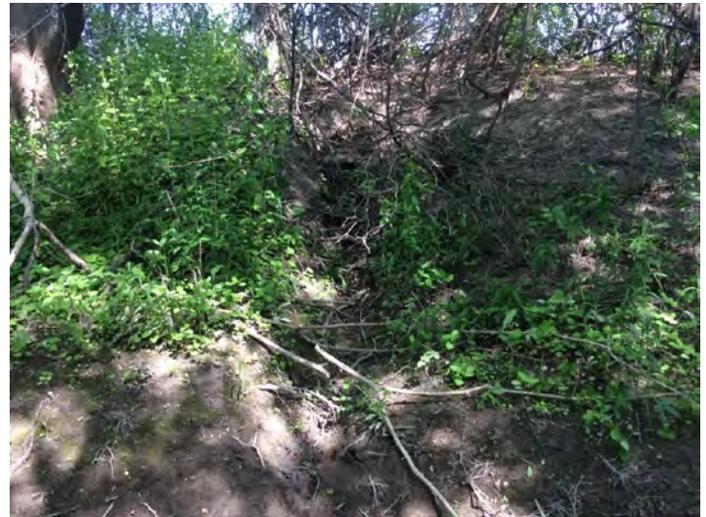
Photo 3

Condition: Failed

4" clay surface outlet pipe. Failed condition. Ends 15" to right of drain. Caused erosion inland. Photos facing east.

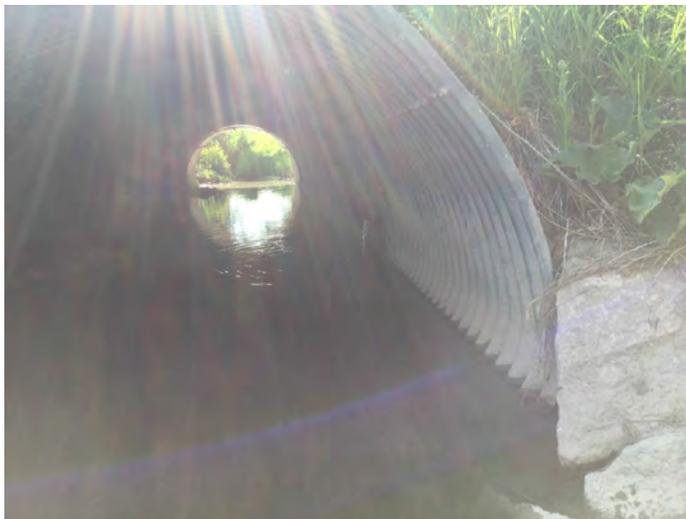
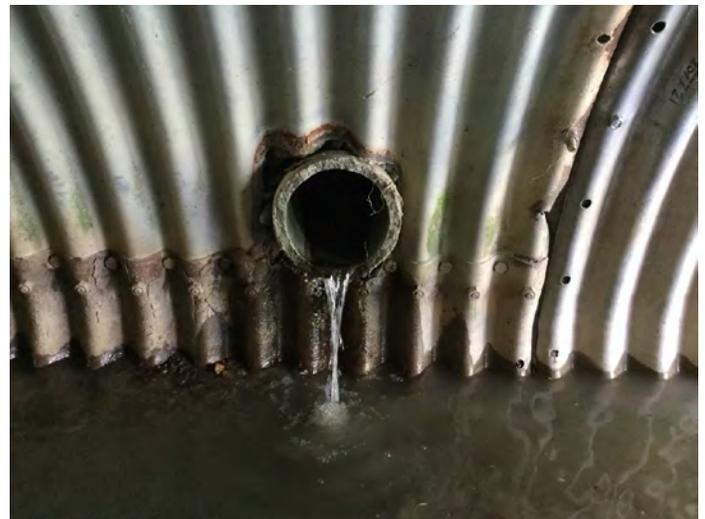
10" surface outlet pipe enters drain. Cut into culvert. Photo1 facing downstream. Photo2 facing north.

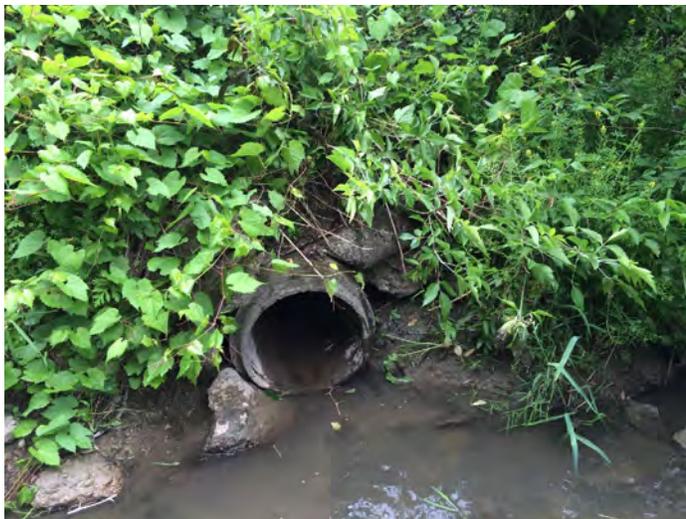
Photo 2

Condition: Fair

18" diam concrete sop enters drain on left. Bag riprap headwall in fair condition. Significant erosion behind it.

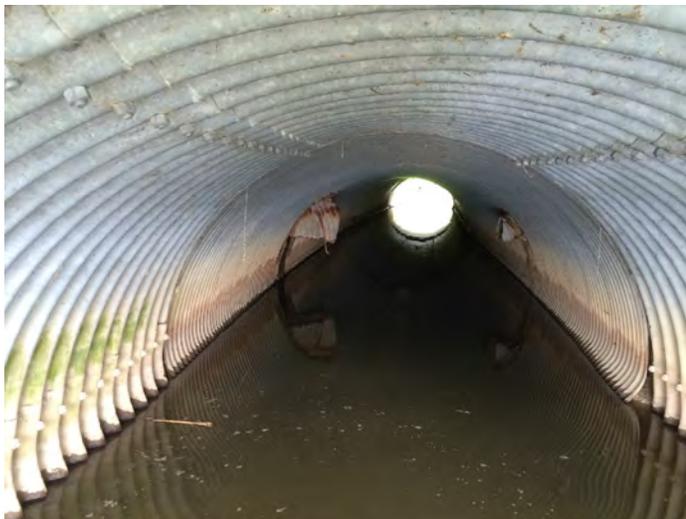
Photo 2

Condition: Poor

24" cmp sop enters drain on left. Photo facing downstream. Rusted at outlet.

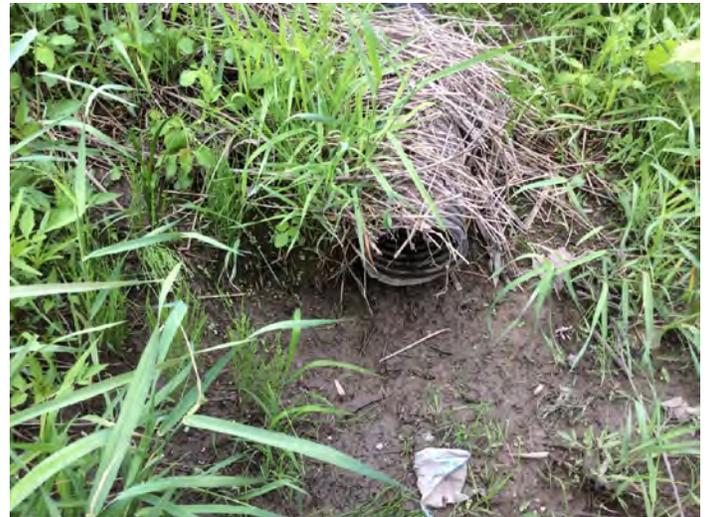
Photo 3

Condition: Fair

Black plastic field tile pipe in decent condition. On right side of drain.

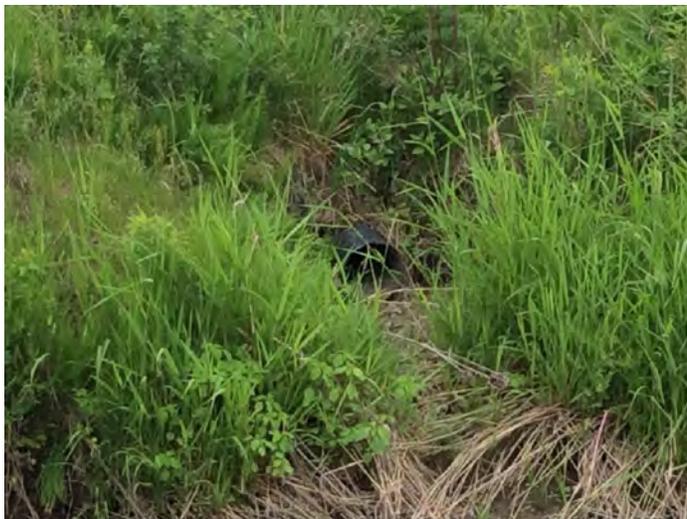
Photo 2

Condition: Good

Field tile pipe on right side of drain. Black plastic HDPE in good condition. About 20" diameter.

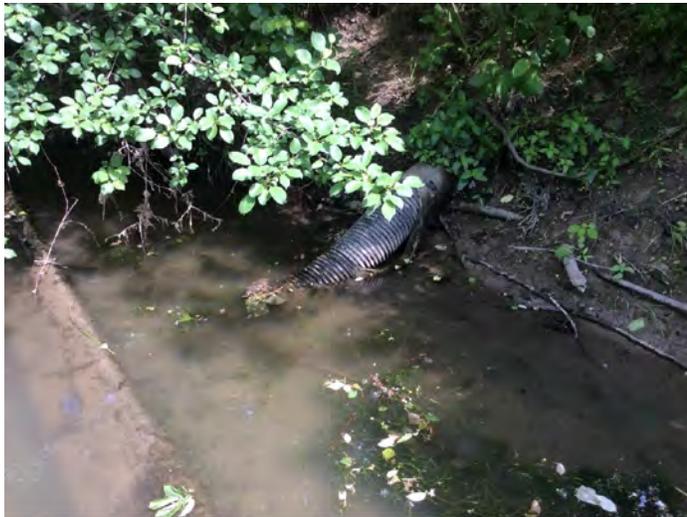
Photo 2

Condition: Fair

Surface outlet HDPE on right side of drain in fair condition. About 12" diameter. Extends into water. Manhole 100 ft right of drain leading to sop.

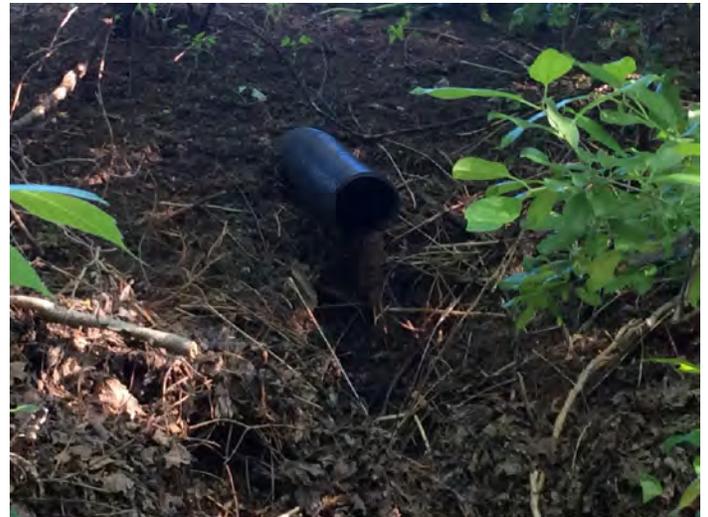
Photo 3

Condition: Good

Surface outlet PVC pipe on left side of drain. Good condition, but bottom of pipe is a little broken off.

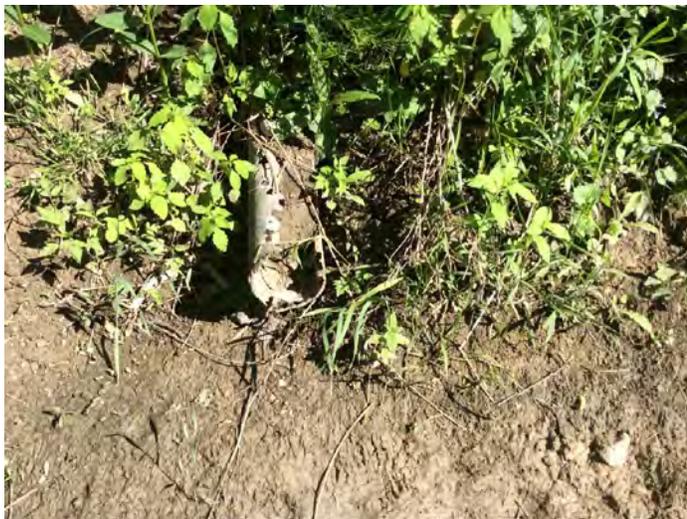
Photo 2

Condition: Failed

Failed CMP surface outlet on left side of drain. 4" pipe. Rusted, broken and filled with dirt. Not in working condition.
