King Street Tile Drain Inspections

Inspection Report for Observation:
Tree1

HUBBELL, ROTH & CLARK, INC CONSULTING ENGINEERS SINCE 1915	555 Hulet Drive P.O. Box 824 Bloomfield Hills, MI 48303-0824 (248) 454-6300 http://www.hrc-engr.com	DATE:	08/16/2016
				SCALE:	
NOTE				SHEET #:	
				JOB #:	20160331

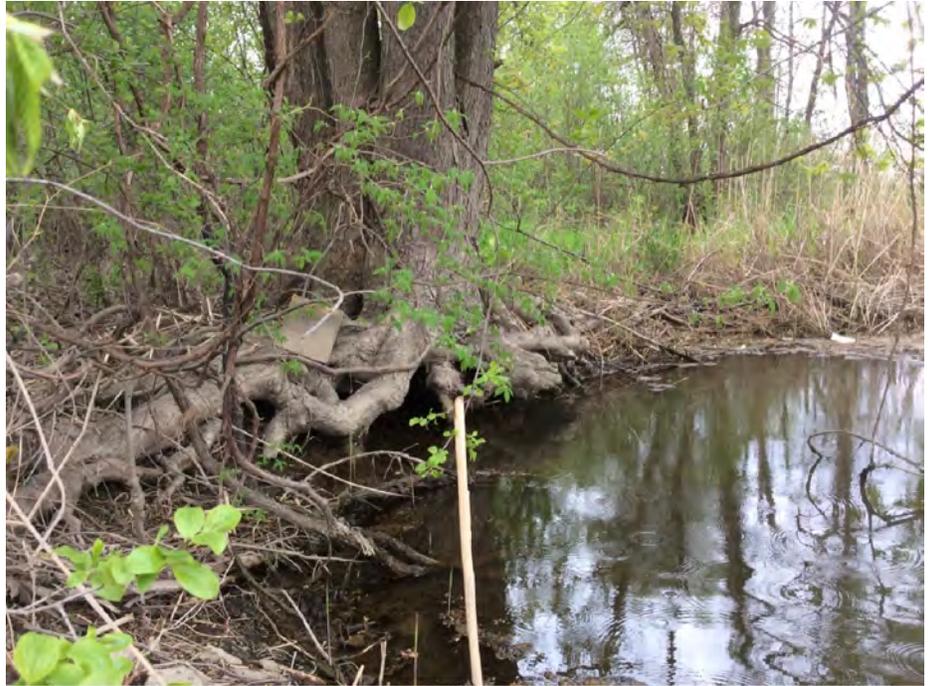
Photo 1

Photo facing upstream. Left side.
Approx 40" diam.

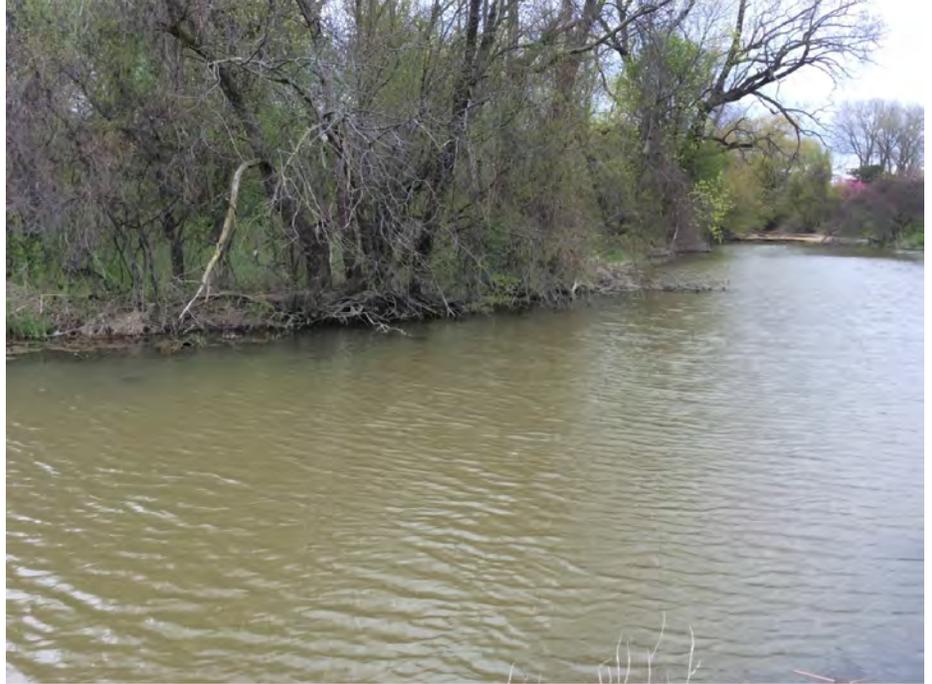
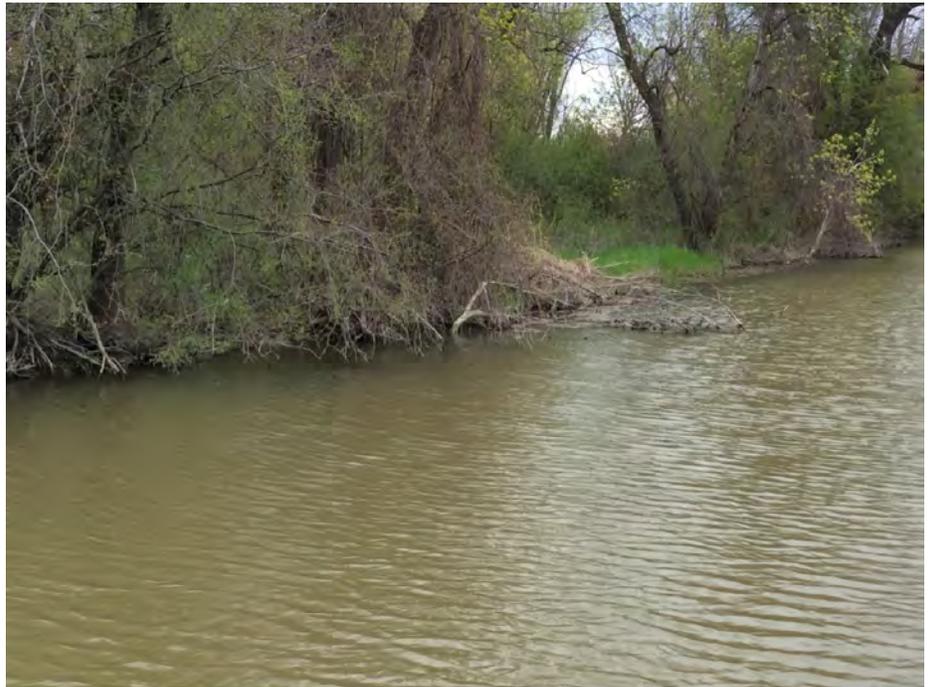
7 trees up to 12" diameter. Both photos facing northeast in different locations.

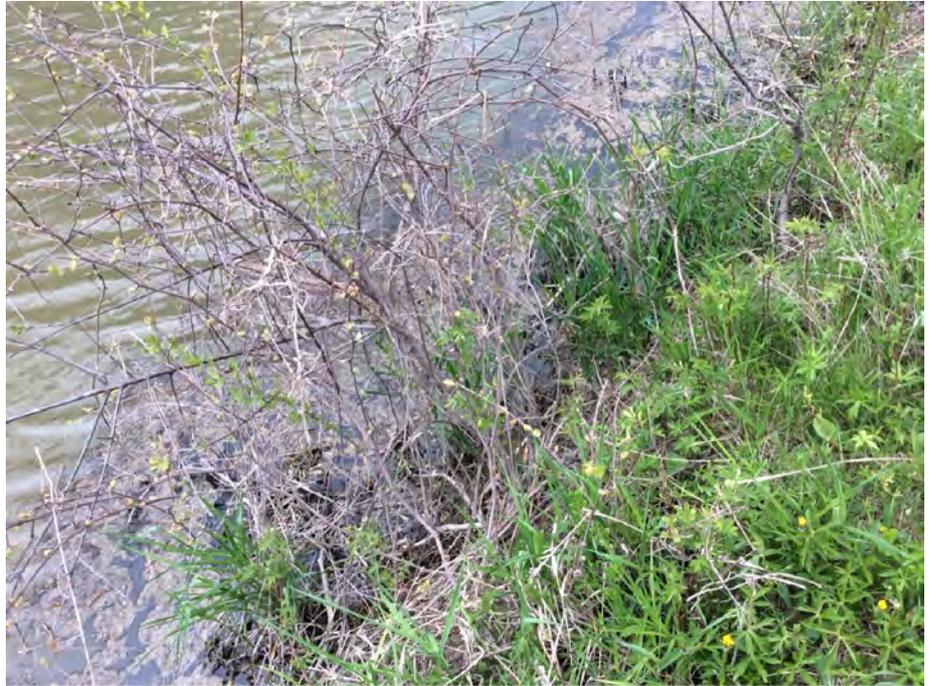
Photo 1

Right side upstream 4" diam.

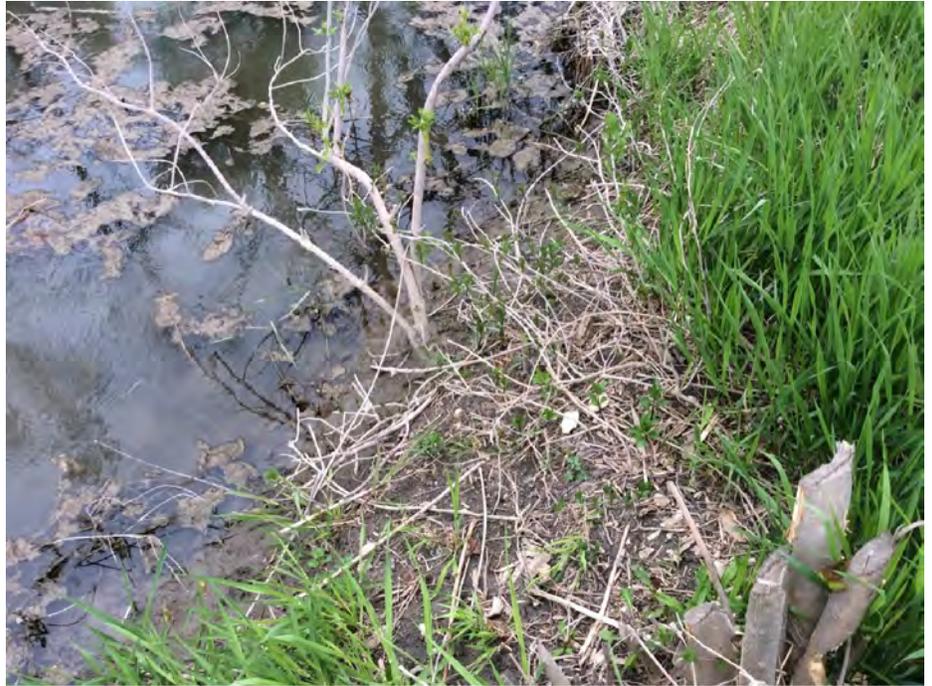
Photo 1

Upstream right 4"

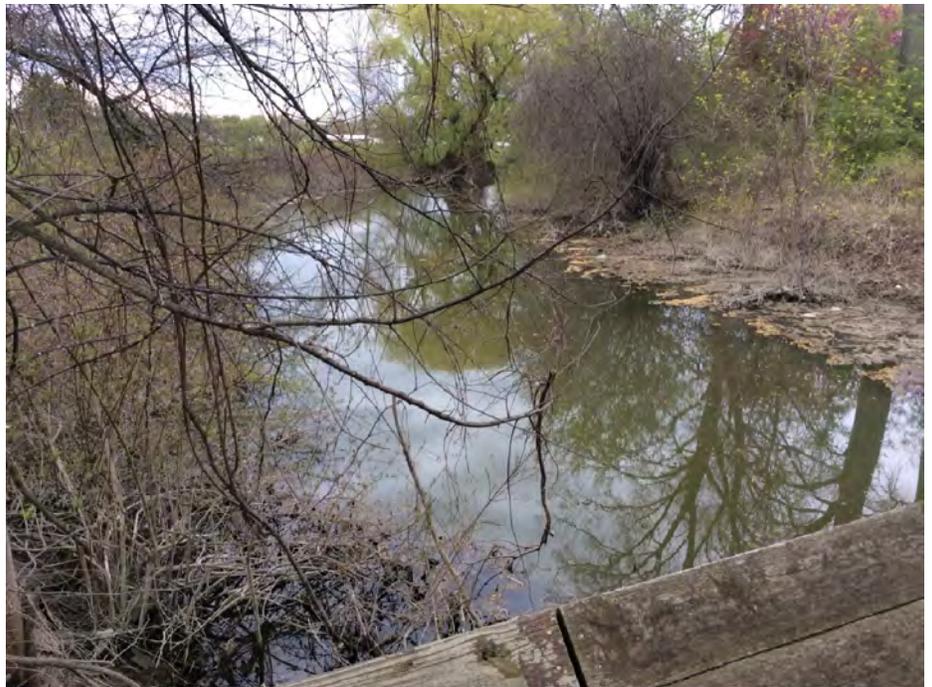
Photo 1

52 6"-72" upstream left right and center

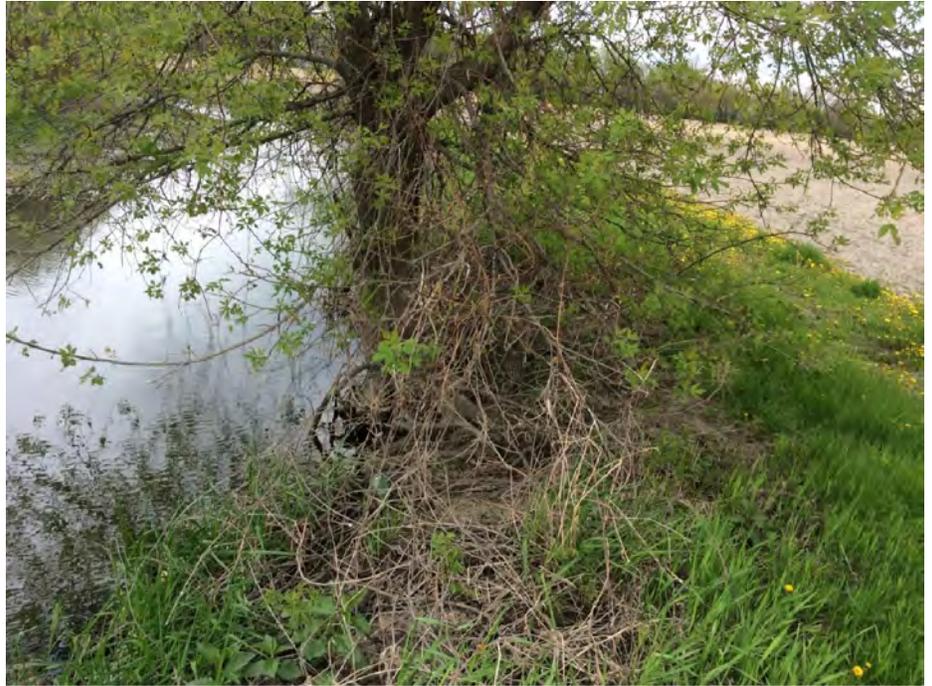
Photo 1

Photo facing upstream, right side, 2 trees up to 24" diam

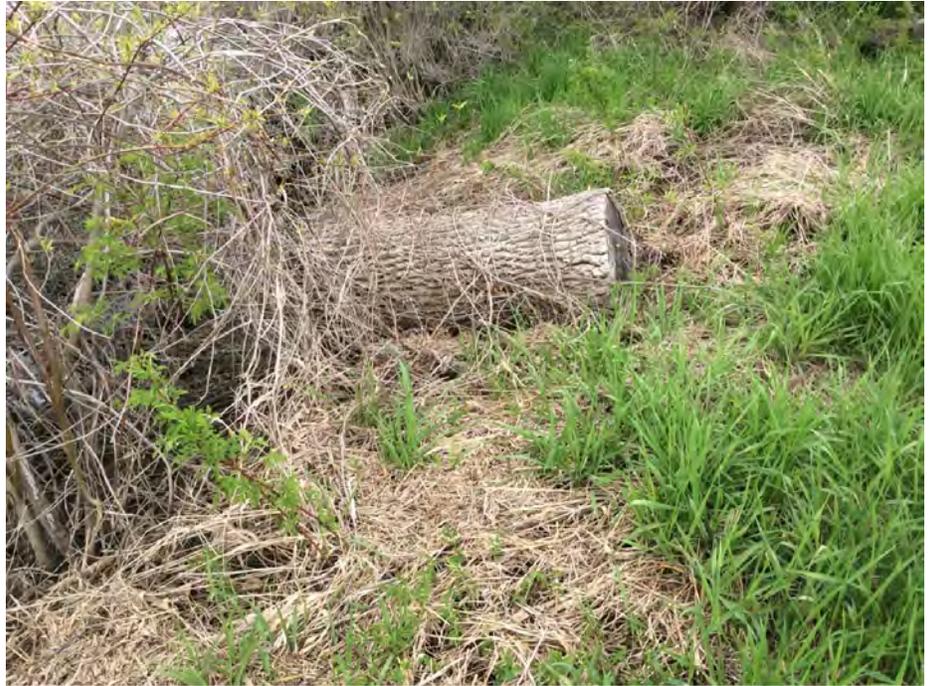
Photo 1

Upstream right 24" diam stump

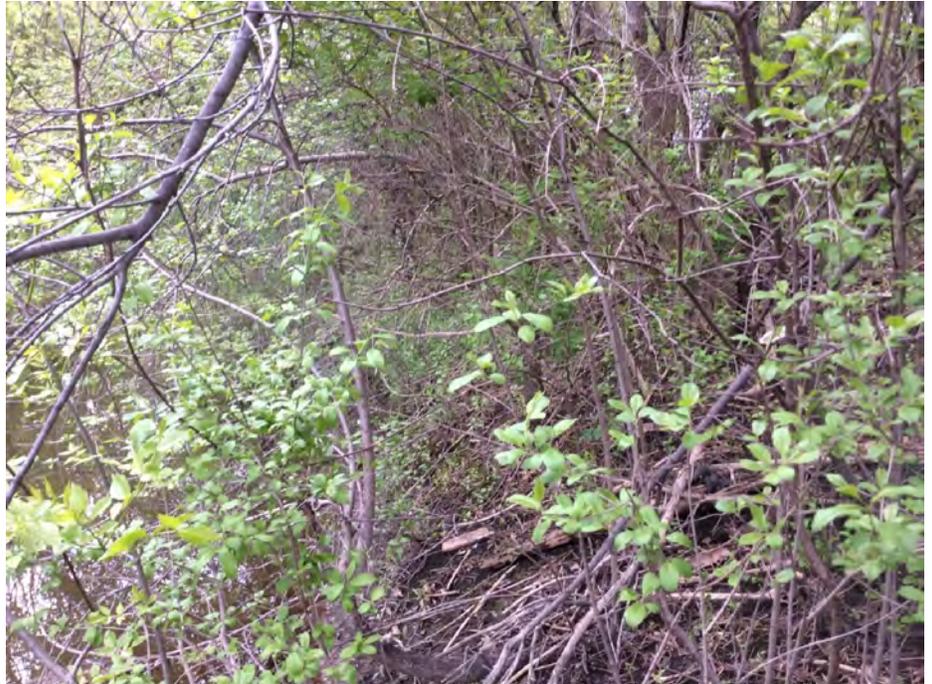
Photo 1

Heavy vegetation. Several trees growing in v on banks on right side for next 300 ft.

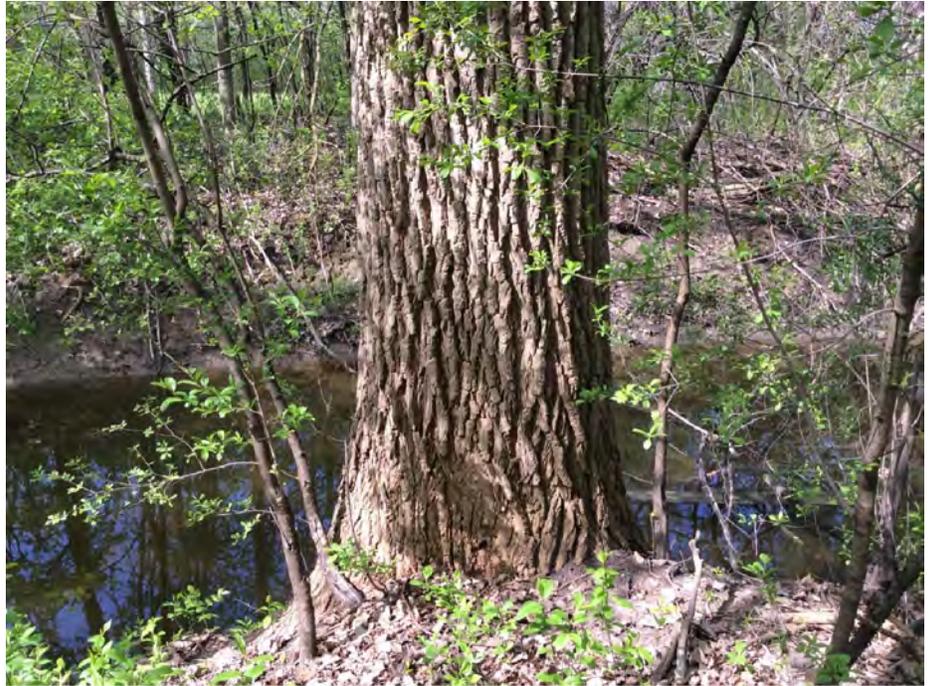
Photo 1

36" diam tree on left side of drain. Photo facing south.

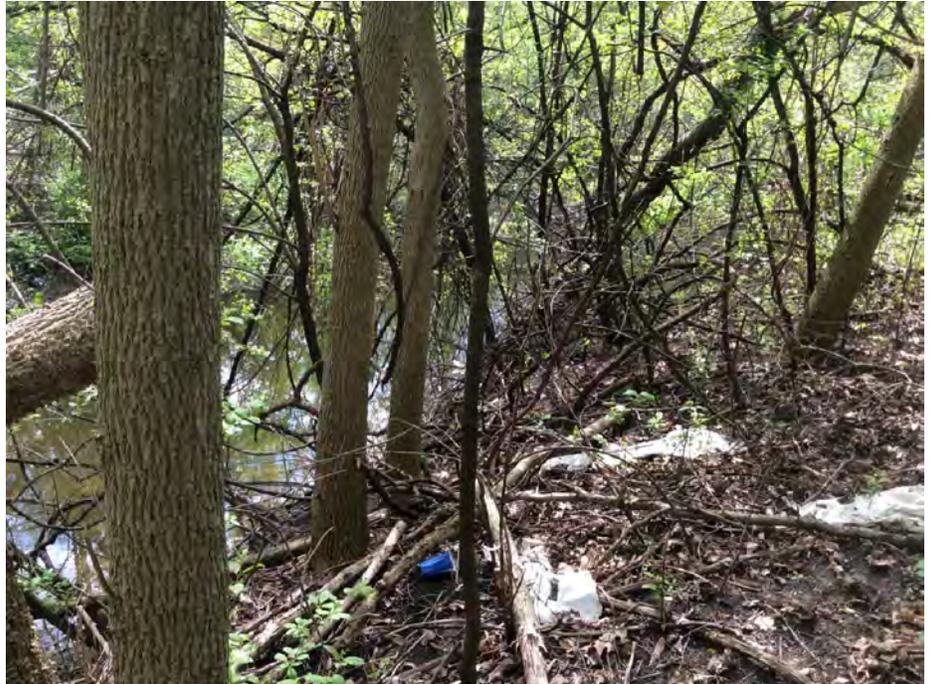
Photo 1

Photo facing upstream. Taken on right side of drain. 22 trees up to 12" diameter on both sides.

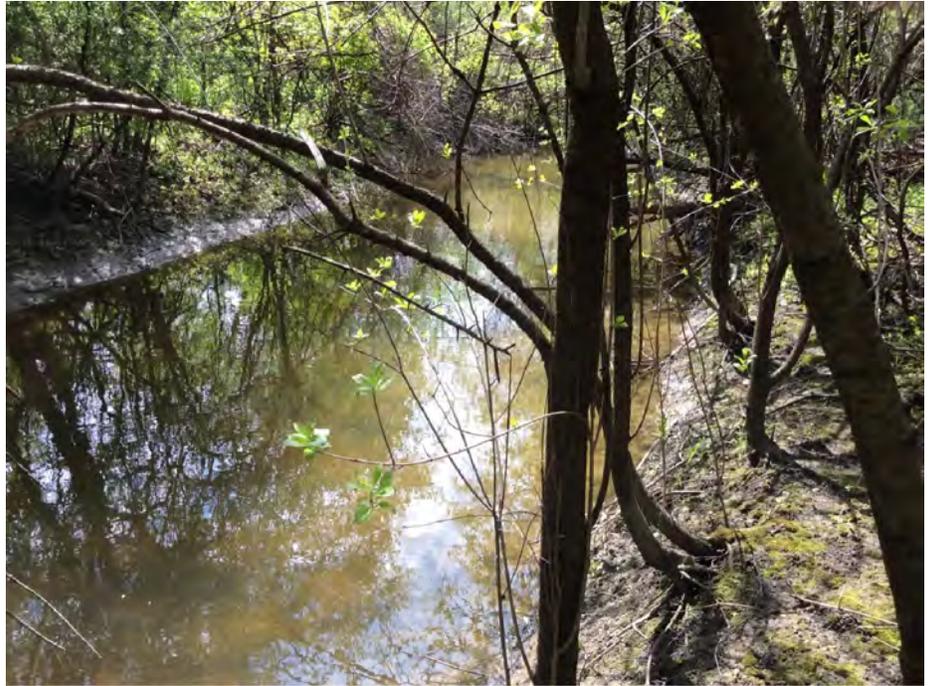
Photo 1

Several 2 to 3 inch diam trees on both sides of drain. About 50 over next 100 ft. Photo facing upstream.

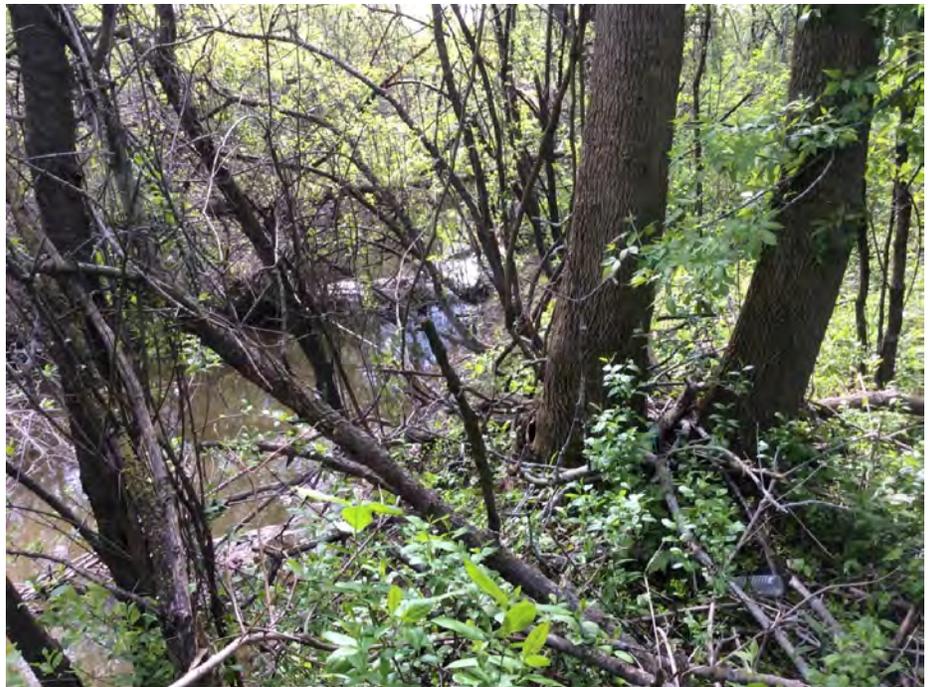
Photo 1

Photo facing upstream. Right side. Individual tree with two trunks, 18" diameter.

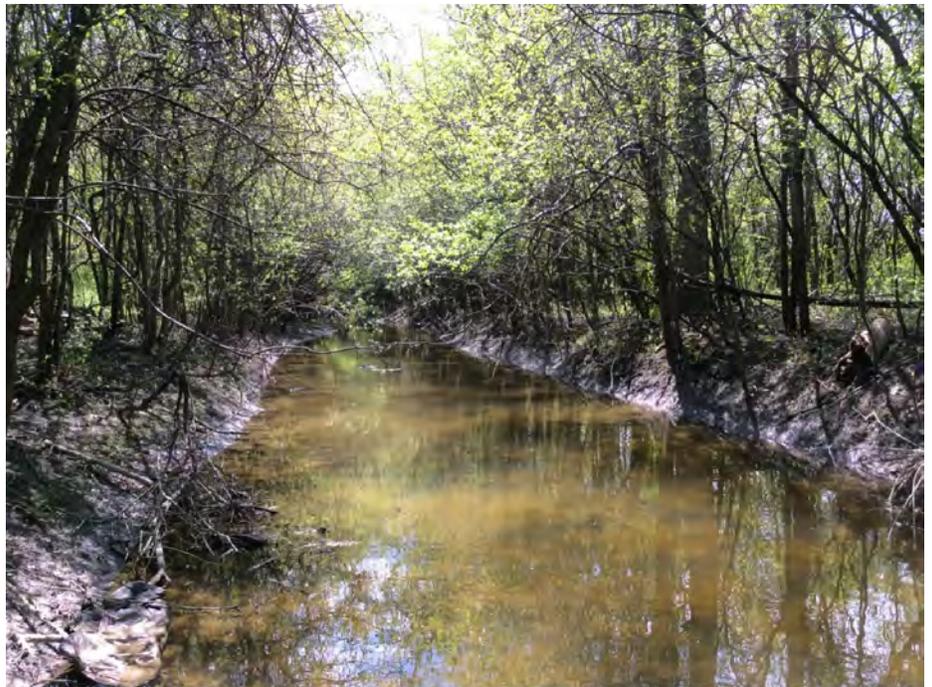
Photo 1

About 80 trees 2 to 3 inch diameter.
Next 200 ft. Heavy both sides. Photo facing upstream.

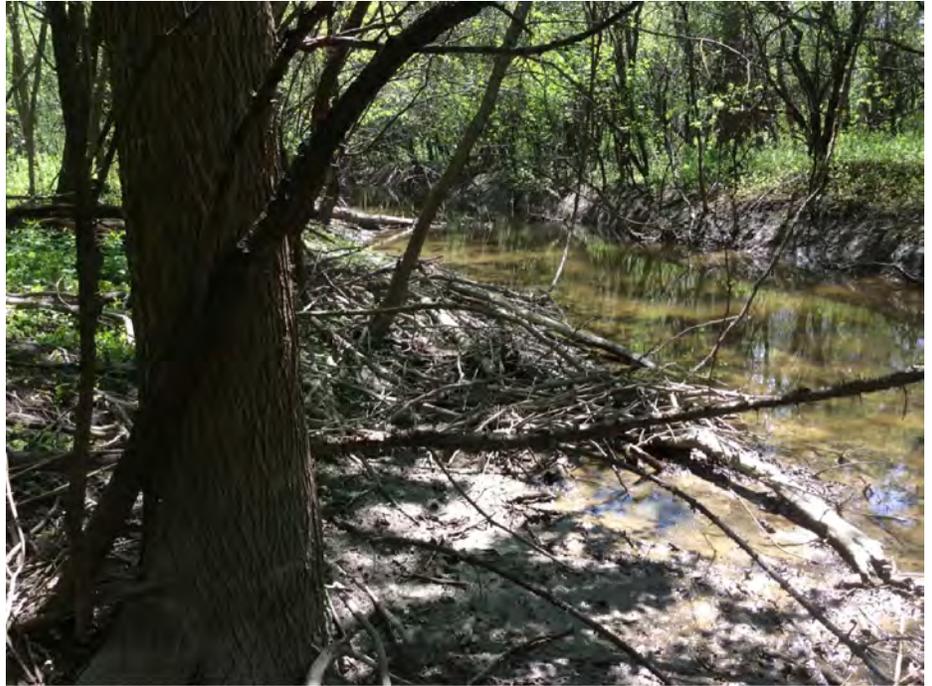
Photo 1

16 trees up to 18" diameter on both sides next 200 ft. Also, several 2"-3" diam trees as well. Photo facing upstream. Does not include large individual tree.

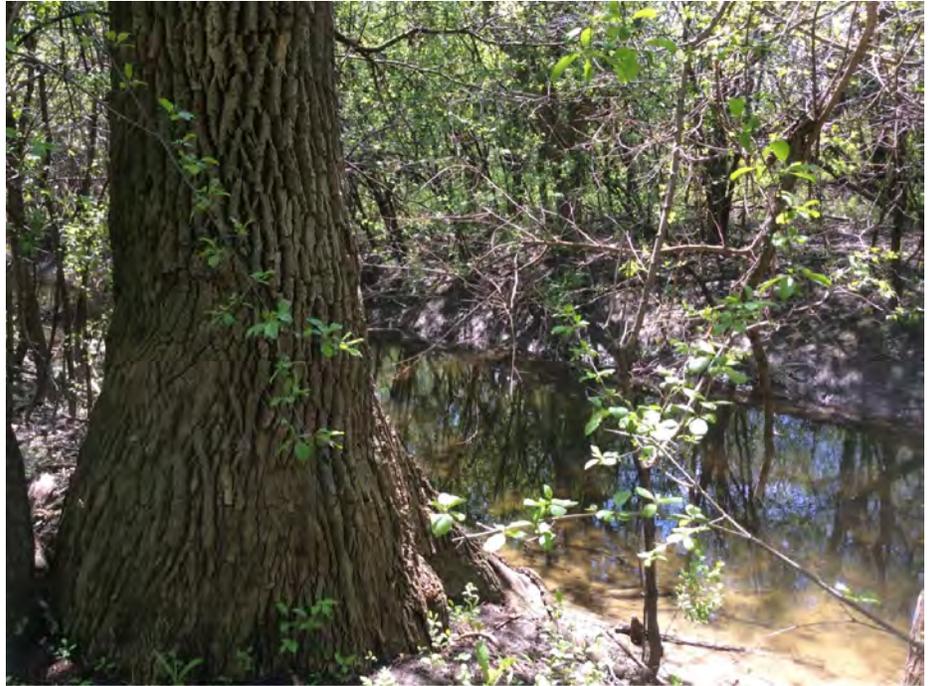
Photo 1

36" diam individual tree on left side. Not included in other count. Photo facing upstream.

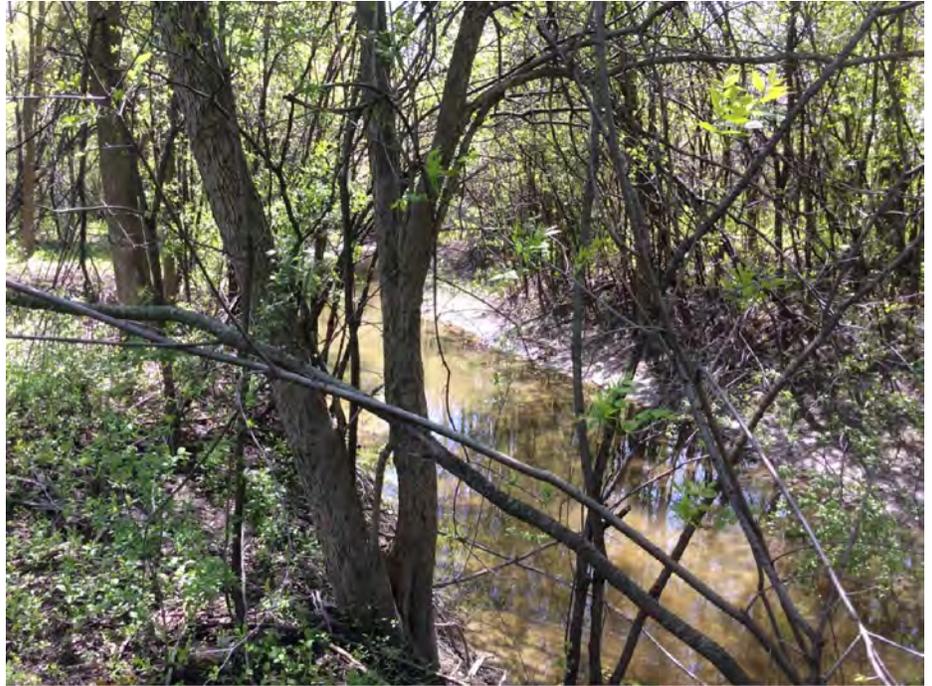
Photo 1

16 trees over next 300 ft. Both sides. Up to 12" diameter. Photo facing upstream.

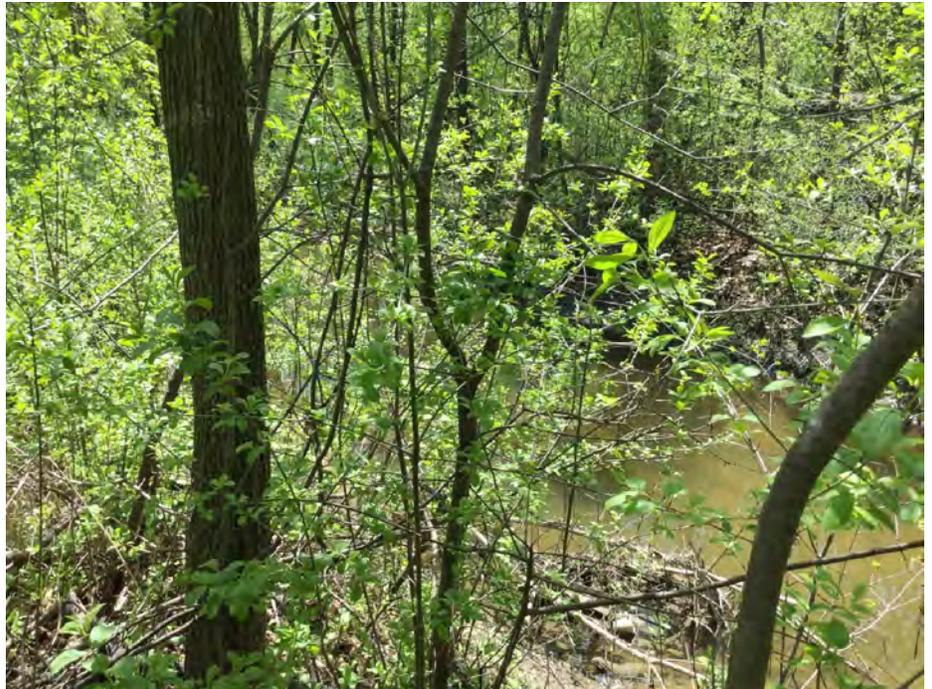
Photo 1

14 trees. Next 250 ft. Up to 18" diam.
Photo facing upstream.

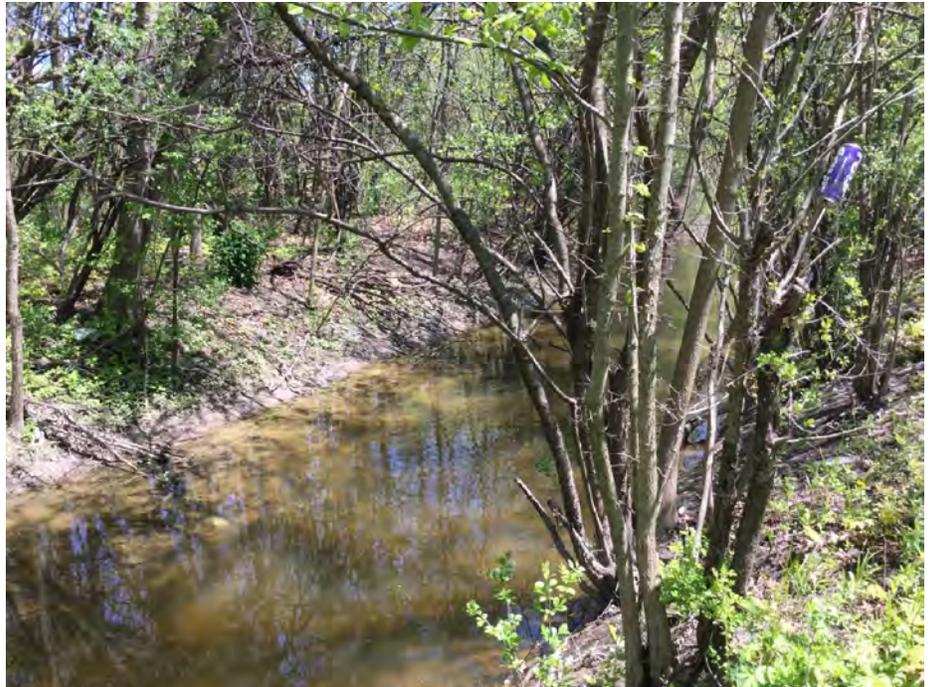
Photo 1

9 trees over next 350 ft. Both sides up to 18" diam. Photo facing upstream.

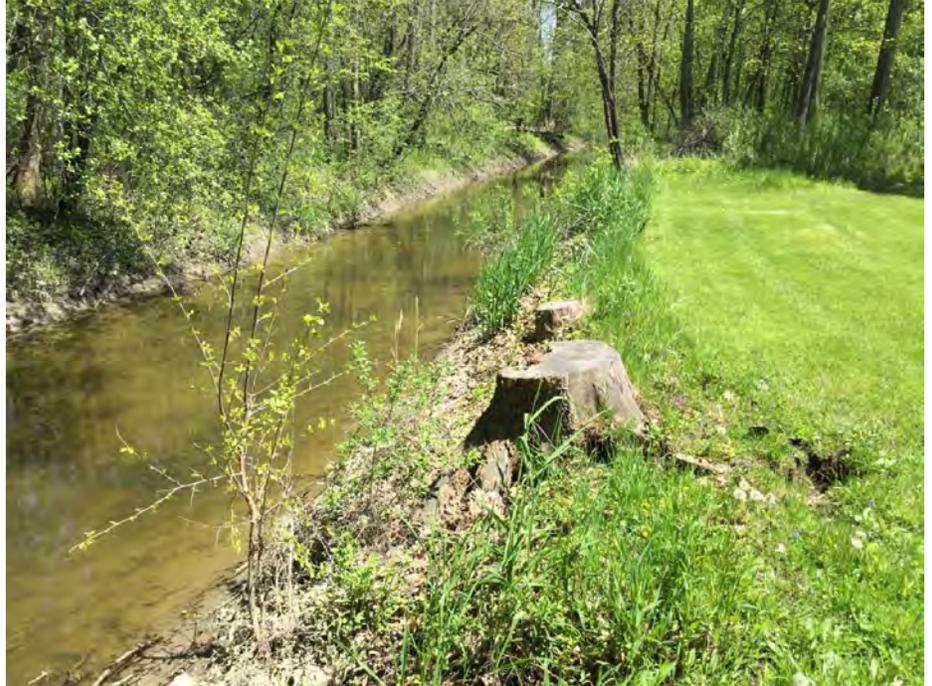
Photo 1

2 stumps on right side of drain. Photo facing upstream.

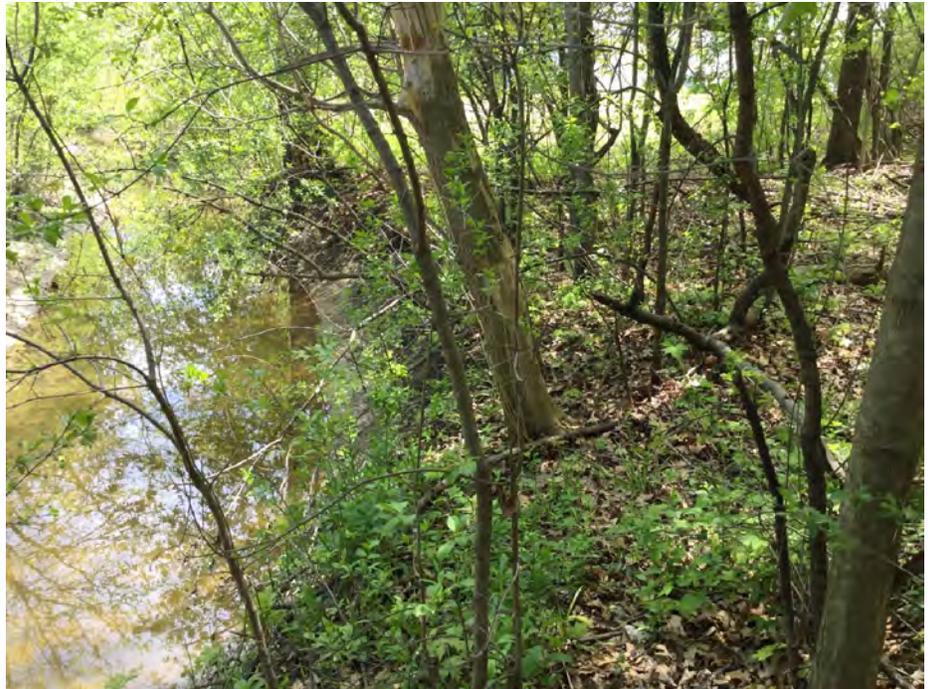
Photo 1

Both sides. Next 200 ft. 7 trees. Up to 18" diam.

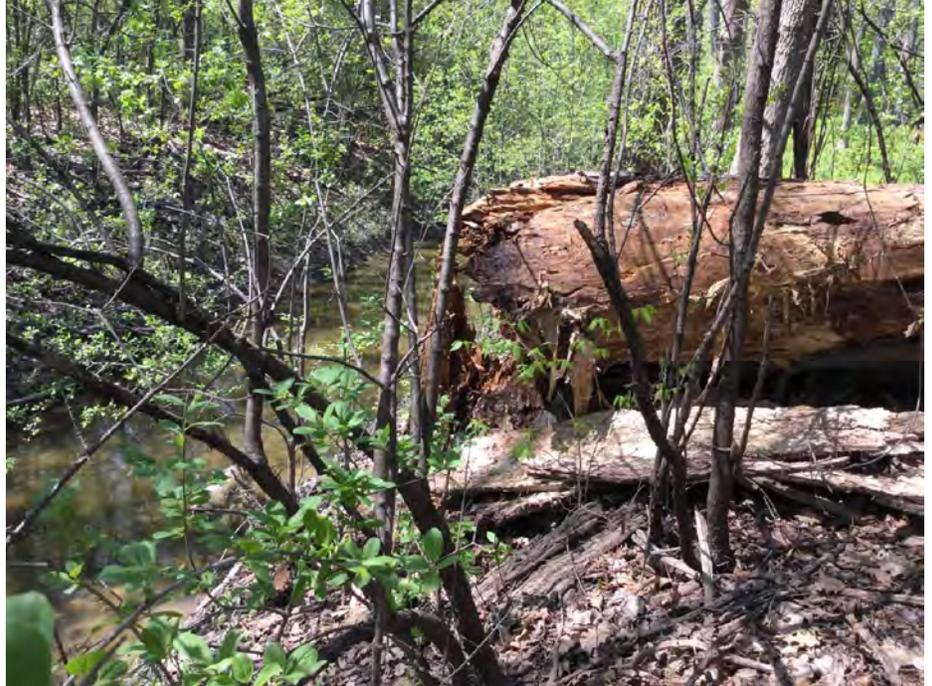
Photo 1

Photo facing downstream. Large stump. 48" diam. Left side.

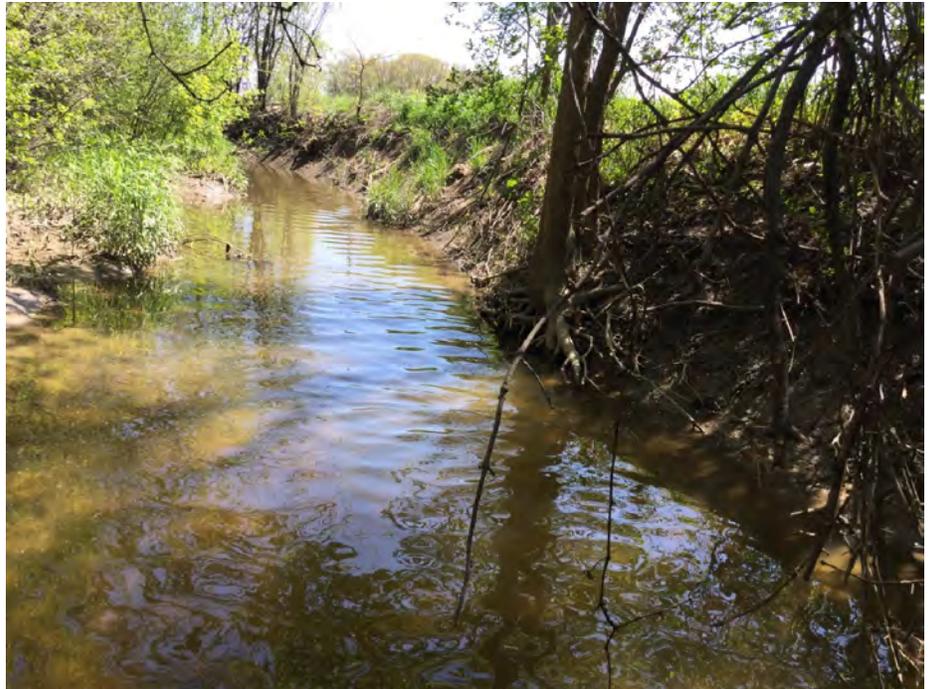
Photo 1

3 trees up to 8" diam on both sides.
Photo facing upstream.

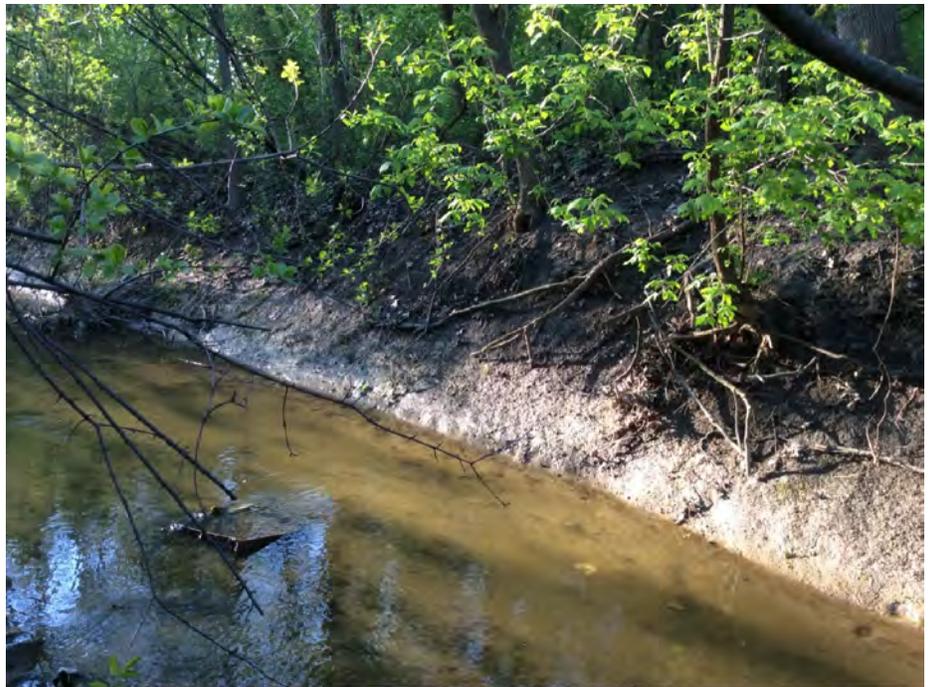
Photo 1

7 trees in v on right side up to 8" diam.
Photo facing upstream.

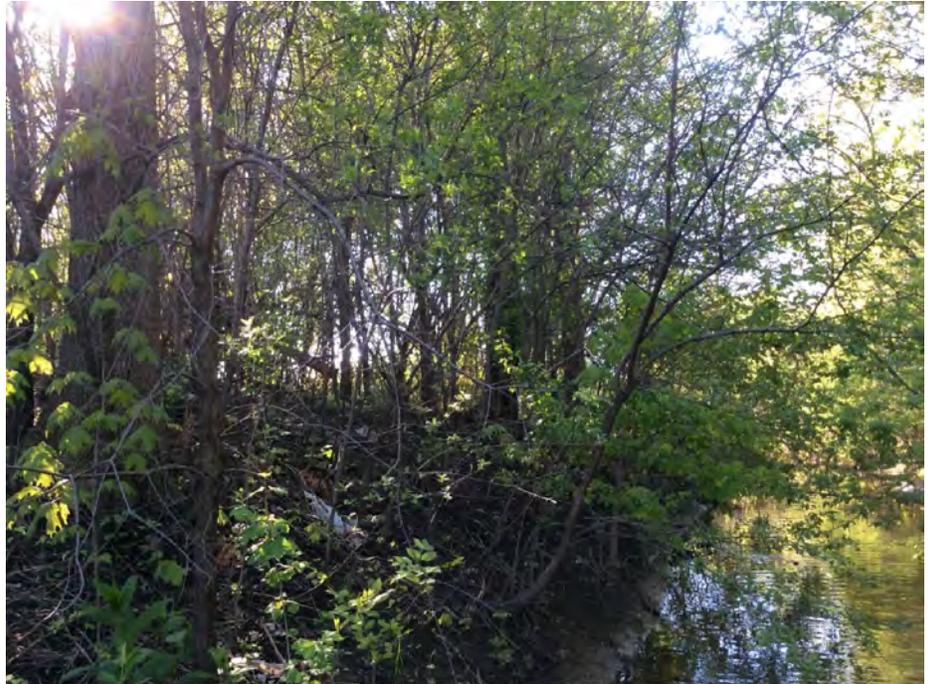
Photo 1

5 trees next 300 ft on both sides. Up to 18" diam. Photo facing upstream.

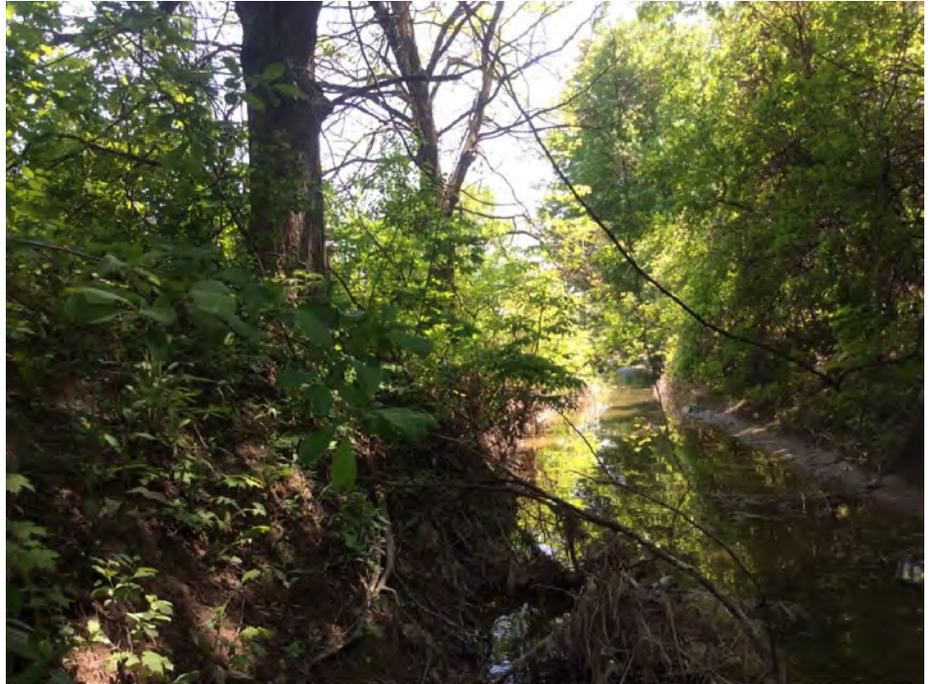
Photo 1

12 trees over next 350 ft. Both sides, up to 18". Photo facing upstream.

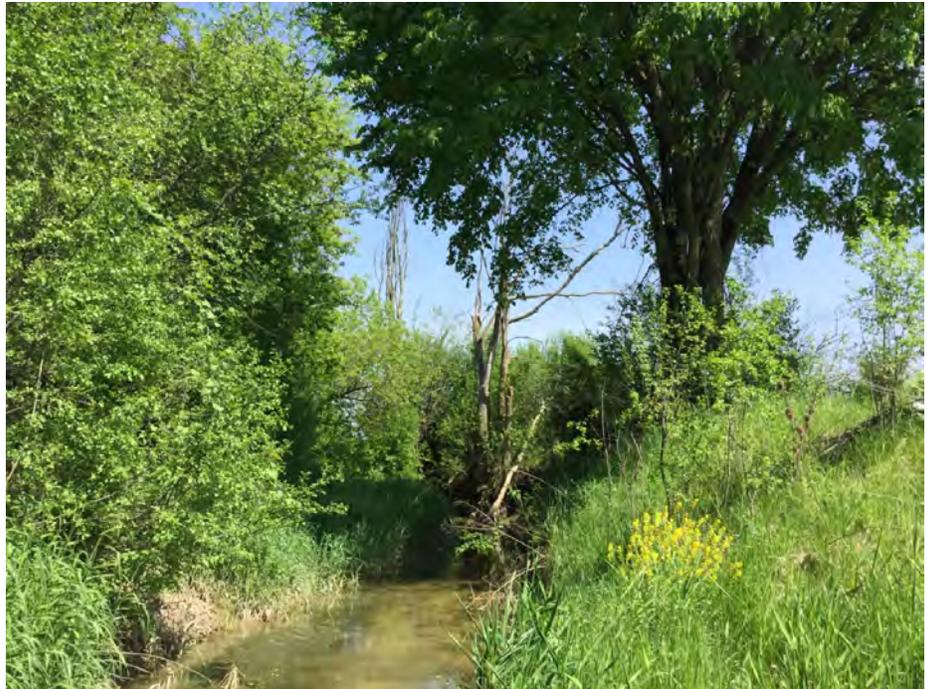
Photo 1

Large tree. South of drain about 10 ft up bank from drain. Photo facing upstream.

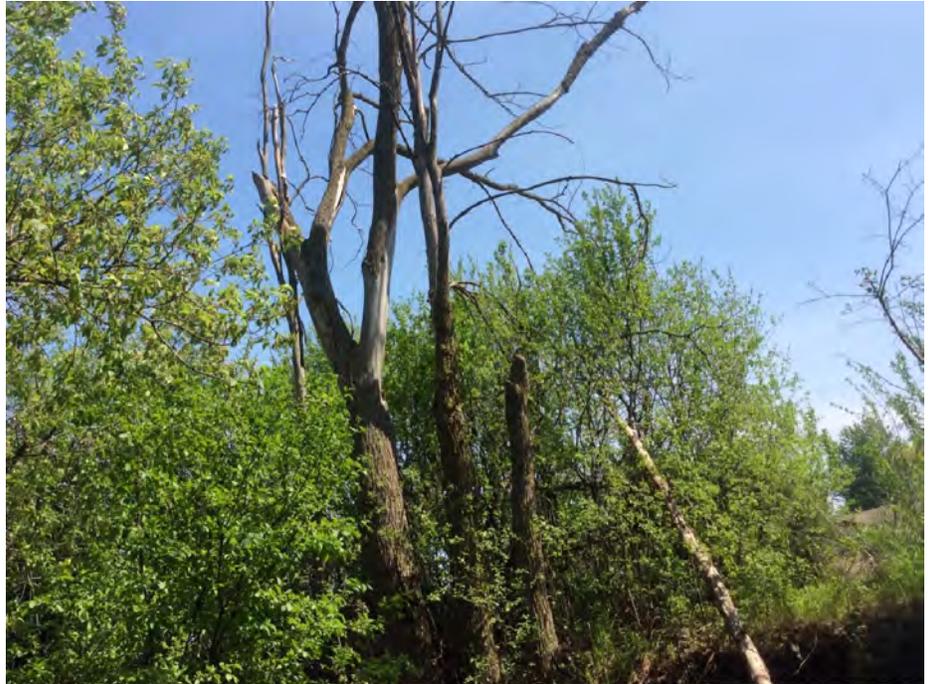
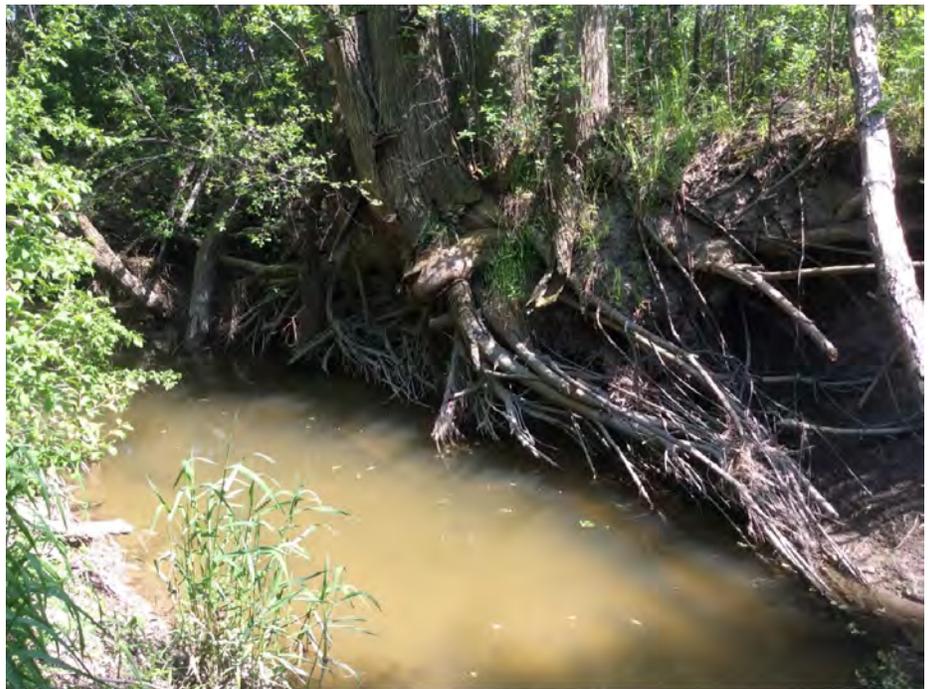
Large dead tree on right side. Approx 40" diam. Bank erosion severely undercutting. And exposing tree roots. Photo facing upstream.

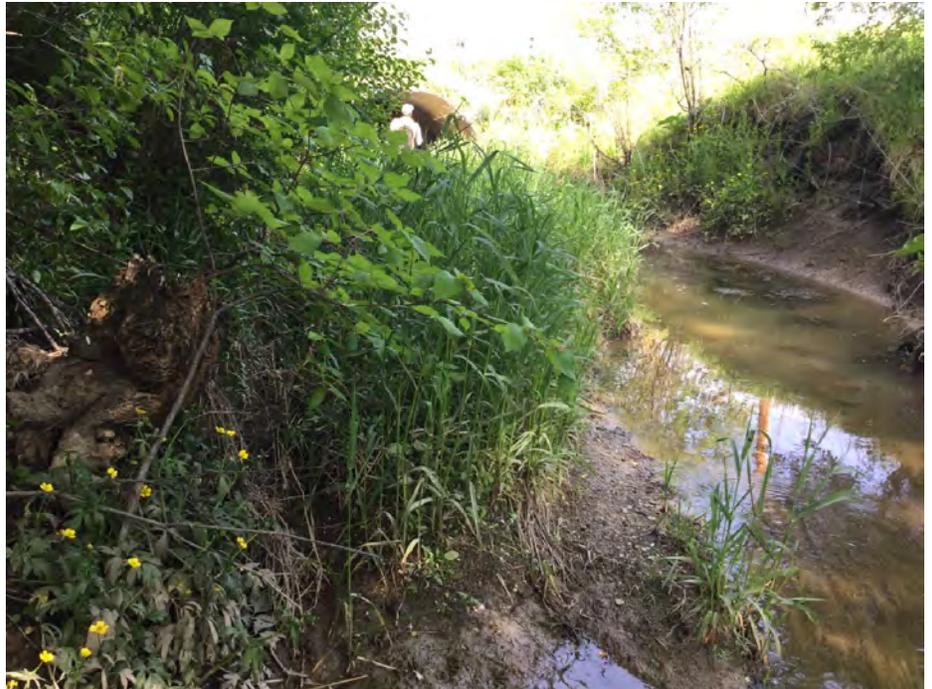
Photo 1

Individual stump on left side of drain.
About 20 in. diameter. Photo taken facing upstream.

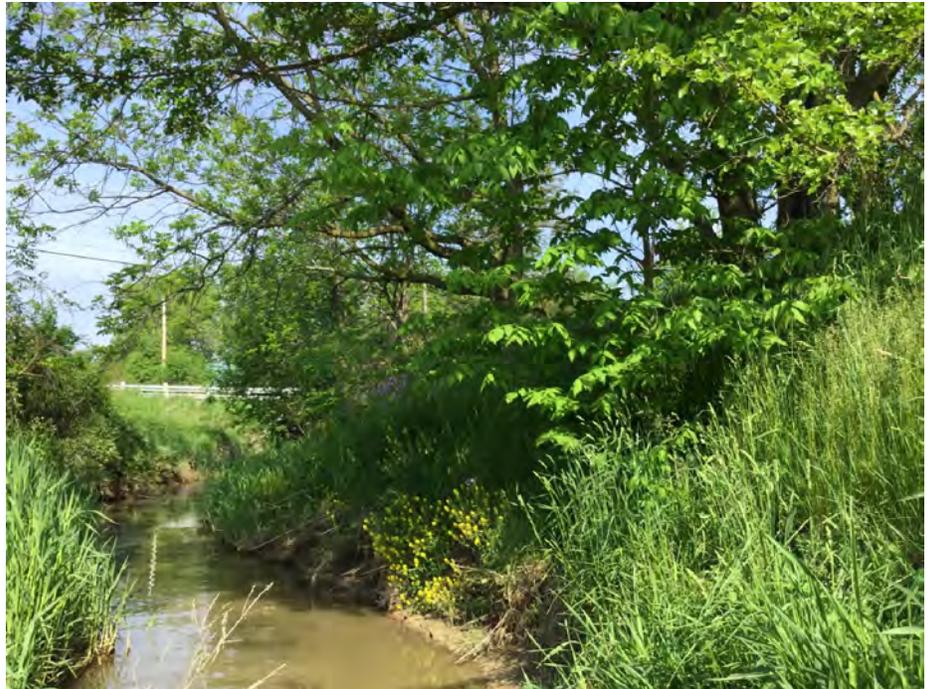
Photo 1

Overhanging trees on left side of drain facing upstream. About 20 in. diameter. Photo taken facing downstream.

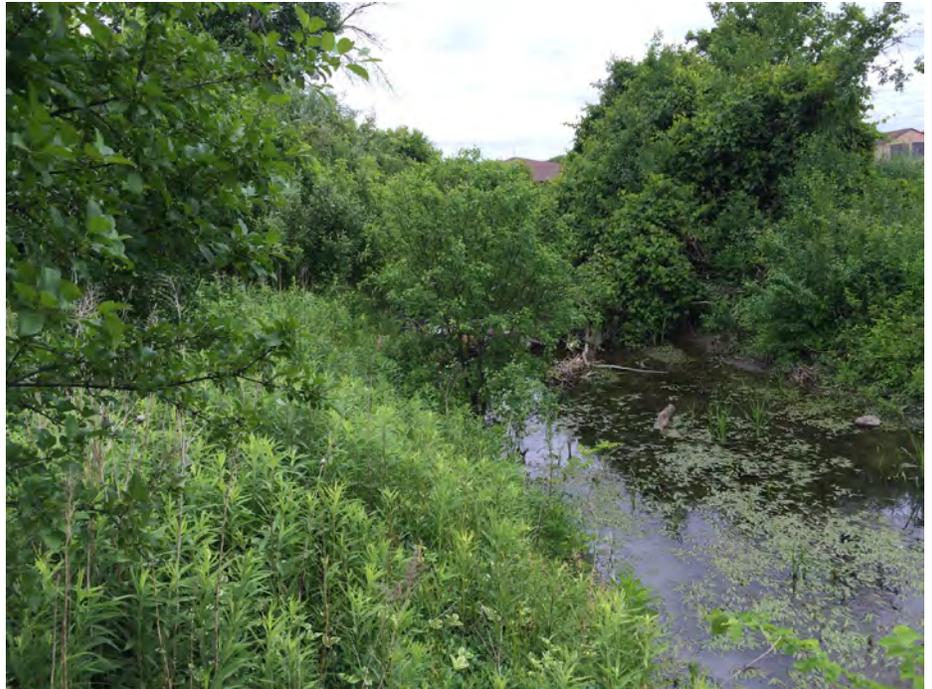
Photo 1

5 trees 3" -8" diam on left side of drain.

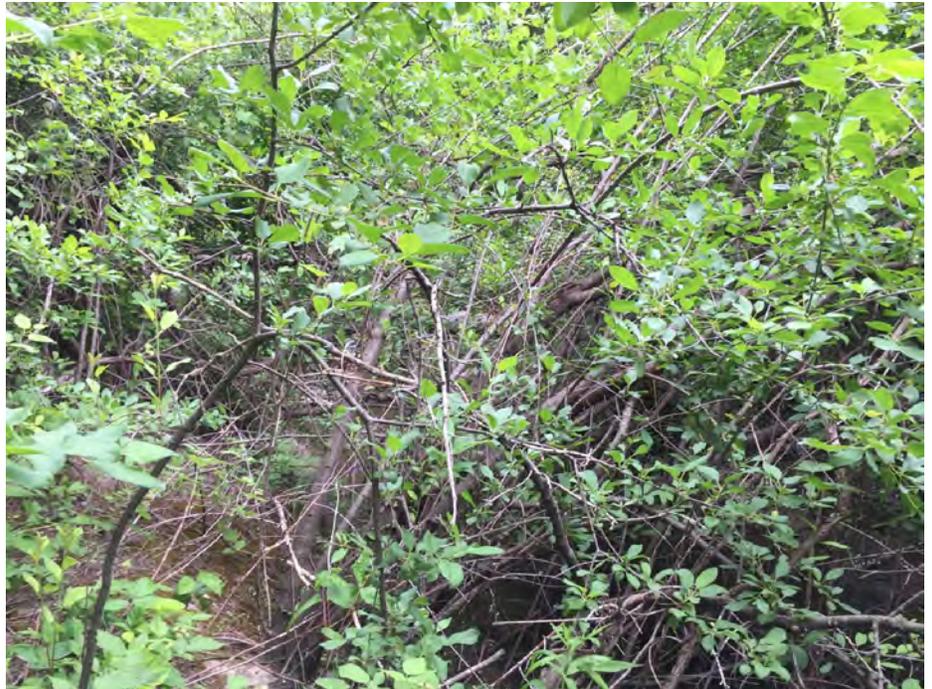
Photo 1

10-20 trees on both sides of the v for next 50'. 6-8" in diameter.

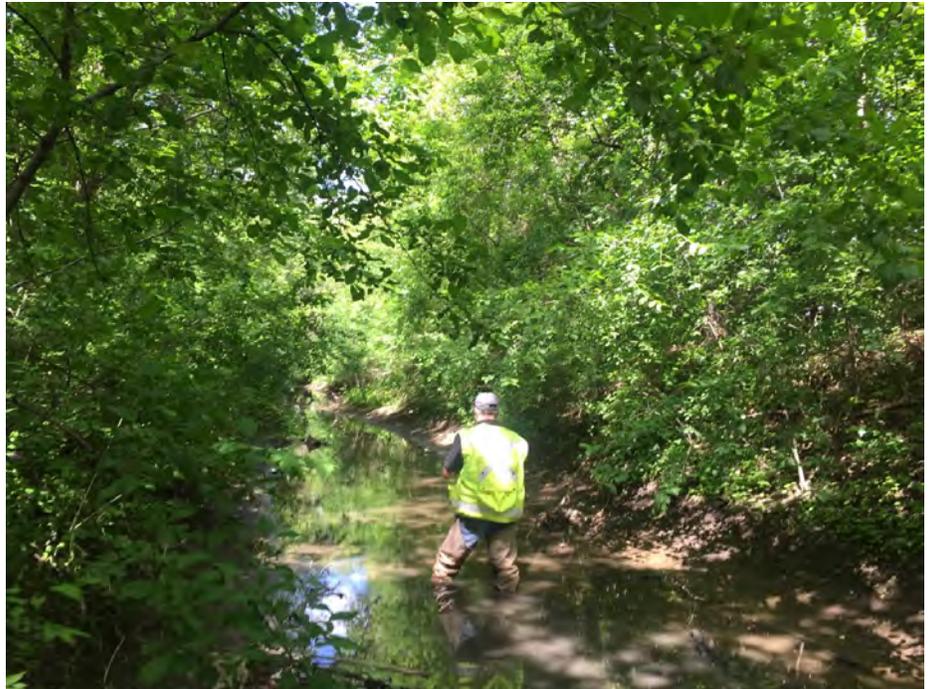
Photo 1

Trees in the v for the next 350' on both sides of drain ranging from 3-18".

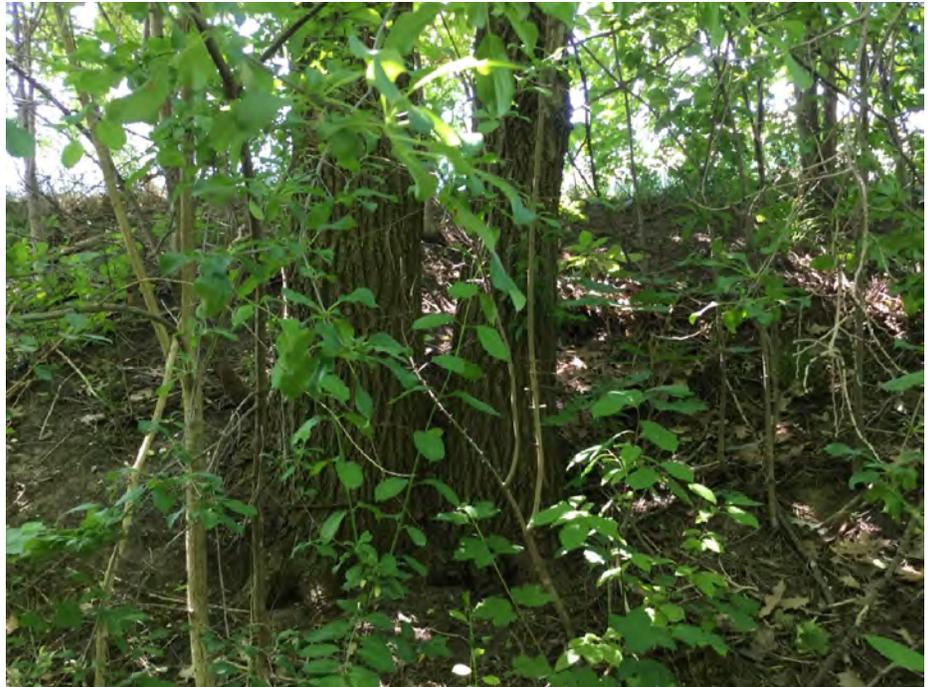
Photo 1

22 trees 3" to 30" diam in v over next 1000 ft up to Dixie hwy.
