King Street Tile Drain Inspections

Inspection Report for Observation:
Tree1

HUBBELL, ROTH & CLARK, INC CONSULTING ENGINEERS SINCE 1915	555 Hulet Drive P.O. Box 824 Bloomfield Hills, MI 48303-0824 (248) 454-6300 http://www.hrc-engr.com	DATE:	08/16/2016
				SCALE:	
NOTE				SHEET #:	
				JOB #:	20160331

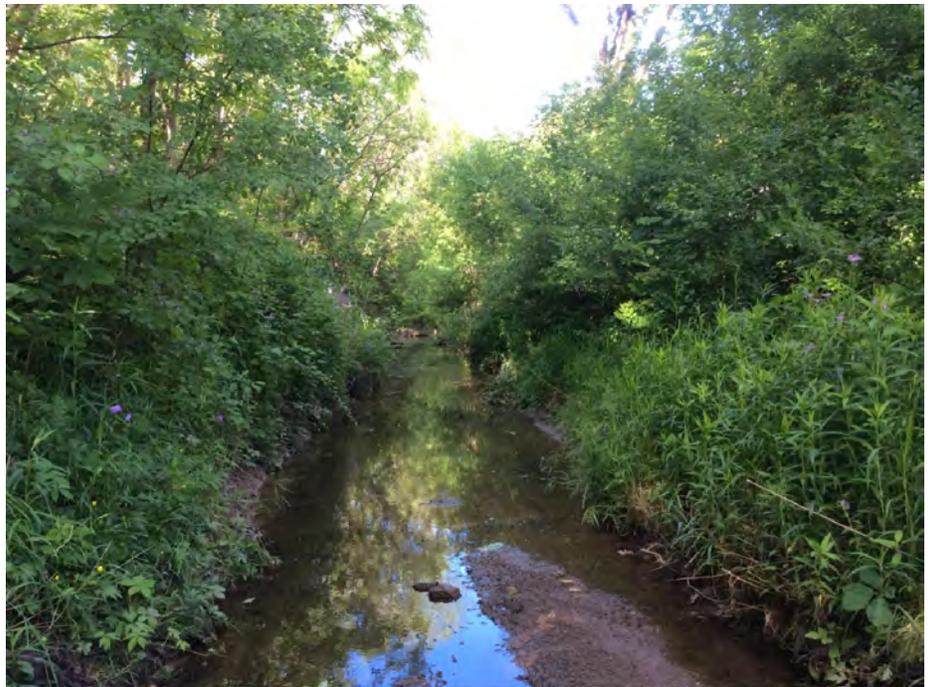
Photo 1

Excessive trees overhanging on both sides of drain over 3" diameter. About 10-20 for 80 ft.

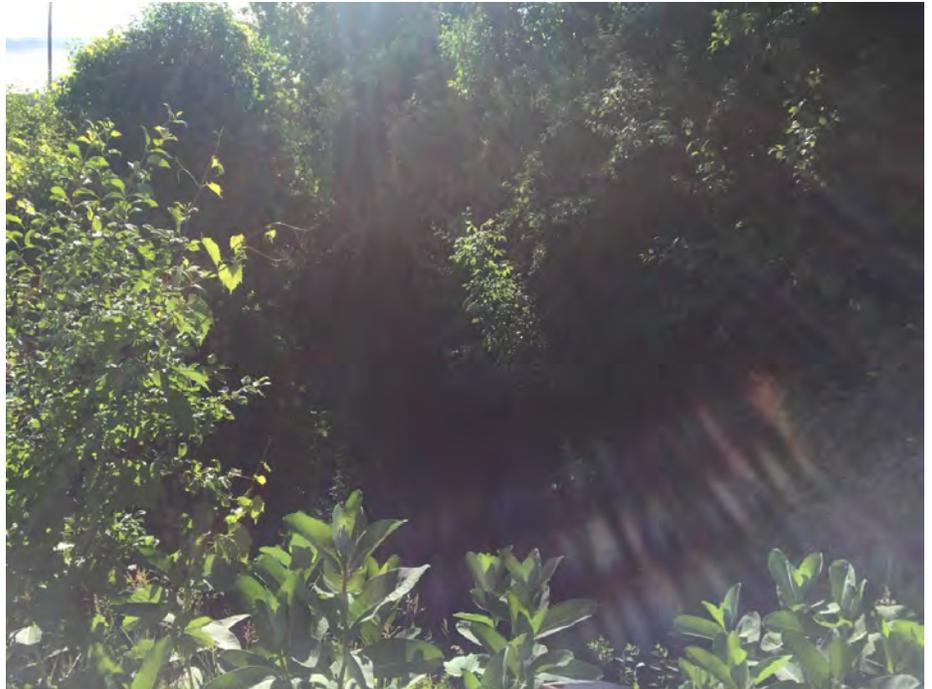
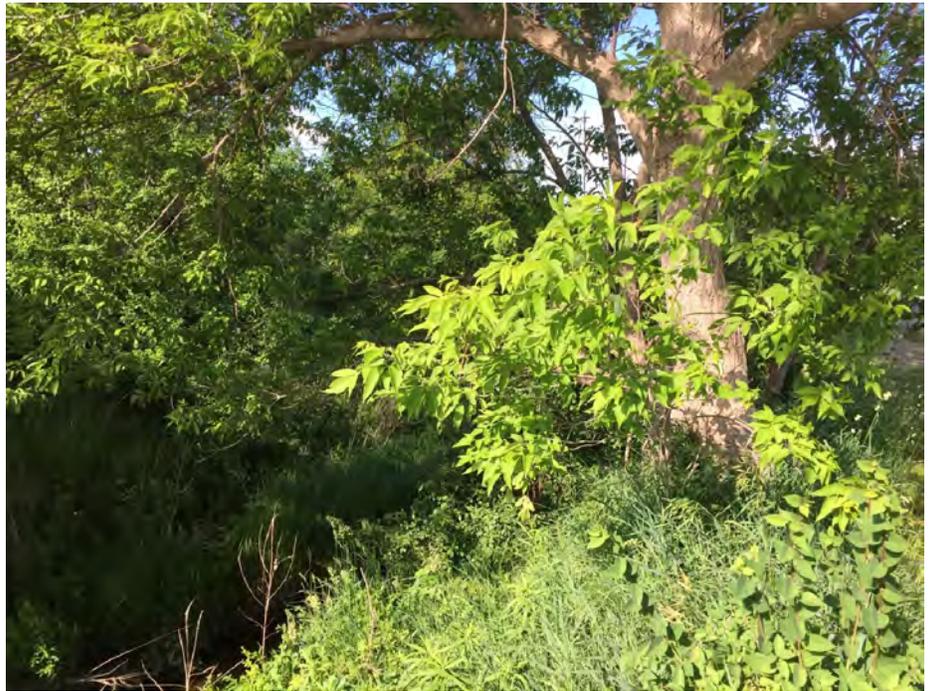
Trees in the v with grouping 20-30 with dia. 3-18" for next 450' to end. Photo 1 facing upstream from upstream end. Photo 2 facing downstream from downstream end.

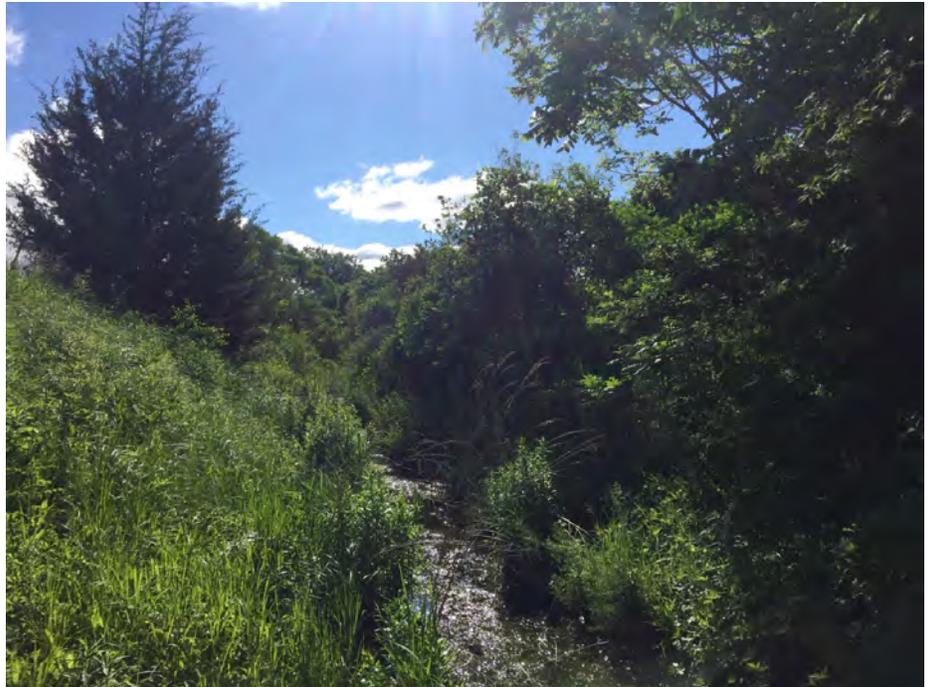
Photo 1

Trees in v on both sides of drain with less than 10 grouping, 3-18" dia. for next 300' to end. Picture facing upstream.
