King Street Tile Drain Inspections

Inspection Report for Observation:
Utility1

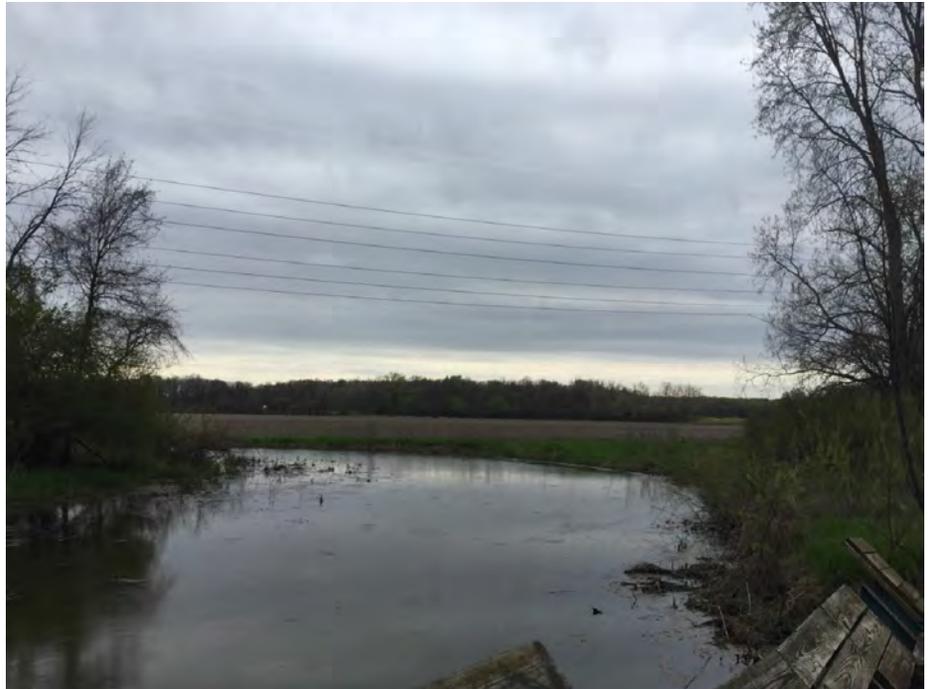
Photo 1

Type: Electric

Location: Overhead

Photo taken facing upstream.

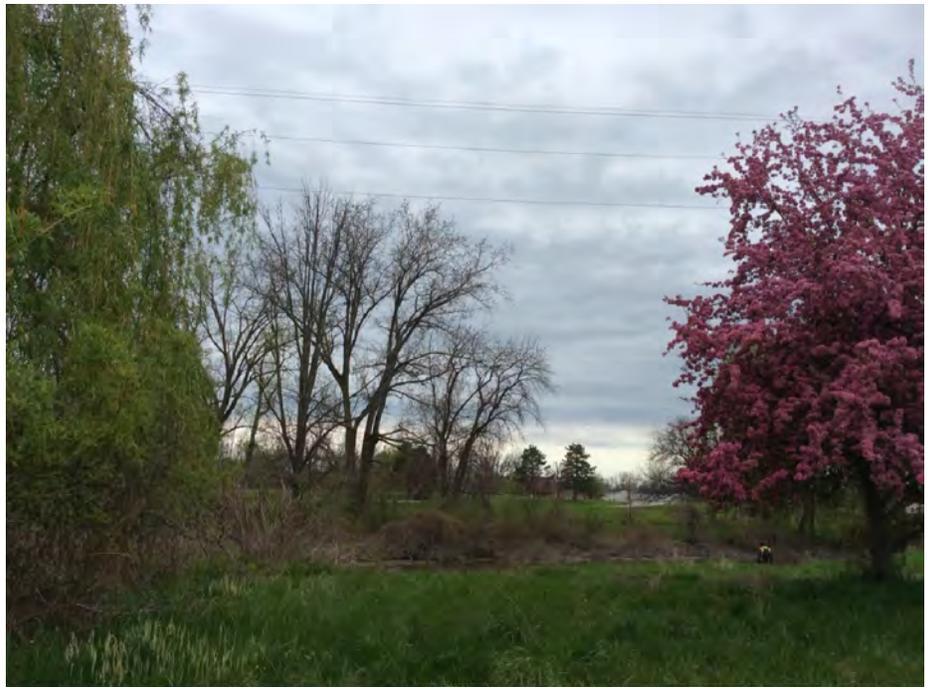
Photo 1

Type: Electric

Electric 40'

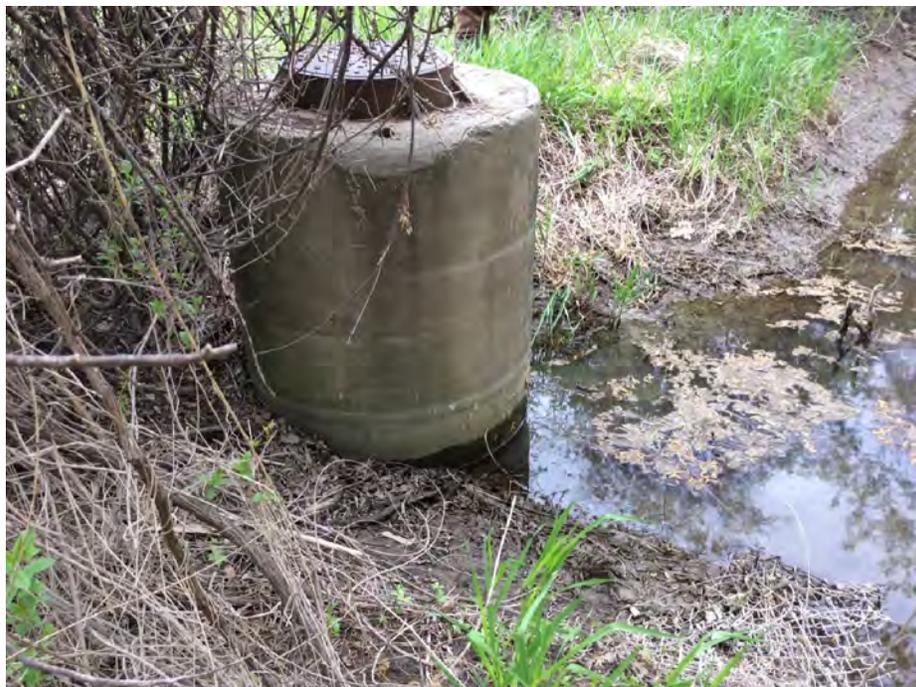
Photo 1

Type: Storm Manhole

Length (inches): 40

Upstream left side erosion at base

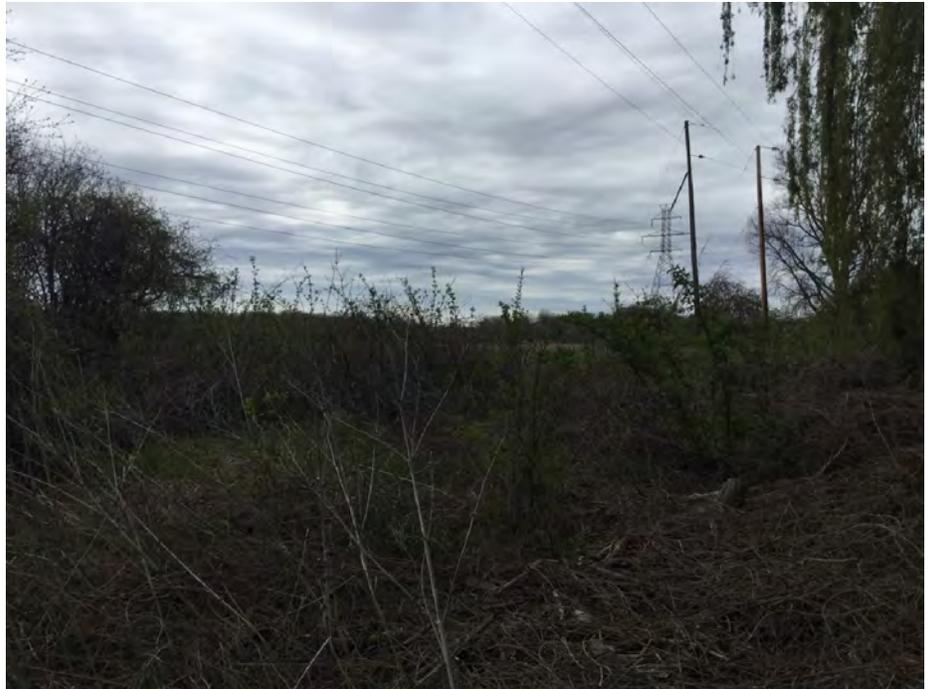
Photo 1

Type: Electric

Photo taken facing southwest. 2 different overhead areas.

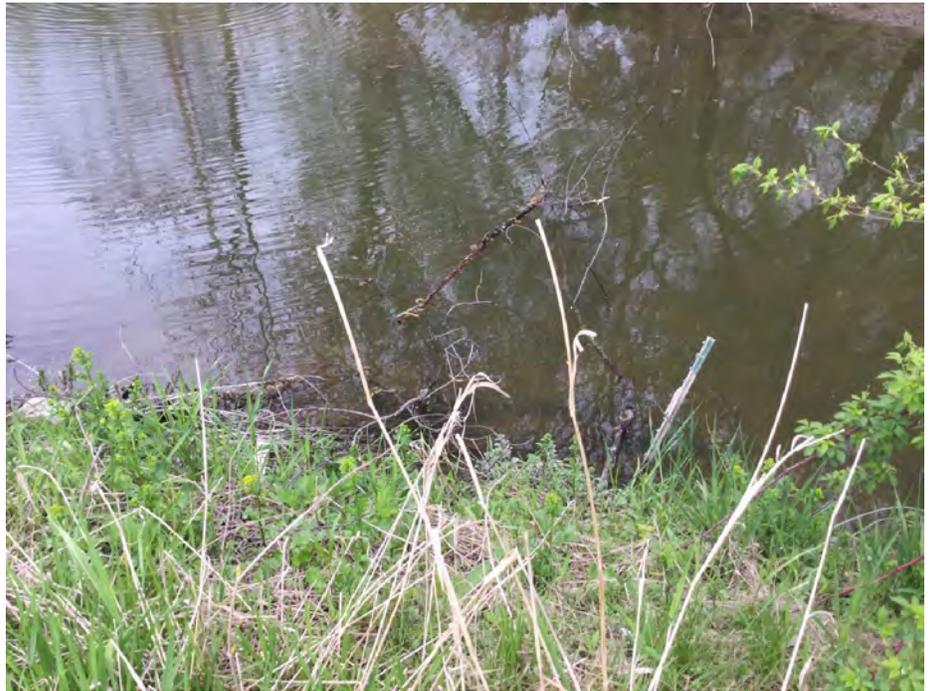
Photo 2

Type: Gas

Gas pipeline markers on left side facing upstream. Could be an old marker. Photo taken facing south.

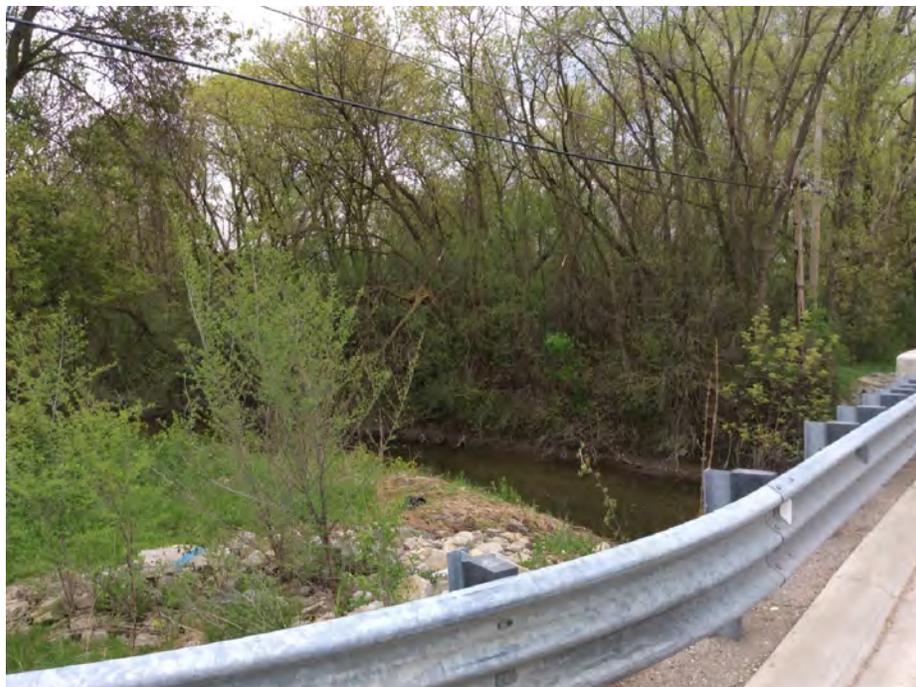
Photo 1

Type: Electric

Downstream 15' overhead east side of m-13

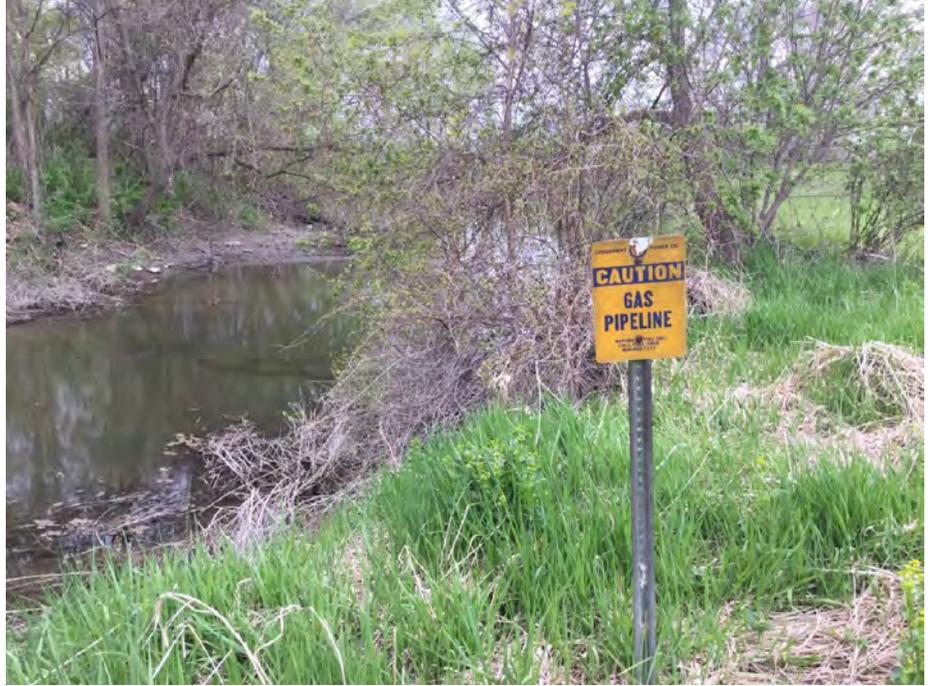
Photo 1

Type: Gas

Marker for gas pipeline. On left side facing upstream. Photo taken facing downstream.

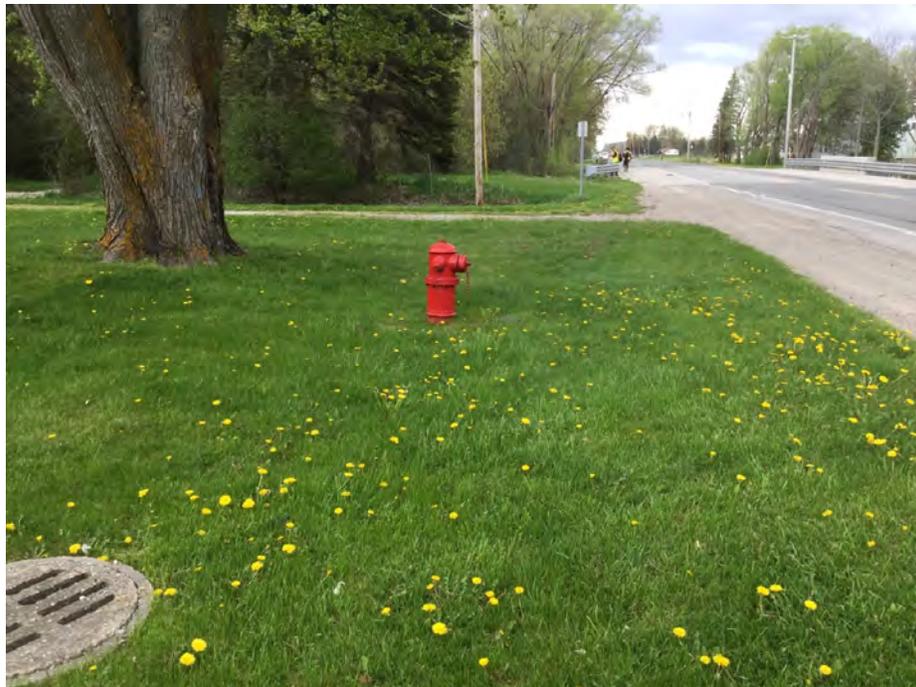
Photo 1

Type: Water Main

150 ft north of drain. Photo taken facing south.

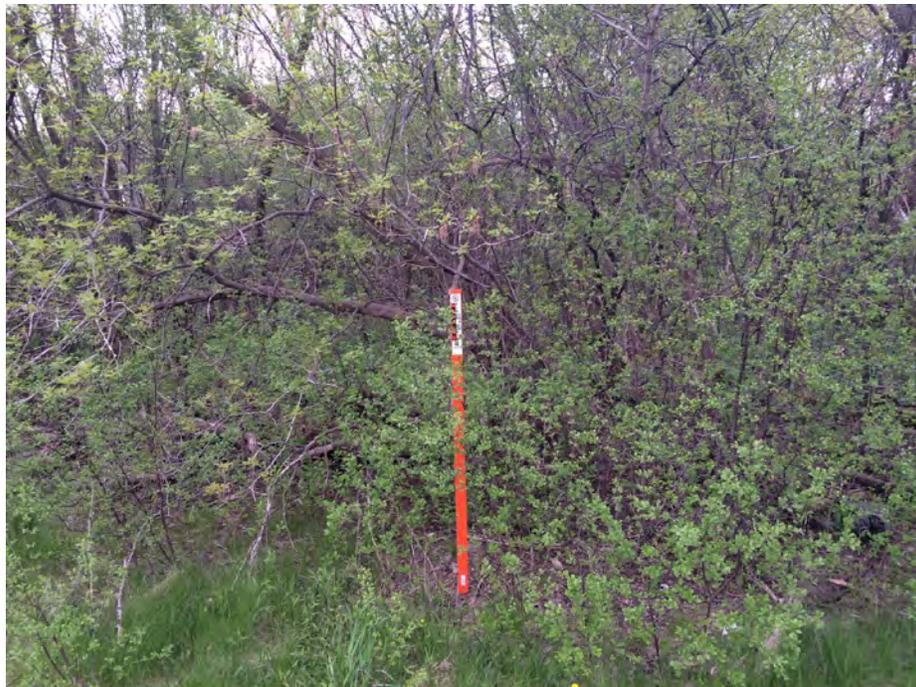
Photo 1

Type: Fiber Optics

Underground. Marker is approx 50 ft right of drain, on east side of M13.

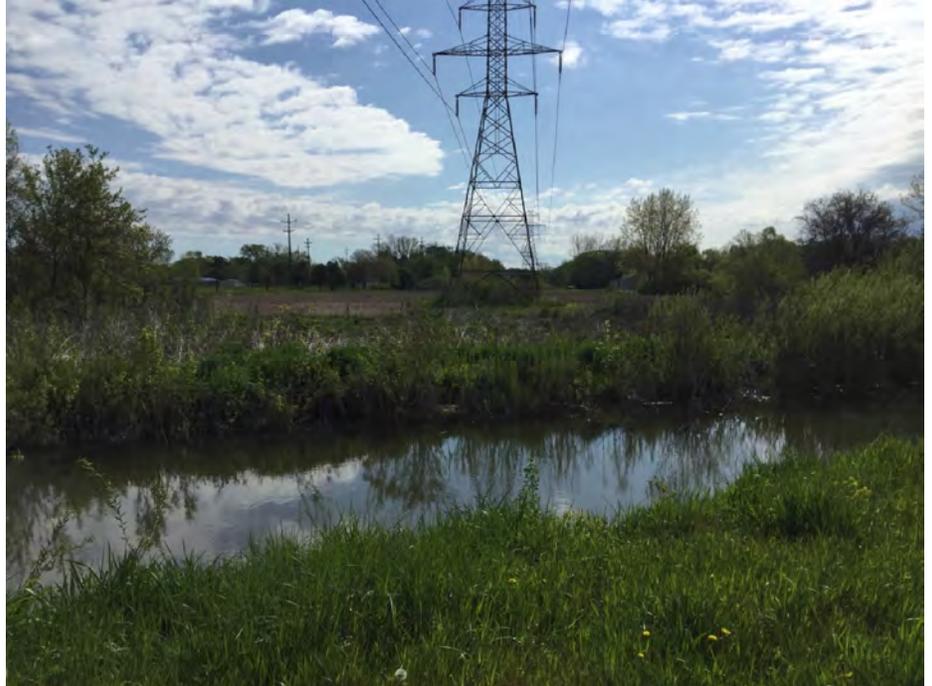
Photo 1

Type: Electric

High tension electric power line crossing the drain. Picture facing East.

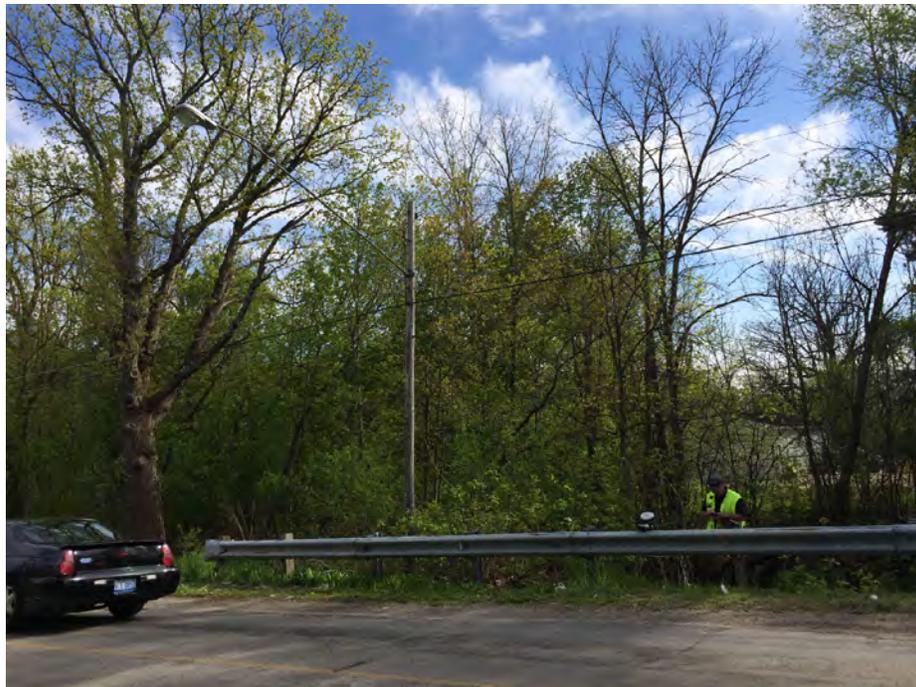
Photo 1

Type: Electric

Overhead utility with light on southwest side of Washington. Photo facing south.

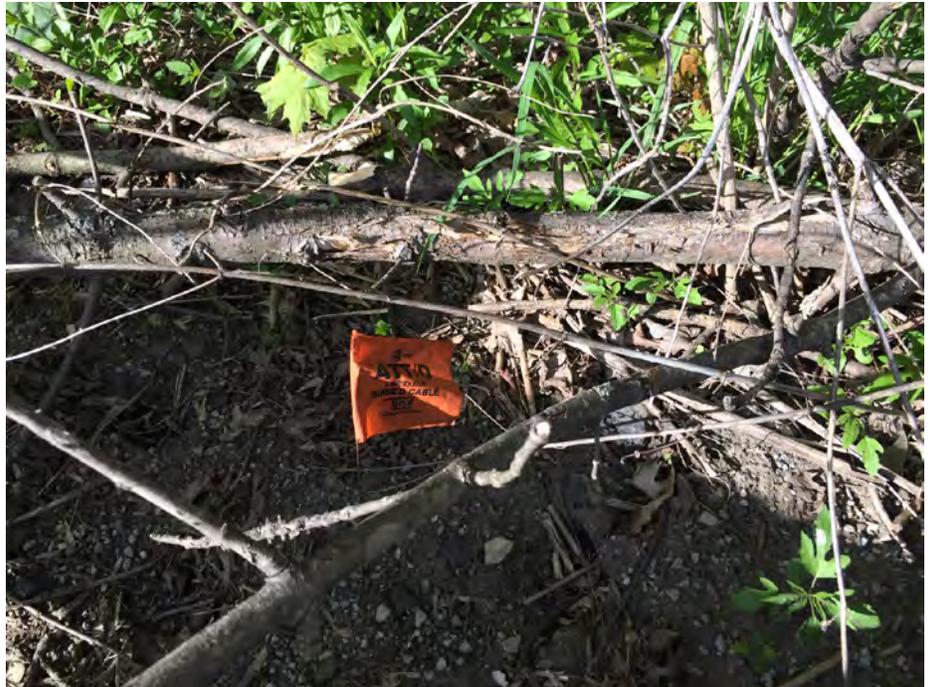
Photo 1

Type: Phone

At&t buried cable marker. 20 ft to right of drain on northeast side of Washington rd.

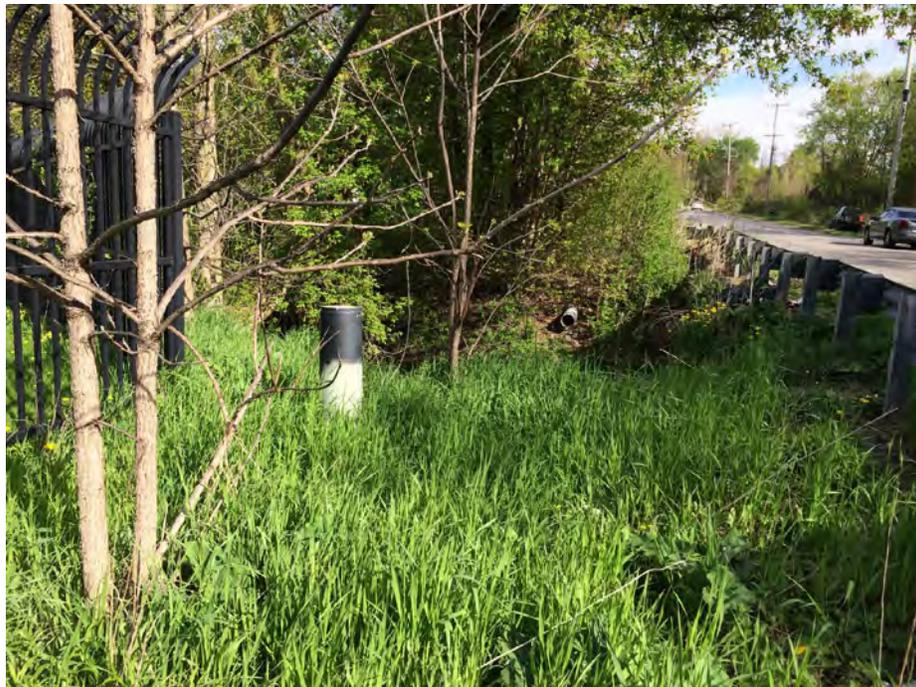
Photo 1

Type: Other

10 ft on left side of drain. Unnamed pedestal. Photo facing southeast

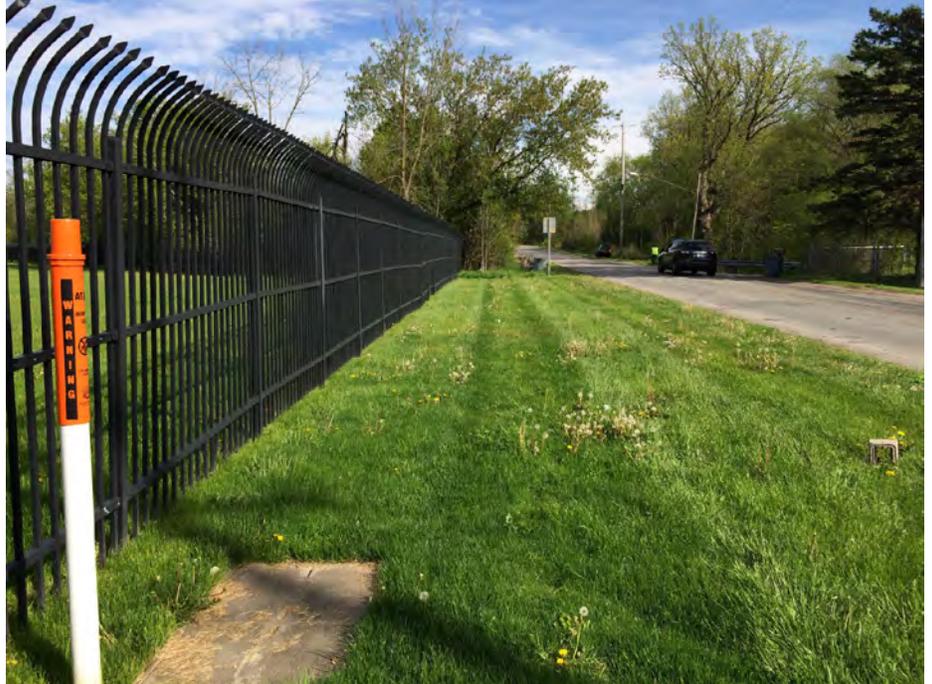
Photo 1

Type: Phone

At&t marker for buried cable 100 ft to left of drain. Photo facing southeast.

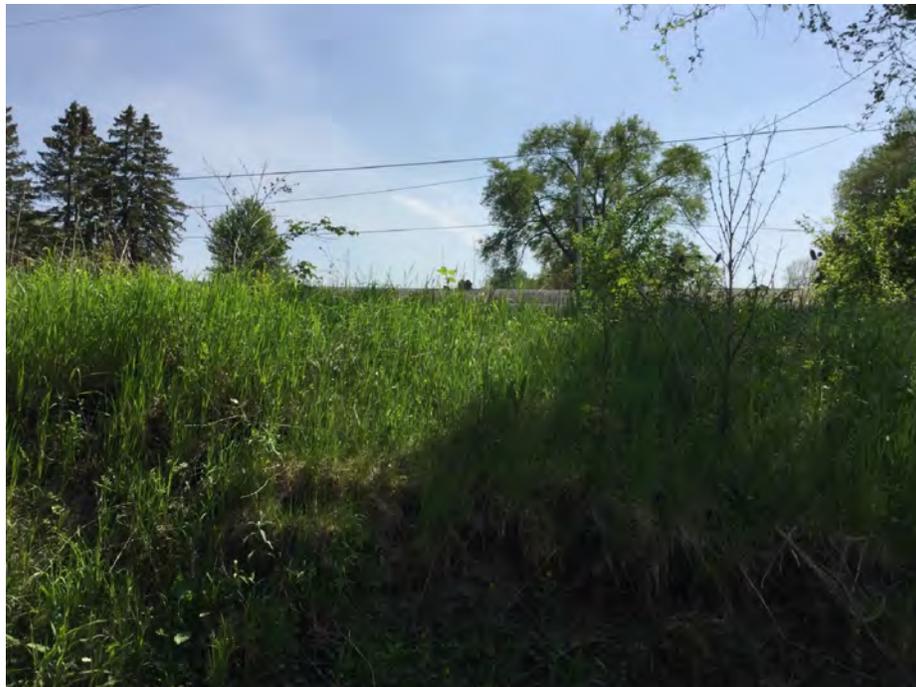
Photo 1

Type: Electric

Electrical line overhead about 15 ft south of drain. Photo taken facing south.

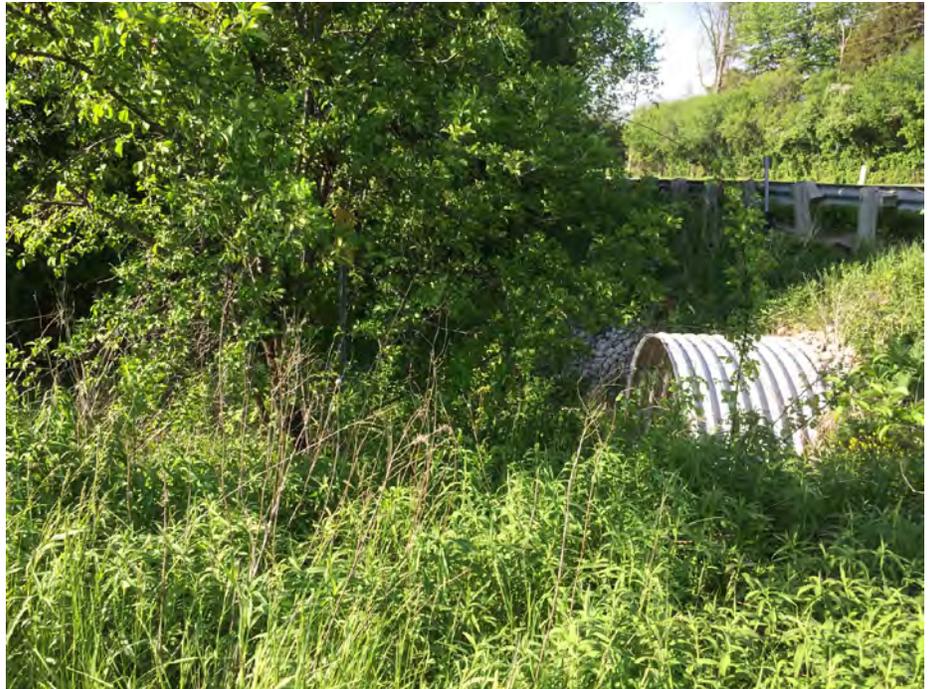
Photo 1

Type: Gas

Gas pipeline marker 10 ft right of drain.
On right side. Photo facing north.

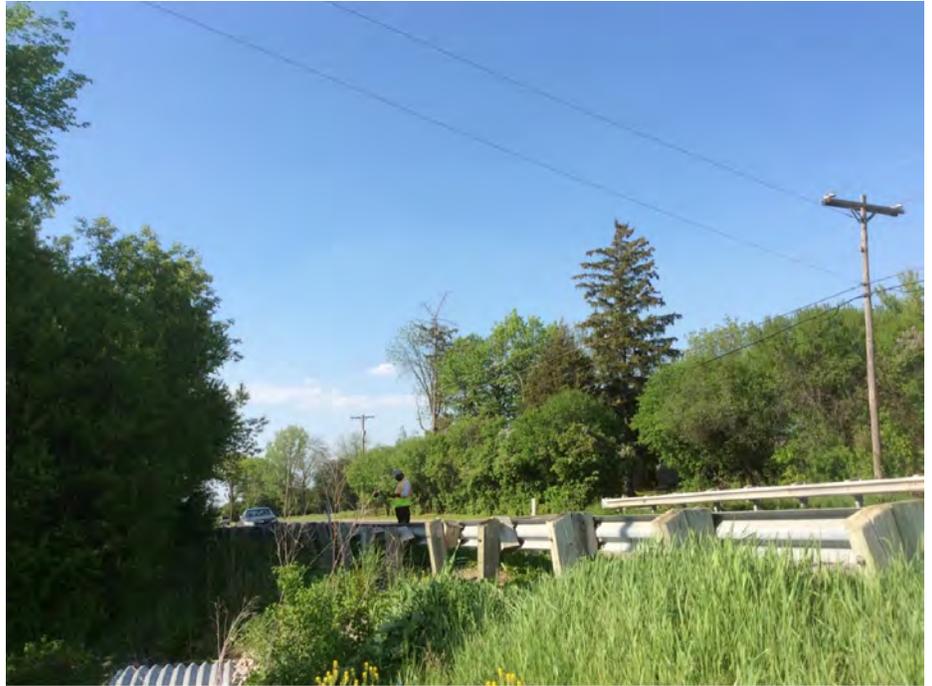
Photo 1

Type: Electric

Electric overhead crossing over culvert same direction as drain. Photo taken facing northeast.

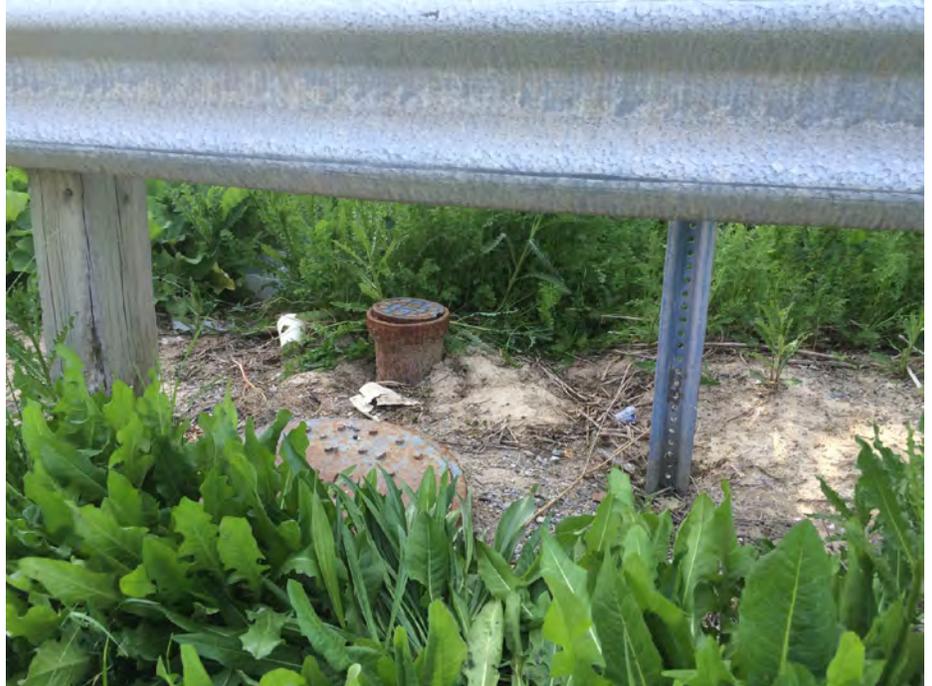
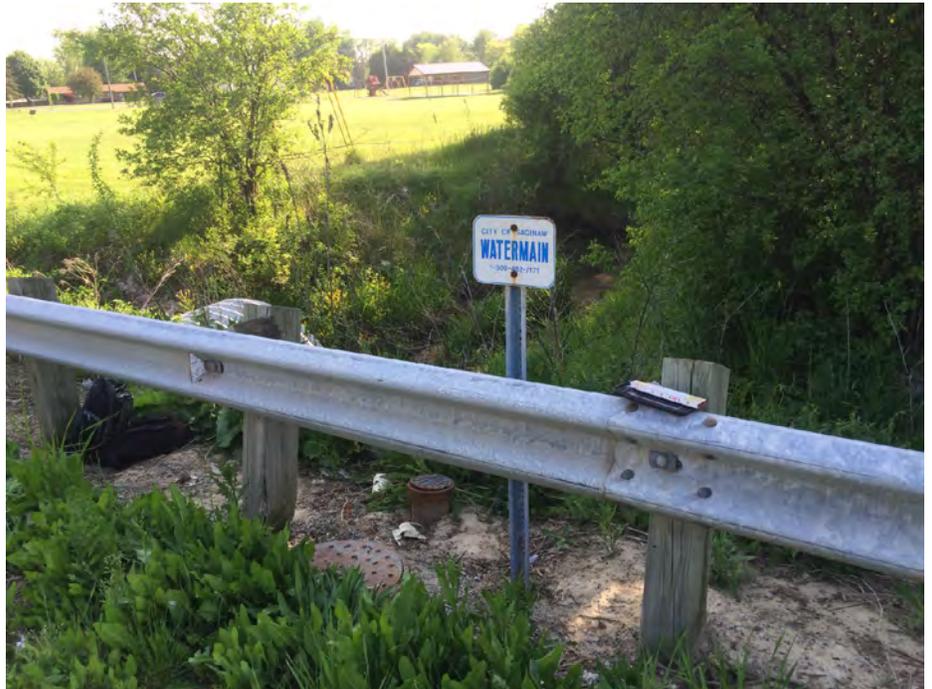
Type: Water Main

Water main manhole and sign 15 ft left of drain. On left side, wwest side of sheridan rd. Photo facing west.

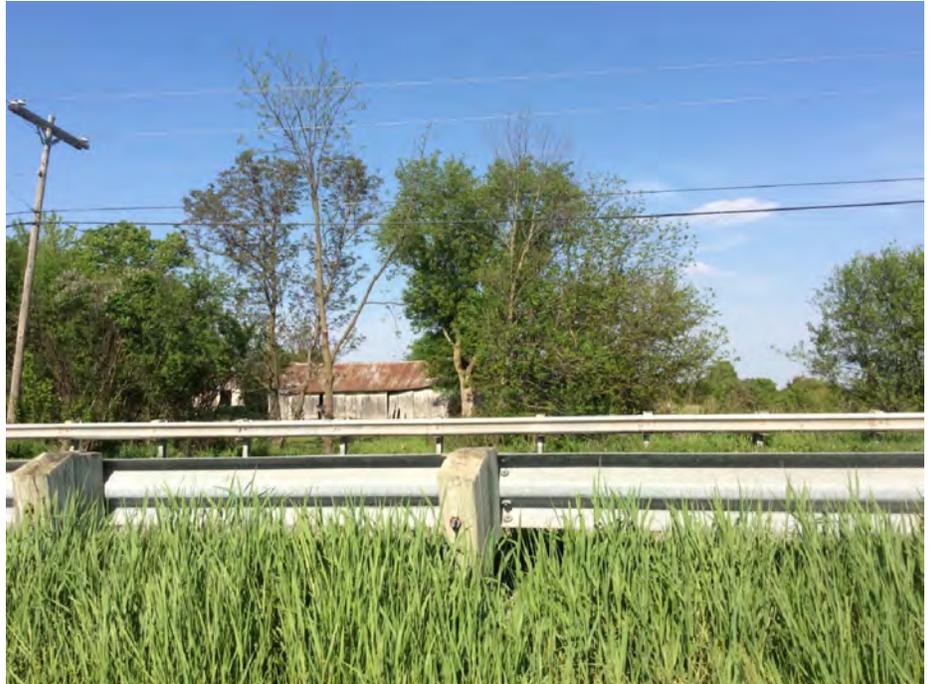
Photo 1

Type: Electric

Overhead electric perpendicular to drain crossing. Photo taken facing east.

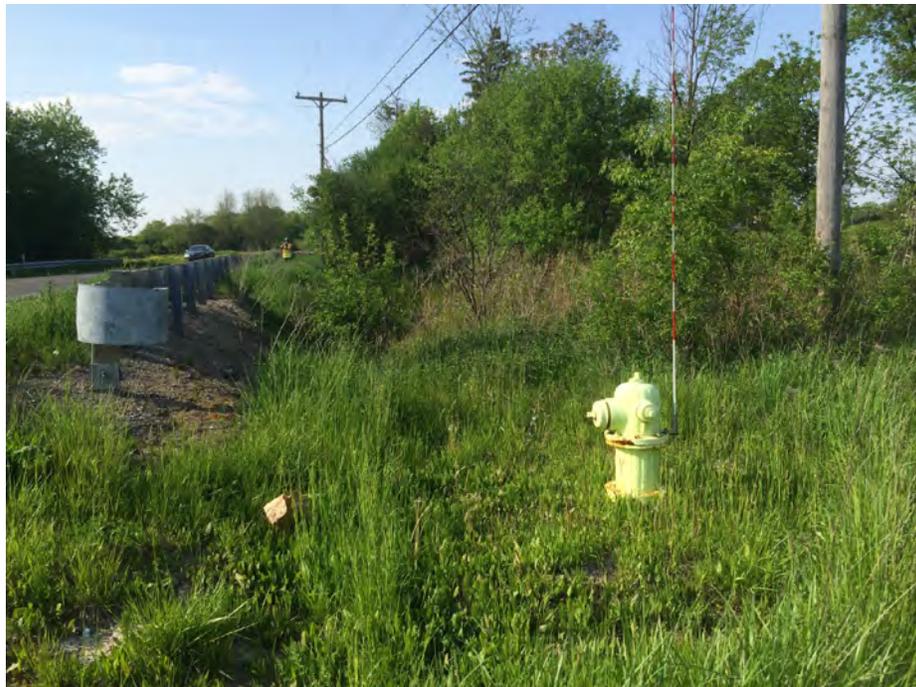
Photo 1

Type: Water Main

Fire hydrant 100 ft right of sheridan rd.
On east side. Photo facing north.

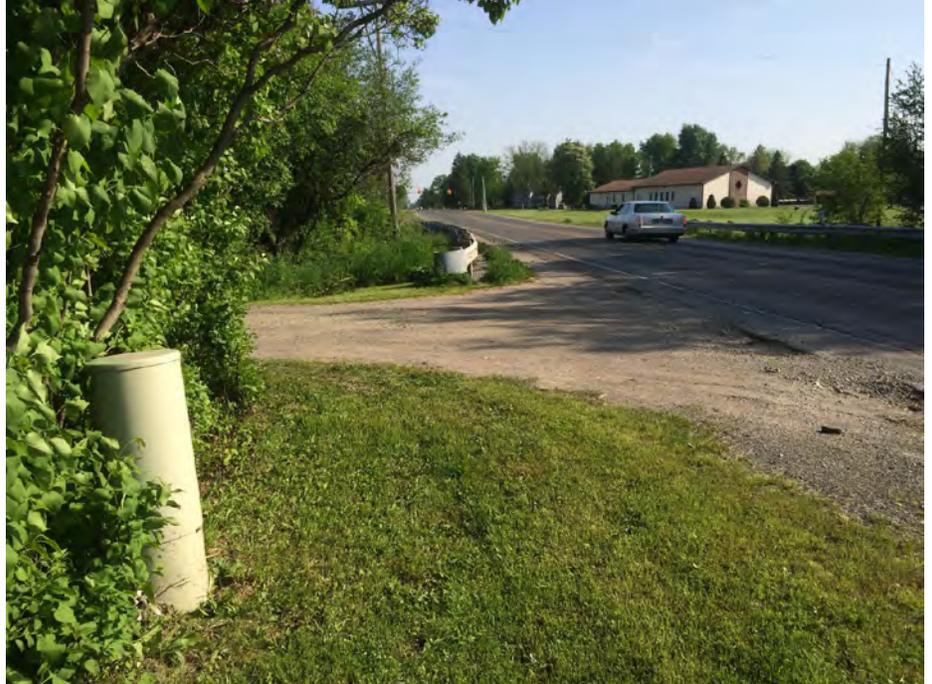
Photo 1

Type: Other

100 ft away On left side of drain. On east side of sheridan rd. Might be cable. Photo facing south.

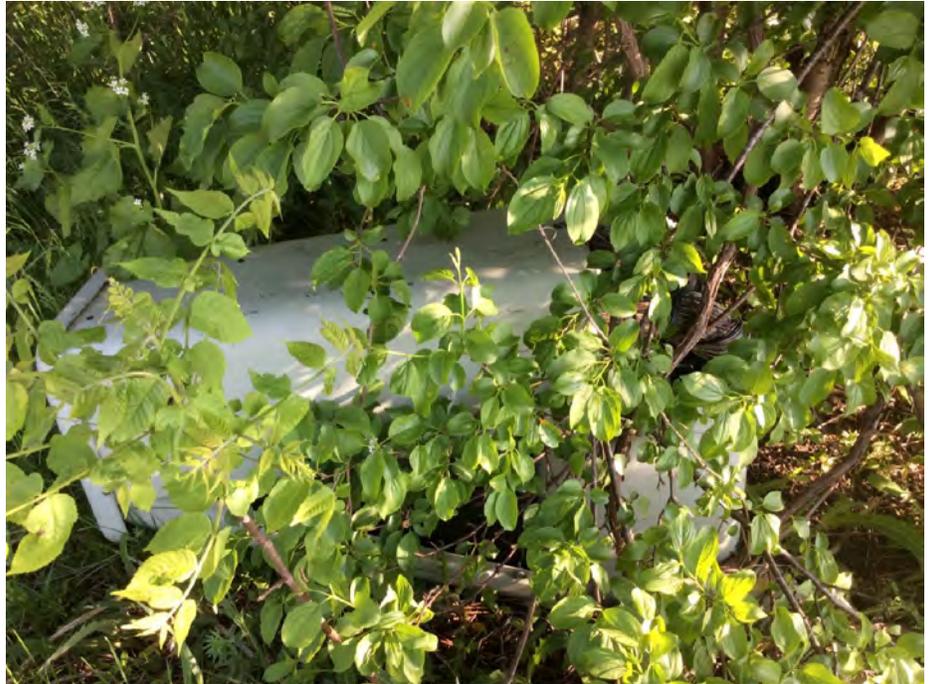
Photo 1

Wrapped up wires in utility box intertwining with tree branches. West of Sheridan Rd. 100 ft left of drain. Photo taken facing southwest.

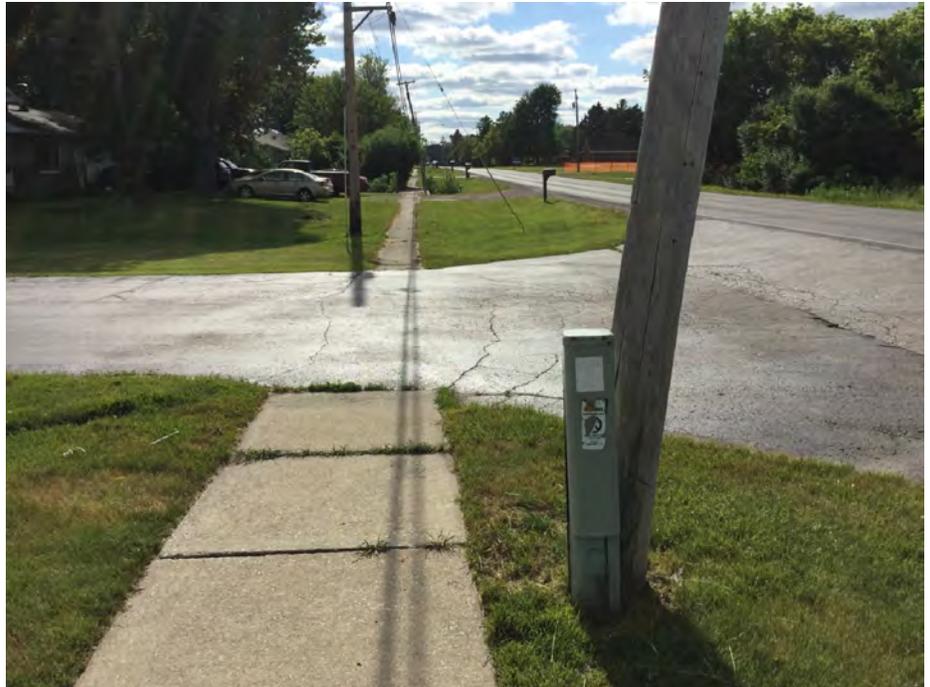
Photo 1

Type: Phone

Underground cable 170 ft to right of drain. On south side of King st.

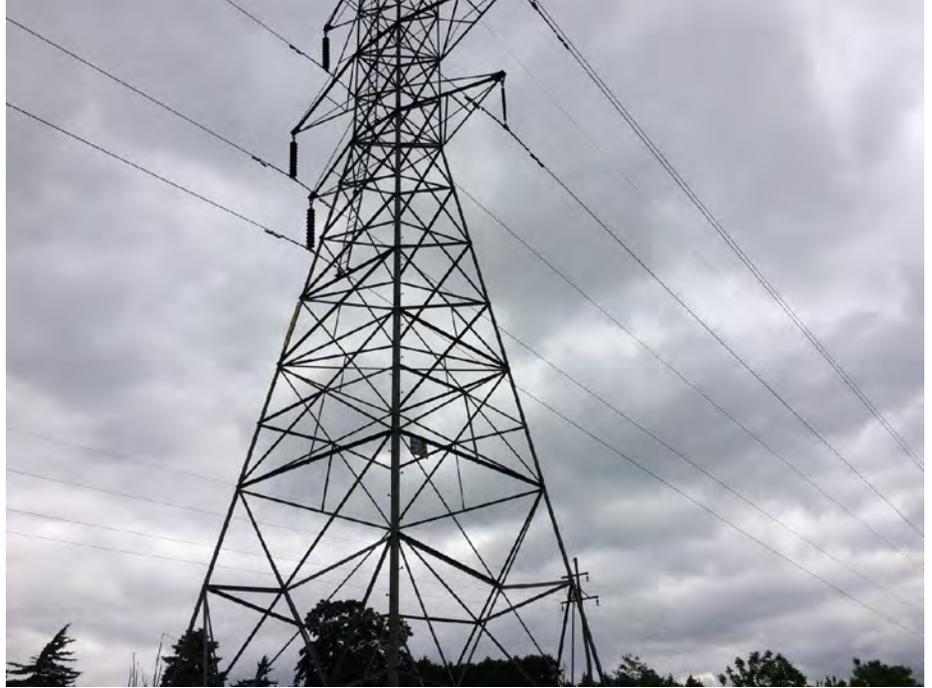
Photo 1

Type: Electric

Electric pole about 100 ft tall on left side of drain.

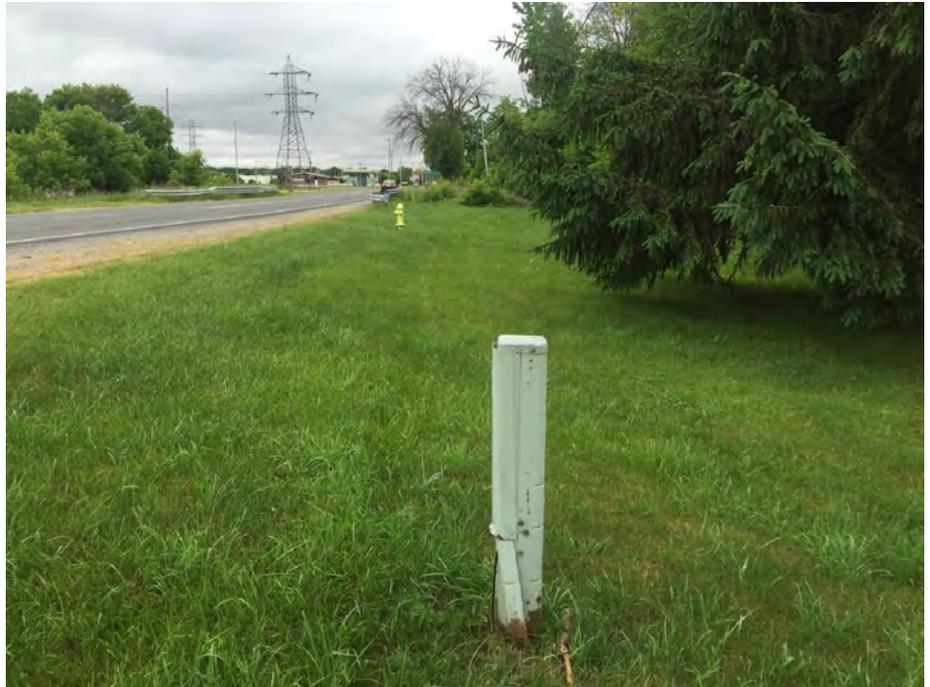
Photo 1

Located 131' northwest of the drain.
Picture facing southeast across the drain.

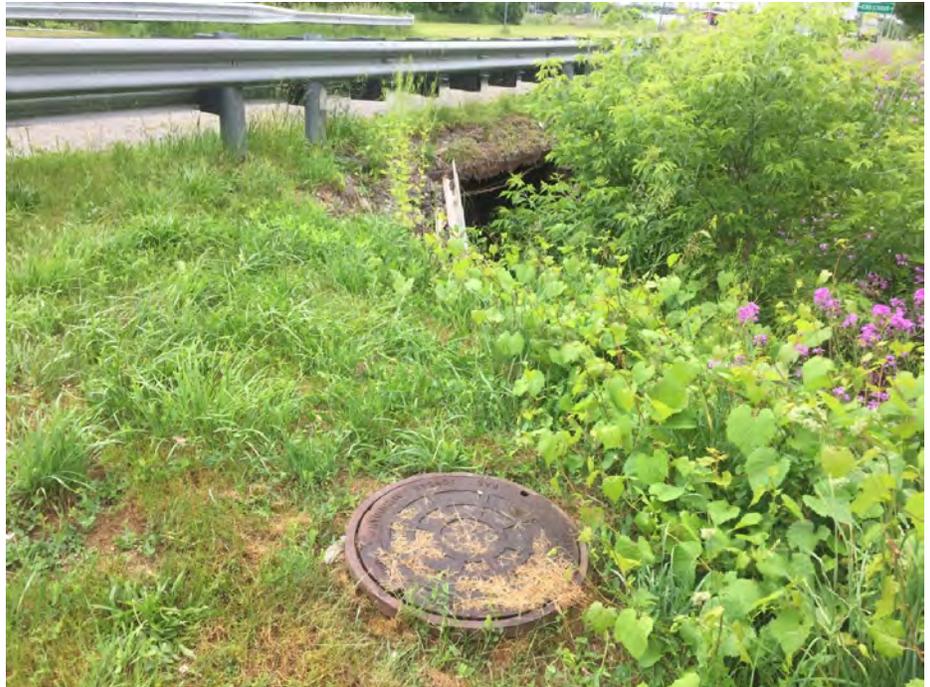
Photo 1

Storm manhole within 10' of northeast side of drain.

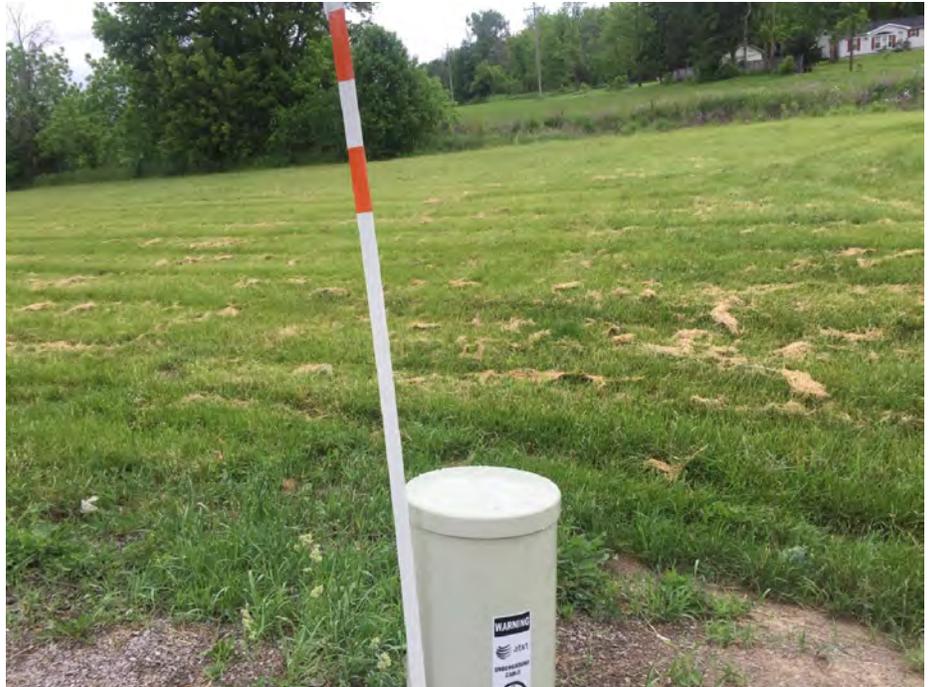
Photo 1

Underground electrical approximately 175' south of drain.

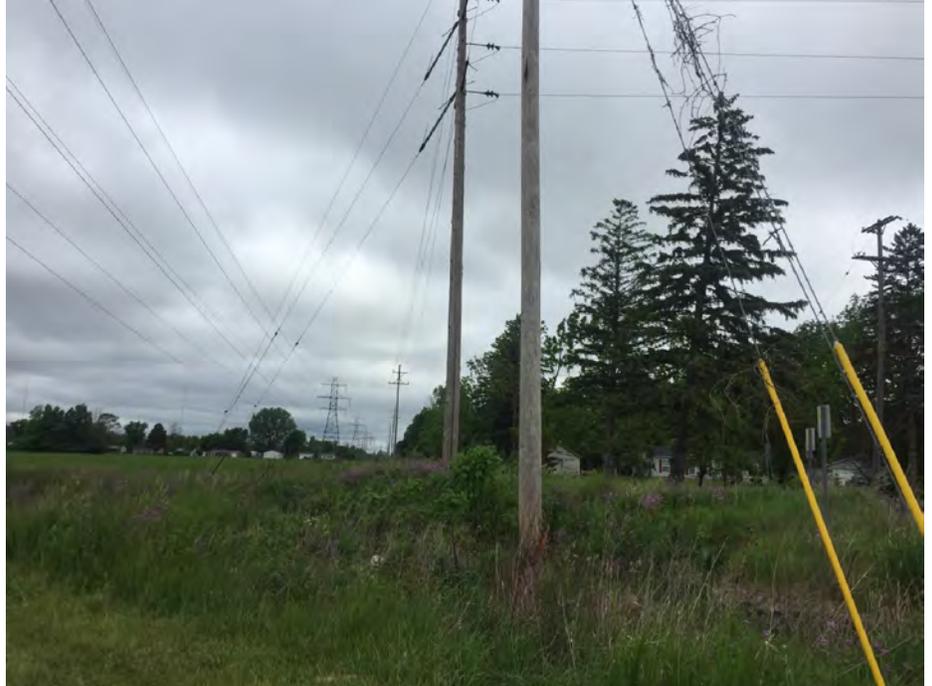
Photo 1

Two large utility poles immediately on either side of drain with electrical going approximately 75' over drain.

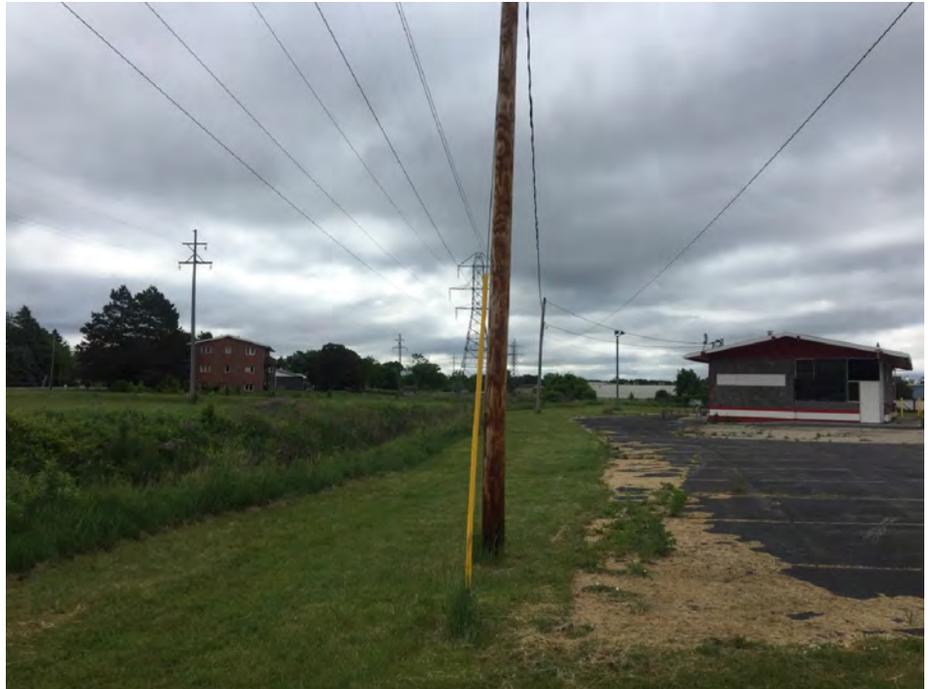
Photo 1

Approximately 25' south of the drain there are two utility poles with overhanging wires 100' apart.

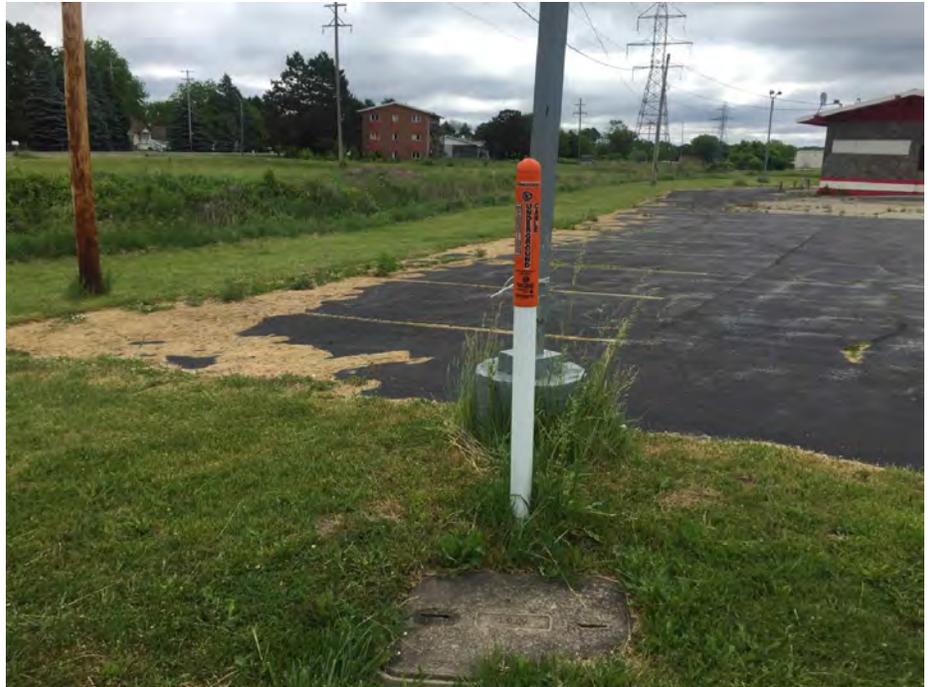
Photo 1

Approximately 40' south of drain there's a buried phone line.

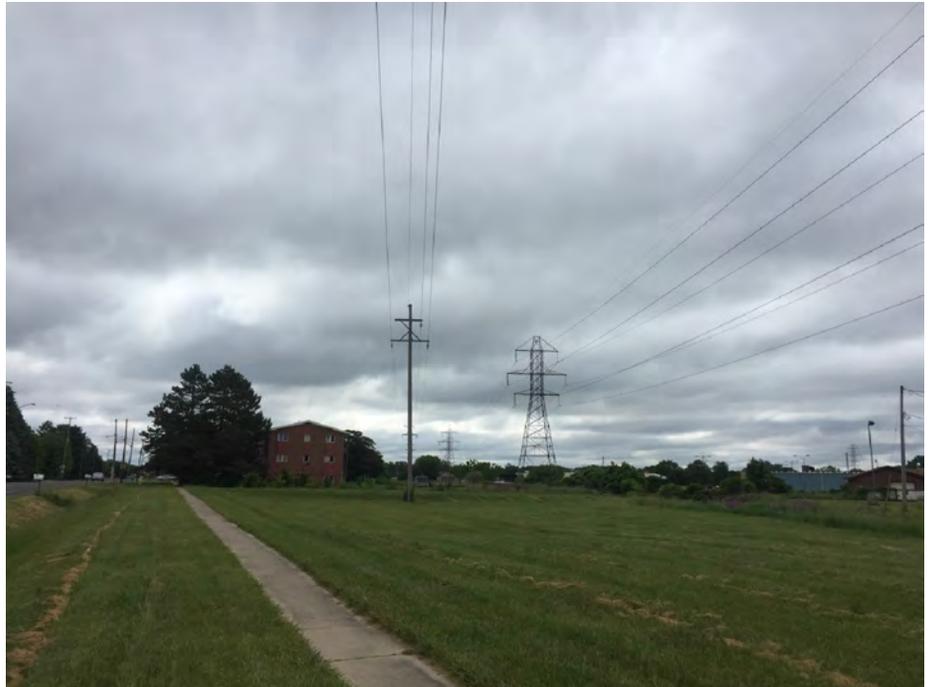
Photo 1

Approximately 50' north of drain for next 500'.

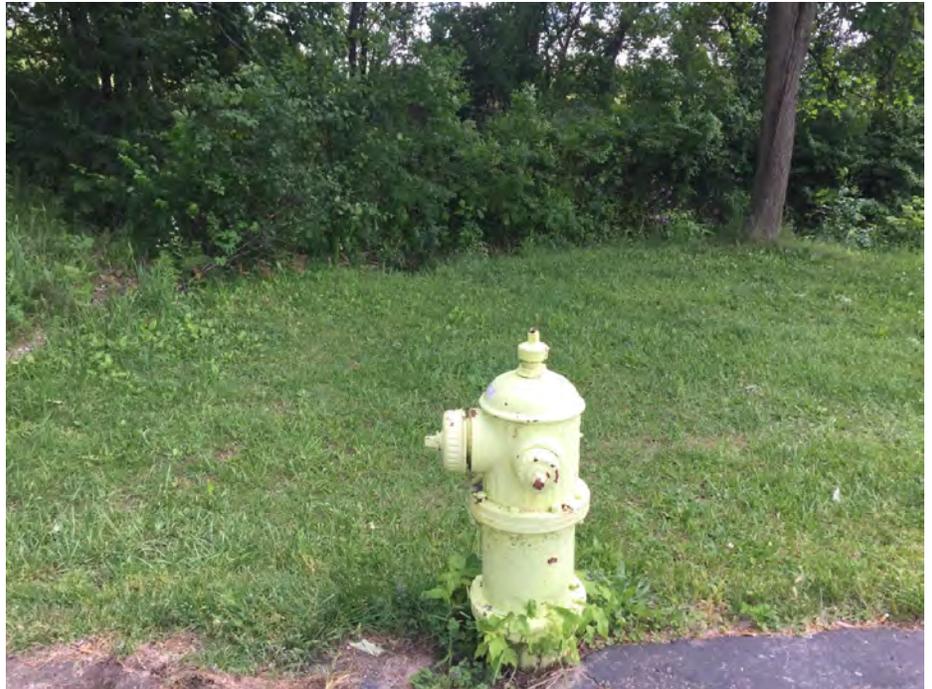
Photo 1

Underground watermain 30' north of drain.

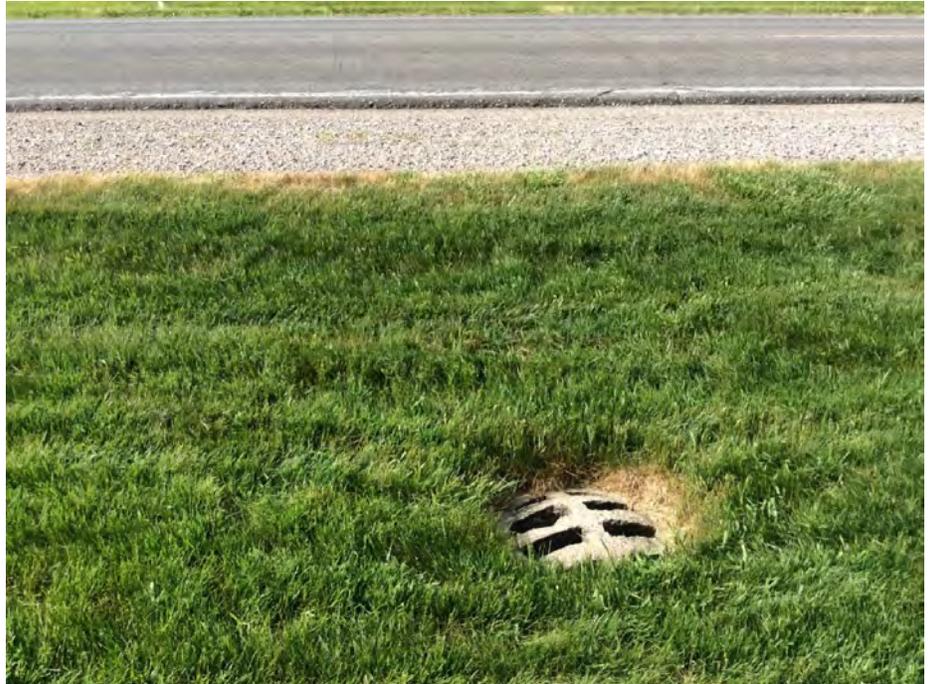
Photo 1

Storm manhole about 5 ft from road and about 260 ft west of drain.

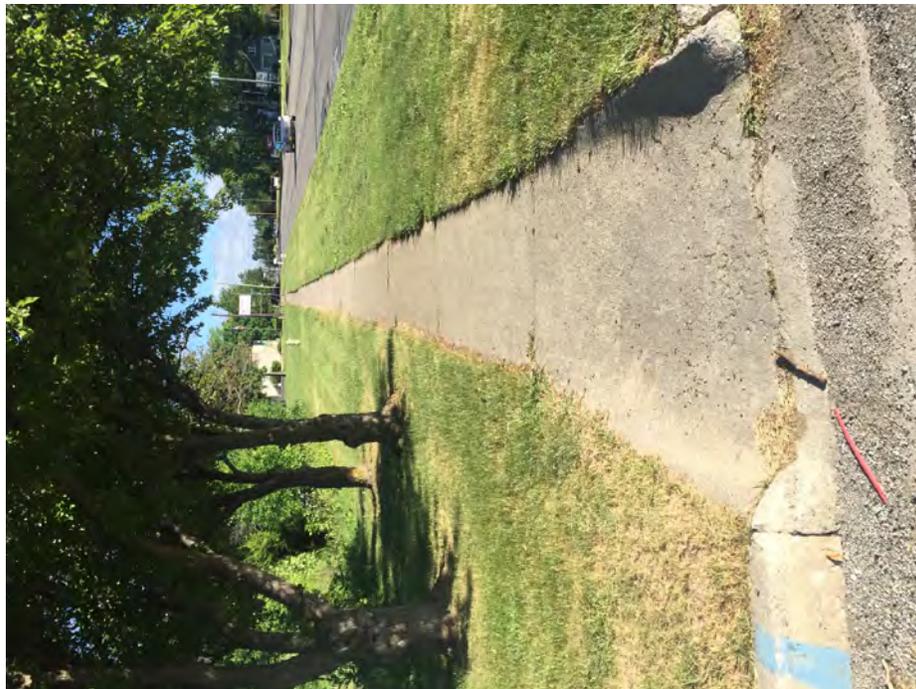
Photo 1

Existing watermain West side of Dixie Hwy. Picture facing Northwest.
