King Street Tile Drain Inspections

Inspection Report for Observation:
Utility1

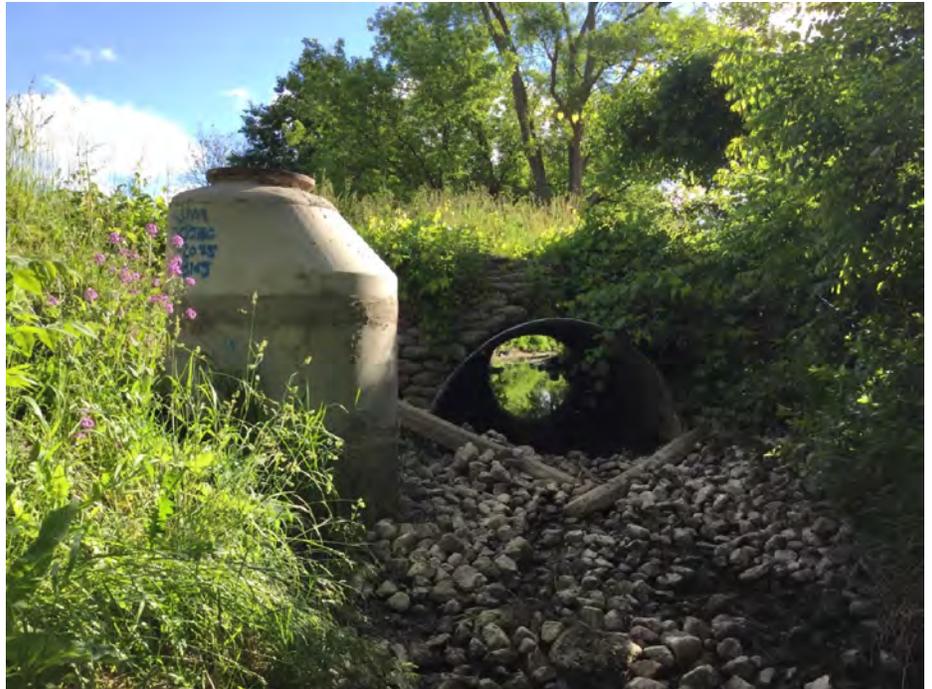
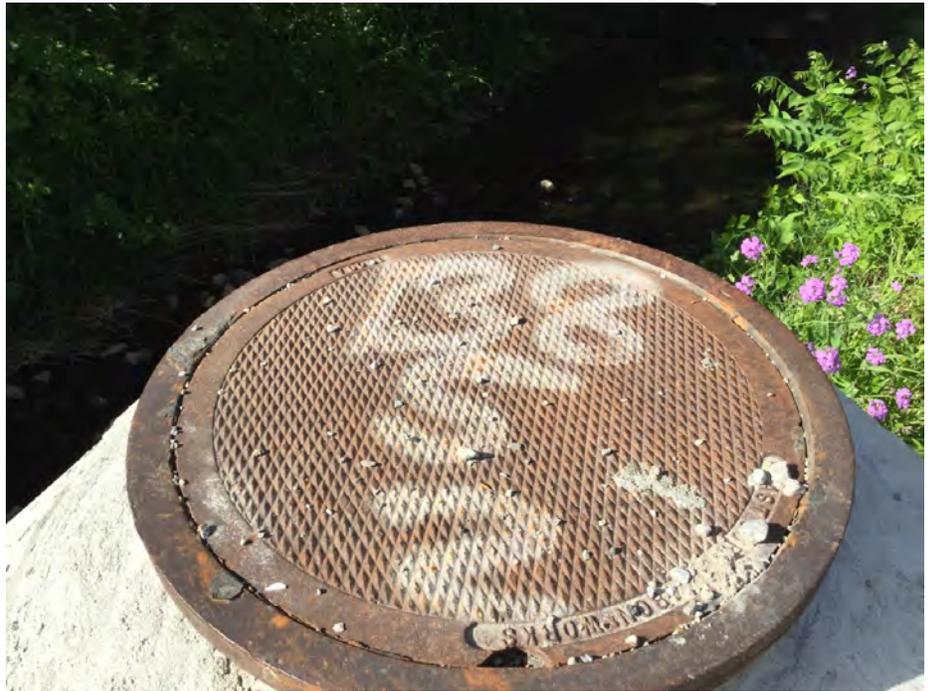
On left side of drain, south side of Kansas st crossing.

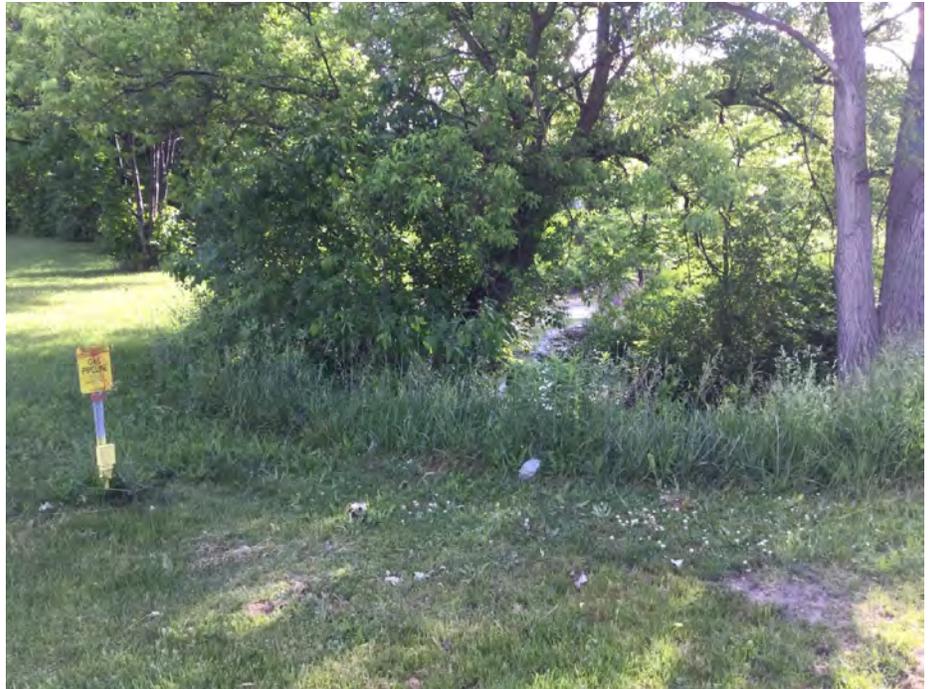
Photo 1

On left side of drain, north side of Kansas St. Gas pipeline marker.

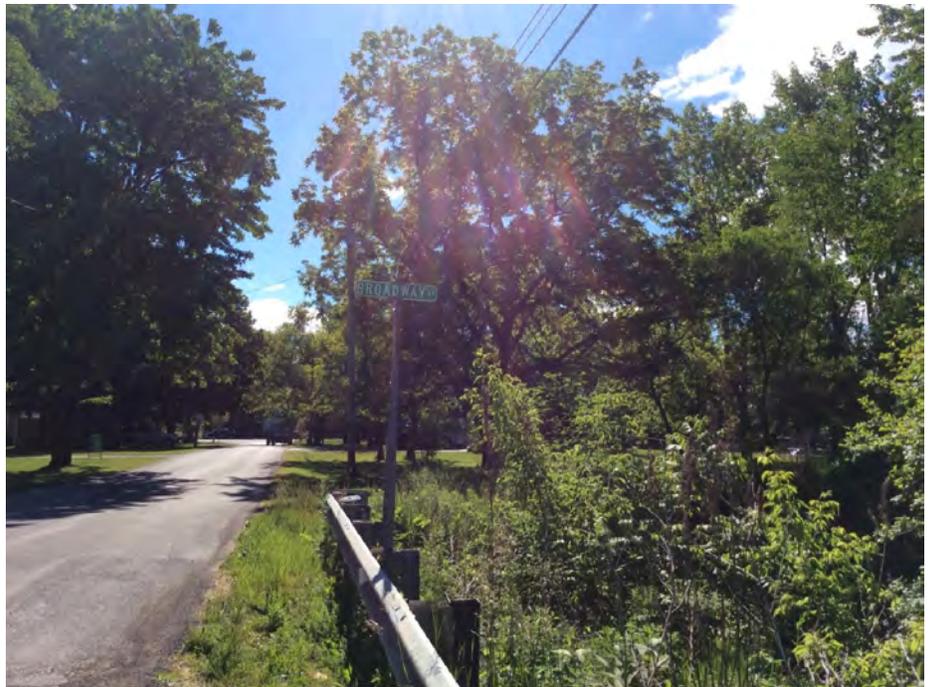
Photo 1

Electric overhead crossing drain next to Kansas St.

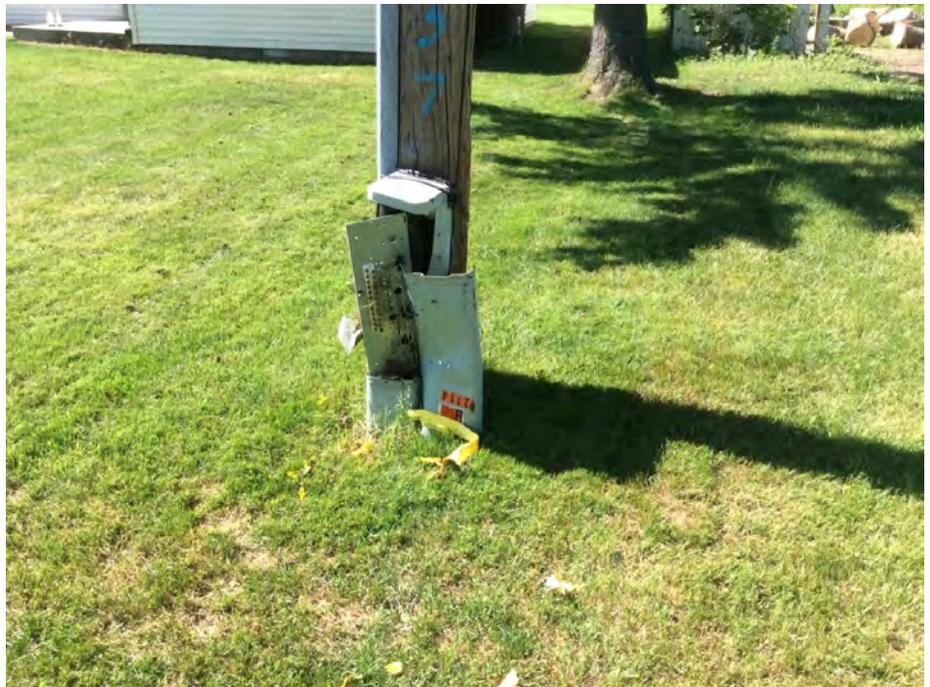
Photo 1

Type: Phone

92 ft right of drain. About 7 ft from Kansas Ave. Failed condition- wires smashed, box not assembled.

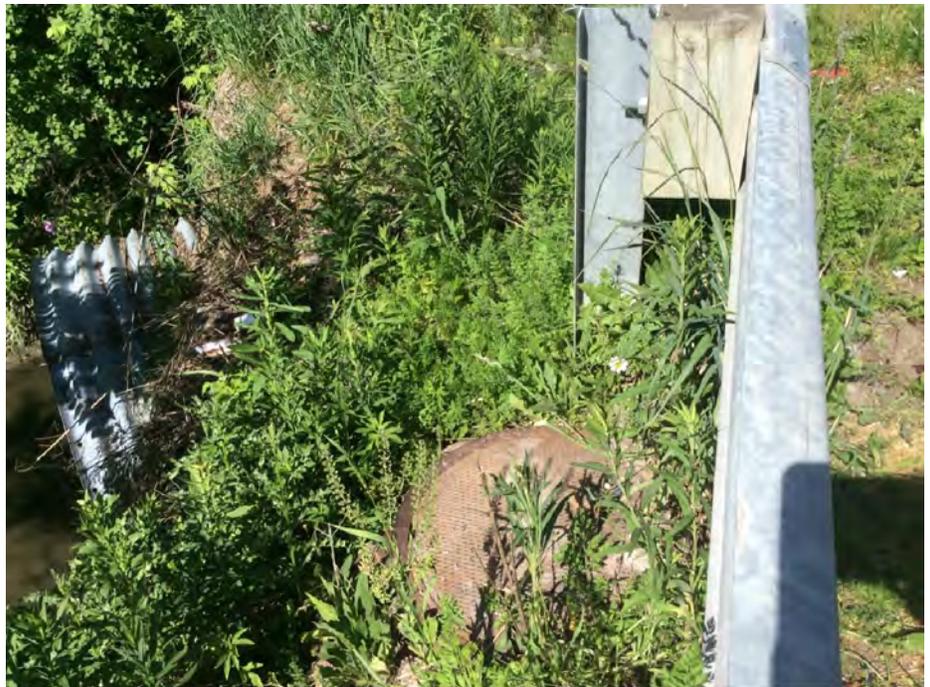
Photo 1

Sanitary manhole at intersection of Kansas and Broadway. Above upstream side of culvert.

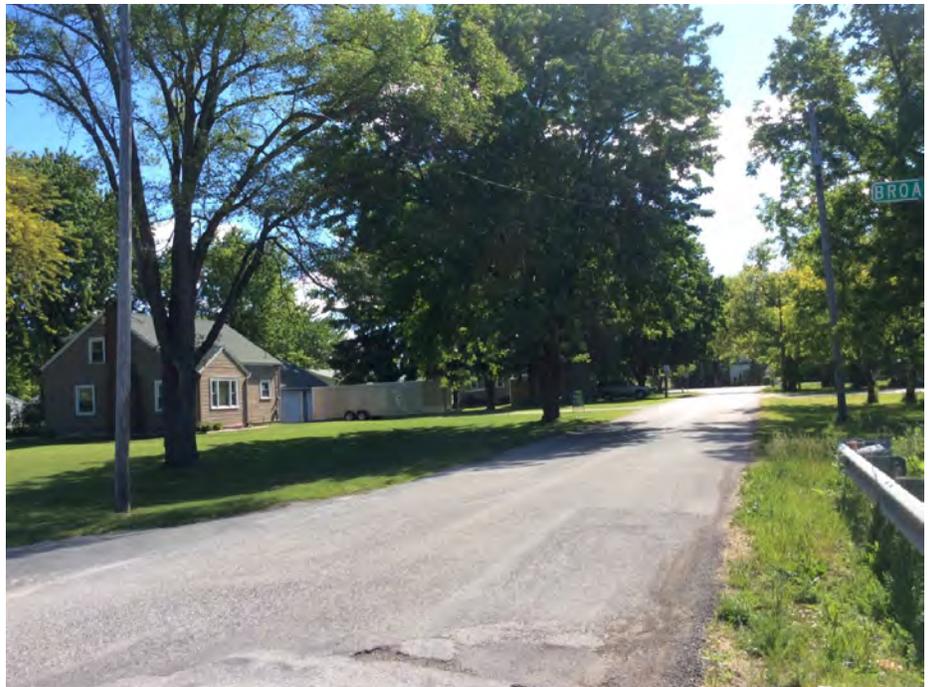
Photo 1

Separate light pole at intersection of Kansas and Broadway. Crosses over Kansas Ave. About 50 ft left of drain.

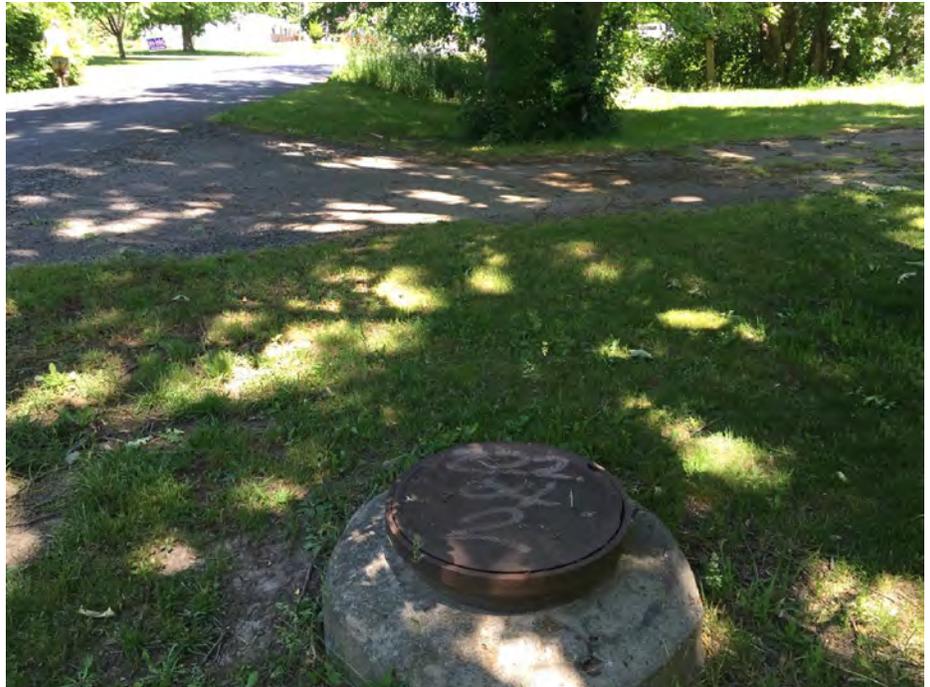
Photo 1

Sanitary manhole 50' south of the drain on the east side of Mack Road. Picture facing north toward drain.

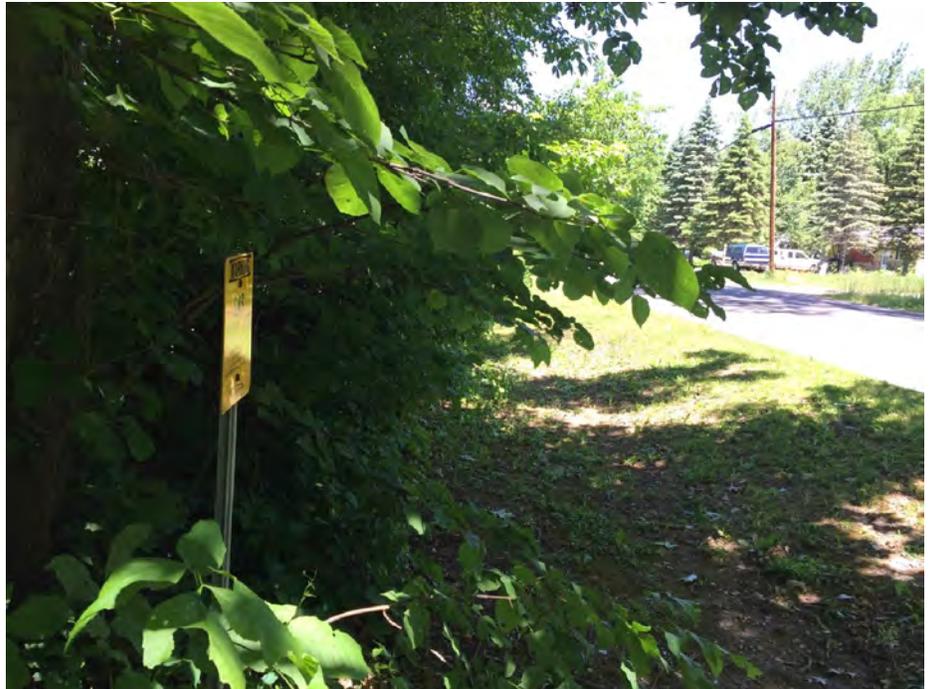
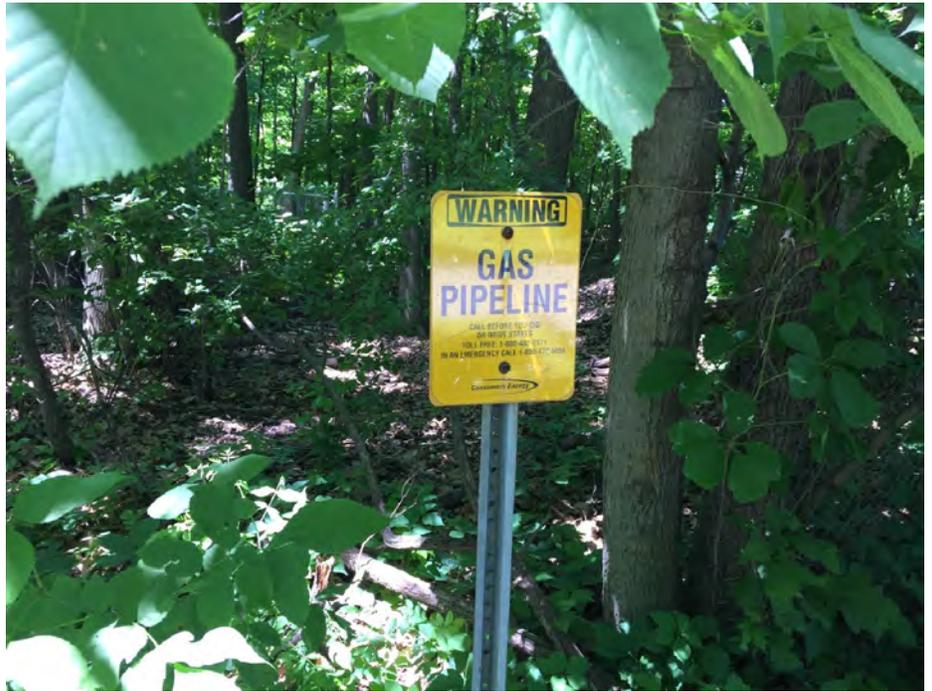
Gas pipeline sign notification 30' south of drain on west side of Mack Road.
Picture one facing north across drain.
Picture two facing west parallel to drain.

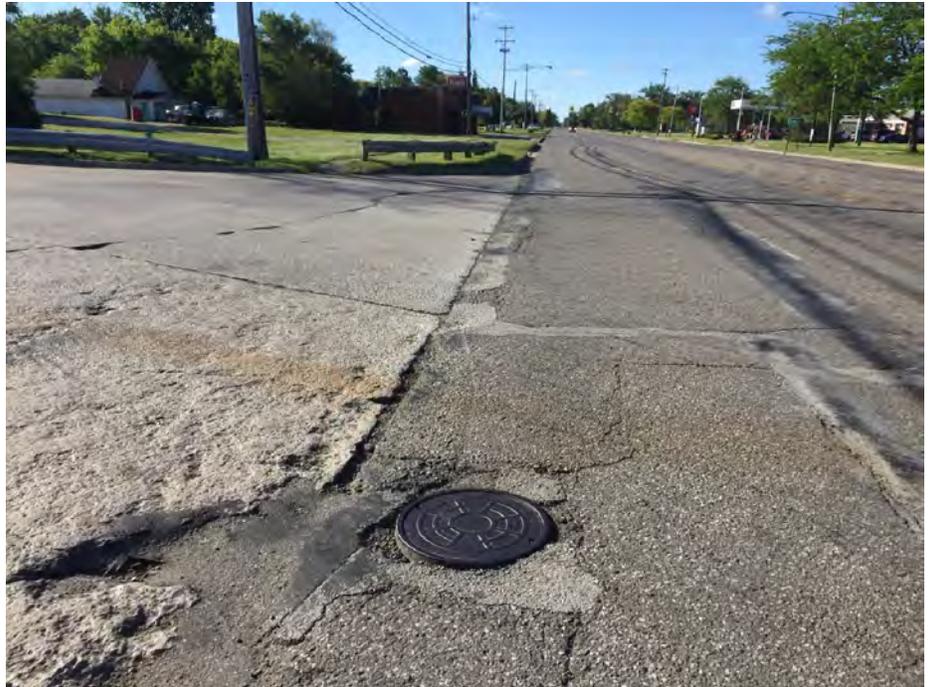
Photo 1

Unknown manhole approx. 30' north of drain. Picture facing south across drain.

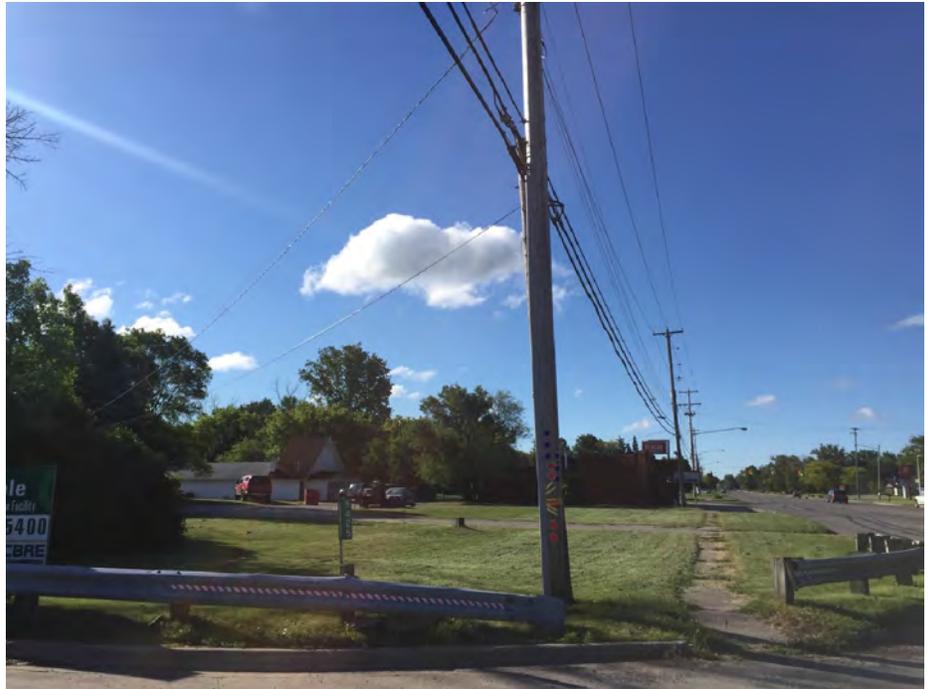
Photo 1

Electric utility pole directly over underground culvert crossing. Overhead wires crossing drain. All on eastern side of Dixie. Picture facing south.

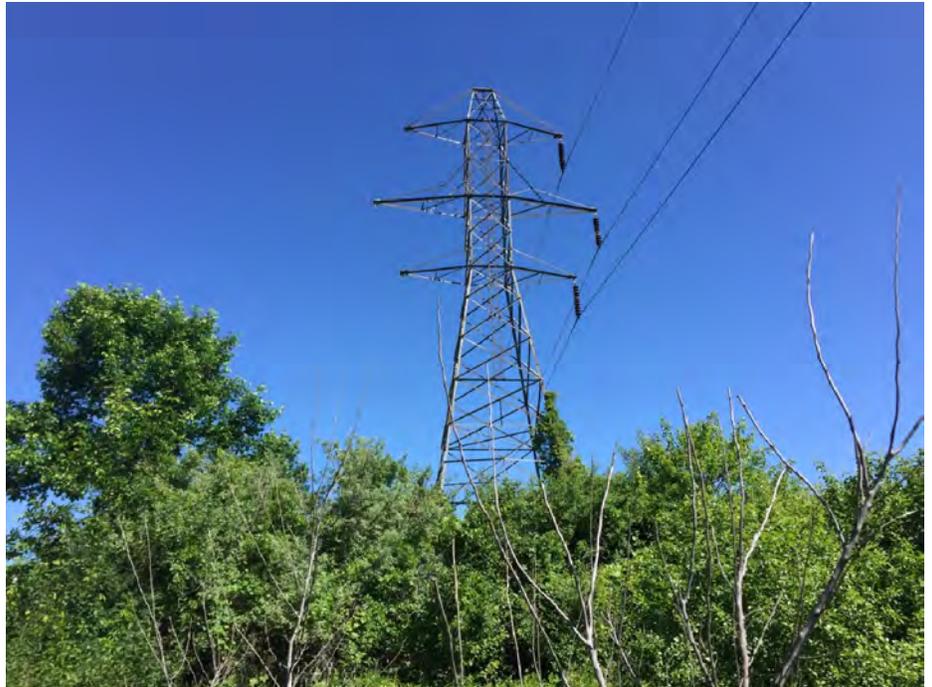
Photo 1

High voltage transmission tower 100' north of drain with wires crossing overhead across the drain. Picture facing north across the drain.

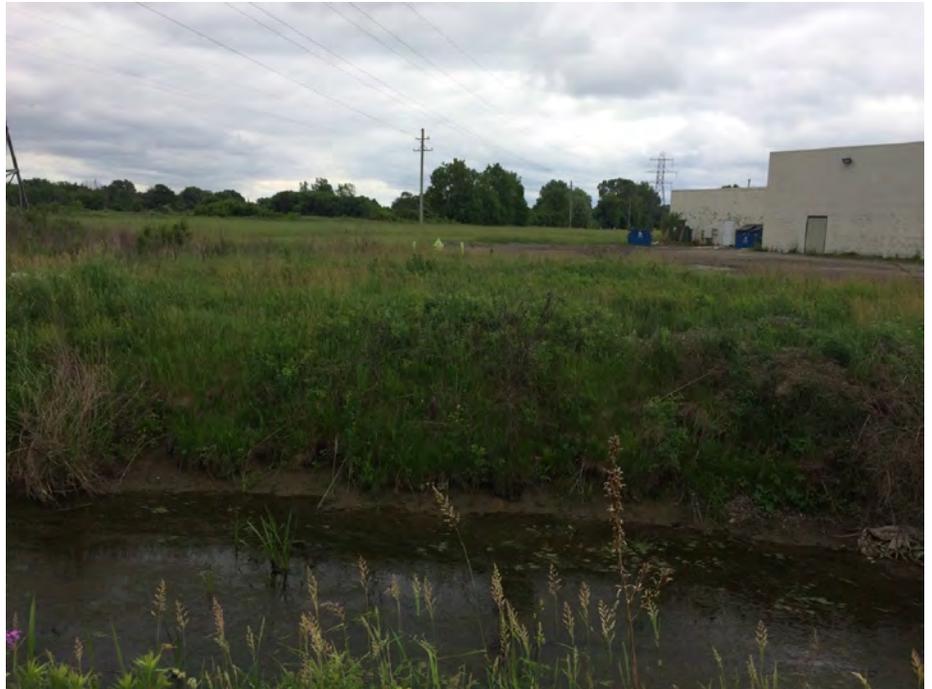
Photo 1

Underground watermain indicated by fire hydrant approximately 40' south of the drain. Picture taken from north bank.

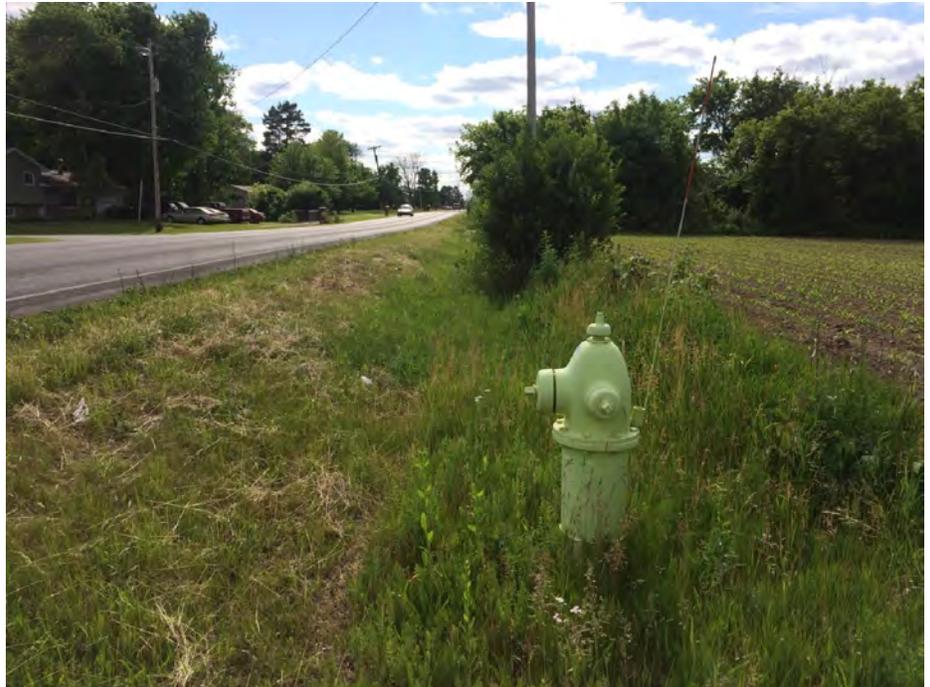
Photo 1

Fire hydrant about 5 ft from road. About 260 ft east of drain.

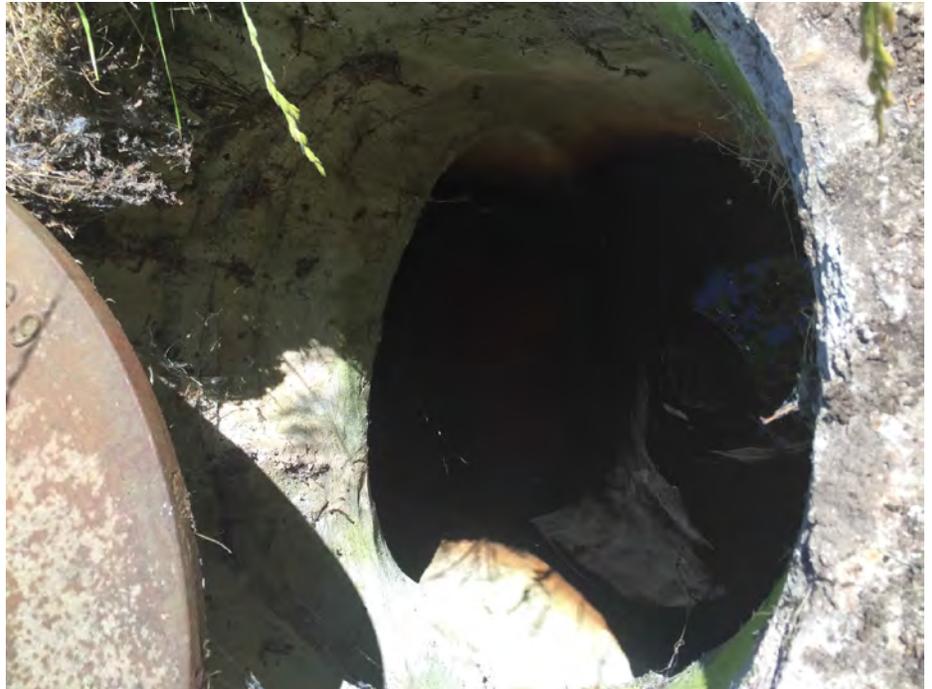
Photo 1

Beehive catch basin South side of King street at the end of the upstream end of described legal drain. Picture facing downstream
