King Street Tile Drain Inspections

Inspection Report for Observation:
Blockage1

HUBBELL, ROTH & CLARK, INC CONSULTING ENGINEERS SINCE 1915	555 Hulet Drive P.O. Box 824 Bloomfield Hills, MI 48303-0824 (248) 454-6300 http://www.hrc-engr.com	DATE:	08/16/2016
				SCALE:	
NOTE				SHEET #:	
				JOB #:	20160331

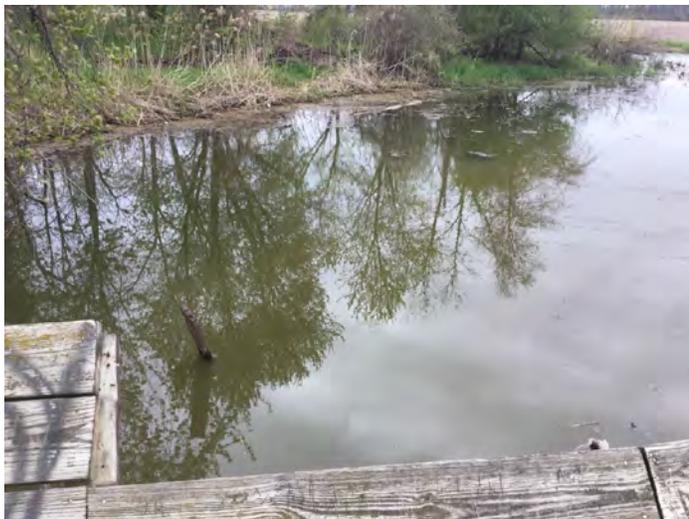
Photo 1

Photo taken facing upstream. Left side. Wood block piece from bridge.

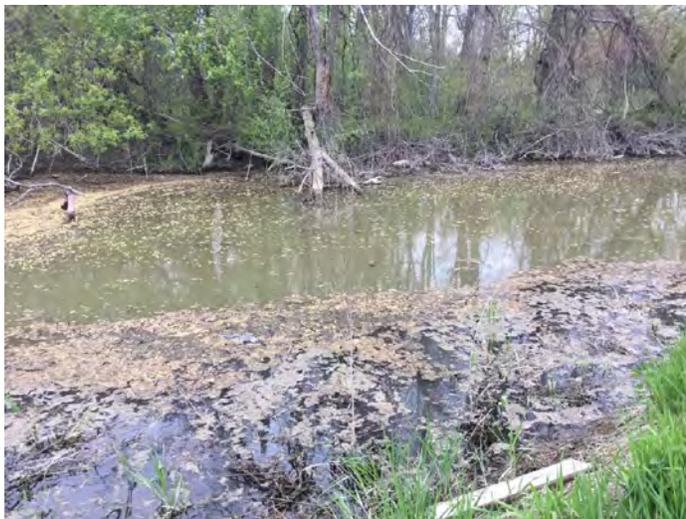
Photo 1

Left side. Fallen tree 3 ft blockage. 20 ft tree. Photo taken facing north.
Additional woody debris. 8 in diameter tree.

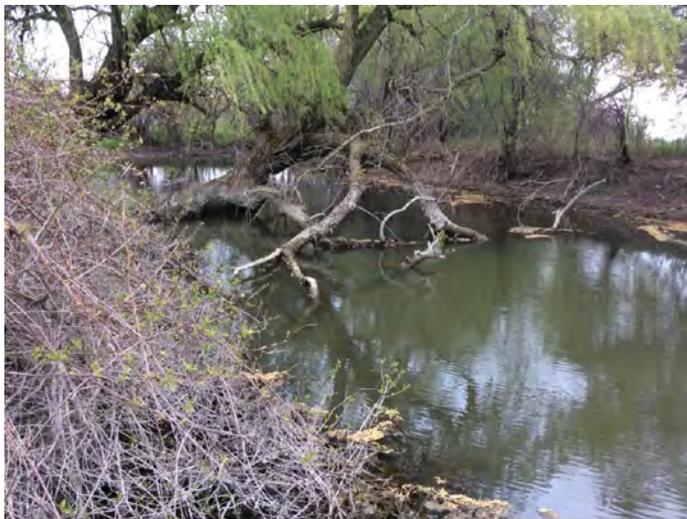
Photo 1

Upstream left side 40" diameter additional log on right side 30" diameter

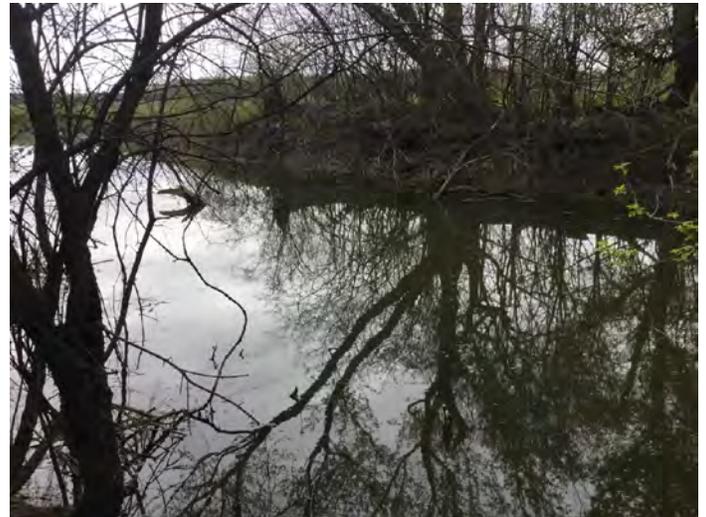
Scattered woody debris across drain. Photo 1 taken from left side facing upstream. Photo 2 facing southwest. At least 5 pieces. Estimate of 100 ft.

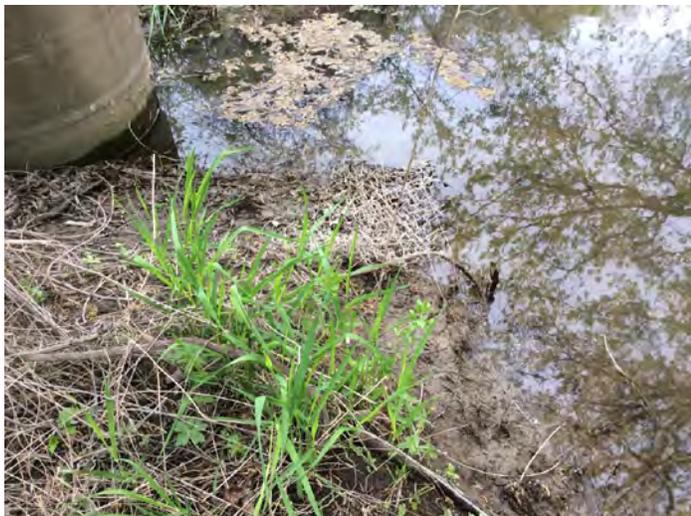
Photo 1

Fence upstream left side

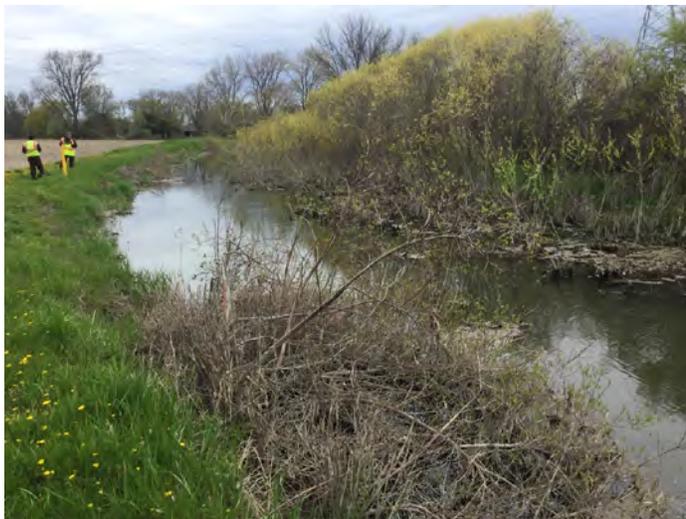
1200 ft long along both sides of the drain. Left side facing upstream continuous. Right side facing upstream in clumps. Photo 1 taken facing downstream. Photo 2 taken facing upstream. Starts at 500 ft.

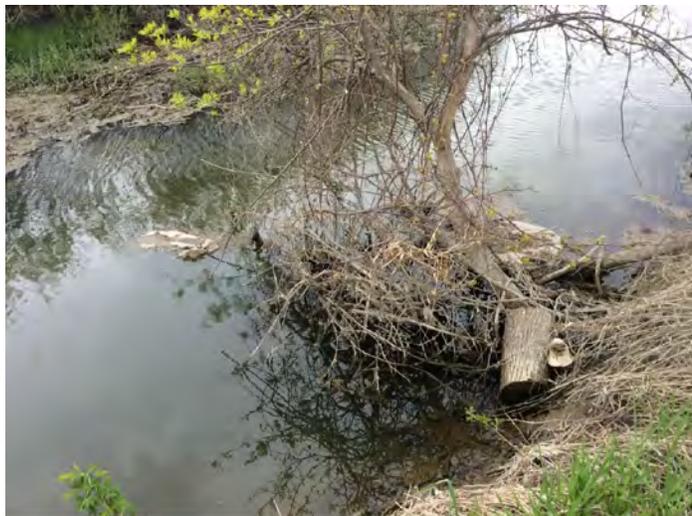
Photo 1

Upstream right side unknown objects

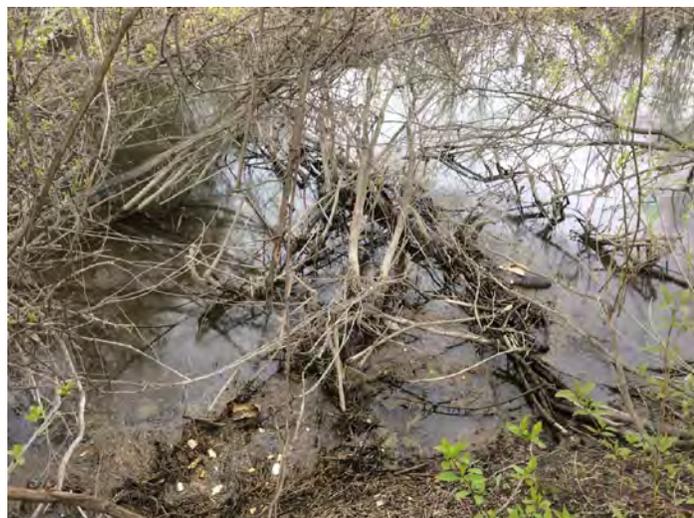
Photo 1

Upstream right diameter up to 6"

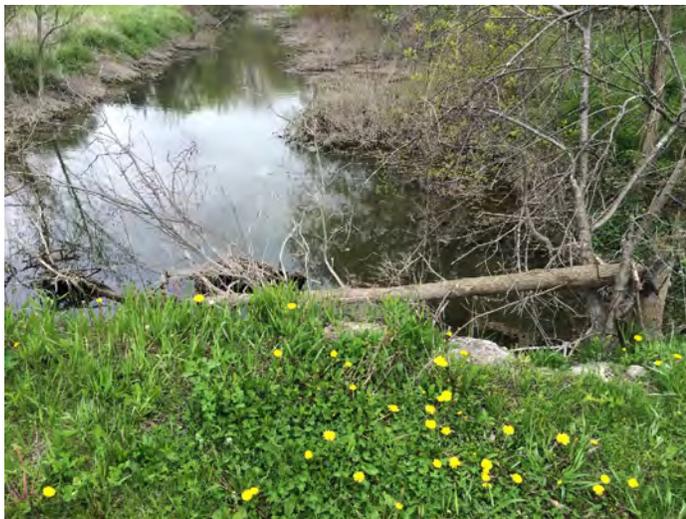
Photo 1

6" diam tree on right side just upstream of farm crossing. Photo taken facing upstream.

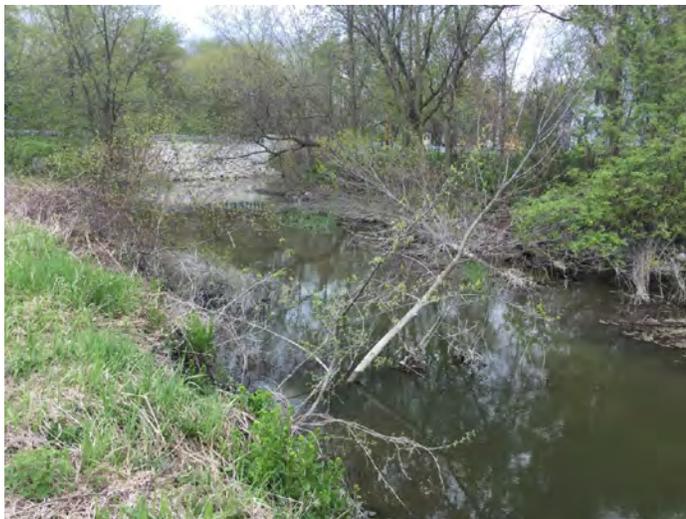
Photo 1

Fallen tree coming from left side facing upstream to center of drain.
Photo taken facing upstream. Additional fallen tree on right side.

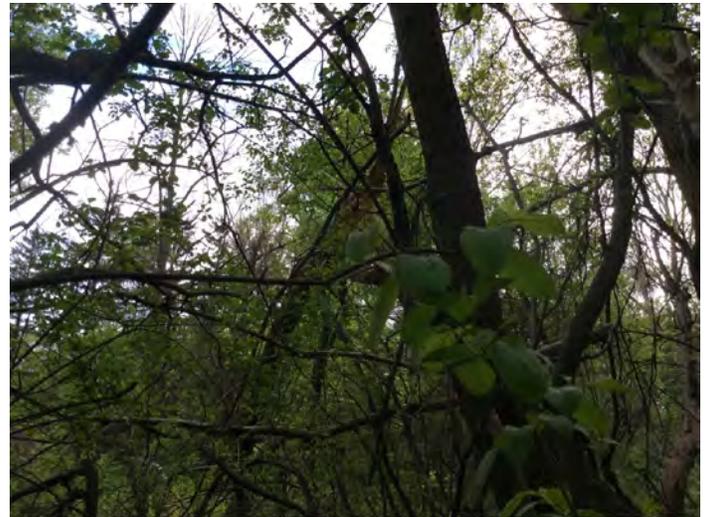
Photo 2

Broken tree limb hanging over drain. Will probably fall soon. Potential log jam. 8" diam. Photo facing north. Right side of drain.

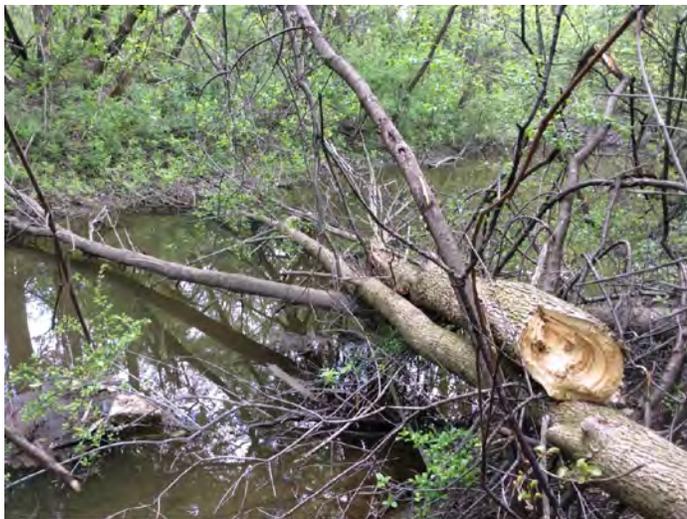
Photo 1

Three large fallen trees up to 14" diameter fallen in drain. Photo facing upstream.

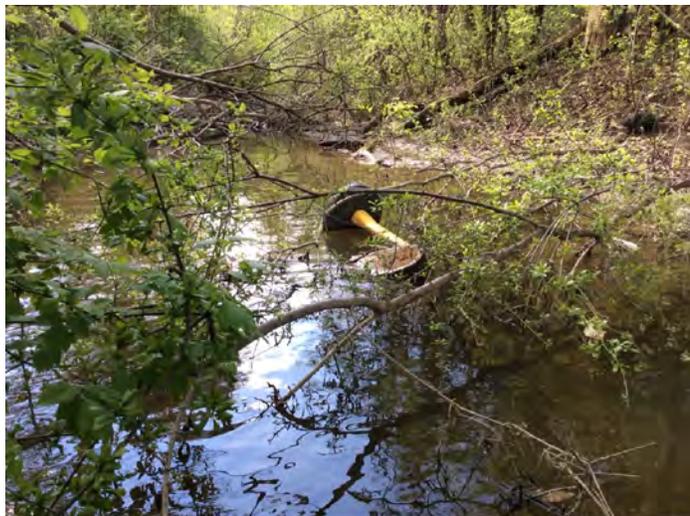
Photo 1

Trash in center of drain. Photo facing upstream.

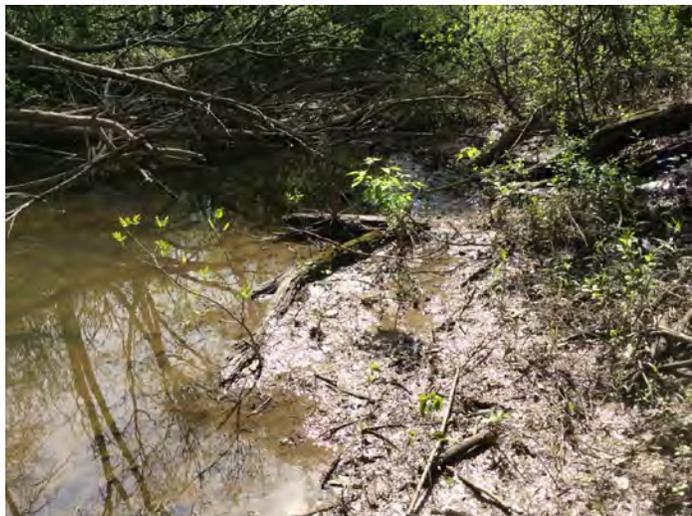
Photo 1

Right side around bend. 40 ft. Photo facing upstream.

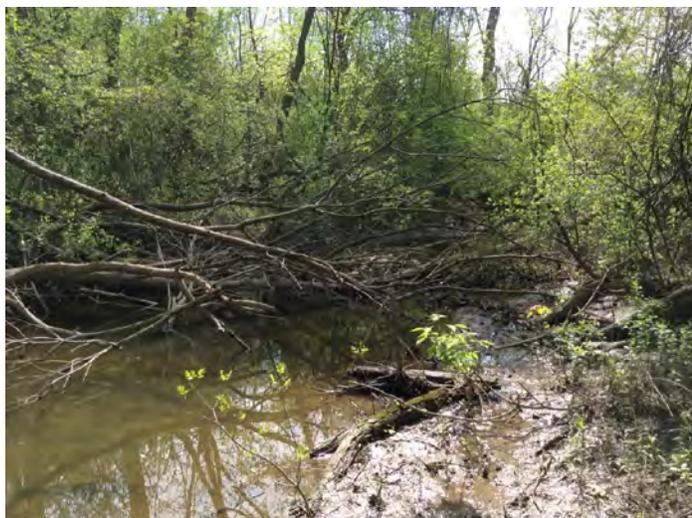
Photo 1

Several fallen trees up to 8" diameter from both sides of drain causing log jam. Photo facing upstream. 40 ft.

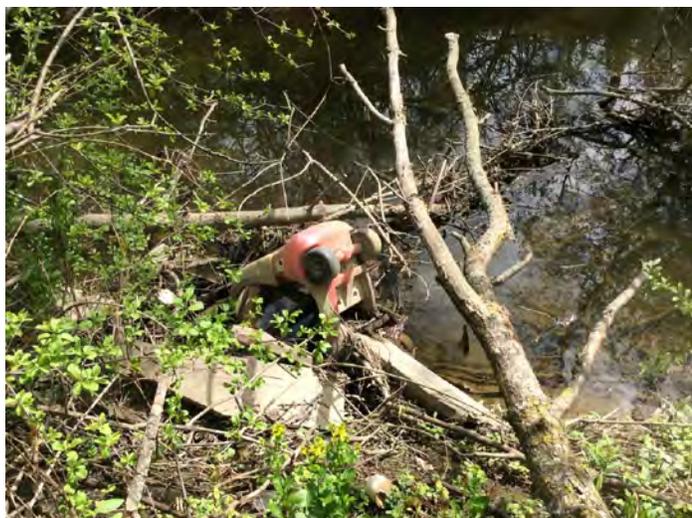
Photo 1

Trash in drain on right side. Photo facing northeast.

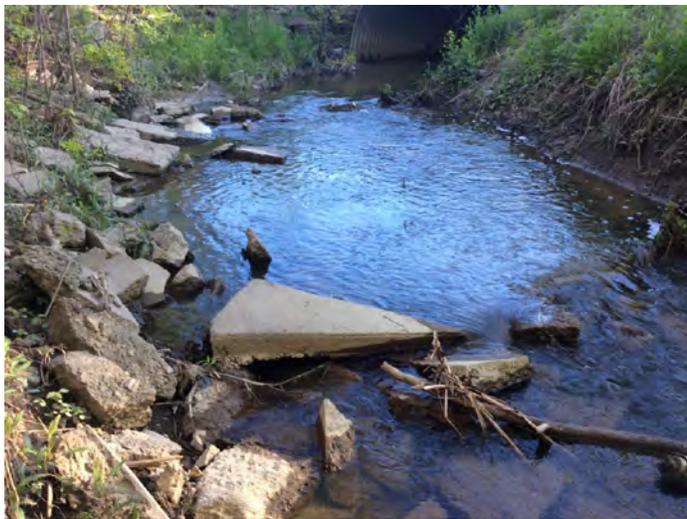
Photo 1

Rocks and broken concrete. Mixed with logs in causing riffle. Probably falling from constructed bank on left. Photo facing upstream.

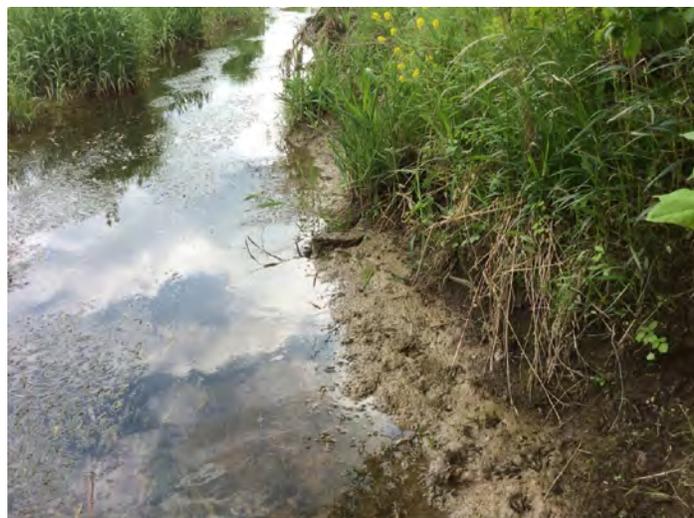
Photo 1

Loose sediment buildup on right side for 20 ft at bend. Photo facing upstream.
