King Street Tile Drain Inspections

Inspection Report for Observation:
Blockage200

CLIENT	Saginaw County Public Works Commissioner

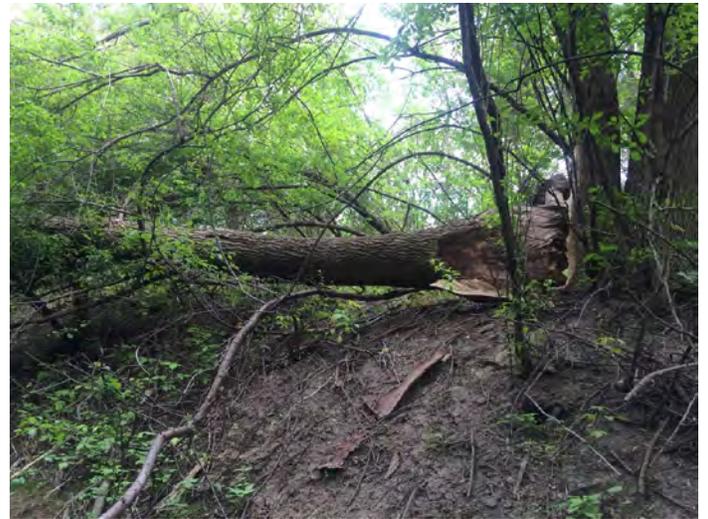
Huge fallen tree from right side of drain extending across drain. About 50" diameter, 30 ft tree. Photo 1 taken facing upstream. Photo 2 taken facing southeast.

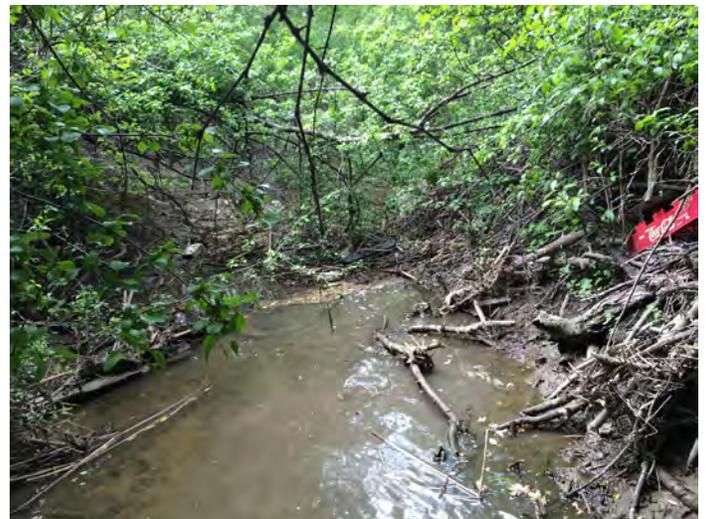
Photo 2

Log jam next 50 ft. Includes trash and woody debris. Photo1 facing upstream. Photo2 facing downstream.

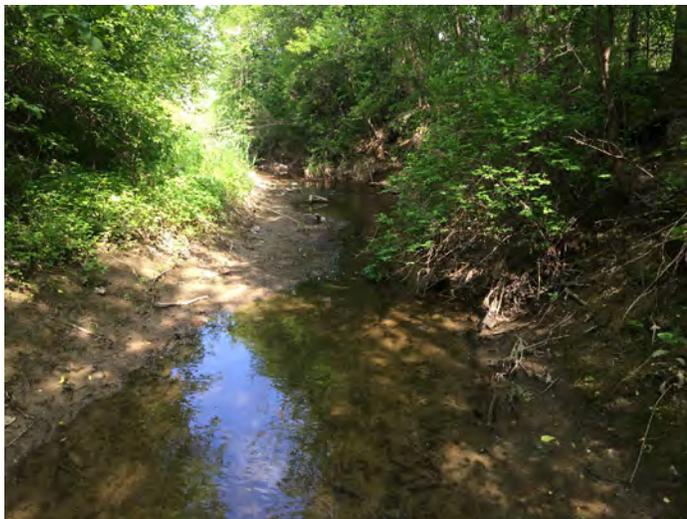
Photo 1

Sediment bar on left side. Photo facing upstream.

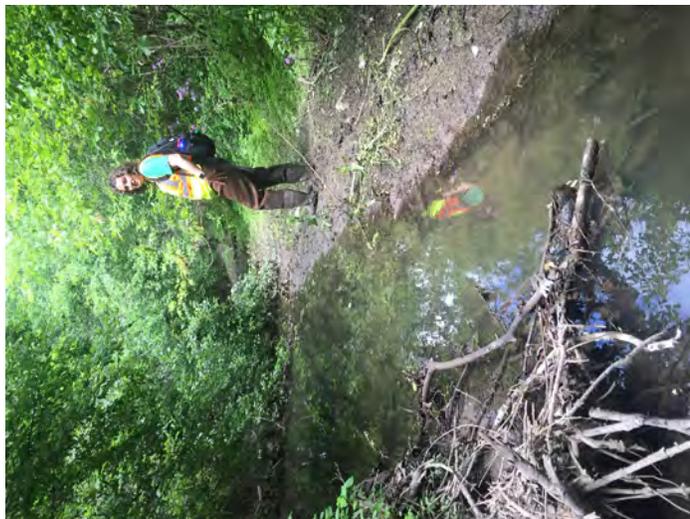
Photo 1

Sediment bar on right side of the drain from this location approx 200'upstream to end. Picture facing upstream

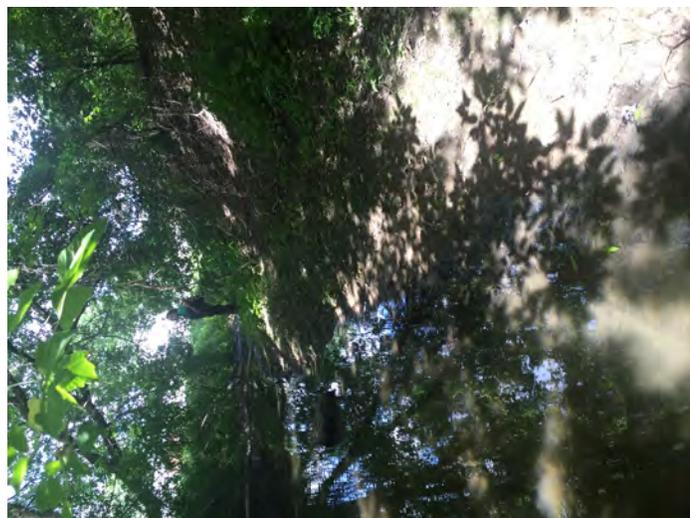
Photo 1

Sediment bar right side of the drain from this location approx 125' upstream to end . Picture facing upstream

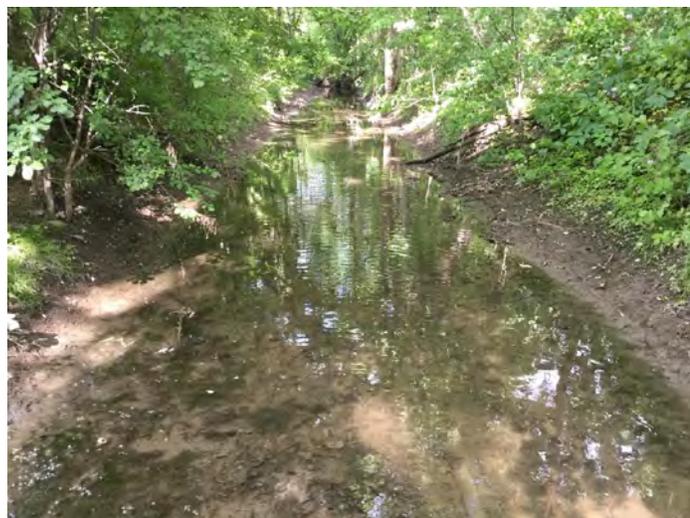
Photo 1

Woody debris up to 3" diam. Minor. Next 150 ft.

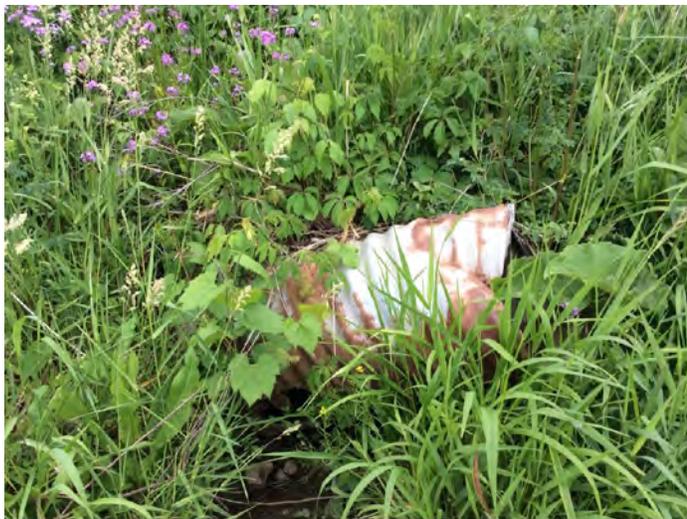
Photo 1

Old rusted pipe with holes. Left side of drain. About 3 ft long.

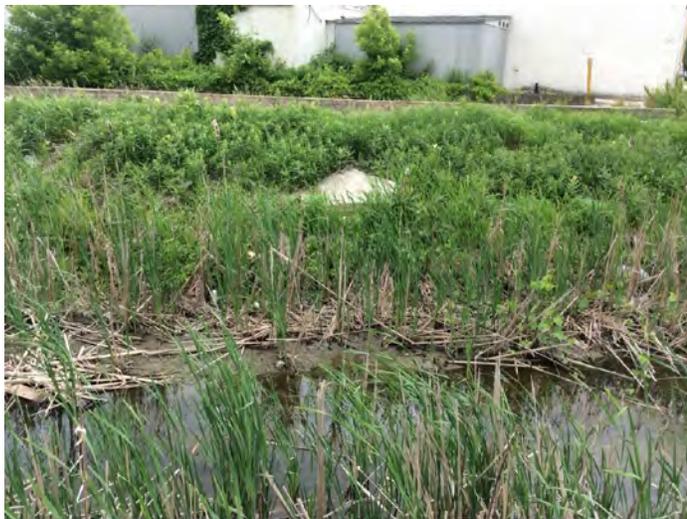
Photo 1

Non-vegetative debris on right side of drain. Concrete broken blocks then 10 ft down on right side are 2 tires.
