King Street Tile Drain

Board of Determination

April 19, 2016

Drain Inspection

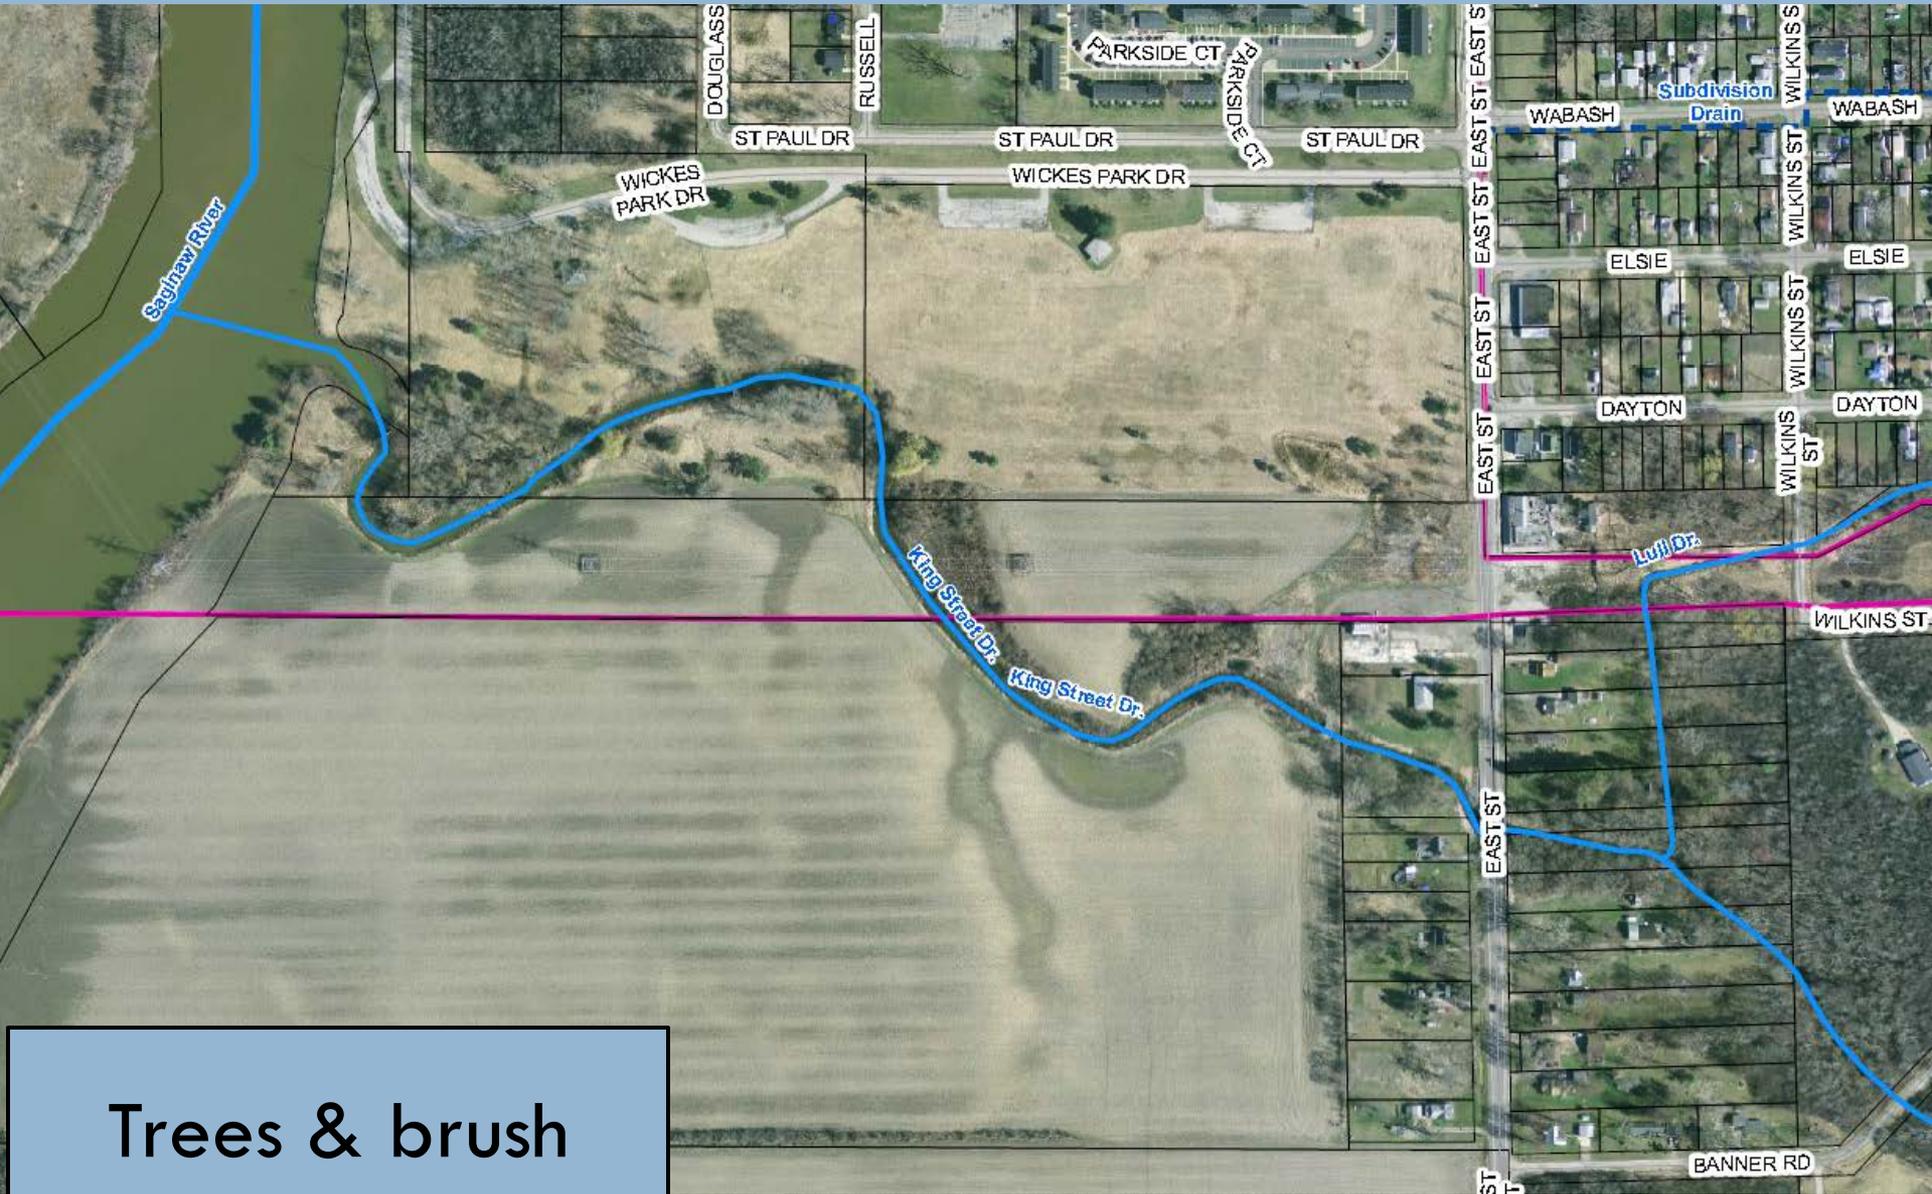
Downstream End of Drain – West of East Street

Trees & brush
along drain

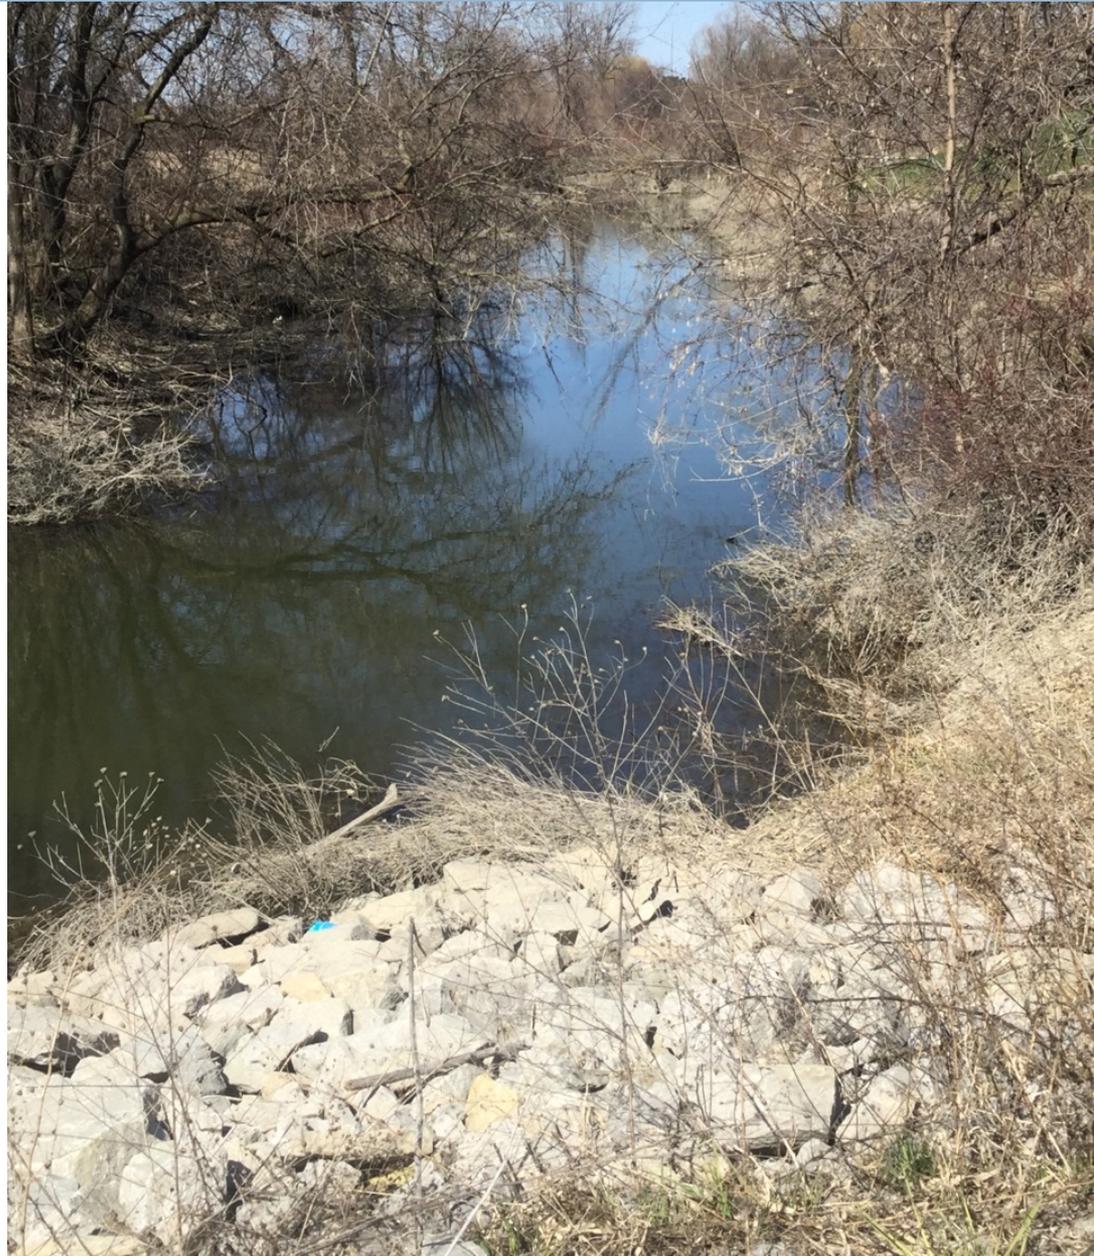
Looking Downstream (West) from East Street April 14, 2016

Trees and brush.
Stagnant water,
possibly
backwater from
the Saginaw River

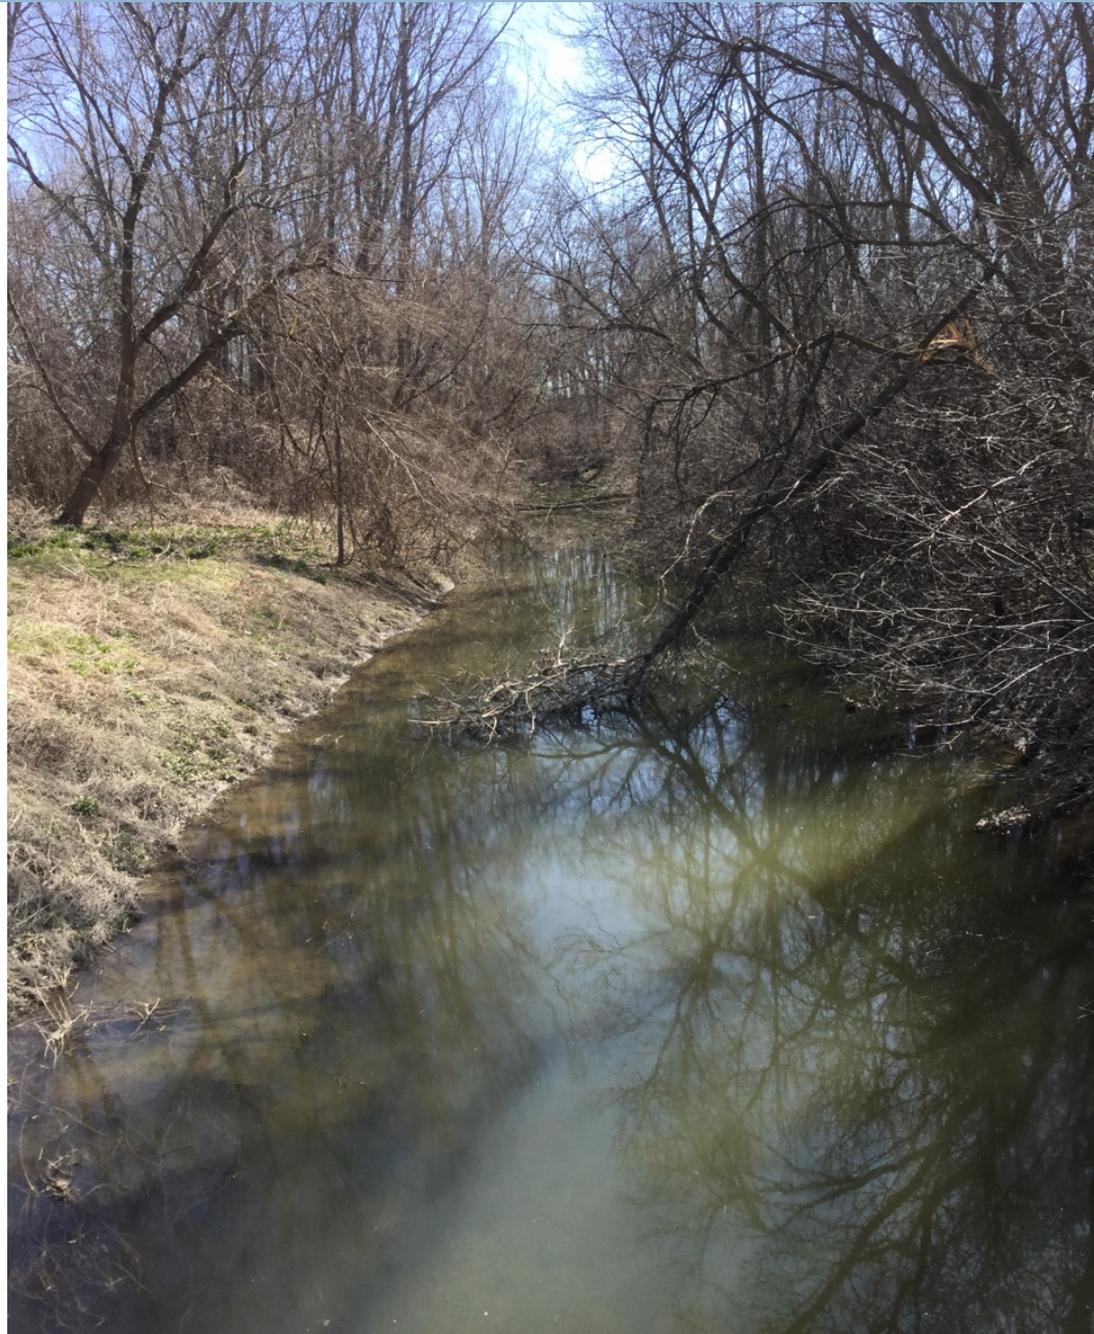
Looking Upstream (East) – East Street

Trees, brush and
stagnant water

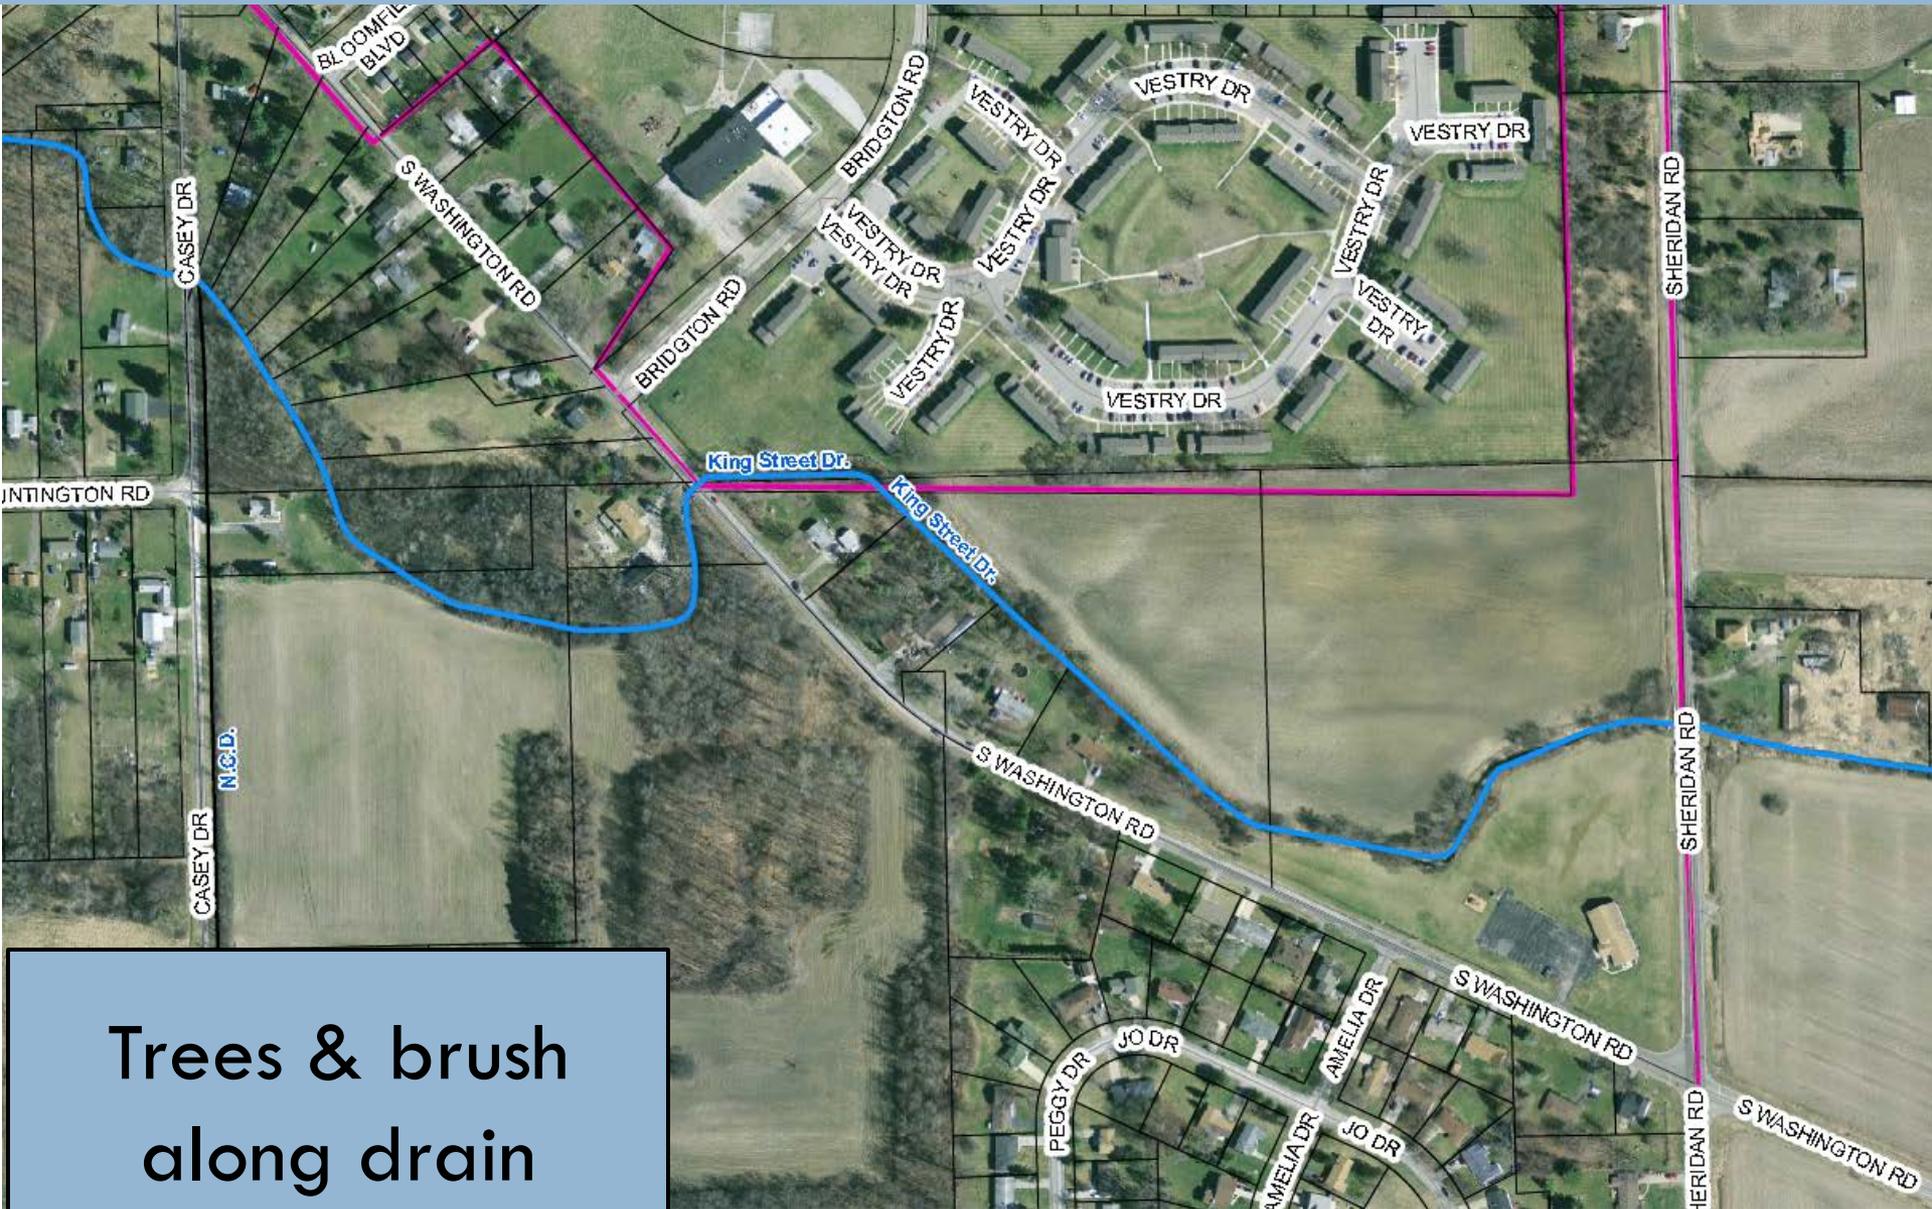
Downstream End of Drain – Casey Drive, S. Washington Road & Sheridan Road

Trees & brush
along drain

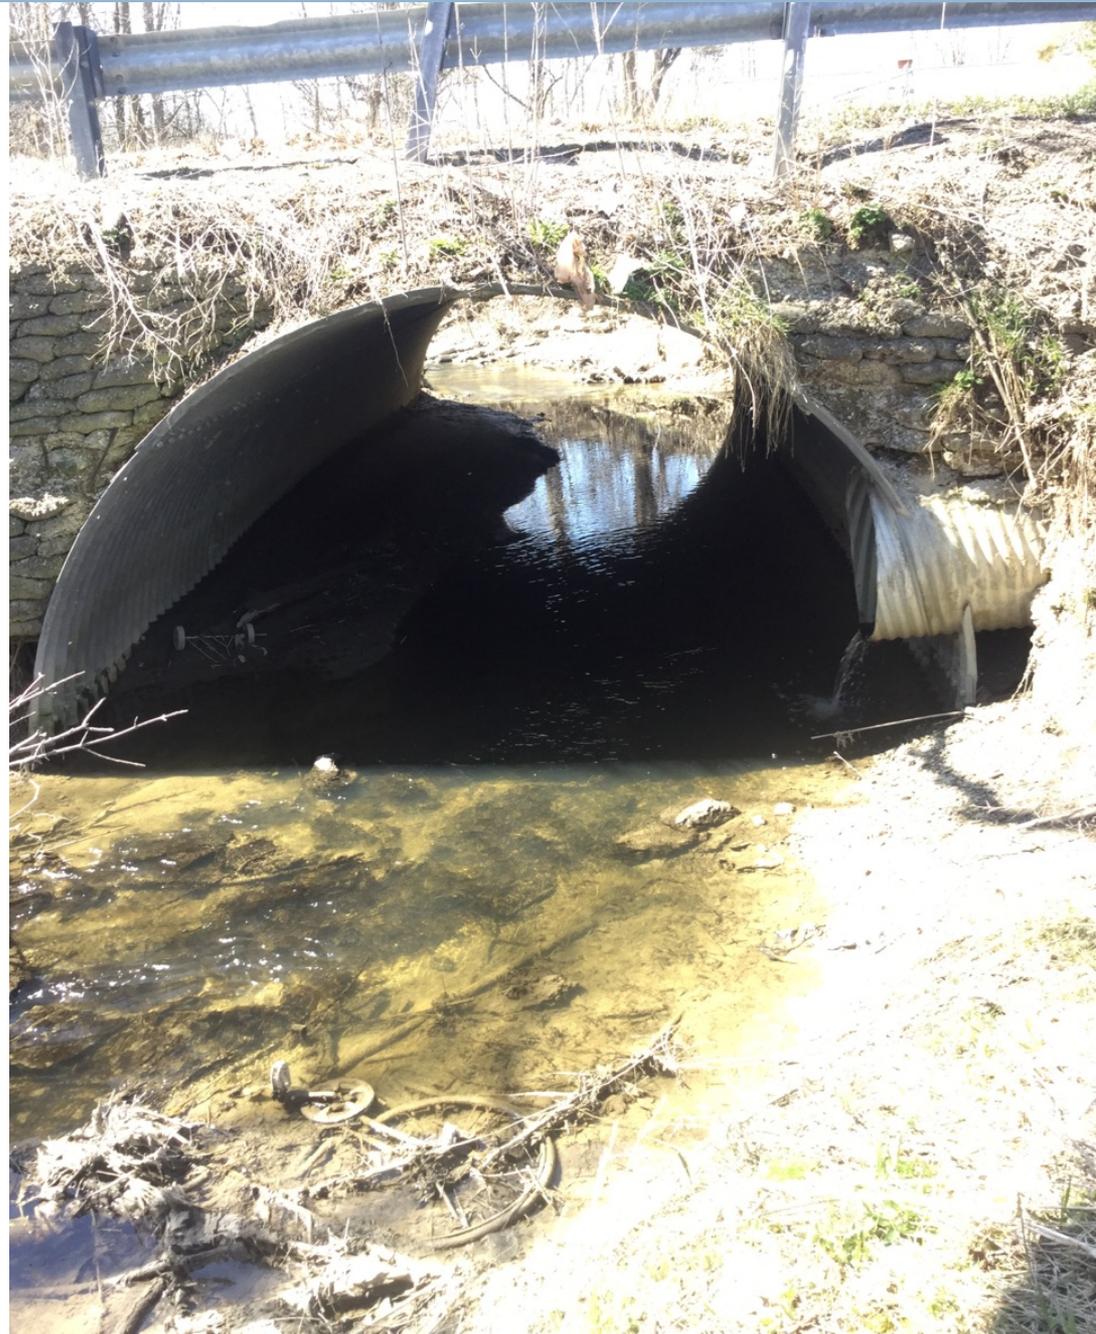
S. Washington Road

Failing bag rip
rap headwalls

Minor
sedimentation,
possibly due to
poor culvert
alignment

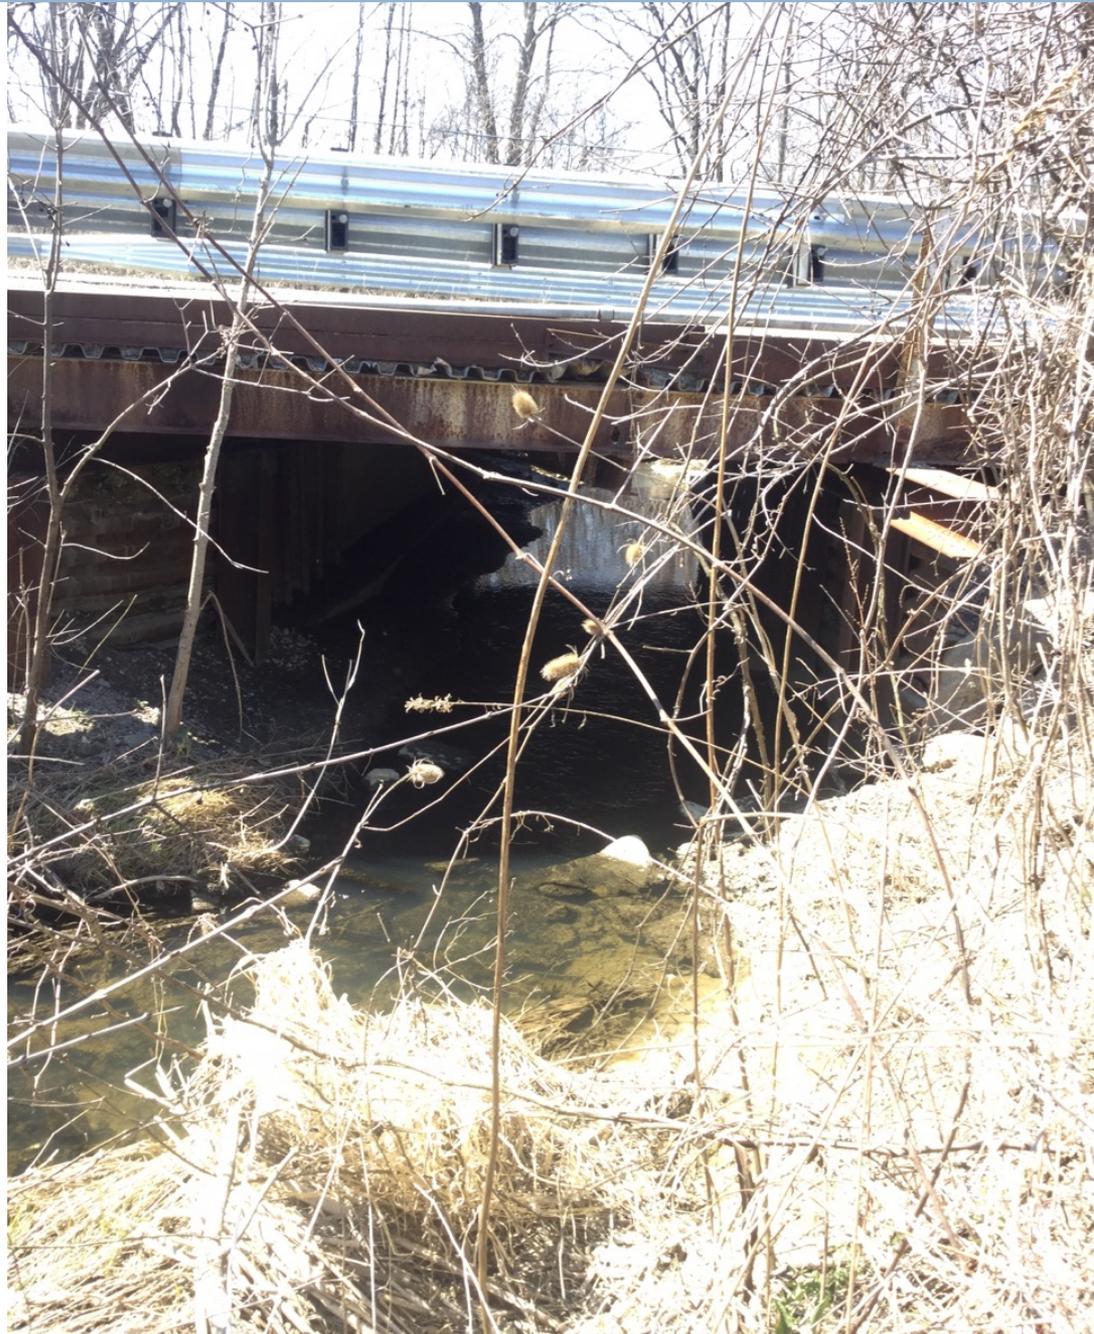
Williamson Road

Failing headwalls,
very poor
condition

Alignment of box
beam bridge
creates
sedimentation

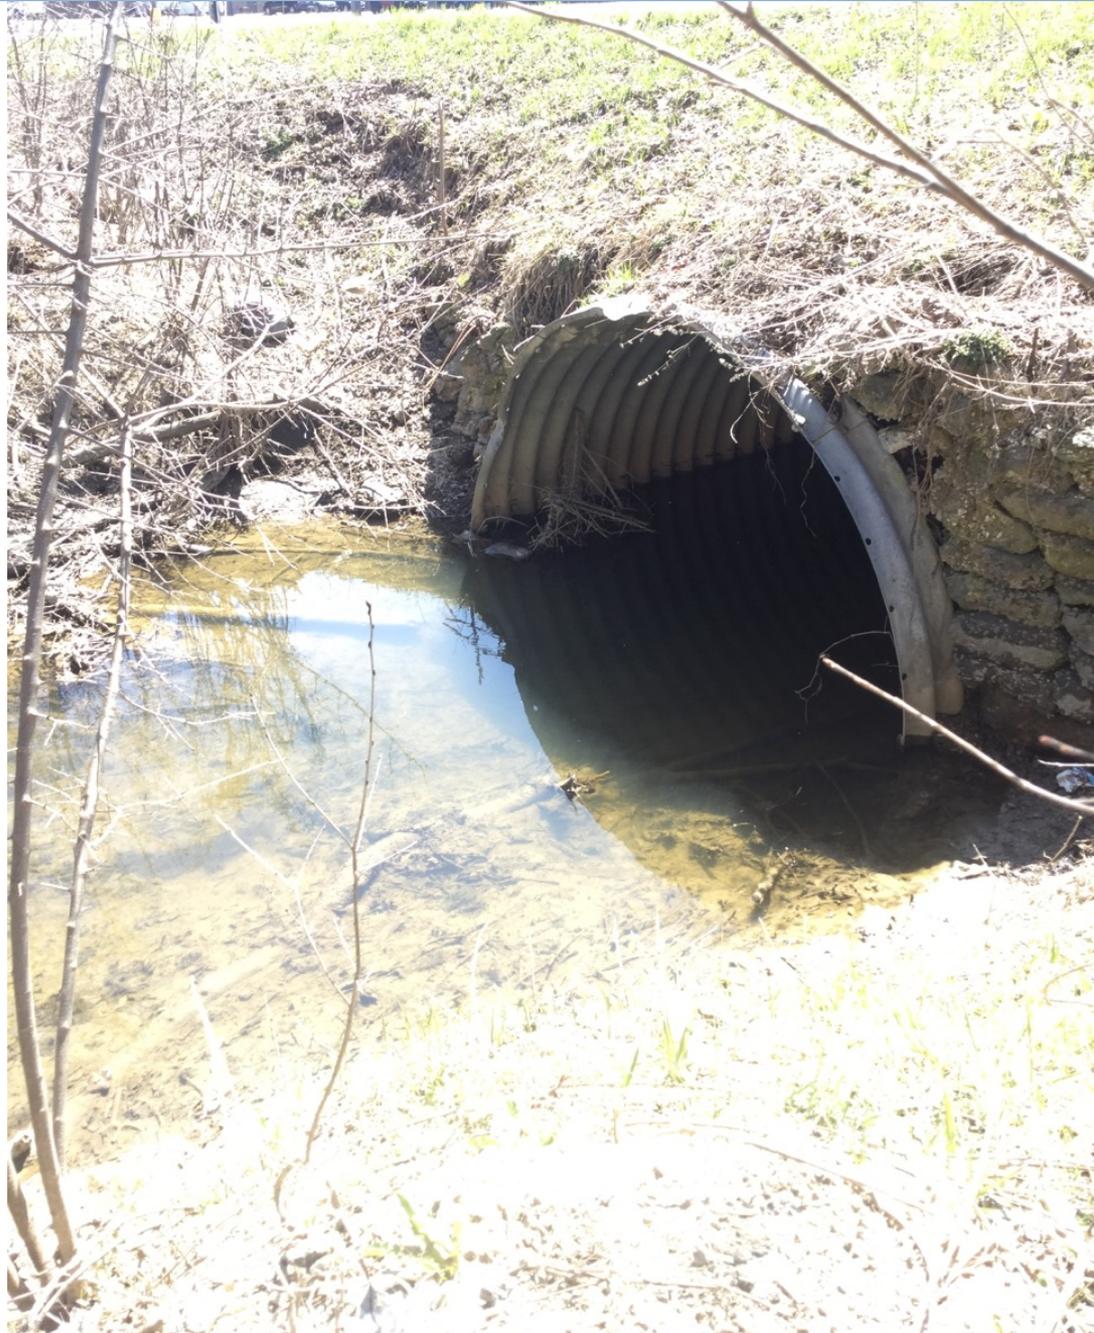
King Road (Second crossing)

Failing bag rip
rap headwalls

Alignment of
culvert creates
some erosion
downstream

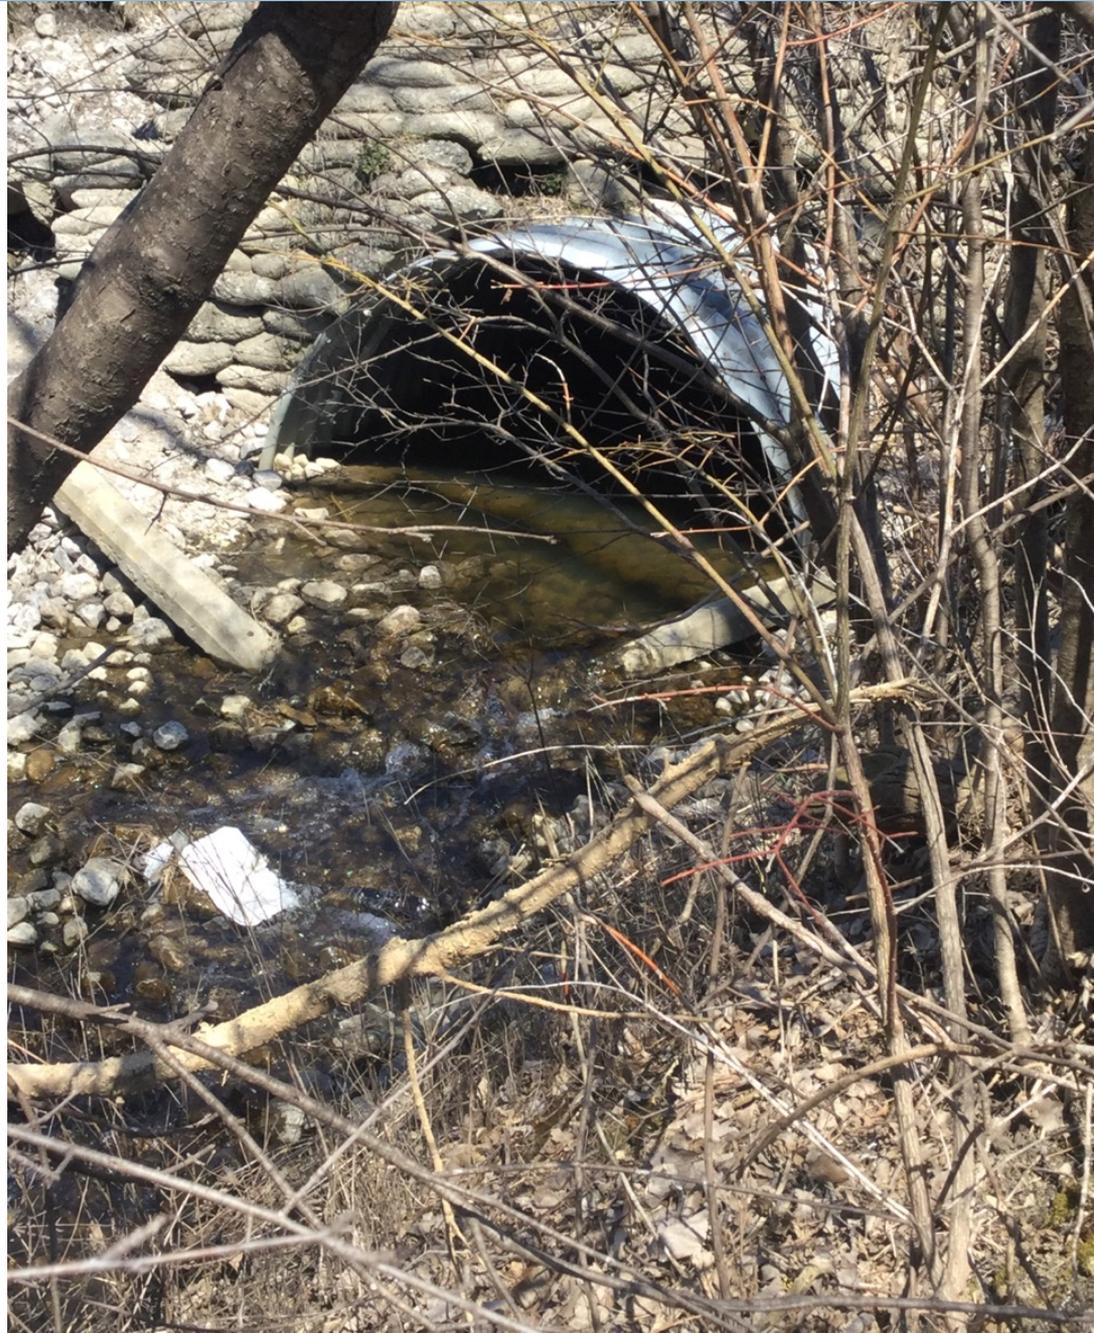
Kansas Avenue (South End of Western Crossing)

Failing bag rip
rap headwalls

Rip rap at culvert
outlet backing up
water in drain
