King Street Tile Drain Inspections

Inspection Report for Observation:
AgriculturalFlooding1

CLIENT	Saginaw County Public Works Commissioner

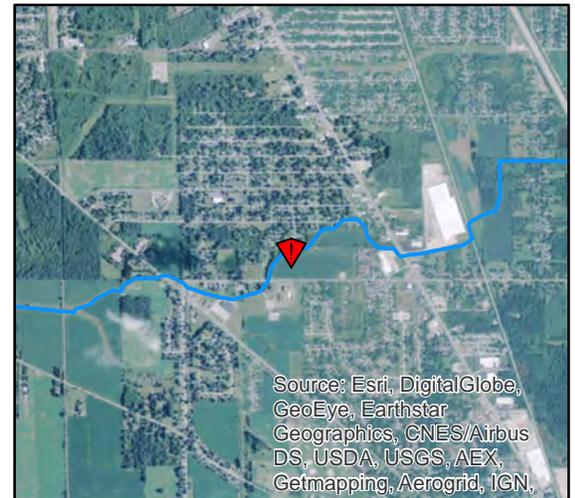
Photo 1

Existing flooding in farm field right side of the drain. Picture facing South.

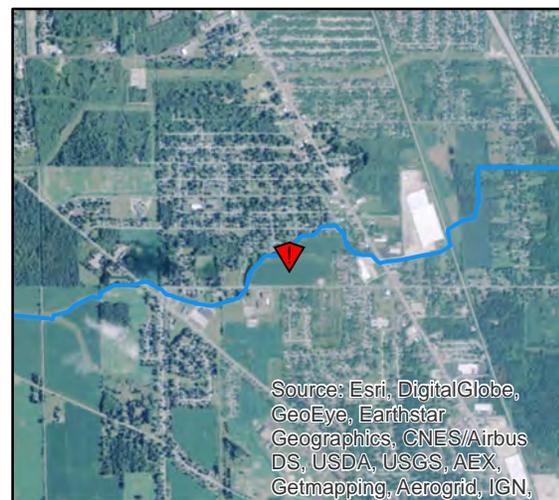
Photo 1

Considerable flooding in farm field right side of the drain. Picture facing East

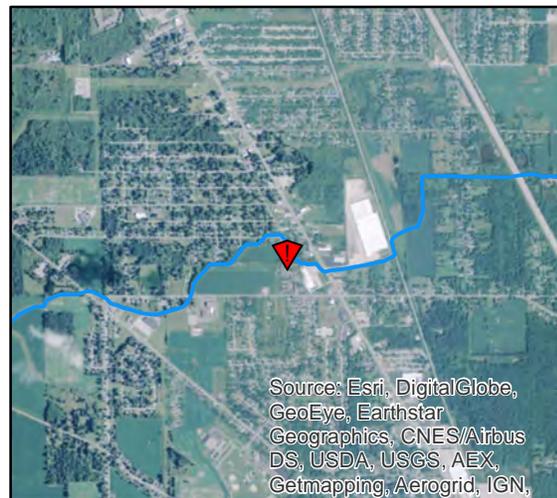
Photo 1

Flooding on edge of farm field right side of the drain . Picture facing Southeast

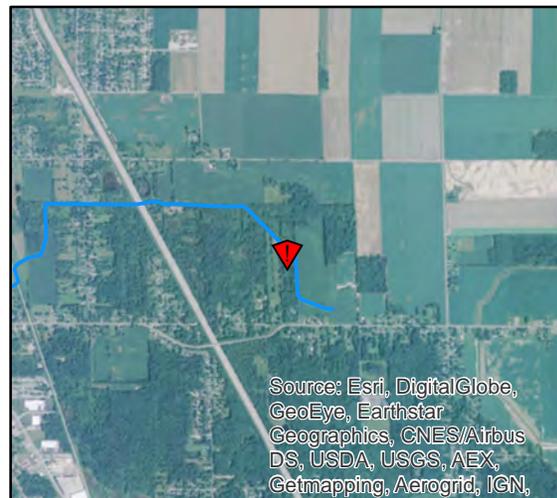
Photo 1

Flooded woods 50' south of the drain. Right side of the drain. Picture facing South.

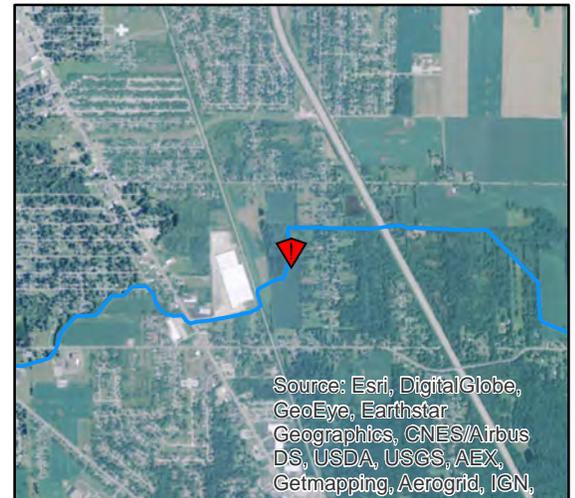
Photo 1

Agricultural flooding on the east side of the drain can be seen in dry conditions where farmland isn't growing. Picture facing east from outside of drain.

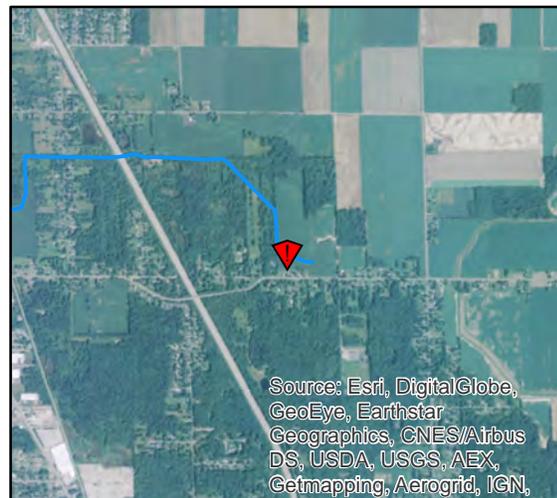
Photo 1

Some agricultural flooding on left side of drain facing upstream. Picture facing east.

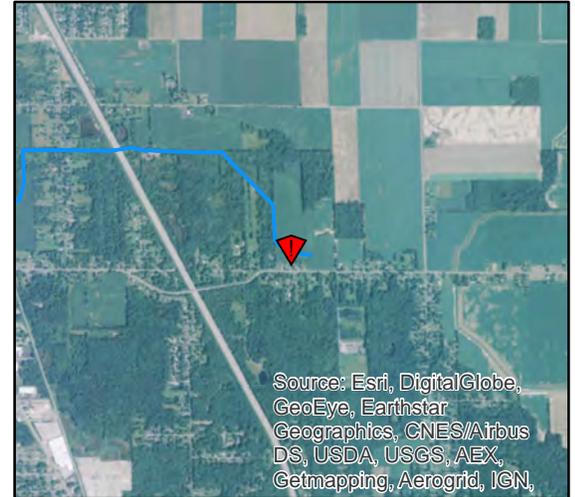
Photo 1

Agricultural flooding on left side of drain facing upstream. It spans about 100' out and 50' wide. Picture facing north from atop the drain crossing.

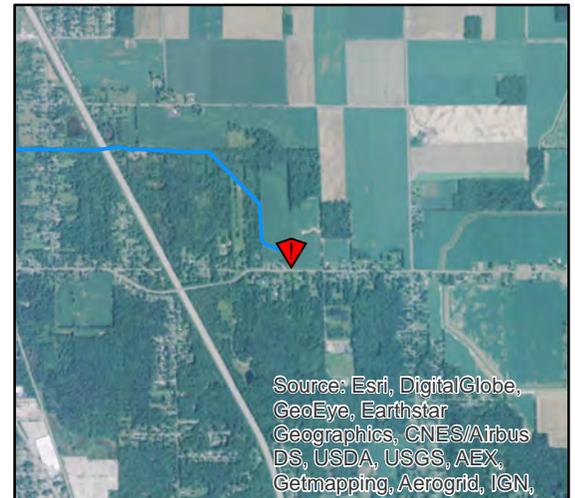
Photo 1

Agricultural flooding on left side of drain facing upstream. It extends from drain approximately 50' and is 15' wide. Picture facing north from drain.

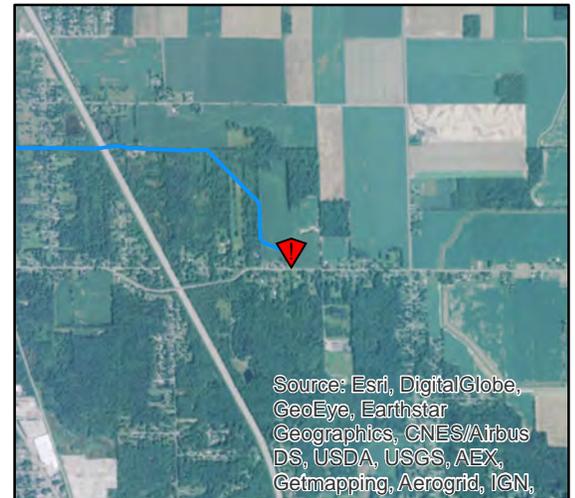
Photo 1

Agricultural flooding on left side of drain facing upstream. Water is about 100' east of the drain and area is 40'x40'. Picture facing east from bend in drain.

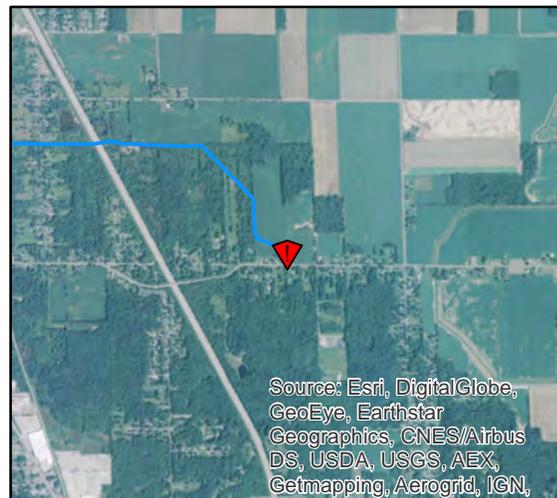
Photo 1

Agricultural flooding on left side of drain facing upstream. Water is approximately 50' east of drain and is 60'x25' in size. Picture facing east from drain.

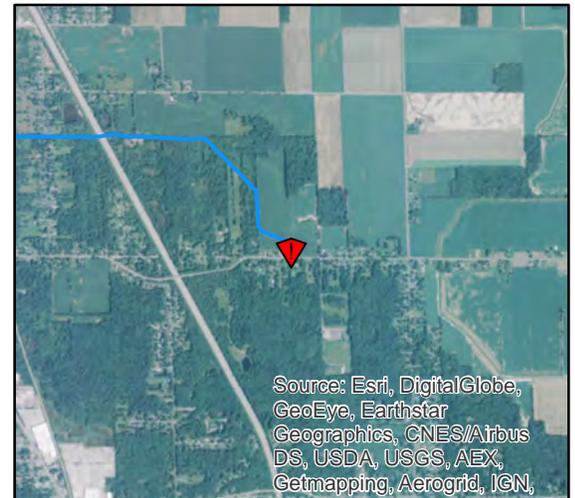
Photo 1

Two agricultural flooding ponds to the northeast of the drain. Near one is 35' away and far one is 50' past it. Near one is 20'x40' and far one is 20'x20'. Picture facing northeast away from drain.
