King Street Tile Drain Inspections

Inspection Report for Observation:
Barrier1

CLIENT	Saginaw County Public Works Commissioner

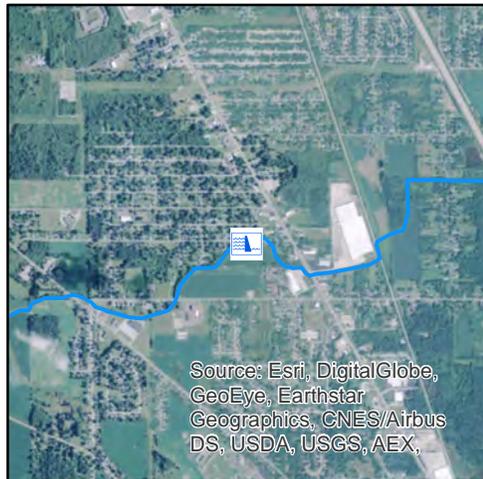
Material: Riprap

Length (feet): 25

Photo 1 Direction: Facing Upstream

On south side of Kansas st crossing. Could be intentional as a flow control device. 25 ft long. Water is dammed up behind it into culvert. Rip rap as well as two pieces of curb.
