# King Street Tile Drain Inspections

Inspection Report for Observation:  
**BridgeCrossing1**

CLIENT	Saginaw County Public Works Commissioner

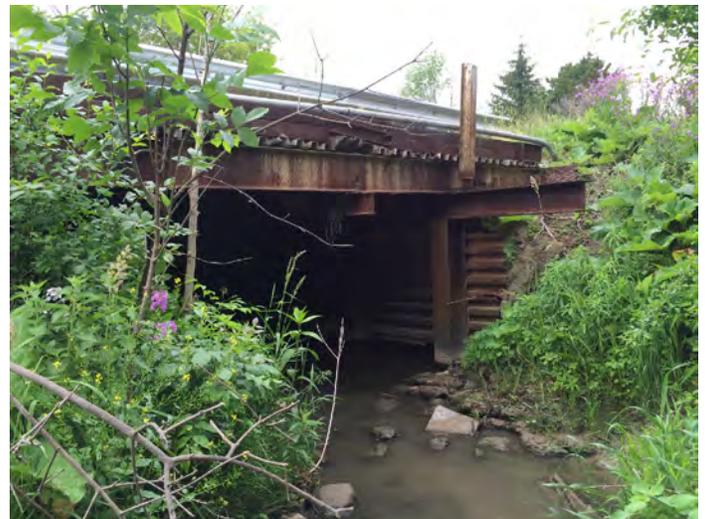
**Photo 2**

**Downstream Comments:**  
 (Williamson Road Bridge) Bridge crossing under williamson rd. Erosion at both banks and headwall. Bridge in poor condition. Rusted out. Sediment deposits downstream of sop. Sop enters from right side under the bridge.

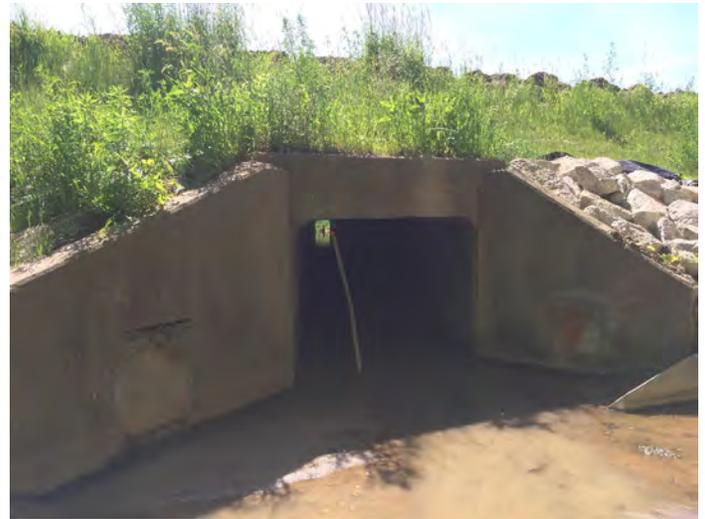
**Photo 2**

**Downstream Comments:**  
 (I-75 Bridge) Headwalls in fair condition. Fence just downstream. Sops enter on each side from I75. Heavy vegetation, sediment, and woody debris just downstream of crossing.
