# King Street Tile Drain Inspections

Inspection Report for Observation:  
**ConstructedBank1**

CLIENT	Saginaw County Public Works Commissioner

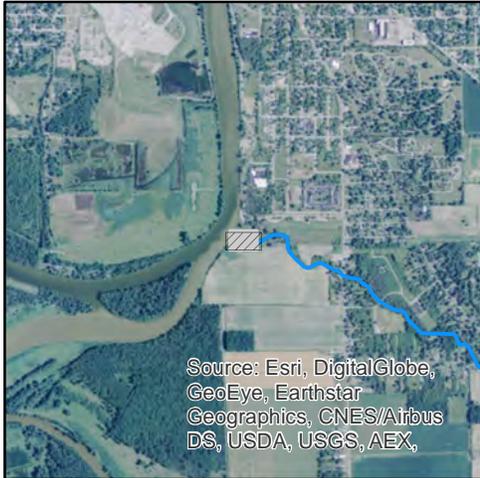
**Material:** Broken concrete. Also rocks.

**Length (feet):** 20

**Location:** Left Side Facing Upstream

Left side. 20 ft. Photo upstream.

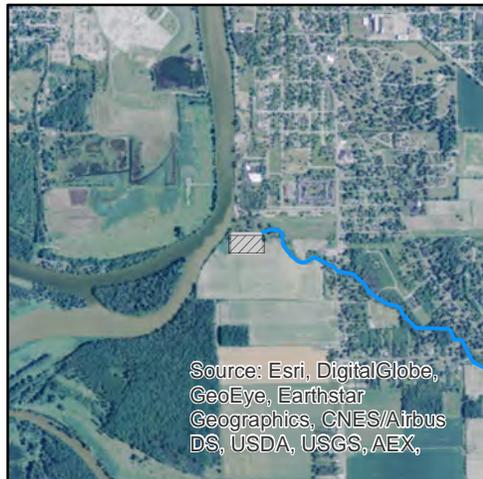
Inspection Report for Observation:  
**ConstructedBank2**

**Material:** Concrete

**Length (feet):** 40

**Location:** Right Side Facing Upstream

Cnnstructed bank with pieces of broken concrete bank on right side for 40 ft. Photo facing upstream.

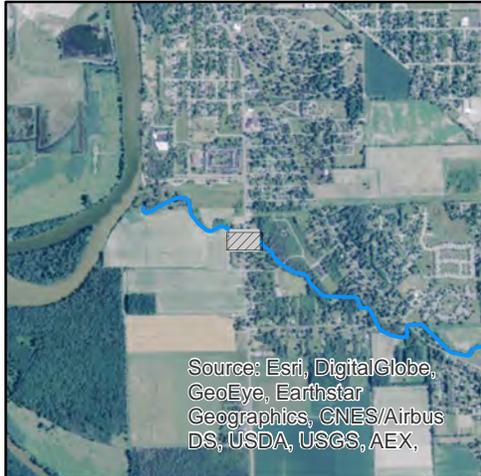
Inspection Report for Observation:  
**ConstructedBank3**

**Material:** Rocks, rip rap

Constructed bank on both sides of drain, downstream of M13 crossing for 40 ft. Photo facing downstream.

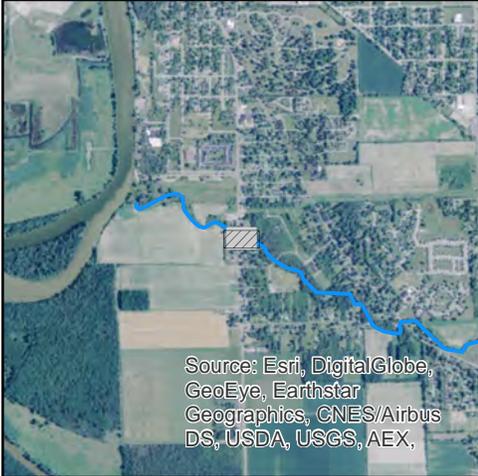
Inspection Report for Observation:  
**ConstructedBank4**

**Material:** Rocks, rip rap

**Length (feet):** 10

Constructed banks on both sides for 10 ft, just upstream of M13 crossing. Photo facing north.

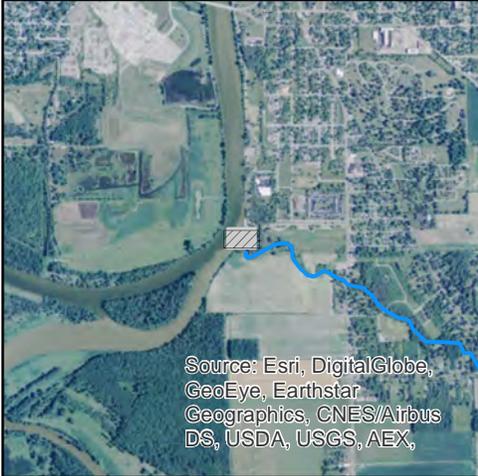
Inspection Report for Observation:  
**ConstructedBank5**

**Material:** Gabion baskets with rip rap

**Location:** Left Side Facing Upstream

Left side of the drain at the outlet to the Saginaw River . Picture facing upstream

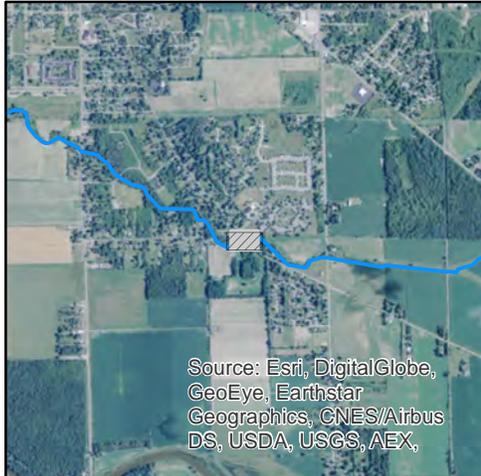
Inspection Report for Observation:  
**ConstructedBank6**

**Material:** Broken concrete

**Length (feet):** 40

**Location:** Left Side Facing Upstream

Constructed bank with broken concrete. 40 ft up to washington rd. In poor condition. Falling apart and leaving debris in the drain. Causing riffle. Photo facing upstream.contains surface outlet pipe at washington rd.

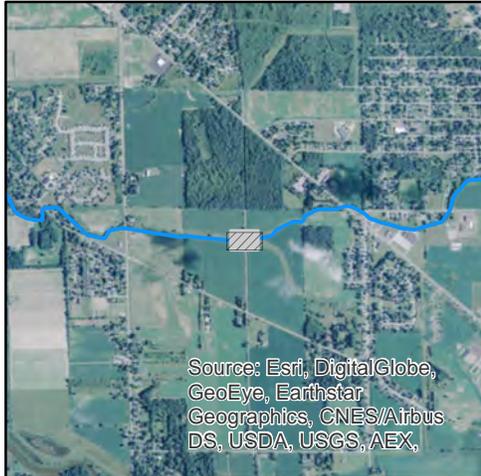
Inspection Report for Observation:  
**ConstructedBank7**

**Material:** Small stones.

**Length (feet):** 30

Constructed banks on both sides under railroad bridge. Small stones. Photo facing north.

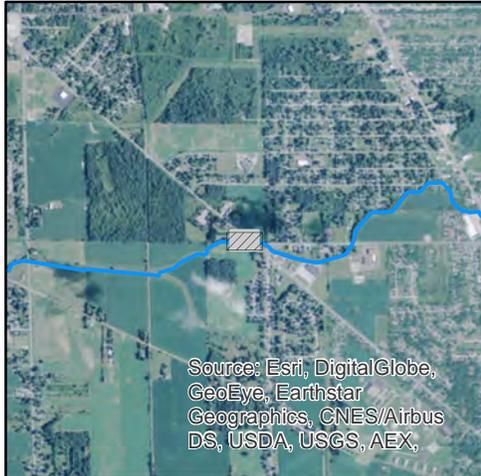
Inspection Report for Observation:  
**ConstructedBank8**

**Material:** Bag riprap

**Length (feet):** 20

**Location:** Left Side Facing Upstream

Bag riprap constructed bank. Serves as headwall for 19" sop on left side and extends to crossing at williamson rd.

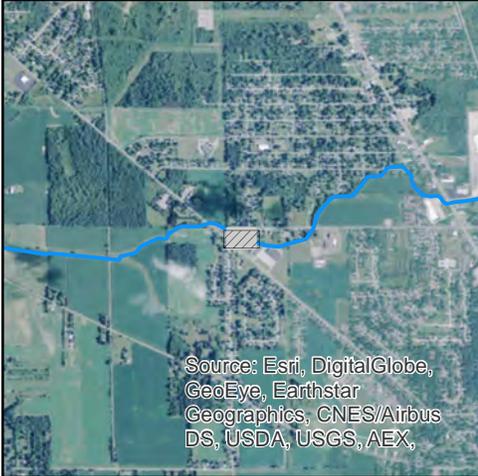
Inspection Report for Observation:  
**ConstructedBank9**

**Material:** Stone

**Length (feet):** 6

**Location:** Right Side Facing Upstream

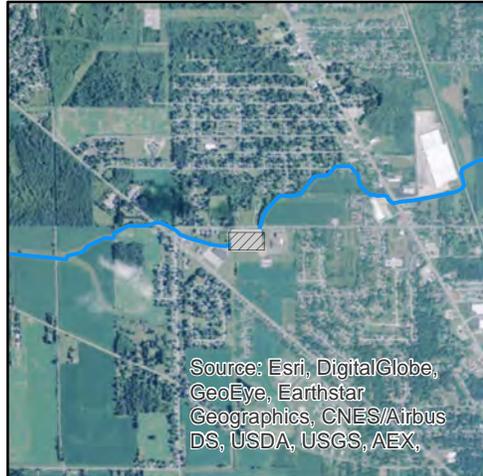
Inspection Report for Observation:  
**ConstructedBank10**

**Material:** Broken concrete

Constructed bank is headwall for 18" hdpe sop. In failed condition.

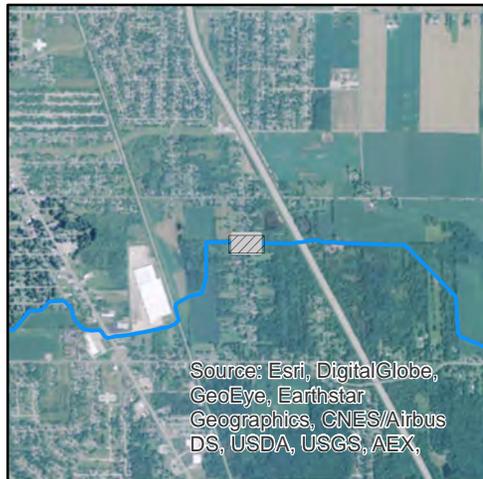
Inspection Report for Observation:  
**ConstructedBank11**

Bag riprap headwall around 30" concrete sop. In fair condition. Some erosion is visible. Just upstream of mack crossing.
