King Street Tile Drain Inspections

Inspection Report for Observation:
CulvertCrossing1

CLIENT	Saginaw County Public Works Commissioner

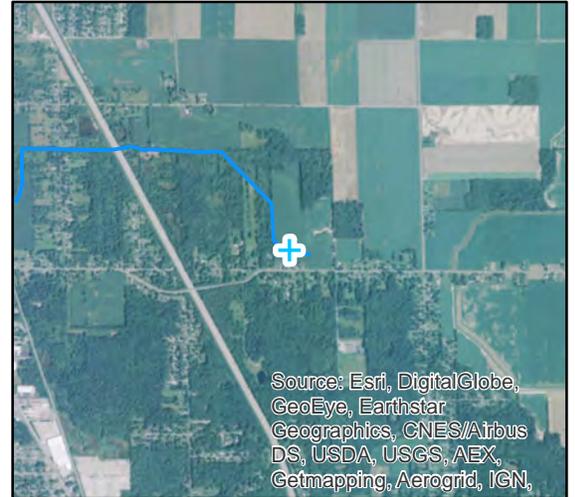
Crossing Type: Farm **Structure Condition:** Failed
Structure Type: RCP **Photo 1 Direction:** Facing Upstream
Downstream Comments:
 (Farm Crossing) Photo 1 downstream end of 30" rcp farm crossing (failed) . Full of water. Picture facing upstream
