SAGINAW COUNTY, MICHIGAN
FACILITY ASSESSMENTS

FINAL
January 25, 2019

Prepared by:
DLZ MICHIGAN, INC.
Project No: 1841-6827-00

2.01 COUNTY OFFICE BUILDING
111 South Michigan Avenue
Saginaw, Michigan 48602
Year: 1964
Size: 36,000gsf
Floors: B-2

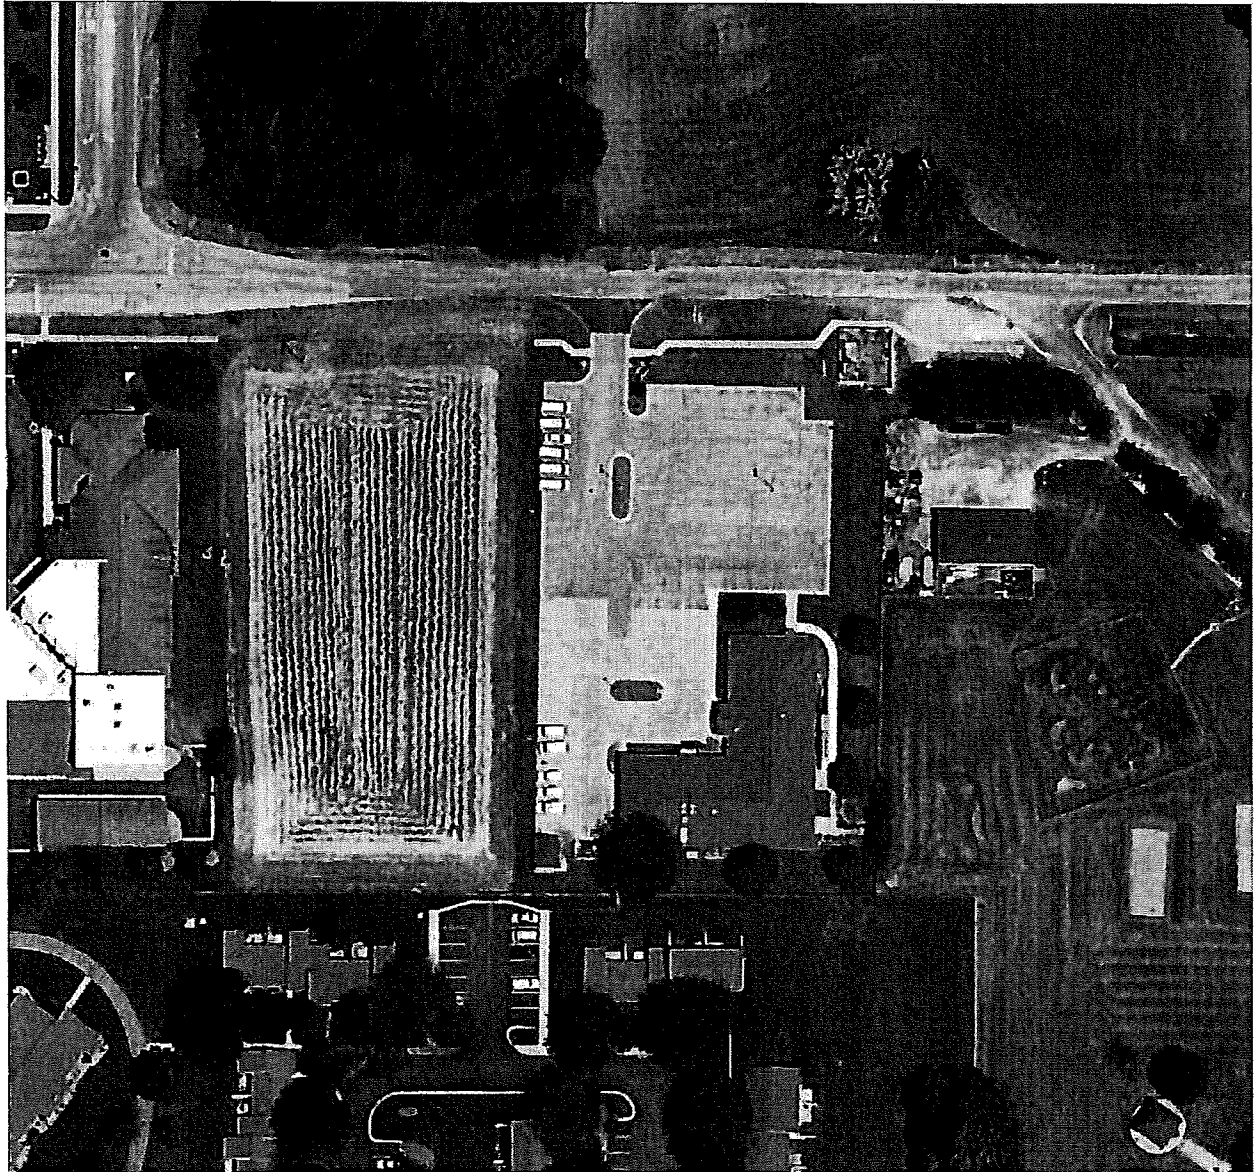
SITE PLAN

2.04 COMMISSION ON AGING
2355 Schust Road
Saginaw, Michigan 48603
Year: 1994
Size: 13,800gsf
Floors: B-1
