King Street Tile Drain Inspections

Inspection Report for Observation:
BankErosion1

| CLIENT | Saginaw County Public Works Commissioner | HUBBELL, ROTH & CLARK, INC CONSULTING ENGINEERS SINCE 1915 | 555 Hulet Drive P.O. Box 824 Bloomfield Hills, MI 48303-0824 (248) 454-6300 http://www.hrc-engr.com | DATE: | 08/16/2016 |

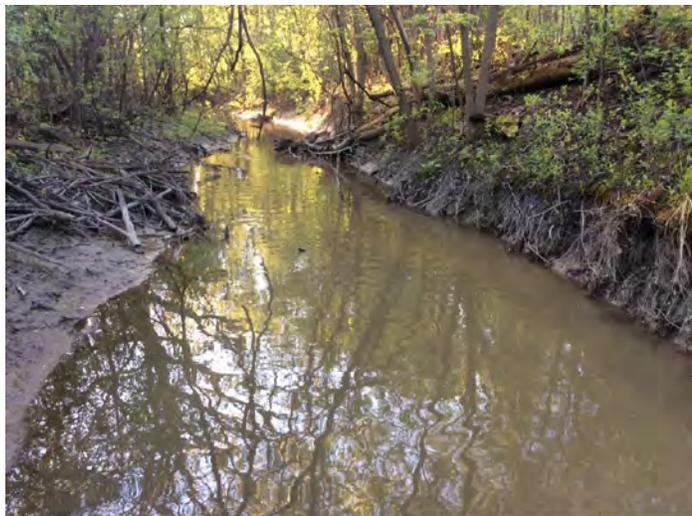
Bank erosion for next 130 ft. More so right side. Photo facing upstream.

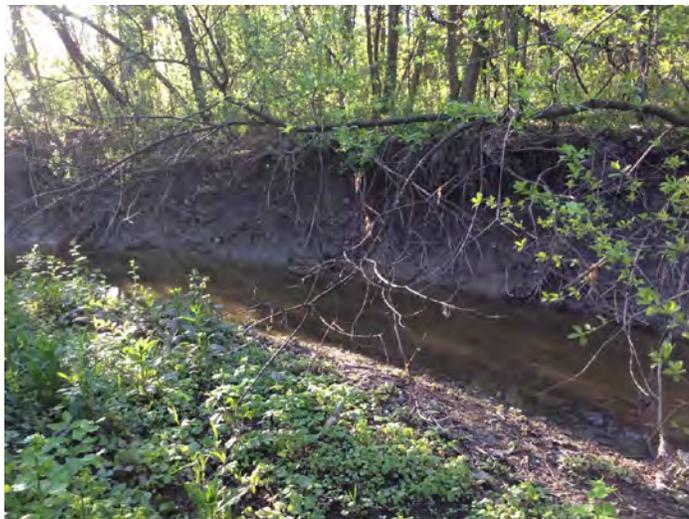
Inspection Report for Observation:
BankErosion29

Significant bank erosion on right side around the bend. 100 ft. Photo facing upstream.

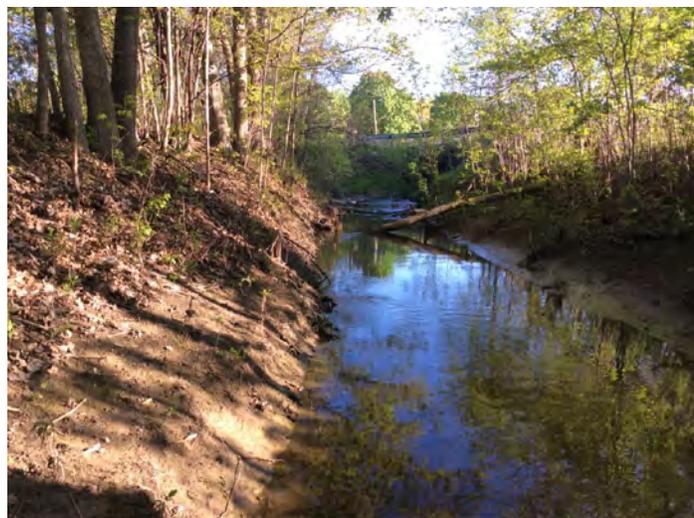
Inspection Report for Observation:
BankErosion30

Bank erosion on left side for 50 ft up to constructed bank. Photo facing upstream.

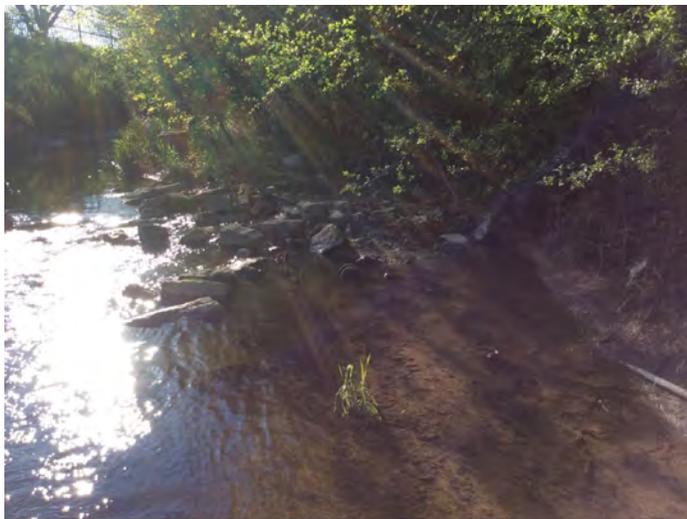
Inspection Report for Observation:
BankErosion32

Bank erosion on right side across from surface outlet pipe. Also note sediment bar and rocks. Photo facing upstream.

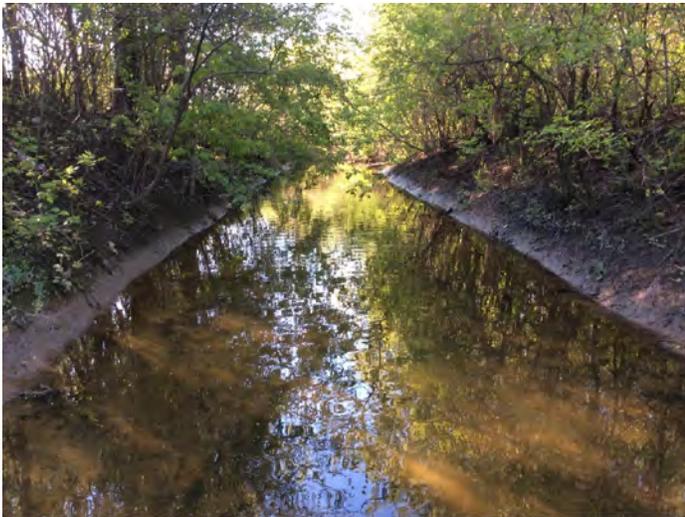
Inspection Report for Observation:
BankErosion34

Bank erosion on both sides next 300 ft. Photo facing upstream.

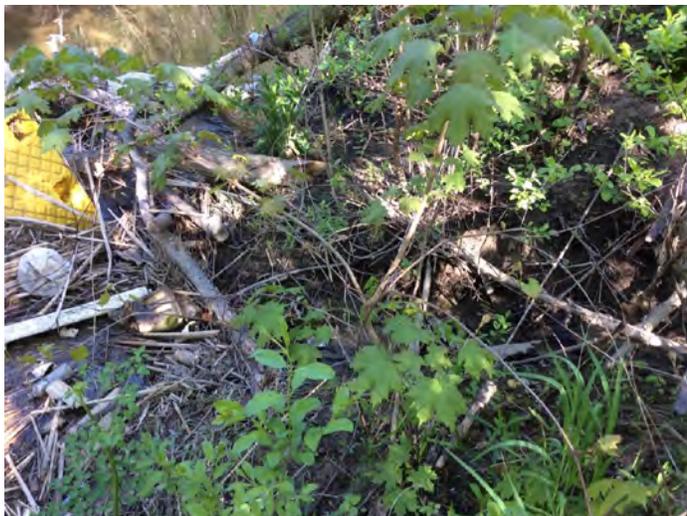
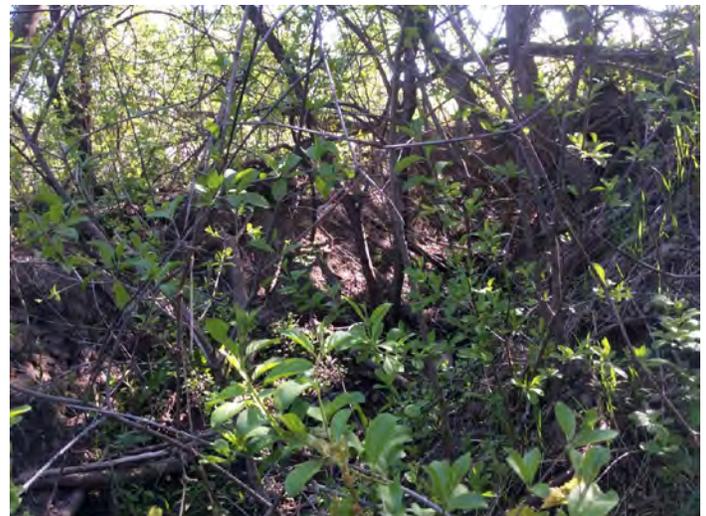
Inspection Report for Observation:
BankErosion35

Significant erosion around field tile outlet. 30 ft inland, 4 ft deep. Photo1 facing downstream. Photo2 facing northwest.

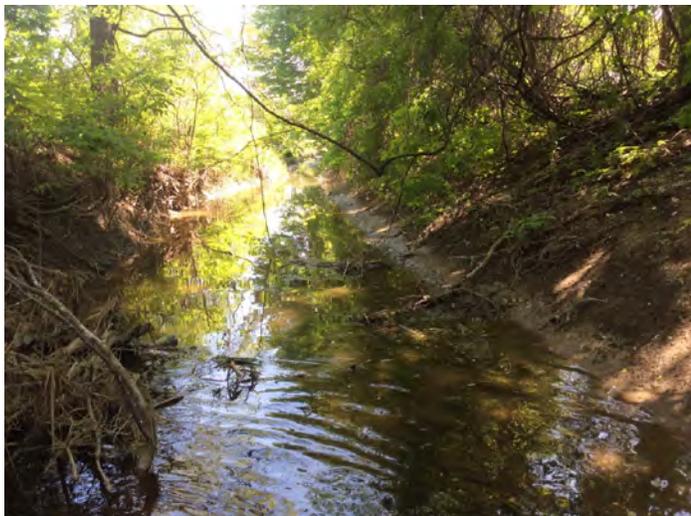
Inspection Report for Observation:
BankErosion36

Bank erosion both sides next 350 ft. Photo facing upstream.

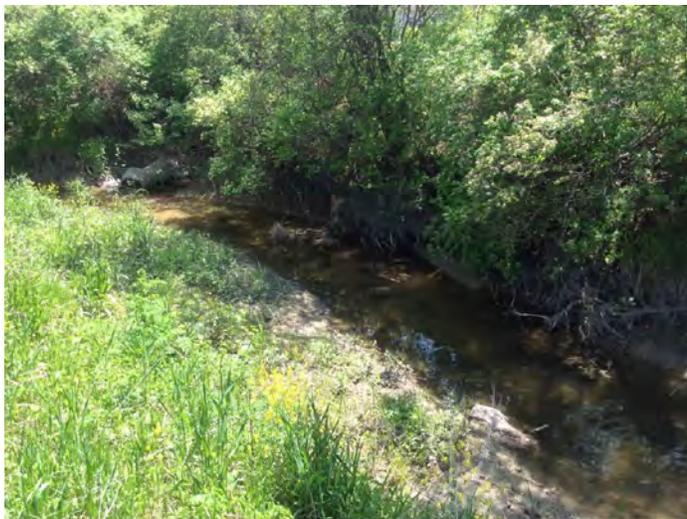
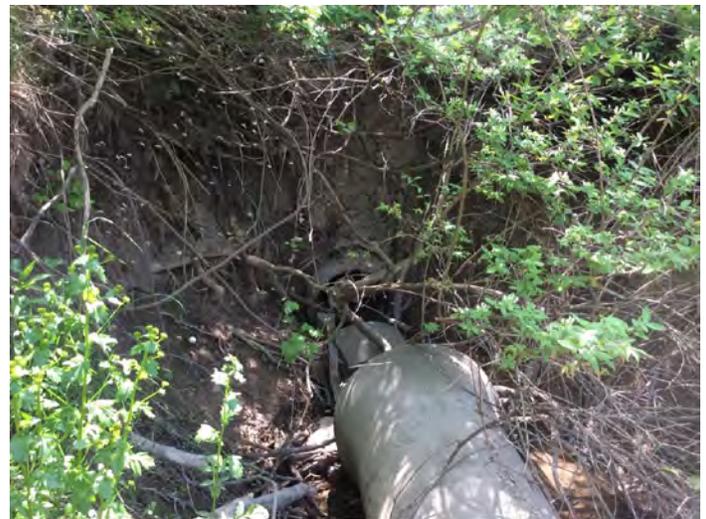
Inspection Report for Observation:
BankErosion37

Significant bank erosion around bend on right side for 80 ft. Photo facing upstream. Undercutting trees and bad around sop on right side.

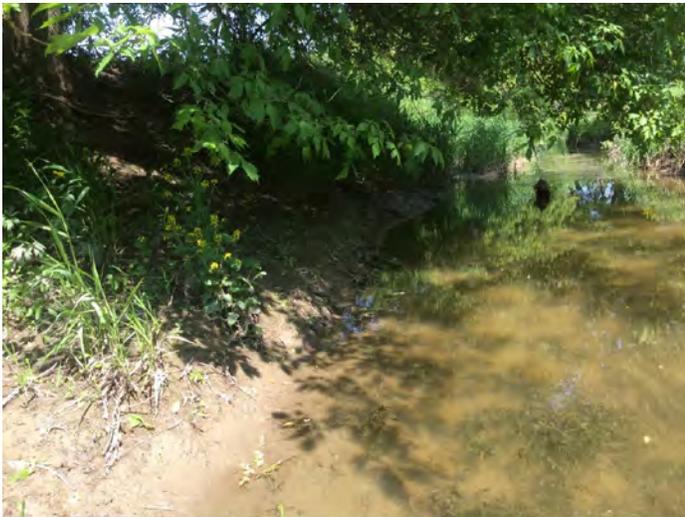
Inspection Report for Observation:
BankErosion38

Bank erosion left side for 30 ft under large tree. Photo facing upstream.

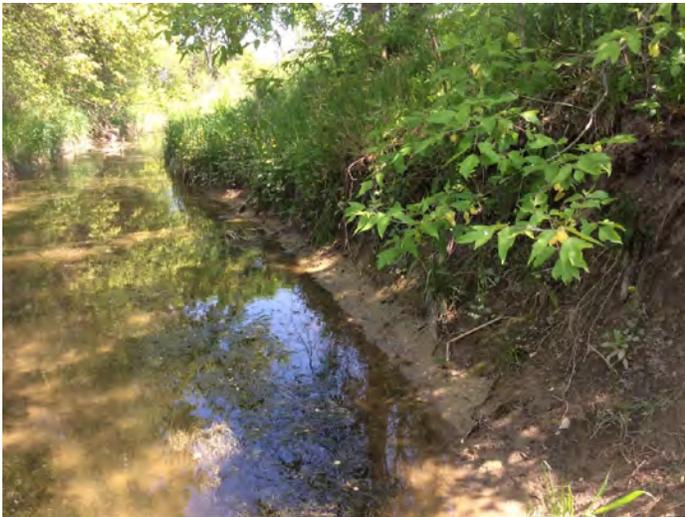
Bank erosion on right side next 30 ft. Photo facing upstream.

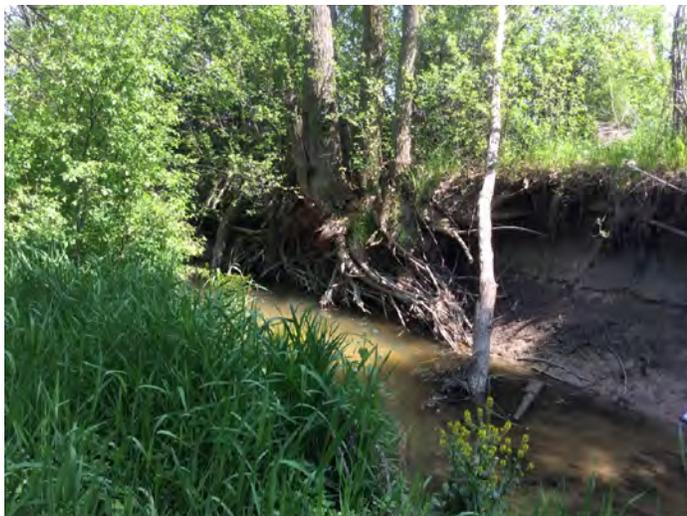
Significant bank erosion on right side next 80 ft around bend. Photo facing upstream.

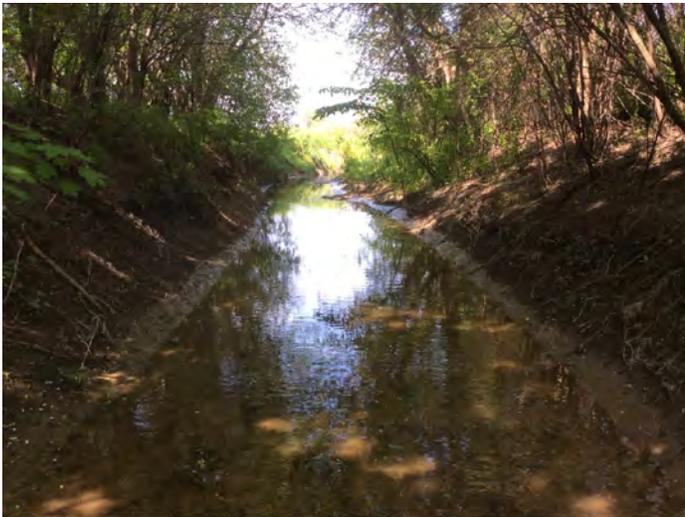
Bank erosion on both sides next 100 ft. Photo facing upstream.

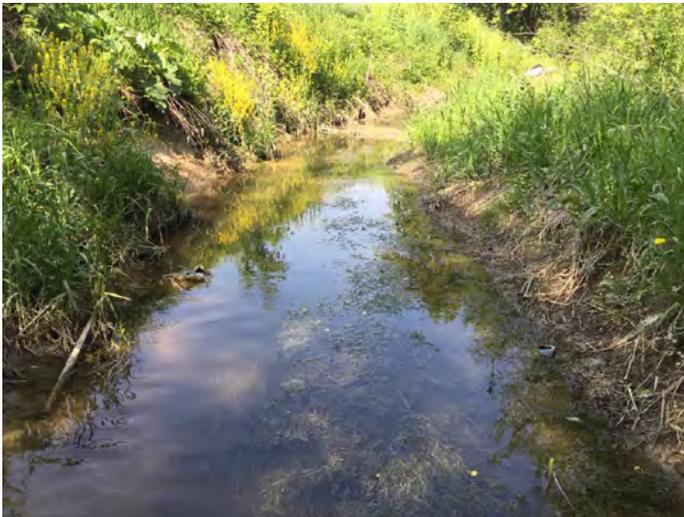
Bank erosion along both sides of drain. Photo facing upstream.

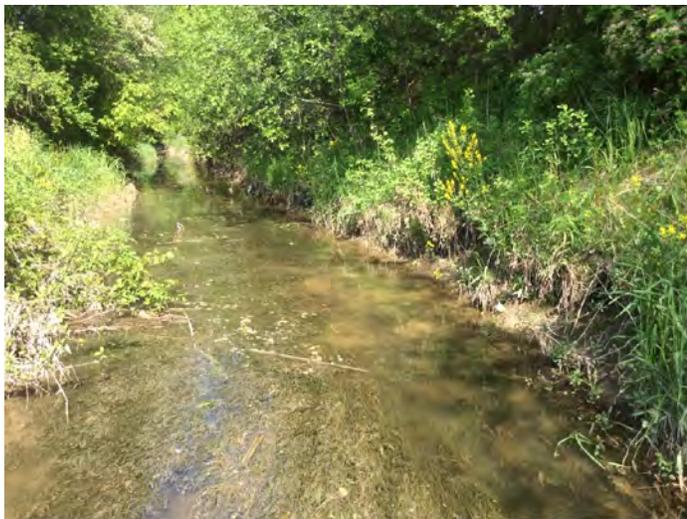
Bank erosion on right side next 200 ft. Photo facing upstream.

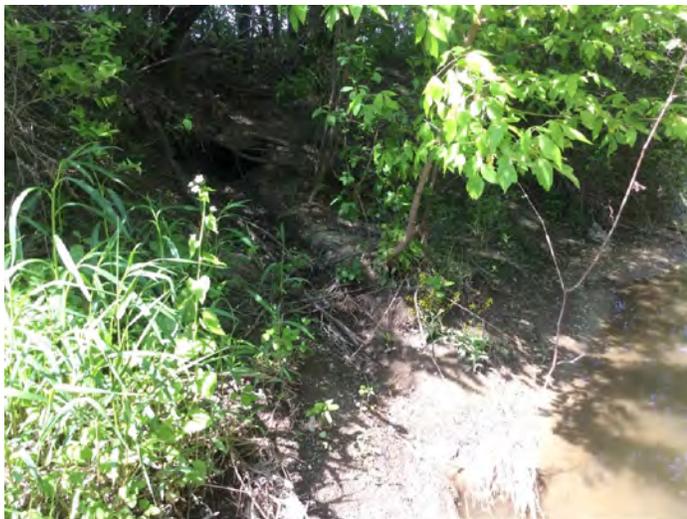
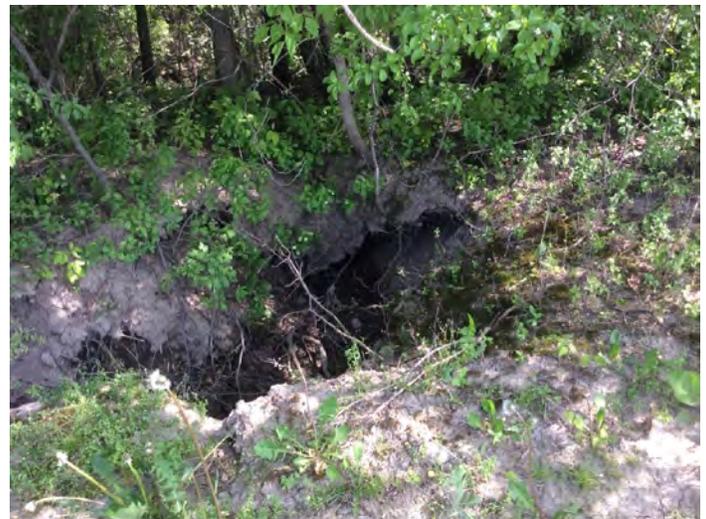
Erosion on left side undercutting tree. Photo1 facing north. Photo2 facing south from farm field.

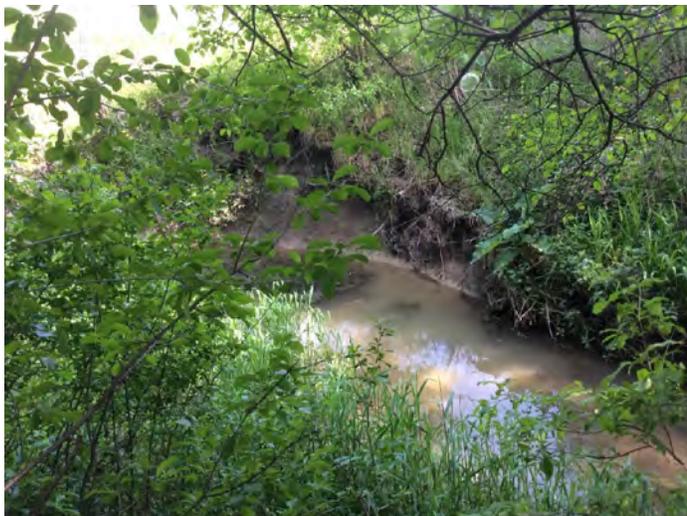
Bank erosion on both sides for 50 ft up to Sheridan rd. sediment deposit on left side as well with vegetation. Photo facing southeast.

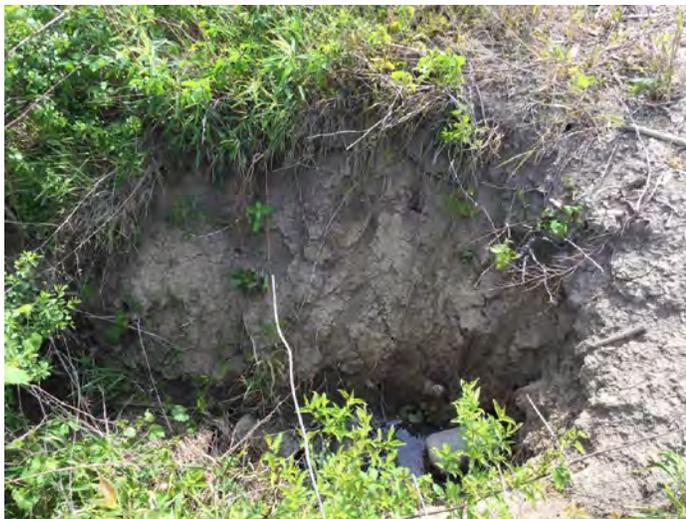
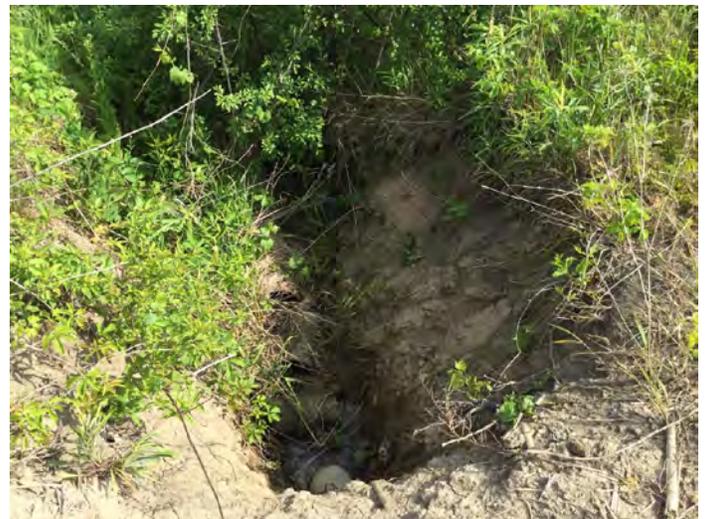
Inspection Report for Observation:
BankErosion48

Location: Right Side Facing Upstream

Length (feet): 20

Bank erosion on right side of drain facing upstream. From field tile outlet. About 20 ft in length. Photo 1 taken facing east (upstream). Photo 2 taken facing north.

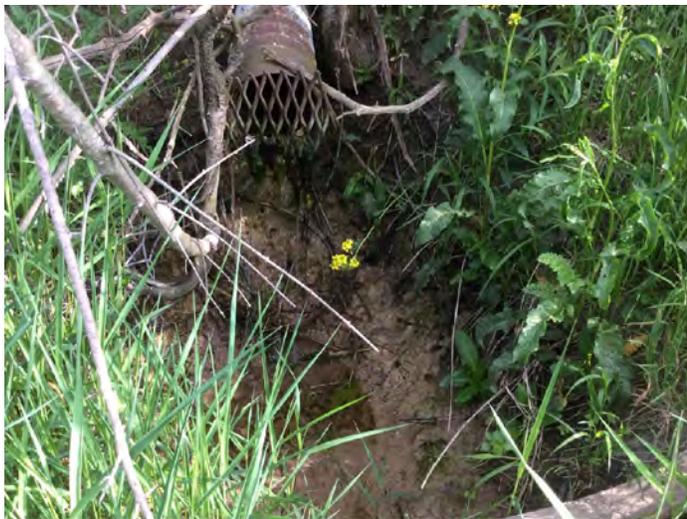
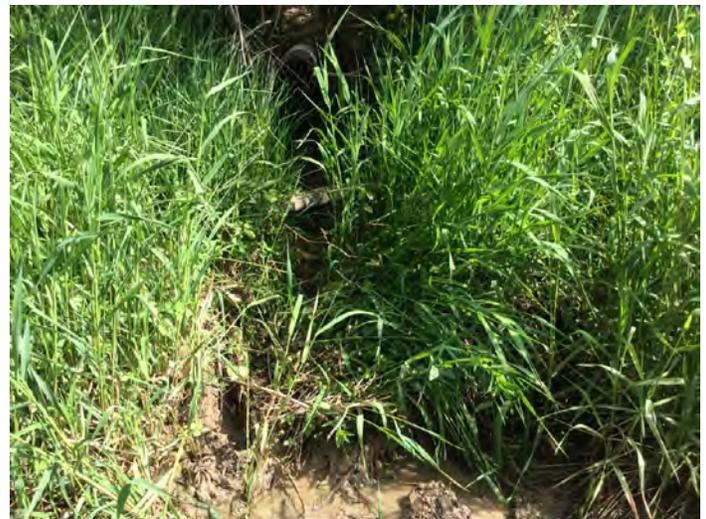
Inspection Report for Observation:
BankErosion49

Location: Left Side Facing Upstream

Bank erosion on left side stretches 8 ft inland to field tile outlet. Both photos facing north.

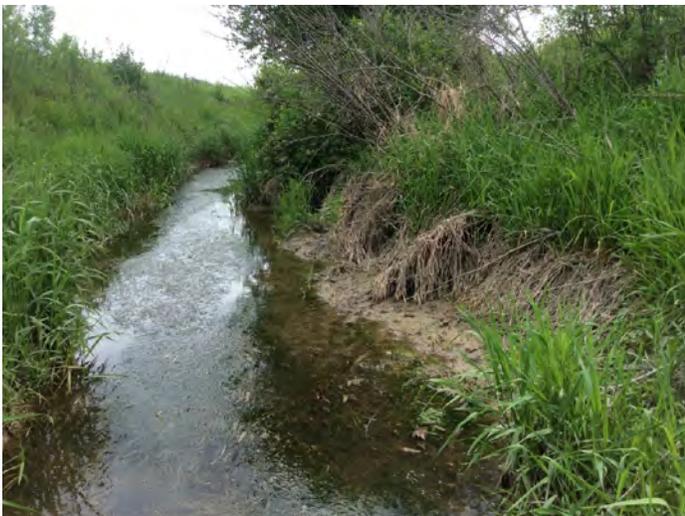
Photo 1

Inspection Report for Observation:
BankErosion50

Length (feet): 300

Bank erosion on both sides around the bend and upstream to crossing. Approx 300 ft. Photo facing upstream.

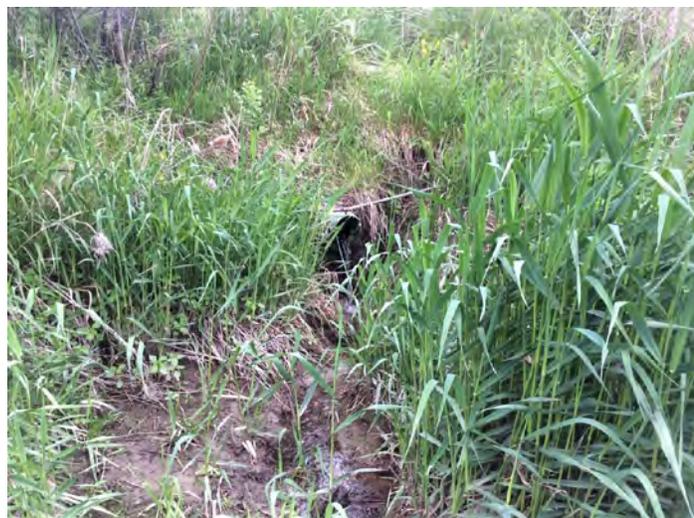
Photo 1

Inspection Report for Observation:
BankErosion51

Location: Right Side Facing Upstream

Bank erosion at field tile outlet, 6 ft inland. Photo facing south.

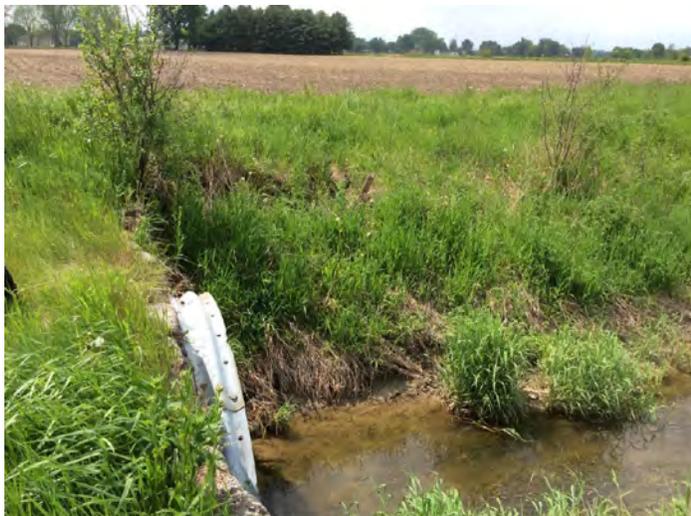
Photo 1

Inspection Report for Observation:
BankErosion52

Sediment cave in at top of bank on right side just downstream of crossing. Photo facing south.

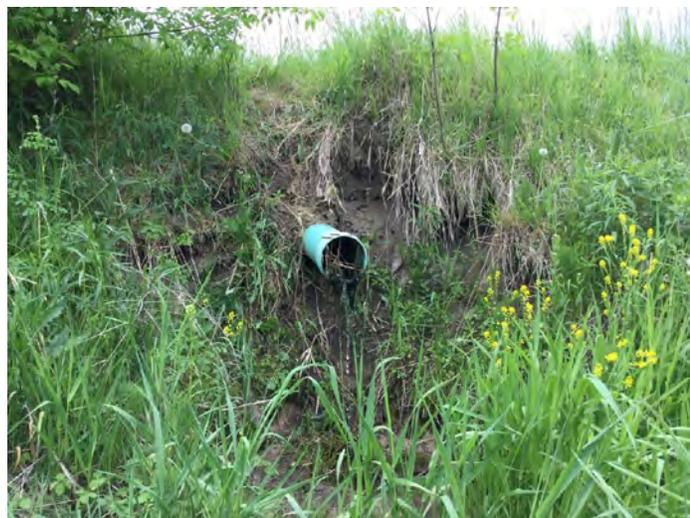
Photo 1

Inspection Report for Observation:
BankErosion53

Bank erosion around field tile outlet on right side of drain facing upstream. About 3 ft of blockage. Photo taken facing south.

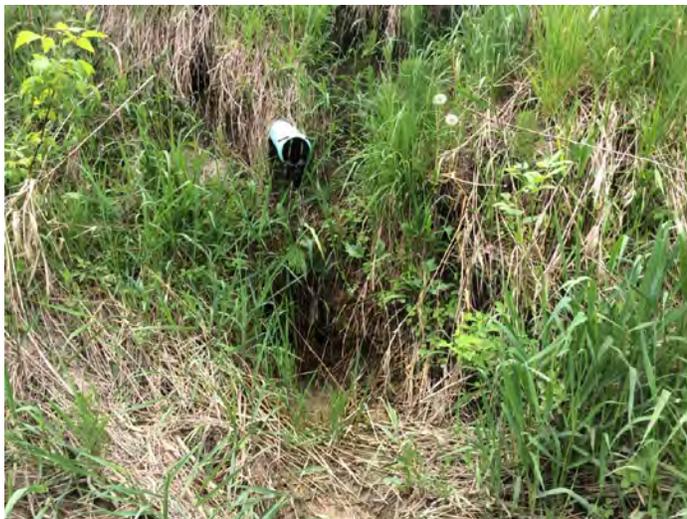
Photo 1

Inspection Report for Observation:
BankErosion54

Bank erosion around field tile outlet. Right side. Photo facing south.

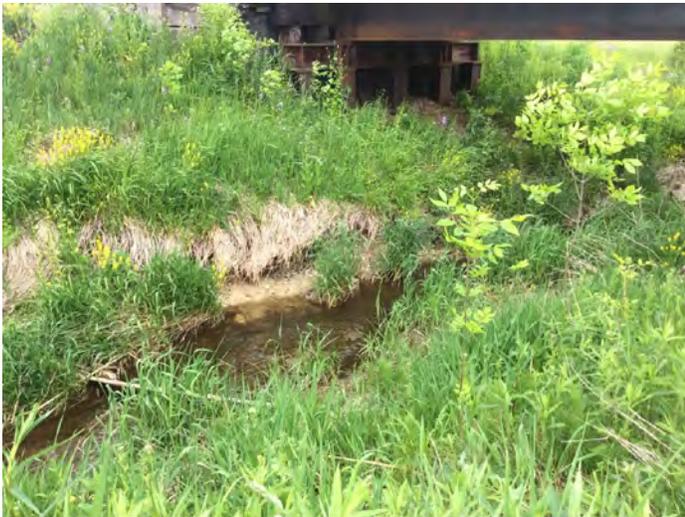
Photo 1

Inspection Report for Observation:
BankErosion55

Bank erosion on both sides under railroad crossing.

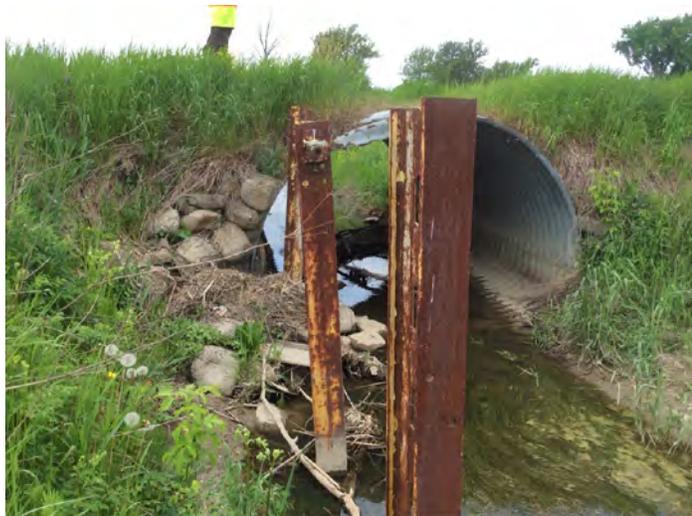
Photo 1

Inspection Report for Observation:
BankErosion56

Bank erosion on headwall of farm crossing. Upstream side. Photo facing downstream.

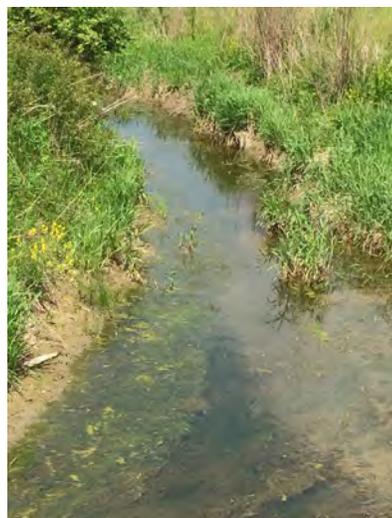
Photo 1

Erosion on both sides of drain. From farm crossing to curve in drain. About 50 ft. Photo taken facing upstream.

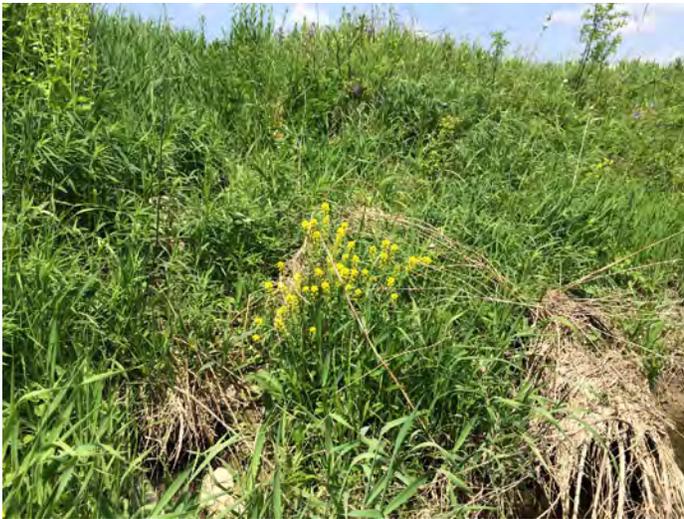
Photo 1

At failed field tile outlet on left side of drain. Photo facing northwest.

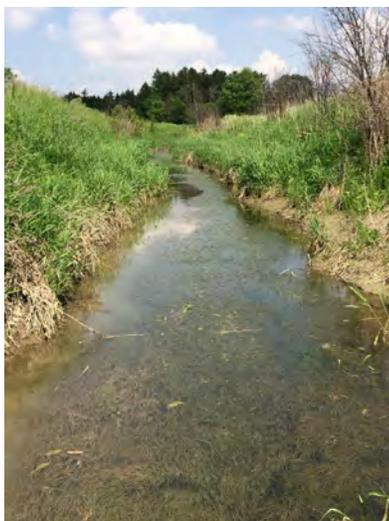
Photo 1

Erosion on both sides of drain. About 100 ft. Photo taken facing upstream.

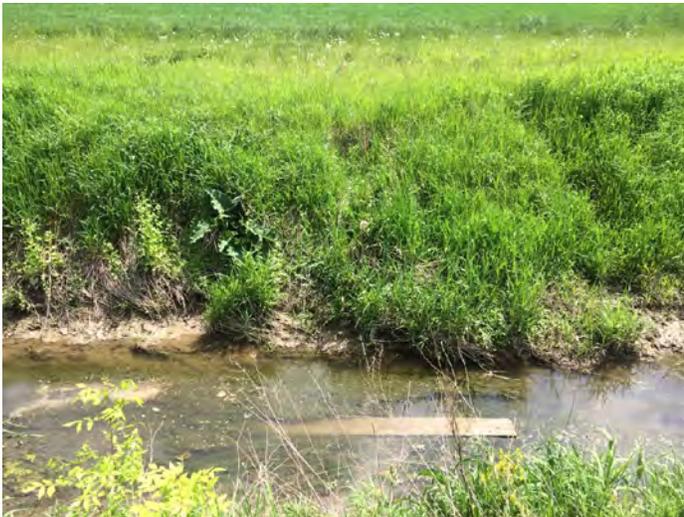
Photo 1

Bank erosion on right side of drain facing upstream. About 15 ft. Photo taken facing south.

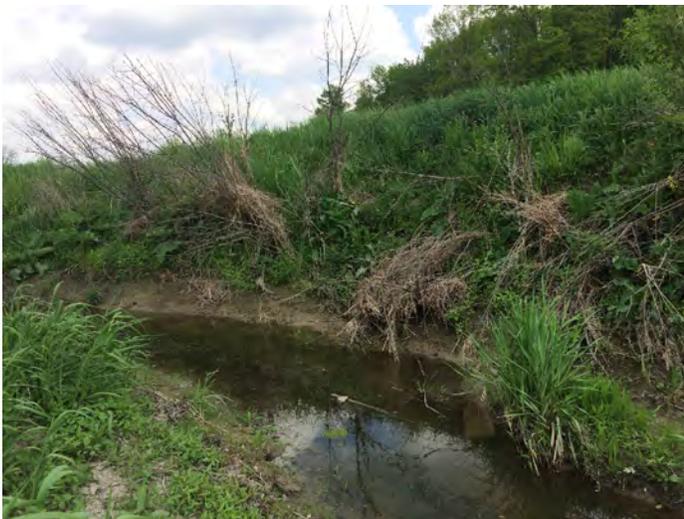
Photo 1

Bank erosion on right side for 80 ft around bend. Photo facing upstream.

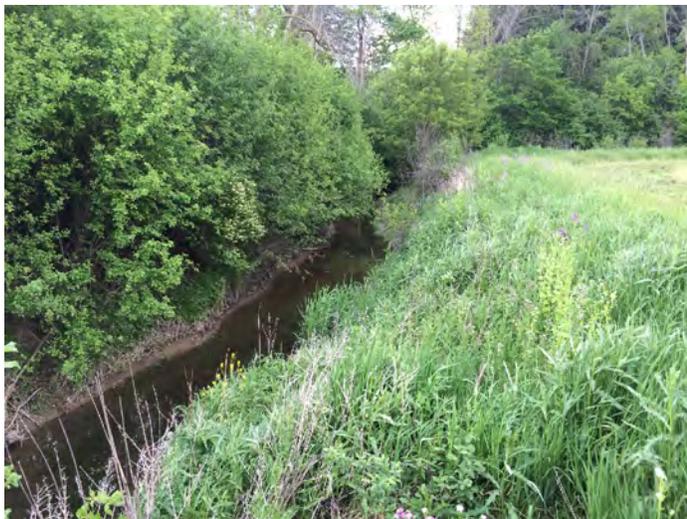
Photo 1

Bank erosion on both sides next 100 ft. Photo facing upstream.

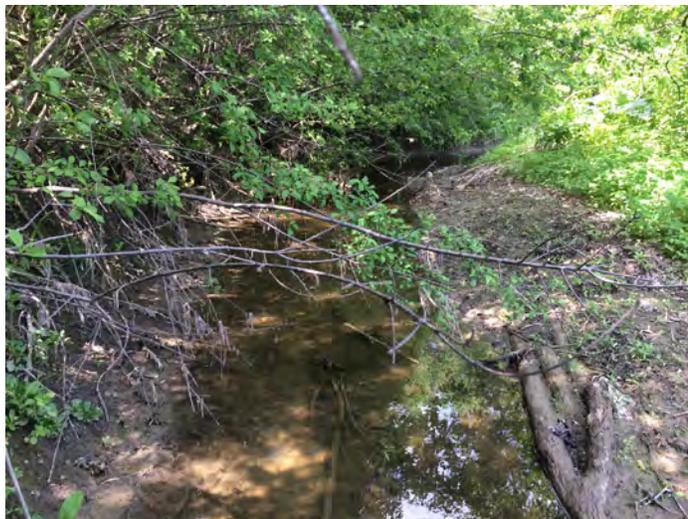
Photo 1

Bank erosion both sides around bend. 60 ft. Photo facing upstream.

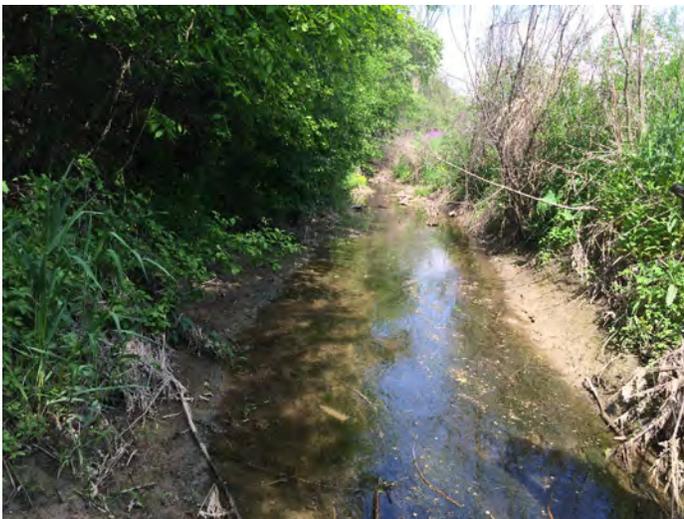
Photo 1

Bank erosion next 300 ft on both sides. Photo facing upstream.

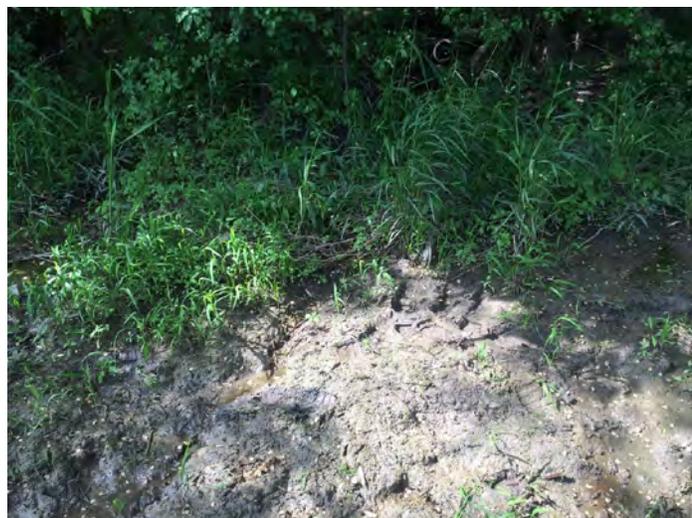
Erosion around clay field tile on left side of drain facing upstream. Photo taken facing north.

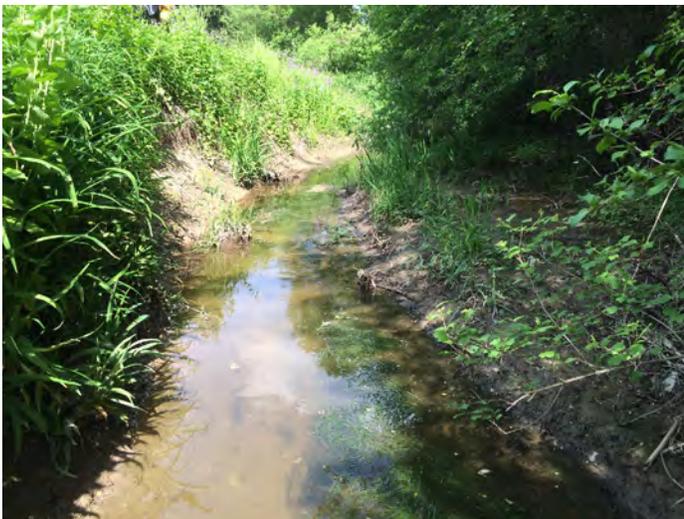
Inspection Report for Observation:
BankErosion67

Bank erosion both sides around bend. 50 ft. Photo facing upstream.

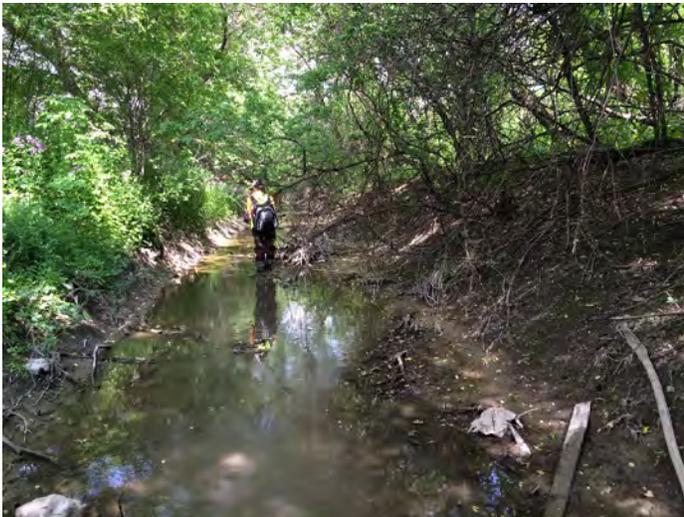
Inspection Report for Observation:
BankErosion68

Bank erosion on both sides next 300 ft. Photo facing upstream.

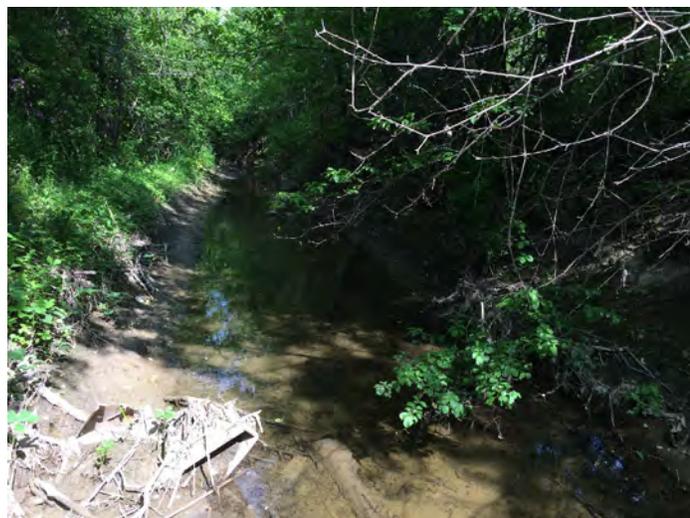
Inspection Report for Observation:
BankErosion69

Bank erosion on both sides next 100 ft. Photo facing upstream.

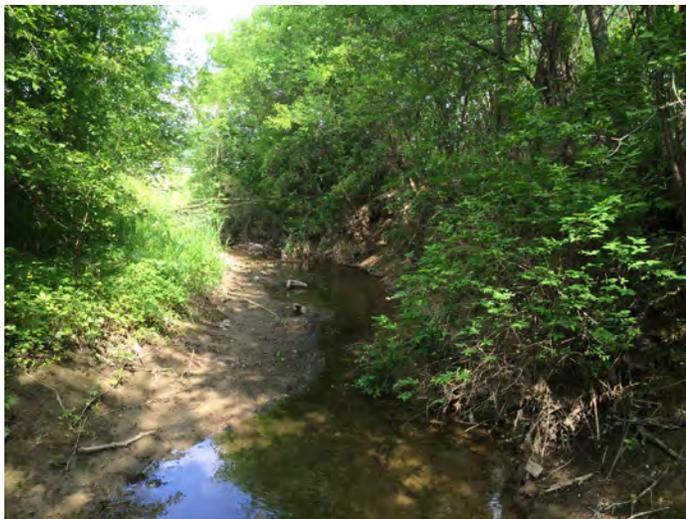
Inspection Report for Observation:
BankErosion70

Erosion on both sides next 100 ft up to Williamson re crossing. Significant on right side. Undercutting trees and exposed roots. Photo facing upstream.

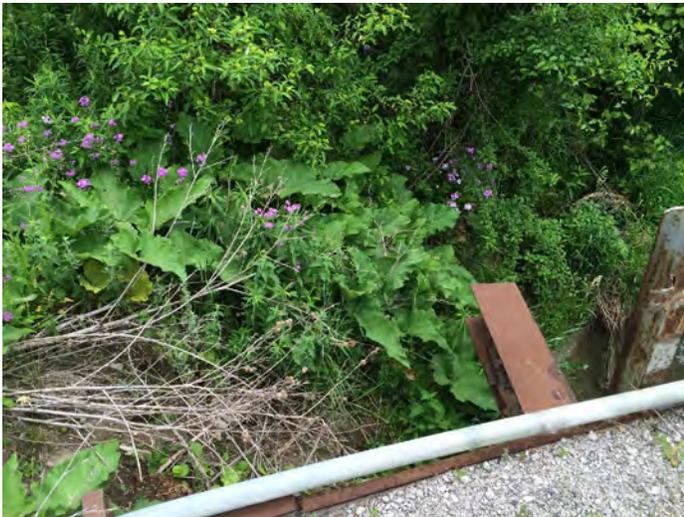
Inspection Report for Observation:
BankErosion72

Bank erosion on left side of drain just upstream of Williamson Rd. crossing.

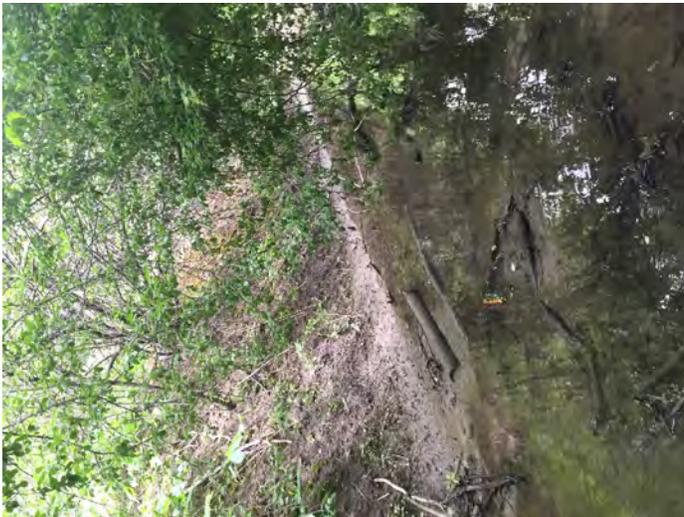
Inspection Report for Observation:
BankErosion73

Bank erosion along the drain from this location approx 500' upstream to end.

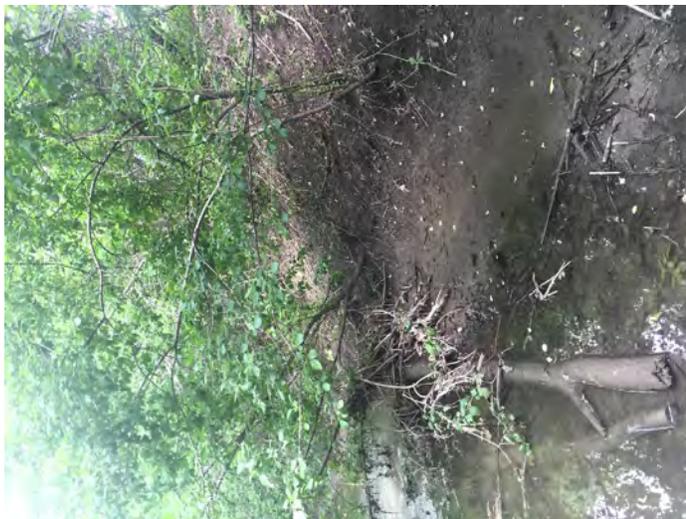
Inspection Report for Observation:
BankErosion74

Bank erosion along the drain due to high water events from this location approx 350' upstream to end. Picture facing upstream.

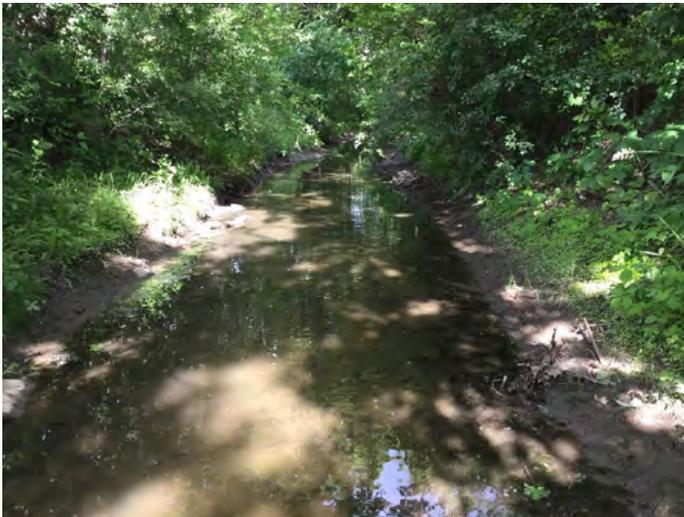
Bank erosion on both sides next 200 ft.

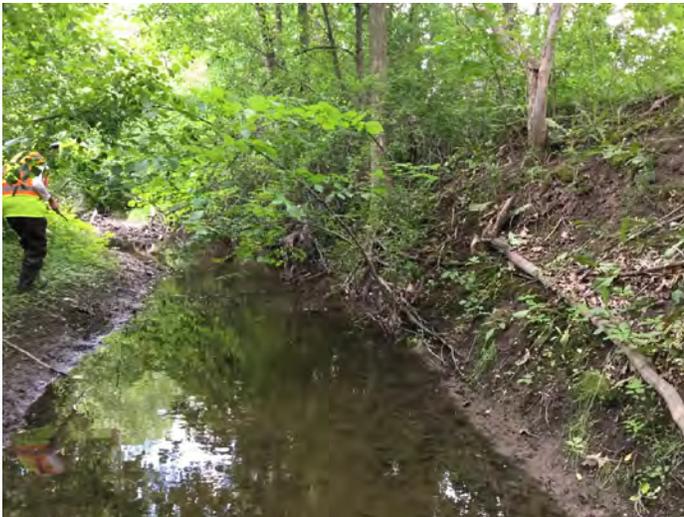
Bank erosion on both sides next 150 ft around bend. Significant erosion on right side with exposed trees roots.

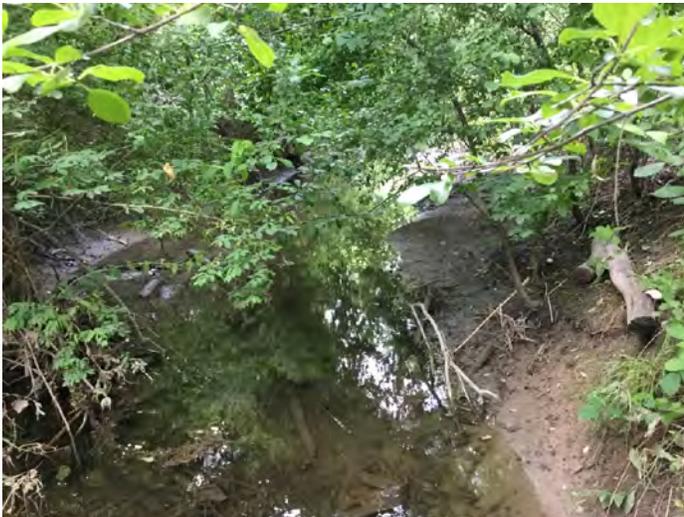
Bank erosion both sides next 400 ft.

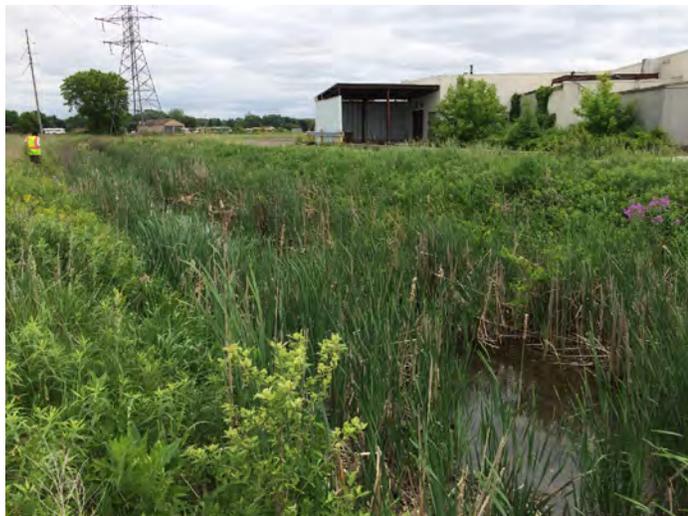
Bank erosion on both sides of drain next 250 ft. Steep banks.

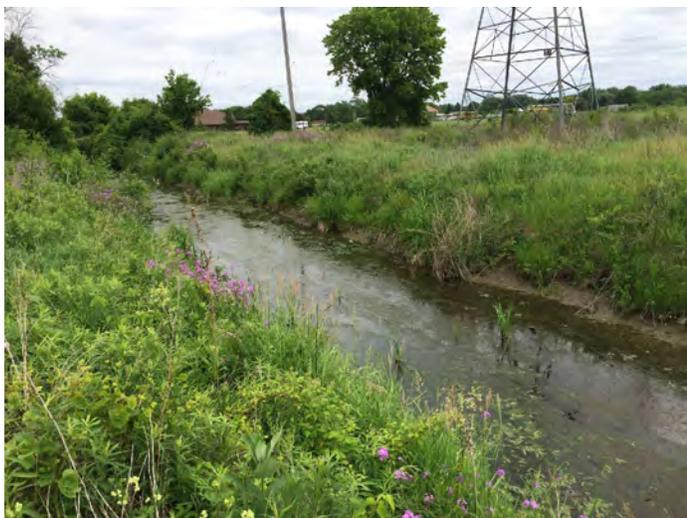
Bank erosion on right side next 250ft.

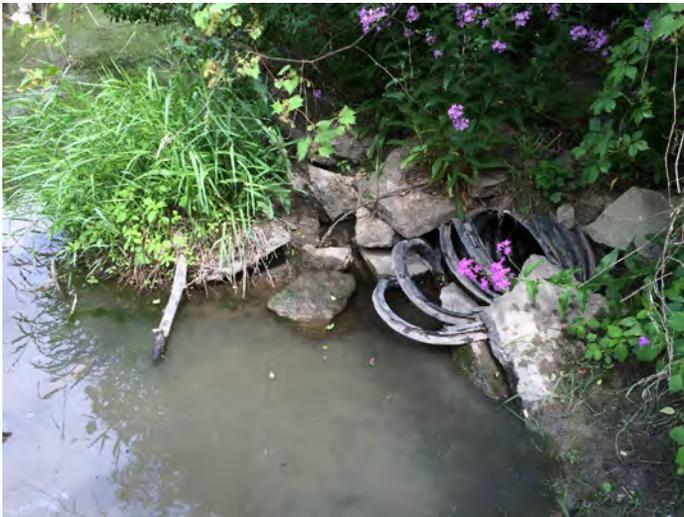
Bank erosion at hdpe sop outlet to drain on right side.

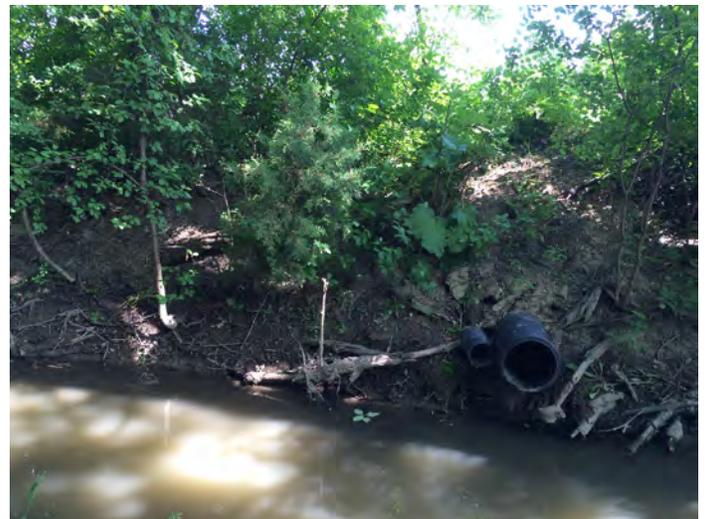
Bank erosion on both sides next 200 ft up to King St.

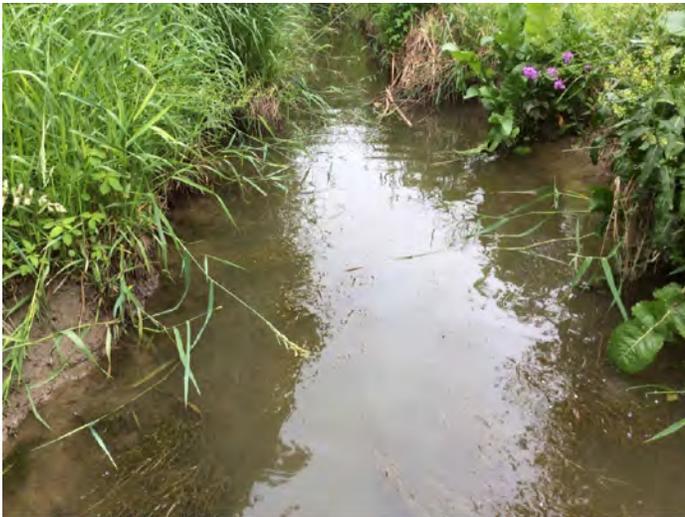
Comments:
Erosion on both sides of drain after crossing.

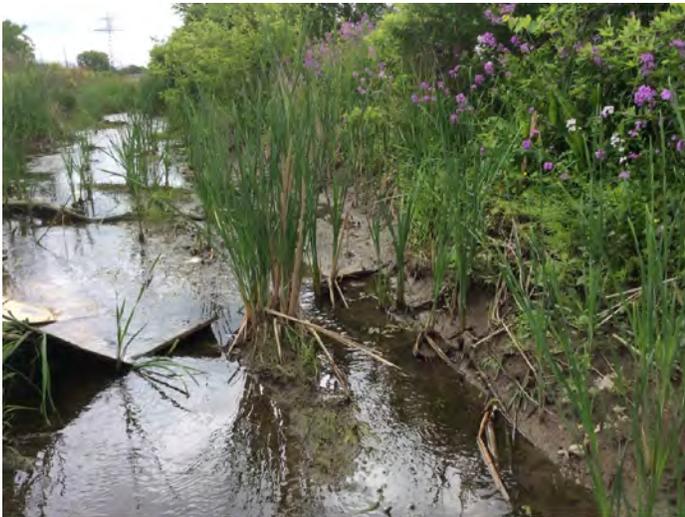
Bank erosion on both sides of drain. About 500 ft.

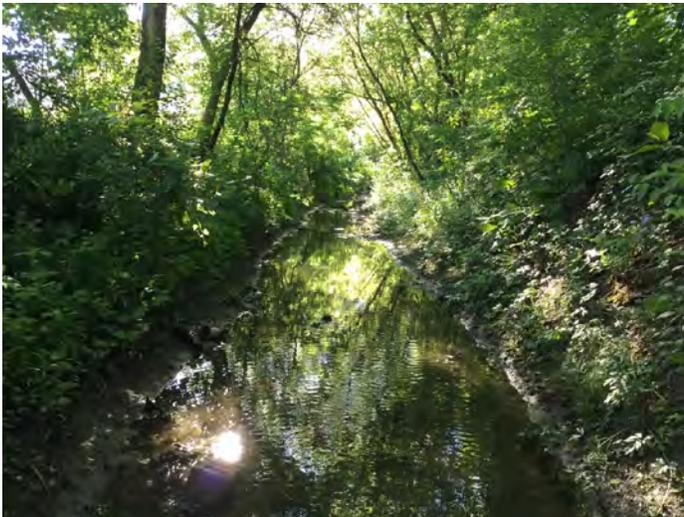
Inspection Report for Observation:
BankErosion86

Bank erosion both sides next 180 ft.

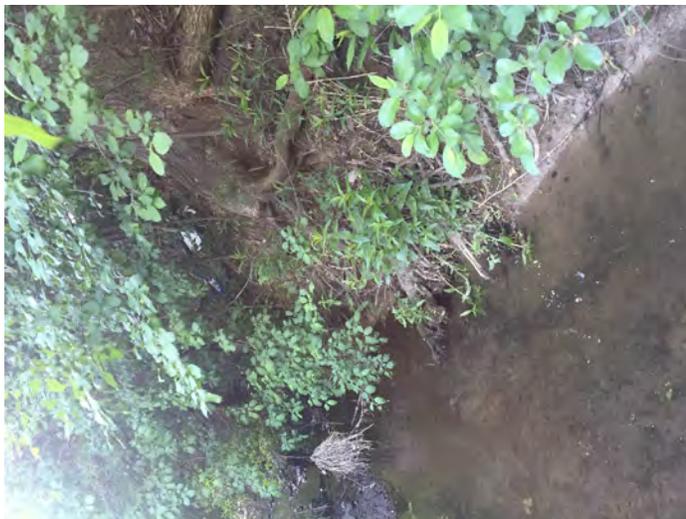
Inspection Report for Observation:
BankErosion87

Bank erosion right side of the drain from this location approx 150' upstream to end. Picture facing upstream.

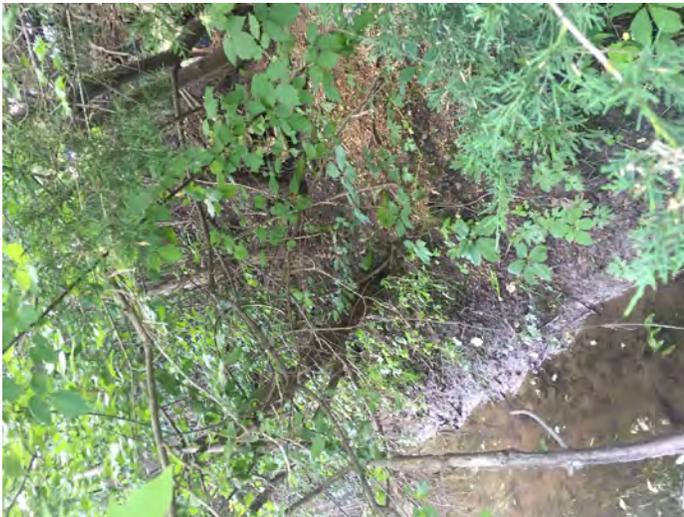
Inspection Report for Observation:
BankErosion88

Bank erosion right side of the drain from this location approx 200' upstream to end.

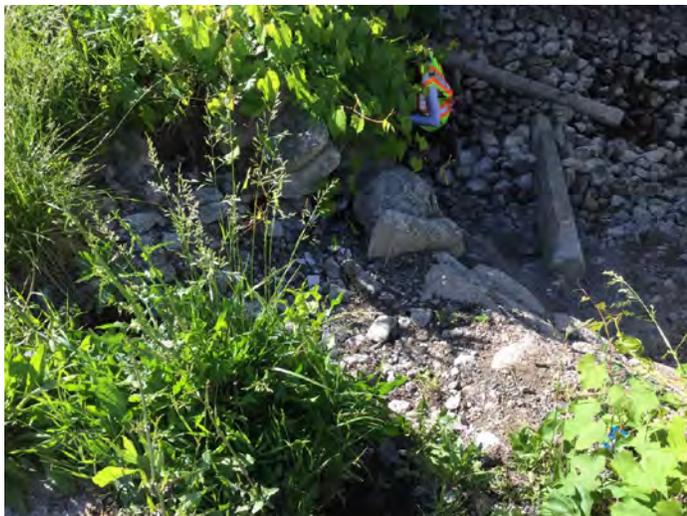
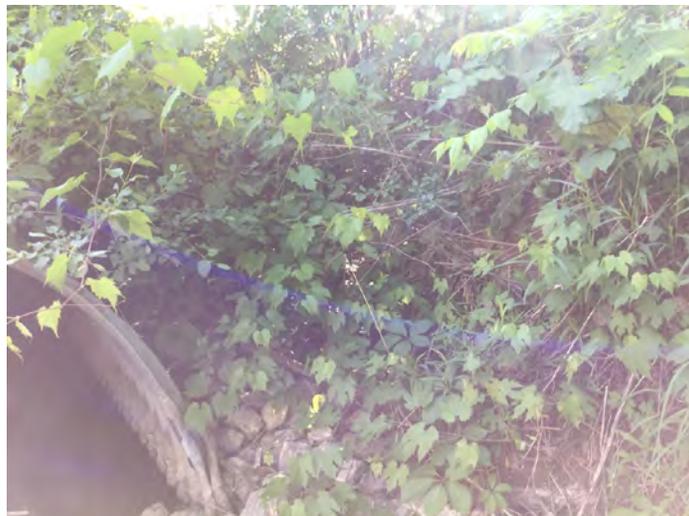
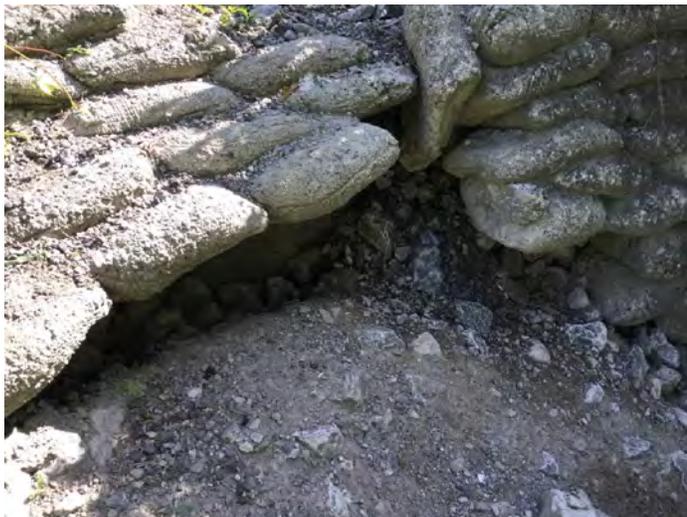
Inspection Report for Observation:
BankErosion89

Significant erosion on downstream side of Kansas St. crossing. Both sides of head wall.
