King Street Tile Drain Inspections

Inspection Report for Observation:
BankErosion1

| CLIENT | Saginaw County Public Works Commissioner | HUBBELL, ROTH & CLARK, INC CONSULTING ENGINEERS SINCE 1915 | 555 Hulet Drive P.O. Box 824 Bloomfield Hills, MI 48303-0824 (248) 454-6300 http://www.hrc-engr.com | DATE: | 08/16/2016 |

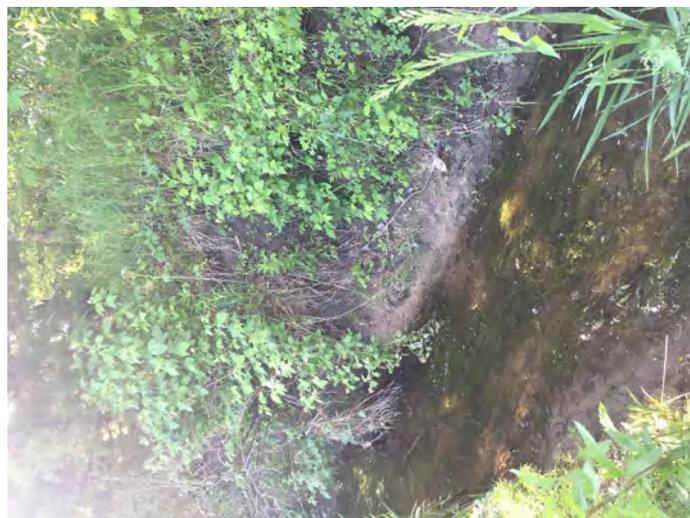
Inspection Report for Observation:
BankErosion90

Bank erosion right side of the drain from this location approx 50' upstream to end. Picture facing upstream.

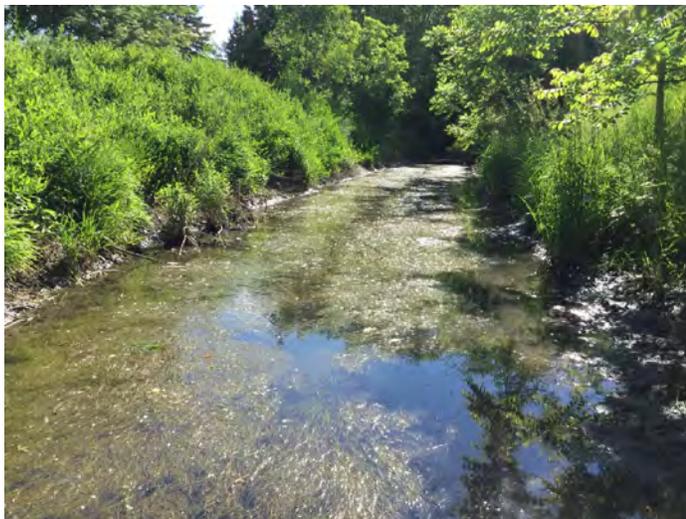
Inspection Report for Observation:
BankErosion91

Bank erosion on left side around bend and upstream for 150 ft.

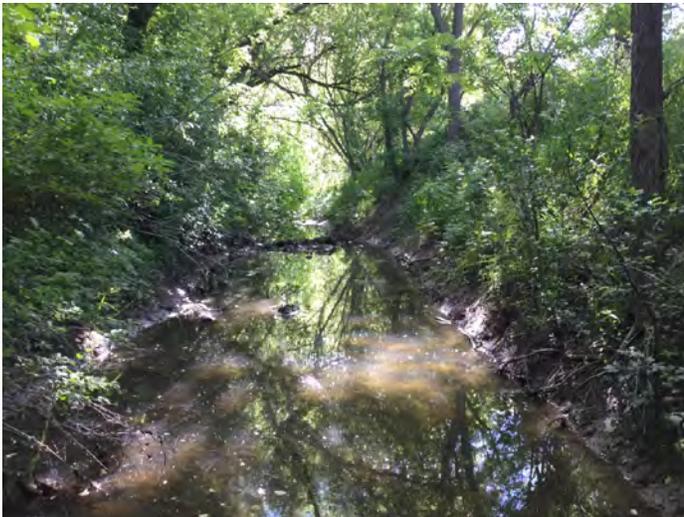
Inspection Report for Observation:
BankErosion92

Bank erosion on both sides next 100 ft.

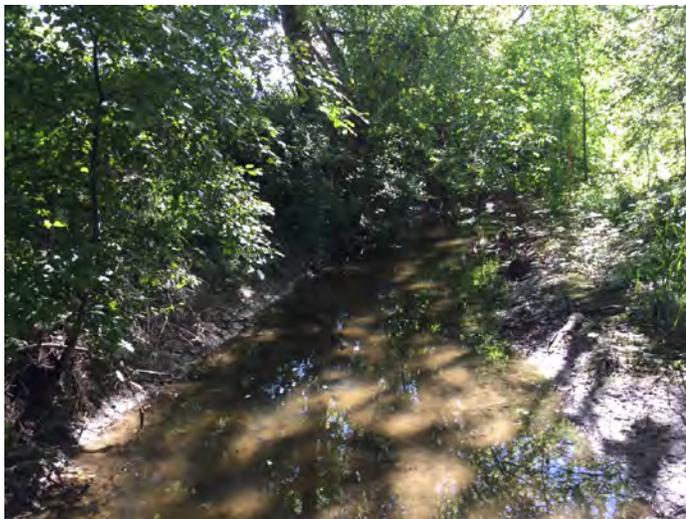
Inspection Report for Observation:
BankErosion93

Bank erosion for 120 ft around bend on both sides up to crossing.

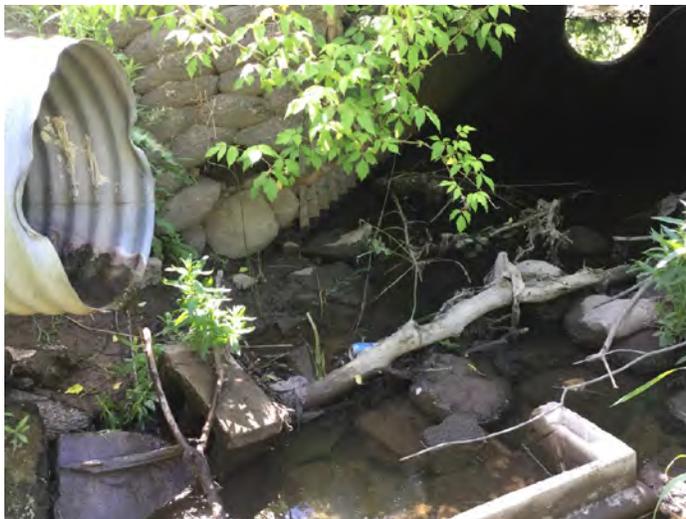
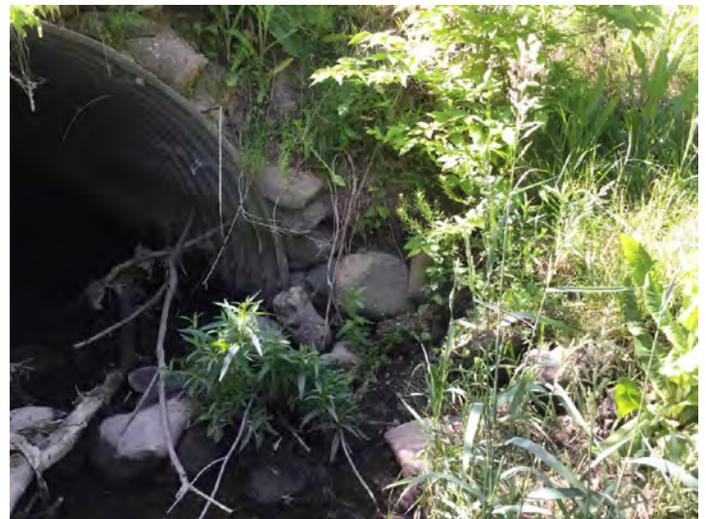
Inspection Report for Observation:
BankErosion94

Erosion on downstream head wall.

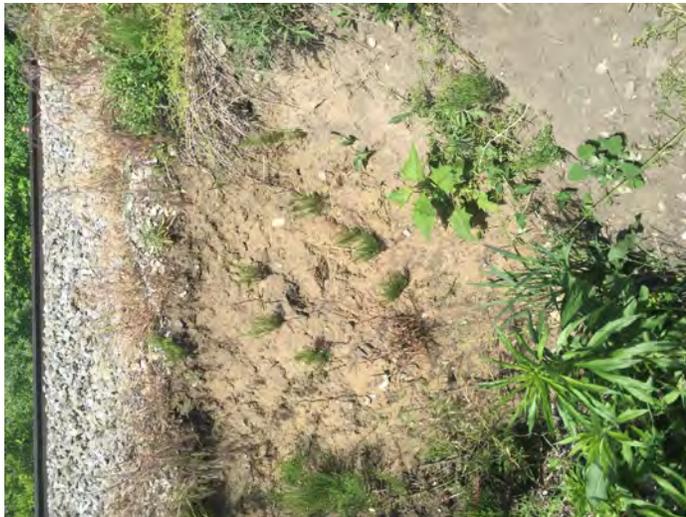
Inspection Report for Observation:
BankErosion95

Bank erosion on East side of railroad tracks possibly due to broken pipe in culvert crossing. Picture facing west

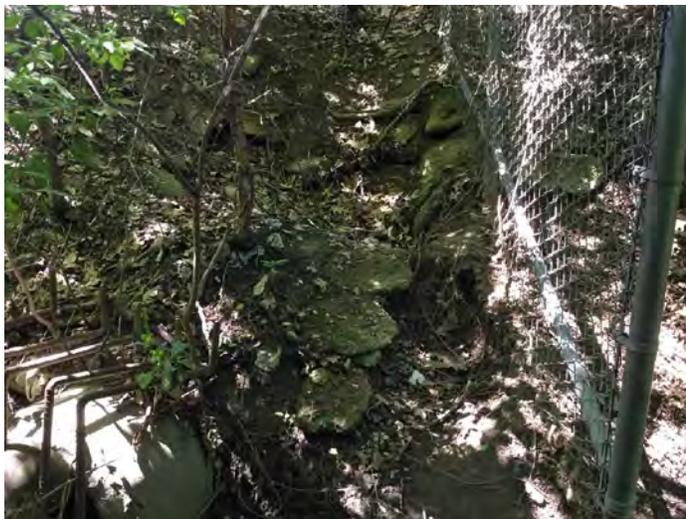
Erosion at head wall for 24" concrete sop. Right side up bank. In between fence and sop outlet.

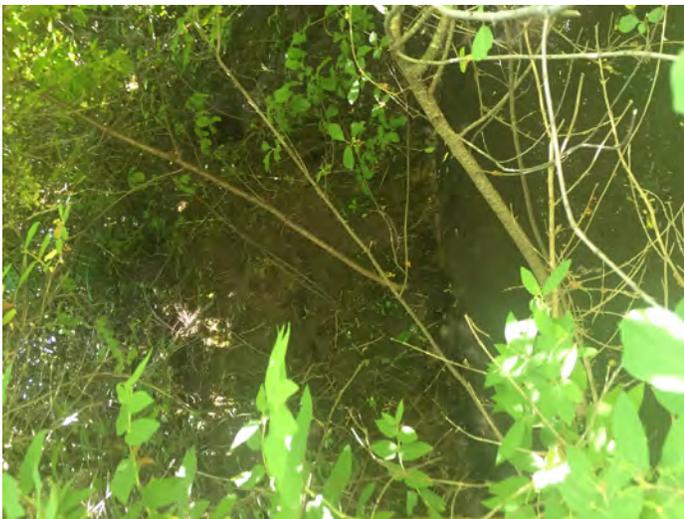
Bank erosion right side from this this location approx 100' upstream to end. Picture facing upstream.

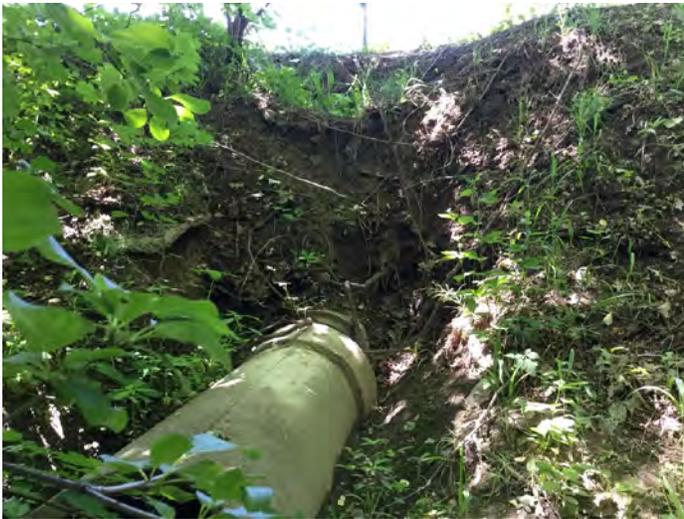
Bank erosion on right side at 24" sop outlet. Around broken segment.

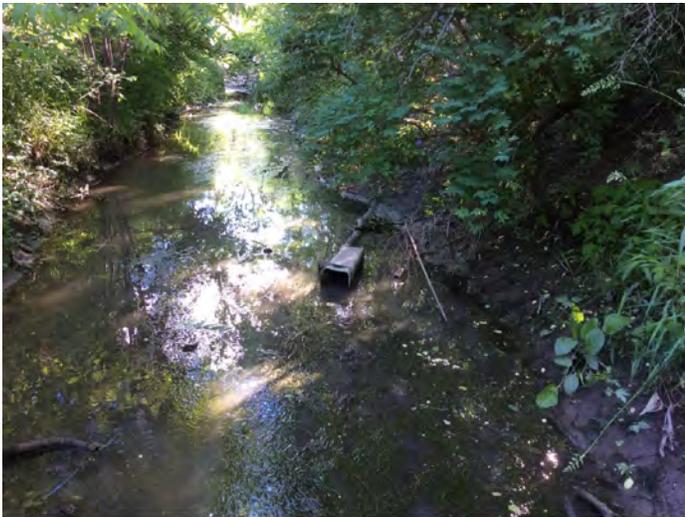
Comments:
Erosion on right side of drain for about 10 ft.

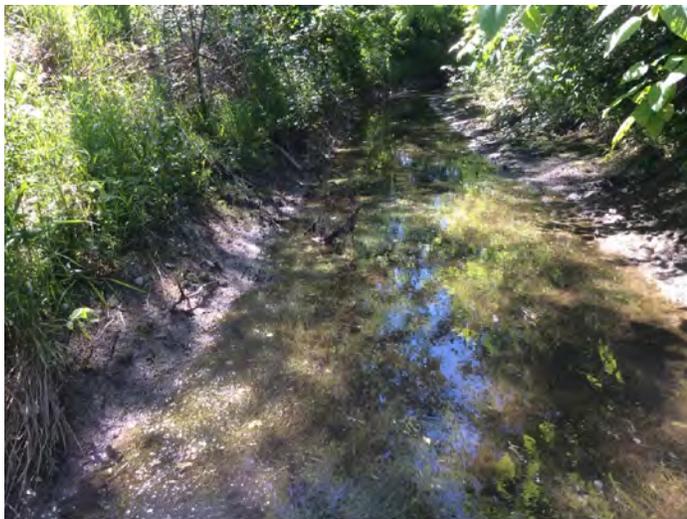
Erosion on both sides of drain for about 1100 ft.

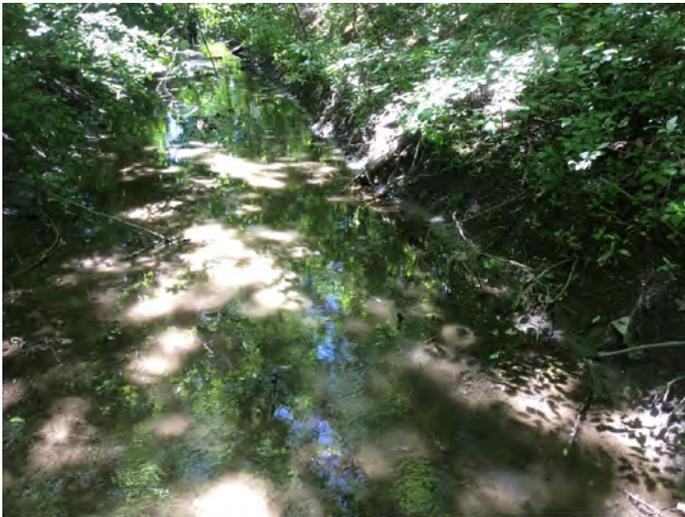
Erosion on both sides of drain for about 100 ft.

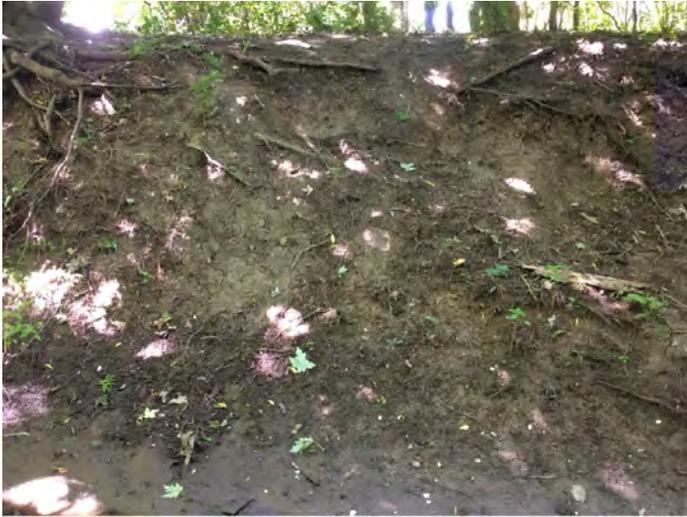
Extremely bad erosion on right side of drain and slightly less bad on left side for about 100 ft.

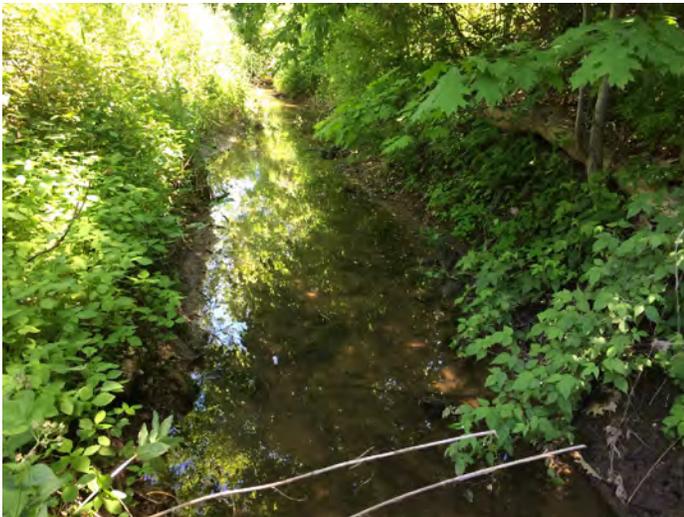
Bank erosion both sides next 650 ft.

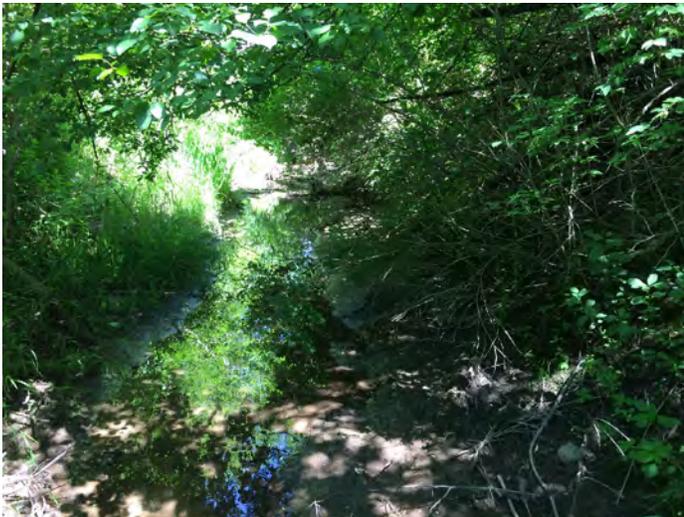
Photo 2

Location: Both Sides Facing Upstream

Length (feet): 500

Photo 1 Direction: Facing Upstream

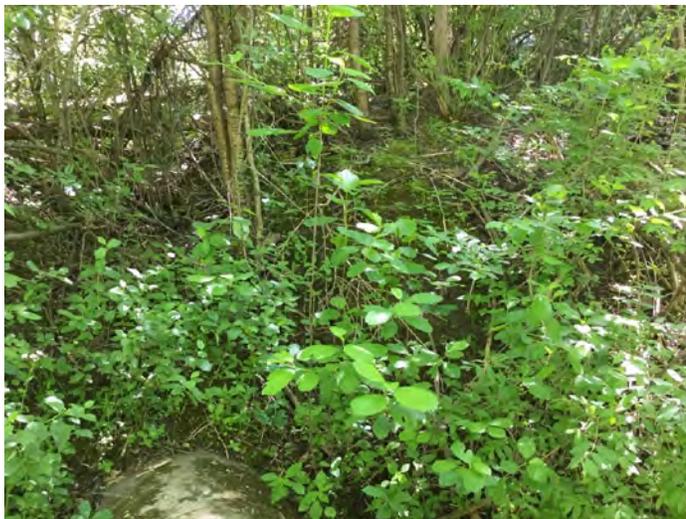
Photo 2

Erosion on right side of drain for about 50 ft. Above surface outlet pipe.

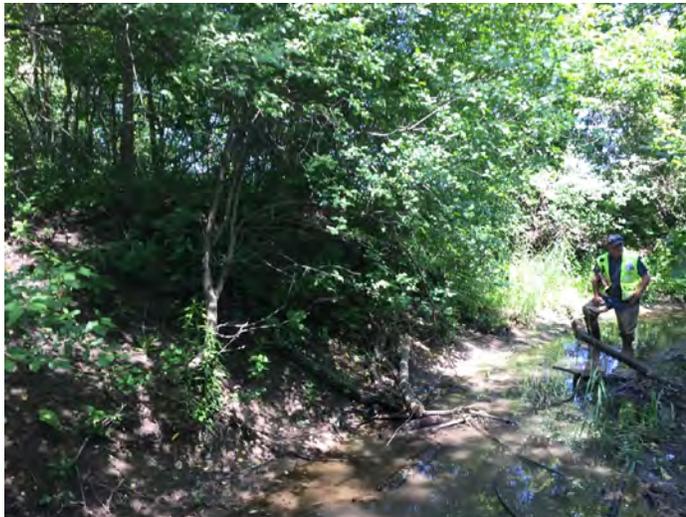
Photo 2

Bank erosion along left bank around bend for next 150'. Bank is approximately 10-12' high. Picture facing upstream.

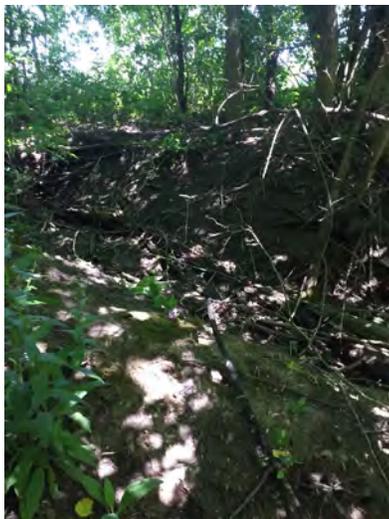
Photo 2

Bank erosion from field tile at corner. Picture facing north.

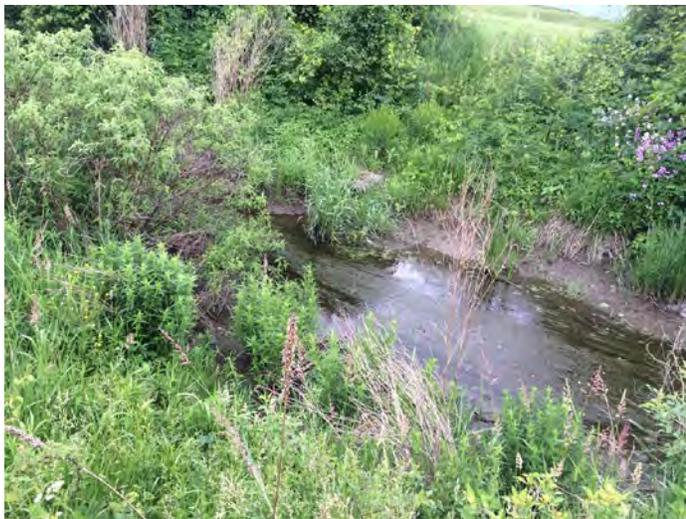
Photo 2

Drain widens behind debris to about 12' for approximately 10-15'. Possible erosion.

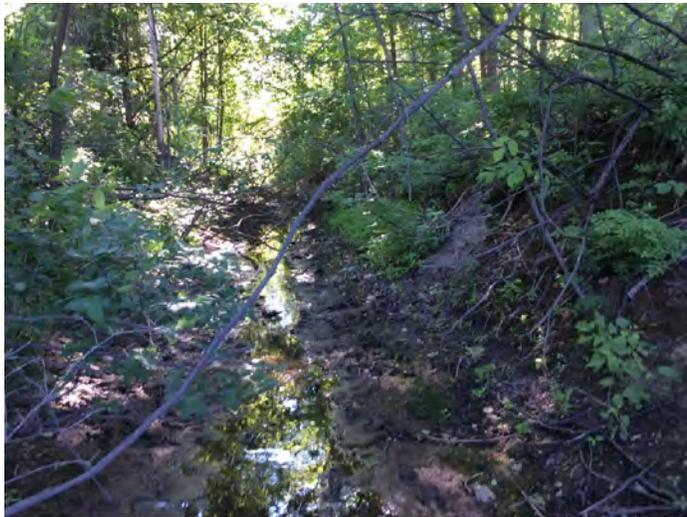
Photo 2

Bank erosion on both sides next 500 ft.

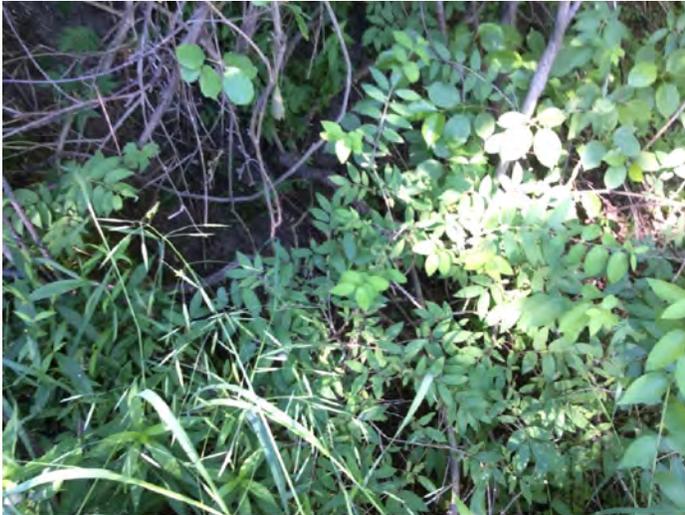
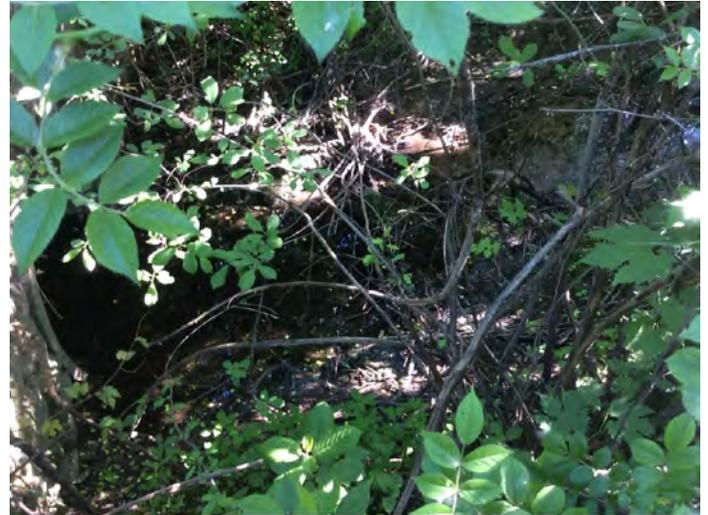
Bank erosion on both banks on both upstream and downstream sides of farm crossing.

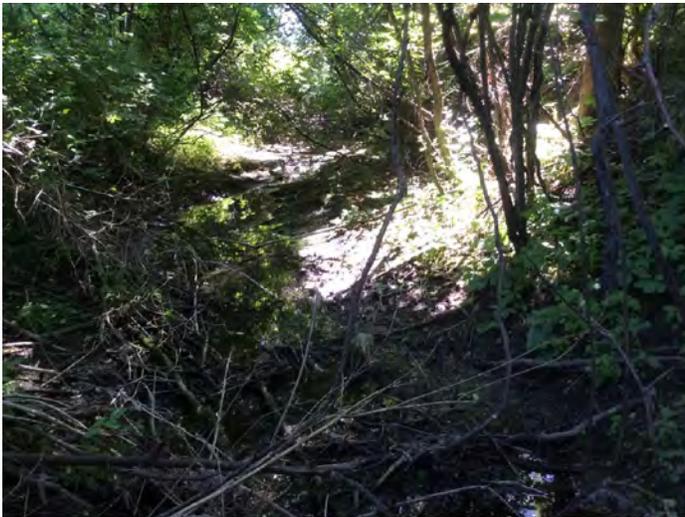
Photo 2

Bank erosion on both sides next 500 ft.

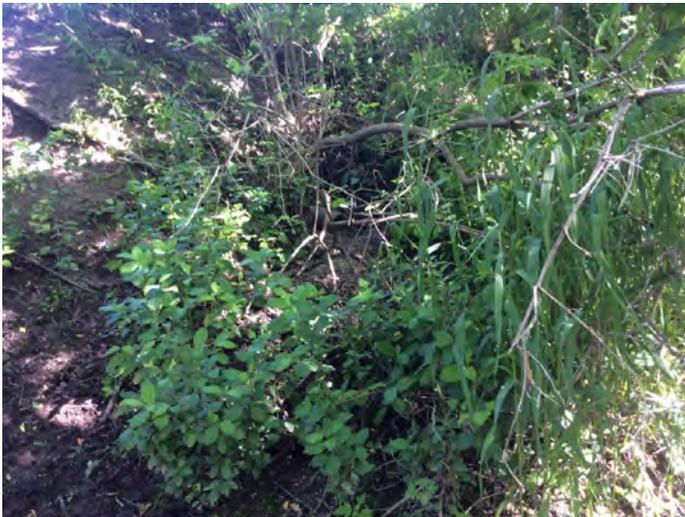
Photo 2

Erosion at field tile outlet, 10 ft inland.

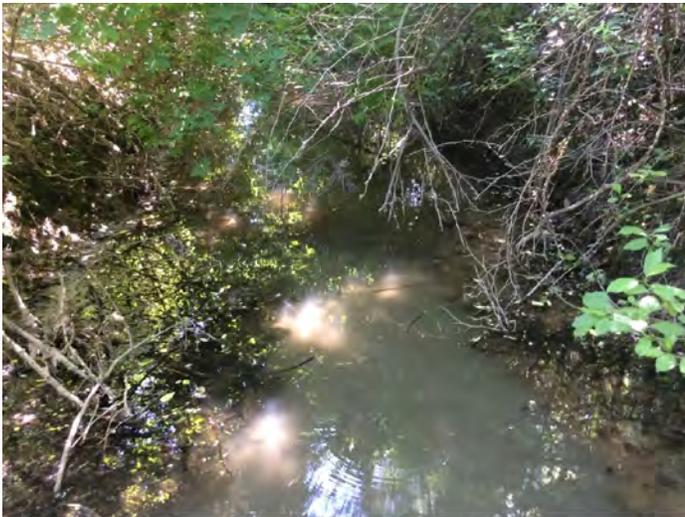
Photo 2

Bank erosion on both sides next 500 ft.

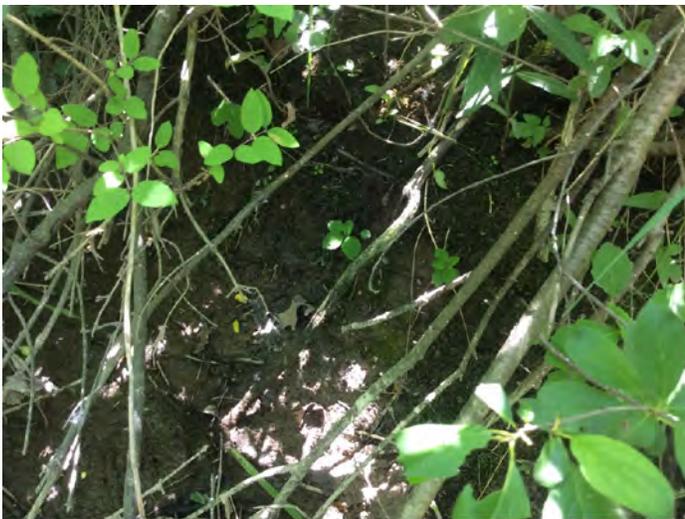
Photo 2

Bank erosion both sides next 250 ft around the bend.

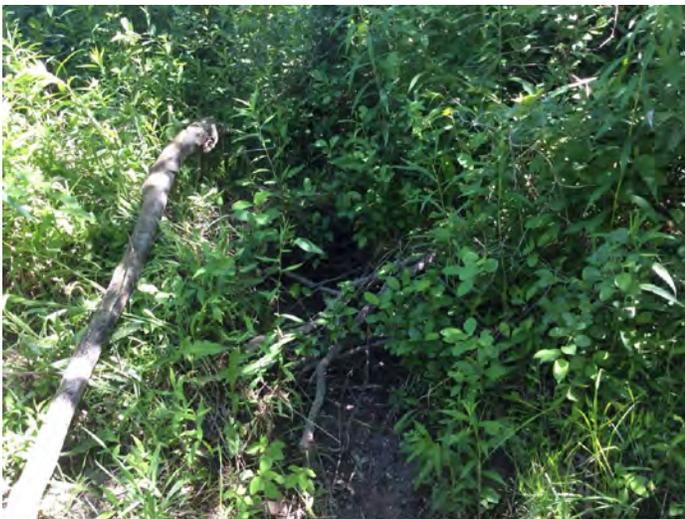
Photo 2

Comments:
Stretches inland 10 ft.

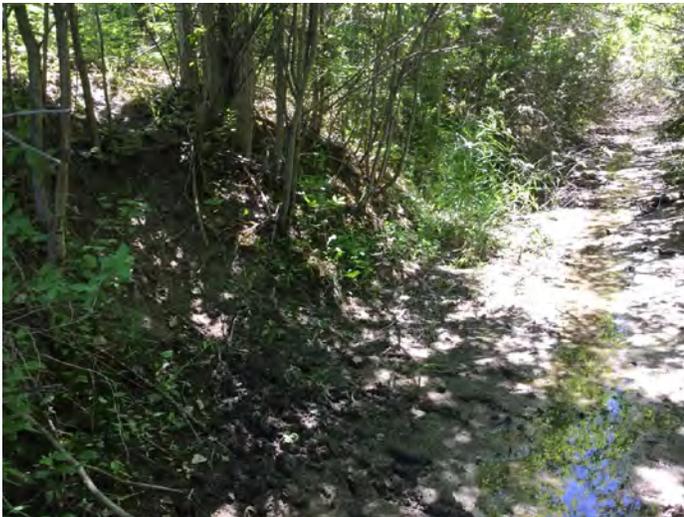
Photo 2

Bank erosion on both sides of drain for about 700 ft.

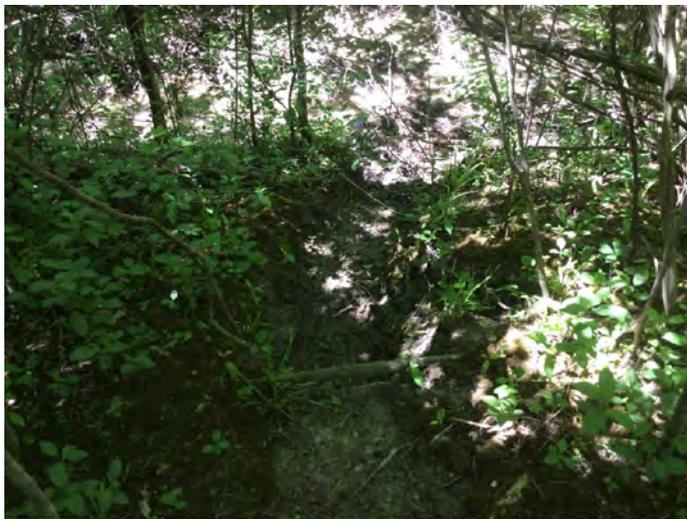
Photo 2

Deer run with excessive erosion on left side of drain.

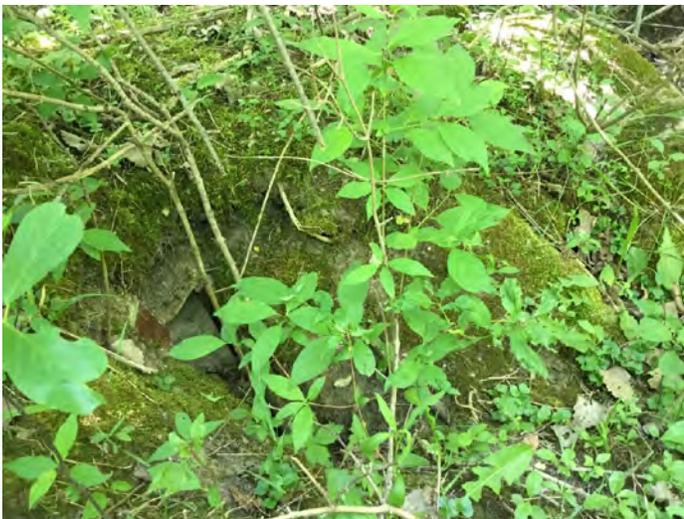
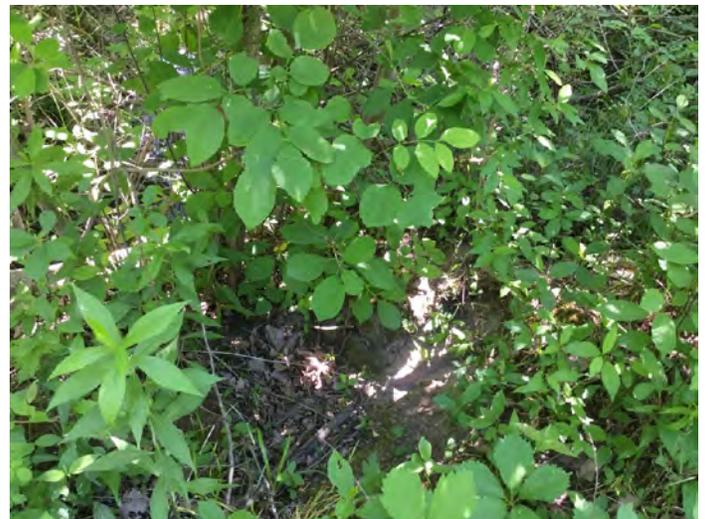
Picture 1= Erosion hole on downstream end of structure on farm crossing. On left side facing upstream. Picture 2= erosion on farm structure crossing at upstream end on left side facing upstream.

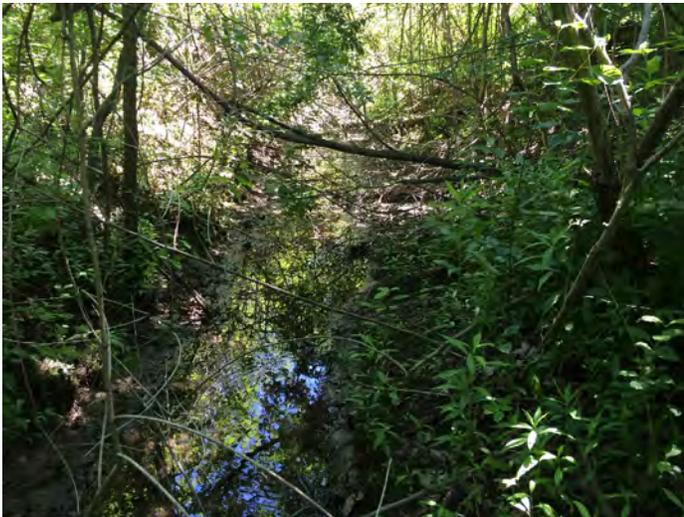
Photo 2

Bank erosion both sides next 500 ft.

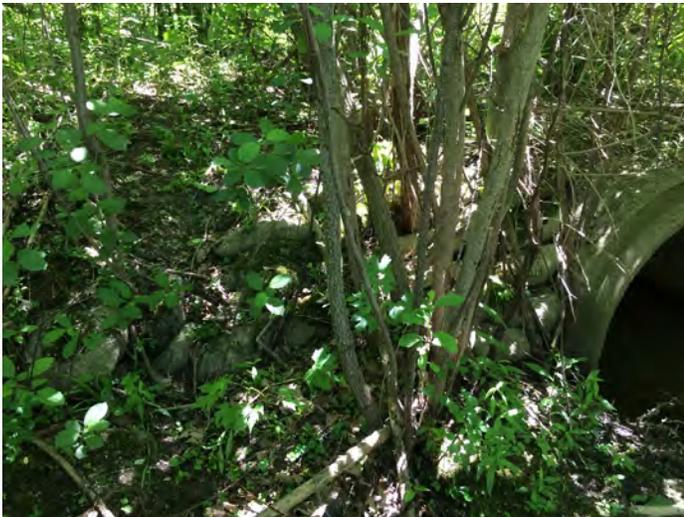
Photo 1

Bank erosion on both headwalls.

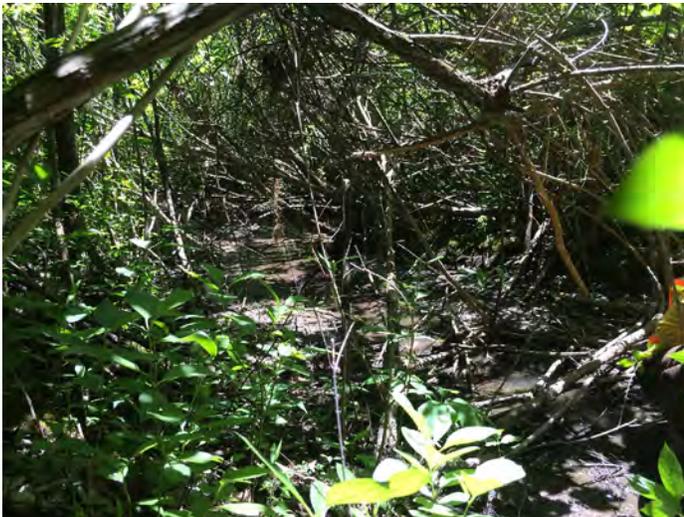
Photo 1

Bank erosion both sides next 400 ft to bend.
