# King Street Tile Drain Inspections

CLIENT	Saginaw County Public Works Commissioner

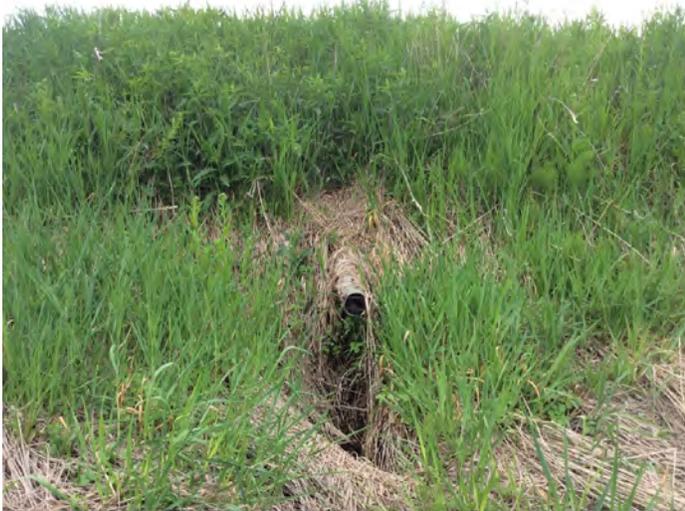
**Photo 1**

3" diam metal field tile outlet enters drain on right. Pipe is rusted. Photo facing south.

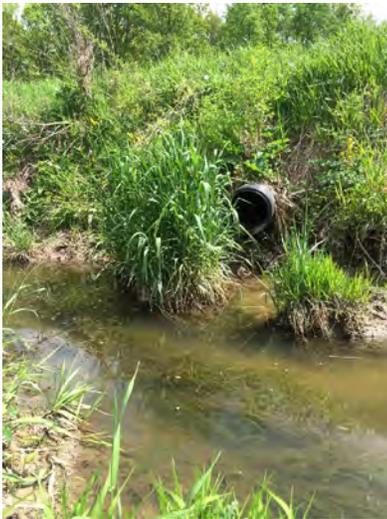
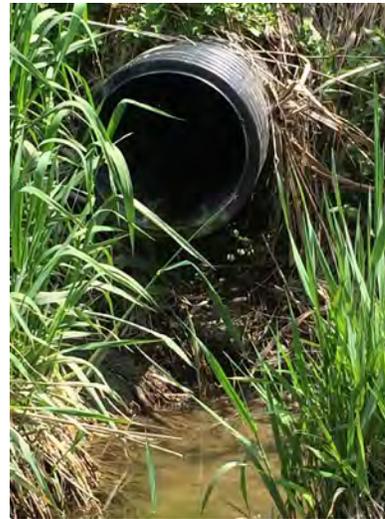
HDPE field tile on right side of drain. Good condition. Photos taken facing south.

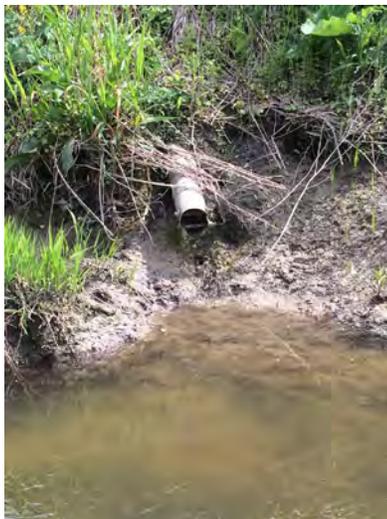
Metal field tile. Decent condition. Little rusty. About 10" diameter. Photo taken facing south.

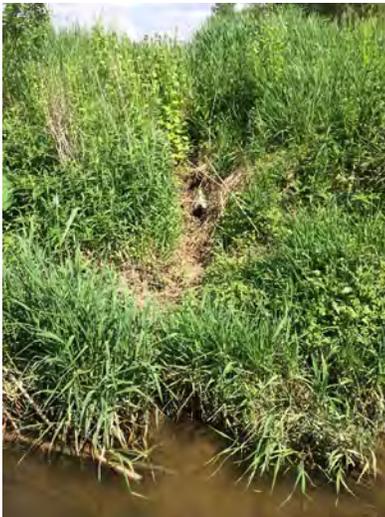
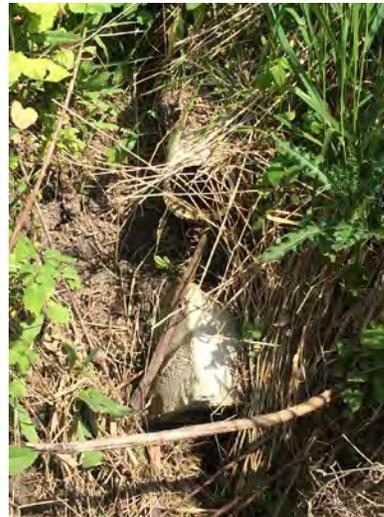
PVC pipe on right side of drain. Good condition, but flow path to drain is not great. Broken concrete below. Photos taken facing south.

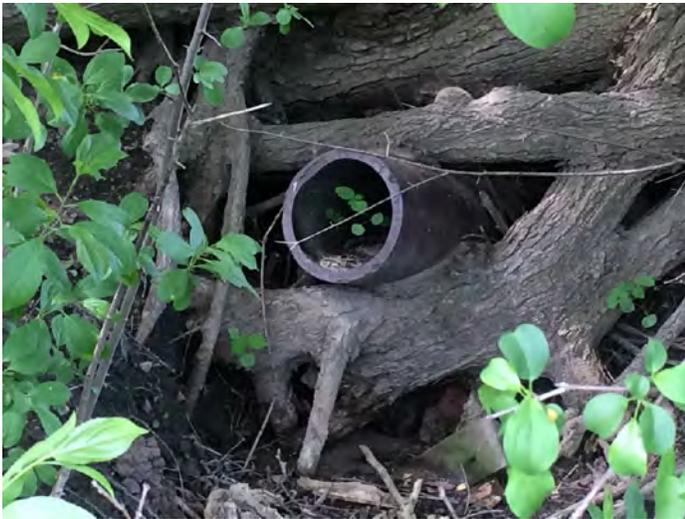
Clay 6" field tile on left side facing upstream. Poking thru tree roots.  
Photo taken facing north. Might just be debris, but has erosion around it.

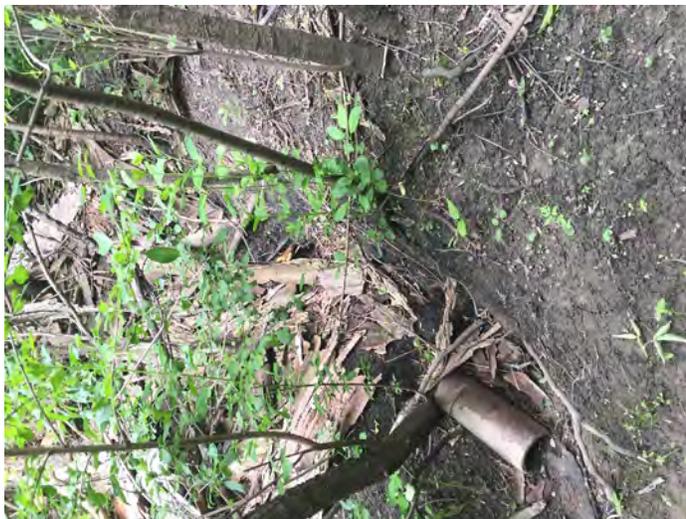
4" clay field tile right side of the drain . Picture facing East

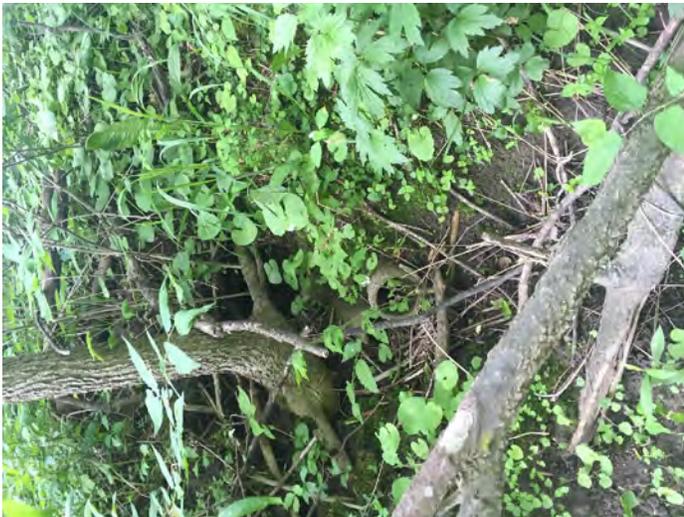
4 " conc field tile left side of the drain. Picture facing upstream.

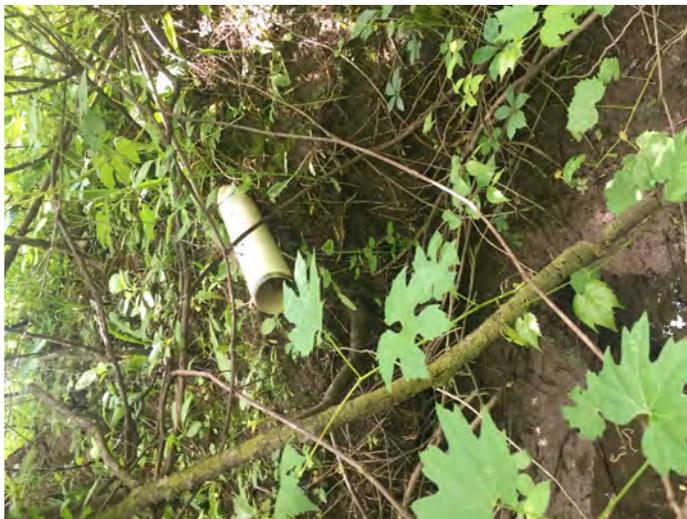
4" pvc field tile left side of the drain. Picture facing east.

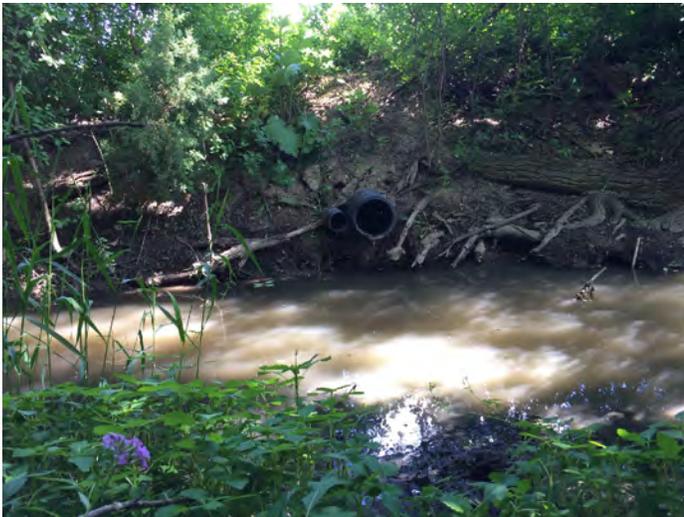
**Photo 1**

4" hdpe field tile outlet enters drain on right. Next to 12" sop.

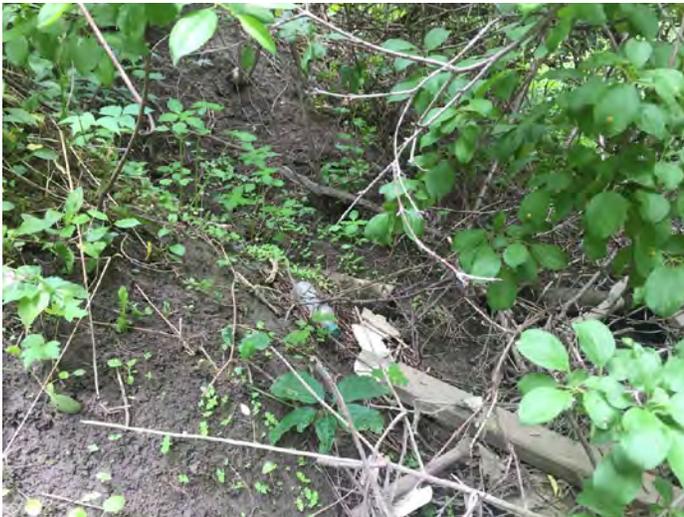
**Photo 1**

**Comments:**  
Erosion at the mouth of the pipe. Pipe possibly made of steel.

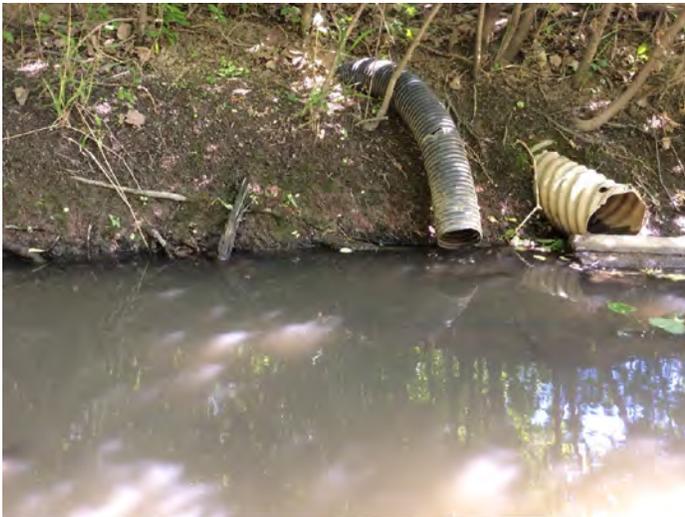
**Photo 1**

Fair HDPE field tile on right side of drain. Hole on top. About 6" diameter. Not sure if field or surface because of soccer field.

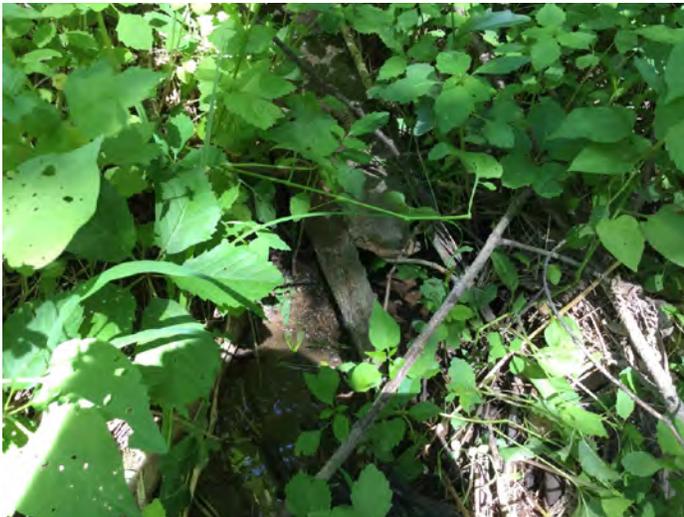
**Photo 1**

Failed field tile on left side of drain. 6" diameter. Broken apart at end.  
Drains into log jam.

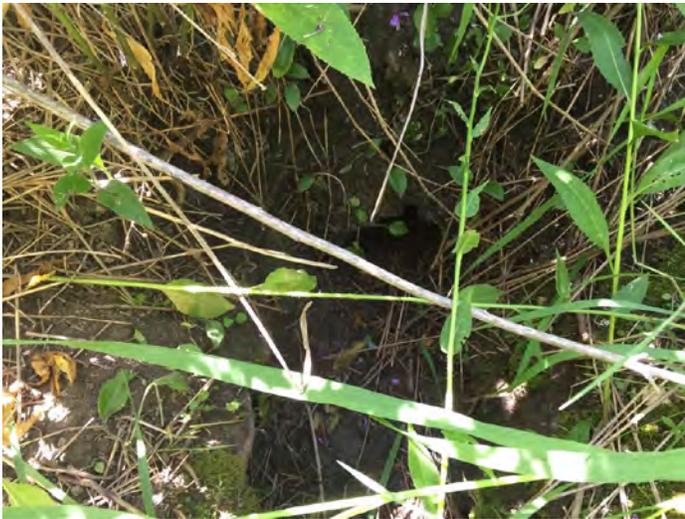
**Photo 1**

Picture facing south from the drain. The field tile is in a hole and doesn't outflow properly.

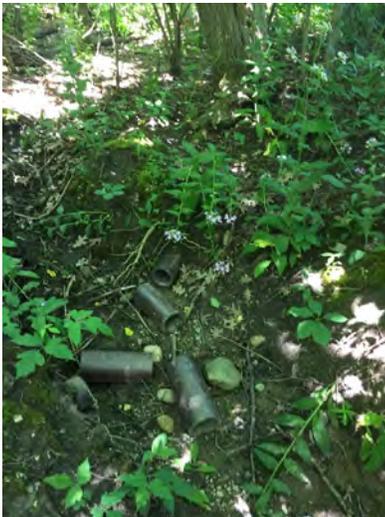
**Photo 1**

**Comments:**  
4" clay field tile left side of drain. Picture facing North west

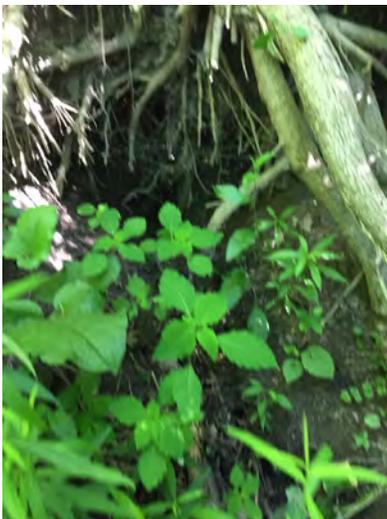
**Photo 1**

4" clay field tile left side of the drain under tree. Picture facing north.

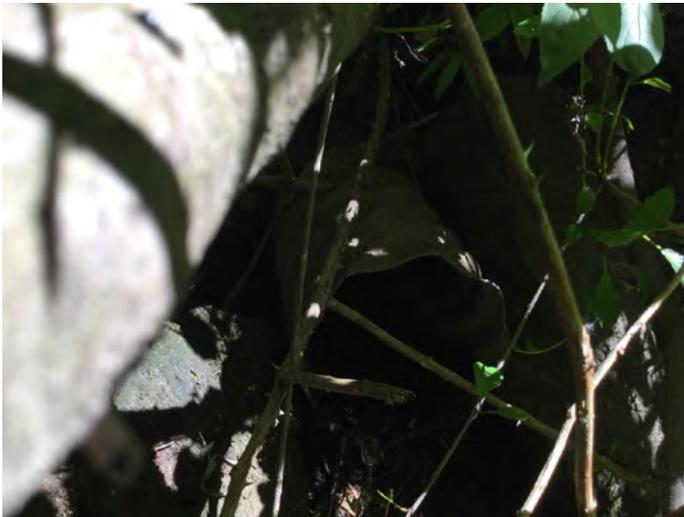
**Photo 1**

Field tile on left side of drain. Hidden under excessive overhanging vegetation. 4 in. in fair shape, little rusty. Hard to get picture. Can see an attempt at a splash pad, but is not in use right now.

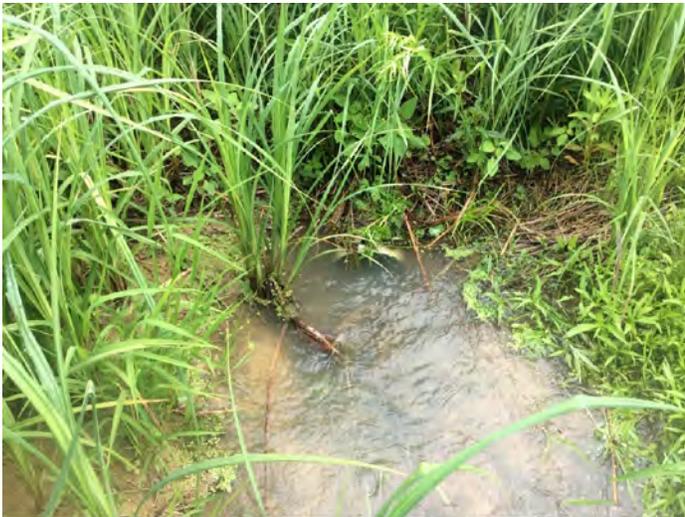
**Photo 1**

8" field tile left side under water. Picture facing Northeast

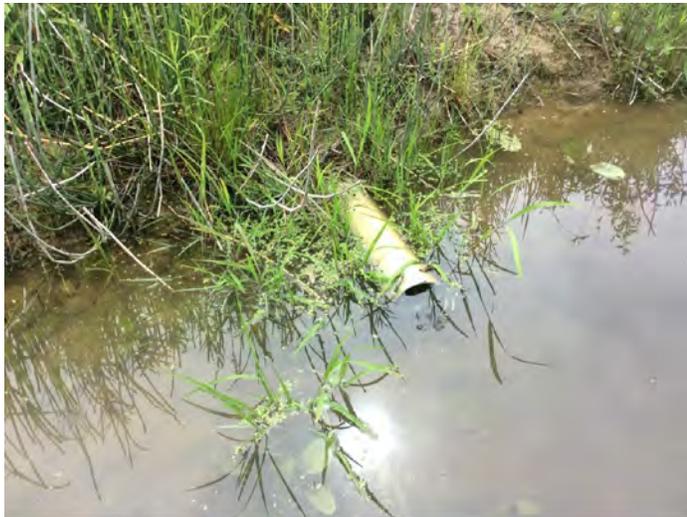
**Photo 1**

4" field tile left side full of water. Picture facing East
