King Street Tile Drain Inspections

Inspection Report for Observation:
GeneralConditionPhoto1

CLIENT	Saginaw County Public Works Commissioner

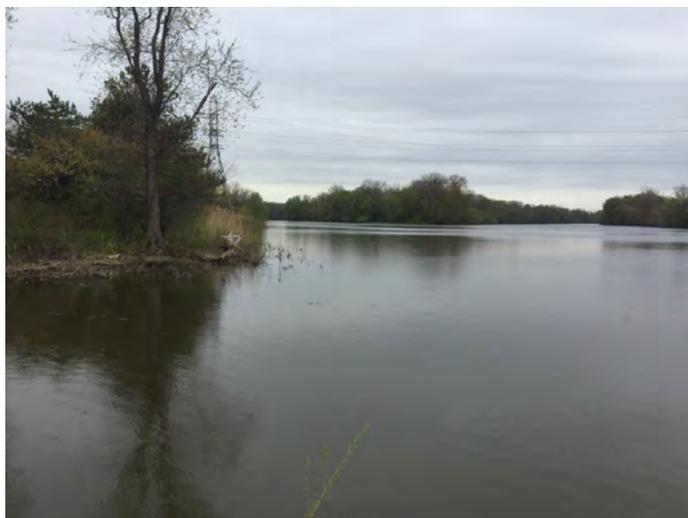
Photo 1 facing downstream. Photo 2 facing upstream.

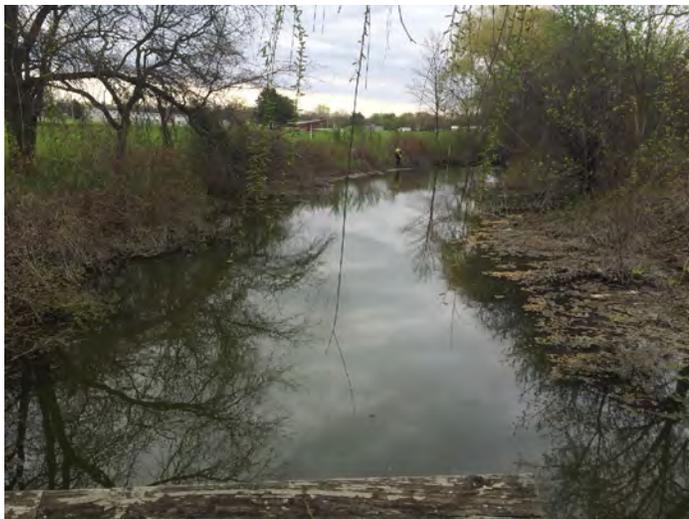
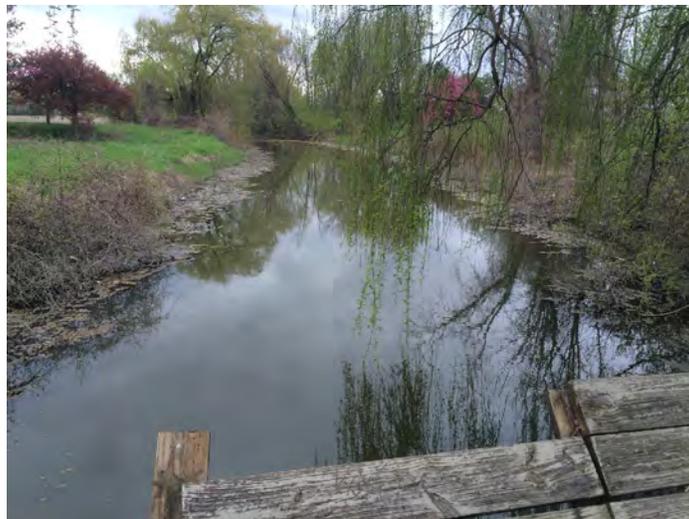
General condition photo from bridge. Photo 1 upstream. Photo 2 downstream.

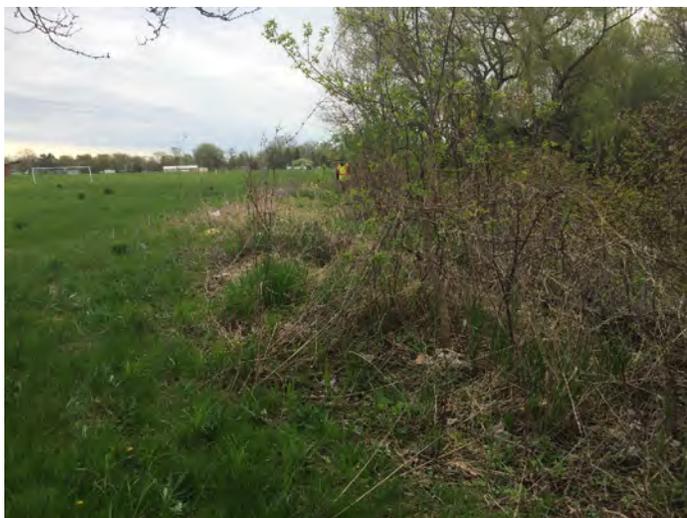
Lots of trash on left side of drain at top of bank.

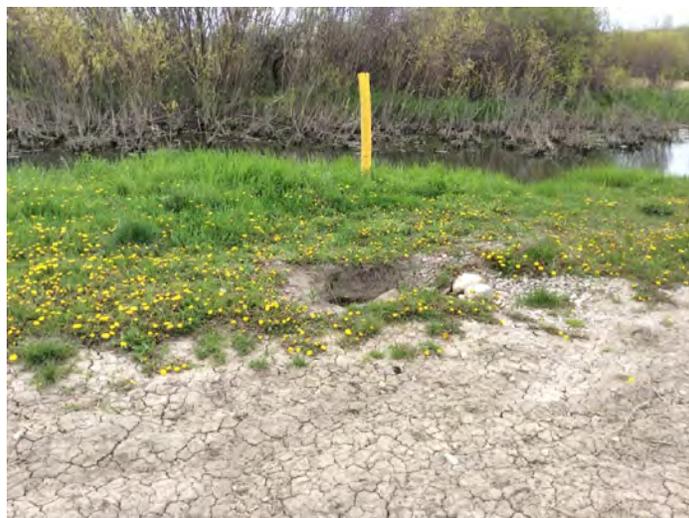
Possible tile marker, sinkhole between marker and position

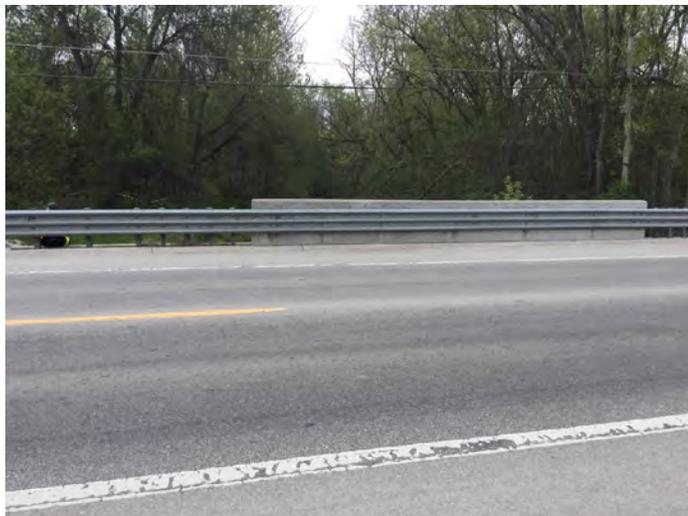
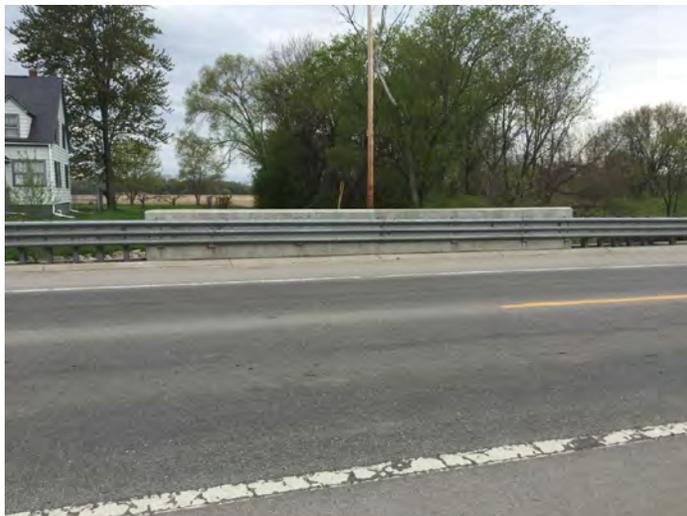
On M13. Photo 1 taken facing east. Photo 2 taken facing west.

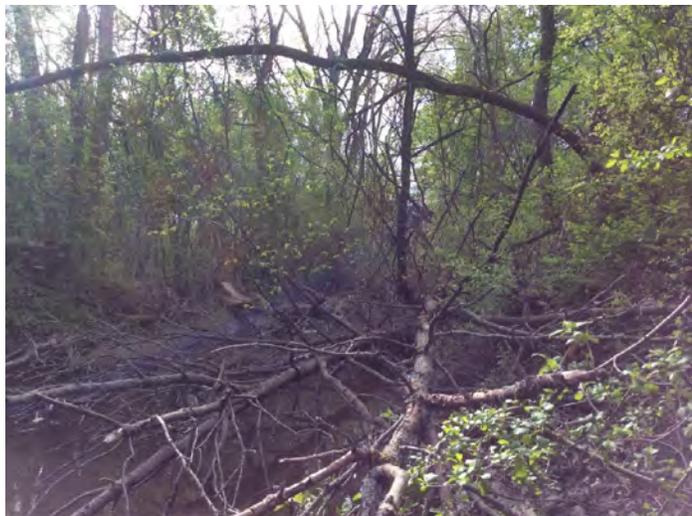
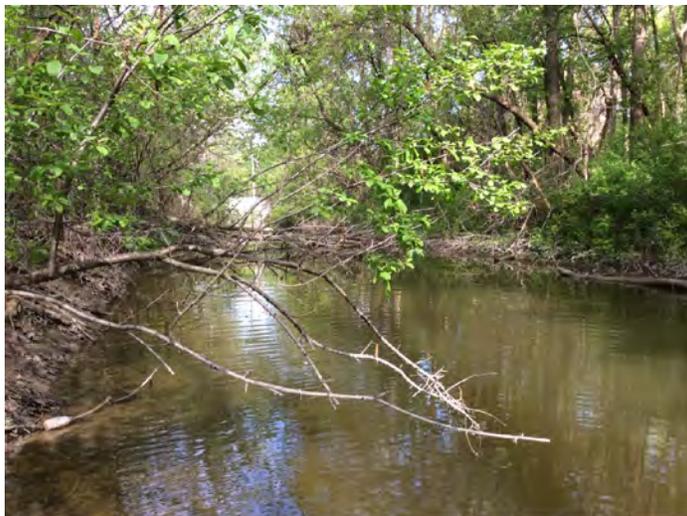
Photo1 facing upstream. Photo2 facing downstream. Width of channel increases downstream of side drain. Approx 15 ft to approx 30 ft.

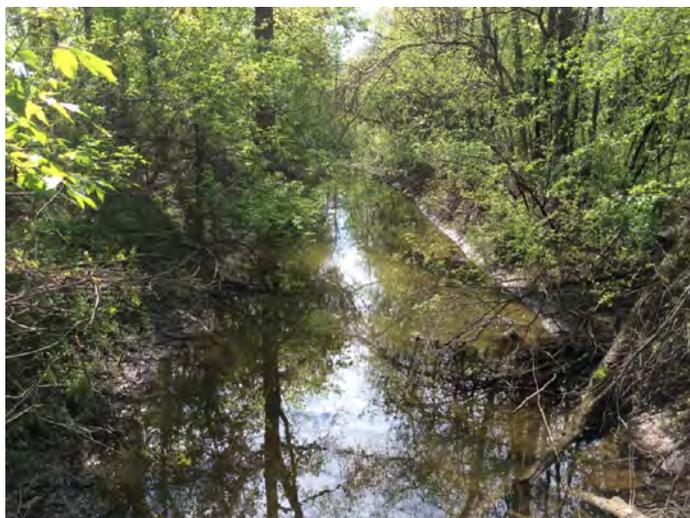
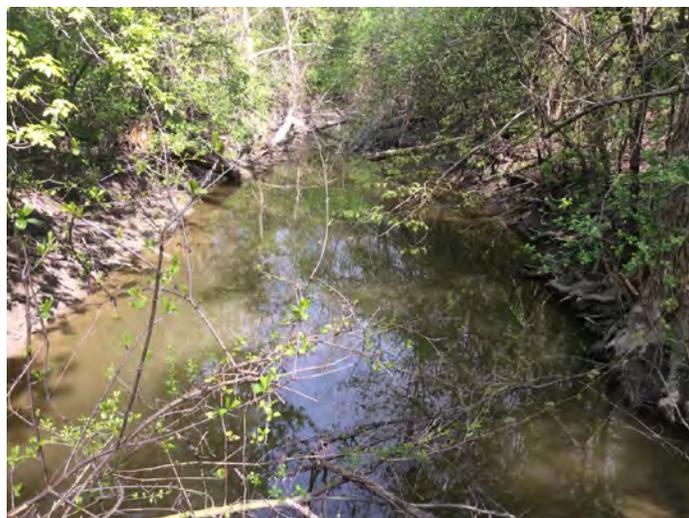
Photo 1 upstream. Photo 2 downstream. Taken on crossing.

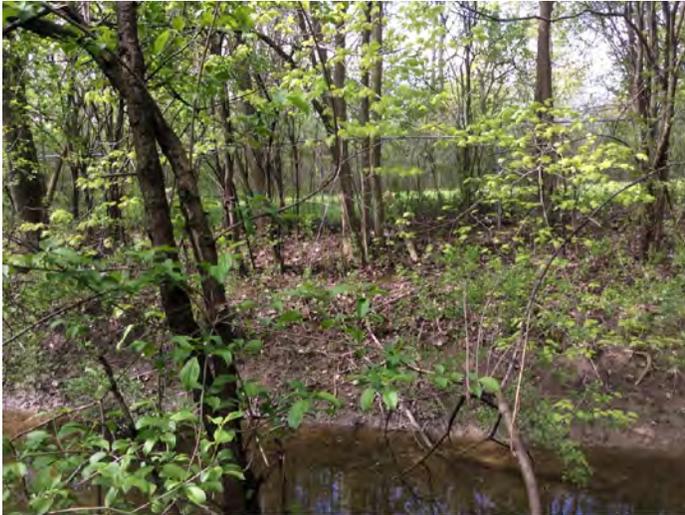
Fence at top of bank runs along the drain on right side for 80 ft. Photo1 facing southwest. Photo 2 facing southeast. Two fences.

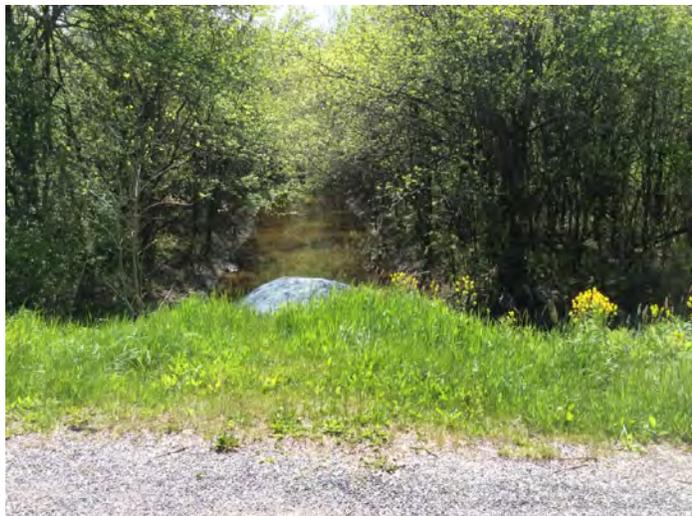
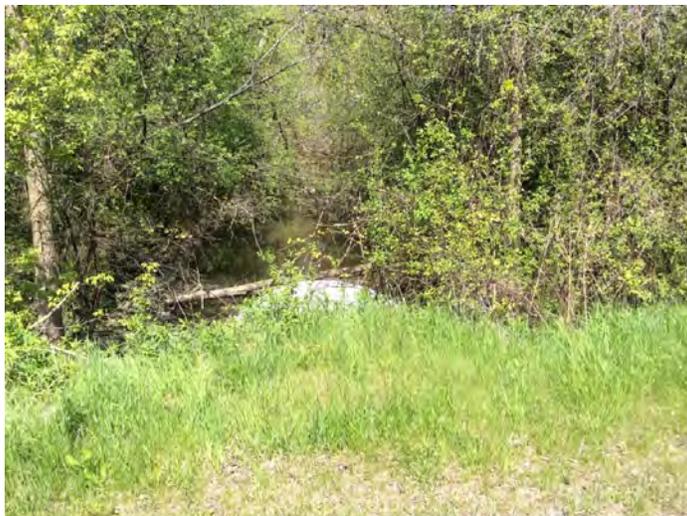
Photo1 upstream. Photo2 downstream. Taken at banner rd culvert crossing.

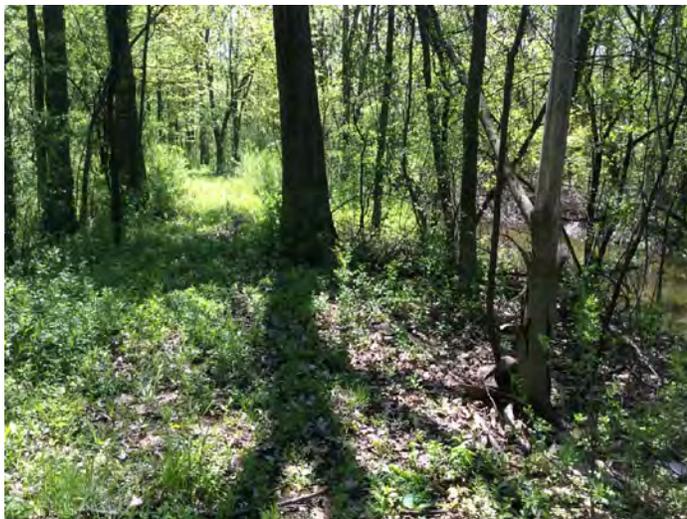
Photo1 upstream. Photo2 downstream. Access path continues on left side of drain. On north side of drain. Next 300 ft.

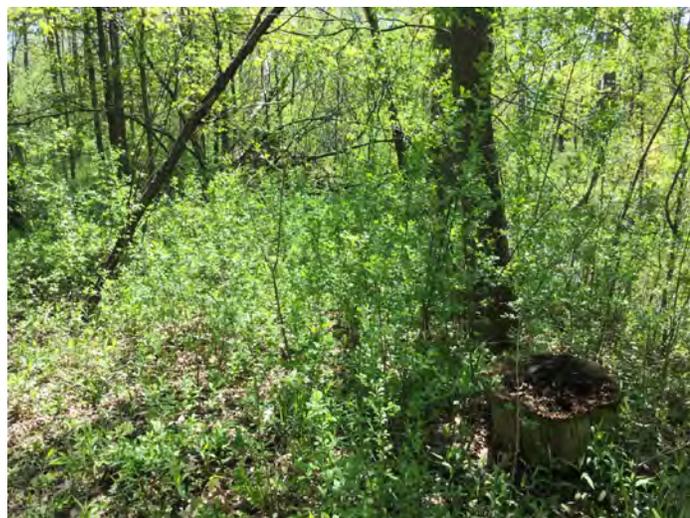
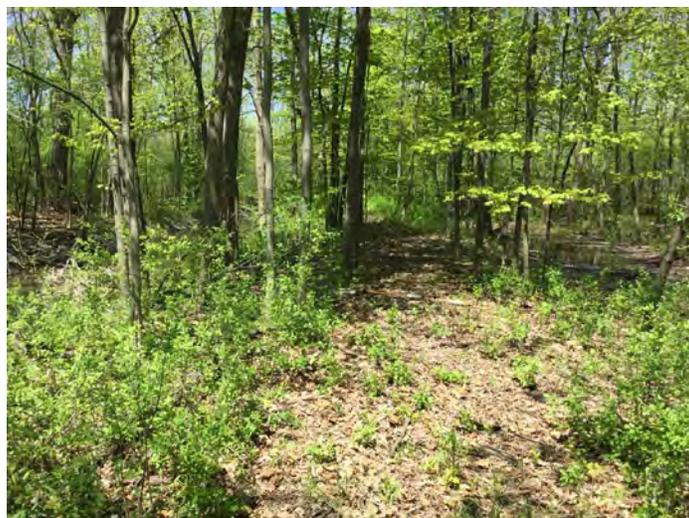
End of clearly defined access path next to drain. Photo1 upstream.
Photo2 downstream.

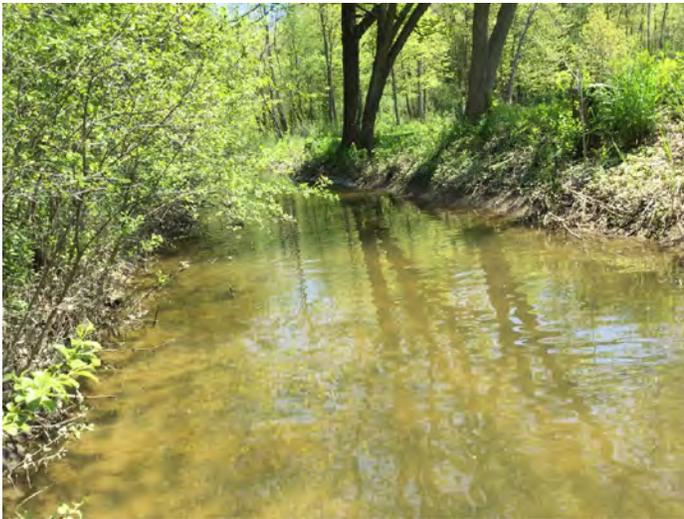
Would you consider this bank erosion ?

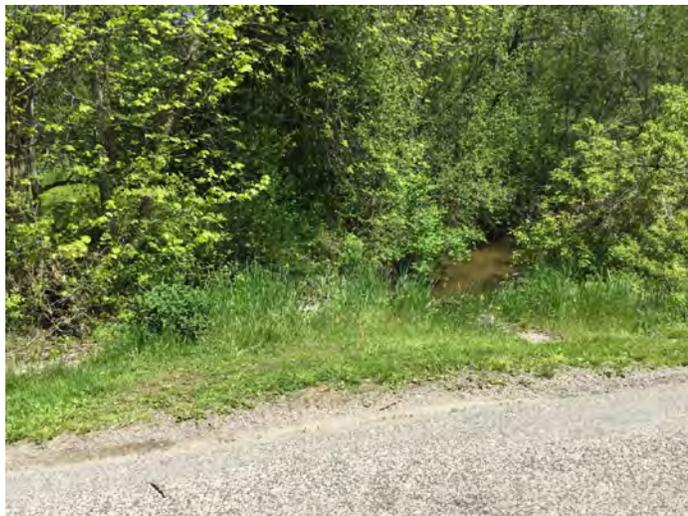
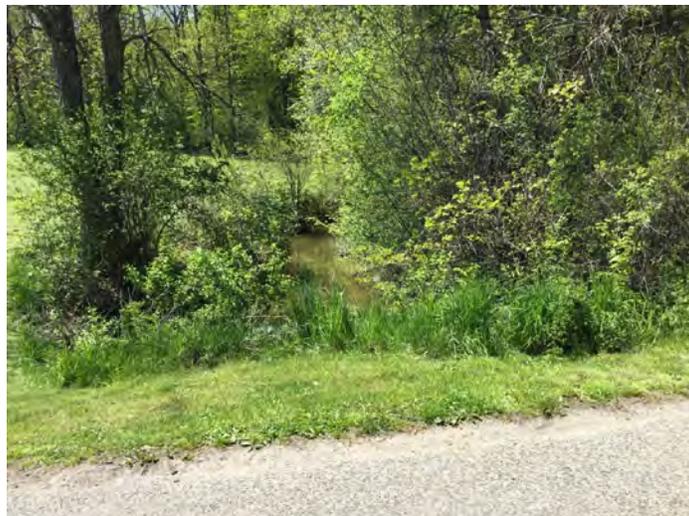
Photo1 upstream. Photo2 downstream. Crossing at Casey dr.

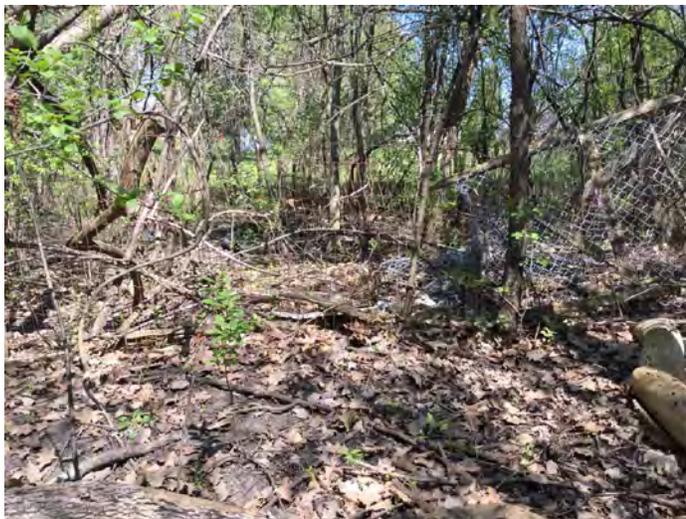
Fence at top of bank, about 20 ft east of drain. Approx 80 ft long. Photo facing east.

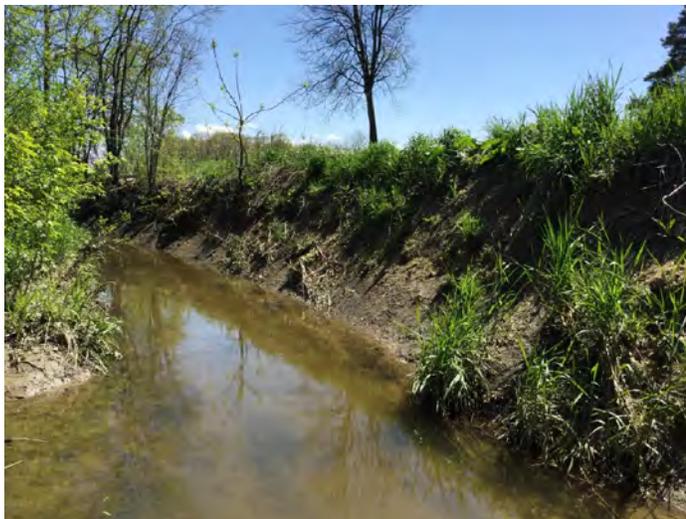
Inspection Report for Observation:
GeneralConditionPhoto20

Significant change in channel width. 6 ft upstream. 12 ft downstream.
 Photo1 upstream. Photo2 downstream.

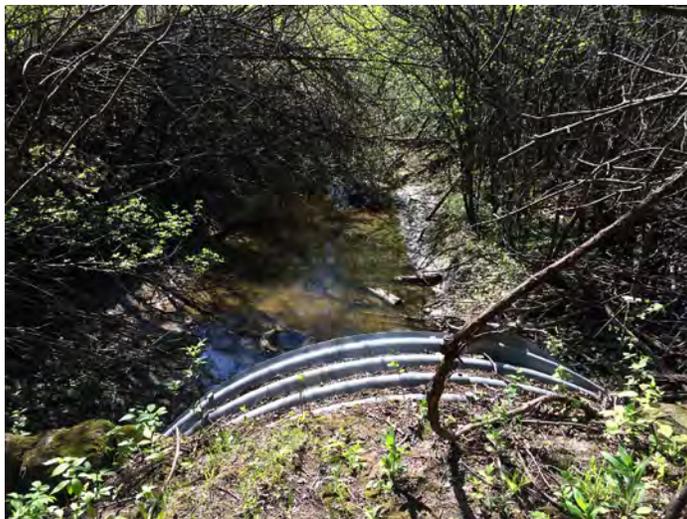
Inspection Report for Observation:
GeneralConditionPhoto21

Photo1 upstream. Photo2 downstream. From culvert crossing.

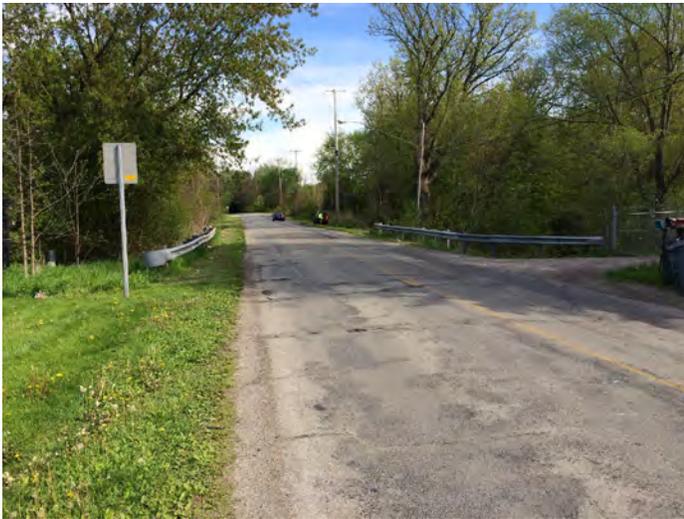
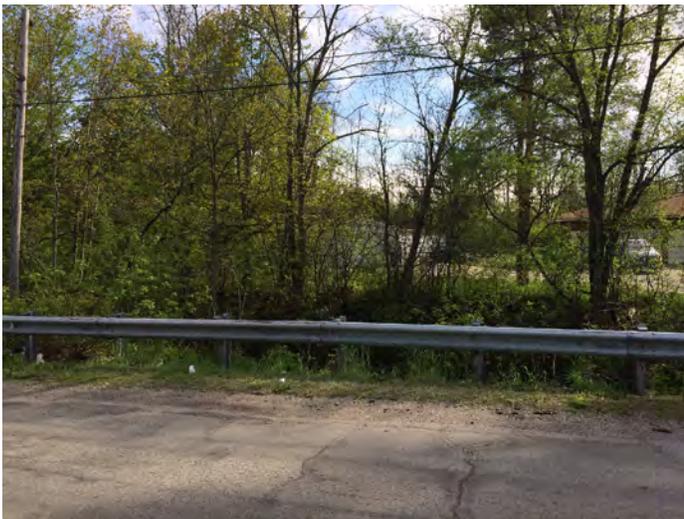
Inspection Report for Observation:
GeneralConditionPhoto22

Photo1 facing southeast. Photo2 facing upstream. Photo3 facing downstream.

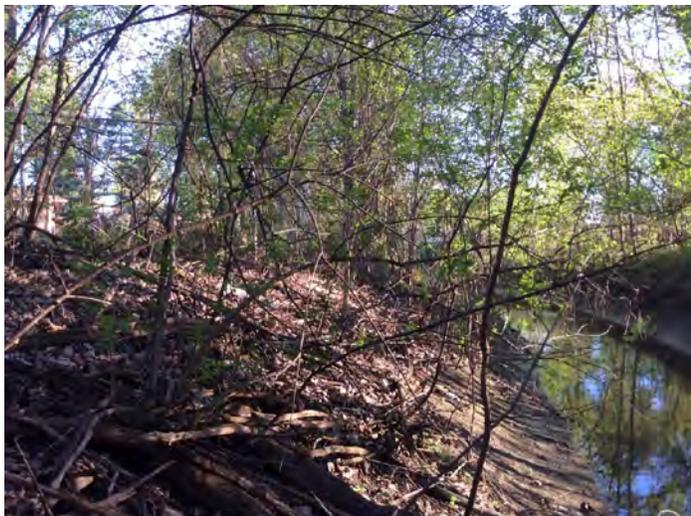
Inspection Report for Observation:
GeneralConditionPhoto23

Fence at top of bank on left side of drain up to Washington rd. Photo facing north.

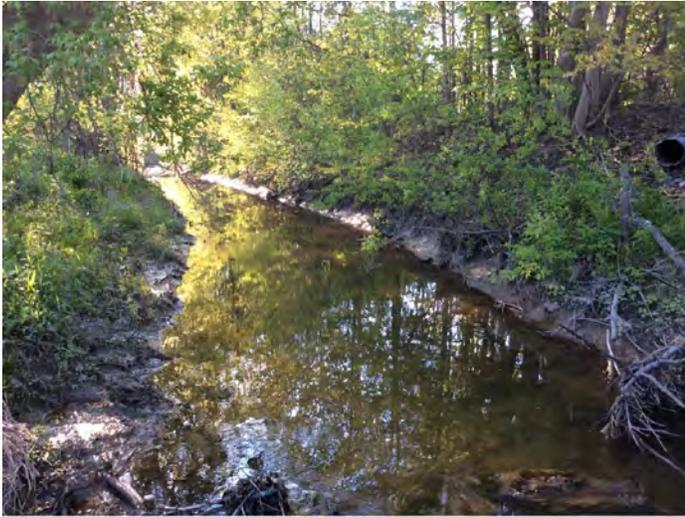
Inspection Report for Observation:
GeneralConditionPhoto24

Photo1 upstream. Photo2 downstream through culvert under Washington rd. Debris and sediment inside culvert.

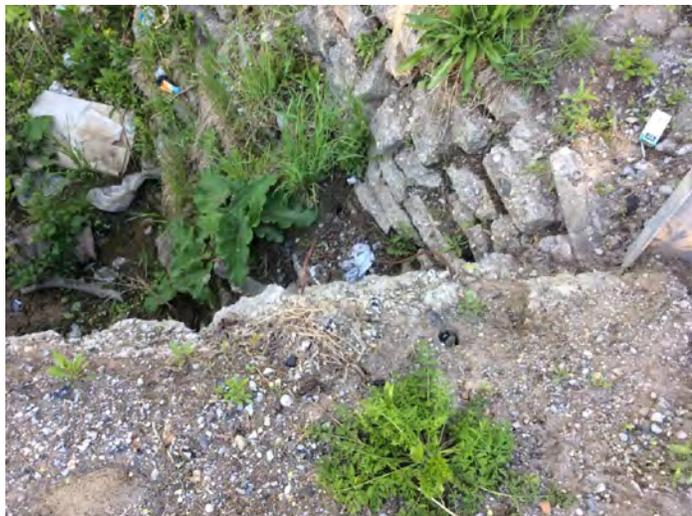
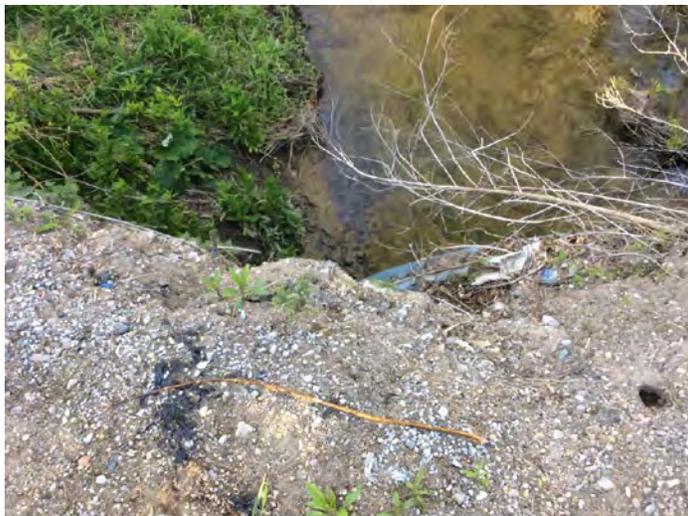
Inspection Report for Observation:
GeneralConditionPhoto25

Exposed re steel at head walls.

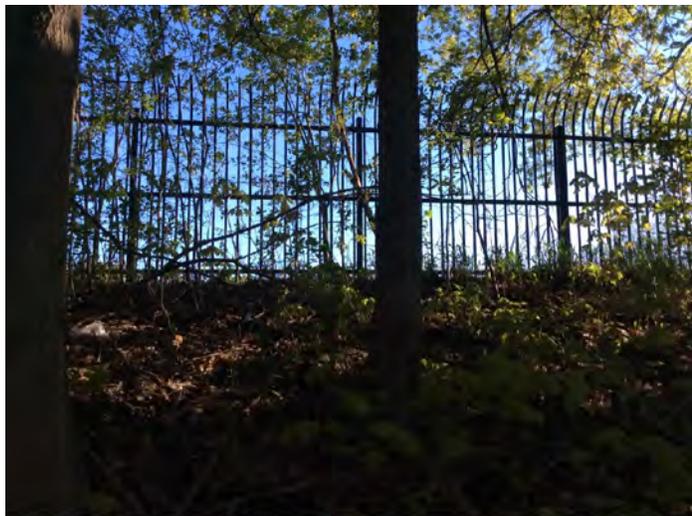
Inspection Report for Observation:
GeneralConditionPhoto26

Fence at top of bank. 300 ft long. Photo facing north.

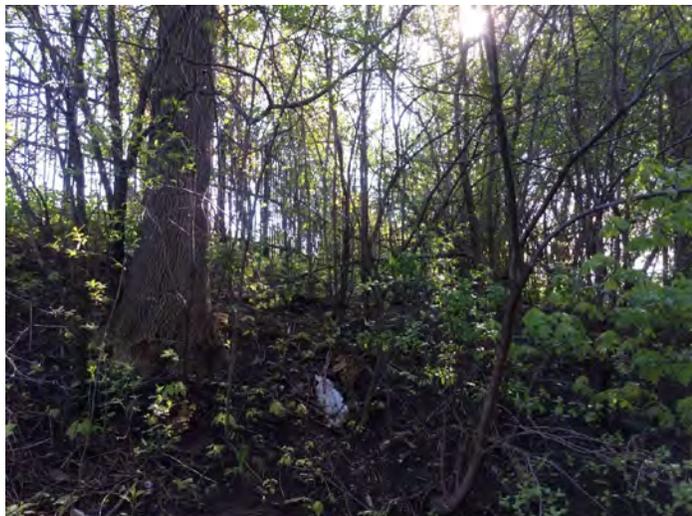
Inspection Report for Observation:
GeneralConditionPhoto28

End of fence at top of bank. Photo facing north.

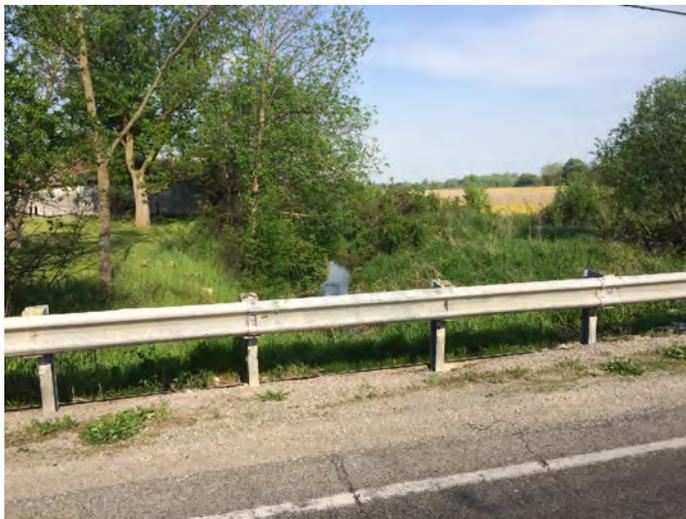
Inspection Report for Observation:
GeneralConditionPhoto32

Photo1 facing upstream. Photo2 facing downstream. Guardrails on both sides. From sheridan rd.

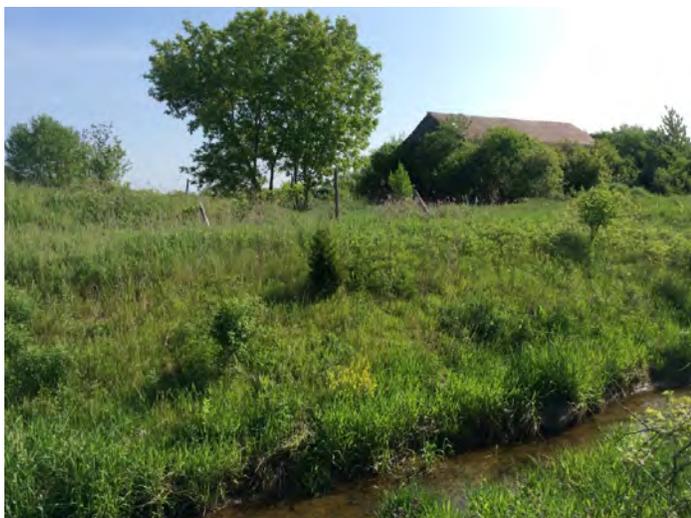
Fence at top of bank on left side. Approx 30 ft long. Photo facing north.

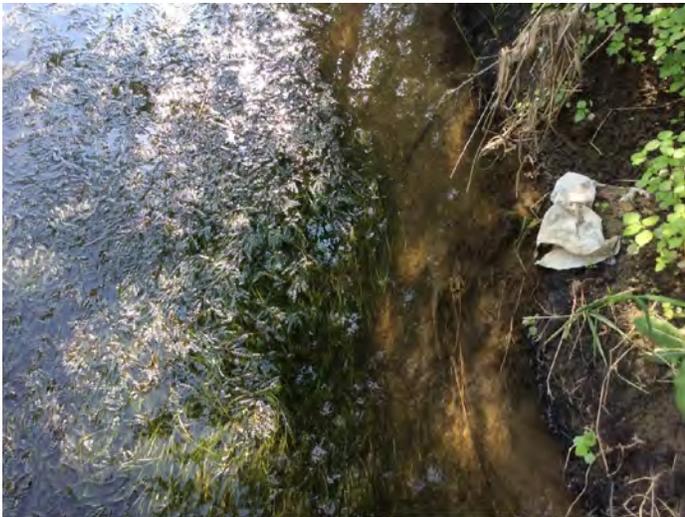
Heavy vegetation growing in the bottom of the drain channel is essentially restricting width to 1.5 ft. Vegetated area is soft sinking sediment. Channel part is hard and easy to walk on.

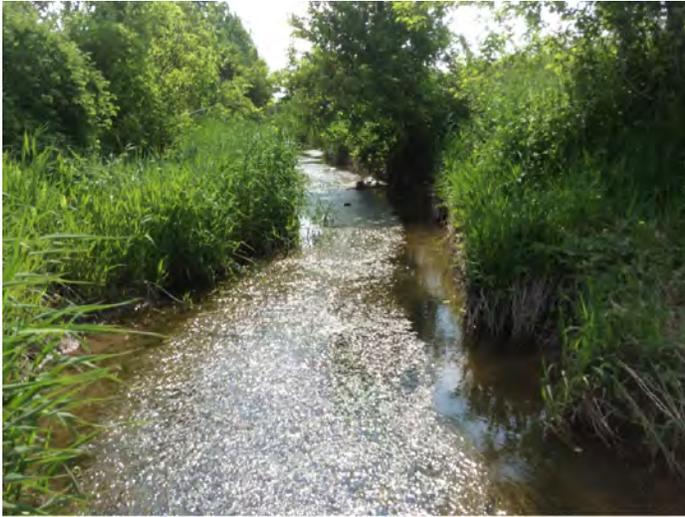
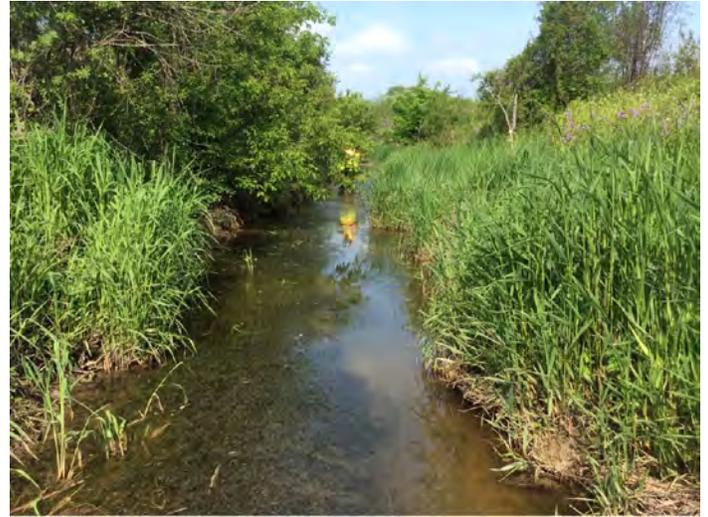
Photo1 facing upstream. Photo2 facing downstream. Drain channel meanders a bit through this stretch. Minor erosion and sediment deposits at the banks. Heavy vegetation in bottom of drain channel is forcing flow along the banks.

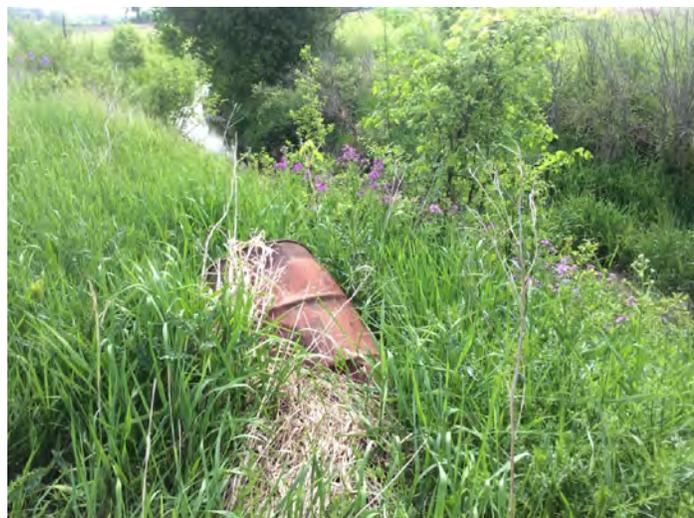
Metal drum at top of bank on left side.

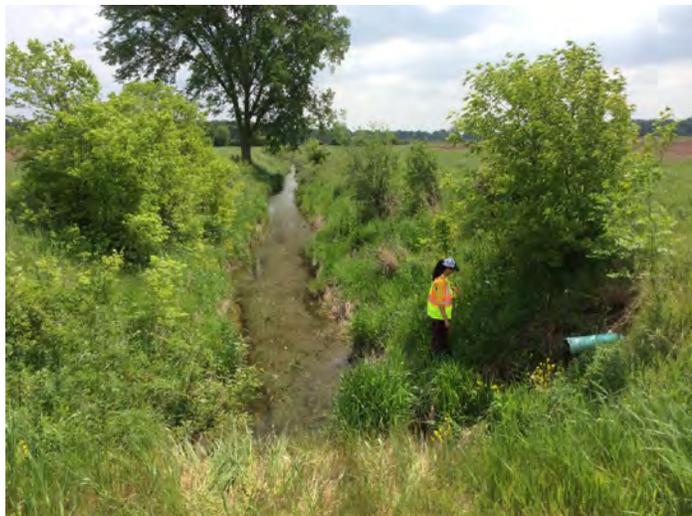
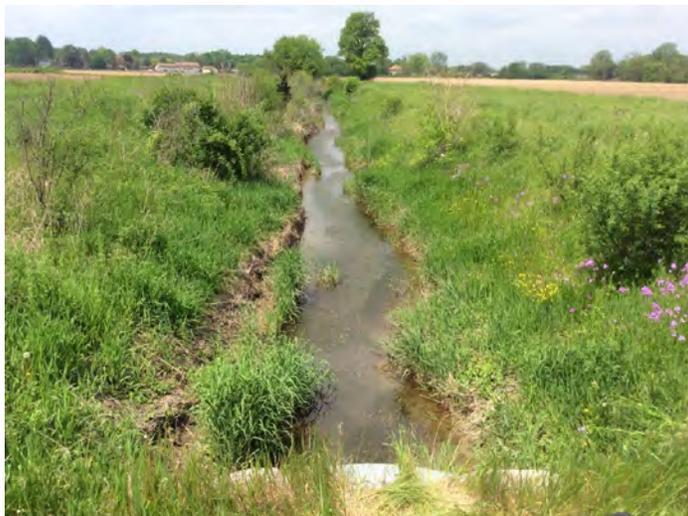
Photo1 upstream. Photo2 downstream. From farm crossing.

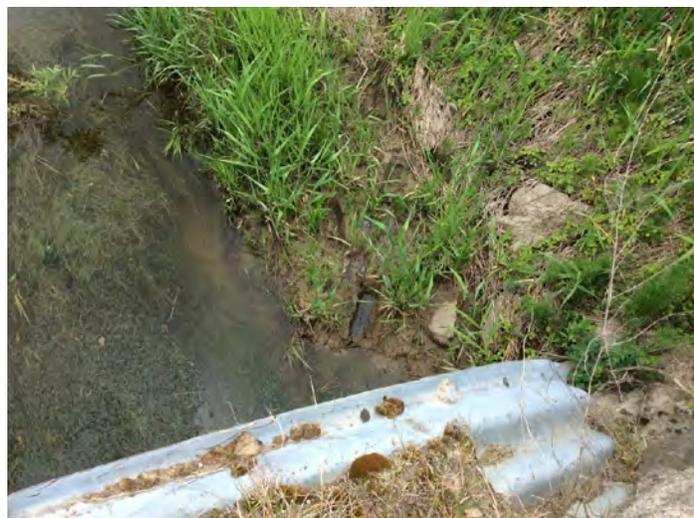
Oily sheen in small area on right side, just upstream of farm crossing.

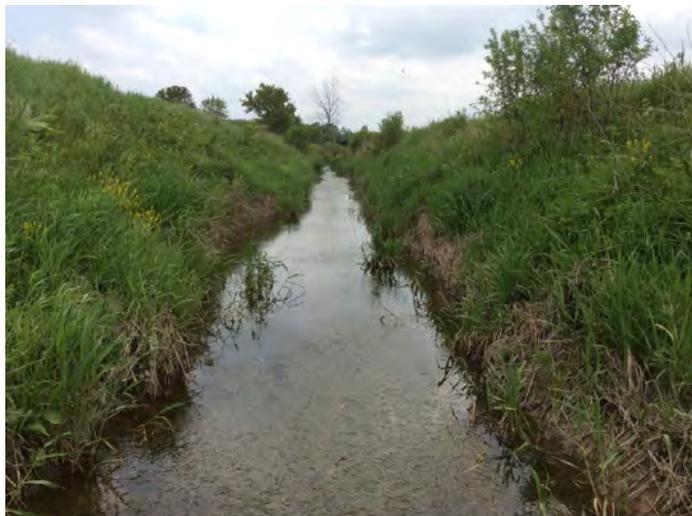
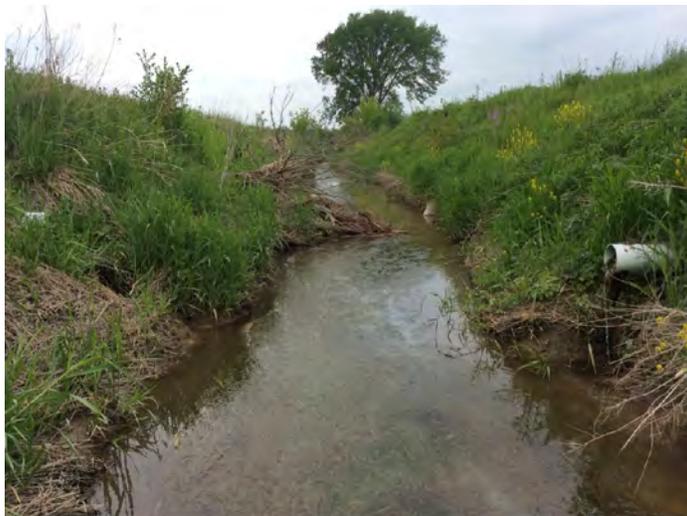
Photo1 upstream. Photo2 downstream.

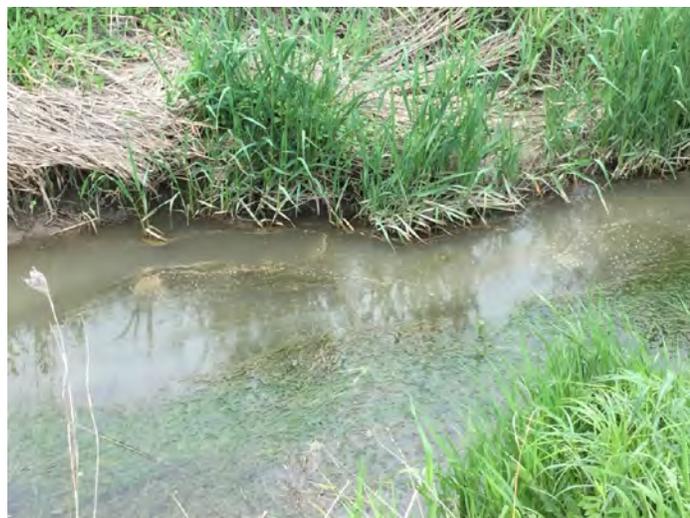
Brown bubbly area in water. Almost looks oily. Photo taken facing southwest.

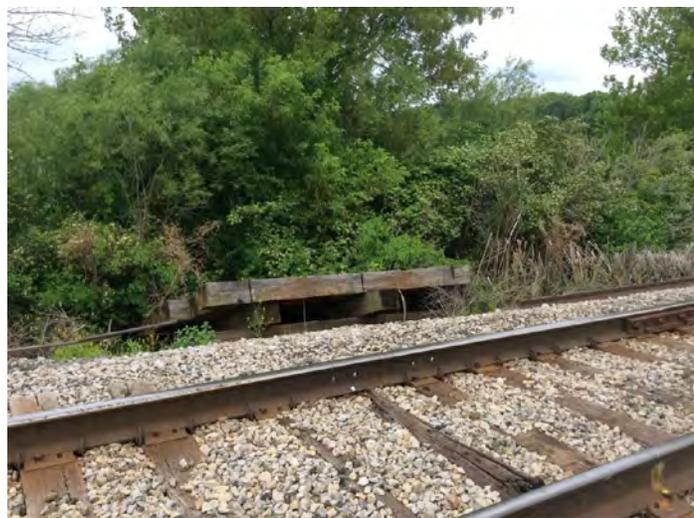
Debris at top of bank on left side of drain.

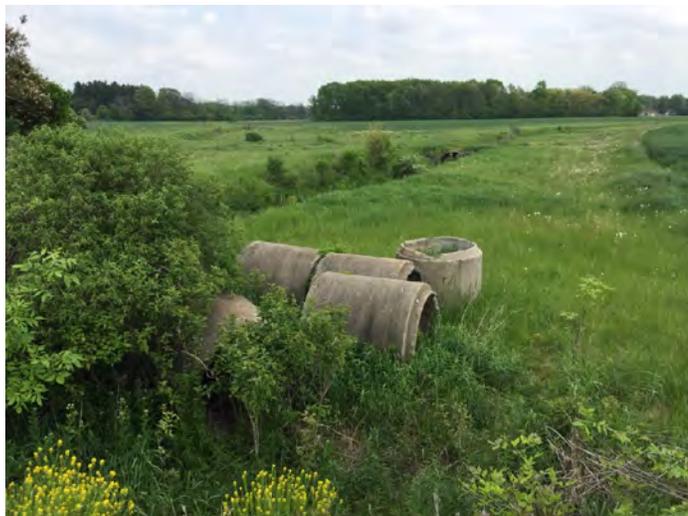
Huge concrete blocks on right side of drain facing upstream. Right past railroad tracks about 20 ft. Photo taken facing northeast.

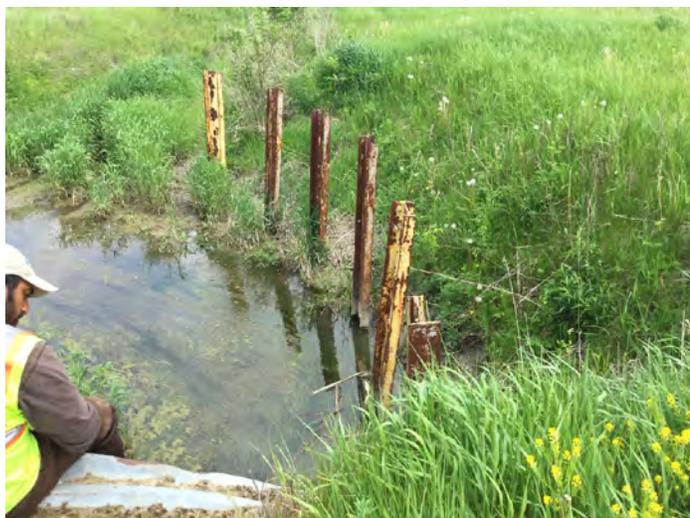
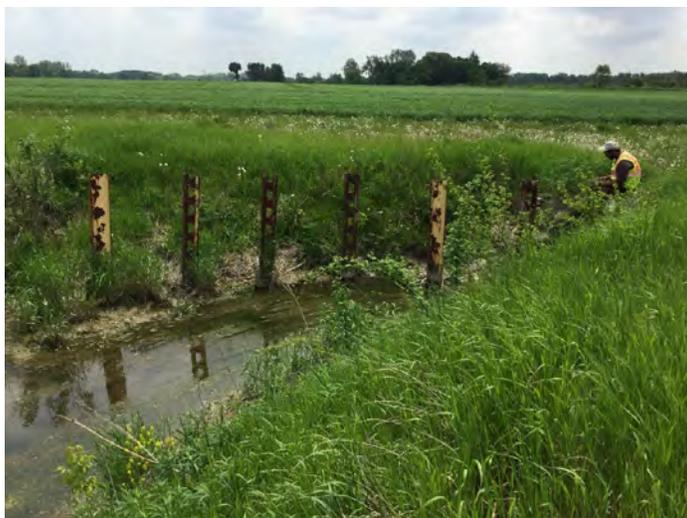
Steel rods after farm crossing. Right side of drain. Photo 1 taken facing east. Photo 2 taken facing south.

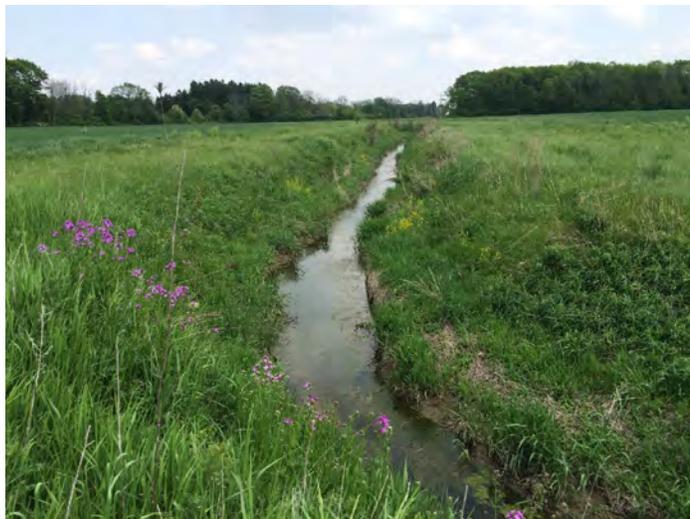
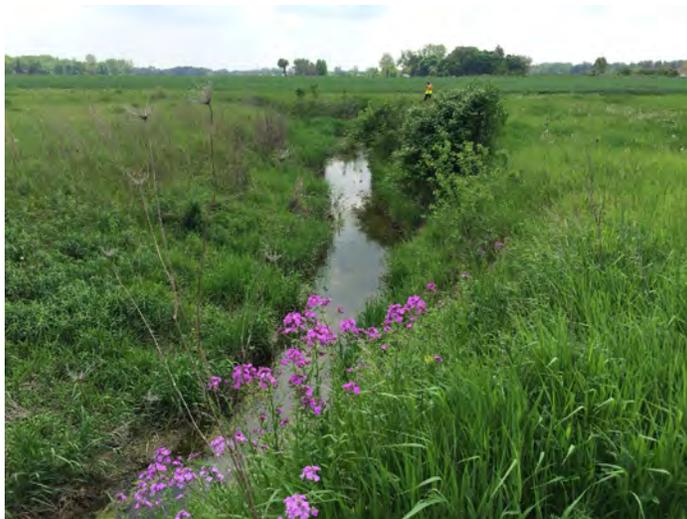
Photo1 facing upstream. Photo2 facing downstream.

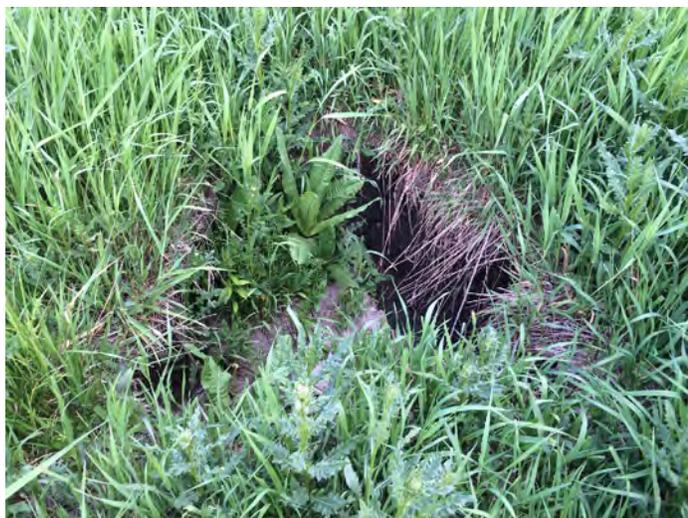
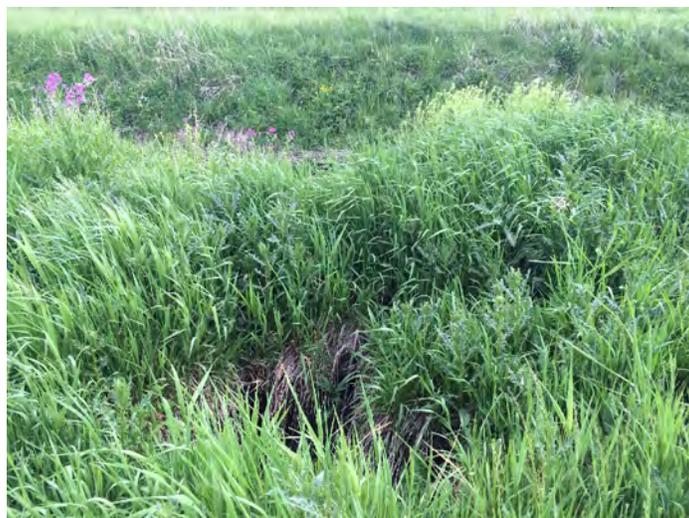
Sediment cave in 5 ft left of top of bank. Photo 2 facing southeast.

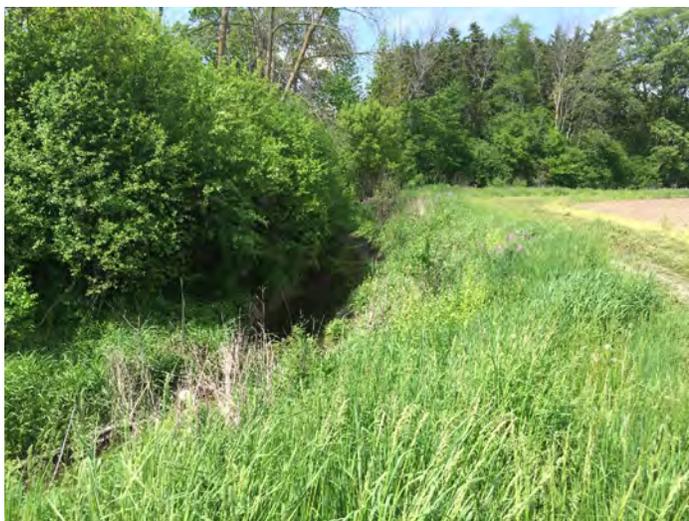
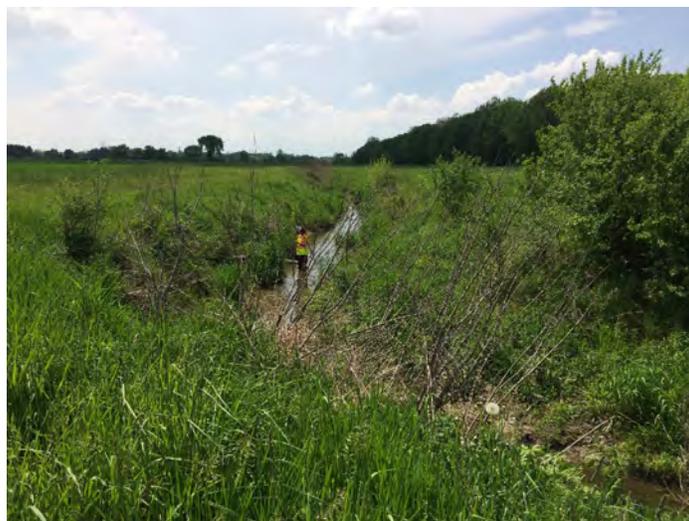
Photo1 upstream. Photo2 downstream.

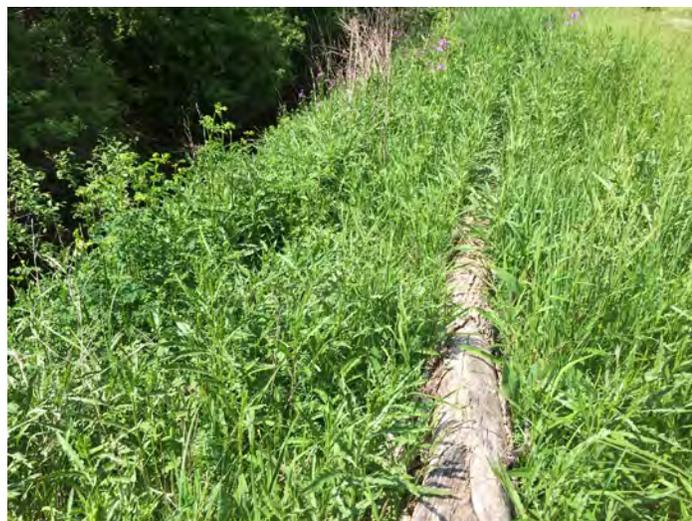
Three fallen trees on top of right bank. 8" diam

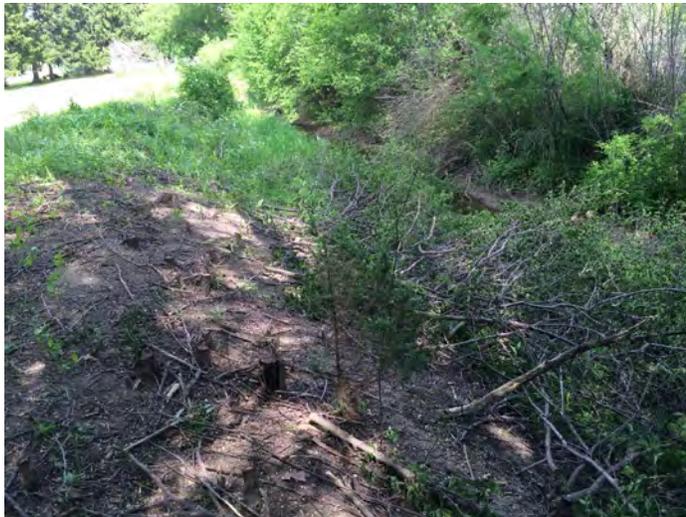
Recent clearing of small trees, excessive vegetation on top of left bank. Debris remains on bank and is overhanging drain. Photo facing upstream.

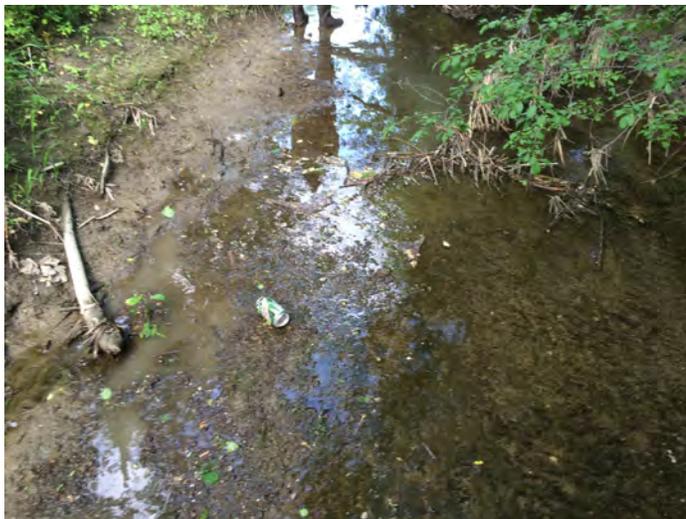
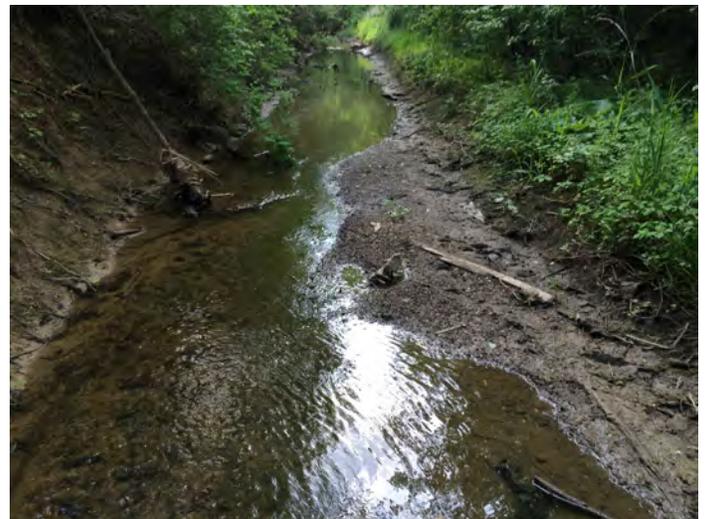
Photo1 facing upstream. Photo2 facing downstream. Channel bottom is very hard. Change in this location.

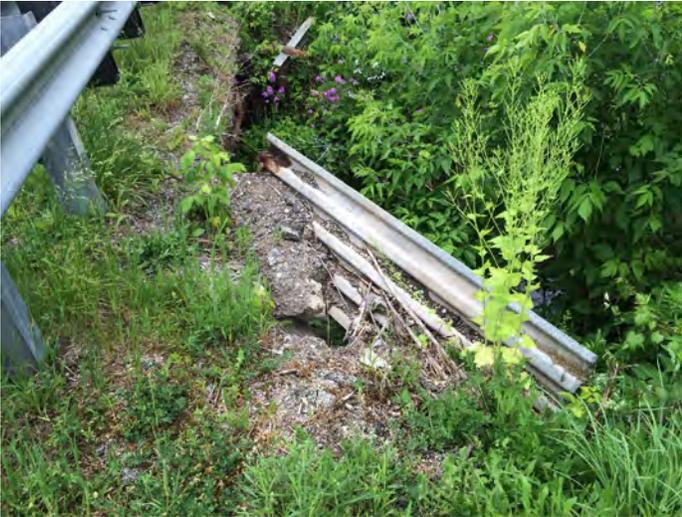
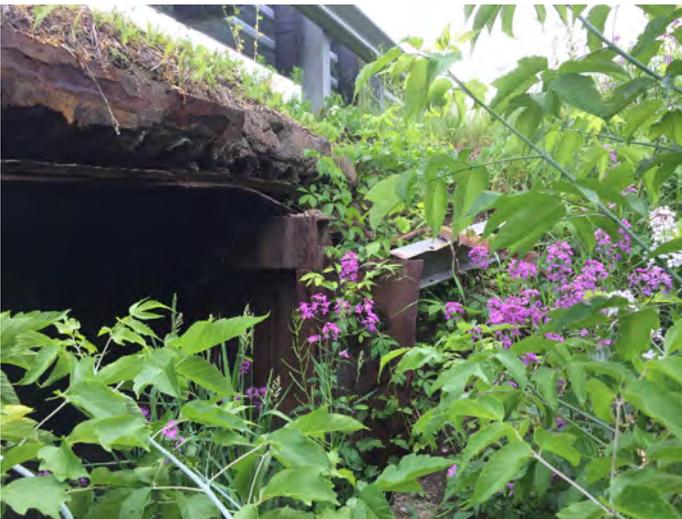
Bridge crossing at williamson rd in poor condition. Photo1 facing southeast on downstream side. Photo2 facing upstream on downstream side. Photo3 downstream side. Photo4 upstream side.

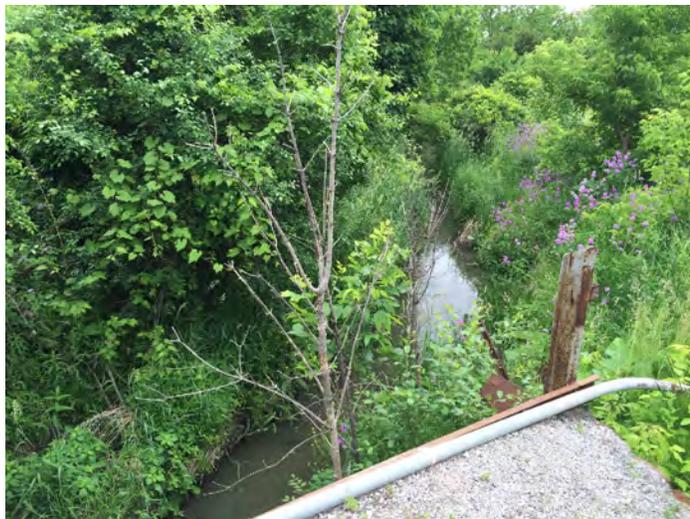
Photos taken from williamson rd. Guardrail on both sides.

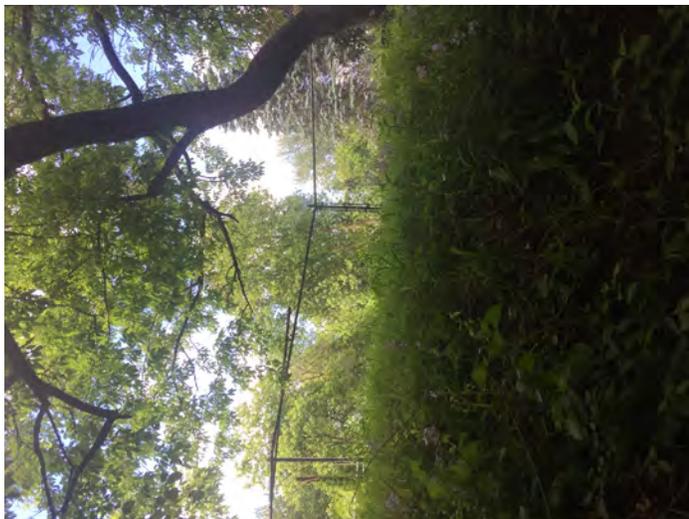
4' chain link fence approx 30' left of drain centerline from this location approx 100' up stream to end.

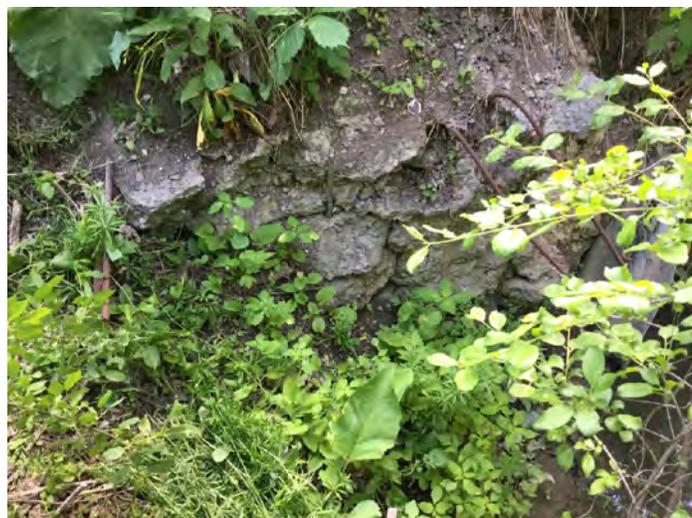
Exposed resteel on north side of King street, on east head wall.
