King Street Tile Drain Inspections

Inspection Report for Observation:
GeneralConditionPhoto1

CLIENT	Saginaw County Public Works Commissioner

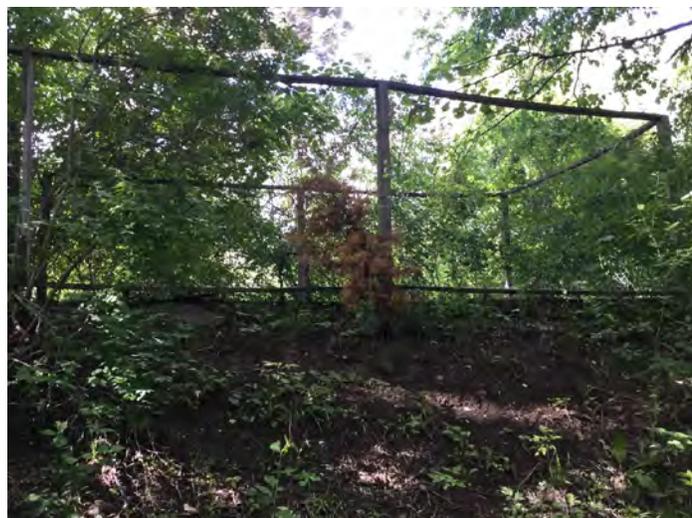
Fenced off area. Approx 20' x10'. On top of bank on left side.

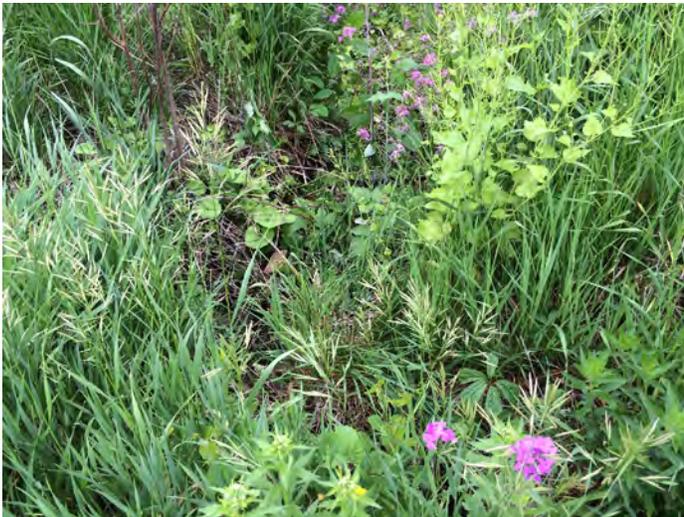
Might be a field tile outlet here on left side but could not find.

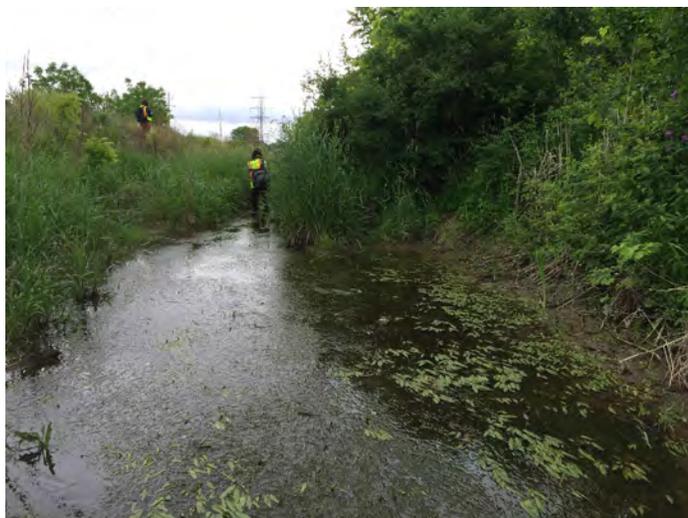
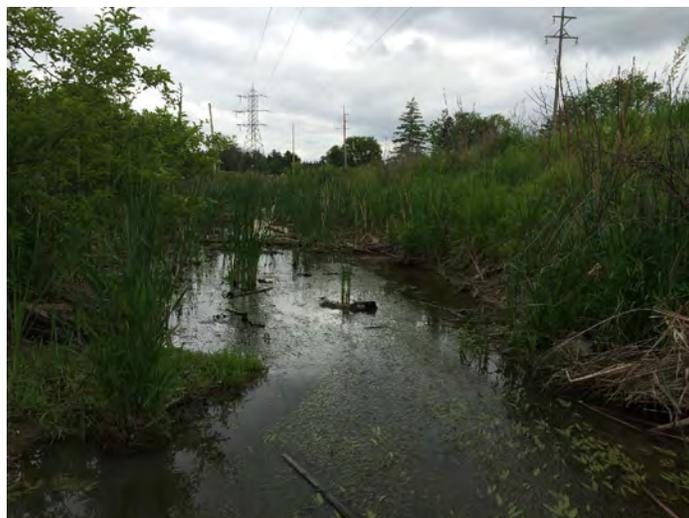
Inspection Report for Observation:
GeneralConditionPhoto59

Photo 1 Direction: Facing Upstream

Photo 2 Direction: Facing Downstream

Channel width is wider upstream of blockage in drain. Causing erosion at banks. Stretch is about 150 ft.

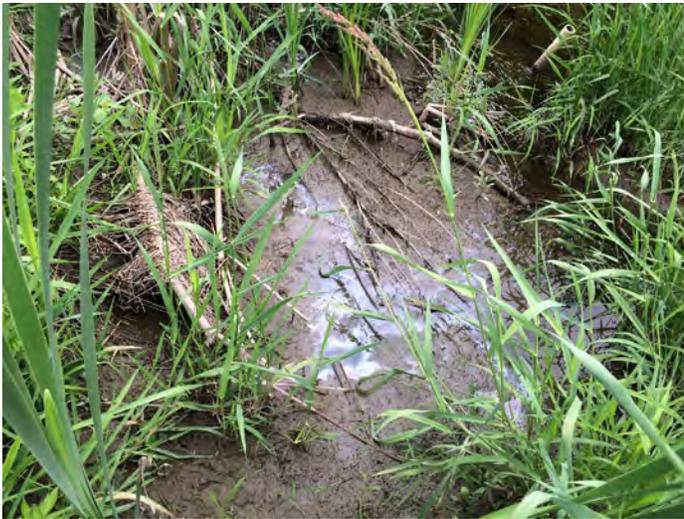
Inspection Report for Observation:
GeneralConditionPhoto60

Oily substance on left side of drain.

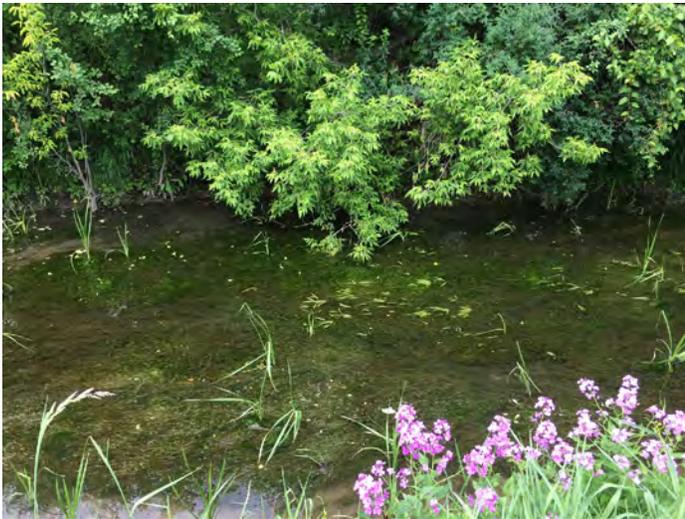
Inspection Report for Observation:
GeneralConditionPhoto61

Drain seems wider at this location.

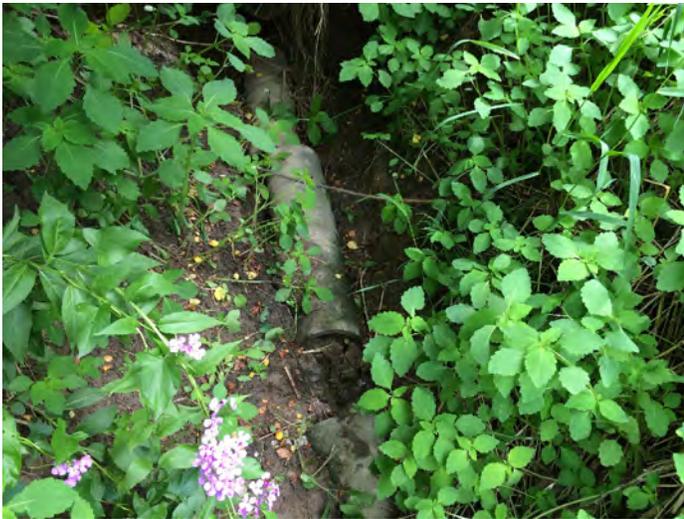
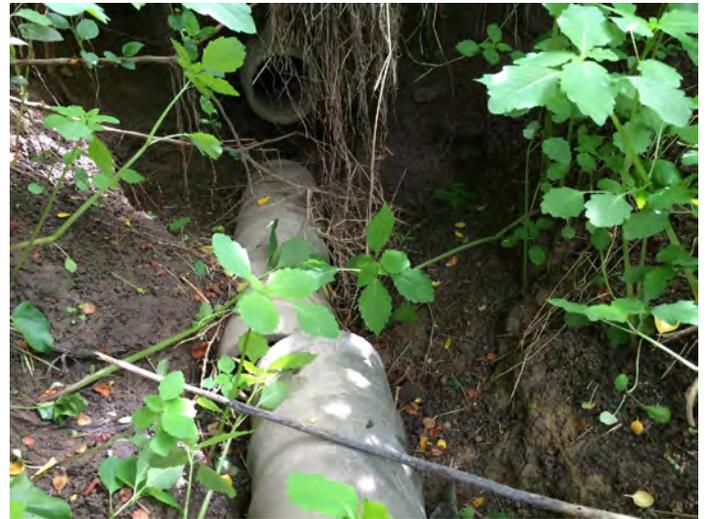
Inspection Report for Observation:
GeneralConditionPhoto62

Field tile outlet. Cannot determine pipe material in field.

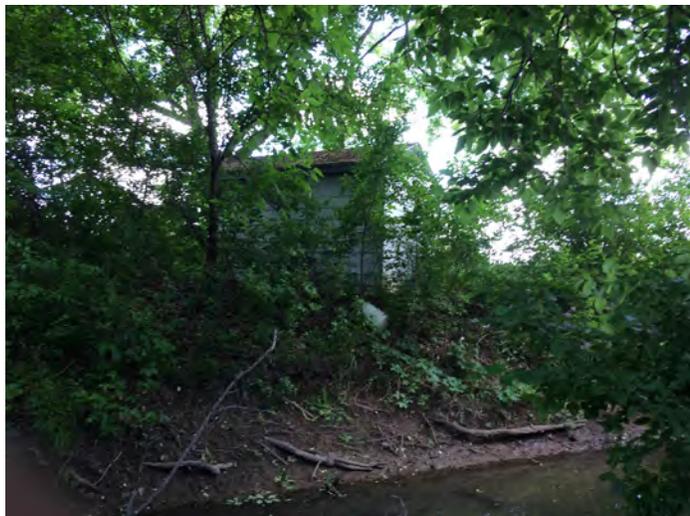
Inspection Report for Observation:
GeneralConditionPhoto63

Shed at top of bank on right side.

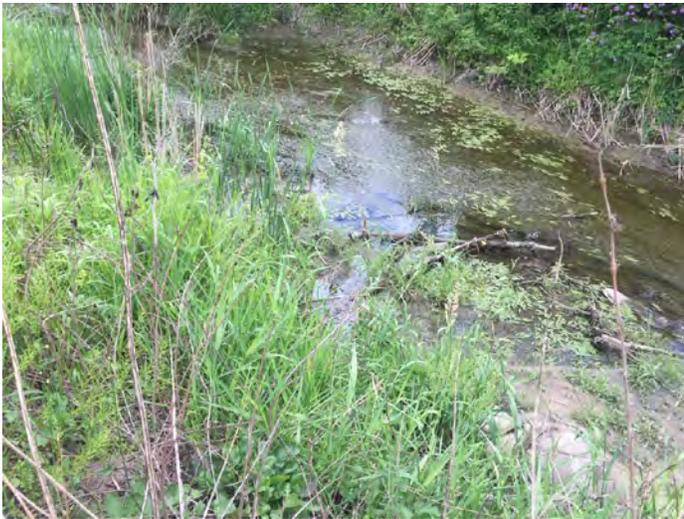
Inspection Report for Observation:
GeneralConditionPhoto64

Oil sheen on left side of drain.

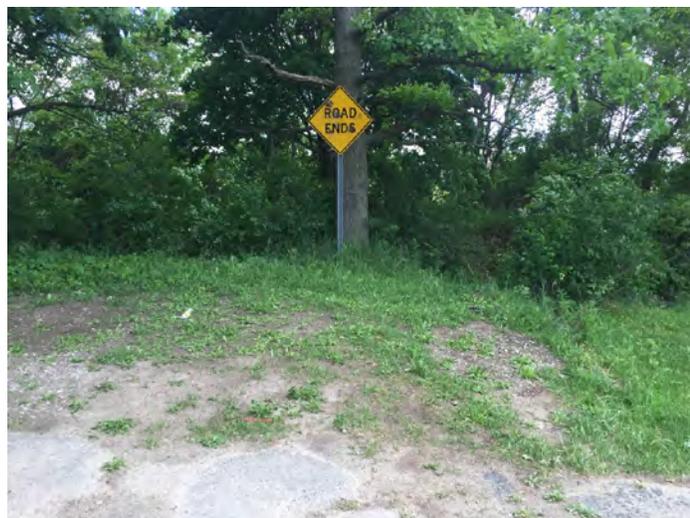
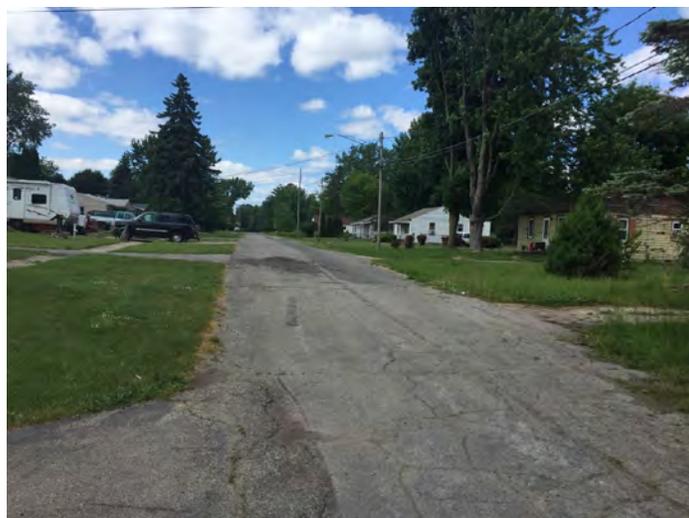
Inspection Report for Observation:
GeneralConditionPhoto65

Road runs perpendicular to drain off the north side. Pictures facing south across the drain and north up the road. Pear Street.

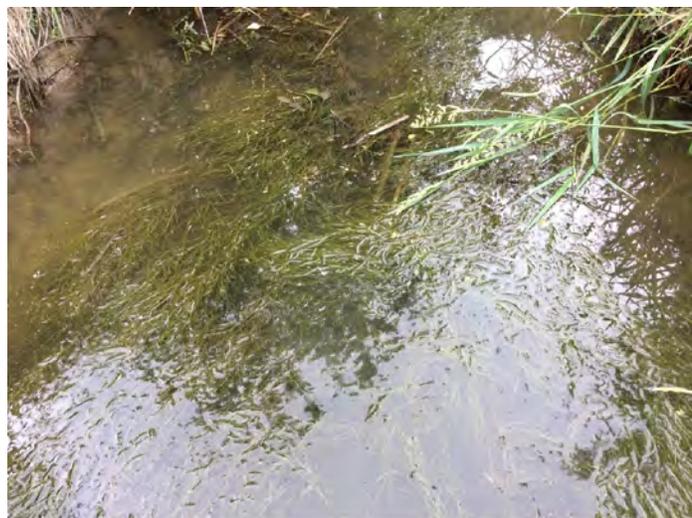
Inspection Report for Observation:
GeneralConditionPhoto66

Lots of obstacles under water. Can't see. Trips up when walking in drain.
Possibly huge rocks or logs. Can't see in picture.

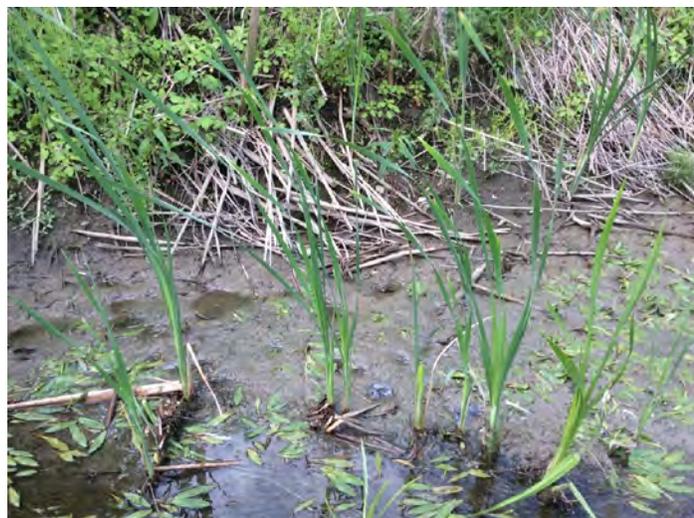
Inspection Report for Observation:
GeneralConditionPhoto67

Some form of sanitary waste in drain. Smells and is thicker than normal sediment.

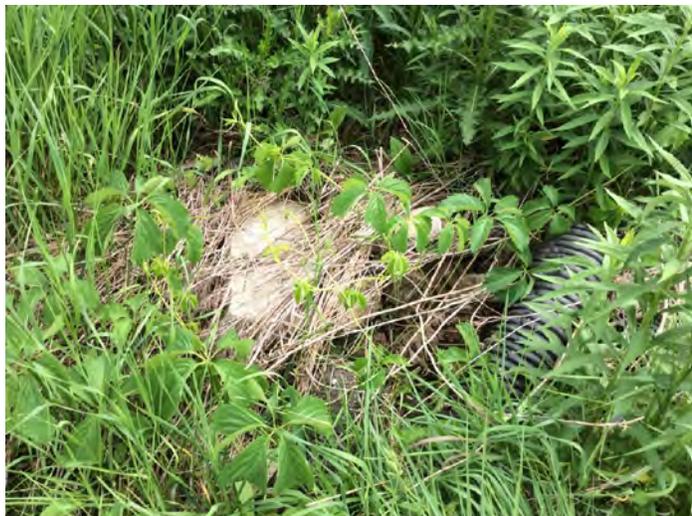
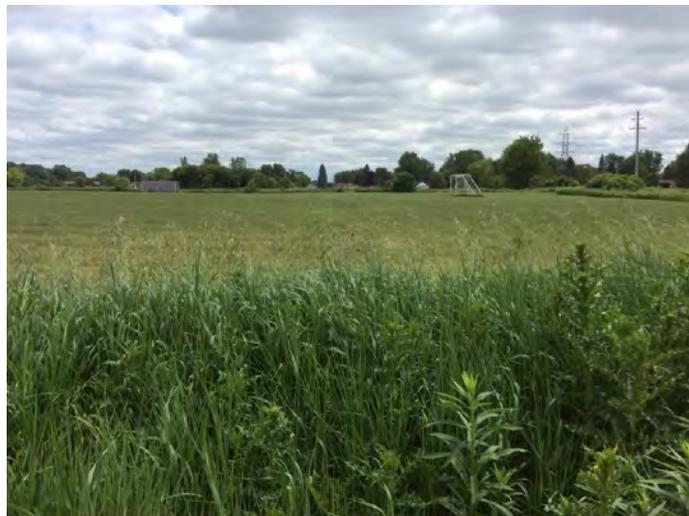
Pieces of field tiles and woody debris north of field, south of drain.

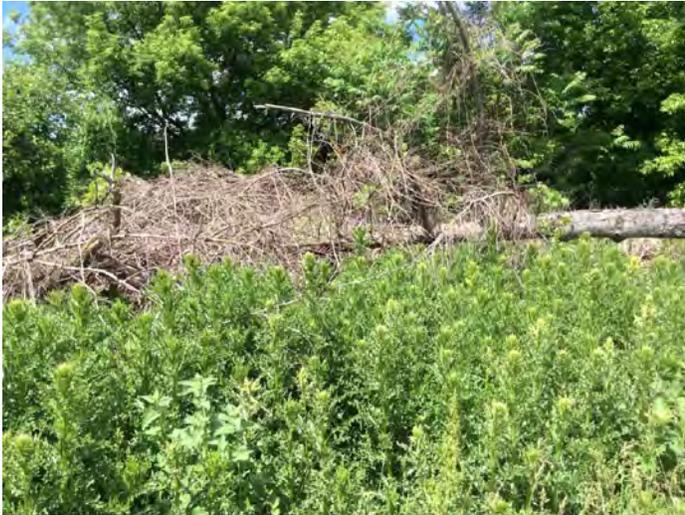
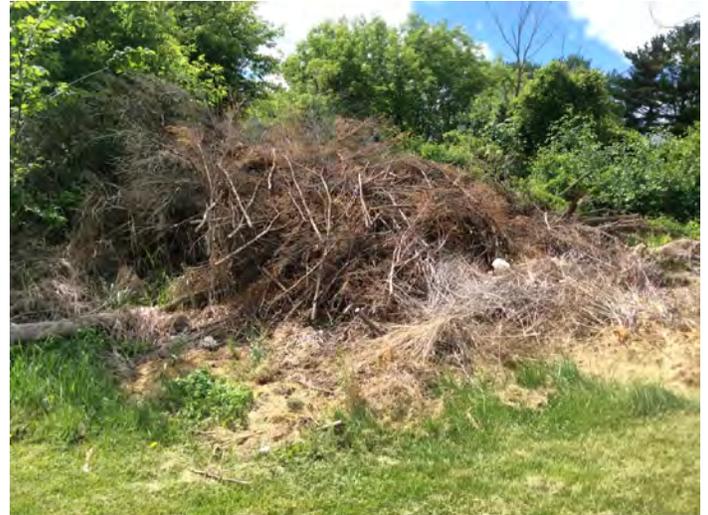
Large fallen tree on right side of drain up about 20 ft up on bank next to soccer field. South of drain. North of field. About 20 ft long. Then 20 ft farther is another fallen tree/woody debris on same side of drain. About 80 ft total.

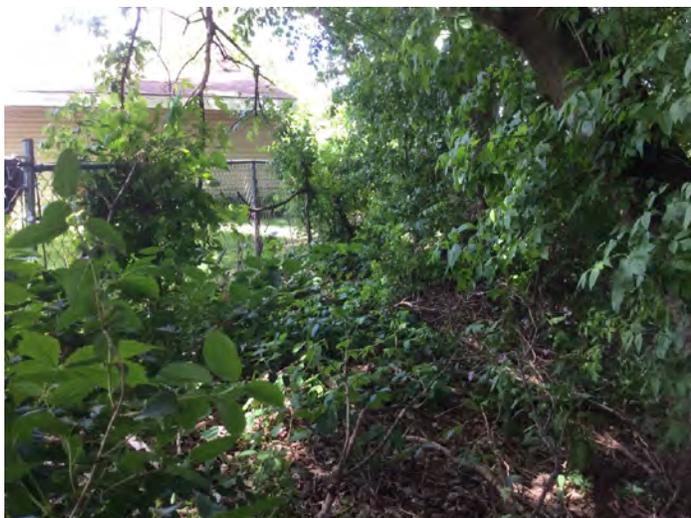
Fence on left side of drain on bank up about 10 ft. About 20 ft long.

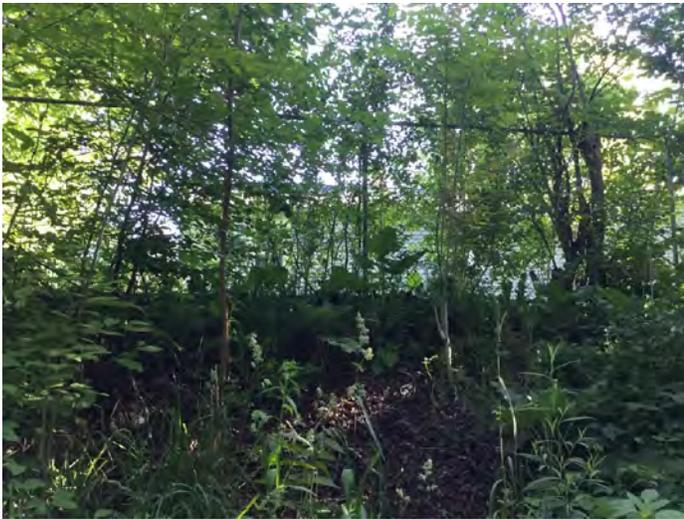
Fence at top of bank on left side. 70 ft long.

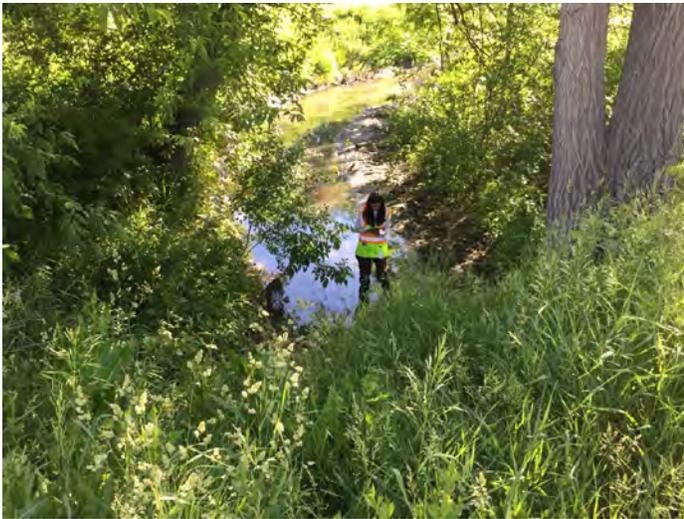
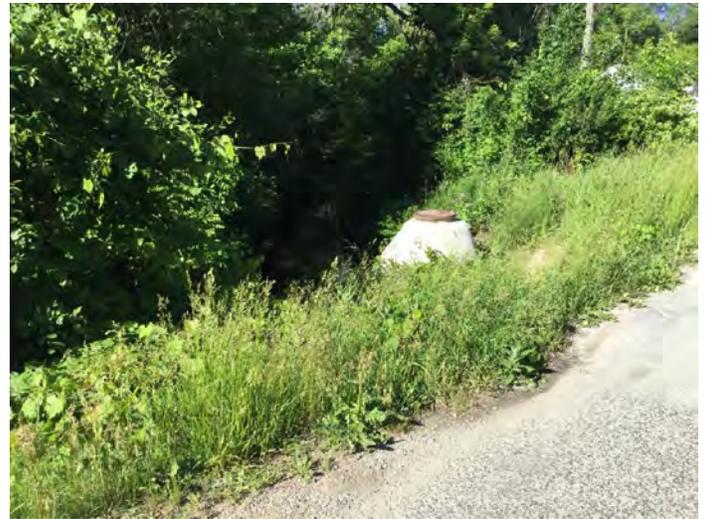
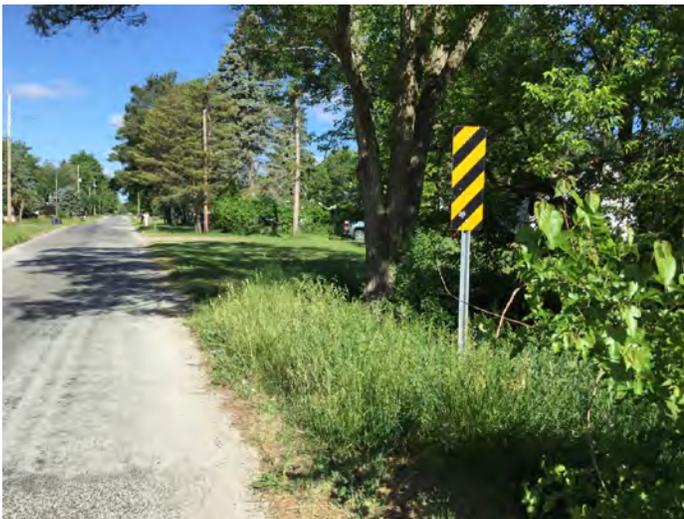
Kansas St crossing. No guard rails. Crossing signs on both directions.

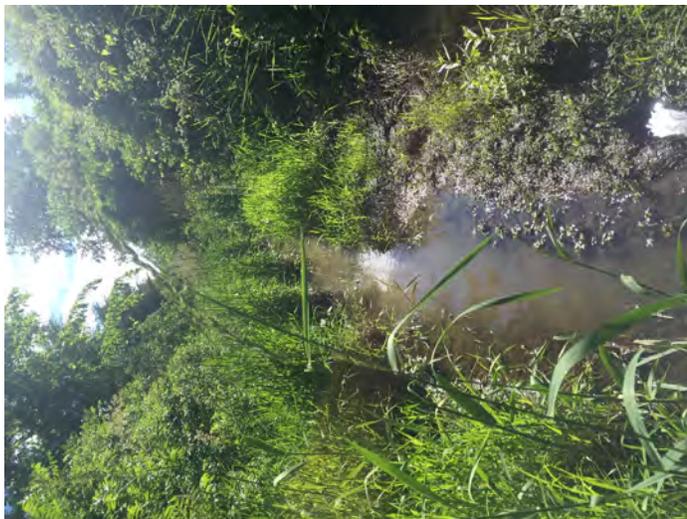
Drain narrows due to sediment deposit with vegetation to approx 2' from this location upstream to rr tracks. Picture facing upstream.

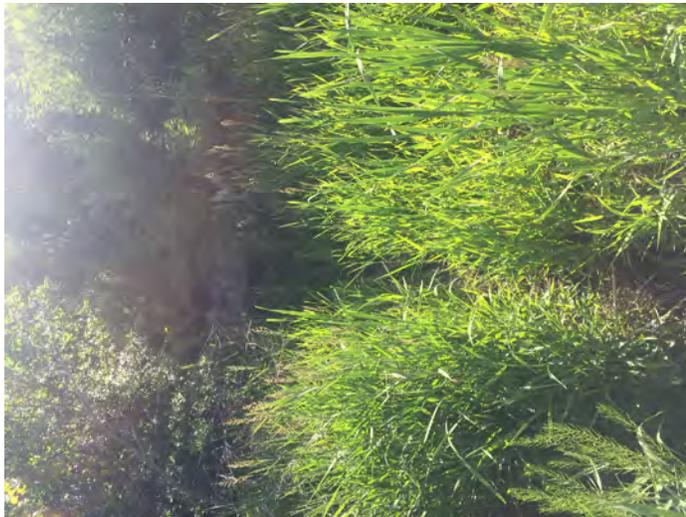
County drain has been rerouted to the west side of the railroad tracks due to a collapsed concrete headwall and sediment blockage at culvert crossing West side. Picture facing upstream.

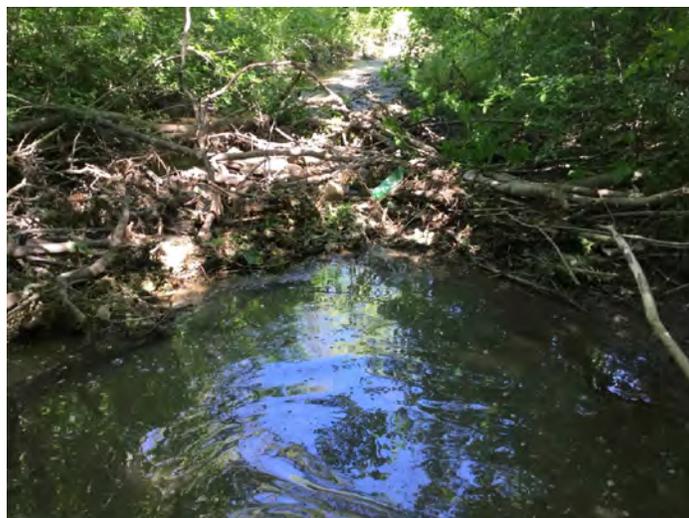
Upstream of log jam. 1.5" water depth. Hard sediment. Weird. Would expect higher water depth and loose sediment.

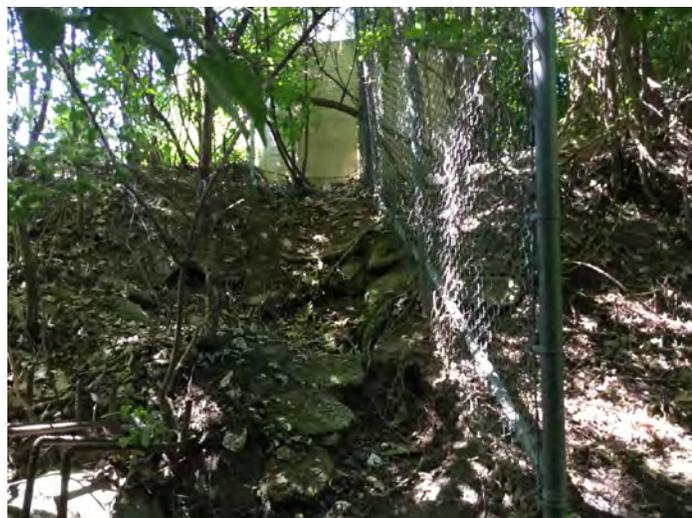
24 ft fence on right bank.

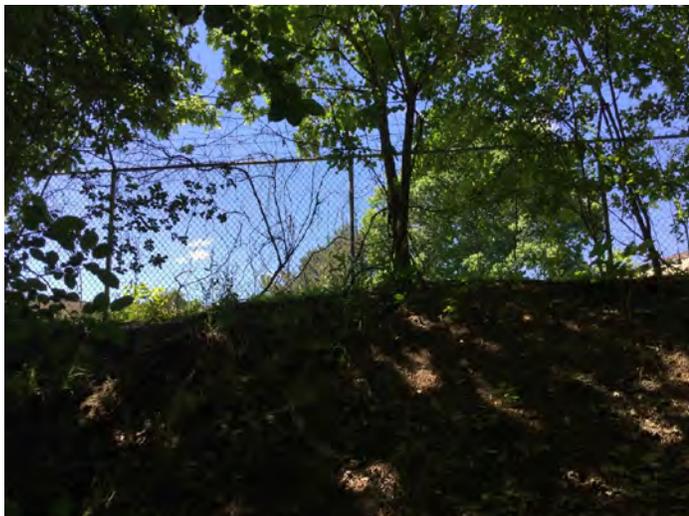
Fence at top of bank on right side. Barb wire. 80 ft.

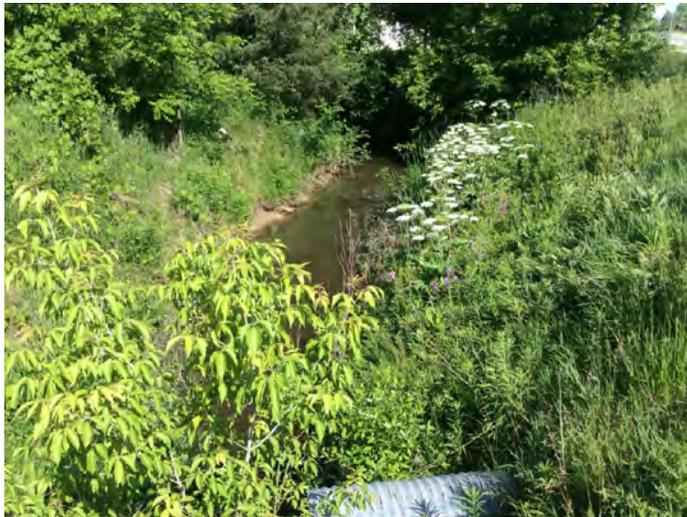
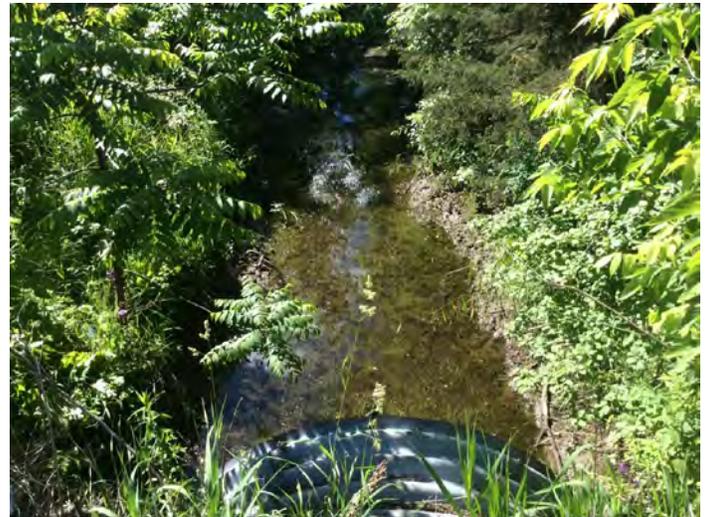
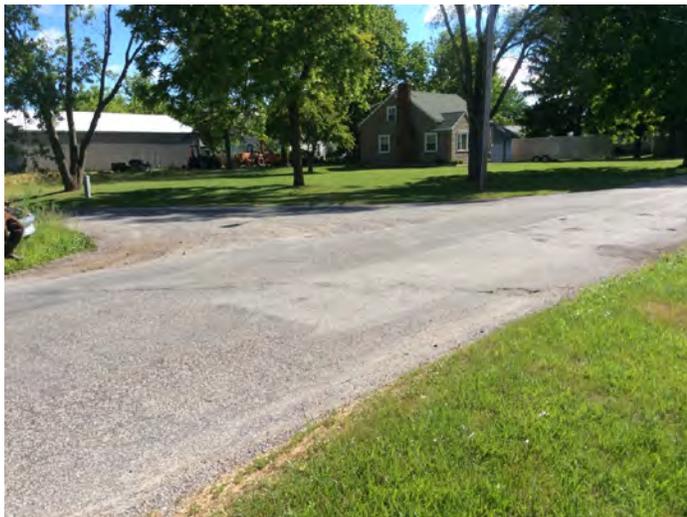
Guardrail on both sides of crossing. Photo 3 facing northeast to show intersection of Kansas Ave and Broadway St. intersection where culvert crosses underneath.

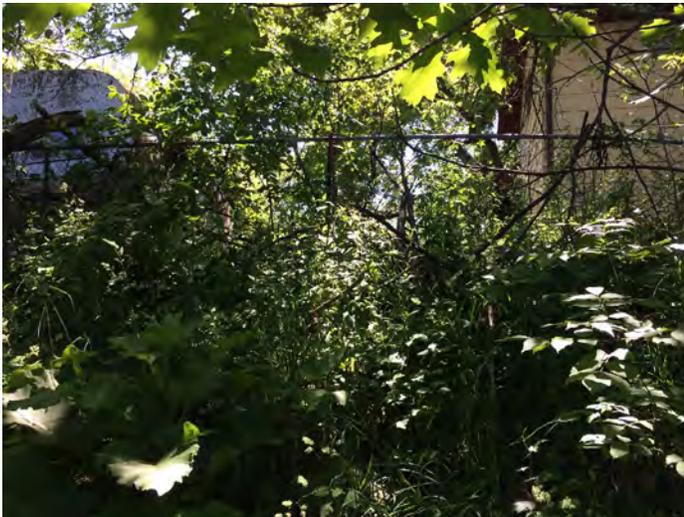
Fence at top of bank on right side. 200ft

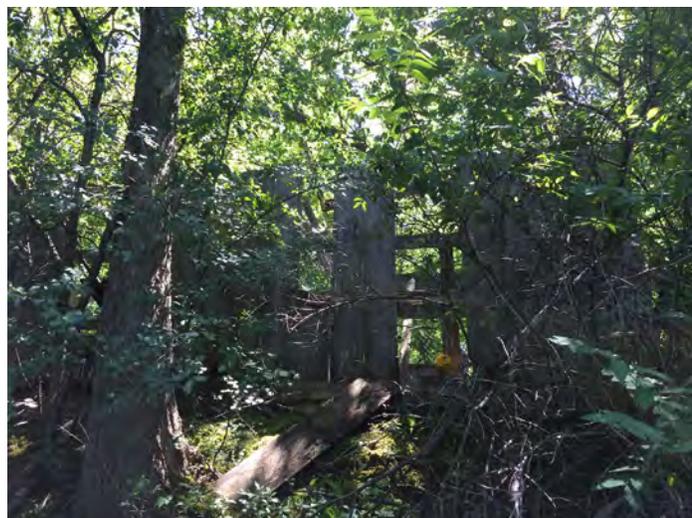
Fence at top of bank on right side. 50 ft

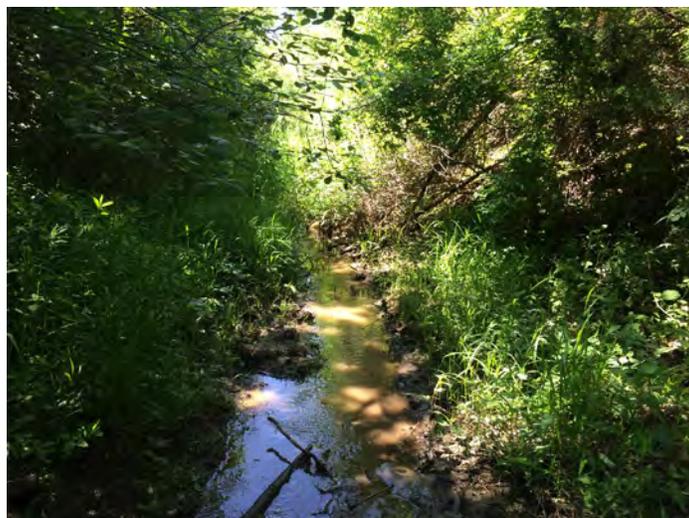
At upstream side of sediment bar and excessive vegetation that significantly reduces channel width.

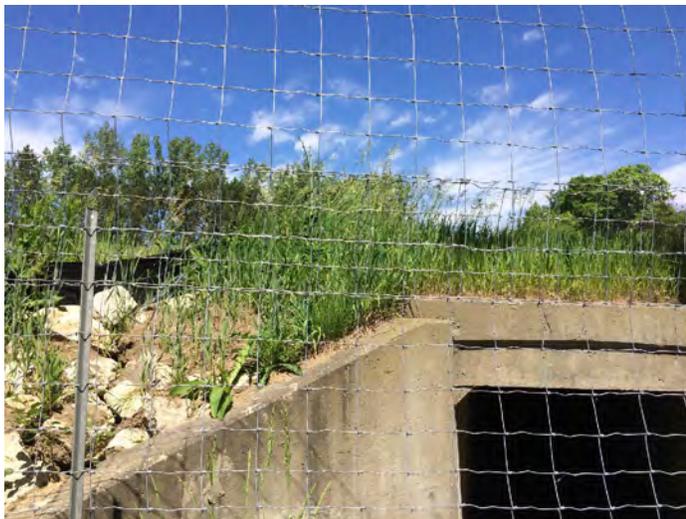
Silt fence at top of culvert on downstream side of I75 crossing.

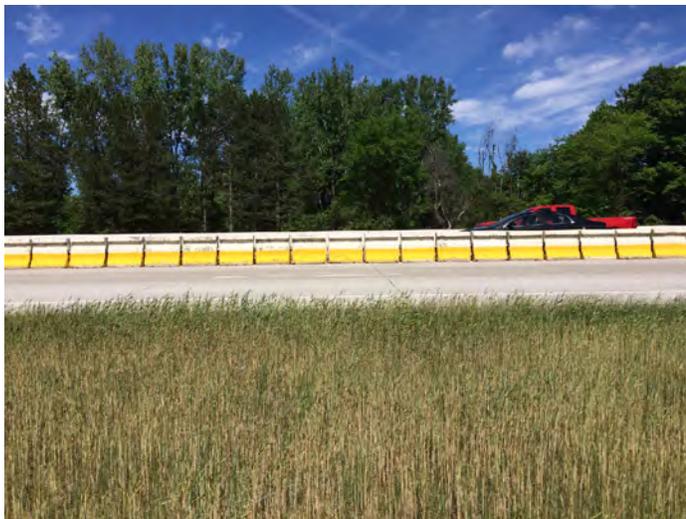
I75 crossing. Highway is currently under construction. Taken at downstream end of crossing.

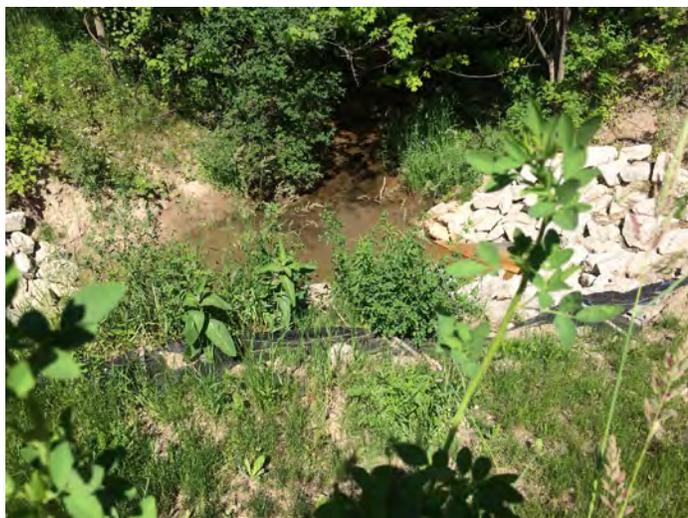
Northbound I75 is currently under construction. Photos taken on upstream side.

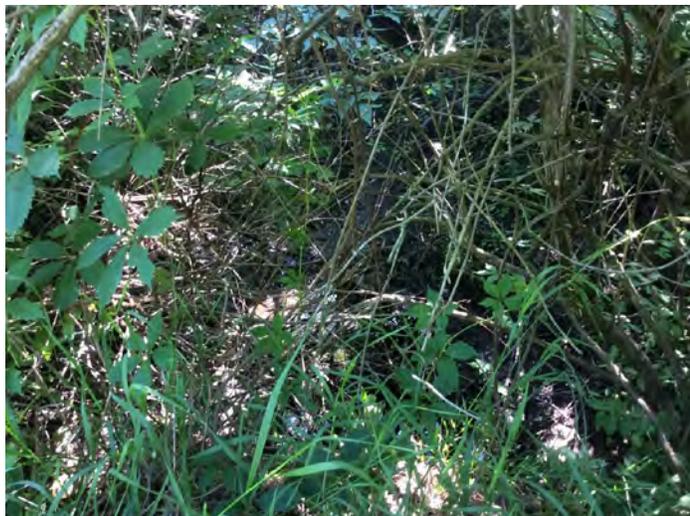
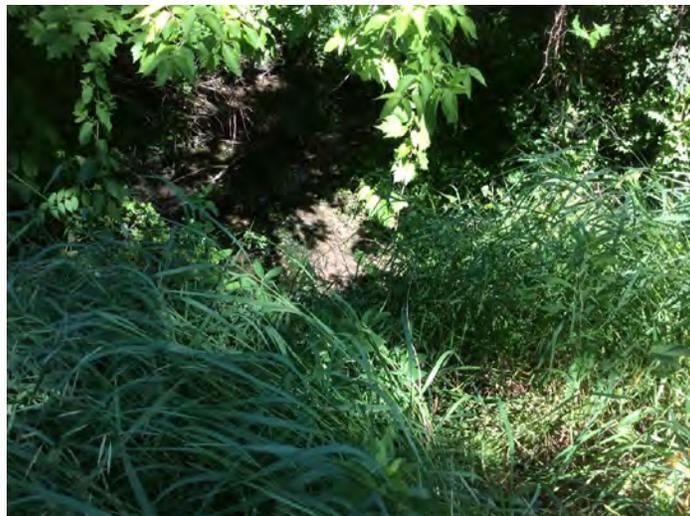
Comments:
Farm crossing.

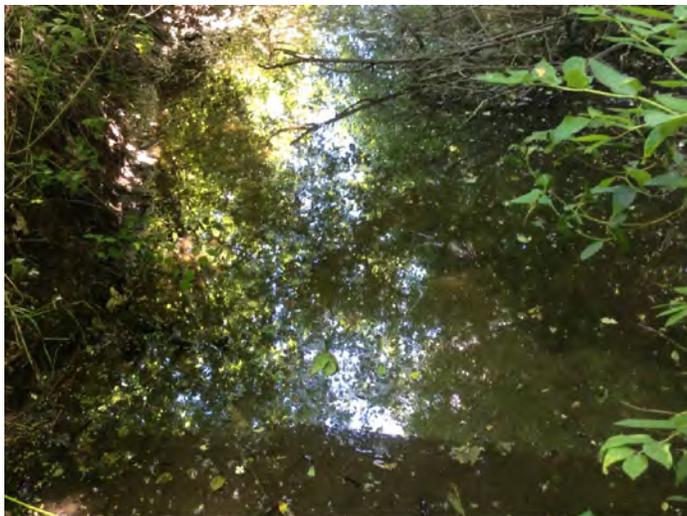
Significant increase in sediment depth and water depth just downstream of bridge crossing and field tile outlet.

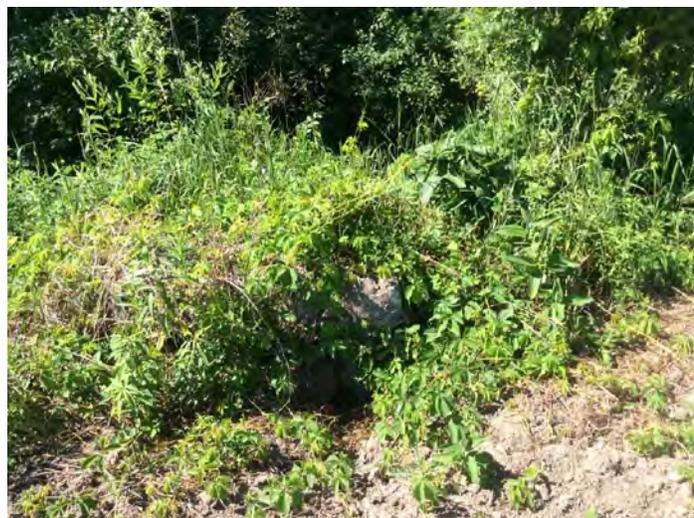
On left side. Facing south towards drain. Depression with headwall.
 Potentially side drain for surface overflow.

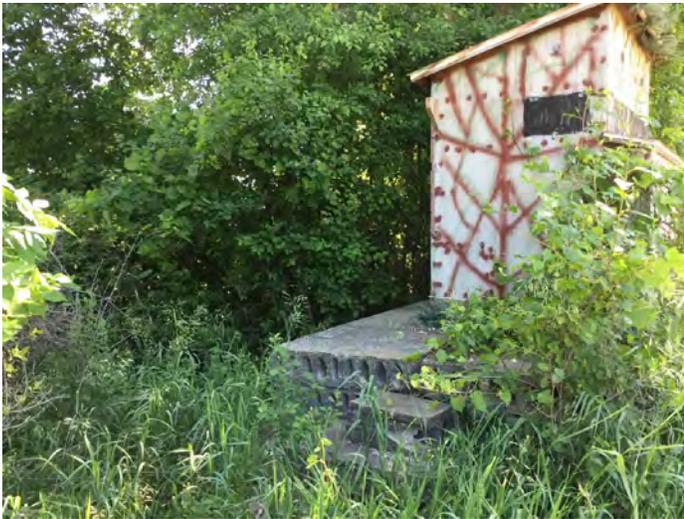
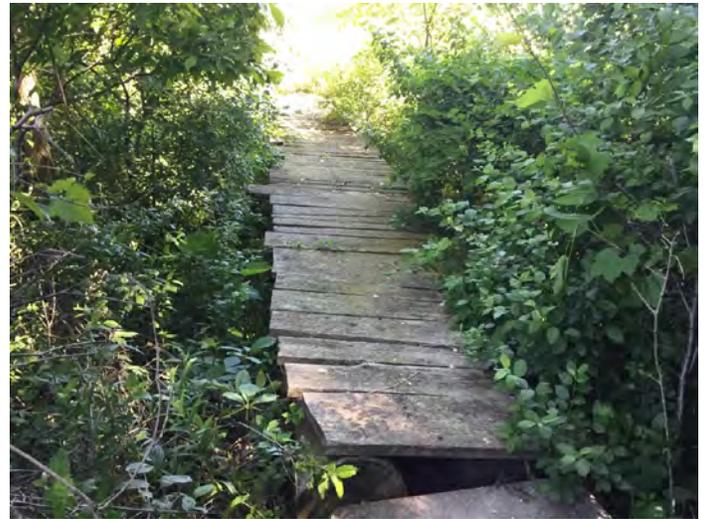
Tree stand on right side of drain up bank about 30 ft. Connects to wood bridge.

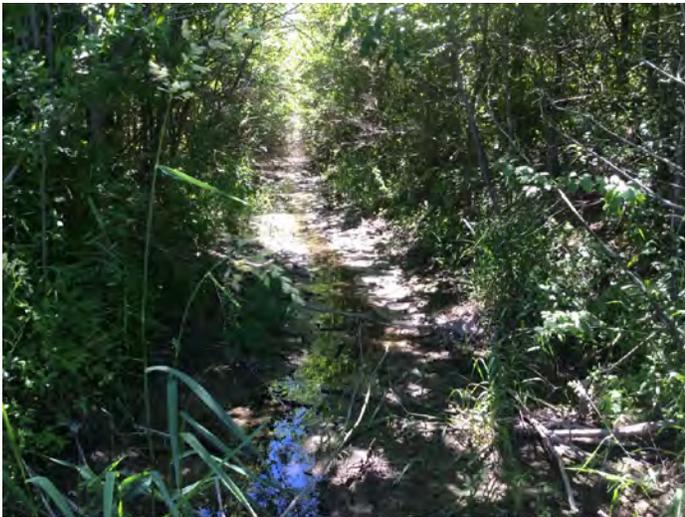
Taken at bend in drain. Upstream seems manageable. Downstream along ag field is loose sediment, heavy vegetation, and very difficult to walk through.

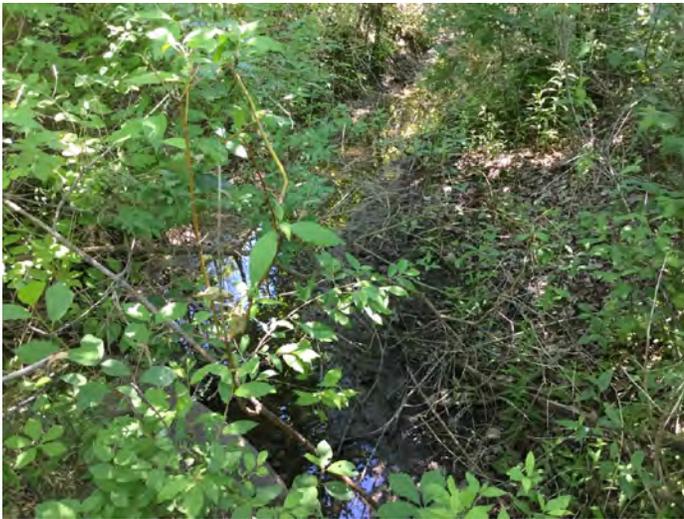
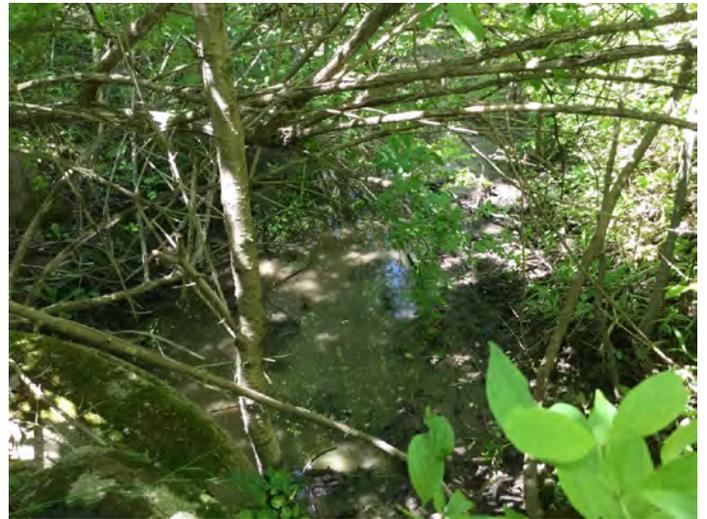
Massive amount of excessive vegetation on both sides of crossing.
Erosion on both sides with a hole on the downstream end of crossing.
Excessive vegetation growing on crossing. No guardrails- farm crossing.

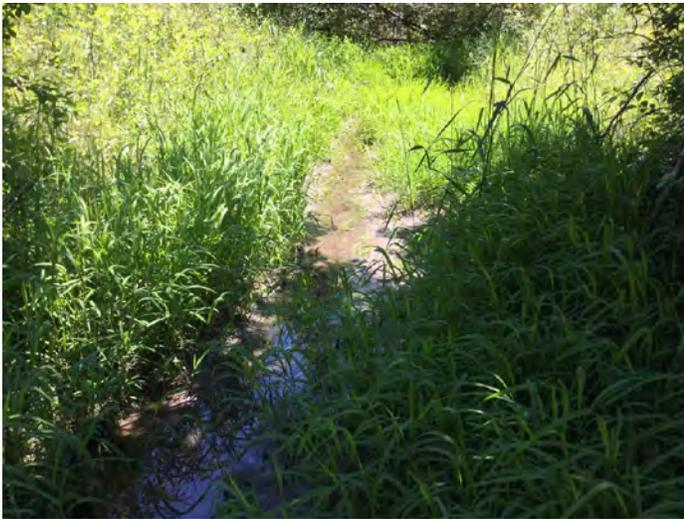
Drain width is significantly smaller- about 1 foot or less. Sediment and excessive grass growing on both sides of drain.

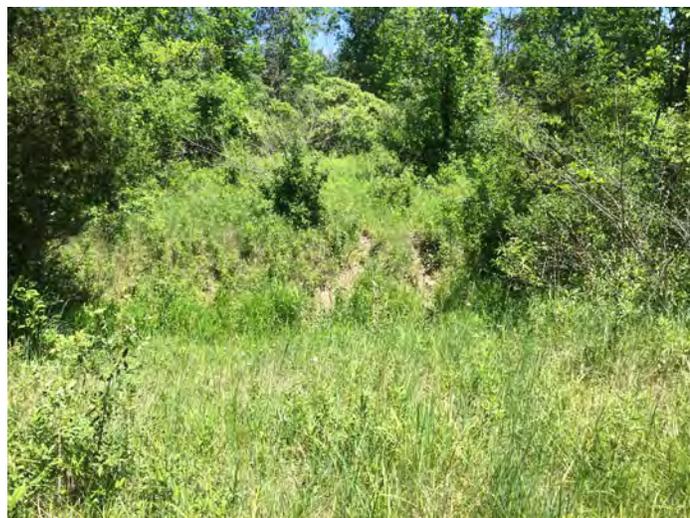
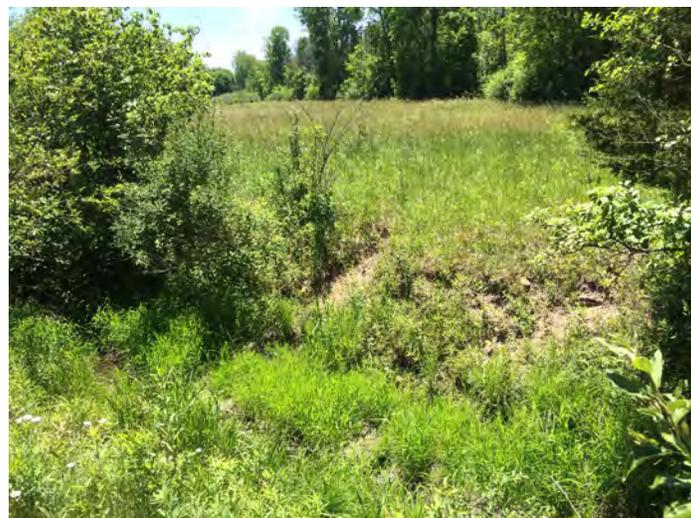
20 ft clearing in excessive vegetation on both sides of drain at northwest corner of grassy field.

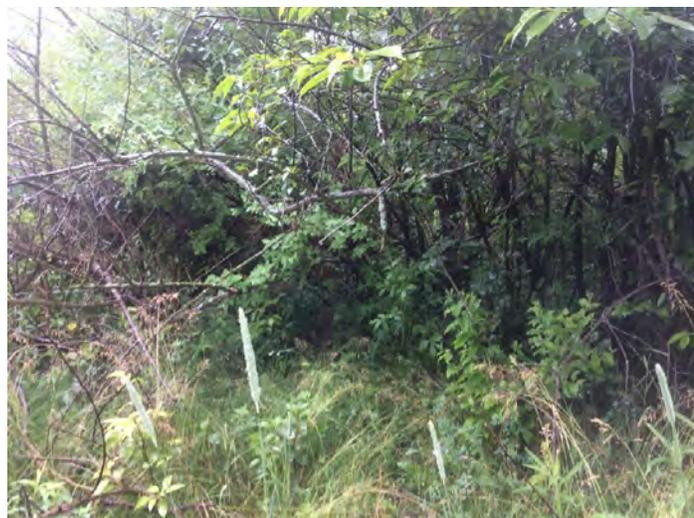
Excessive vegetation up to unimproved far crossing.. Picture facing downstream

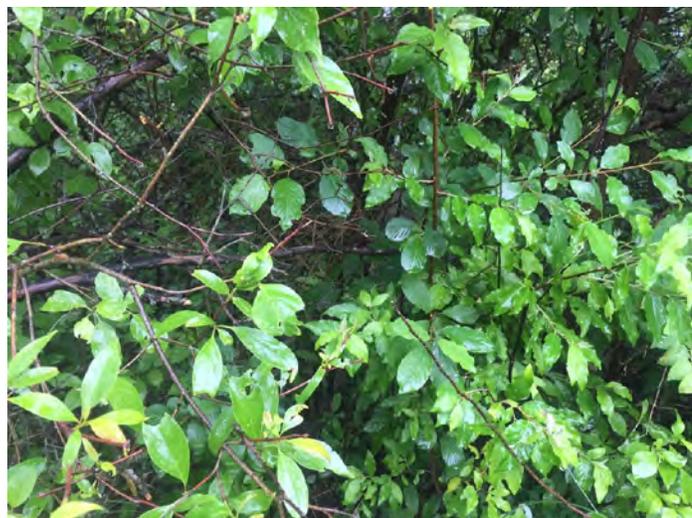
Unimproved farm crossing facing upstream.

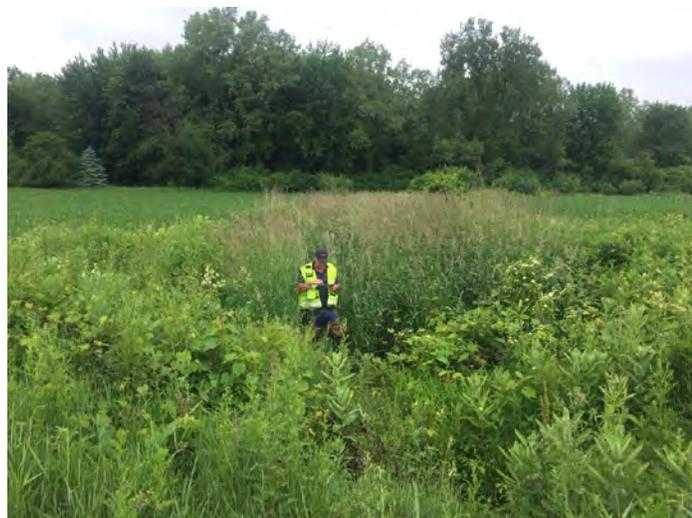
24" culvert farm crossing. Picture facing downstream.

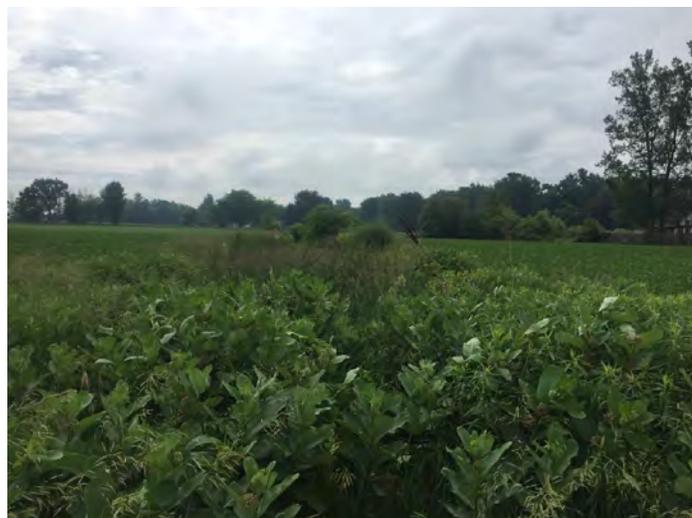
24" culvert farm crossing picture facing upstream.

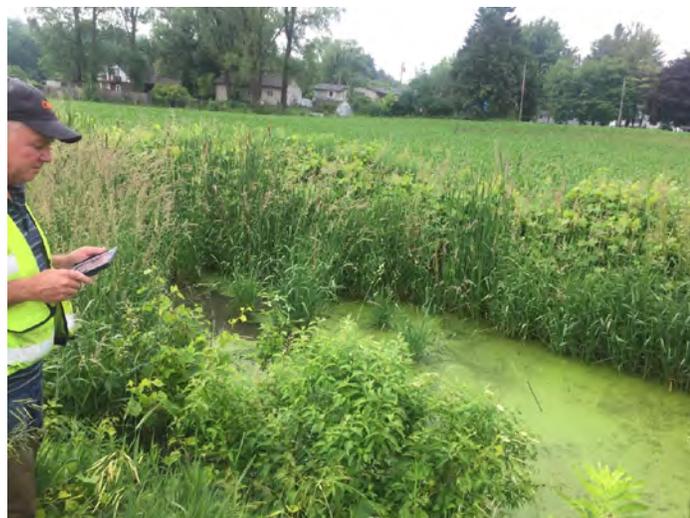
Stagnant water on upstream end of 24" culvert farm crossing. Picture facing upstream.
