# King Street Tile Drain Inspections

Inspection Report for Observation:  
**SideDrain1**

CLIENT	Saginaw County Public Works Commissioner

<b>HUBBELL, ROTH &amp; CLARK, INC</b> CONSULTING ENGINEERS SINCE 1915	555 Hulet Drive P.O. Box 824 Bloomfield Hills, MI 48303-0824 (248) 454-6300 <a href="http://www.hrc-engr.com">http://www.hrc-engr.com</a>	DATE:	08/16/2016
				SCALE:	
NOTE				SHEET #:	
				JOB #:	20160331

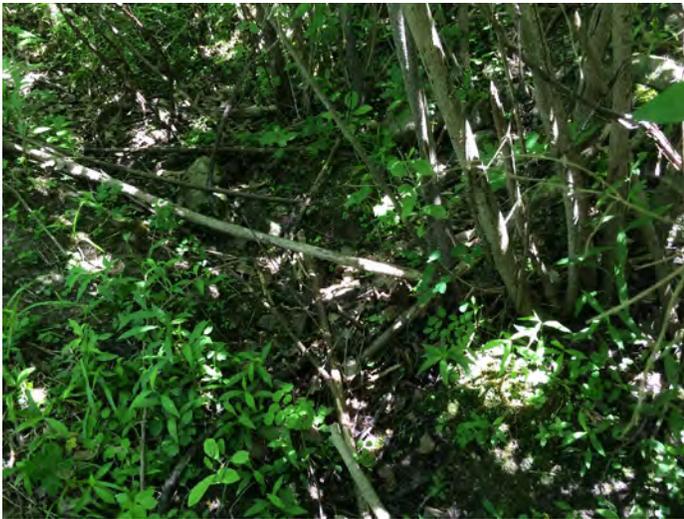
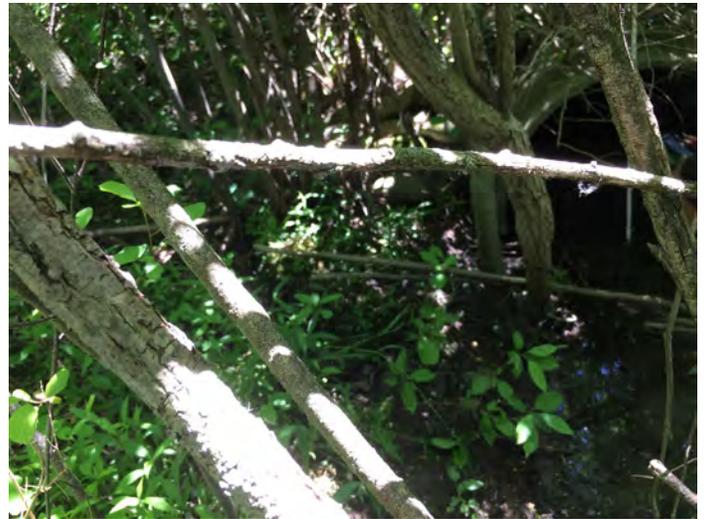
**Comments:**  
Side drain enters on left on downstream side of farm crossing.
