King Street Tile Drain Inspections

Inspection Report for Observation:
SurfaceOutletPipe1

CLIENT	Saginaw County Public Works Commissioner

HUBBELL, ROTH & CLARK, INC CONSULTING ENGINEERS SINCE 1915	555 Hulet Drive P.O. Box 824 Bloomfield Hills, MI 48303-0824 (248) 454-6300 http://www.hrc-engr.com	DATE:	08/16/2016
				SCALE:	
NOTE				SHEET #:	
				JOB #:	20160331

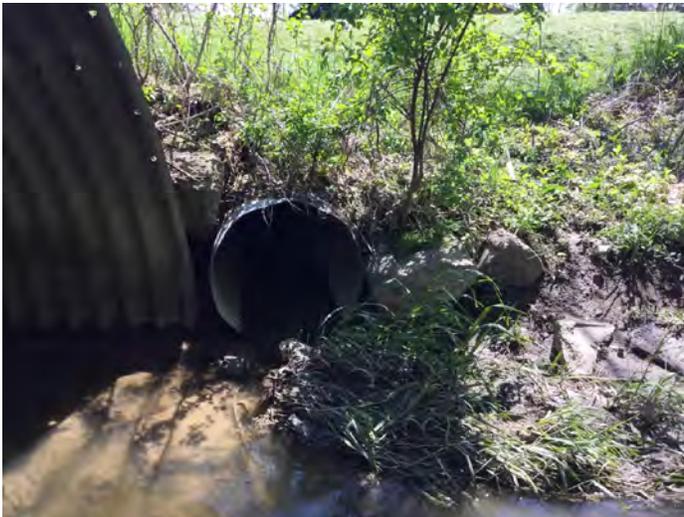
Condition: Fair

30" cmp enters drain from right side. Photo facing south. Broken concrete pieces around outlet to support as head wall.

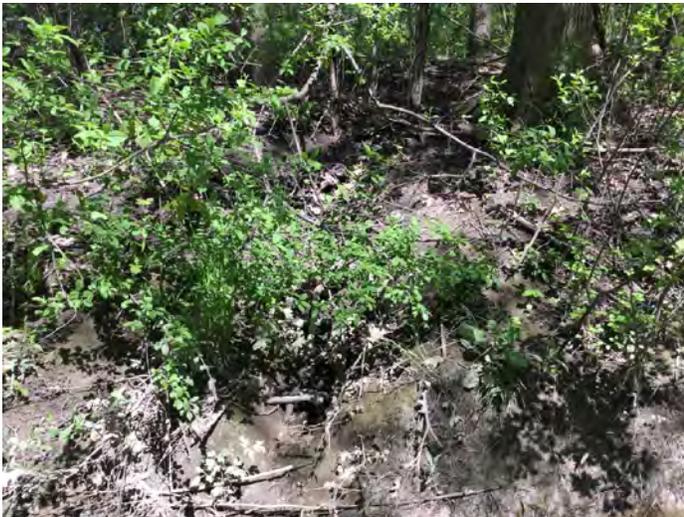
Condition: Fair

3" concrete pipe enters drain from left. Photo facing east.

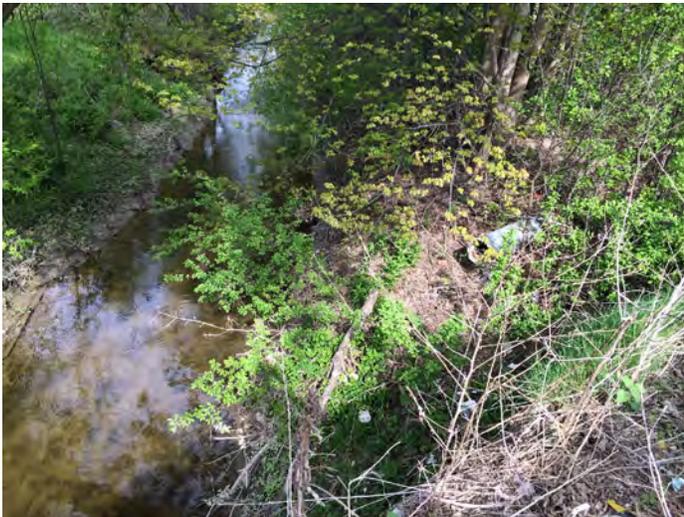
Condition: Poor

12" cmp enters drain on right side. Rusted out in bottom. Photo1 facing upstream. Rusted out in bottom. 20 ft culvert carrying roadside ditch on southeast side of Washington rd. flows northwest.

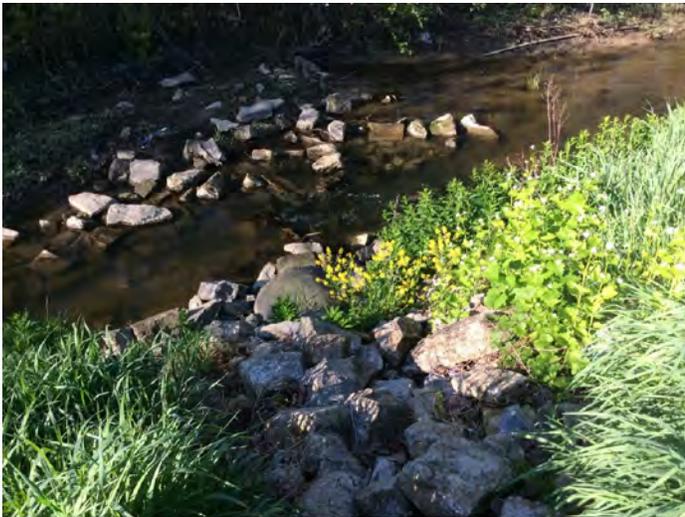
Condition: Fair

24" diam concrete surface outlet pipe. Head wall structure is falling and possibly depositing large rocks in drain. Photo1 facing south. Photo2 facing north.

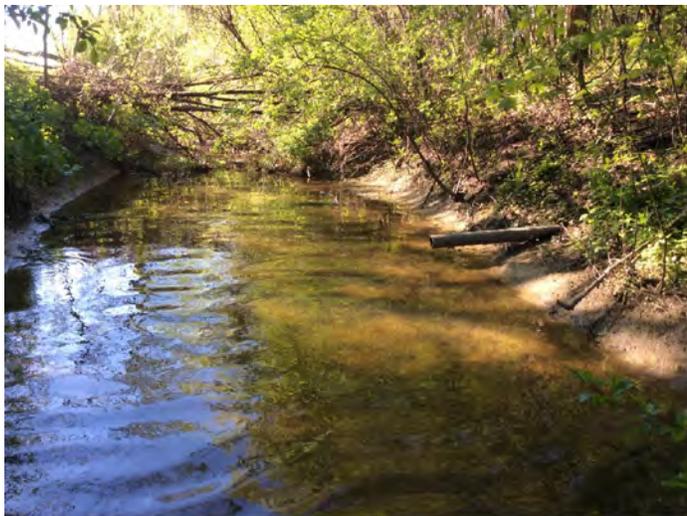
Condition: Fair

4" diam metal pipe enters drain from right. Photo facing upstream.

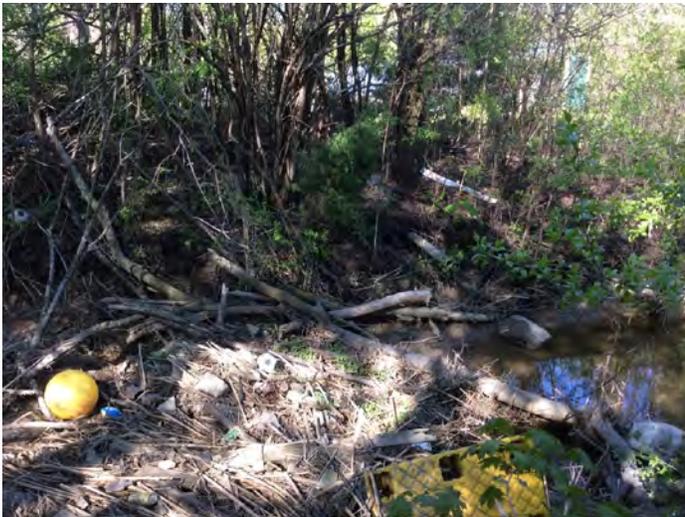
Condition: Fair

Comments:
4" diam metal surface outlet pipe enters drain on right. Photo facing southwest.

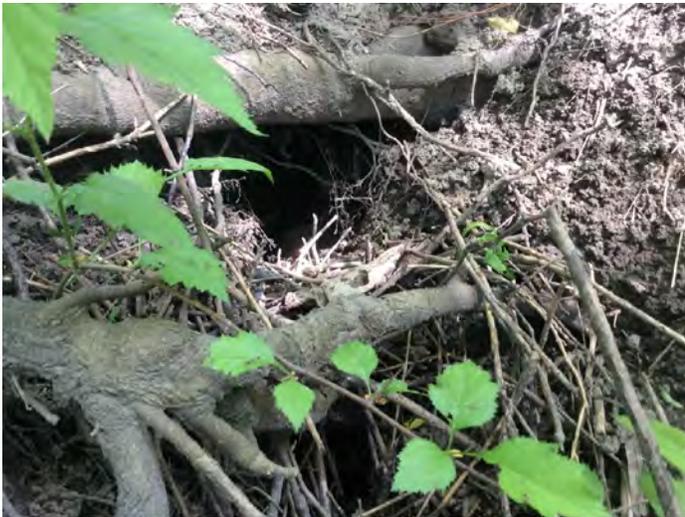
Condition: Failed

4" clay surface outlet pipe. Failed condition. Ends 15" to right of drain. Caused erosion inland. Photos facing east.

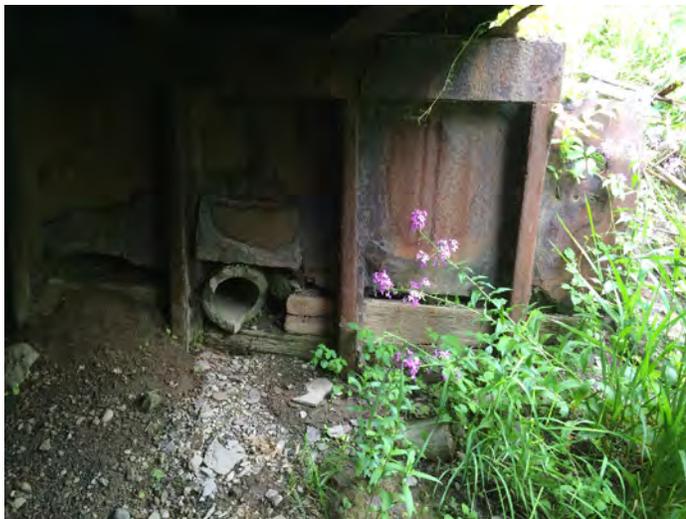
Condition: Fair

8" concrete sop enters drain on right side under bridge.

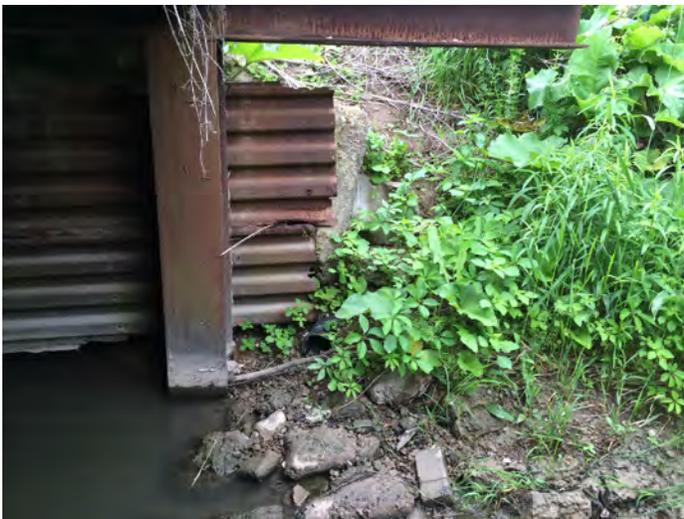
Condition: Fair

6" hdpe sop enters drain on left.

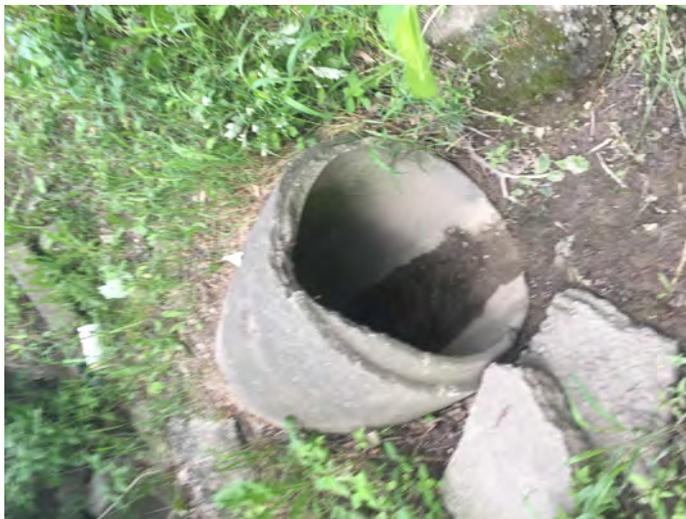
Condition: Poor

30" rcp left side of the drain. Picture facing North

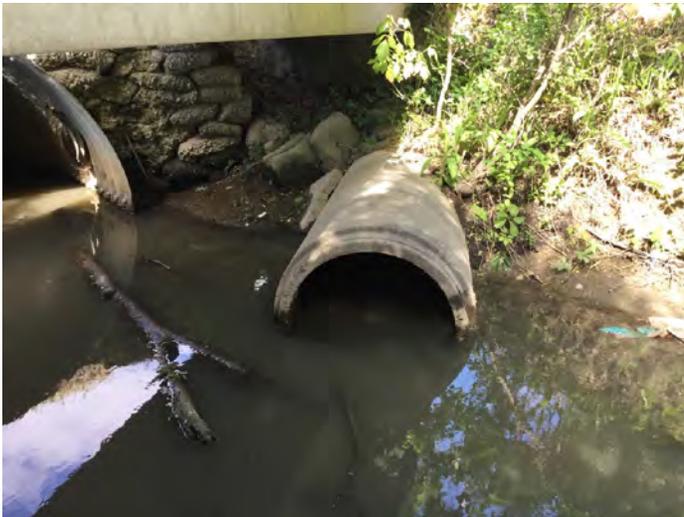
Condition: Good

30" concrete sop enters drain on right side under bridge crossing. Flows west. On south side of King st.

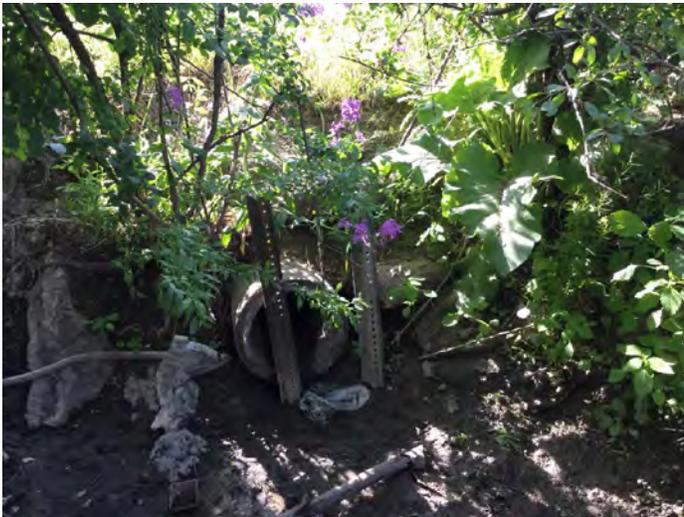
Condition: Fair

12" concrete sop enters drain on left. Flows east. On south side of King st.

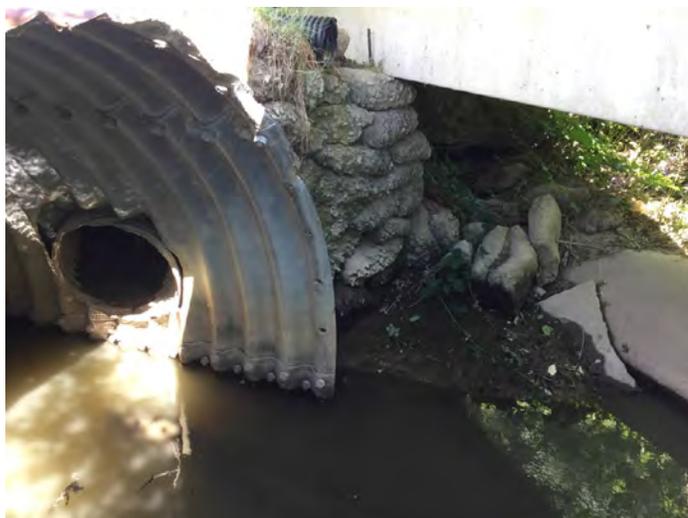
Condition: Fair

18" cmp enters drain on right. Cuts into culvert. In addition to 30" concrete sop. Flows west. On south side of King st.

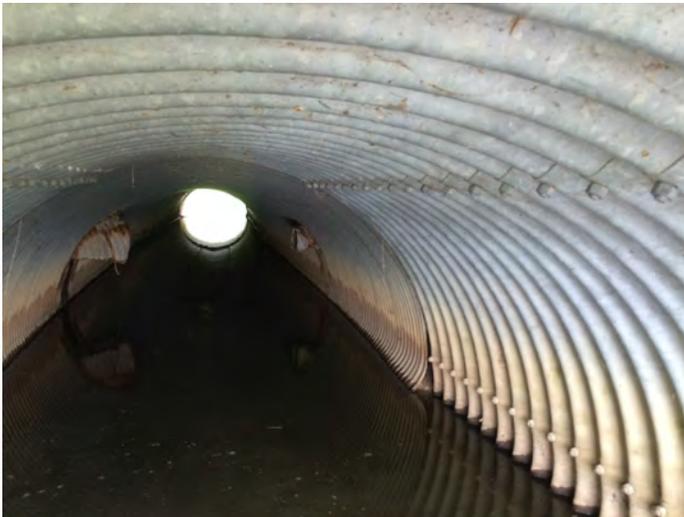
Photo 1

Condition: Poor

8" cmp enters drain on left. Photo facing downstream. Rusted out. Enters drain under King St.

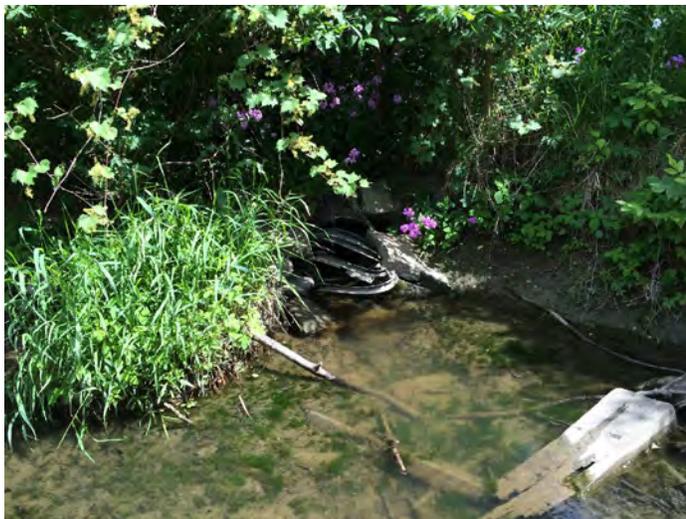
Photo 1

Condition: Poor

18" hdpe sop enters drain on right. End is falling apart. Headwall is eroding. Resulted in bank erosion and sediment bar.

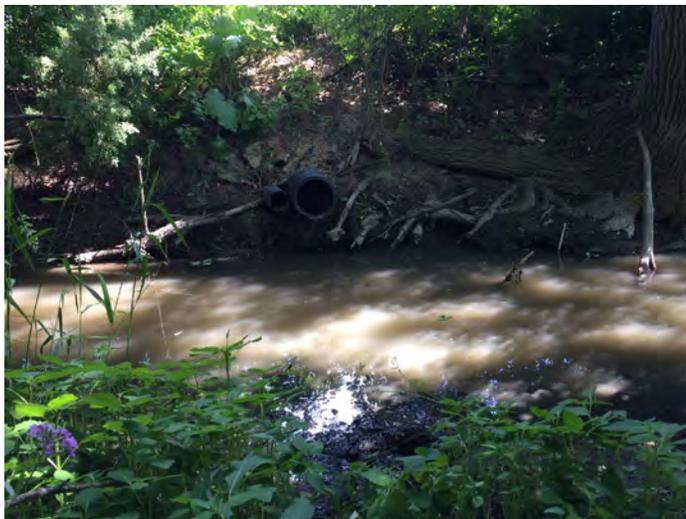
Photo 1

12" hdpe sop. Outlet to storm manhole. Enters drain on right. Flows north.

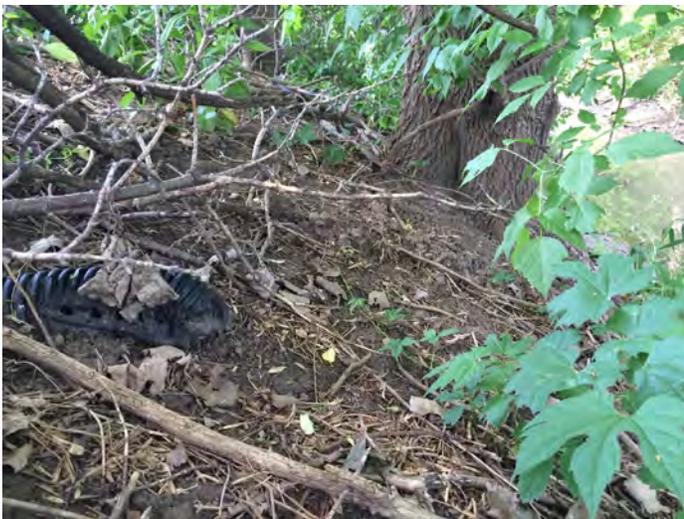
Photo 1

Condition: Poor

3" hdpe sop enters drain on left at top of bank.

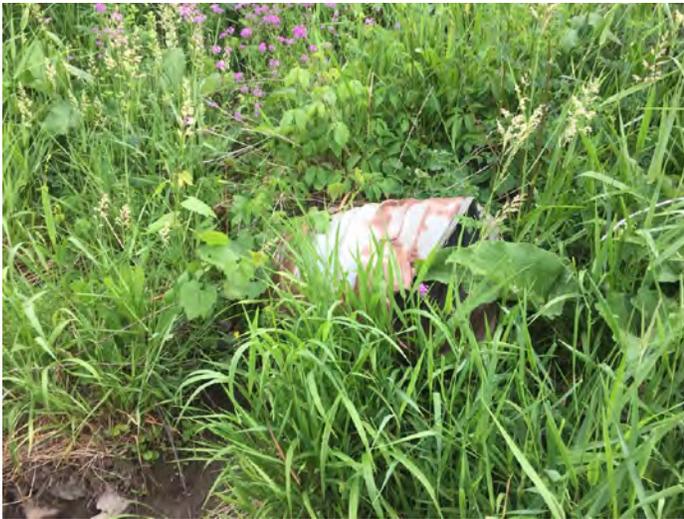
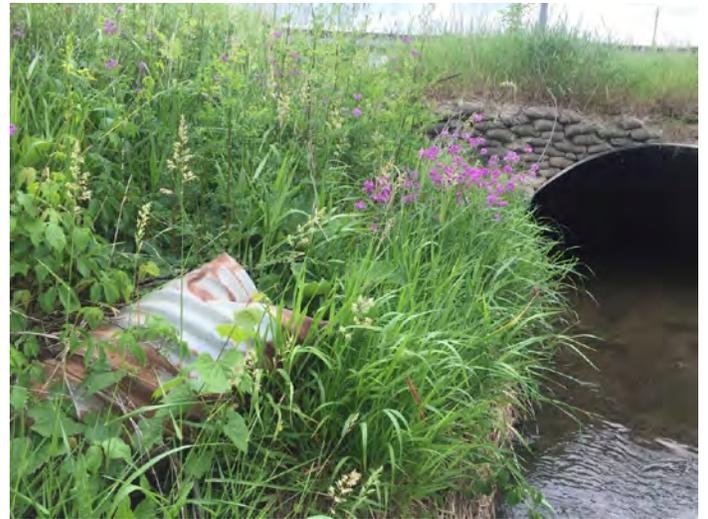
Photo 1

Condition: Poor

Surface outlet pipe is turned up at the end and crushed slightly.

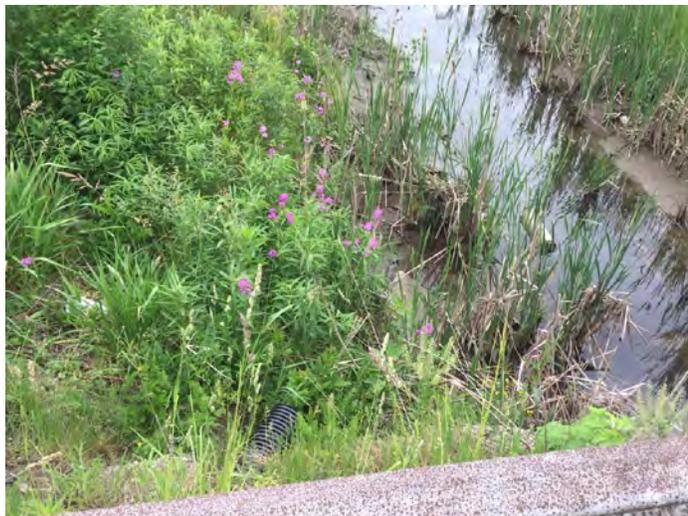
Photo 1

HDPE inlet on left side of drain.

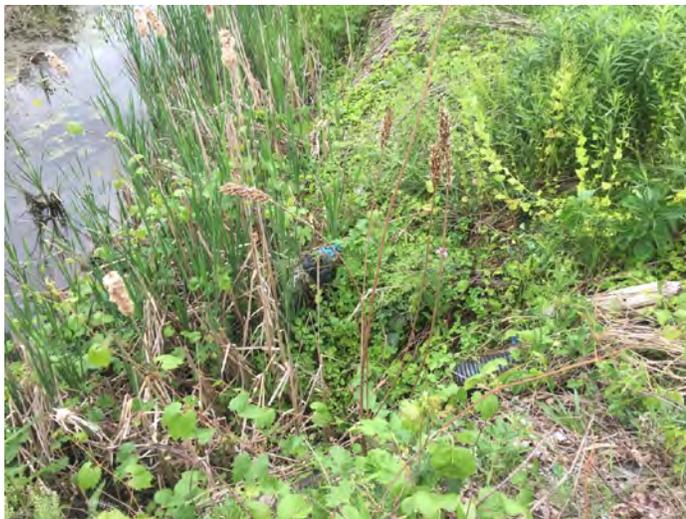
Photo 1

Comments:
HDPE inlet at King Street crossing.

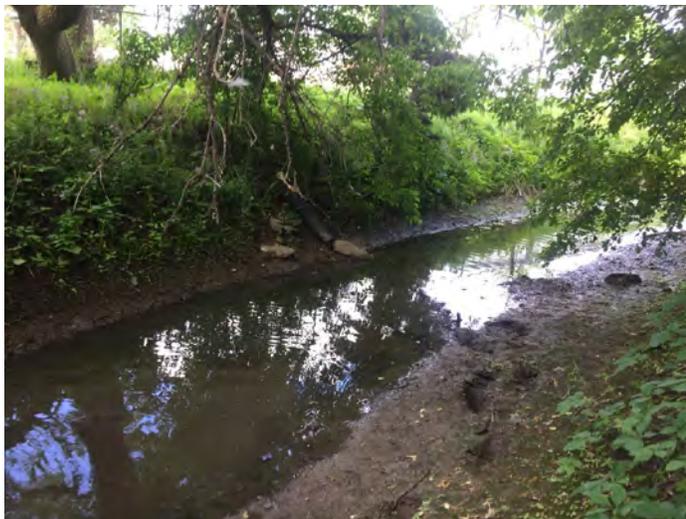
Photo 1

Surface outlet 6" HDPE on left side of drain.

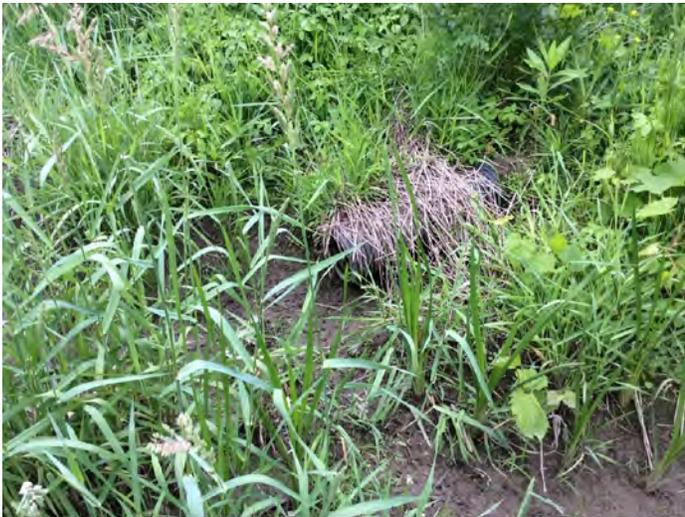
Photo 1

Condition: Fair

Black plastic field tile pipe in decent condition. On right side of drain.

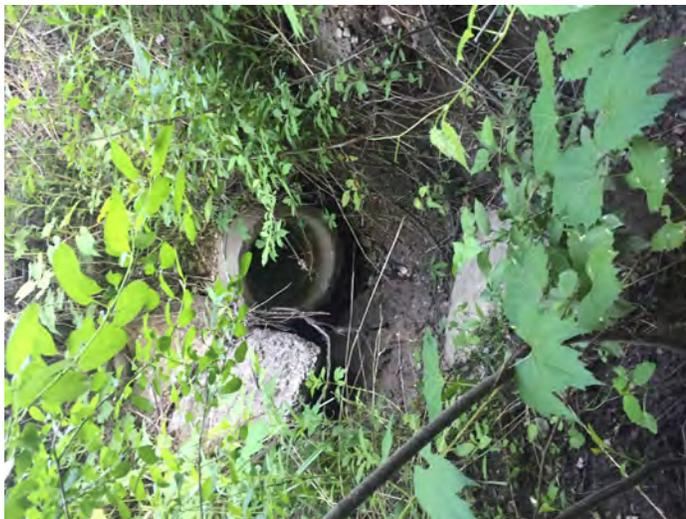
Photo 1

12"rcp left side of the drain . Picture facing North

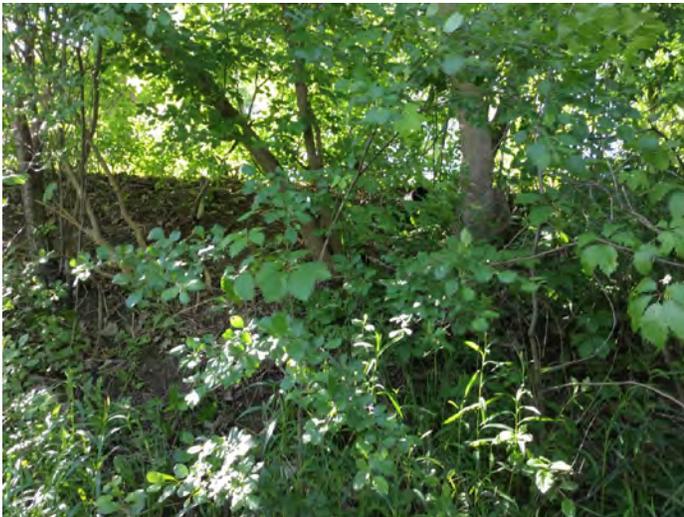
Photo 1

3" metal sop enters drain on right. Flows northwest.

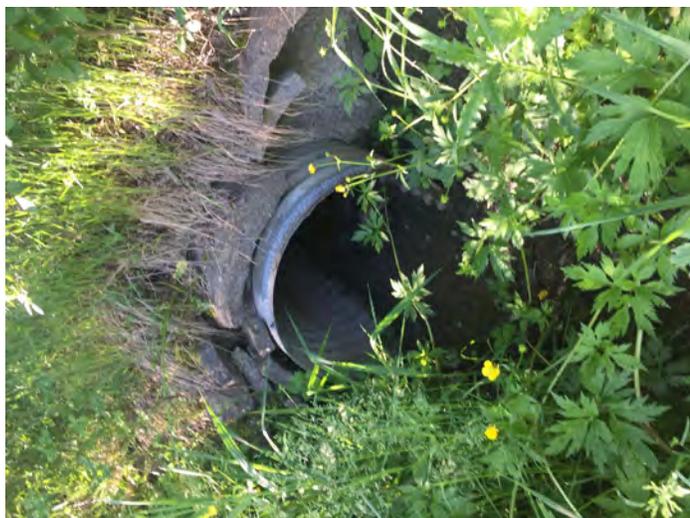
Photo 1

24" cmp right side of the drain. Picture facing South.

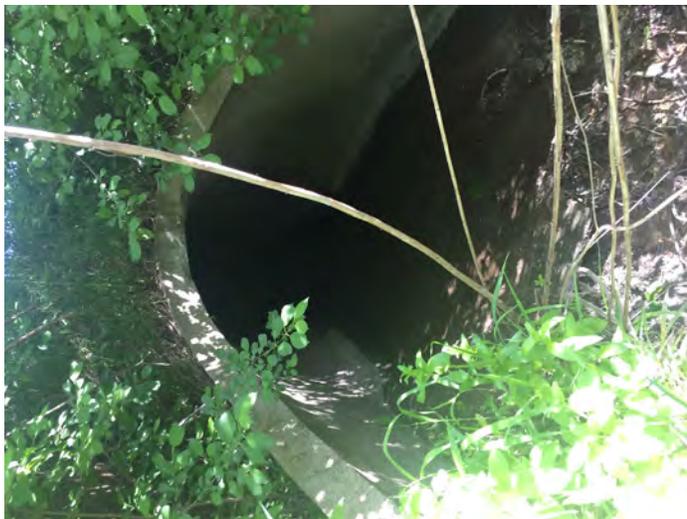
Photo 1

42" rcp end section left side of the drain. Picture facing north.

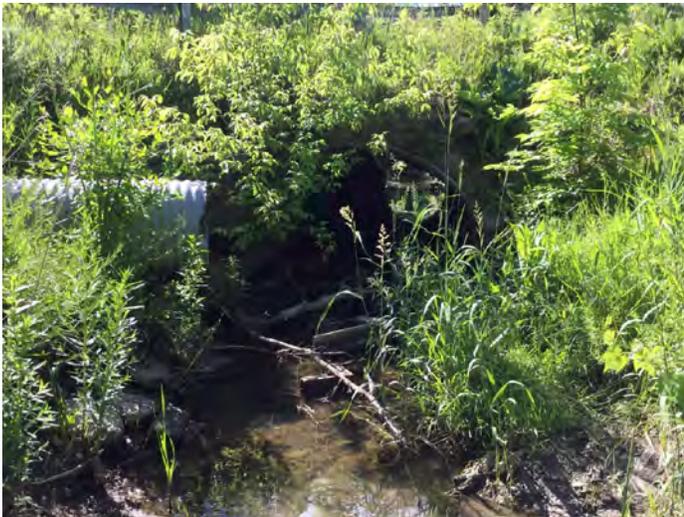
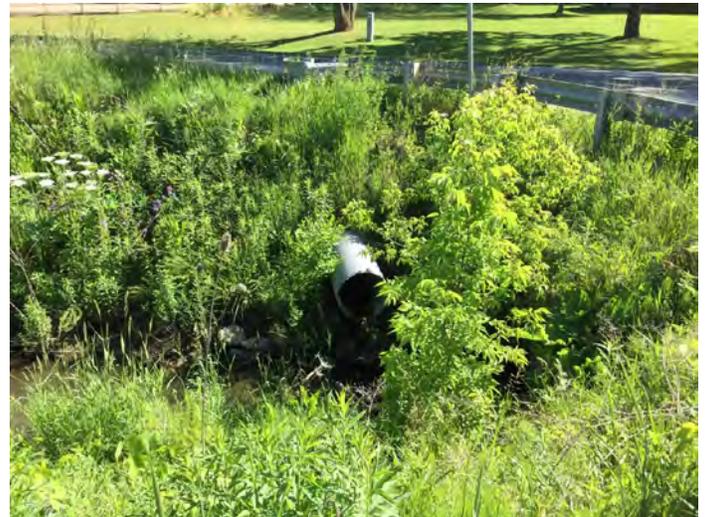
Photo 1

Condition: Fair

24" cmp sop flows southeast, on west side of Broadway st. Enters drain on left.

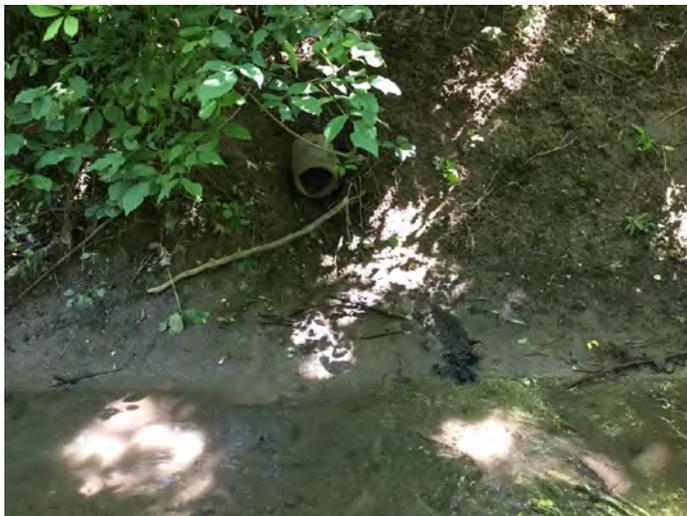
Photo 1

6" concrete sop enters drain on left.

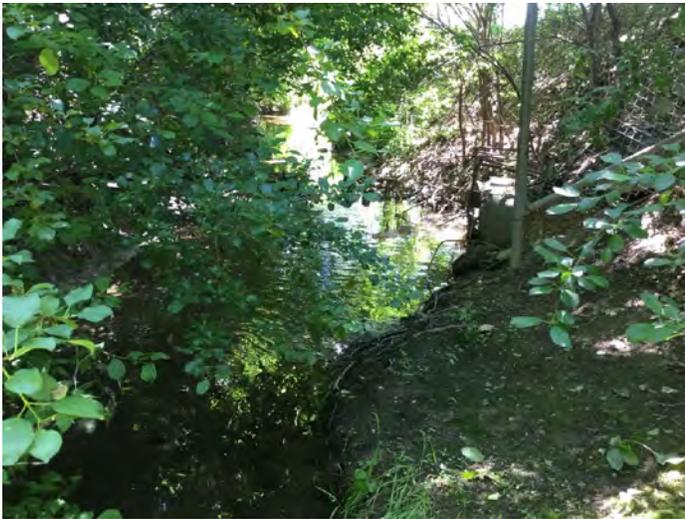
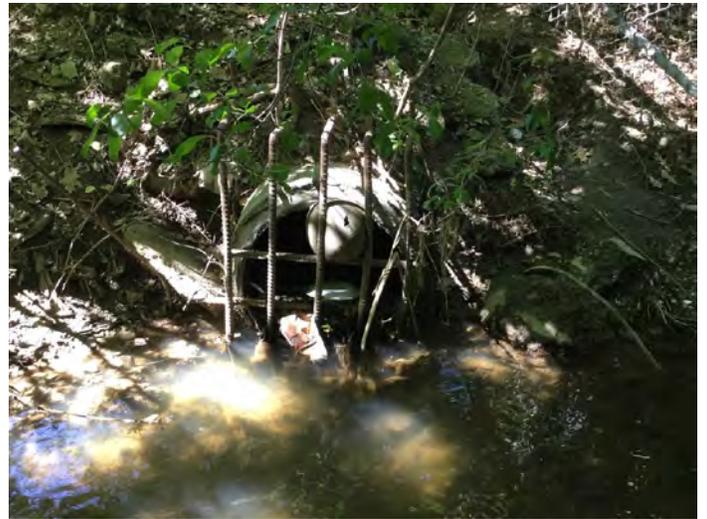
Photo 1

Condition: Fair

24" concrete pipe with grate enters drain on right. Flows north. Erosion around head wall. Upstream of fence.

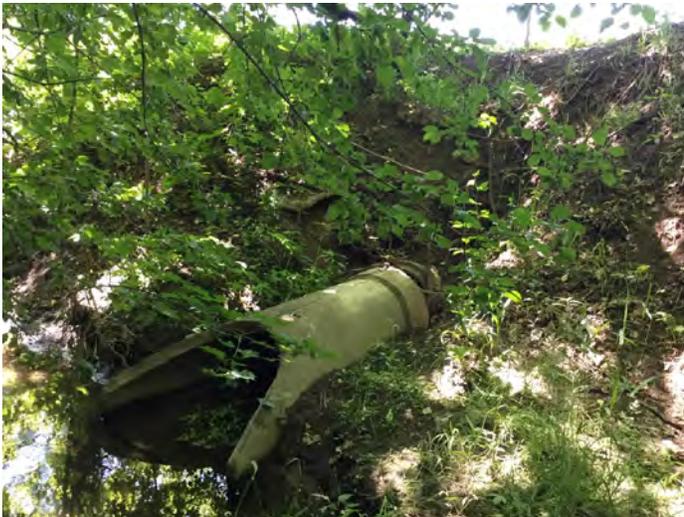
Condition: Failed

24" concrete sop enters drain on right. Flows north. End section has broken off. Significant erosion at broken part of outlet.

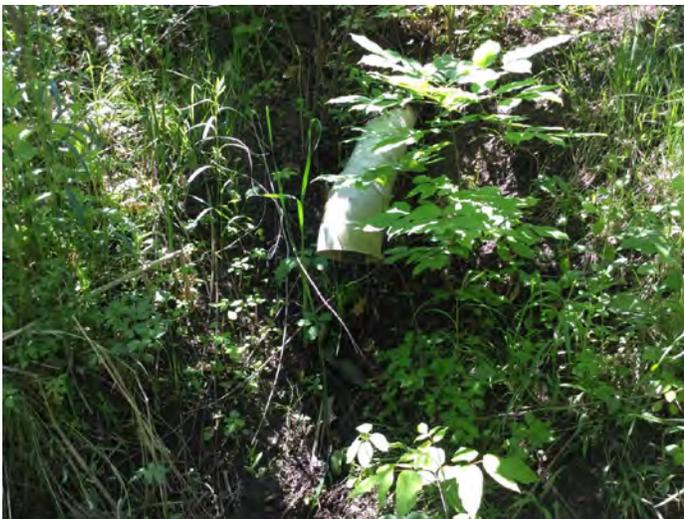
Inspection Report for Observation:
SurfaceOutletPipe48

Condition: Fair

6" pic sop enters drain on right.

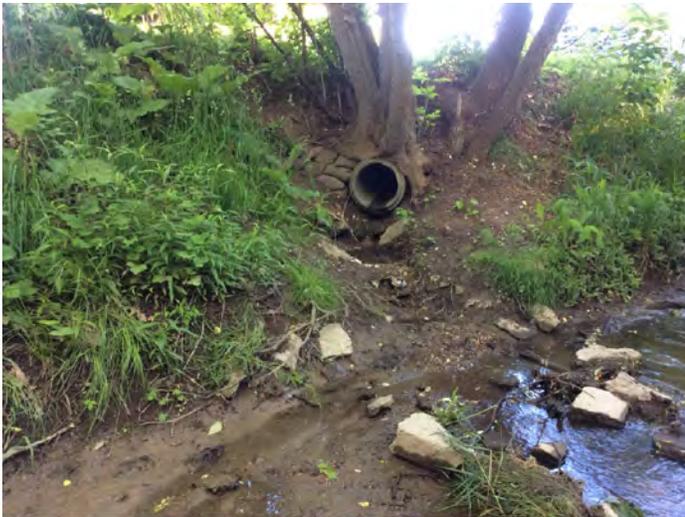
Inspection Report for Observation:
SurfaceOutletPipe49

Condition: Good

Surface outlet concrete pipe on left side of drain protruding from underneath tree. About 40" diameter in good condition. Flow path beneath there is broken stone/concrete.

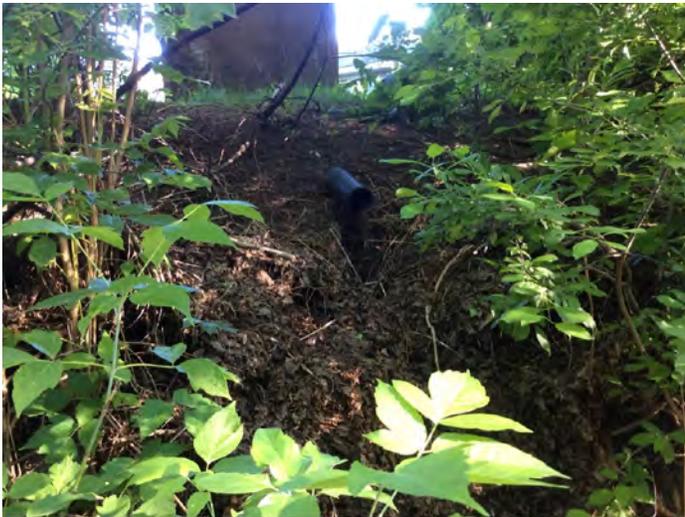
Inspection Report for Observation:
SurfaceOutletPipe50

Condition: Good

Surface outlet PVC pipe on left side of drain. Good condition, but bottom of pipe is a little broken off.

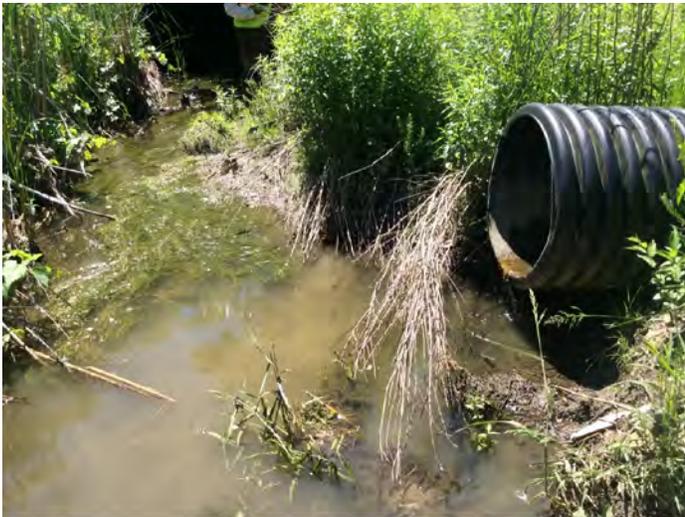
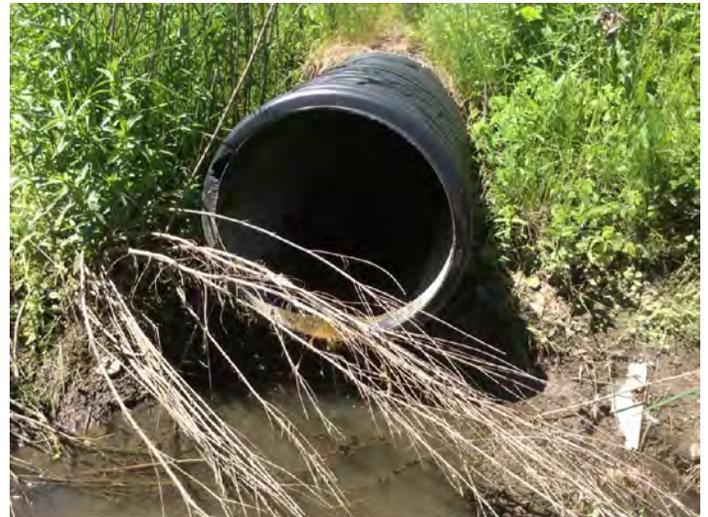
Inspection Report for Observation:
SurfaceOutletPipe52

Condition: Good

PVC 24" pipe on right side of drain. Significant drop in drain depth where pipe is. Some woody debris in front of pipe.

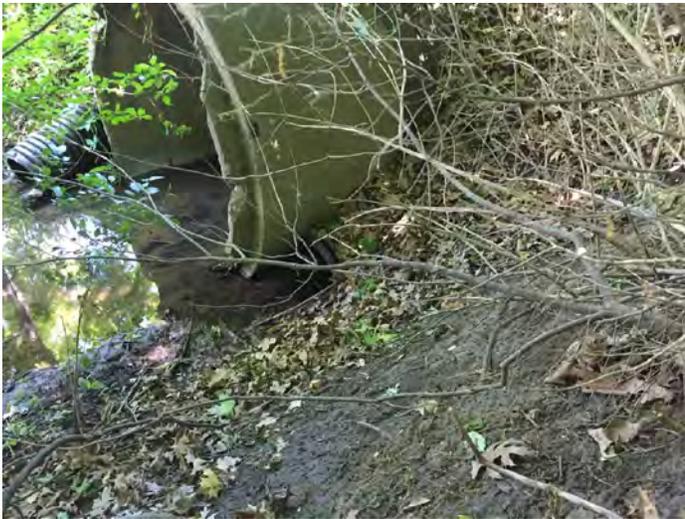
Condition: Good

12" HDPE surface outlet pipe on either side of drain. Picture facing upstream.

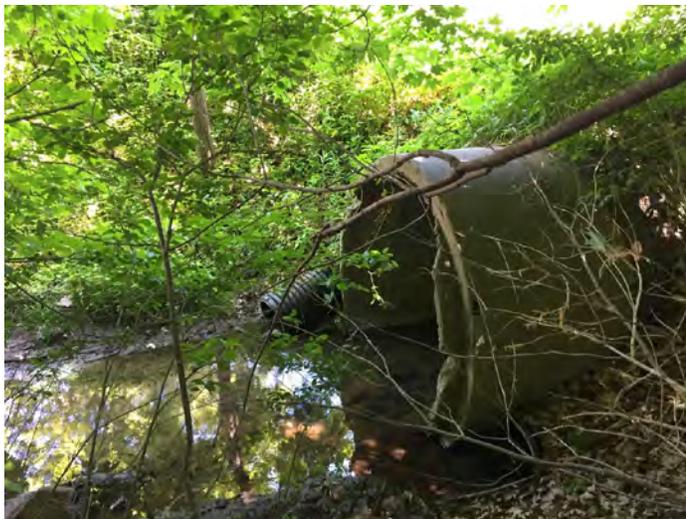
Condition: Good

12" HDPE surface outlet pipes on either side of culvert crossing. Picture facing upstream.

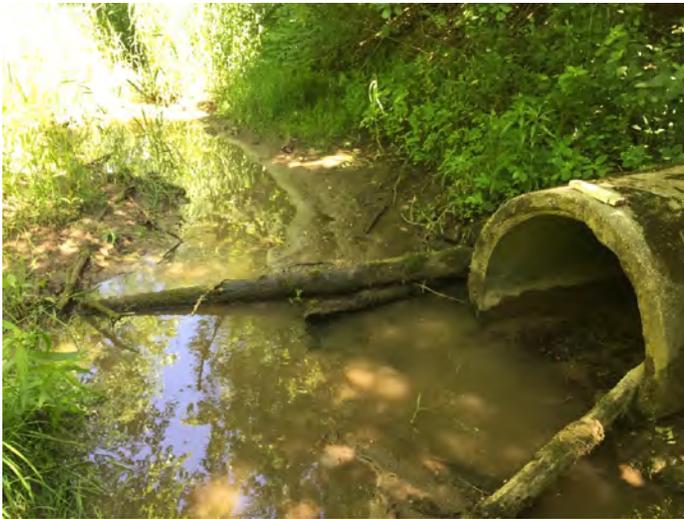
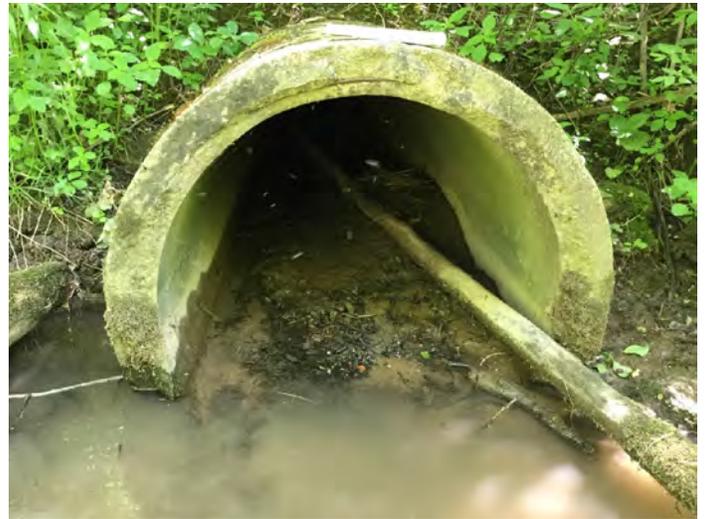
Condition: Fair

Surface outlet metal concrete pipe on right side of drain. 30" wide. Has sediment built up inside and extending log protruding out. Erosion above and around pipe.

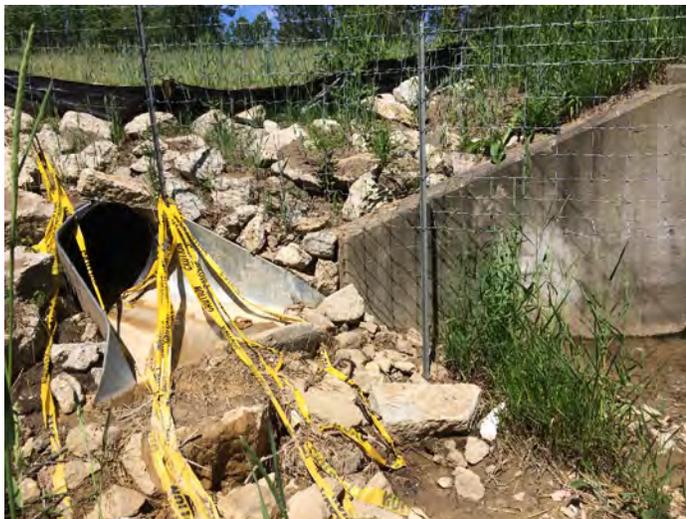
Condition: Good

24" hdpe flows south on I75. Large stone head wall. Enters drain on left.

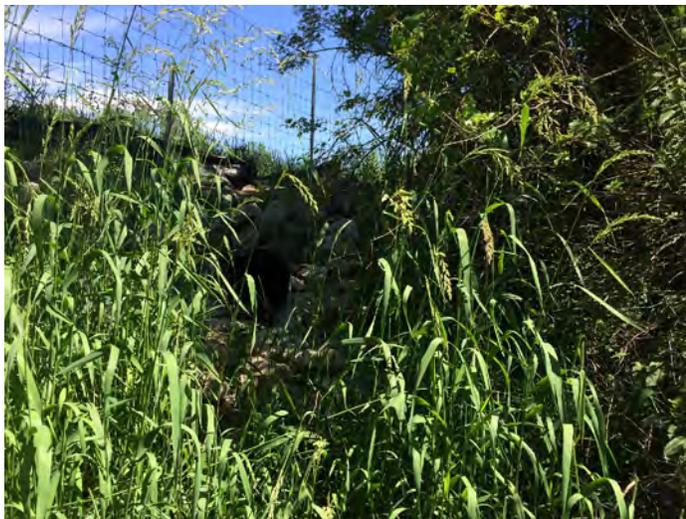
Condition: Good

24" hdpe flows north along I75 and enters drain on right.

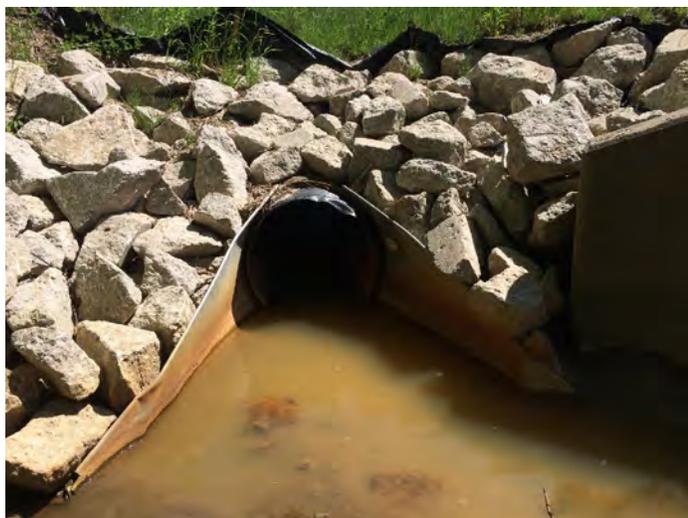
Condition: New

24" hdpe sop enters drain on right from I75. New riprap headwall.

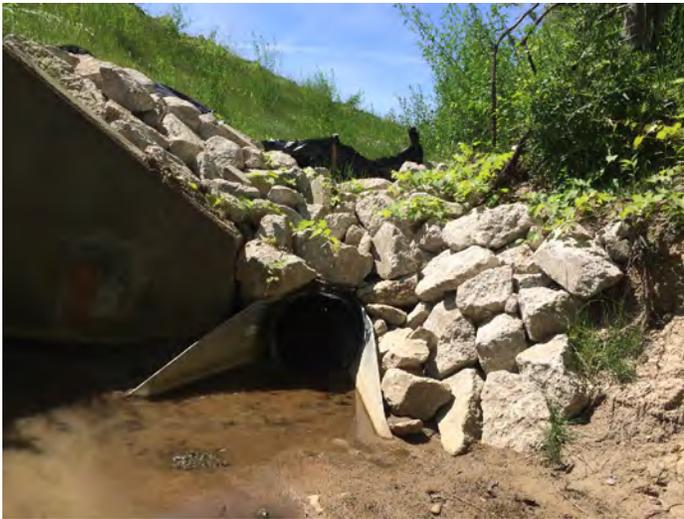
Condition: New

24" diam hdpe sop enters drain on left. Flows south along I75. New riprap headwall.

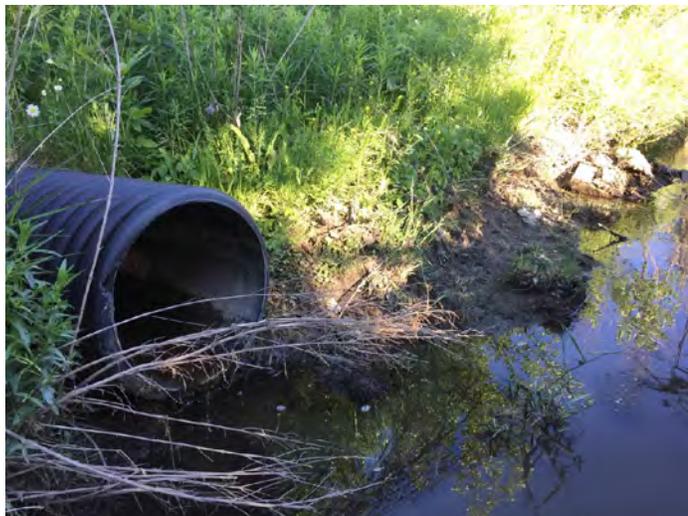
Condition: Good

24" HDPE entering drain on right side facing upstream.

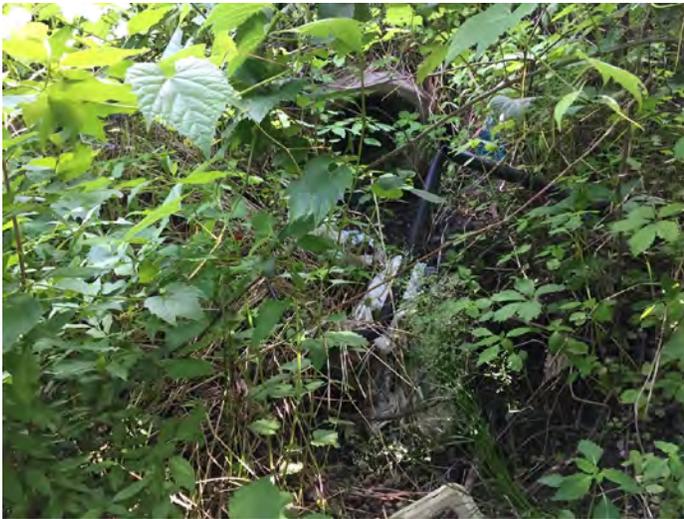
Condition: Good

12" concrete bell outlet side drain on left side of drain facing upstream. Erosion at the mouth. Picture facing north from center of drain.

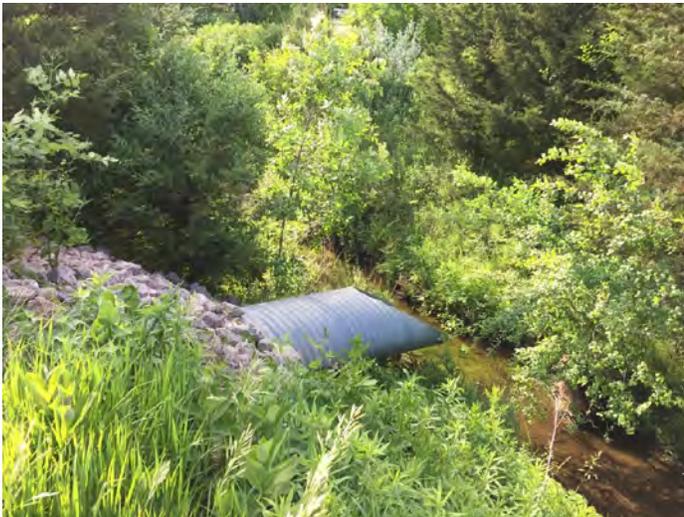
Condition: Good

Comments:
24" CMP surface outlet pipe with rip rap. Picture facing upstream.

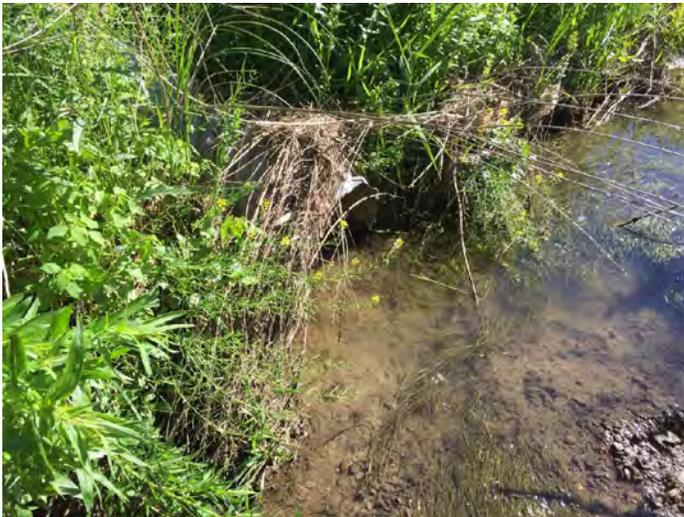
Condition: Good

12" CMP surface outlet pipe coming into drain on left side facing upstream. Picture facing upstream.

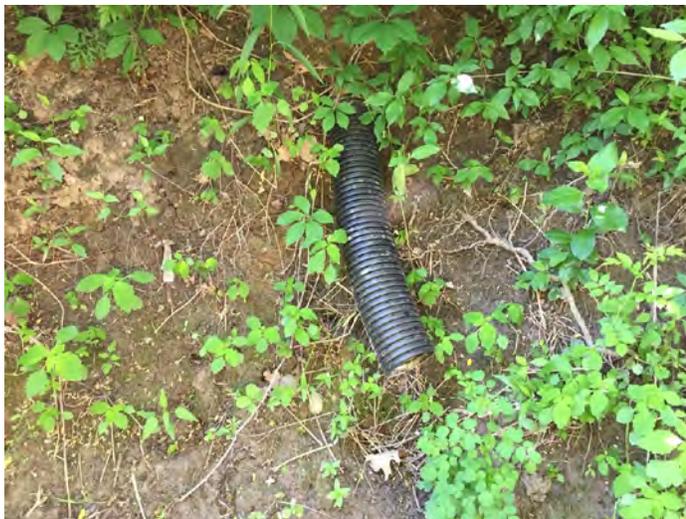
Condition: Good

Surface outlet pipe on the right side. 6" HDPE. Picture facing south from drain.

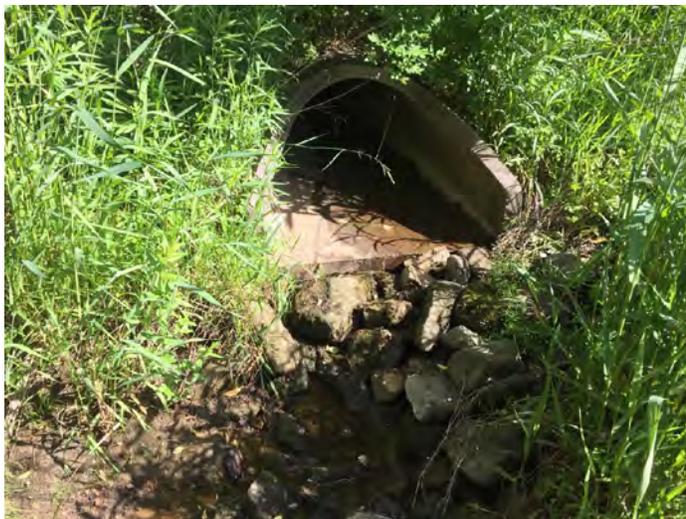
Condition: Good

18" concrete surface outlet pipe with splash pad on left side of drain facing upstream. Picture facing north from center of drain.

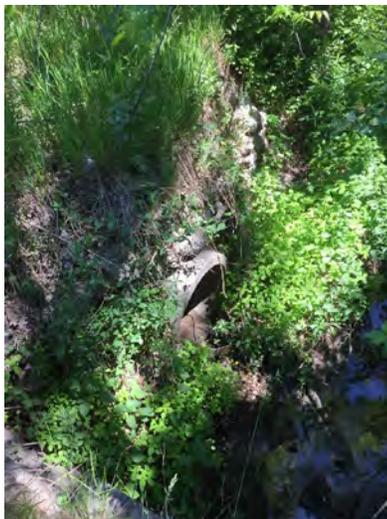
Condition: Fair

30" RCP left side of the drain. Picture facing upstream.

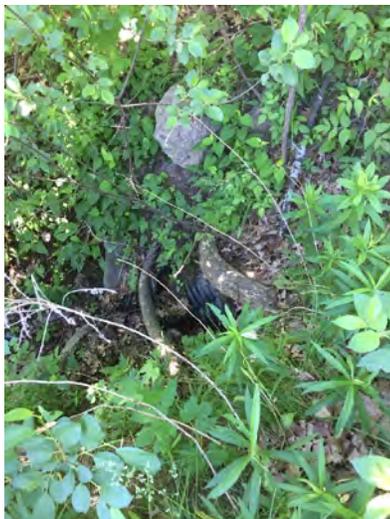
Condition: Failed

10" HDPE right side of drain. Picture facing upstream.

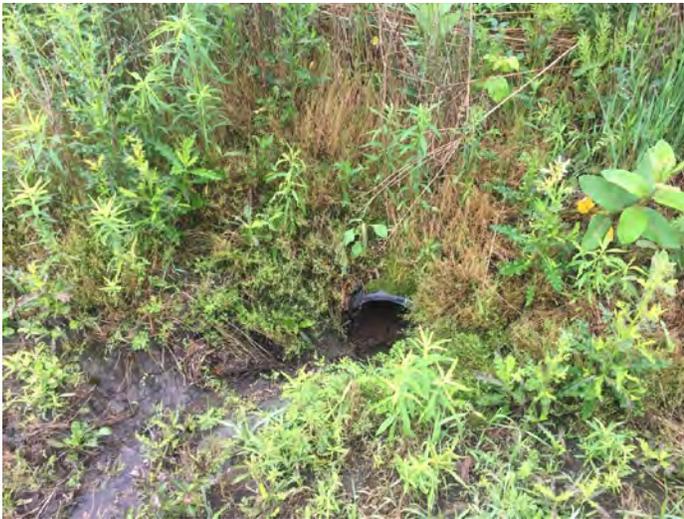
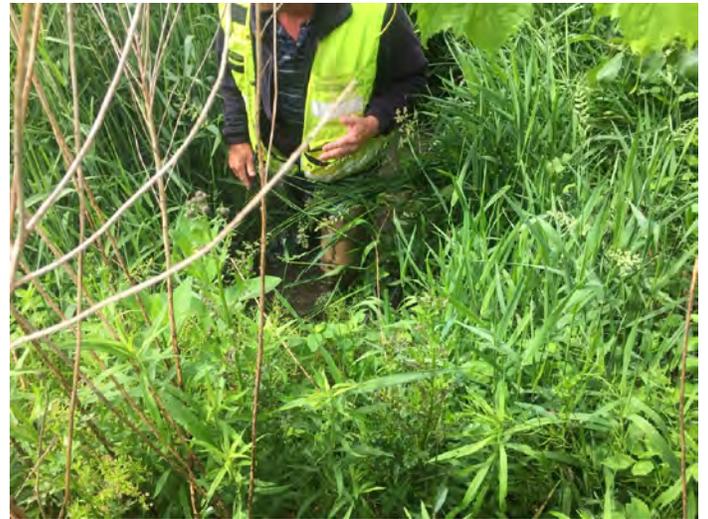
Condition: Good

Surface outlet pipe located on left side of drain facing upstream. Picture one is of inlet end of pipe facing south across drain. Picture two is outlet end facing south. Unable to locate outlet end.

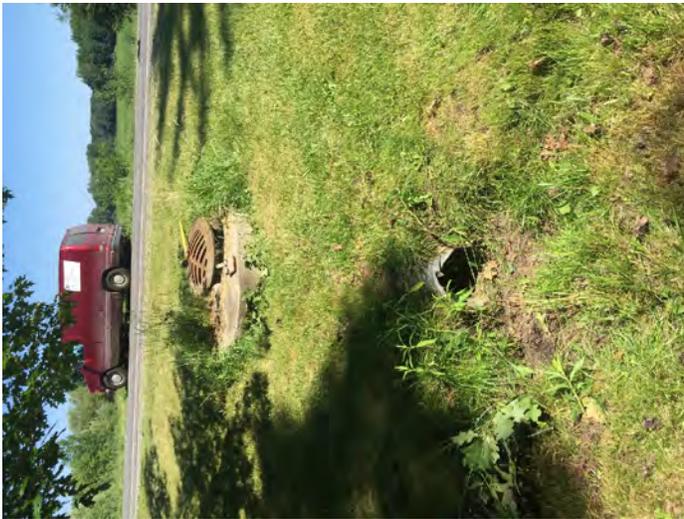
Condition: Fair

10" cmp draning swale from the south into beehive catch basin approx 20' Northwest. Picture facing downstream
