King Street Tile Drain Inspections

Inspection Report for Observation:
Tree1

HUBBELL, ROTH & CLARK, INC CONSULTING ENGINEERS SINCE 1915	555 Hulet Drive P.O. Box 824 Bloomfield Hills, MI 48303-0824 (248) 454-6300 http://www.hrc-engr.com	DATE:	08/16/2016
				SCALE:	
NOTE				SHEET #:	
				JOB #:	20160331

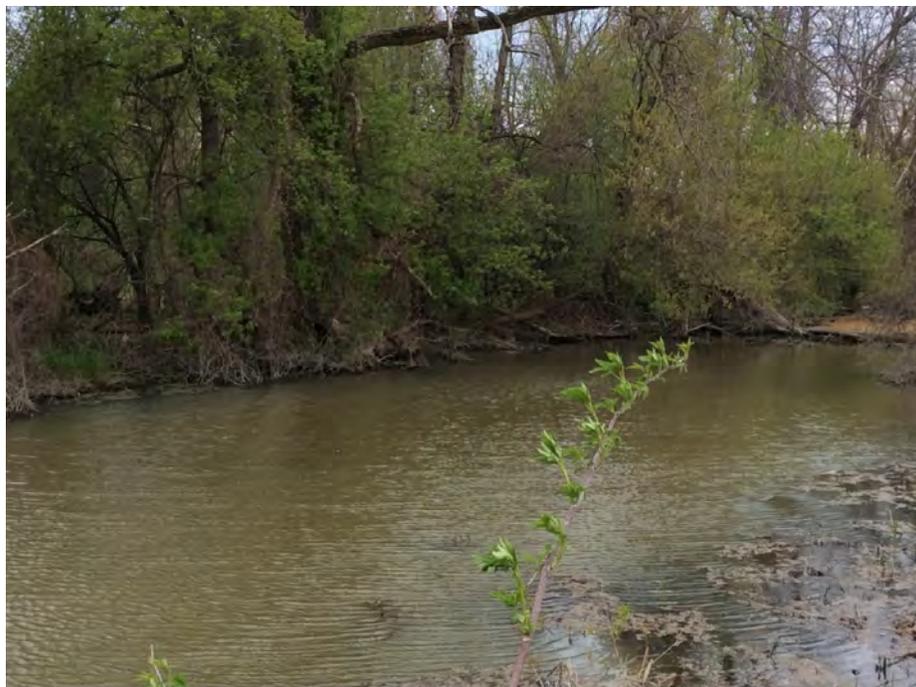
Inspection Report for Observation:
Tree5

Upstream left 25 trees up to 48". Next 300 ft.

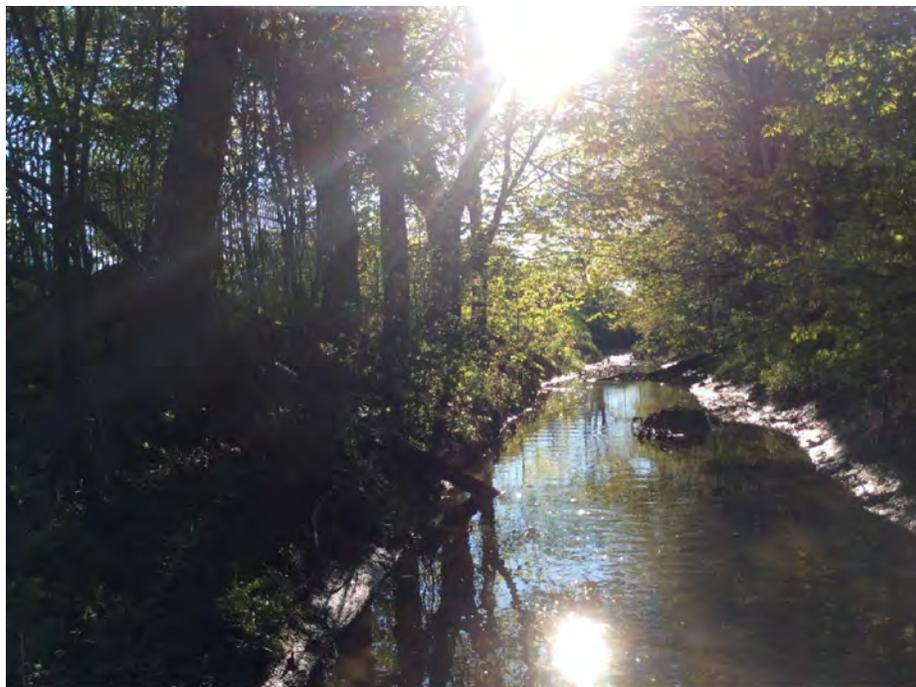
Inspection Report for Observation:
Tree30

6 large trees, up to 18" diam, on left side over next 50 ft. Photo facing upstream.

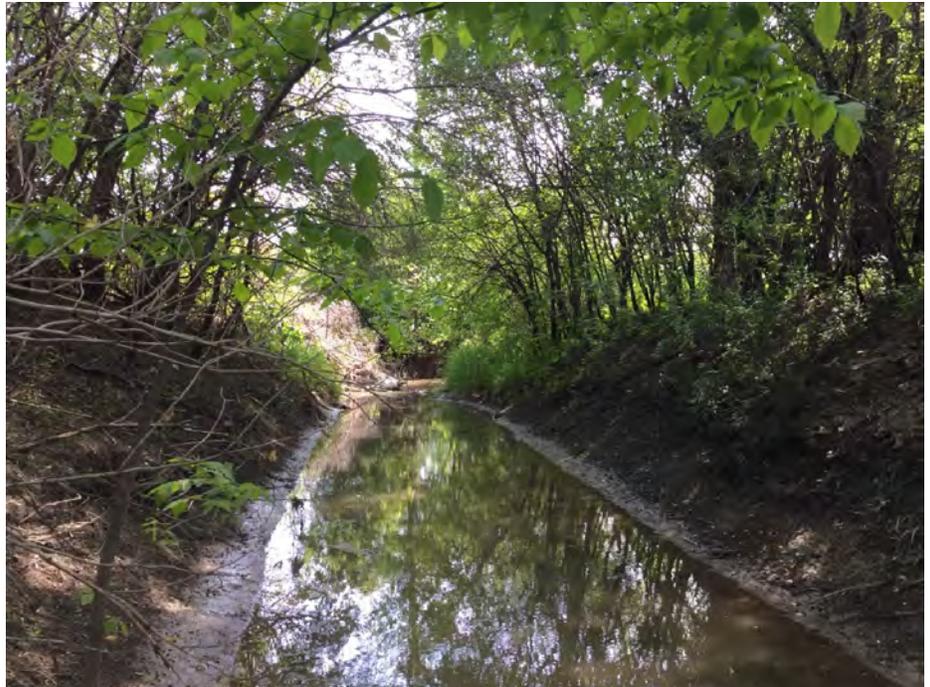
Photo 1

Trees over drain greater than 3 in. diameter. About 10-15. Photo facing downstream.

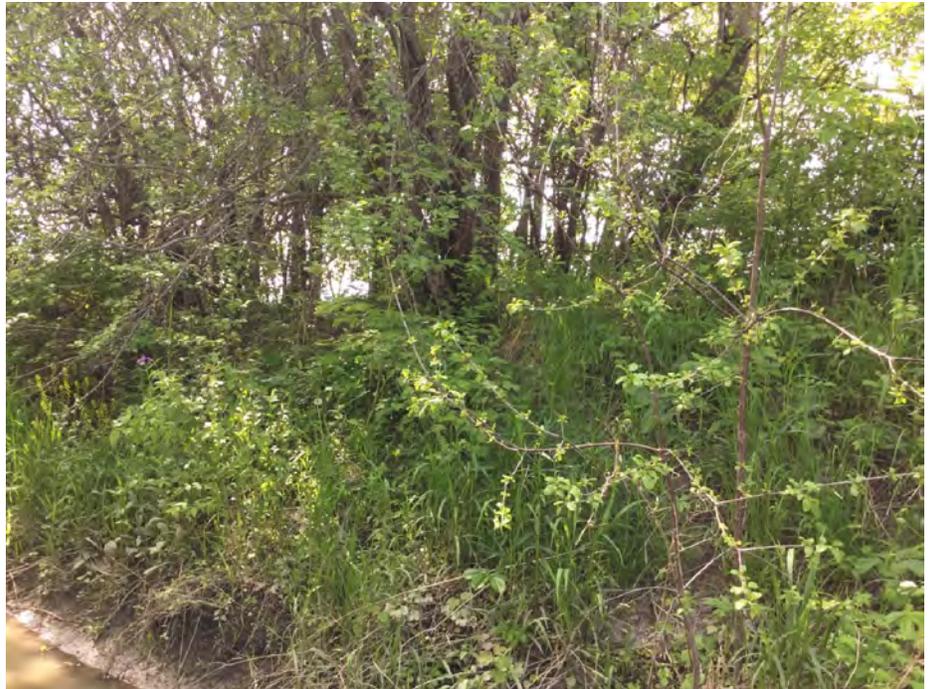
Photo 1

Trees overhanging. Over 3 in. diameter. About 6 trees. Left side of drain. Photo taken facing west.

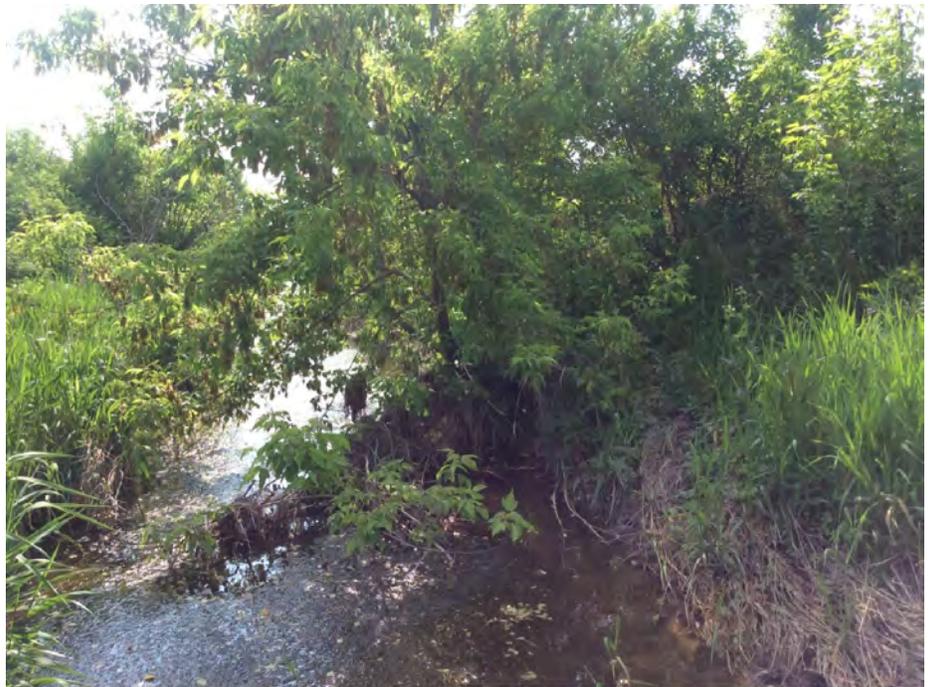
Photo 1

3" diam tree on right side. Branches and limbs are overhanging drain. Photo facing upstream.

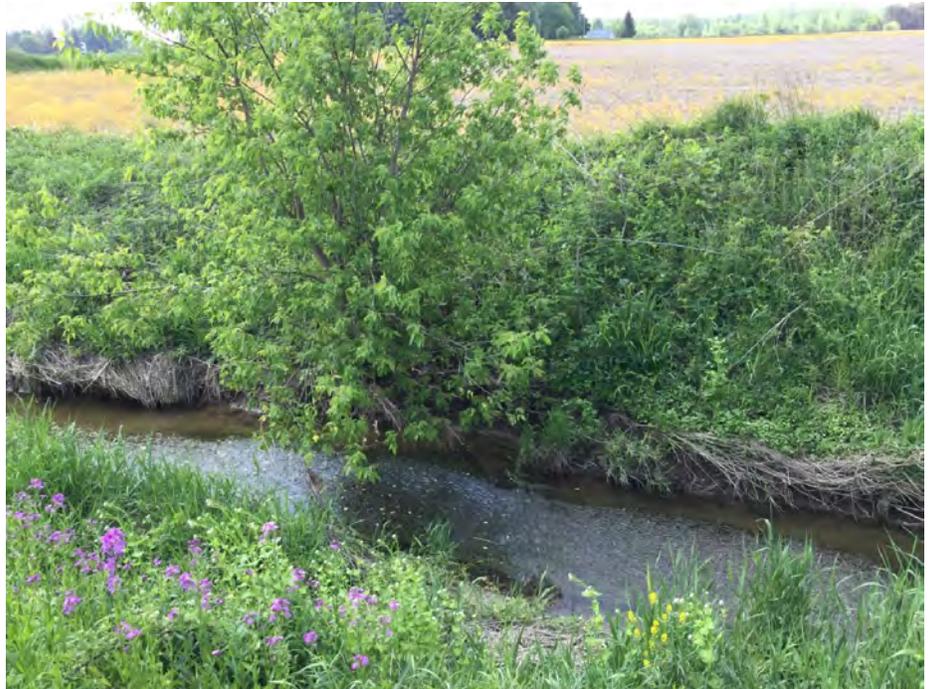
Photo 1

Overhanging tree on right side of drain. Diameter about 15". Photo taken facing south.

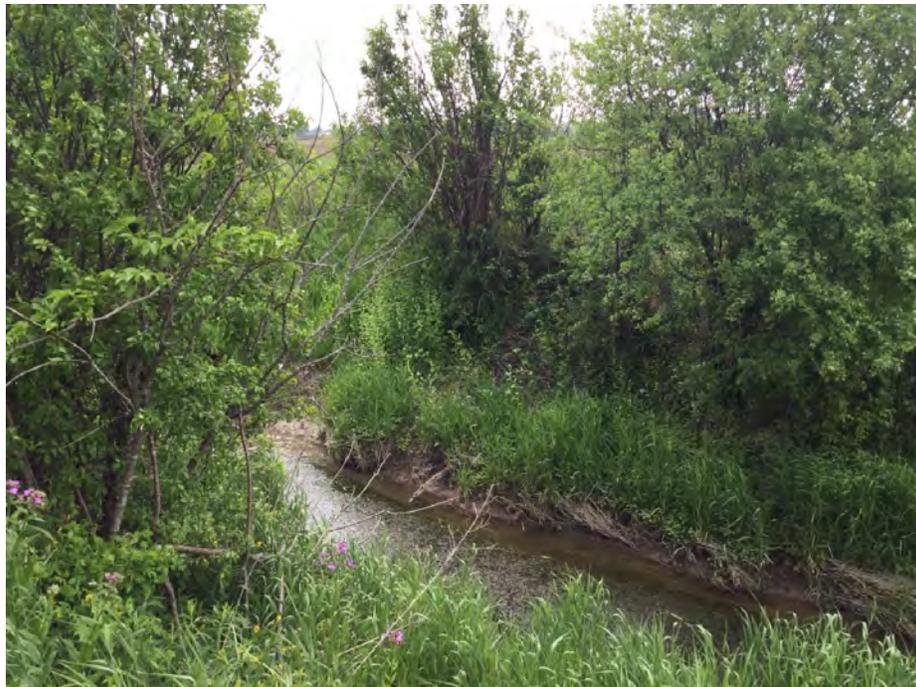
Photo 1

Clumps of trees on both sides of drain. Around 3" diameter, but clumped together looks like 1 tree. About 10-20. Photo taken facing southeast.

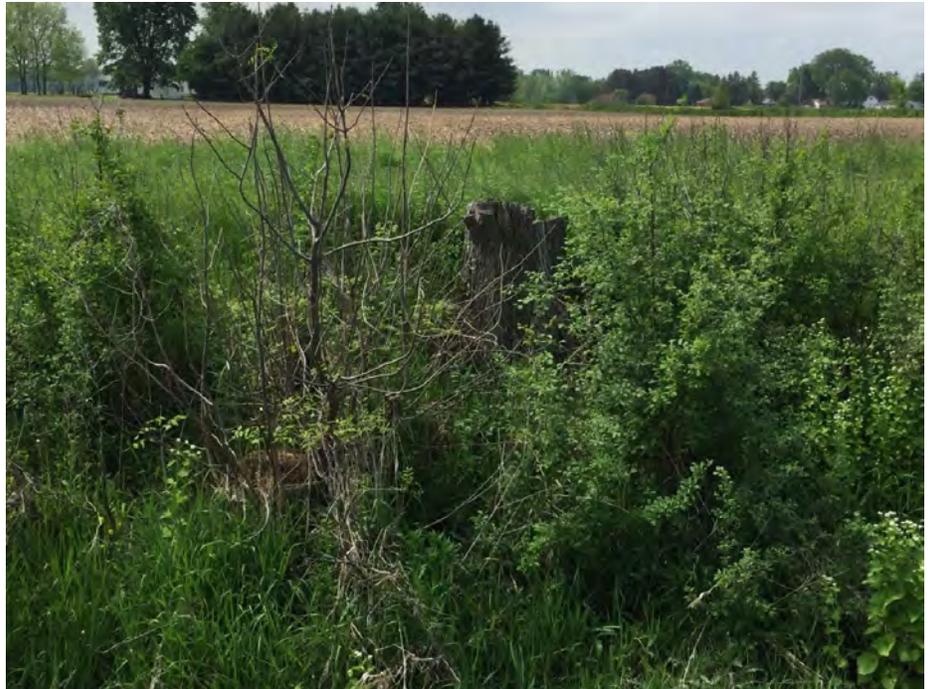
Photo 1

6 tree stumps on right side of drain.
About 92 ft apart from first stump to last.
Photo taken facing south.

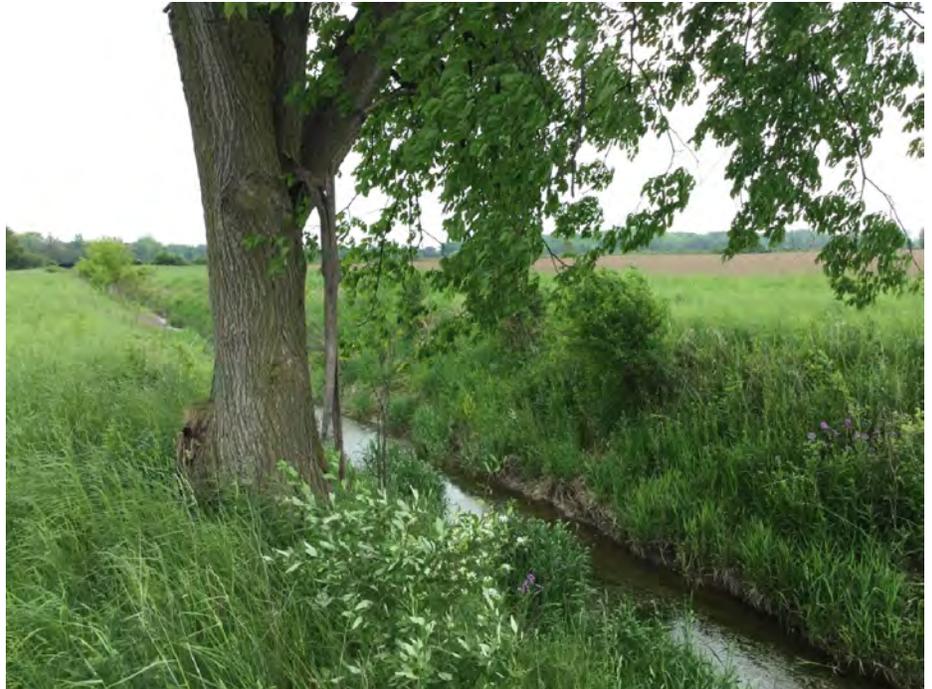
Photo 1

Tree on left side of drain facing upstream. About 50" diameter. Photo taken facing southeast.

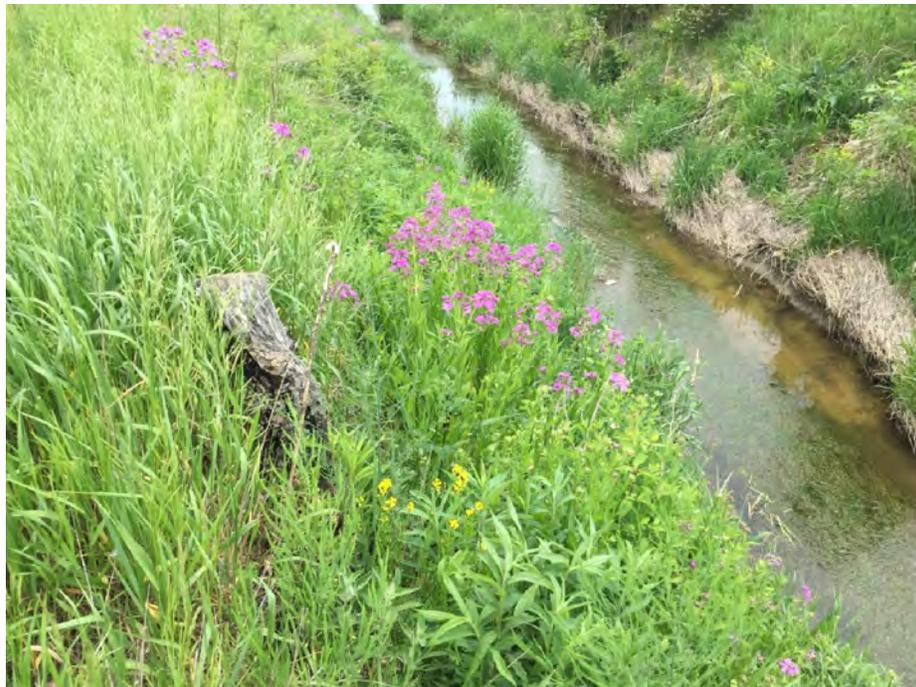
Photo 1

Small stump on left side of drain facing upstream. About 10" diameter. Photo taken facing upstream.

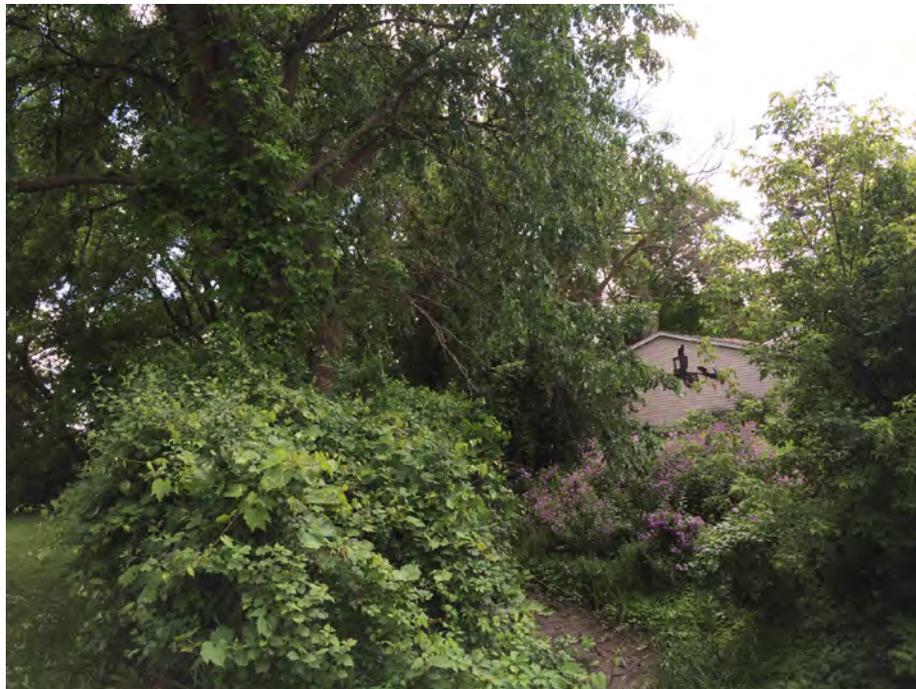
Photo 1

18" diam large tree on right side.

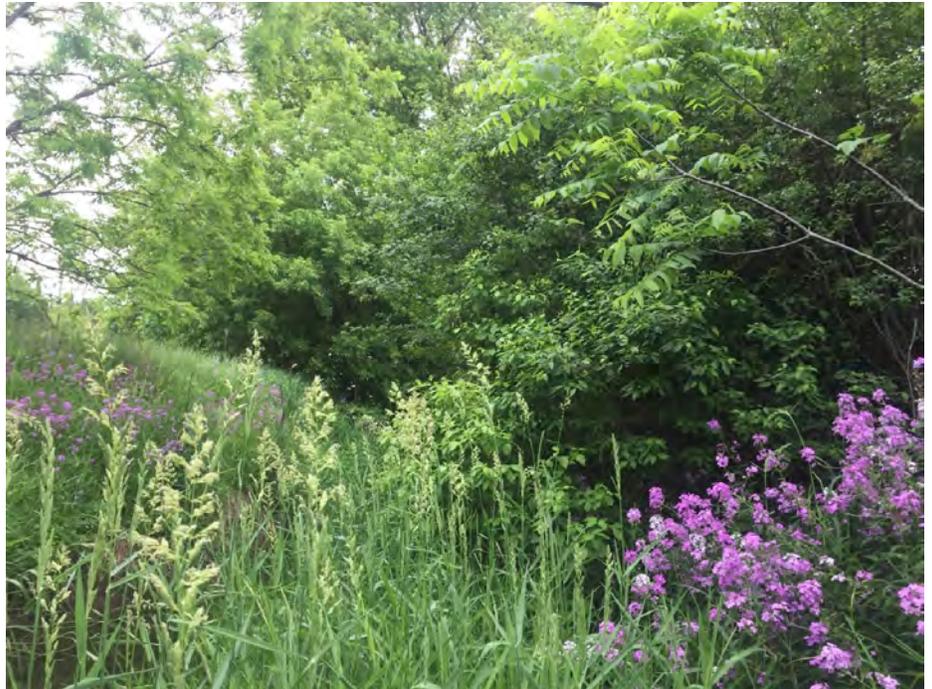
Photo 1

Approximately 10-20 trees in the v on both sides of drain ranging for 4-12" for next 100'.

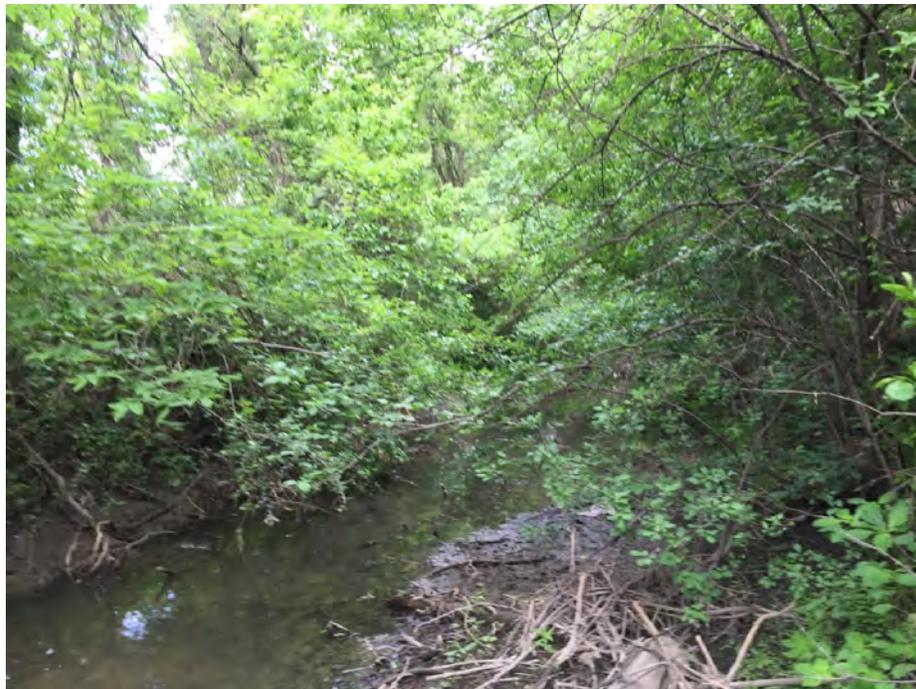
Photo 1

Trees in the v for next 200' with a grouping of 10-20 ranging from 6-18".

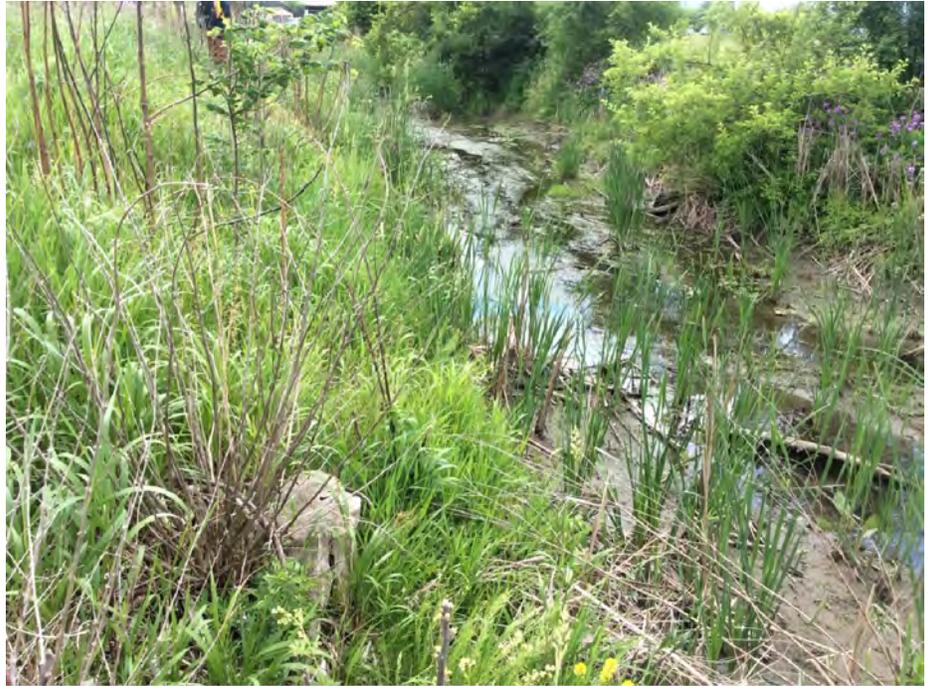
Photo 1

Stump about 20 in on left side of drain.

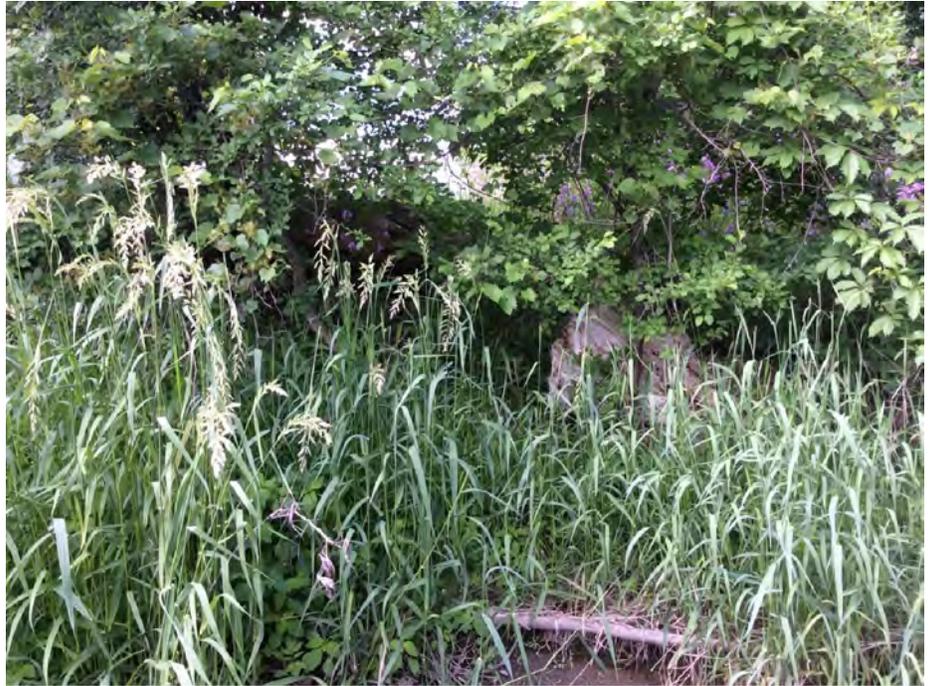
Photo 1

2 stumps on left side of drain. About 50" diameter.

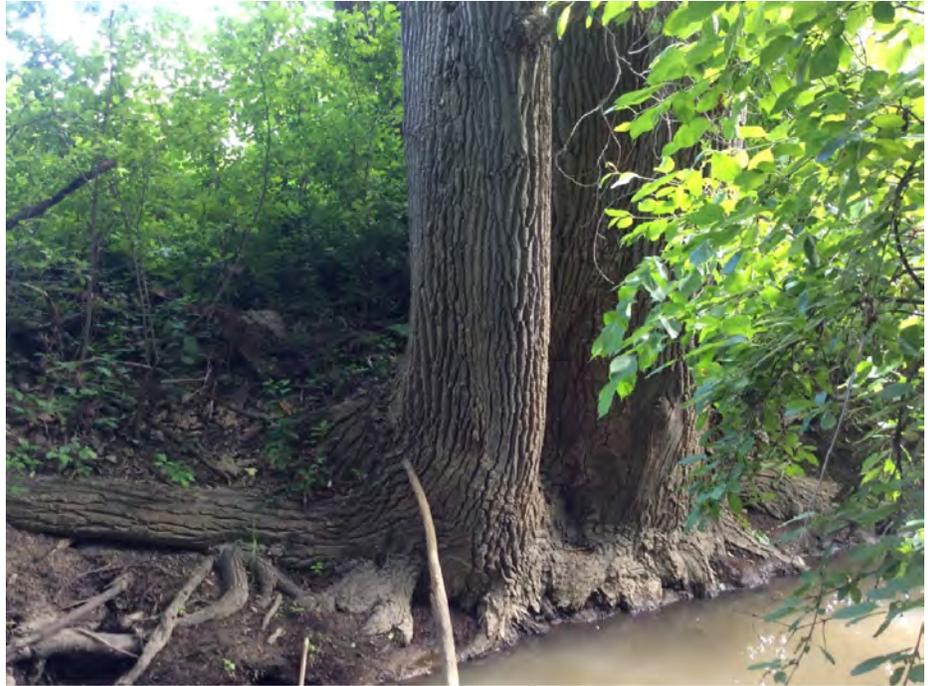
Photo 1

Excessive overhanging tree on right side of drain greater than 3". About 100" diameter.

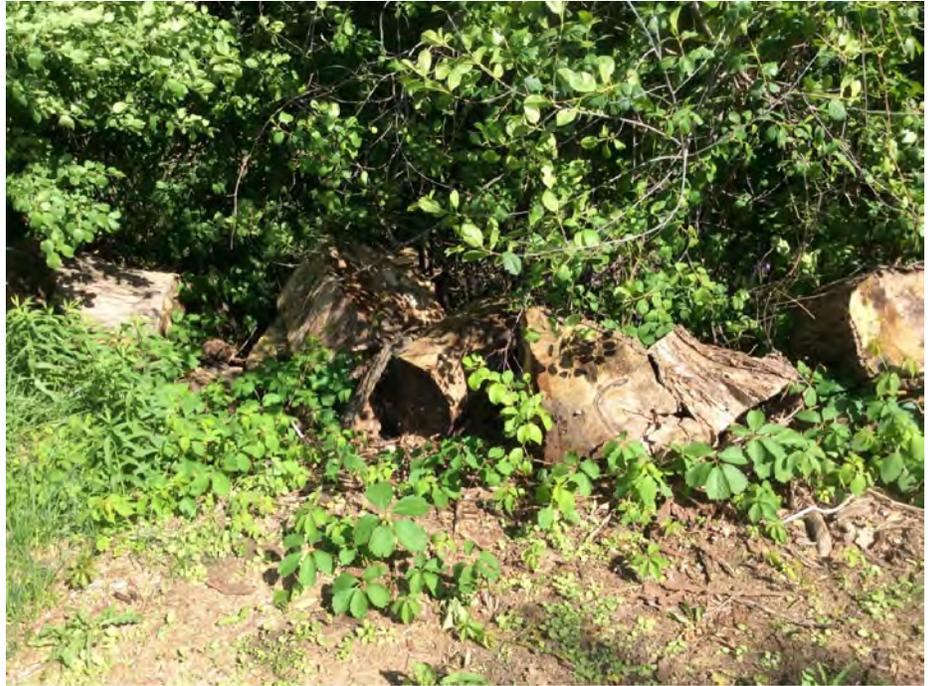
Photo 1

9 stumps on left side of drain. About 50" diameter.

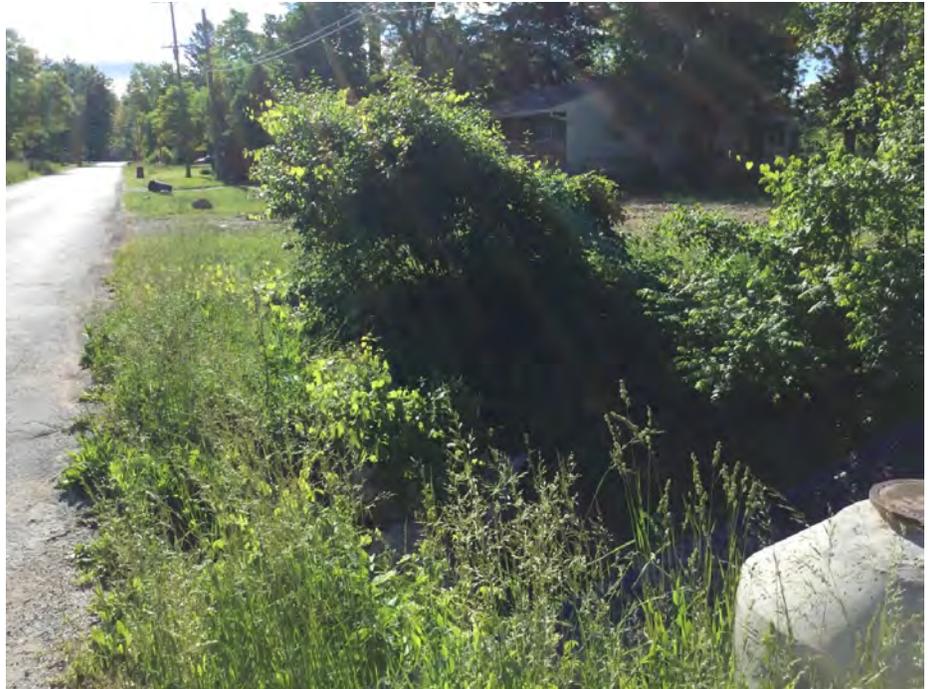
Photo 1

Tree on right side, on south side of Kansas st.

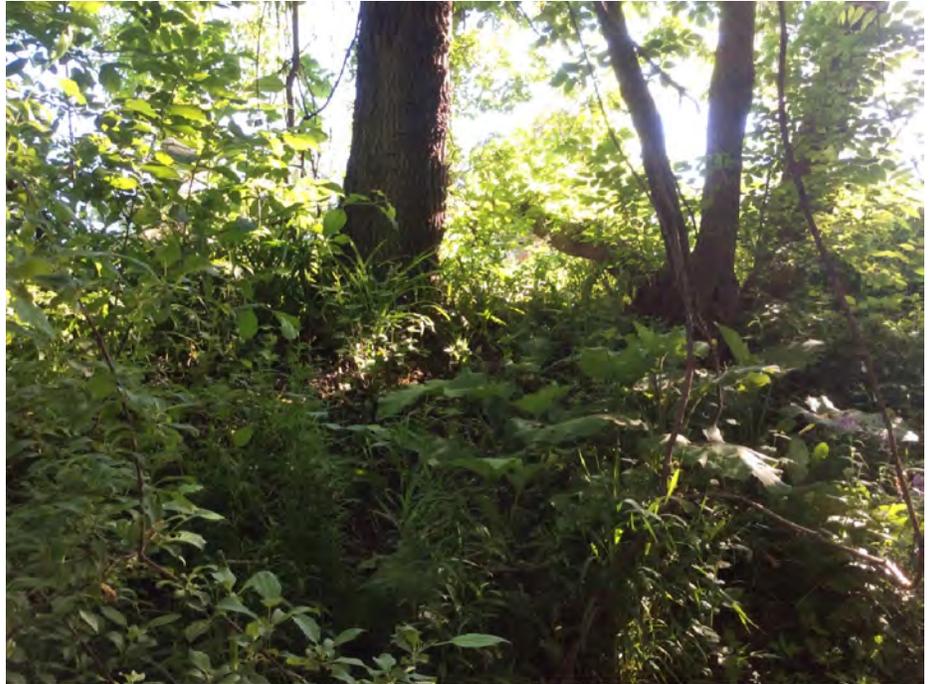
Photo 1

Excessive overhanging vegetation trees over 3" diameter on both sides of drain. About 19-20 for 180 ft.

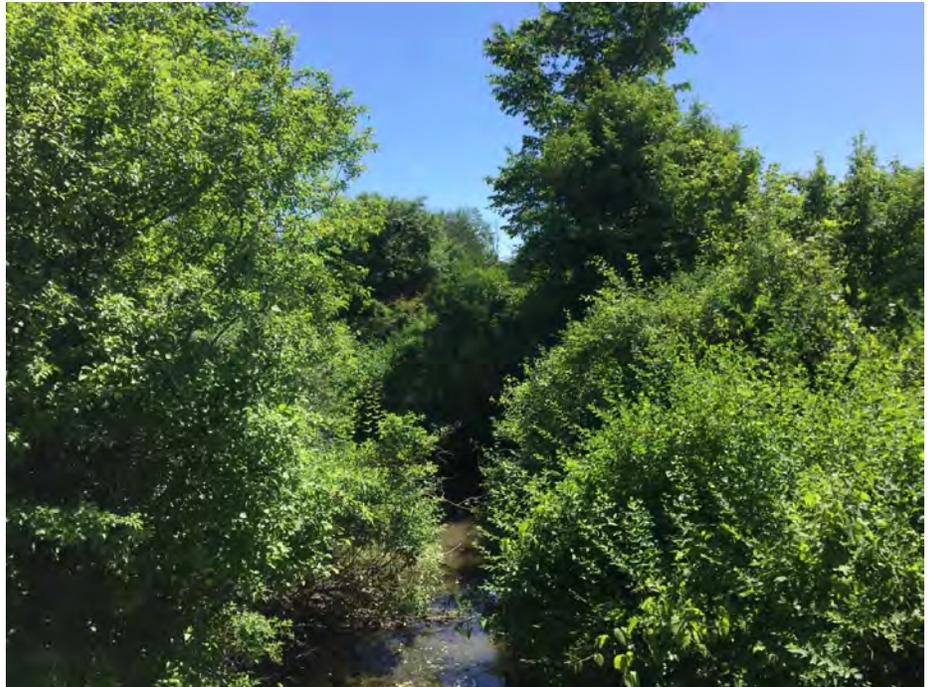
Type: Tree

Grouping: More than 30

Location: Both

Photo 1 Direction: Facing Upstream

Thick brush and trees on both sides of drain for next 2000' to the road. At least 30 trees every 500'. Diameters ranging 4-18". Picture facing upstream.

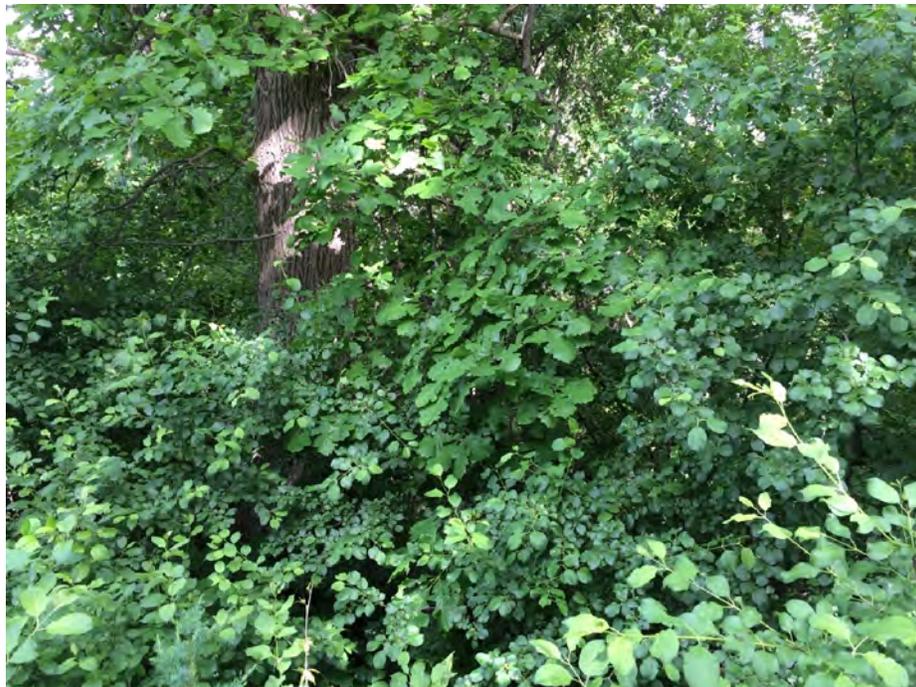
Type: Tree

Grouping: 10 to 20

Location: Both

Photo 1 Direction: Facing Upstream

Trees overhanging on both sides of drain. 50" diameter.

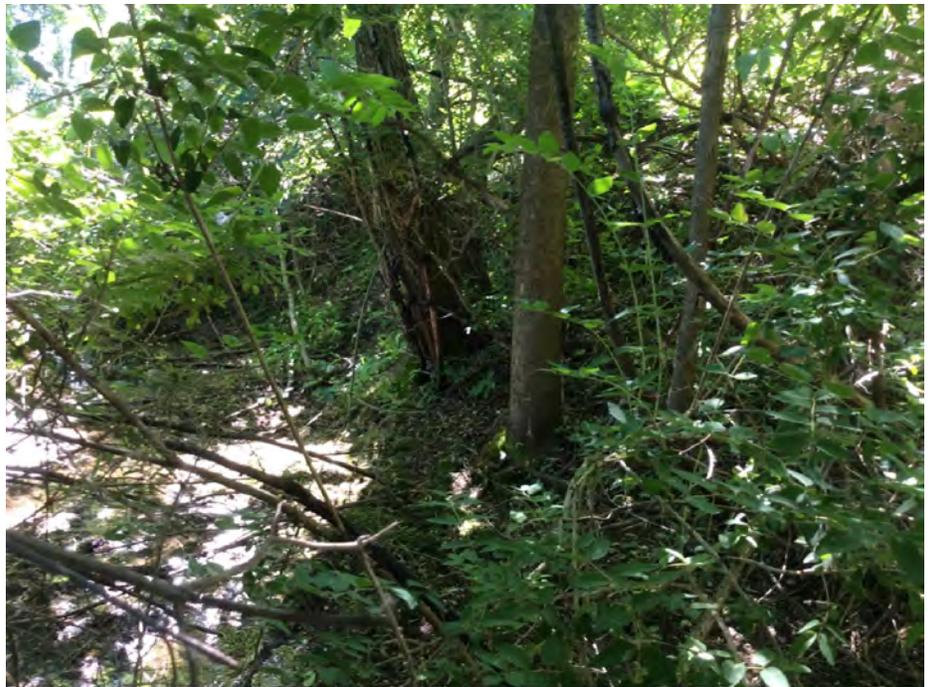
Type: Tree

Grouping: More than 30

Location: Both

Photo 1 Direction: Facing Upstream

Approx 70-80 trees 3"-18" diam on both sides next 1500 ft.

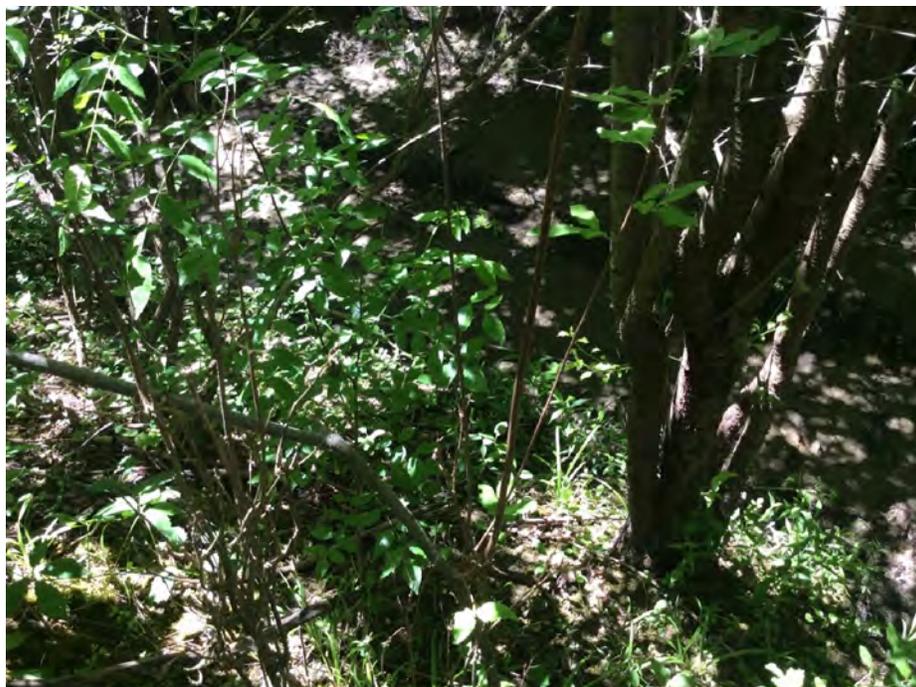
Type: Tree

Grouping: 10 to 20

Location: Both

Photo 1 Direction: Facing Upstream

19 trees up to 8" diam on both sides next 300 ft up to crossing.

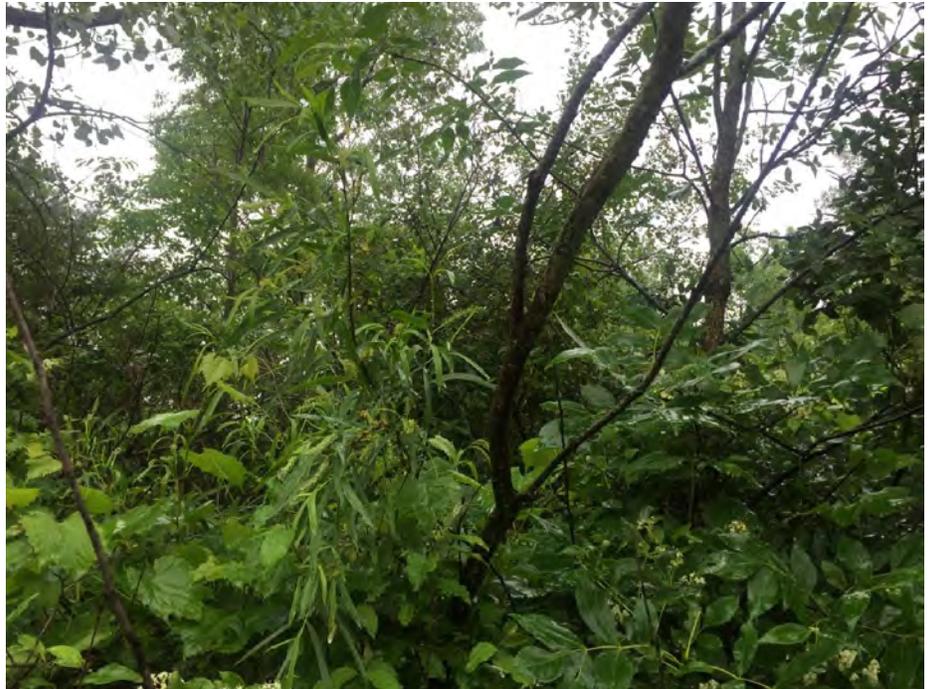
Type: Tree

Grouping: More than 30

Location: Both

Photo 1 Direction: Facing Upstream

Trees in the v along both sides of drain for the length of the drain for next 1200' to end. At least 30 trees ranging 4-24".

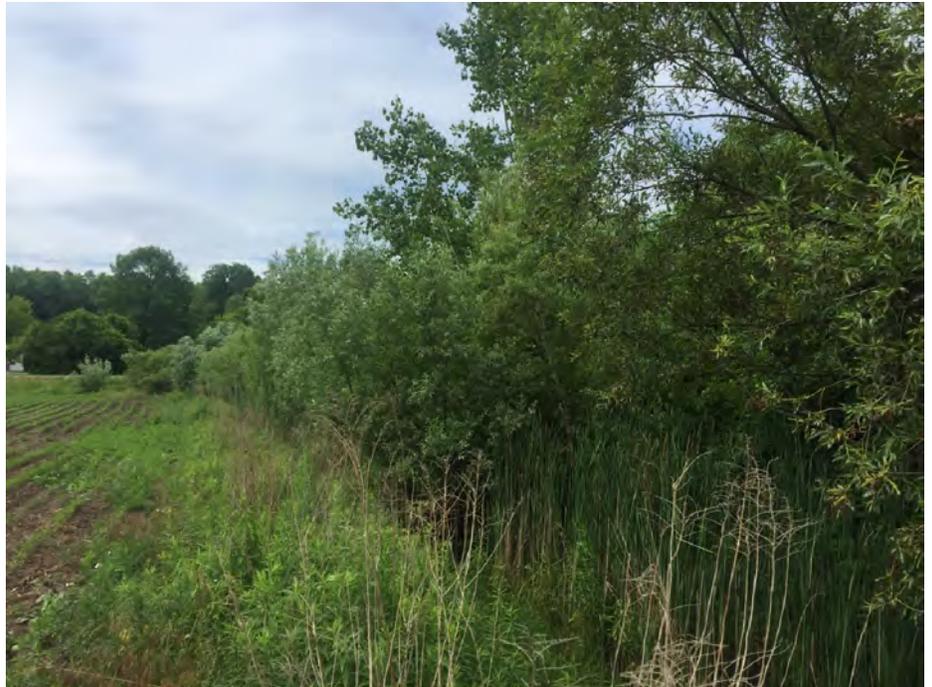
Photo 1

Type: Tree

Grouping: 10 to 20
