King Street Tile Drain Inspections

Inspection Report for Observation:
Utility1

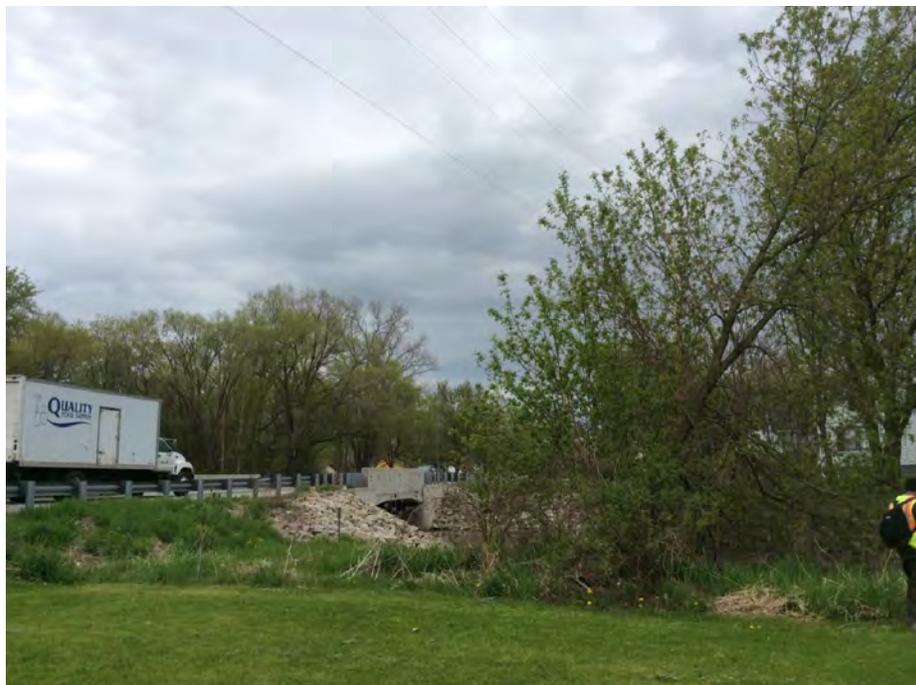
Upstream 30' overhead west side of m-13

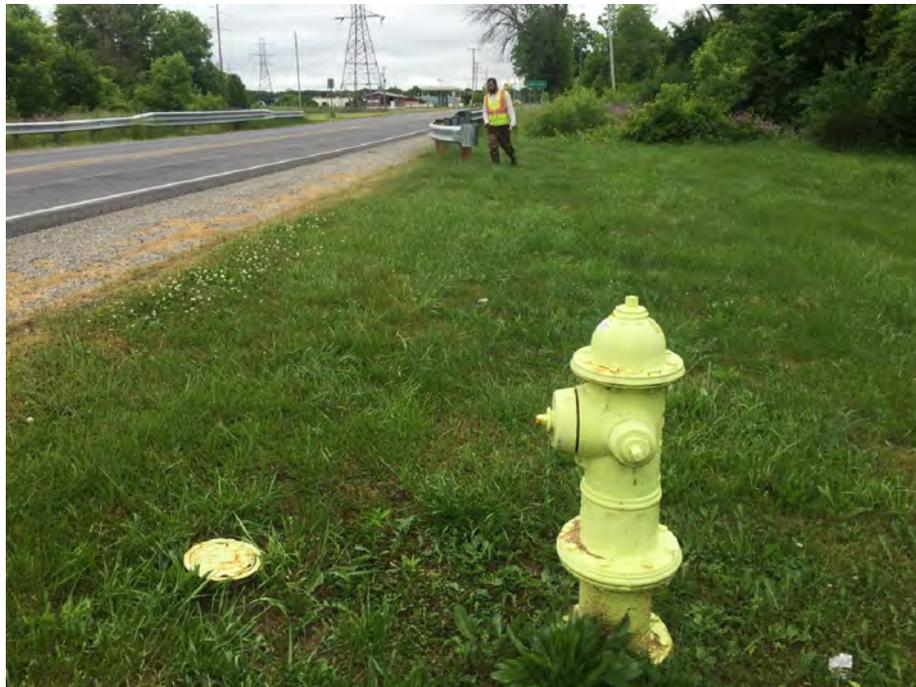
Photo 1

Fire hydrant located approximately 100' northeast of drain.

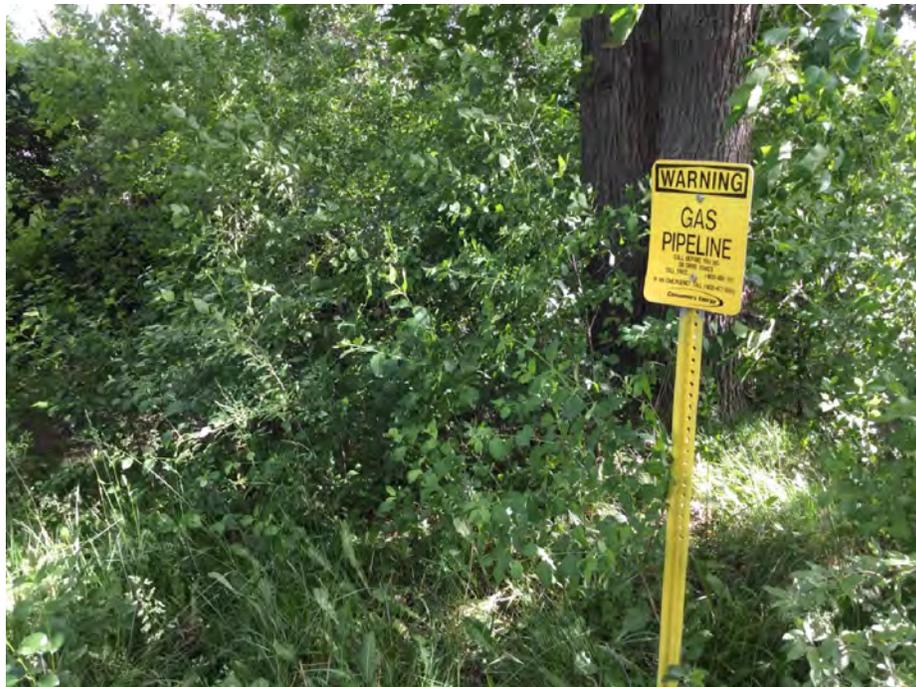
Photo 1

Gas utility sign about 20 ft north of drain.

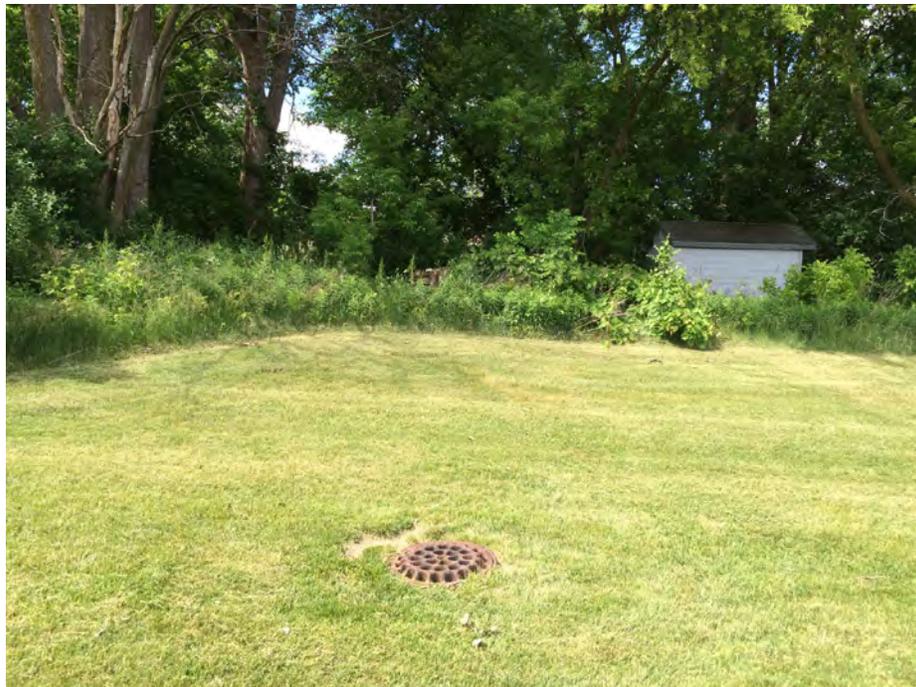
Photo 1

Storm manhole 100 ft right of drain.
Photo facing north.

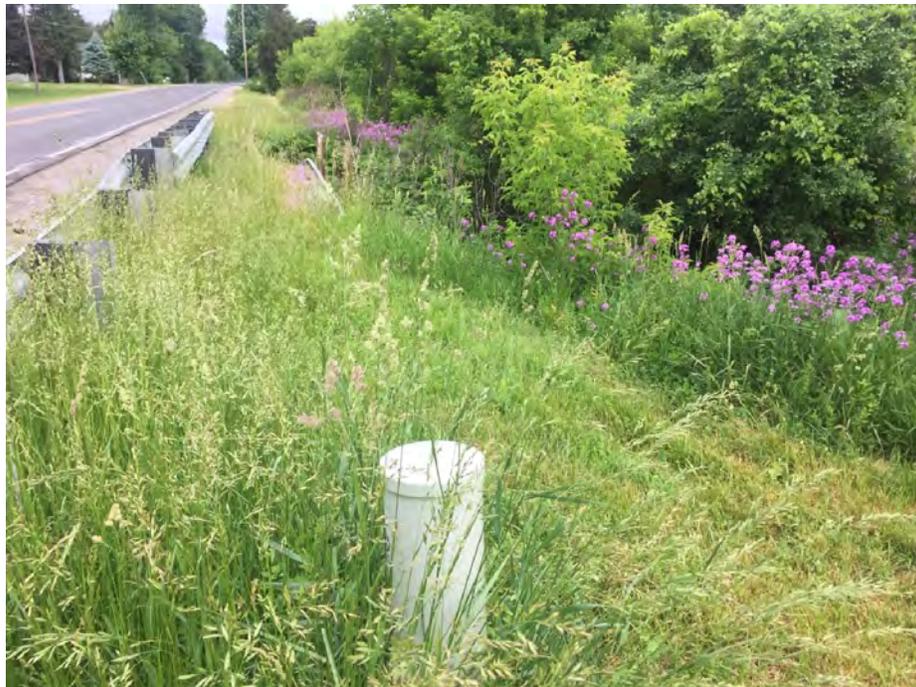
Photo 1

Underground electrical approximately 20' south of drain.

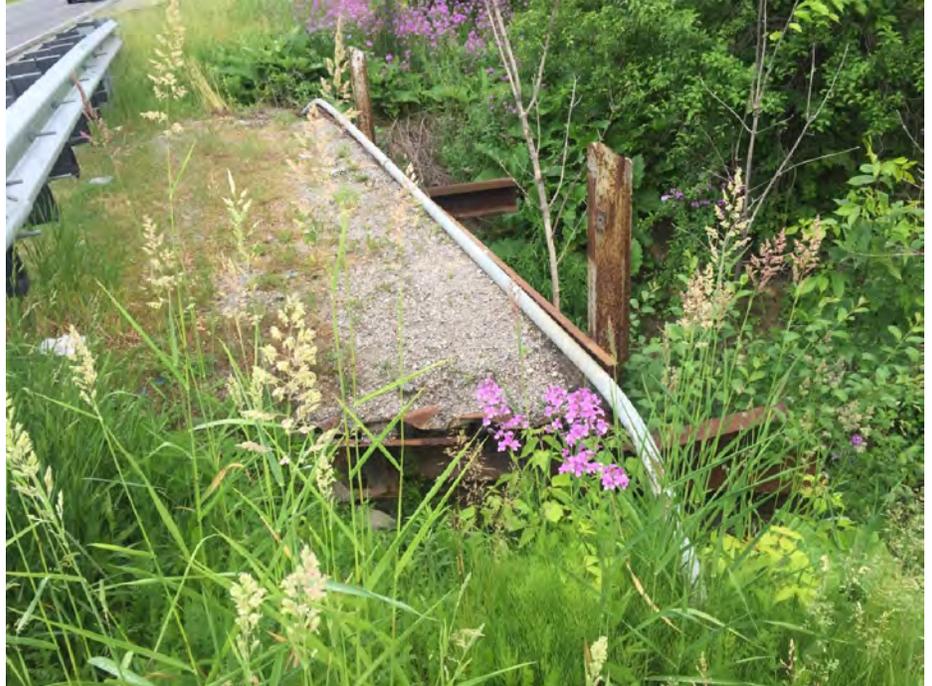
Photo 1

Unknown utility pipe crossing over drain from underground on both sides.

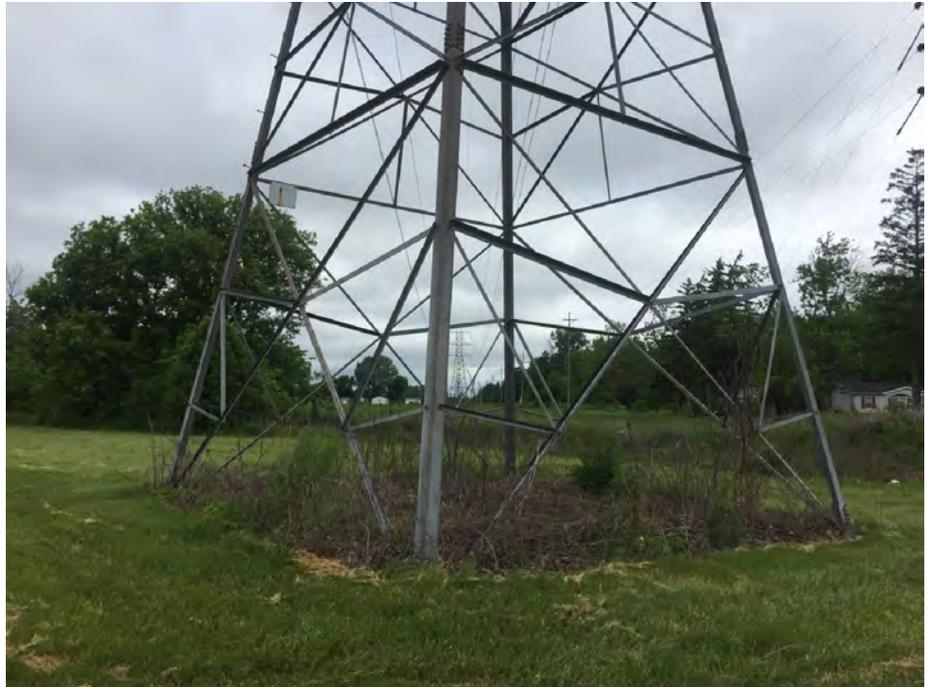
Photo 1

Large electrical pole 75' south of drain with wires overhanging approximately 100' over the drain.

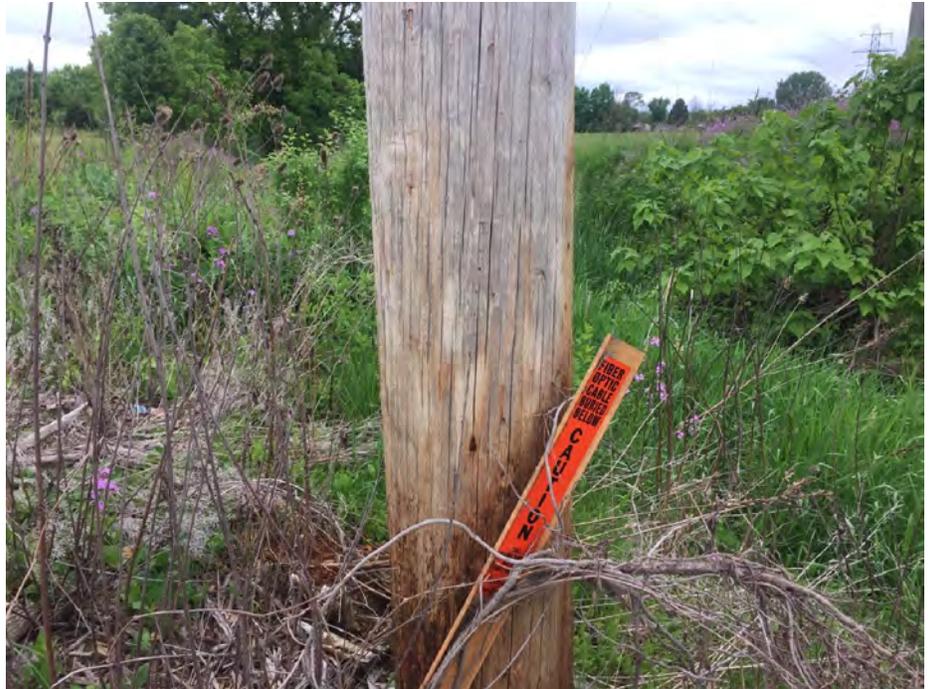
Photo 1

Approximately 10' to the south of drain.
Fiber optic cable buried notice.

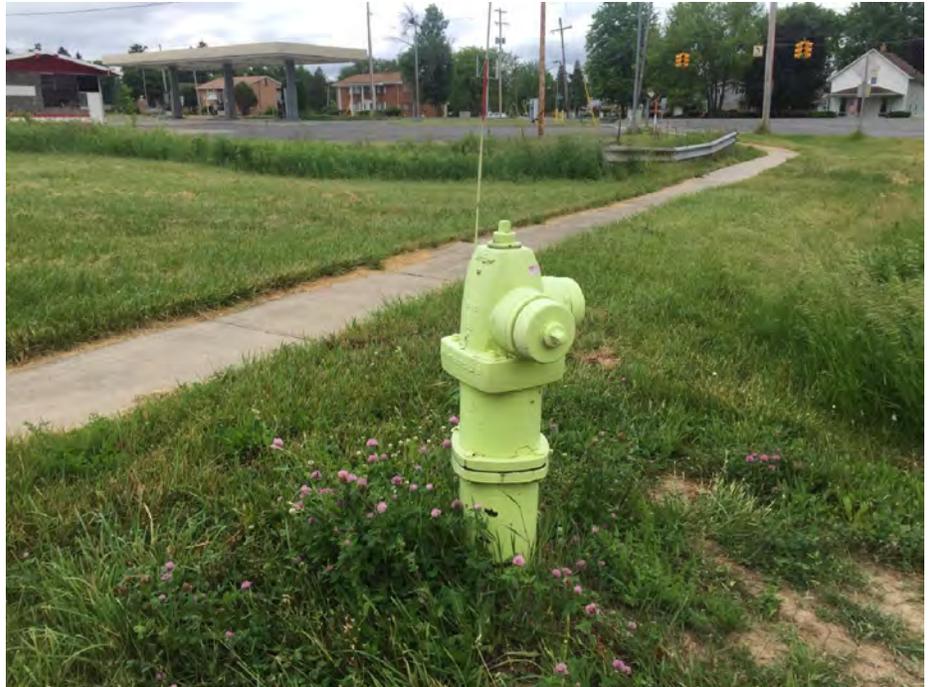
Photo 1

Underground watermain indicated by fire hydrant approximately 45' north of drain.

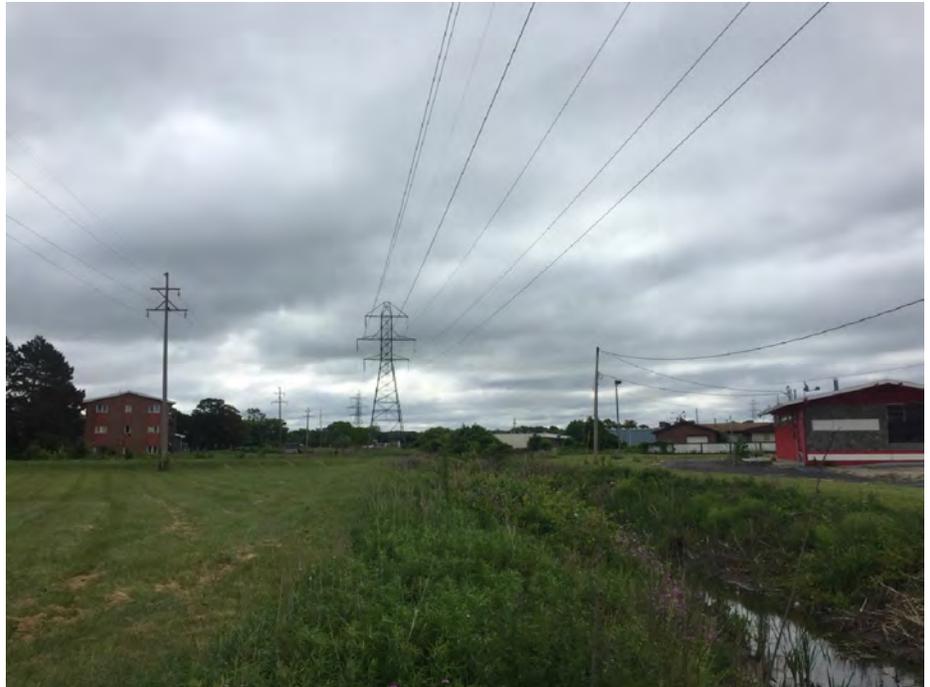
Photo 1

Beginning over drain at crossing and going for the next 500' approximately 20' north of drain and 100' above it.

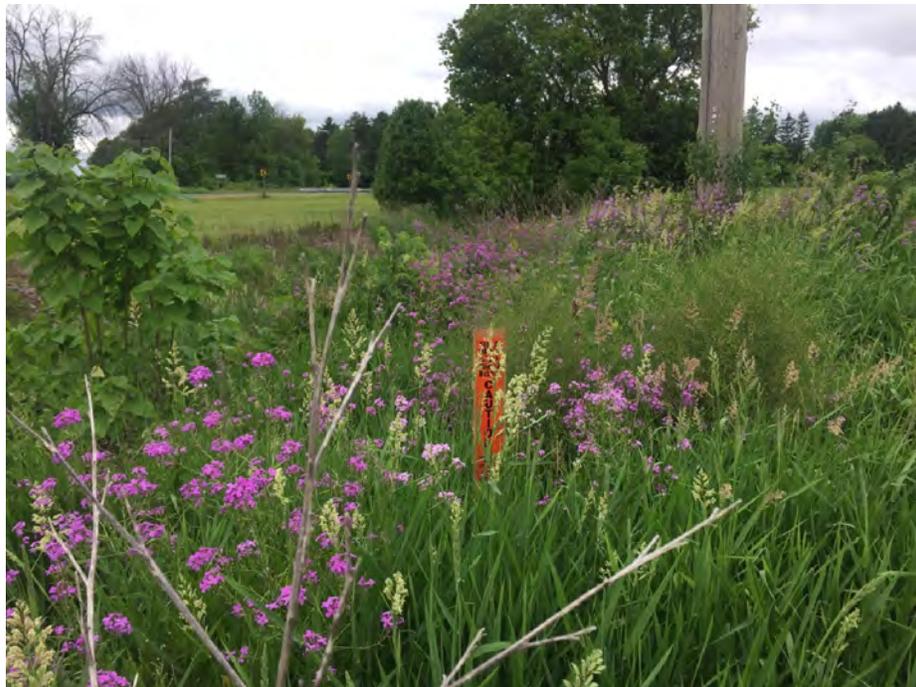
Photo 1

Approximately 15' north of drain.

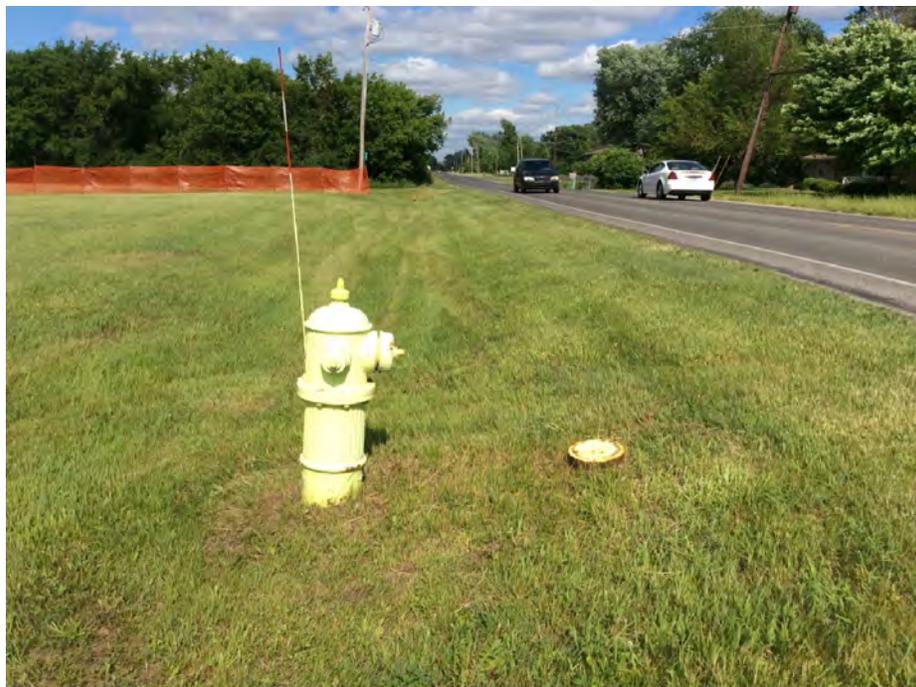
Photo 1

Fire hydrant about 5 ft from road. About 260 ft west of drain.

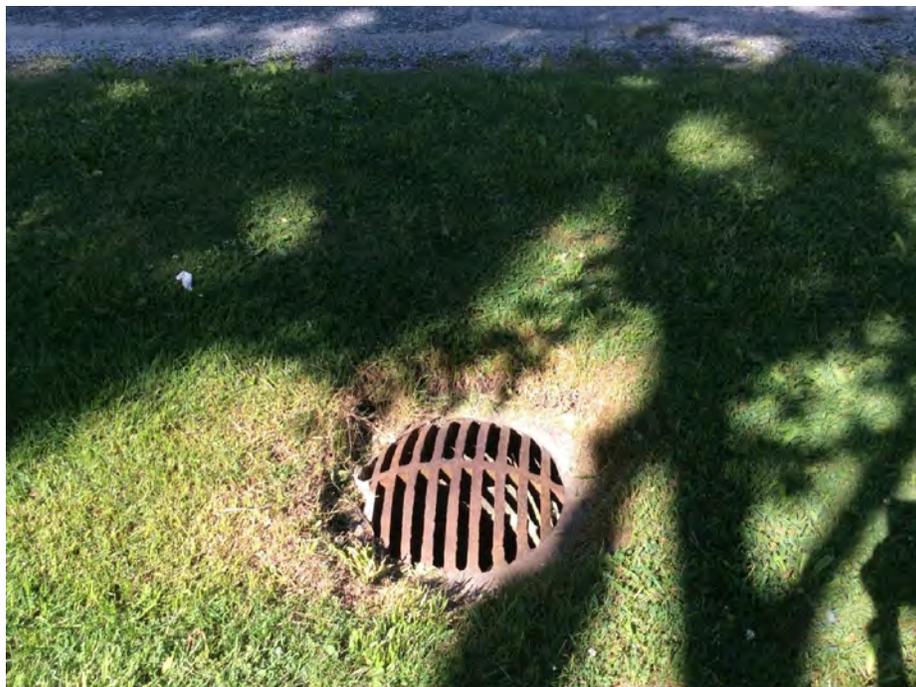
Photo 1

50 ft left of drain. Steel storm manhole.
About 3 ft left of Broadway St.

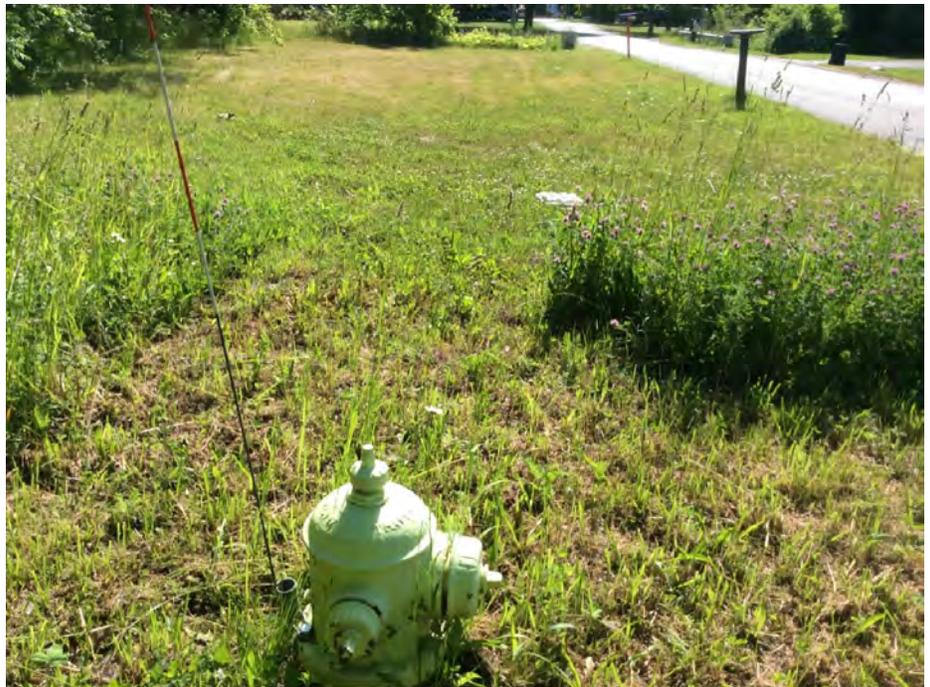
Photo 1

125 ft right of drain is fire hydrant. Grass clear cut around it.

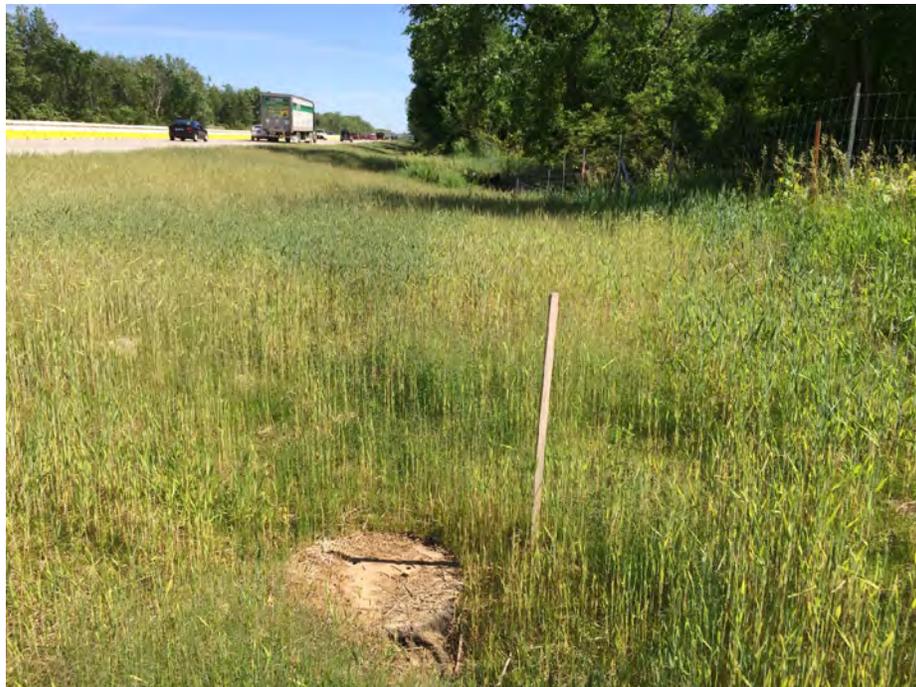
Photo 1

Manhole 100 ft left of drain. Unknown type. On southbound side of I75.
