King Street Tile Drain Inspections

Inspection Report for Observation:
Blockage1

HUBBELL, ROTH & CLARK, INC CONSULTING ENGINEERS SINCE 1915	555 Hulet Drive P.O. Box 824 Bloomfield Hills, MI 48303-0824 (248) 454-6300 http://www.hrc-engr.com	DATE:	08/16/2016
				SCALE:	
NOTE				SHEET #:	
				JOB #:	20160331

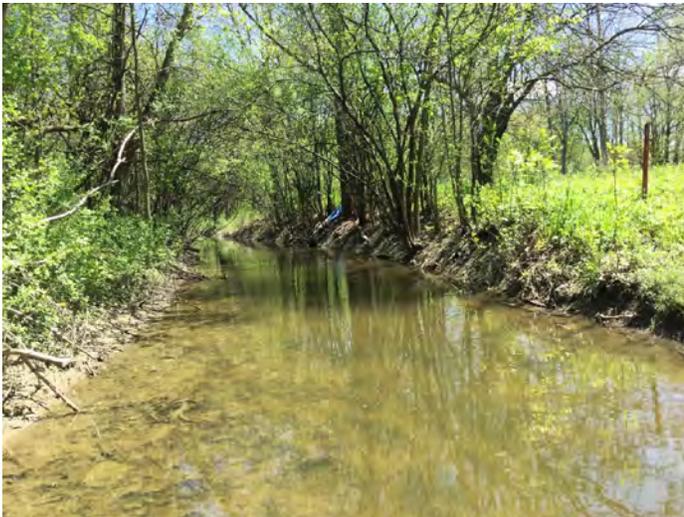
Excessive vegetation on both sides of drain next 150ft. Photo facing upstream. Mainly 1"-3" diam trees.

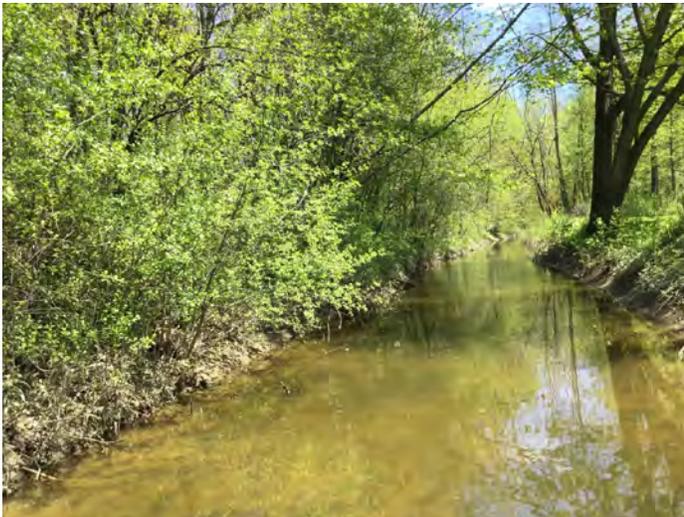
Inspection Report for Observation:
Blockage47

Type: Excessive Vegetation

Blockage Length (feet): 200

Excessive vegetation on left side of drain next 200 ft. Photo facing upstream.

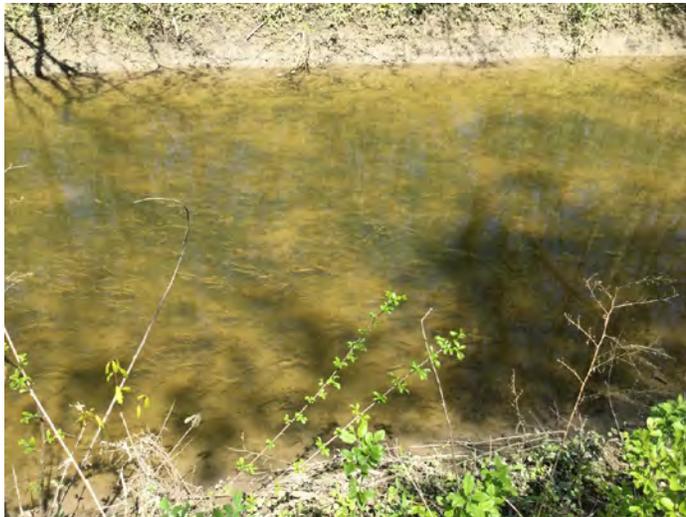
Inspection Report for Observation:
Blockage48

Type: Excessive Vegetation

Blockage Length (feet): 100

Vegetation in bottom of channel. Low flow, high nutrients. Photo facing north.

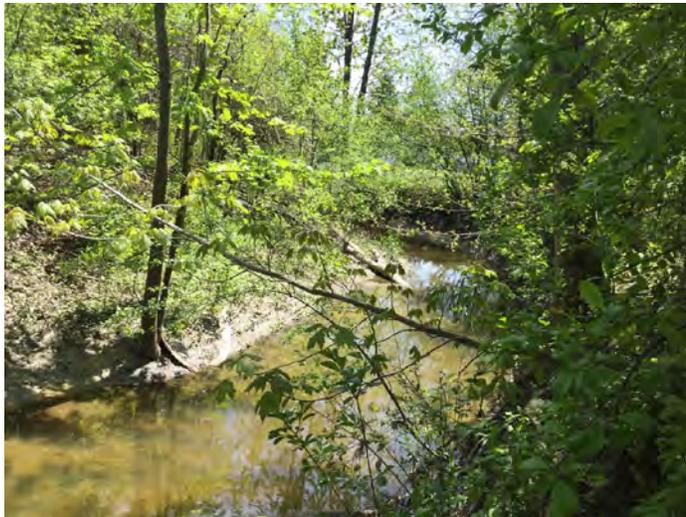
Inspection Report for Observation:
Blockage49

Type: Fallen Tree

Blockage Length (feet): 20

6" diam log on left and other woody debris. Photo facing upstream.

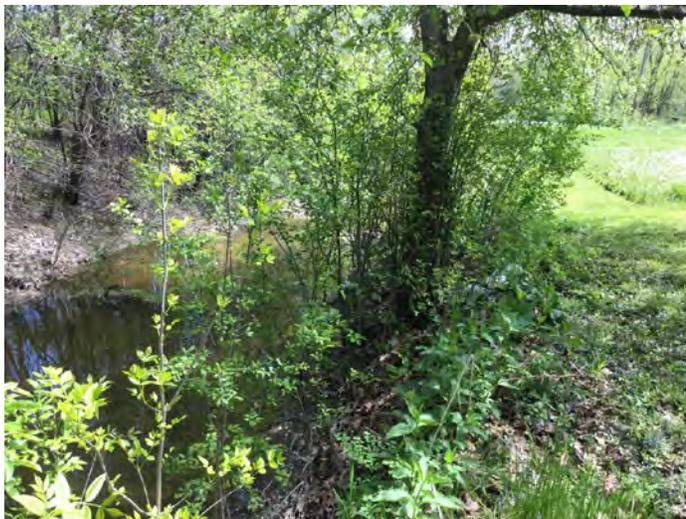
Inspection Report for Observation:
Blockage50

Type: Excessive Vegetation

Debris Length (feet): 100

Excessive vegetation on right bank next 100 ft up to crossing. Photo facing upstream.

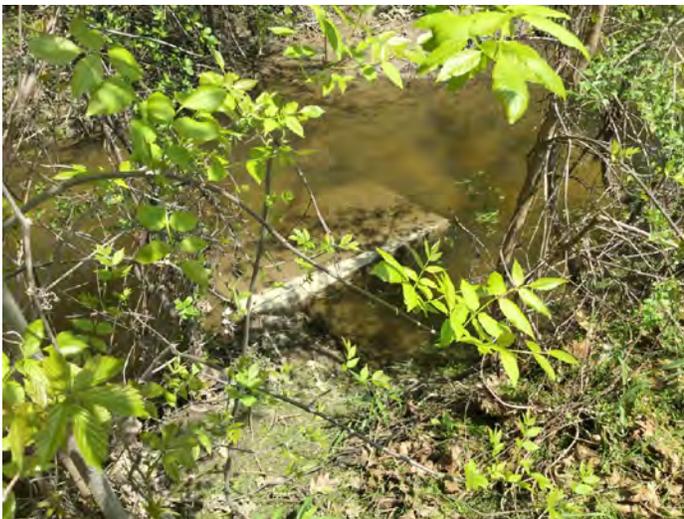
Inspection Report for Observation:
Blockage51

Type: Non-Vegetative Debris

Concrete block in drain. 3' x 6'.

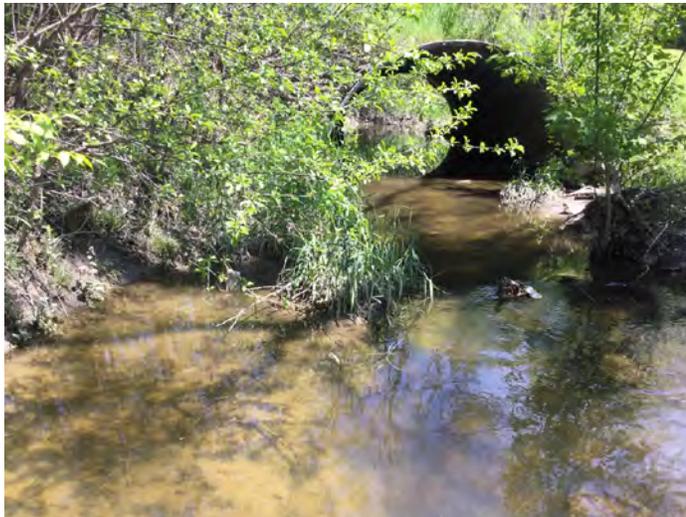
Inspection Report for Observation:
Blockage52

Type: Sediment

Blockage Length (feet): 15

Sediment bar with vegetation on left just downstream of Casey dr. Photo facing upstream.

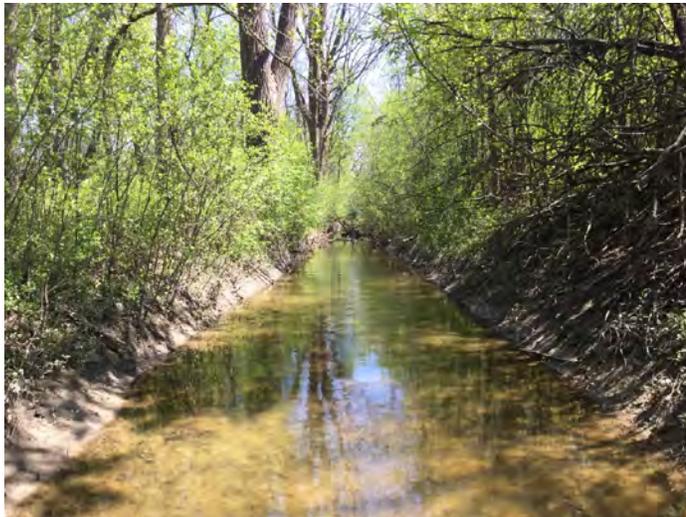
Inspection Report for Observation:
Blockage53

Type: Excessive Vegetation

Blockage Length (feet): 400

Excessive vegetation on both sides next 400 ft. Photo facing upstream.

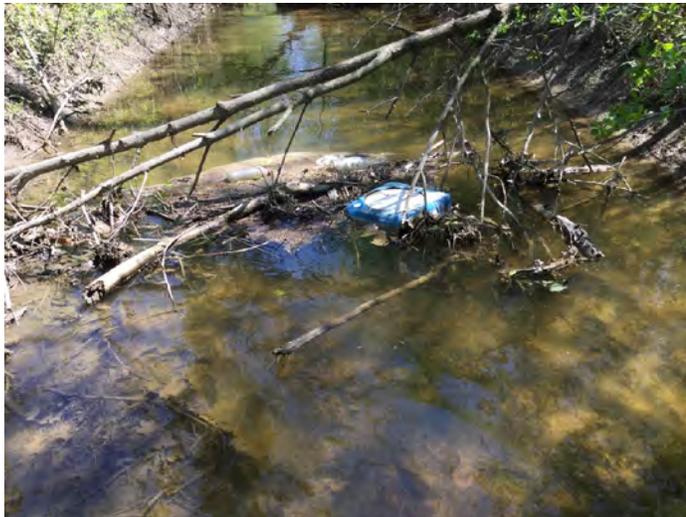
Inspection Report for Observation:
Blockage54

Type: Non-Vegetative Debris

Trash in drain adding to woody debris blockage. Photo facing upstream.

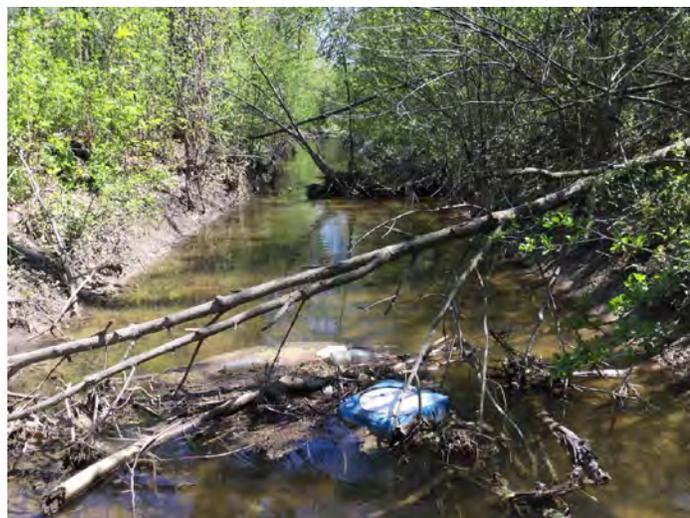
Fallen woody debris in two locations. Photo facing upstream.

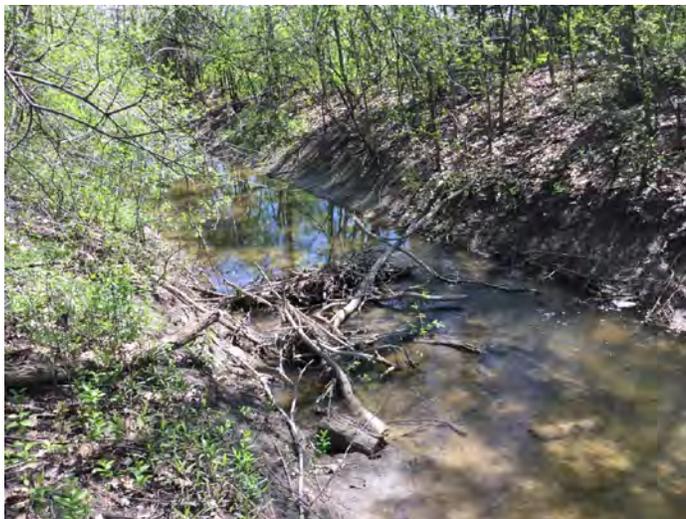
Log jam in center of drain impeding flow. Photo facing upstream.

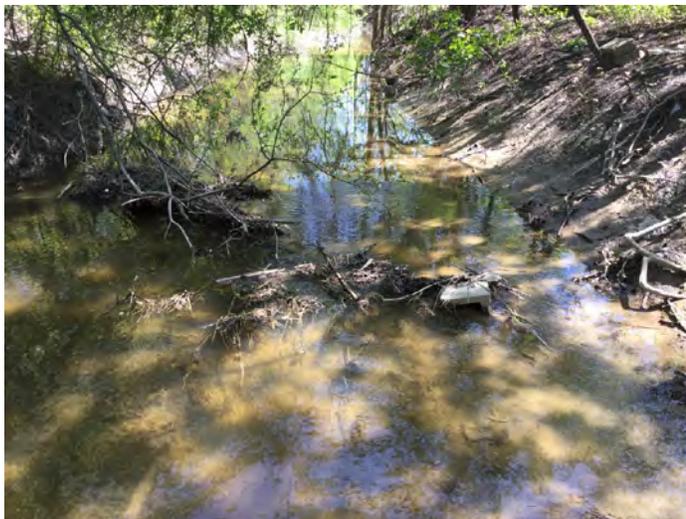
Concrete block and other debris in center of drain. Photo facing upstream.

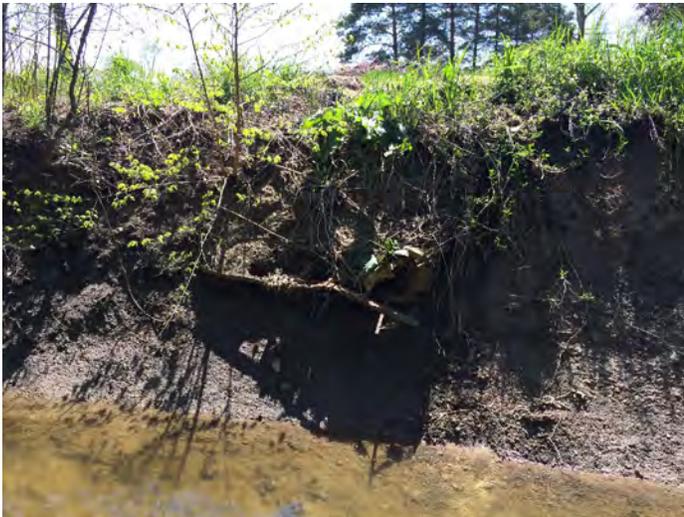
Need to move! On right side. Stuck in bank. Photo facing northeast.

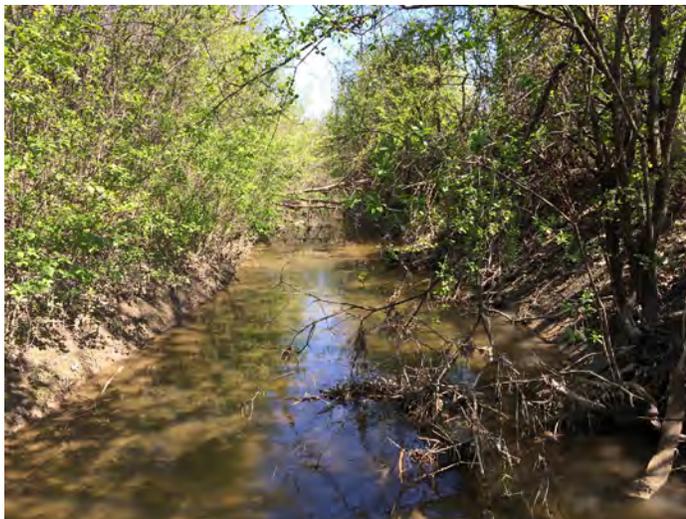
Fallen trees up to 4" diam and scattered woody debris over next 100 ft.
Photo facing upstream.

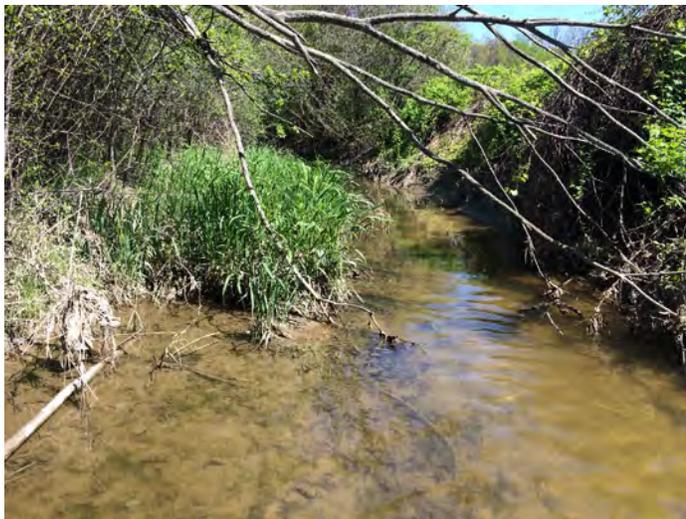
Excessive vegetation clump on left side impeding flow in drain. Photo facing upstream. Downstream of field tile outlet.

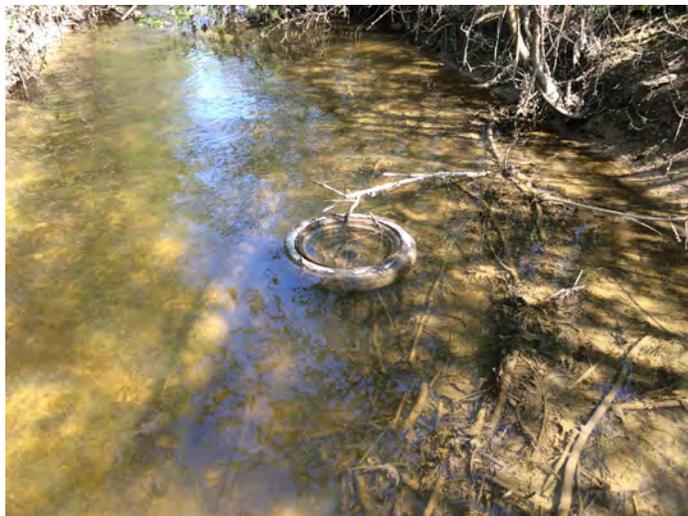
Tire in center in of drain.

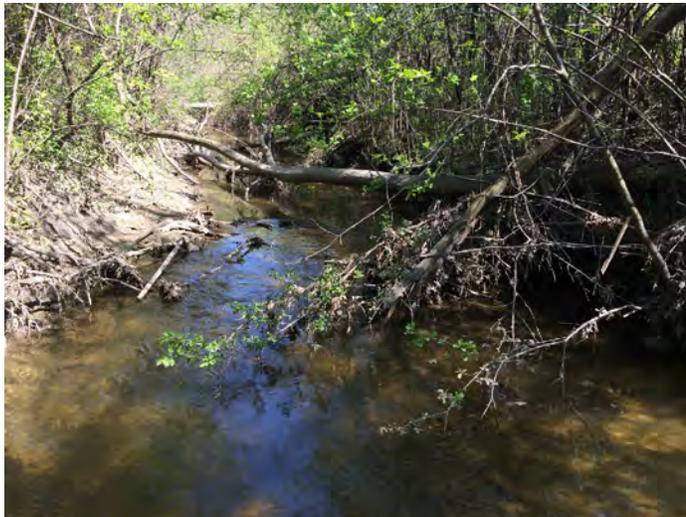
Three fallen trees ip to 8" diam in center of drain along with other woody debris. Photo facing upstream.

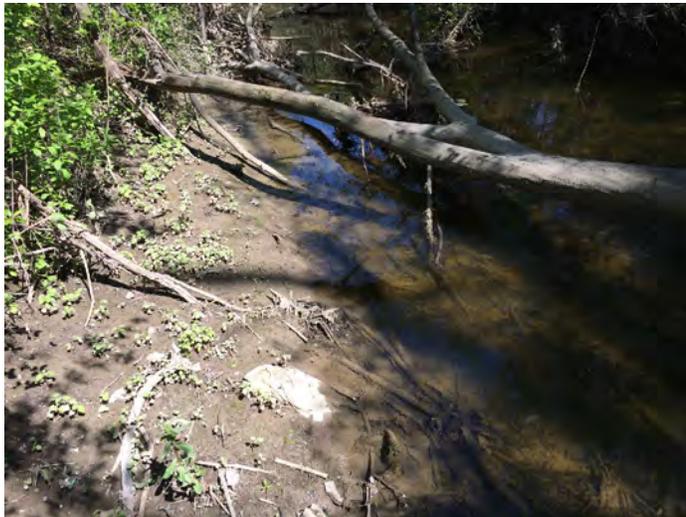
Sediment bar on left side within of fallen tree area. Erosion on right side. Photo facing upstream.

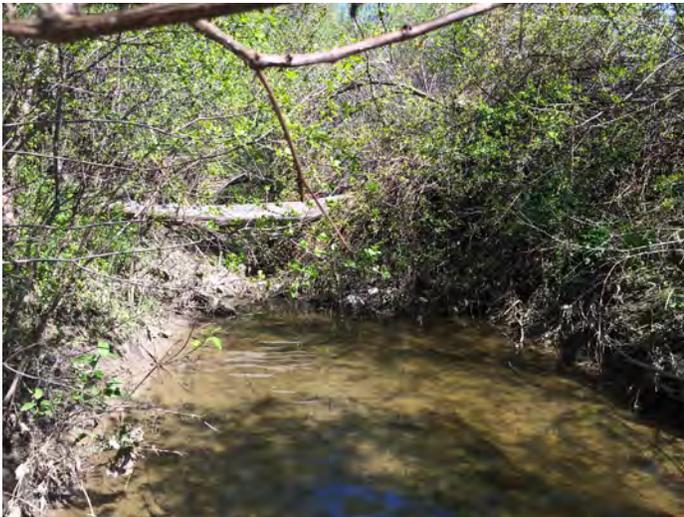
Fallen tree overhanging the drain. Leaves and branches are causing blockage. 12" diam. Photo facing upstream.

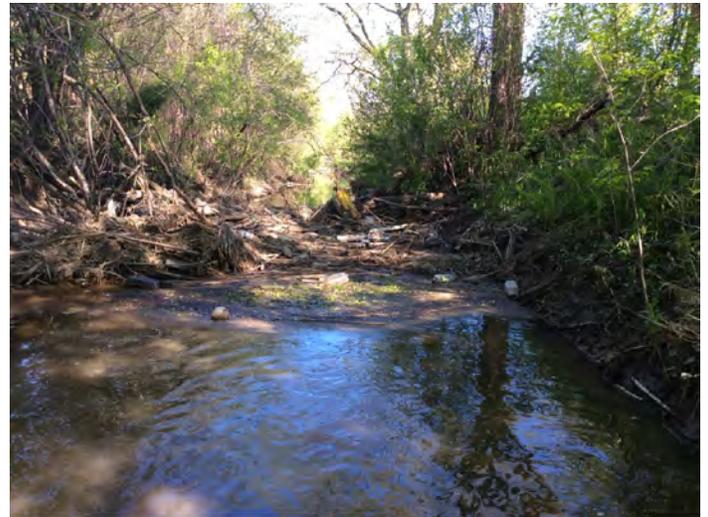
Significant log jam along with trash and woody debris. Full for 20 ft.
Photo1 facing upstream. Photo2 facing downstream.

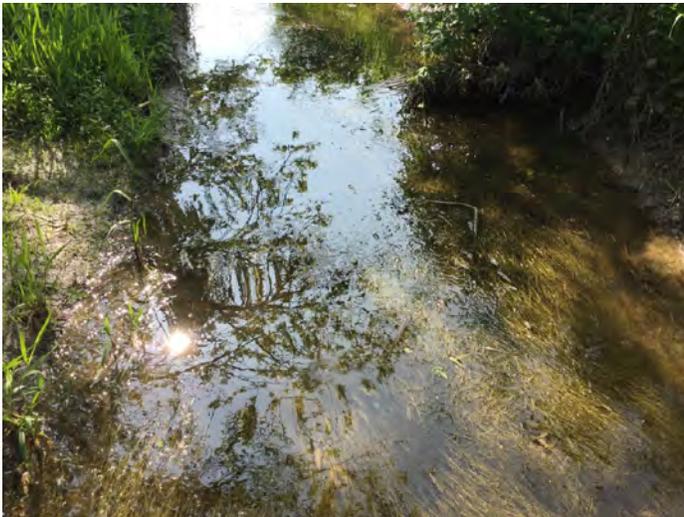
Excessive vegetation in the drain growing from the bottom. Photo 1 taken facing upstream. Photo 2 taken looking down at drain.

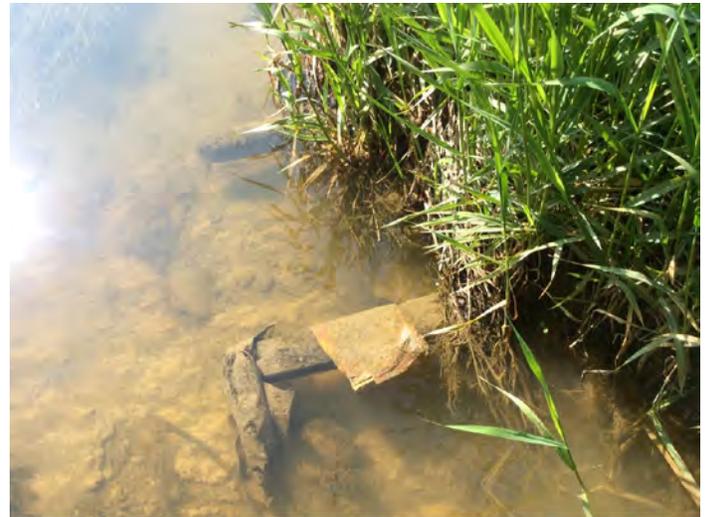
Photo 1

Sediment bar on right side with excessive vegetation growing on it. Next 20 ft. Photo1 facing upstream. Looks like it settled on some kind of debris. Photo3 facing downstream.

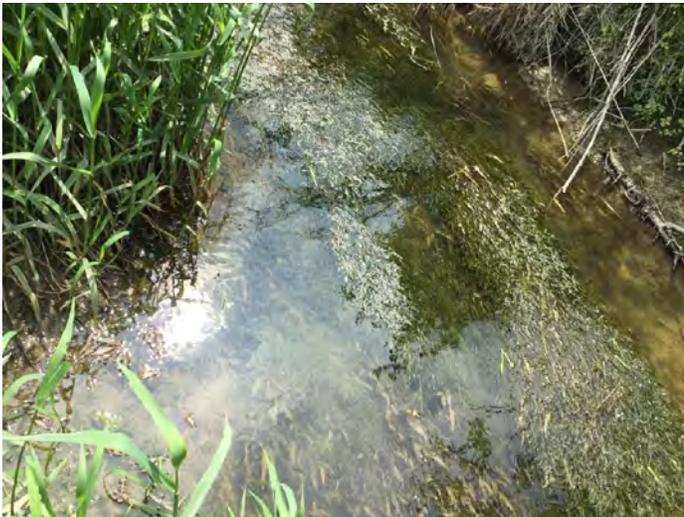
Excessive vegetation growing from bottom of drain. Photo taken facing upstream. Photo taken 500 ft upstream from data point.

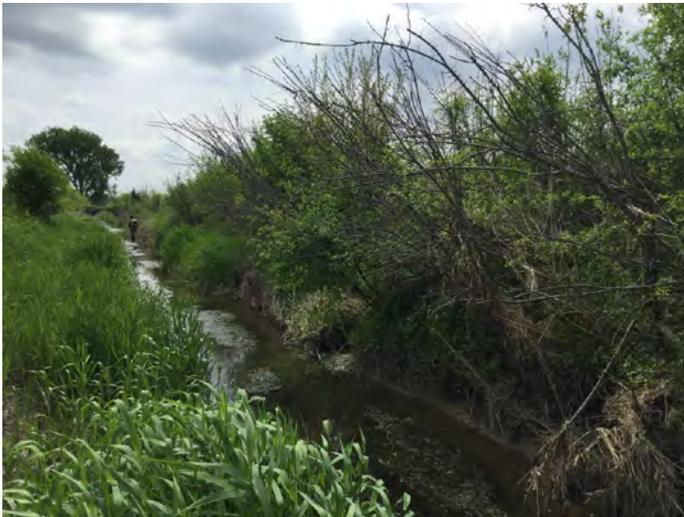
Excessive vegetation on right side of drain and overhanging trees. About 50 ft of blockage. Photo taken facing upstream.

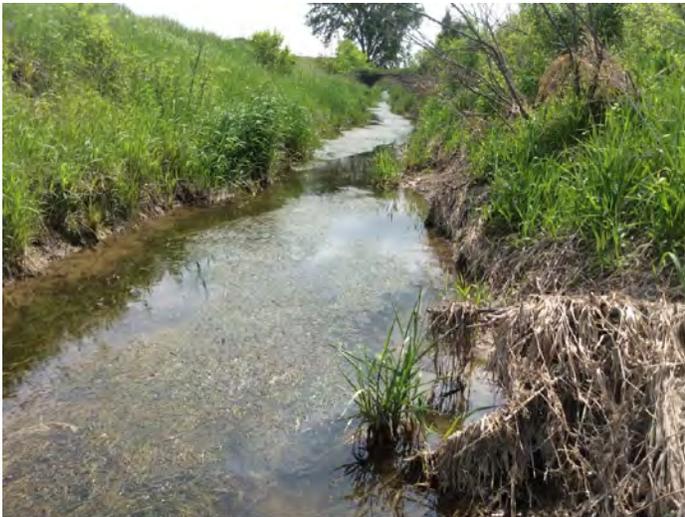
Sediment deposits in scattered clumps with vegetation over next 250 ft up to crossing. Photo facing upstream.

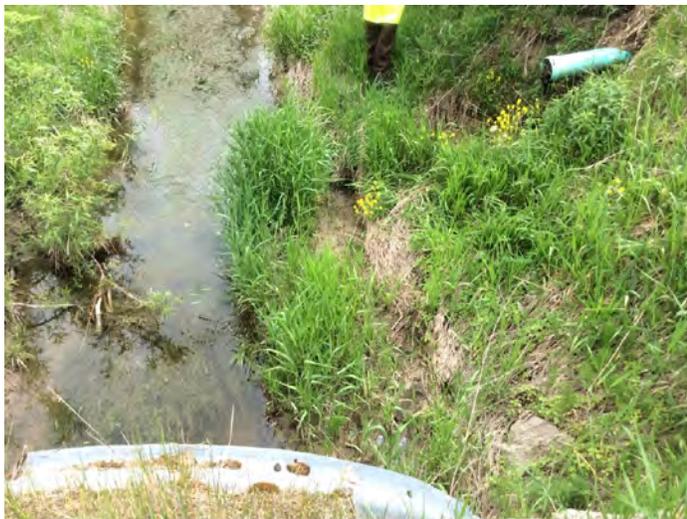
On right side in between field tile outlet and farm crossing. Photo facing upstream.

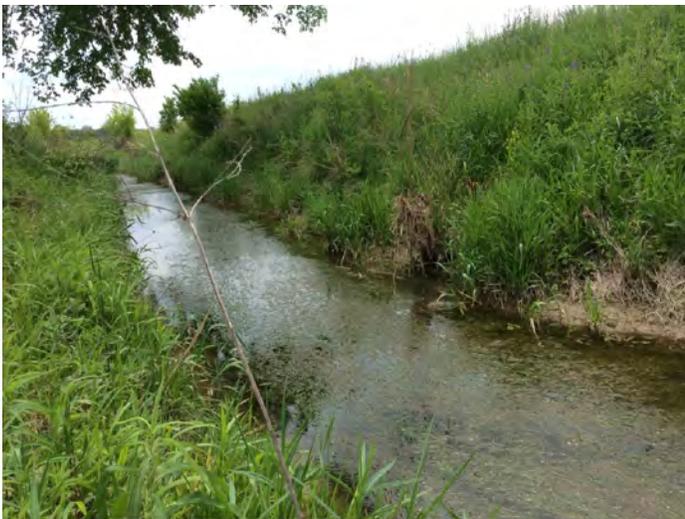
Sediment in clumps on either bank with vegetation. Next 700 ft. Photo facing upstream.

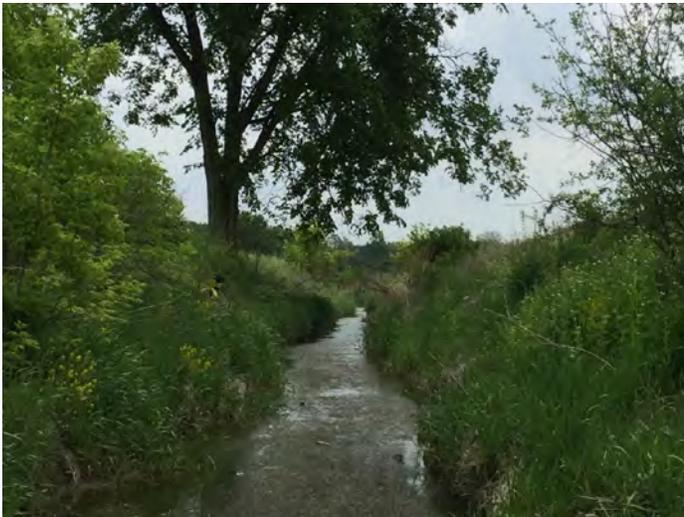
Overhanging excessive vegetation. Photo taken facing upstream.

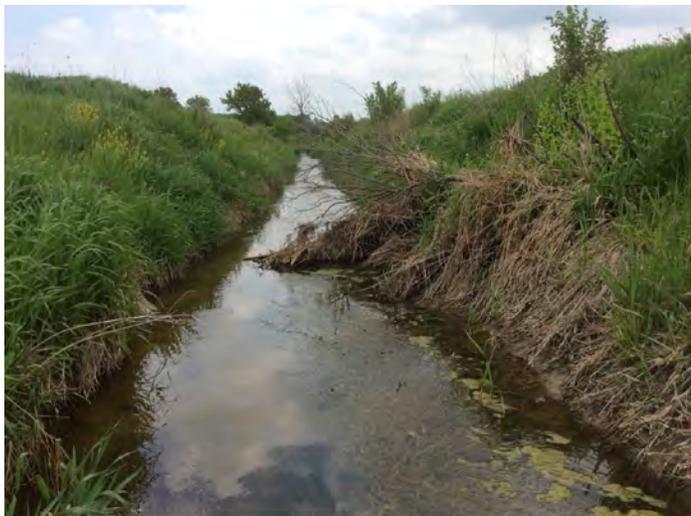
Fallen woody debris on right side. Photo facing upstream.

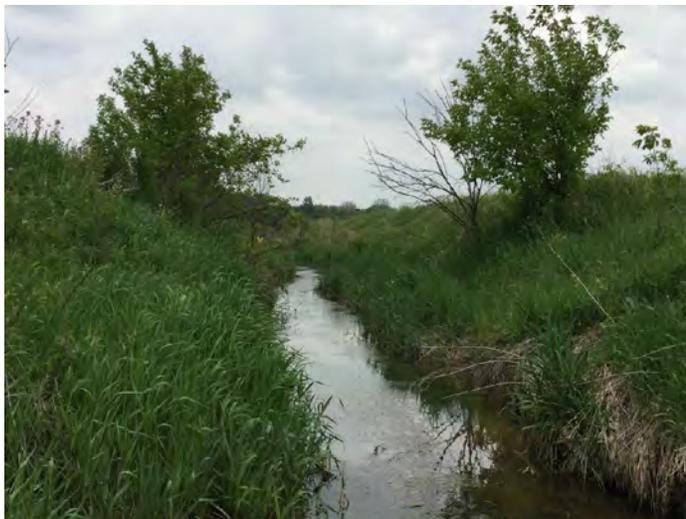
Excessive overhanging vegetation on both sides of drain. 1st branch on right side. 20 ft farther 2 trees on either side. Photo taken facing upstream.

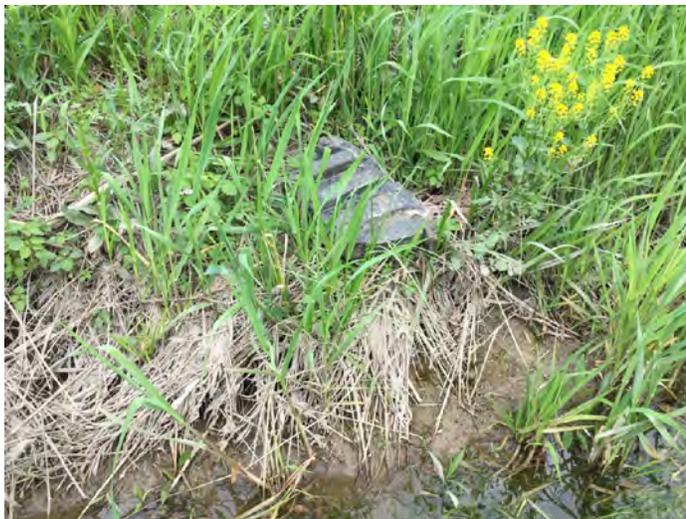
Styrofoam/garbage on left side of drain. Less than 1 ft in length. Photo taken facing north.

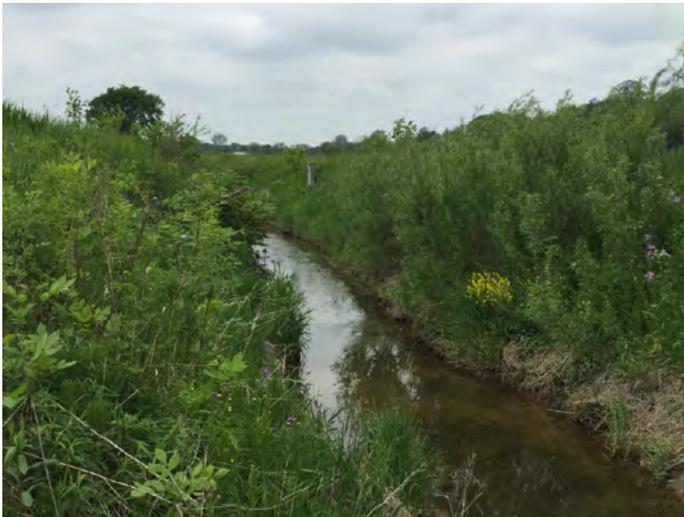
Excessive vegetation on both sides of drain. Photo taken facing downstream.

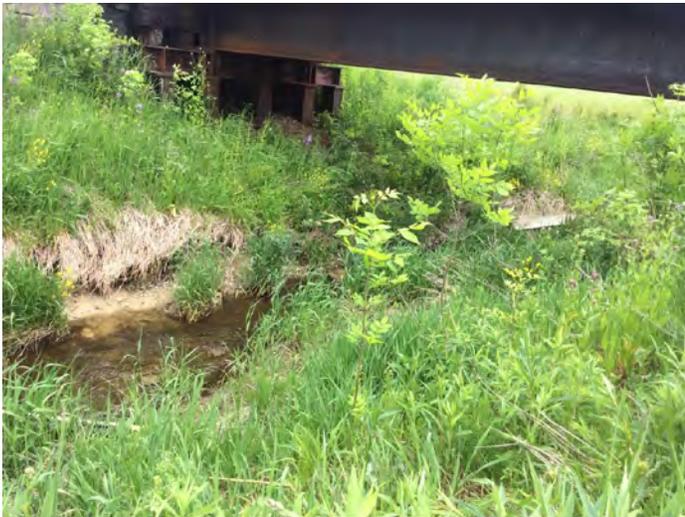
Excessive vegetation growing on sediment bars upstream, underneath, and downstream of railroad crossing. Photo facing upstream.

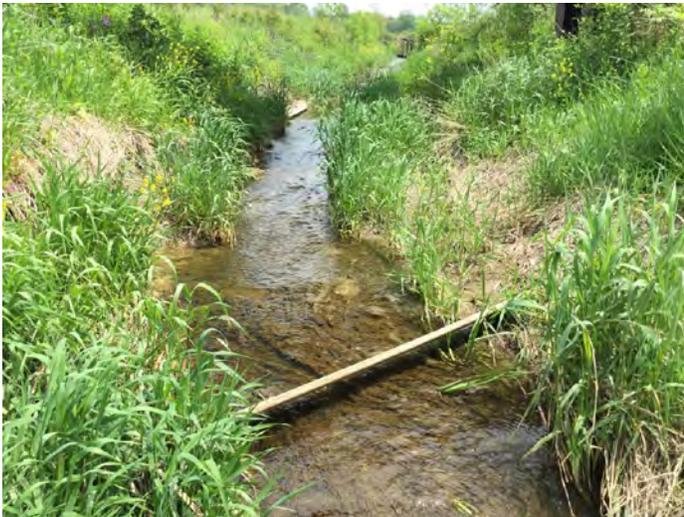
Blocks of wood debris. About 10 ft long. 1st block crossing drain then 30 ft down another block on left side of drain. Photo facing upstream.

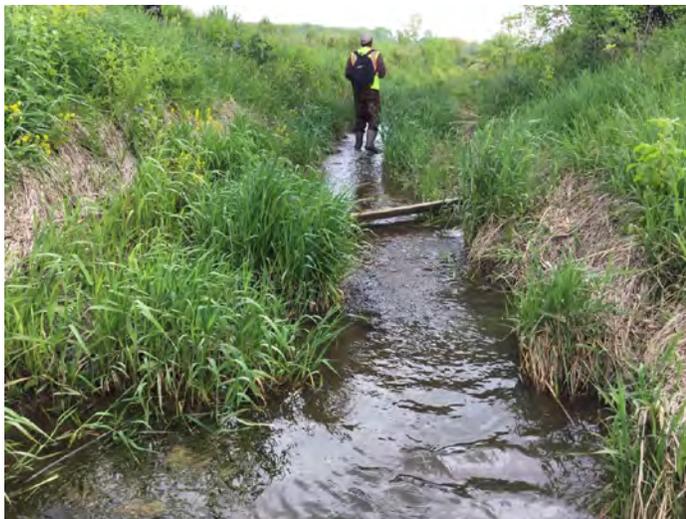
Sediment on both sides of drain and under railroad. Water kind of meanders through sediment bars. Photo taken facing upstream.

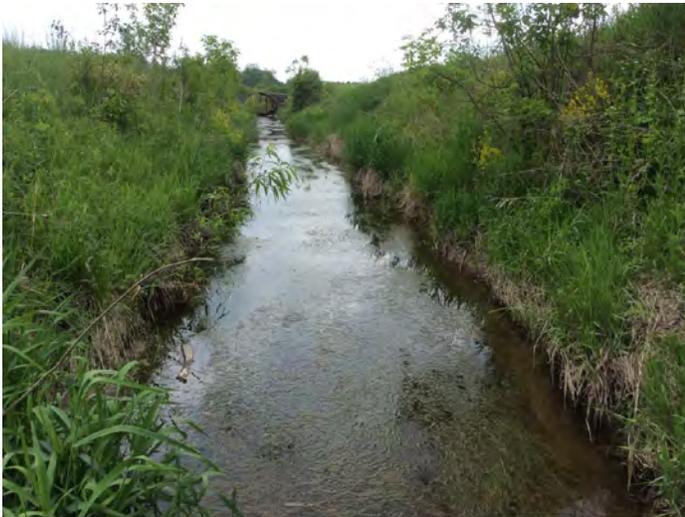
Excessive vegetation. Overgrowth on bottom. Next 180 ft up to farm crossing.

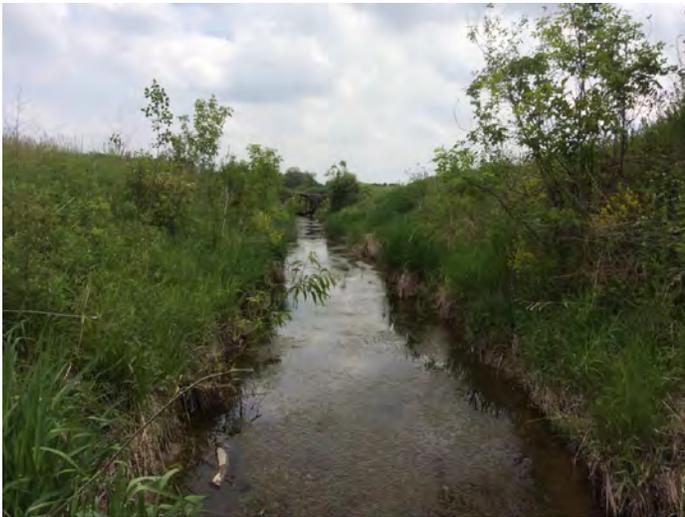
Excessive vegetation. Overgrowth of small trees on banks next 180 ft up to farm crossing.

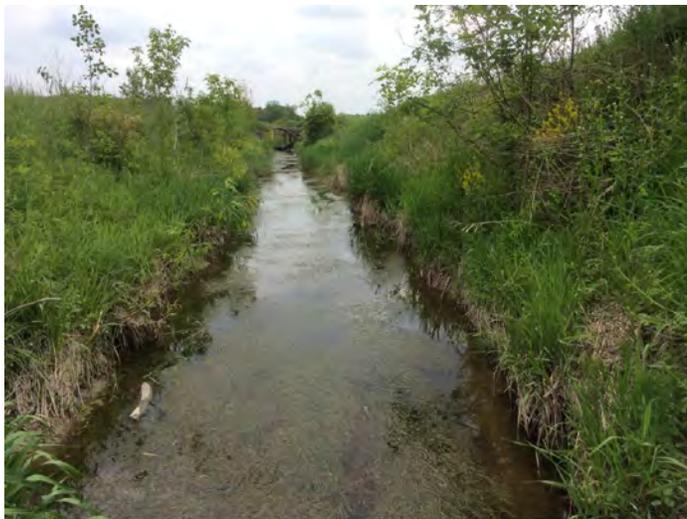
Sediment deposits at banks in clumps with vegetation. Next 180 ft up to farm crossing. Photo facing upstream.

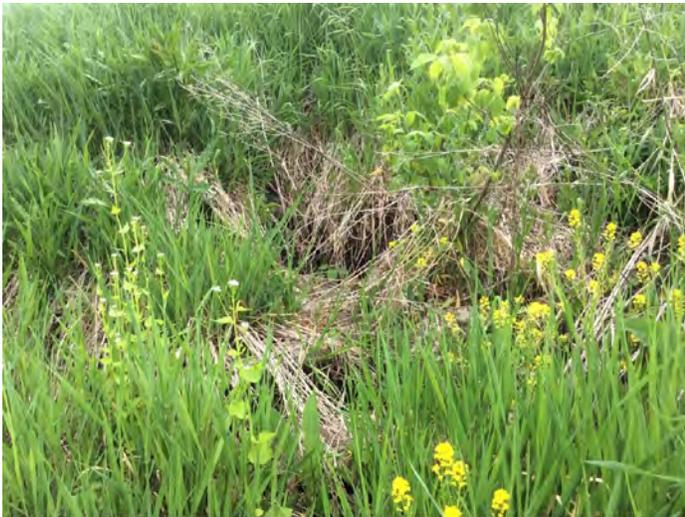
Concrete blocks on right side. No field tile visible. Photo facing south.

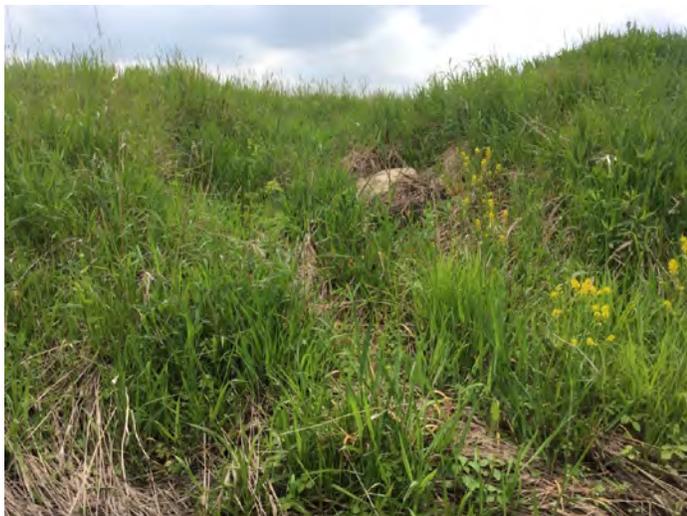
Concrete blocks on right bank. Evidence of erosion, but no field tile or surface outlet pipe visible. Photo facing south.

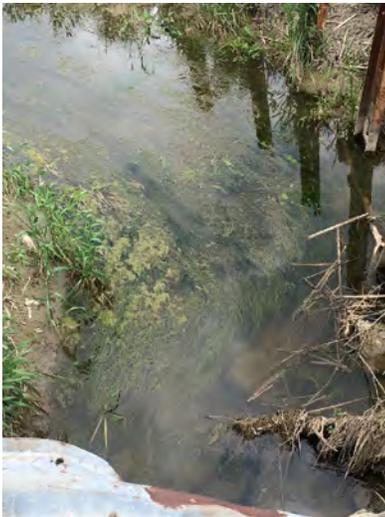
Excessive vegetation growing from bottom of drain. After farm crossing.
Photo taken facing upstream.

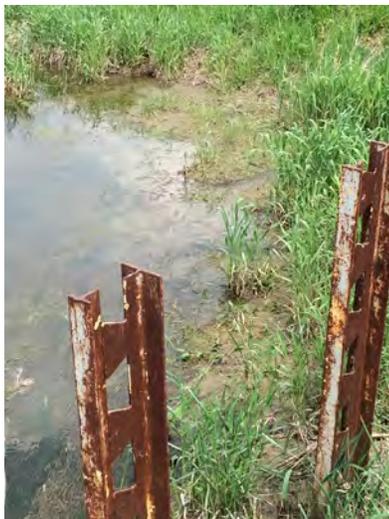
Sediment bars on right side of drain. After farm crossing. Along steel rods. Photo taken facing upstream.

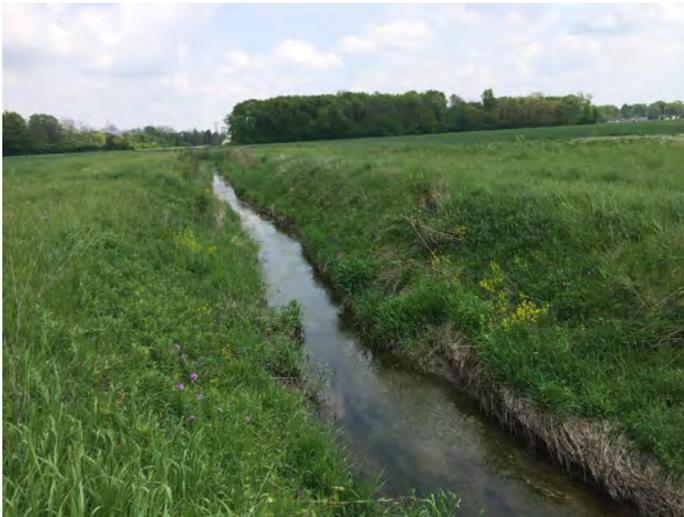
Inspection Report for Observation:
Blockage164

Type: Sediment

Blockage Length (feet): 300

Sediment deposits on both sides next 300 ft. Photo facing upstream.

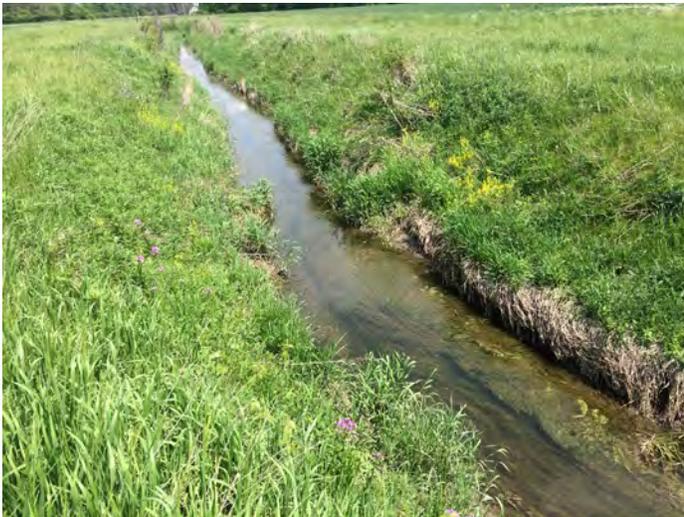
Inspection Report for Observation:
Blockage165

Type: Excessive Vegetation

Blockage Length (feet): 300

Excessive vegetation at bottom of drain channel next 300 ft. Photo facing upstream.

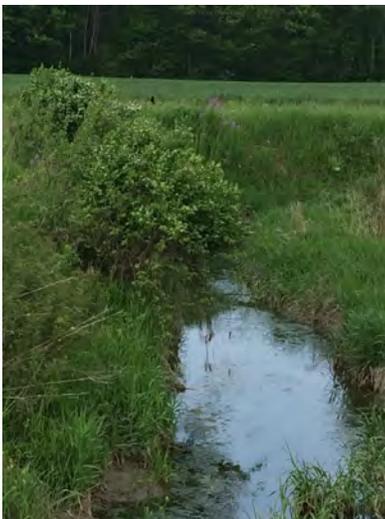
Inspection Report for Observation:
Blockage166

Type: Excessive Vegetation

Blockage Length (feet): 20

Excessive overhanging vegetation on left side of drain. After farm crossing. About 20 ft. of blockage. Photo taken facing upstream.

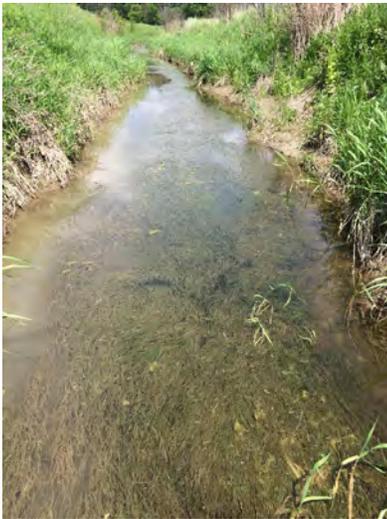
Inspection Report for Observation:
Blockage167

Type: Excessive Vegetation

Blockage Length (feet): 100

Excessive vegetation growing from bottom of drain. About 100 ft from one curve to the other. Photo taken facing upstream.

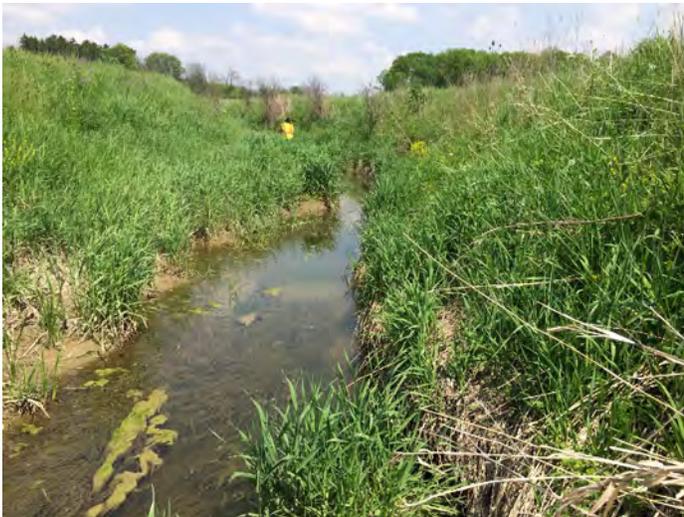
Inspection Report for Observation:
Blockage168

Type: Sediment

Blockage Length (feet): 60

Significant sediment deposit with heavy vegetation on left side around bend. Restricting flow channel width. Photo facing upstream.

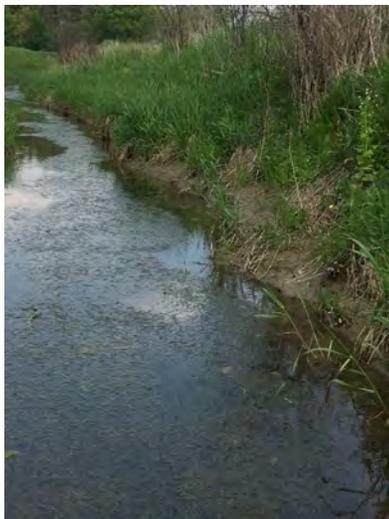
Inspection Report for Observation:
Blockage169

Type: Sediment

Blockage Length (feet): 15

Sediment bar on right side of drain. About 15 ft. Photo taken facing upstream.

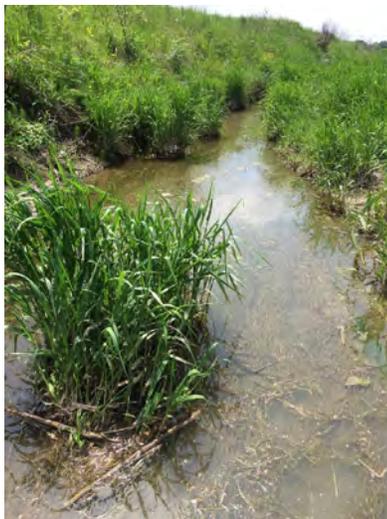
Inspection Report for Observation:
Blockage170

Type: Excessive Vegetation

Blockage Length (feet): 10

Islands of overgrown vegetation blocking flow. About 10 ft from first to last. Photo taken facing downstream.

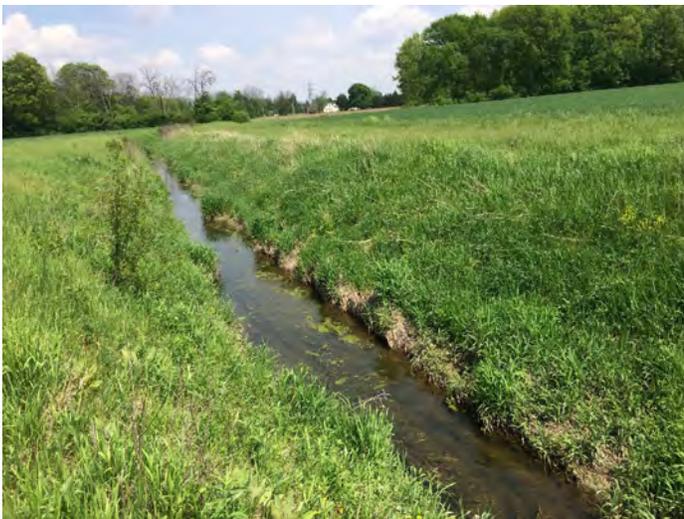
Inspection Report for Observation:
Blockage171

Type: Excessive Vegetation

Blockage Length (feet): 300

Excessive vegetation at bottom of drain channel over next 300 ft. Photo facing upstream.

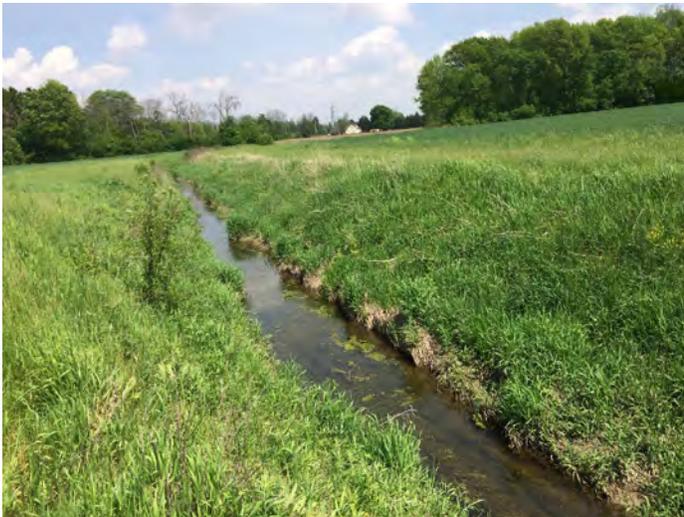
Inspection Report for Observation:
Blockage172

Type: Sediment

Sediment deposits on both sides of drain with vegetation growing. Continuous next 300 ft. Photo facing upstream.

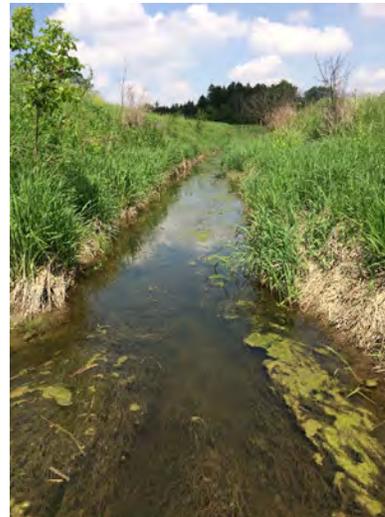
Excessive vegetation overgrown on both sides of bank. About 100 ft.
Photo taken facing upstream.

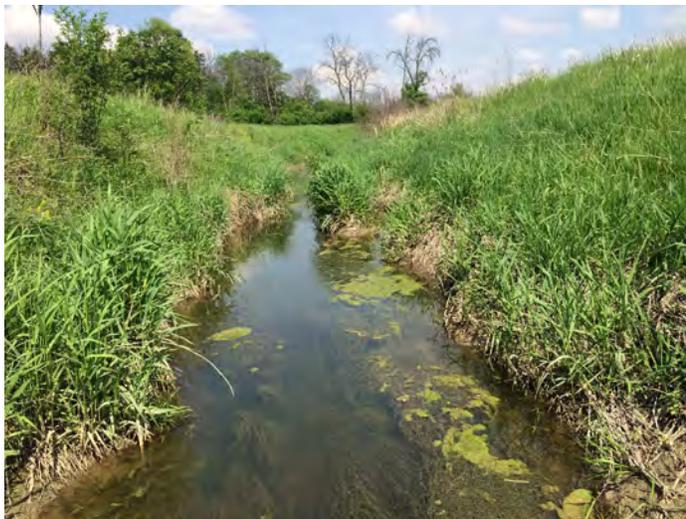
Mid channel sediment bar with vegetation. Photo facing upstream.

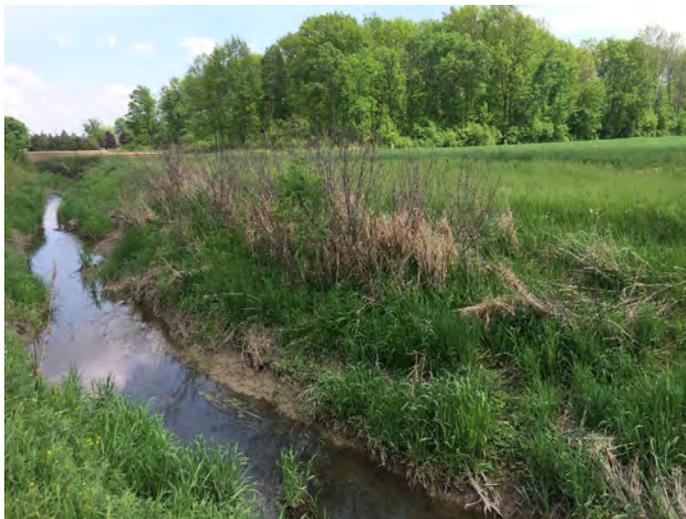
Tall shrubs on right side of drain in channel on bank. 40 ft. Photo facing upstream.

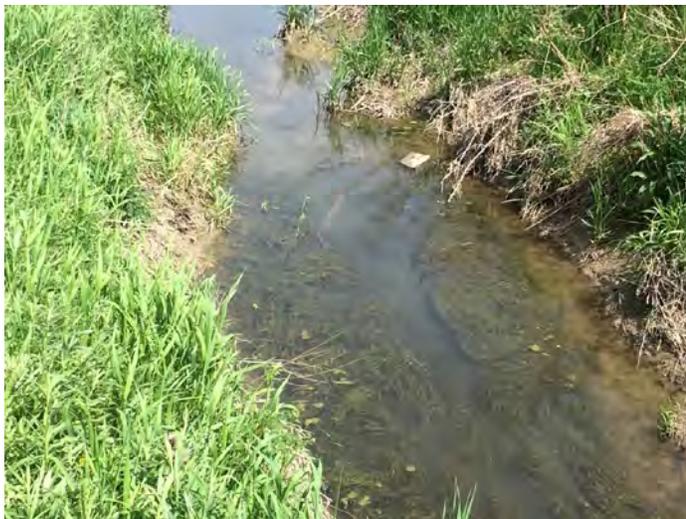
Excessive vegetation growing from bottom of drain. About 80 ft. Photo taken facing upstream.

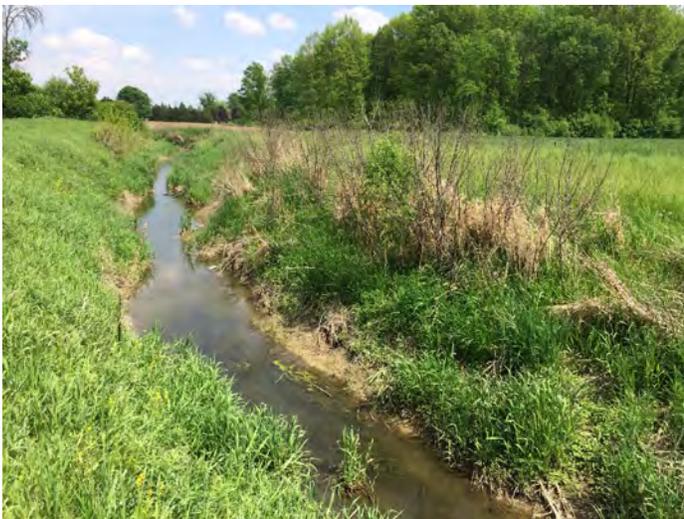
Sediment deposits on both banks next 100 ft with vegetation Photo facing upstream.

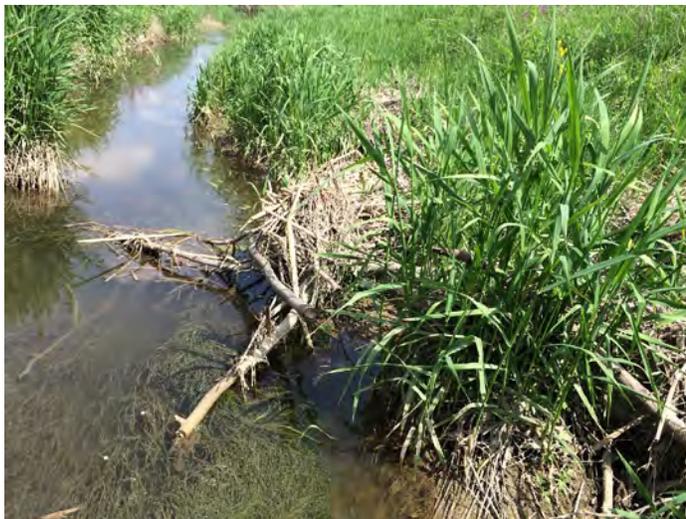
Woody debris up to 2" diam clump on my right side. Photo facing upstream.

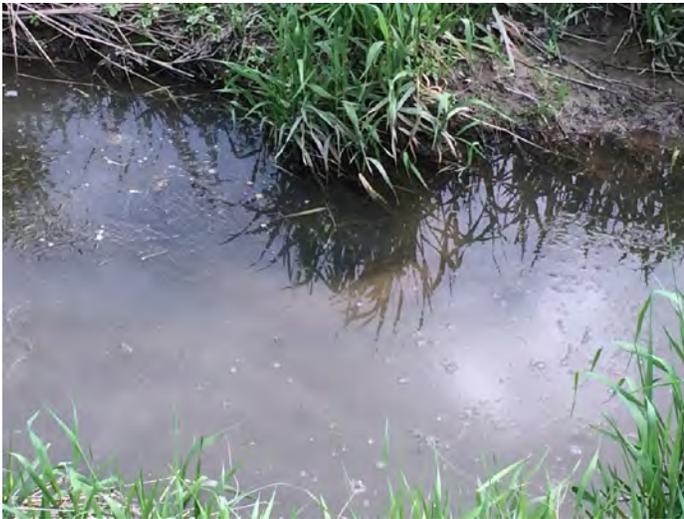
Tire on right side of drain underwater. About 1 ft. Photo taken facing south.

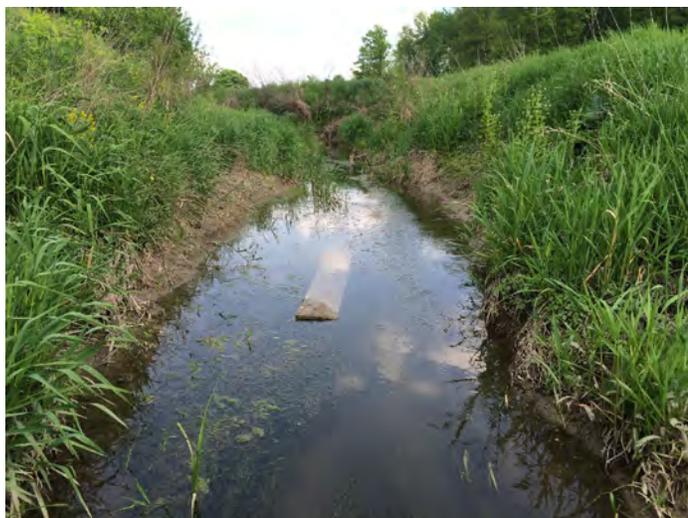
2 pieces of wood in center of drain. Photo facing upstream.

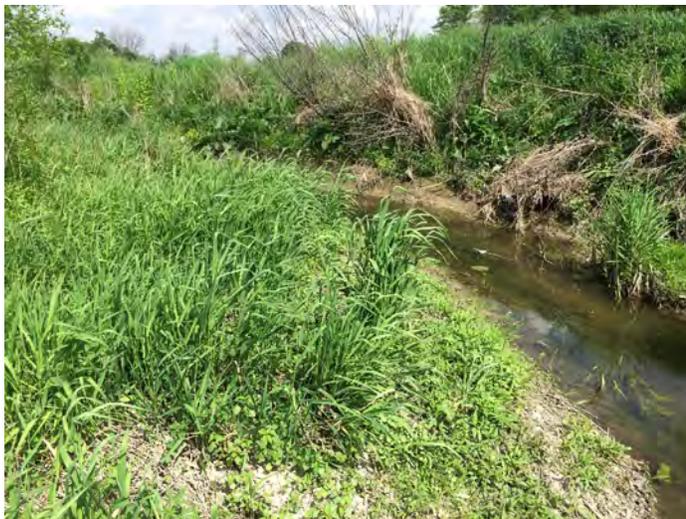
Sediment bar on left side. Photo facing upstream.

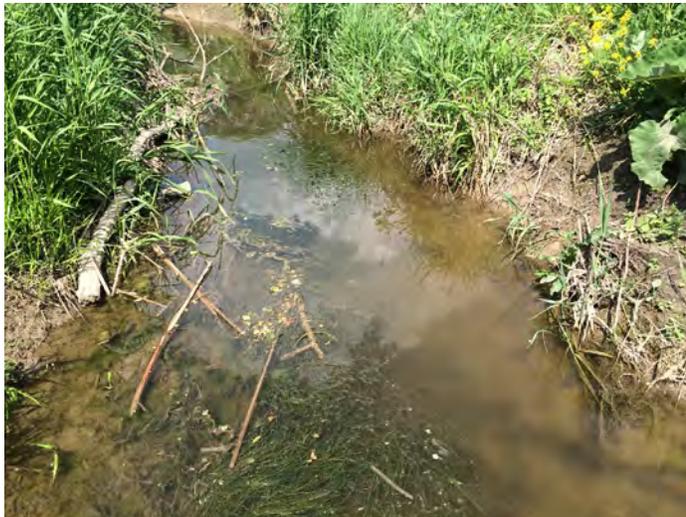
Excessive vegetation on bottom of drain channel next 30 ft. Photo facing upstream.

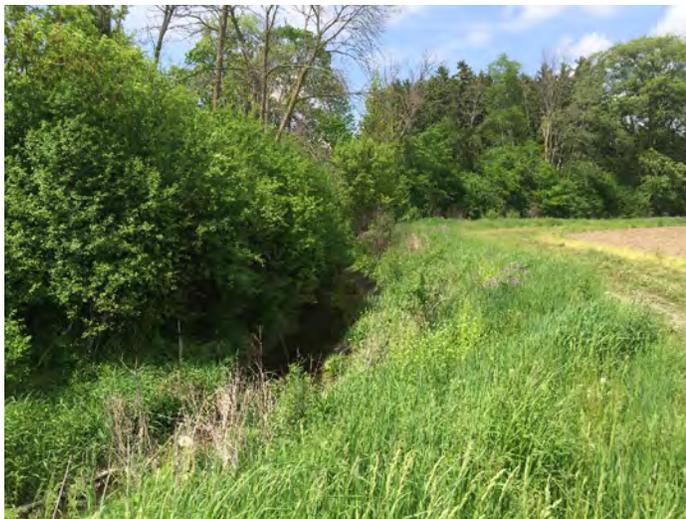
Photo 2

Excessive vegetation on left bank from trees next 100 ft. Photo facing upstream.
