King Street Tile Drain Inspections

Inspection Report for Observation:
Blockage1

HUBBELL, ROTH & CLARK, INC CONSULTING ENGINEERS SINCE 1915	555 Hulet Drive P.O. Box 824 Bloomfield Hills, MI 48303-0824 (248) 454-6300 http://www.hrc-engr.com	DATE:	08/16/2016
				SCALE:	
NOTE				SHEET #:	
				JOB #:	20160331

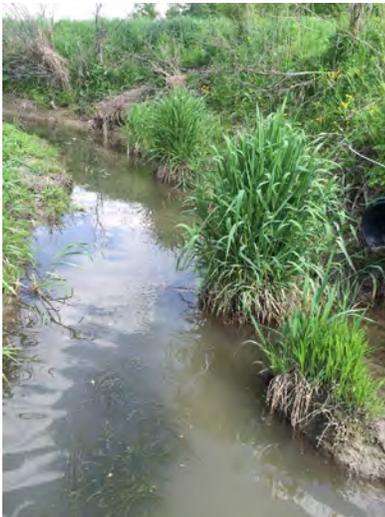
Photo 2

Excessive vegetation growing in drain blocking flow. Right side. Photo taken facing upstream.

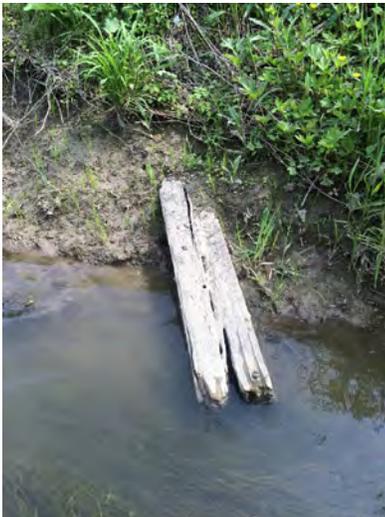
Photo 2

Log blocking some flow on right side of drain. About 1 ft long. Photo taken facing south.

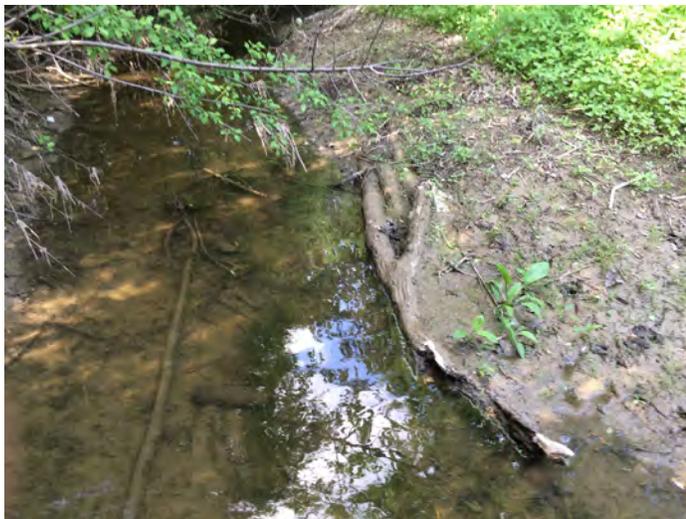
Photo 2

Logs and woody debris on right side. 4" diam. Photo facing upstream.

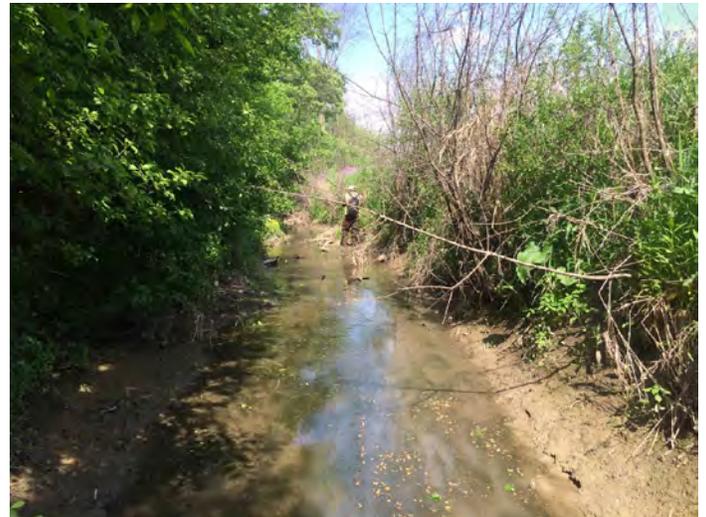
Photo 3

Overhanging excessive vegetation on both sides of drain. Photo taken facing upstream.

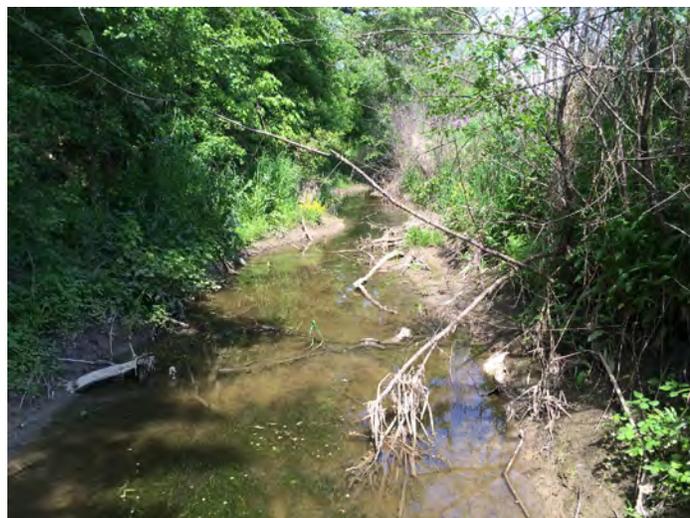
Photo 2

Woody debris up to 3" diam next 100 ft. Photo facing upstream.

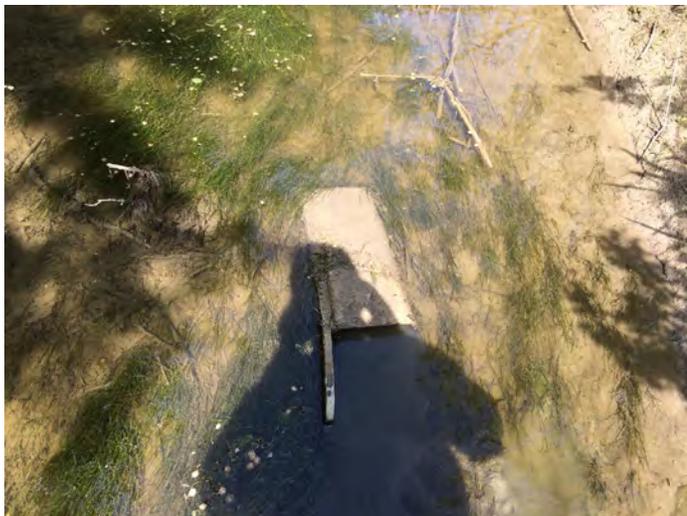
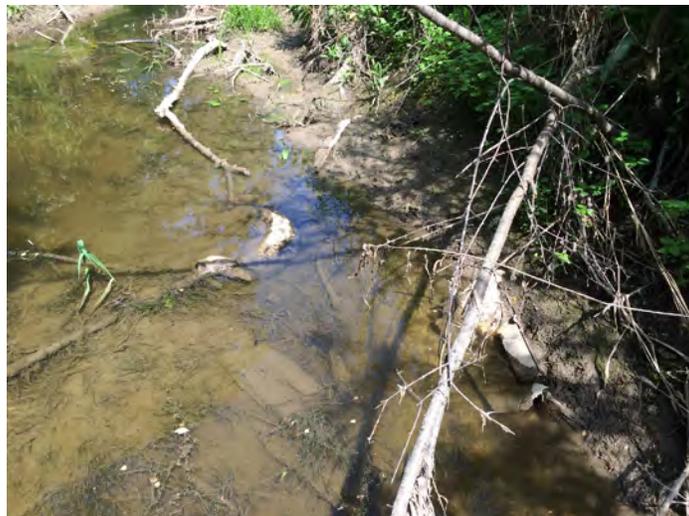
Trash in center of drain. Photo facing upstream.

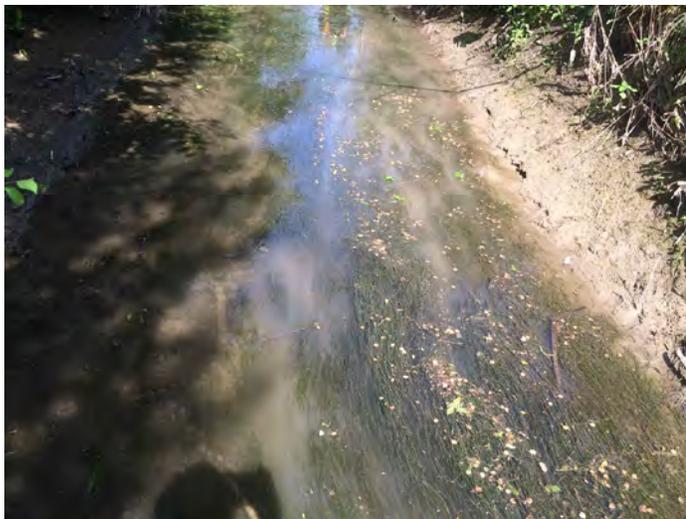
Photo 2

Excessive vegetation growing from bottom of drain. About 300 ft. Photo taken facing upstream.

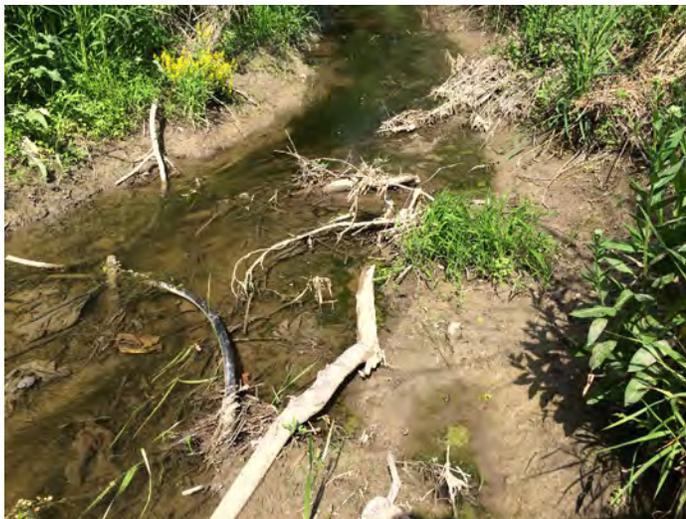
Photo 2

Point sediment bar on right for 12 ft. Photo facing upstream.

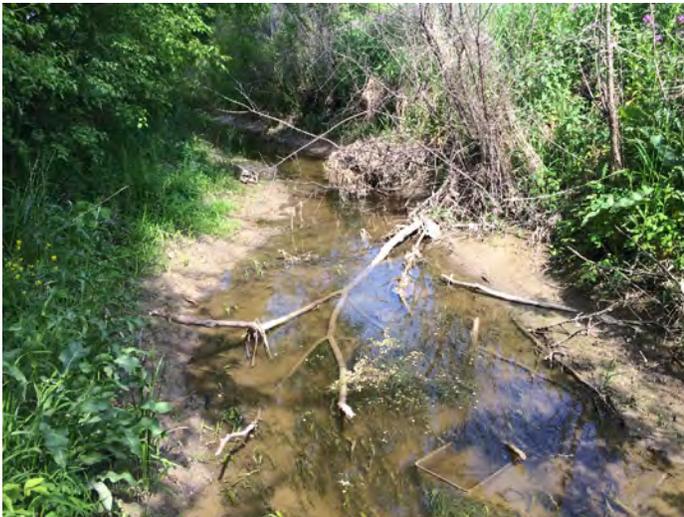
Photo 2

Sediment deposits on both sides of drain. Flow meanders around them. Photo facing upstream.

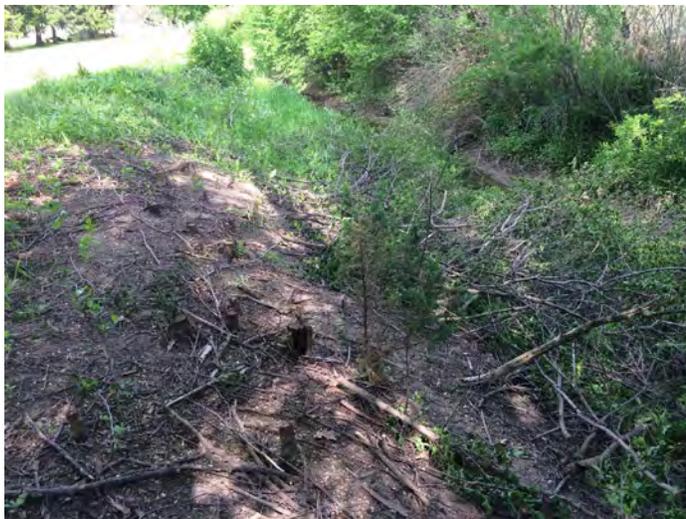
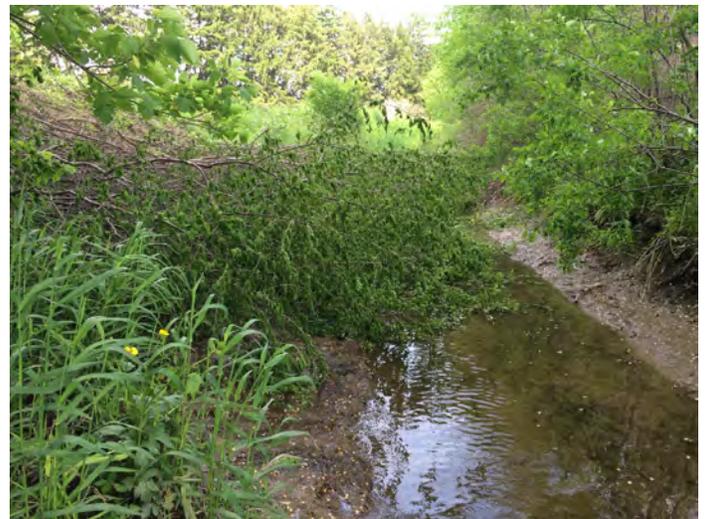
Woody debris on left bank and in drain. Recently cut. Photo1 facing upstream at top of bank. Photo2 facing upstream in drain.

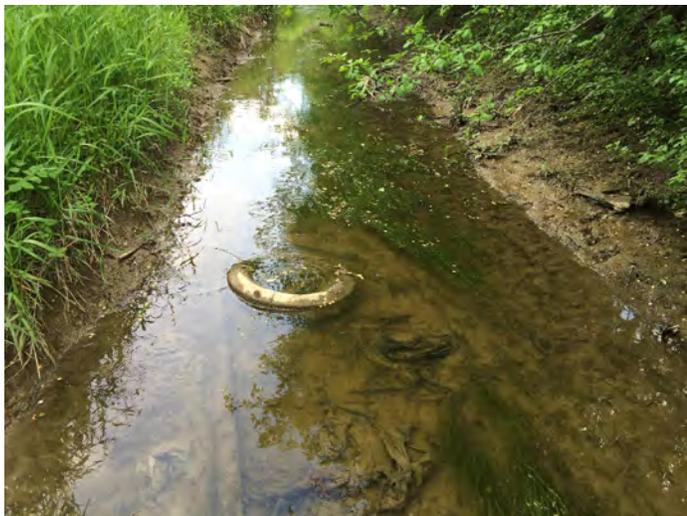
Photo 2

Tire in center of drain. Photo facing upstream.

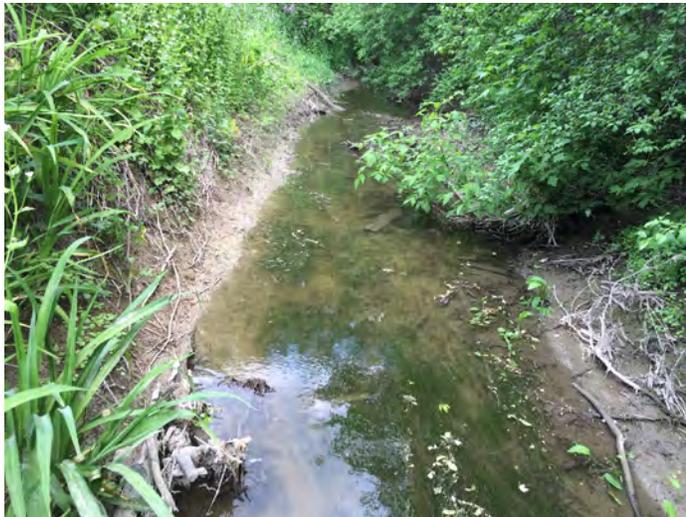
Photo 2

Scattered woody debris up to 4" diam over next 100 ft. Photo facing upstream.

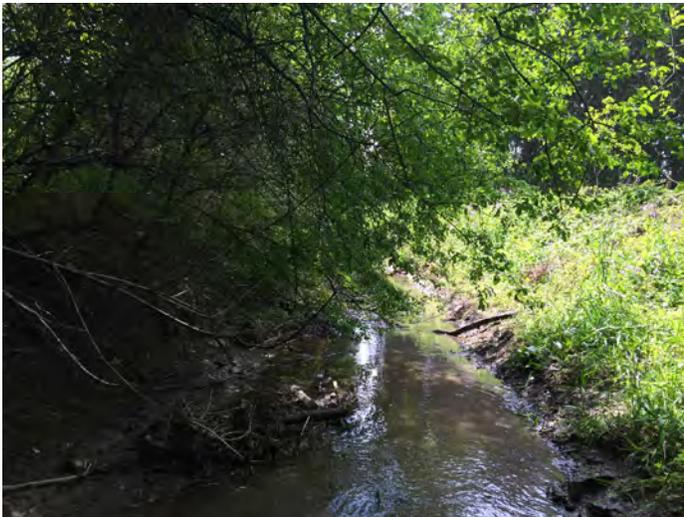
Photo 2

Overgrowth from trees on right bank overhanging drain. Photo facing downstream.

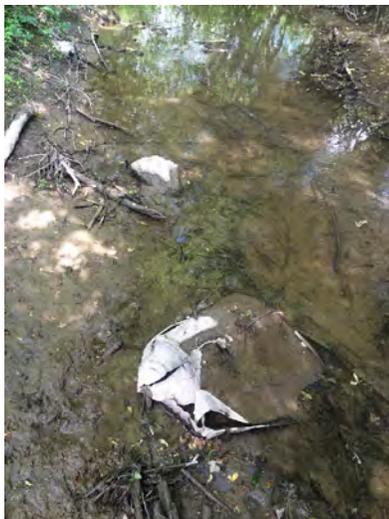
Photo 2

Trash and rocks on left side of drain. Photo taken facing upstream.

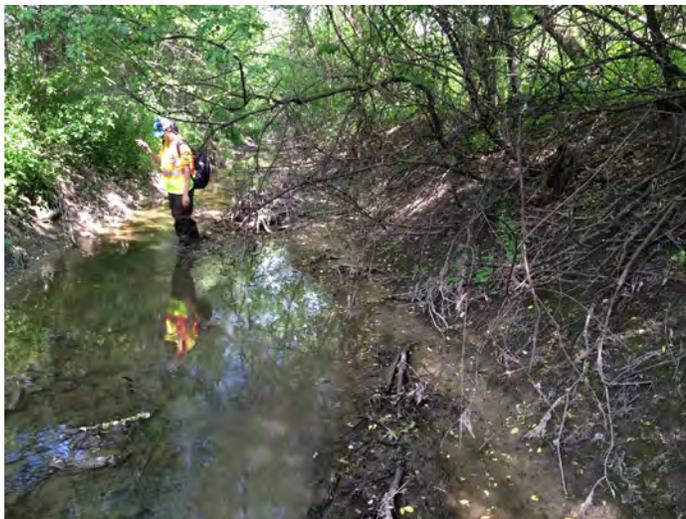
Photo 2

Several sediment bars on right side next 300 ft. Photo facing upstream.

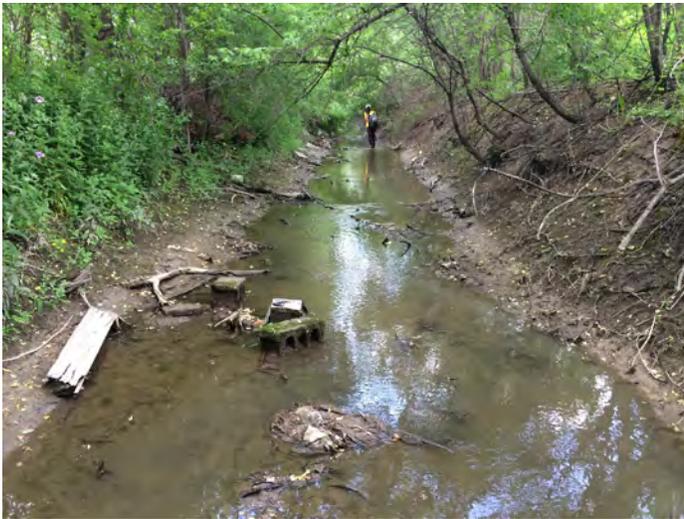
Photo 2

Trash and concrete blocks in drain next 300 ft. Photo facing upstream.
