King Street Tile Drain Inspections

Inspection Report for Observation:
Blockage200

CLIENT	Saginaw County Public Works Commissioner

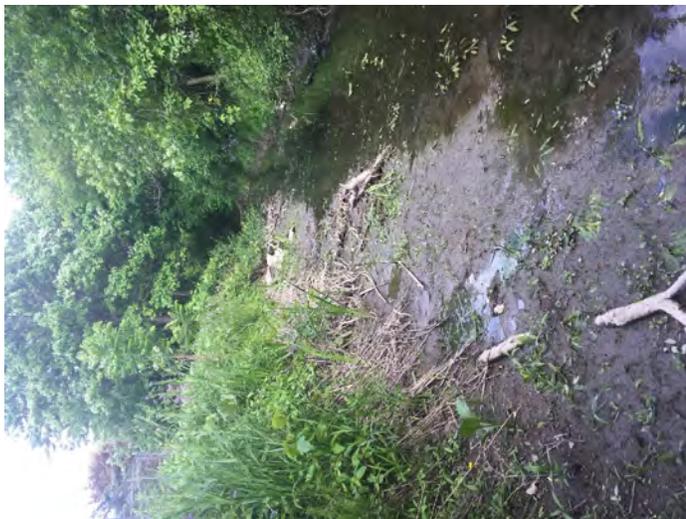
Inspection Report for Observation:
Blockage222

Type: Sediment

Sediment bar left side of the drain from this location approx 100' upstream to end. Picture facing upstream

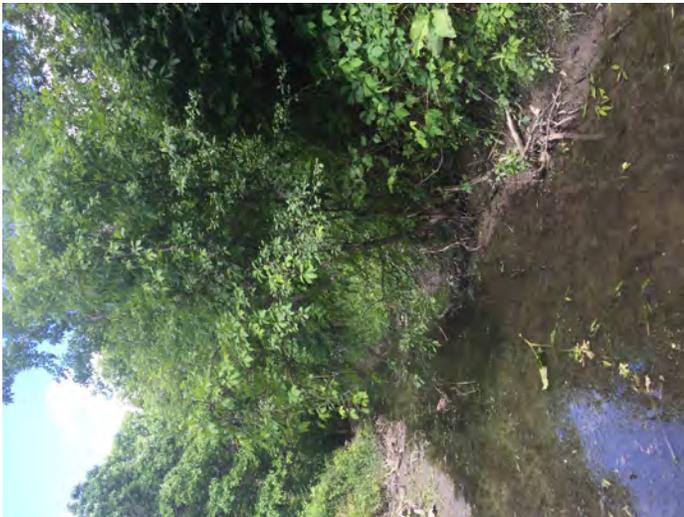
Inspection Report for Observation:
Blockage223

Type: Excessive Vegetation

Excessive vegetation right side of the drain from this location approx 300' upstream to end . Picture facing upstream

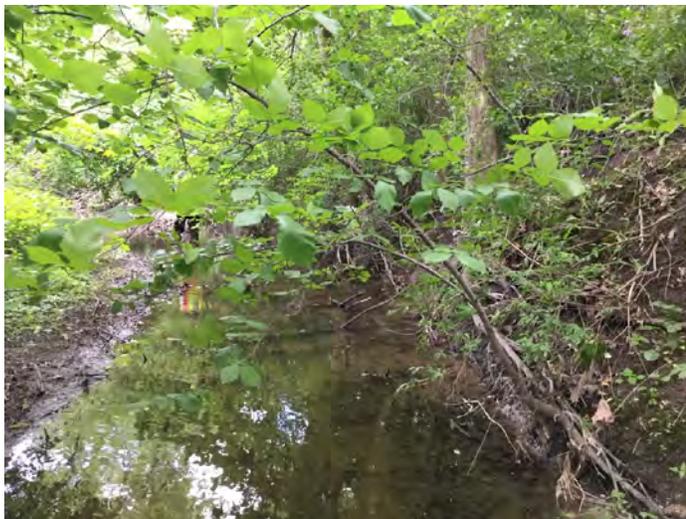
Inspection Report for Observation:
Blockage226

Type: Excessive Vegetation

Overhanging vegetation from banks on both sides next 100 ft.

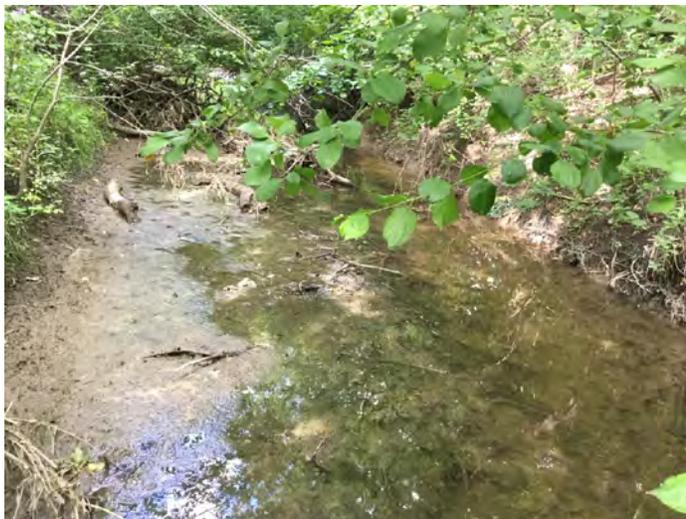
Inspection Report for Observation:
Blockage227

Type: Non-Vegetative Debris

Sediment buildup on left side of drain. Visible that most flow is on tight side of channel.

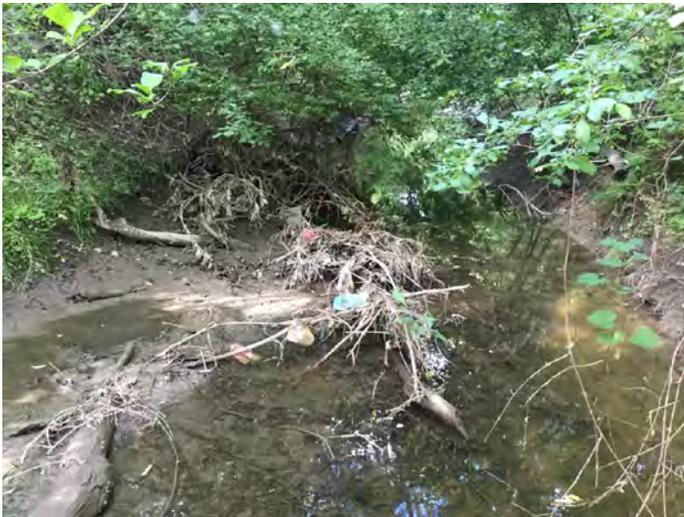
Inspection Report for Observation:
Blockage228

Type: Log Jam

Log jam on left side of drain impeding flow and directing to right side. Led to sediment buildup downstream and bank erosion. 25 ft.

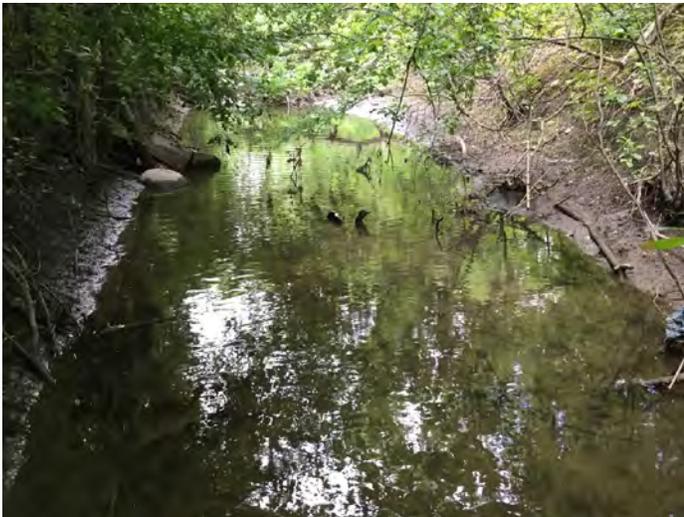
Inspection Report for Observation:
Blockage229

Type: Non-Vegetative Debris

Scattered pieces of trash in drain over next 50 ft.

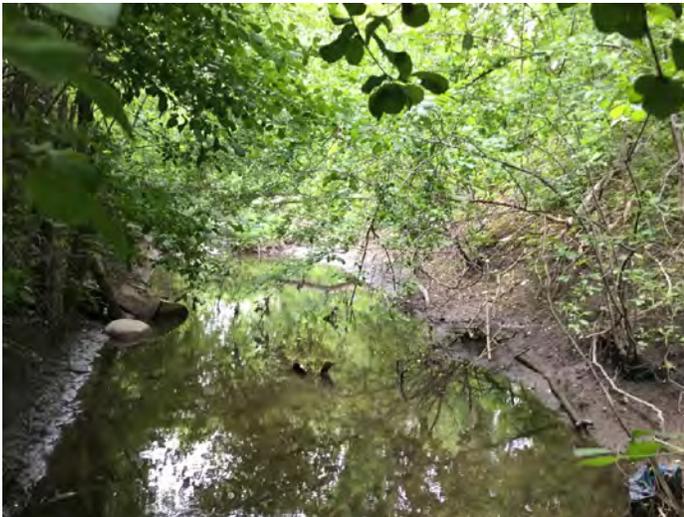
Inspection Report for Observation:
Blockage230

Type: Excessive Vegetation

Overhanging from banks on both sides. Next 400 ft.

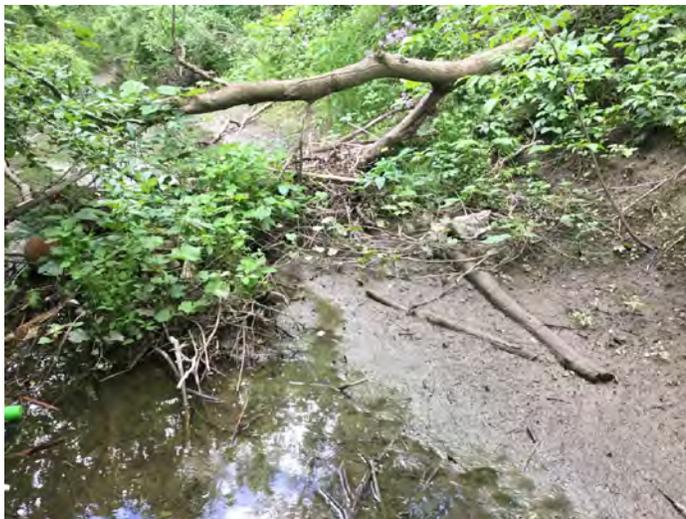
Sediment bar on tight extends on both sides of log jam. 40 ft. 5 ft wide.

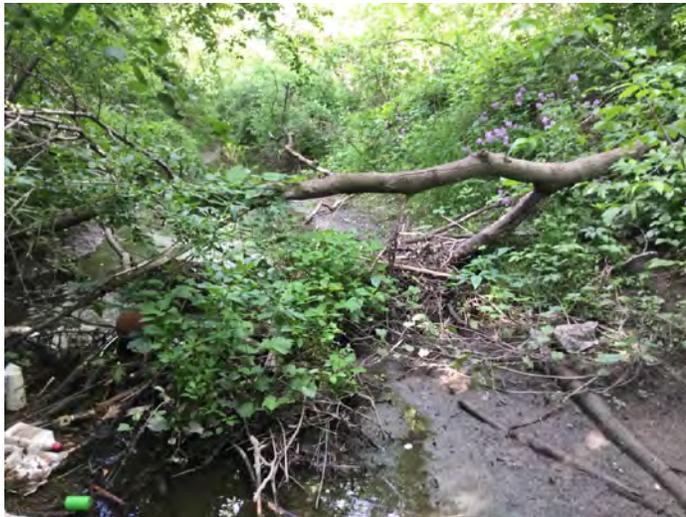
Log jam due to fallen tree from right side. 6" diam. Significant amounts of trash as well.

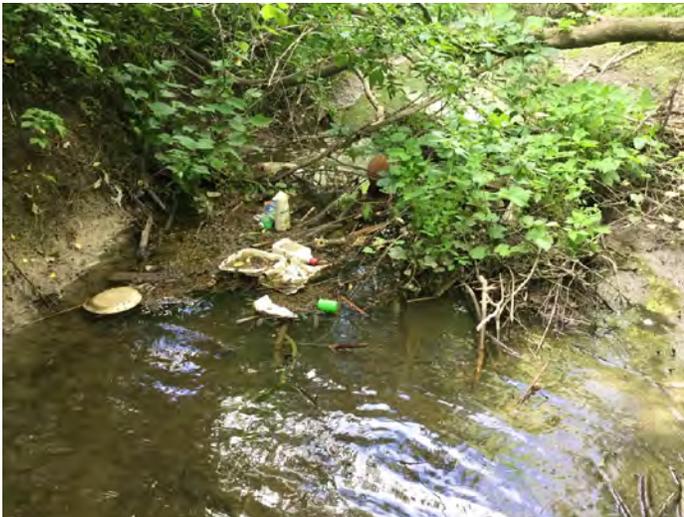
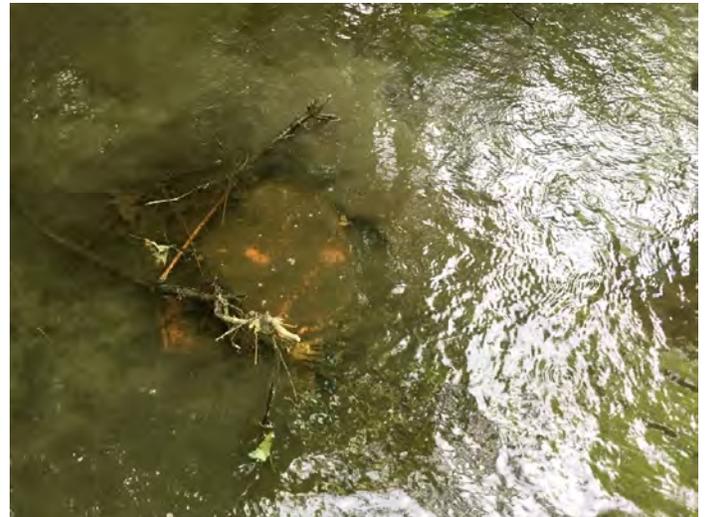
Significant amounts of trash over next 50 ft at log jam including a folding chair and fire extinguisher.

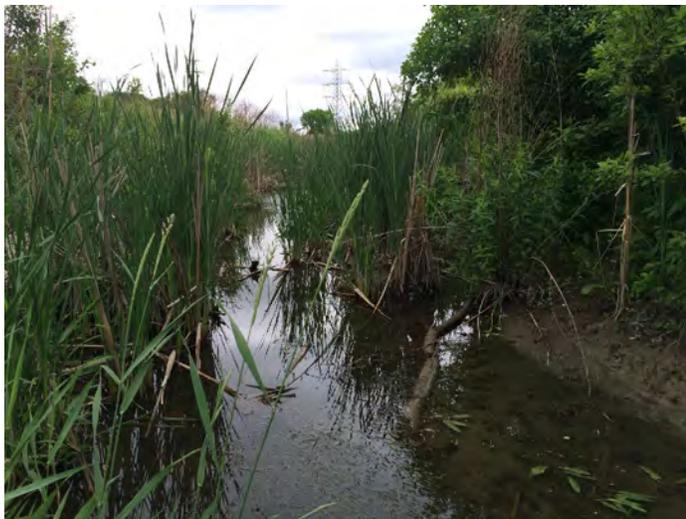
Excessive vegetation growing in center of drain. Loose sediment and stagnant water.

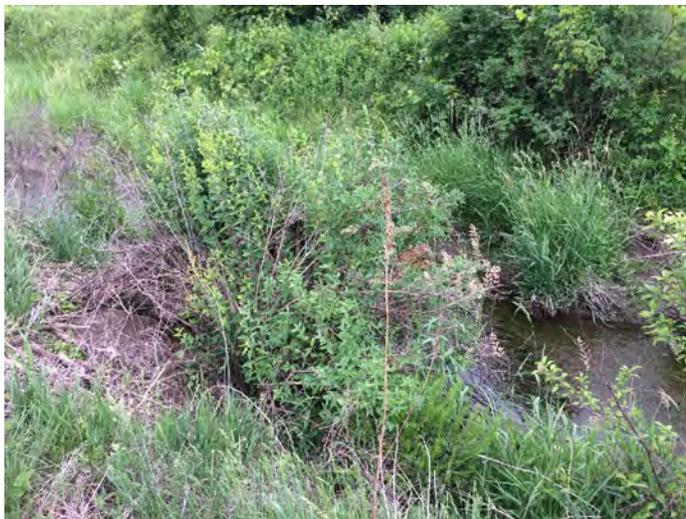
Clump on left side.

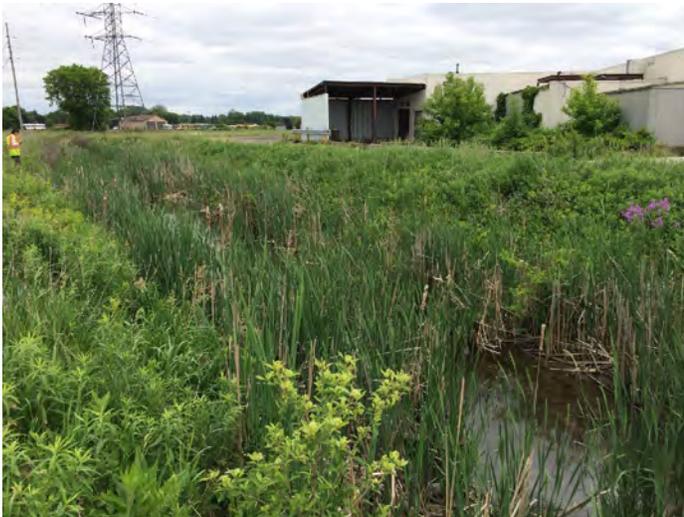
Excessive vegetation in bottom of drain channel. Cattails and grass. Next 250 ft.

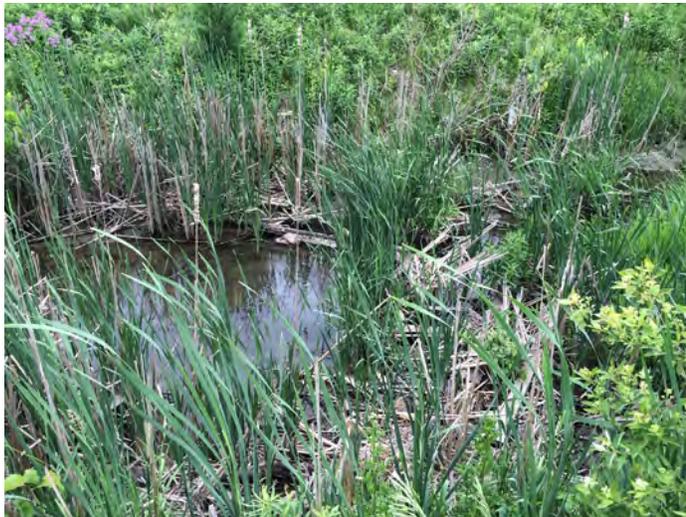
Woody debris scattered in bottom of drain channel next 250 ft.

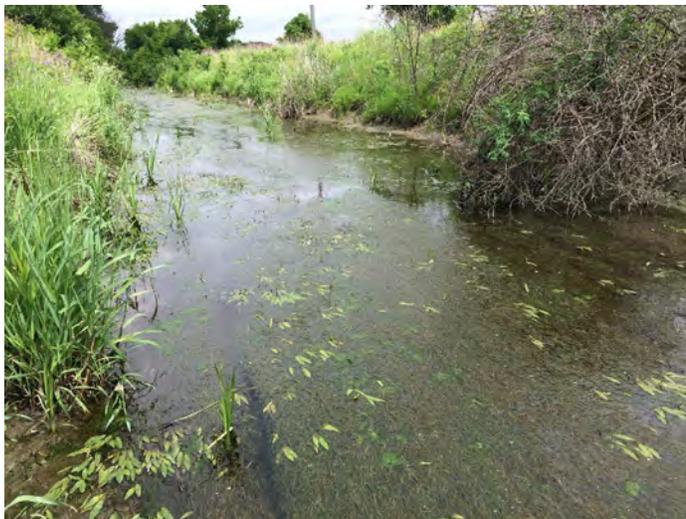
Excessive vegetation. Heavy grass growing in bottom of drain channel.

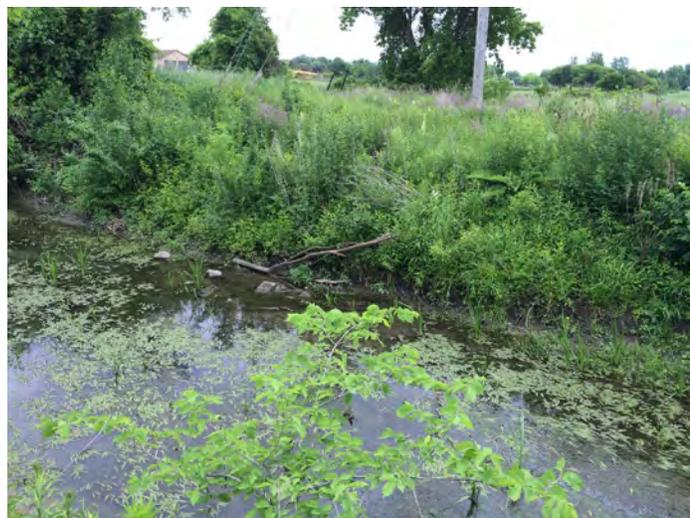
Photo 1

3" diam branch on right side.

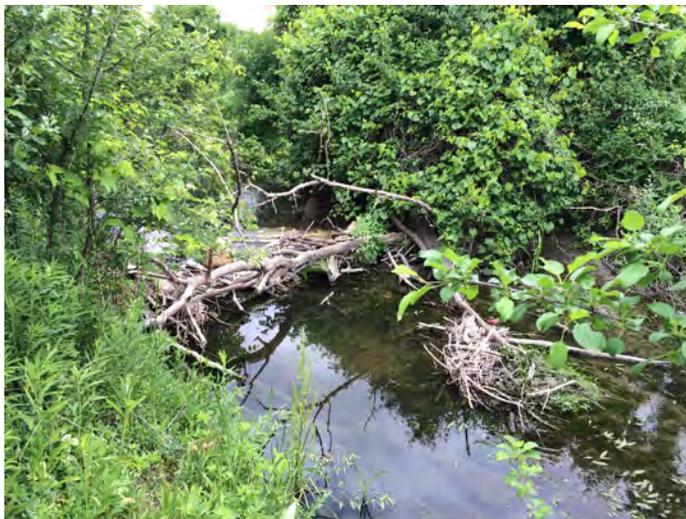
Photo 1

Log jam across the drain. Fallen tree and other woody debris. Up to 8" diam. Lots of trash as well.

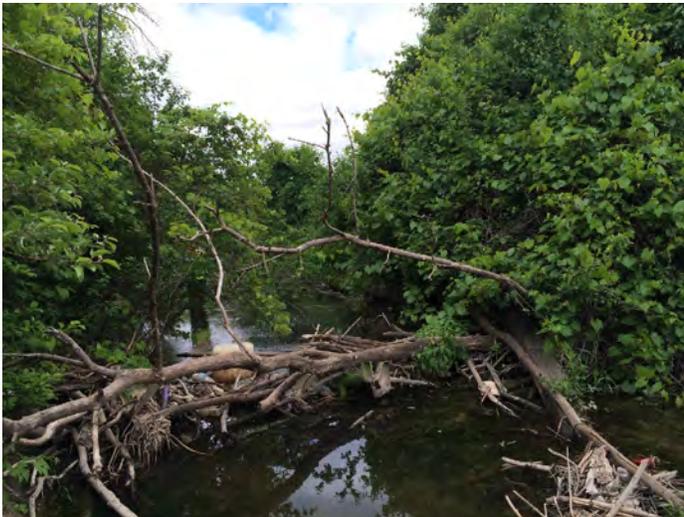
Photo 1

Overhanging vegetation growing off left bank next 300 ft.

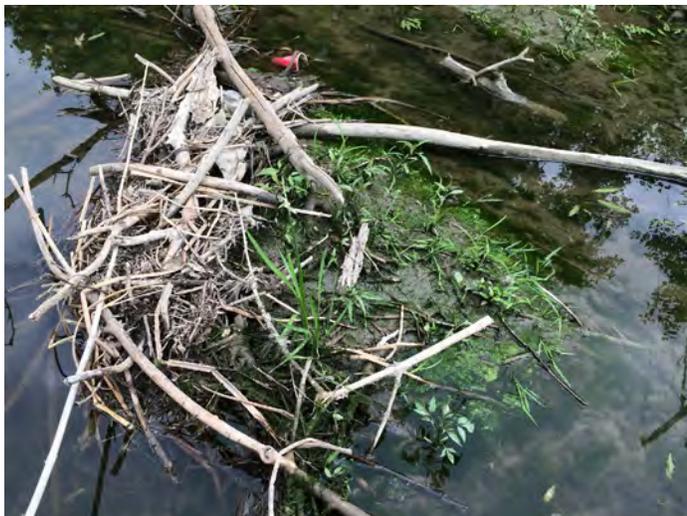
Photo 1

3 ftx5ft midchannel sediment bar just downstream of log jam.

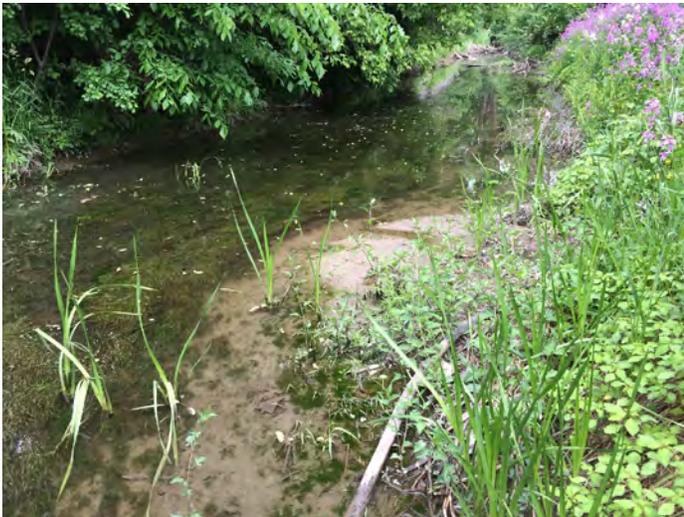
Photo 1

Sediment bar on right side of drain. At field tile outlet.

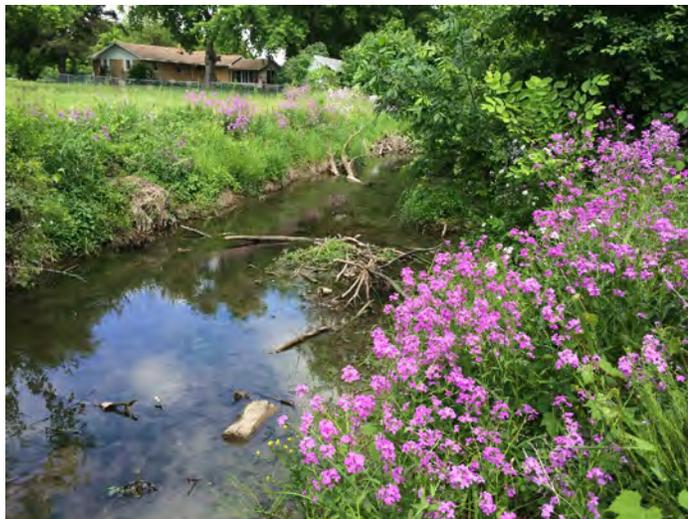
Photo 1

Mid channel sediment bar. 8 ft long.

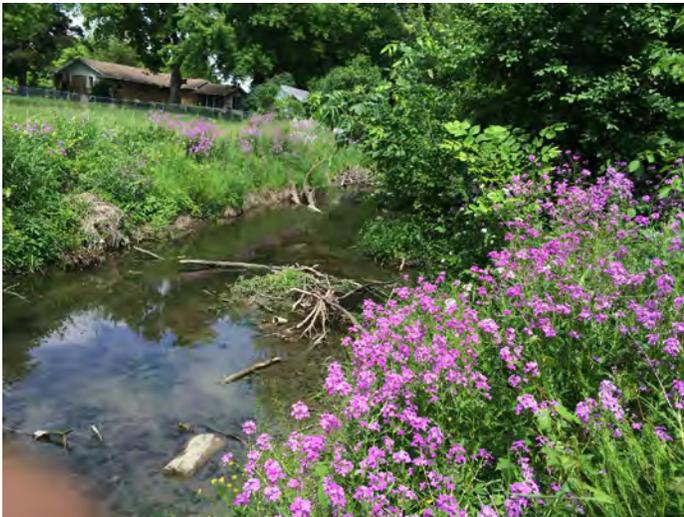
Photo 1

Fallen tree with 8" diam and other woody debris over next 100 ft up to log jam.

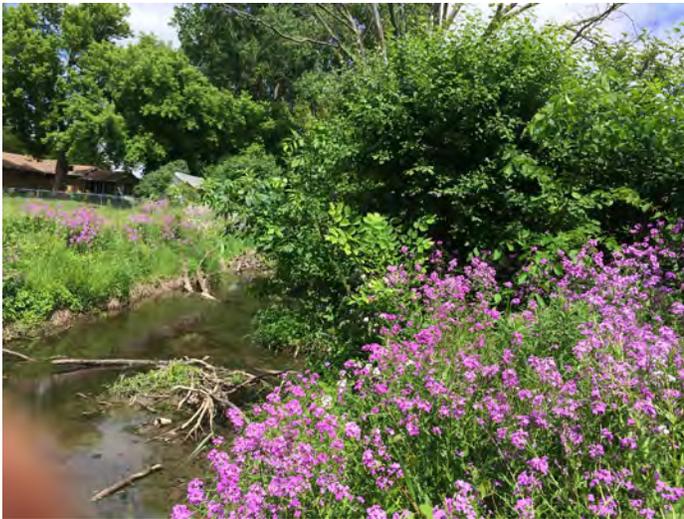
Photo 1

Excessive vegetation growing on right banks next 150 ft overhanging the drain.

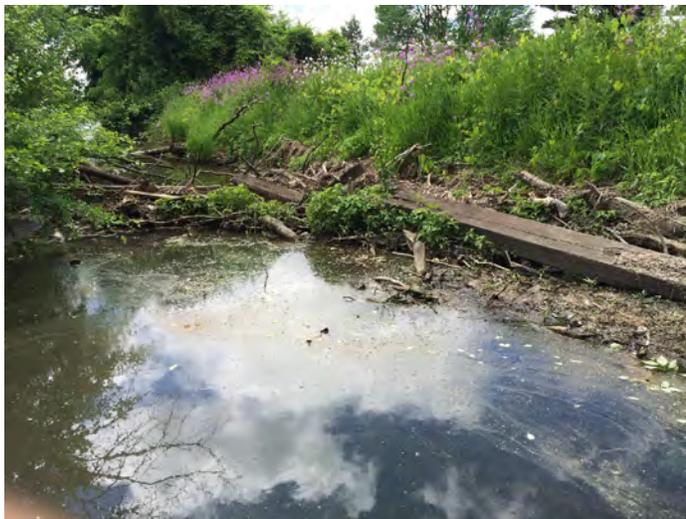
Photo 1

Significant log jam impeding flow in center of drain. 50 ft long. Photo facing downstream.

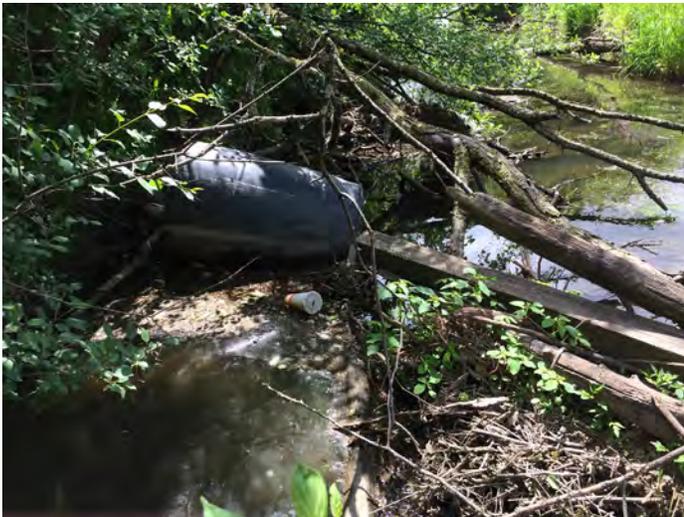
Photo 1

Garbage bin and other trash in center of drain.

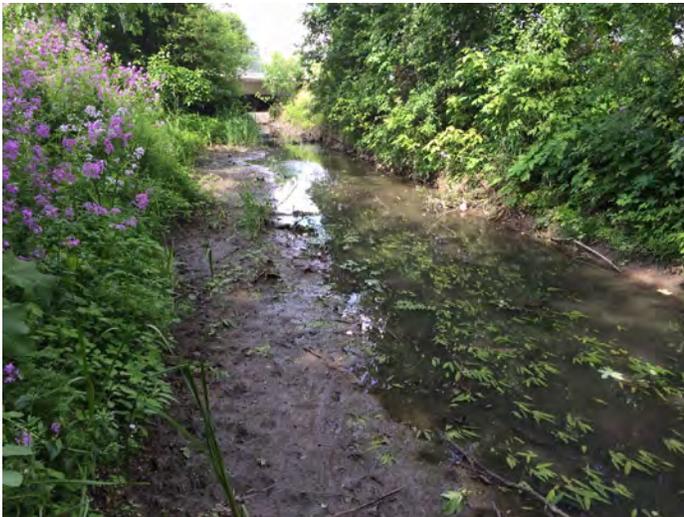
Photo 1

Continuous sediment buildup on left side.

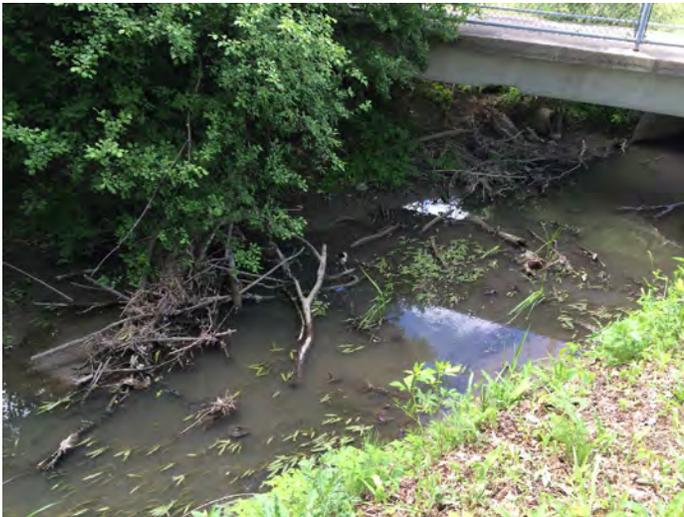
Photo 1

Woody debris on left side of drain over 40 ft. Up to 3" diam.

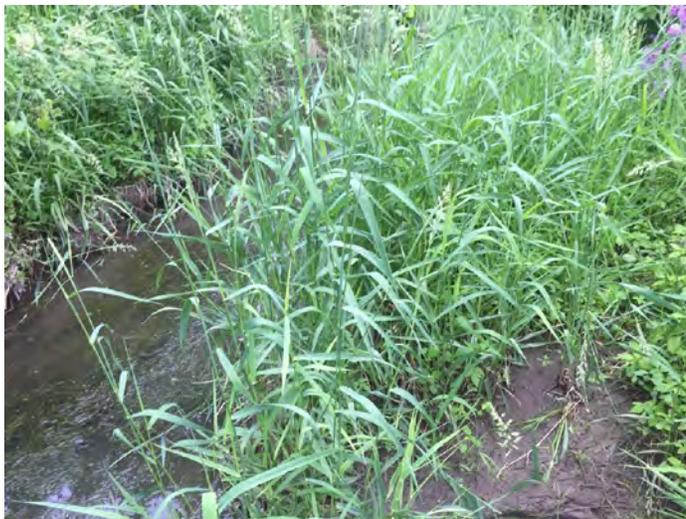
Photo 1

Sediment bar on right side of drain extends for next 15'. Contains established vegetation.

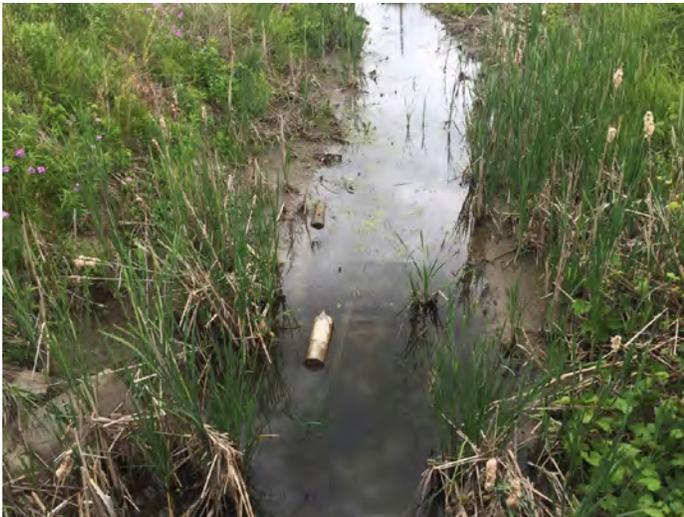
Photo 1

Mailbox in the middle of the drain with trash on both banks.

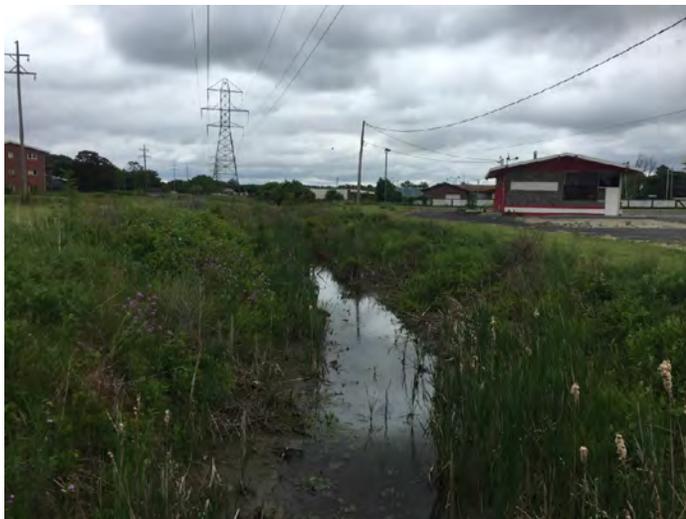
Photo 1

Excessive vegetation on both sides of drain for the next 500'.

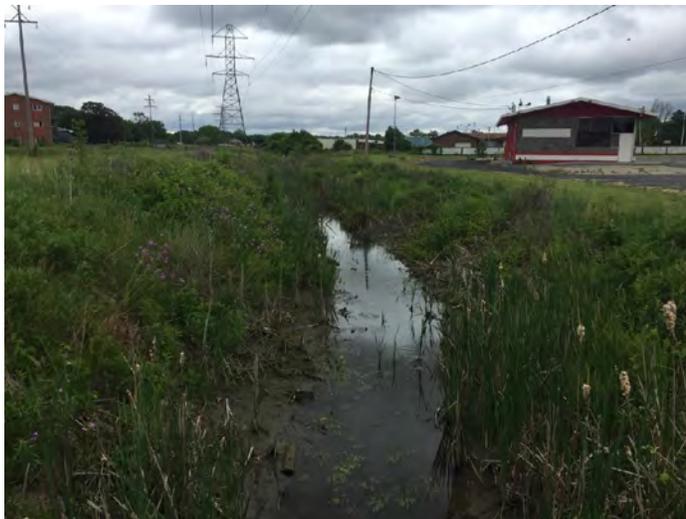
Photo 1

Excessive vegetation in the drain for the next 500'.

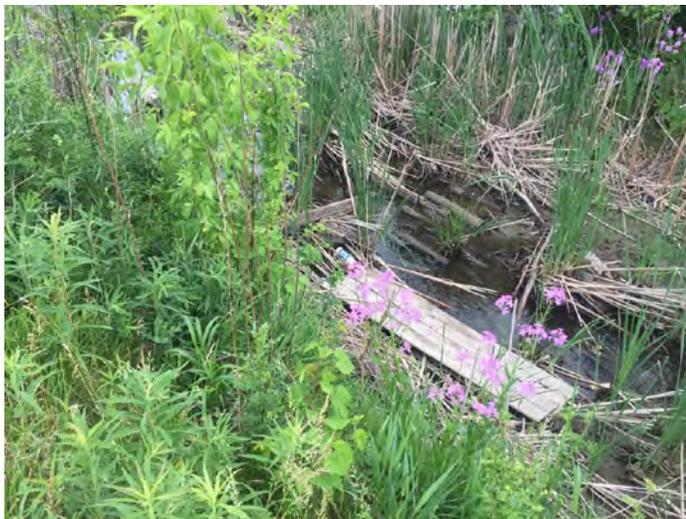
Photo 1

Wood plank on left side of drain with scattered trash on both sides of drain.

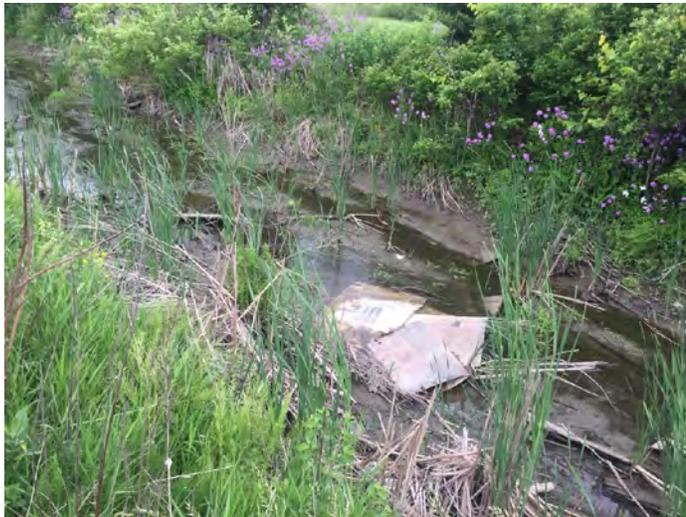
Photo 1

Old signs in the drain along the left bank for approximately 10' and 5' across.

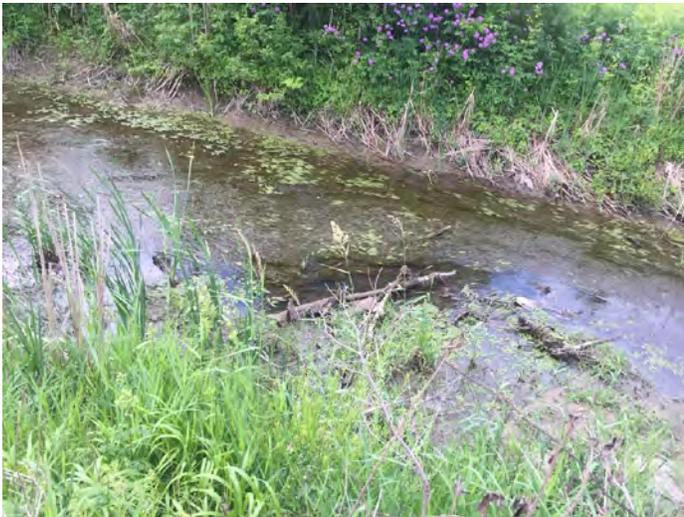
Photo 1

Woody debris buildup about 10' long and 10' wide on the left side of drain.

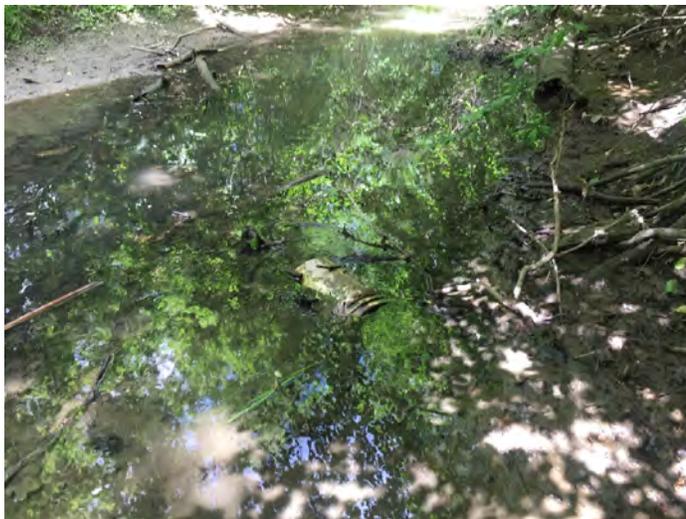
Bucket in the drain on the right side of the drain.

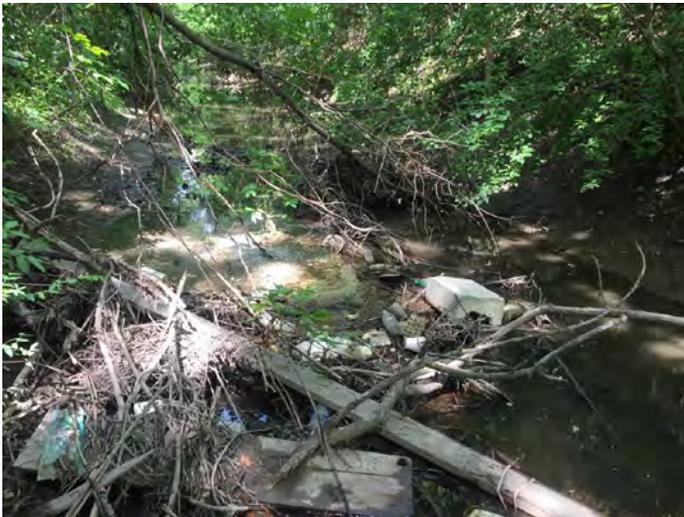
Log jam across drain for next 25' with logs ranging in size from 4-6" containing a lot of non-woody debris.

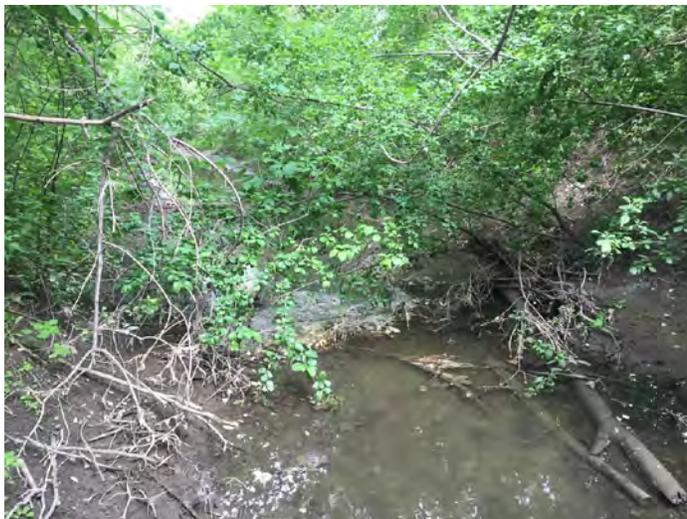
Fallen trees for next 25' on both sides of drain ranging in size from 6-10".

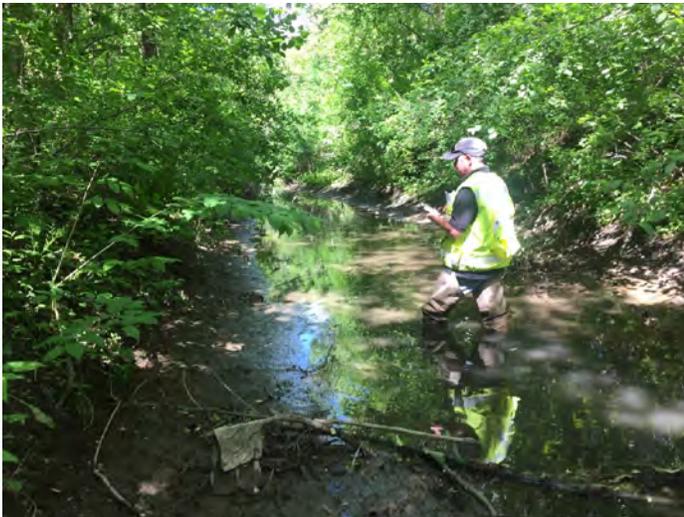
Woody debris on both sides of drain for the next 250' ranging in diameter from 4-8".

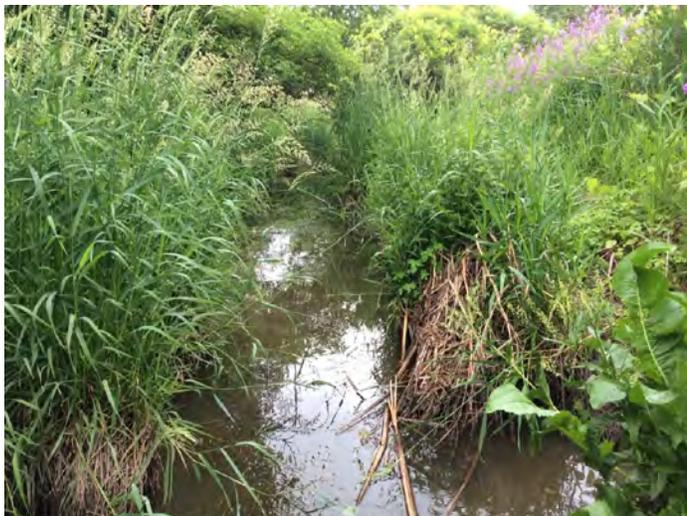
Excessive vegetation on both sides of drain after crossing. Especially right side extends further into drain, about 1 ft. Photo taken facing upstream.

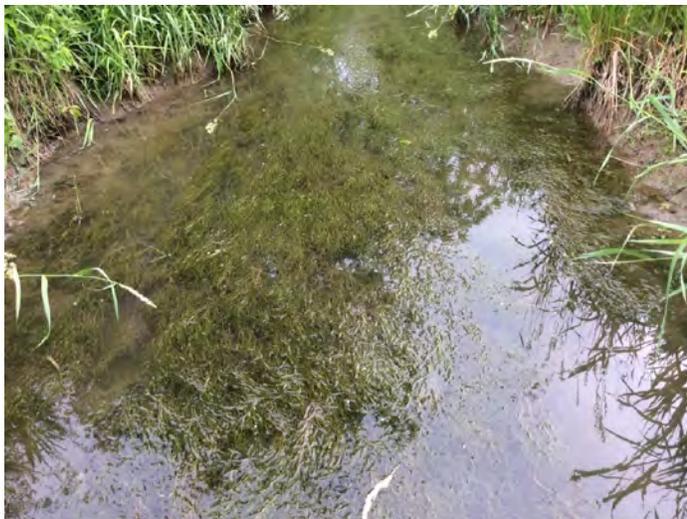
Excessive vegetation growing in drain from bottom. Starts about 20 ft after crossing.

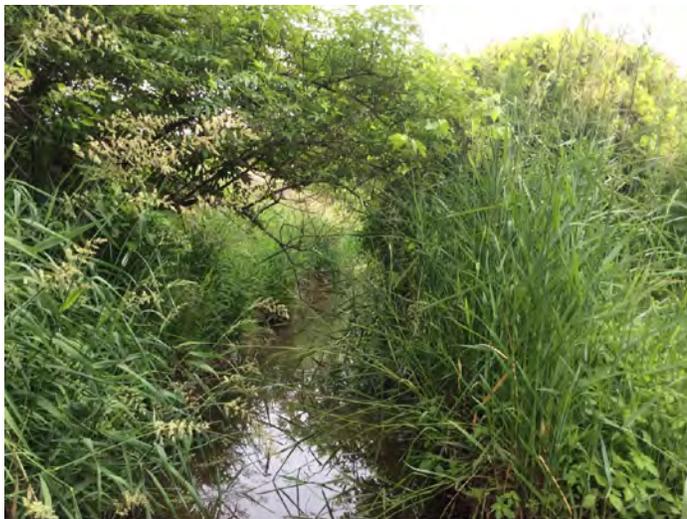
Excessive vegetation growing over drain on both sides. About 20 ft from crossing.

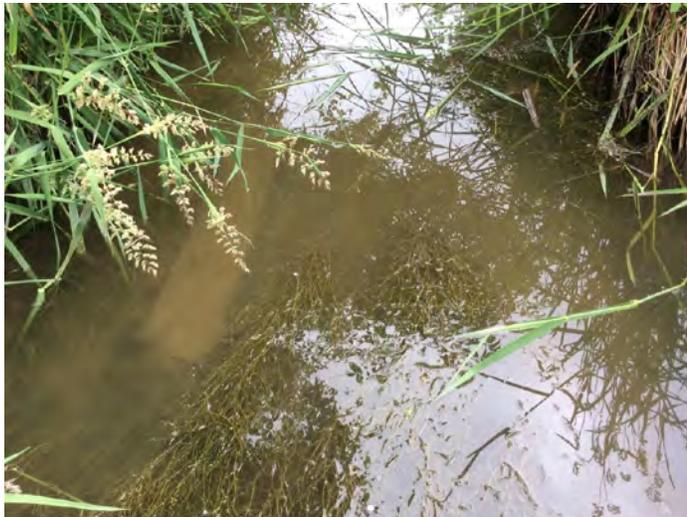
Woody debris in drain under water on left side. 3 pieces of wood about 20 ft from crossing. Then 10 ft down is a piece of wood across drain under water.

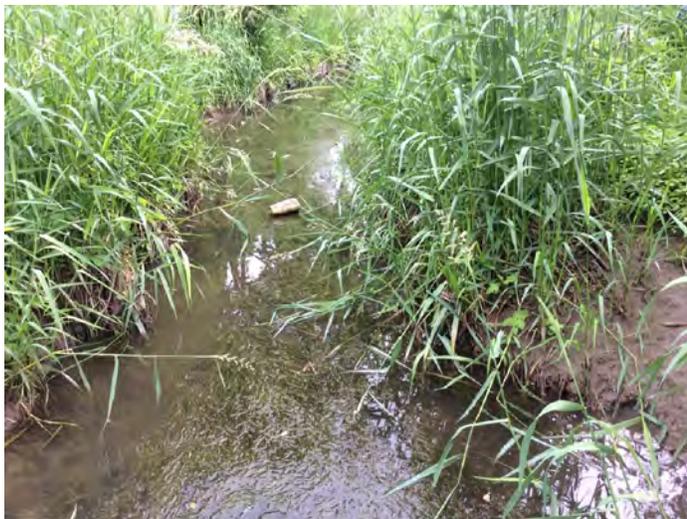
Blockage from sediment on both sides of drain. Starts about 20 ft after crossing. Picture taken 20 ft after point. Throughout whole drain.

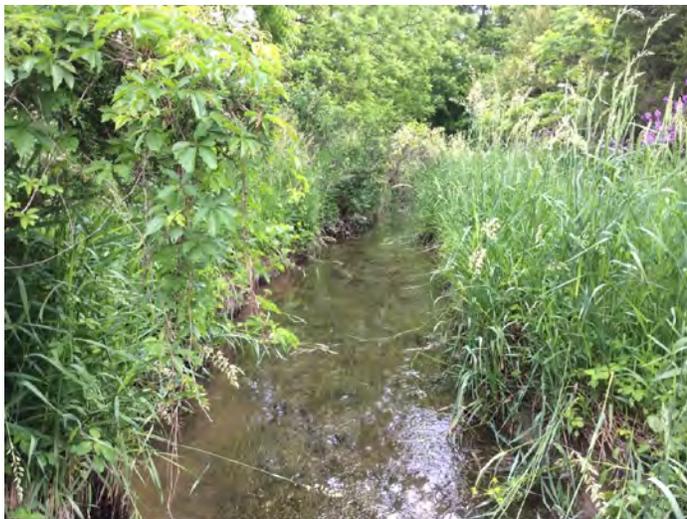
Excessive vegetation overhanging on left side of drain. Then 15 ft down overhanging on both sides.

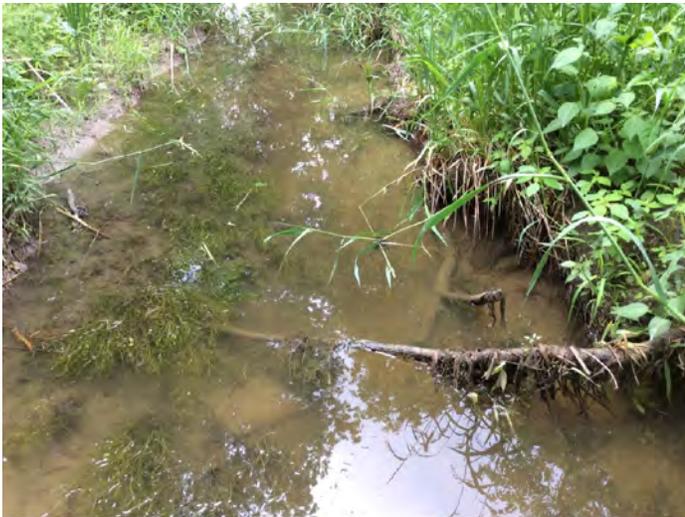
Woody debris extending from right side of drain into center. About 3 ft long. Then 10 ft farther down drain is more woody debris on both sides of drain. 10 ft farther down are logs on left side of drain. Afterwards throughout entire drain on both sides.

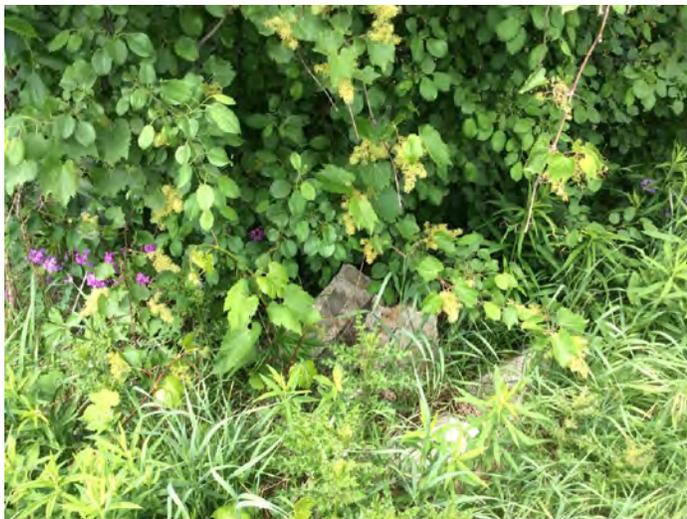
Blocks of concrete on right side of drain on bank. Hidden behind tree.

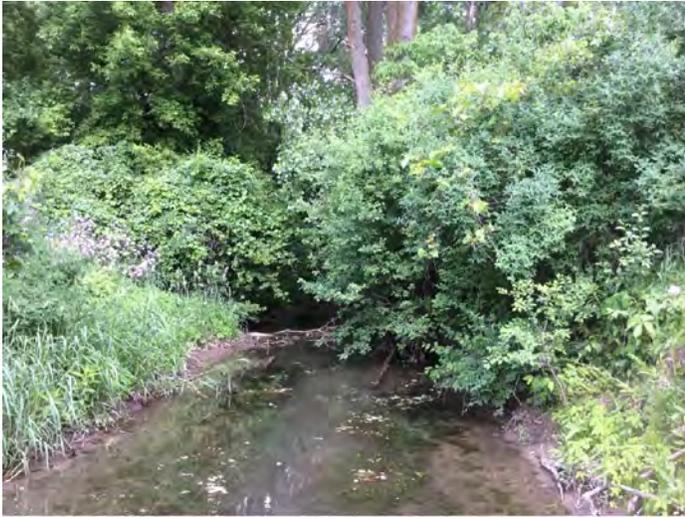
Excessive overhanging vegetation on both sides of drain. About 300 ft down.

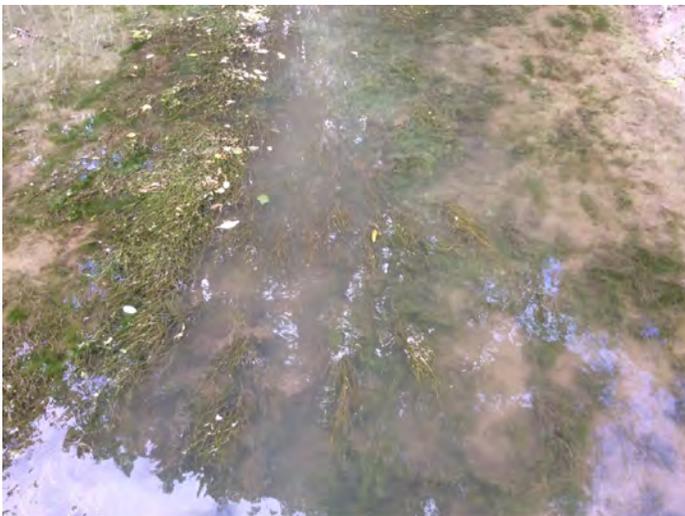
Excessive vegetation growing from bottom of drain. About 100 ft.

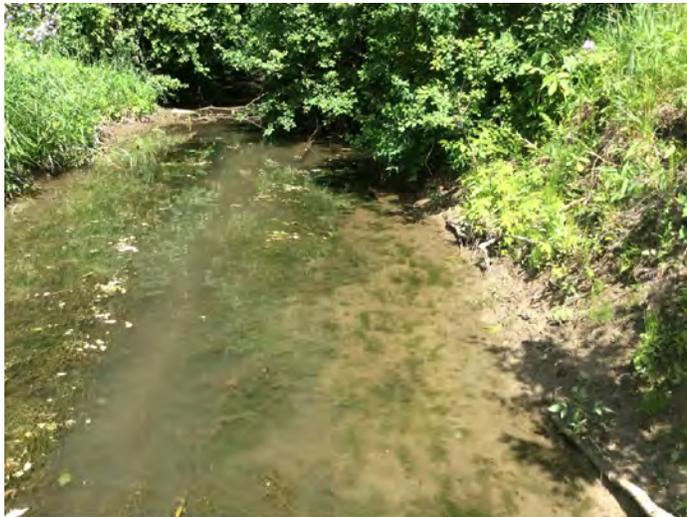
Excessive sedimentation on both sides of drain for about 300 ft to crossing.

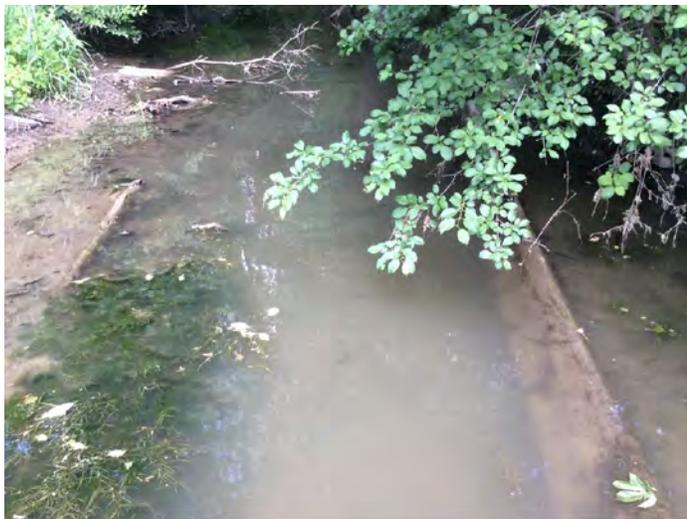
Woody debris on both sides of drain. Especially large log on right side about 10 ft in length.

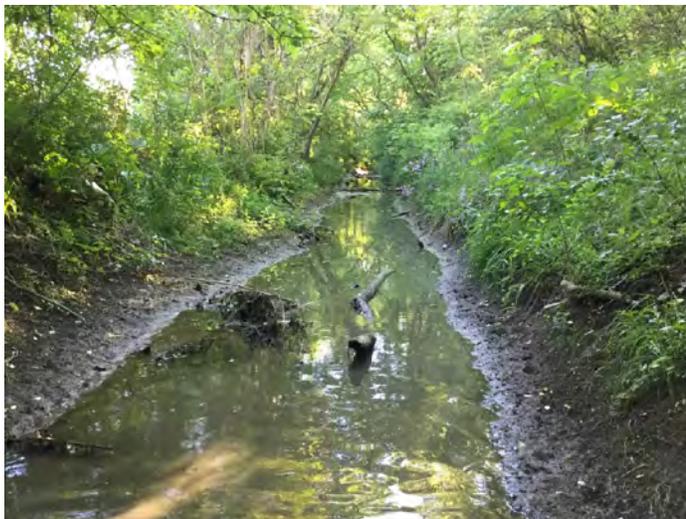
6" diam log in center of drain and other woody debris over next 50 ft.

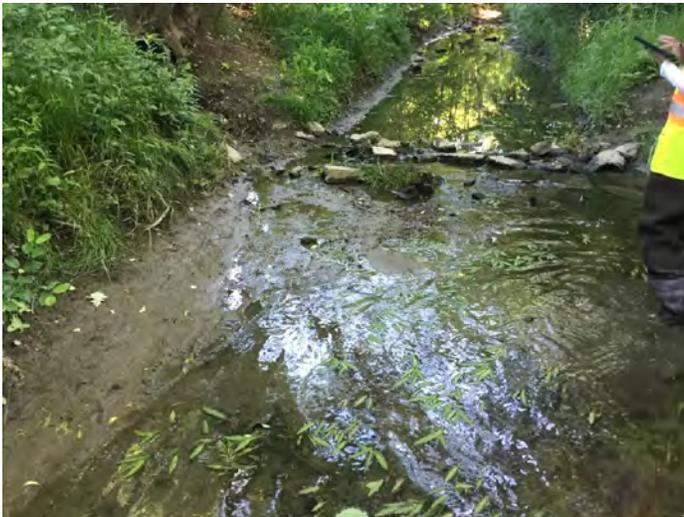
On left side at outlet of sop. Also downstream of riffle.

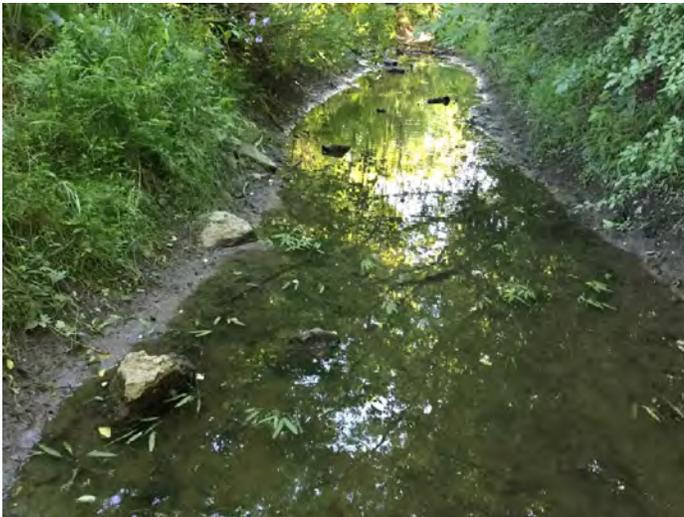
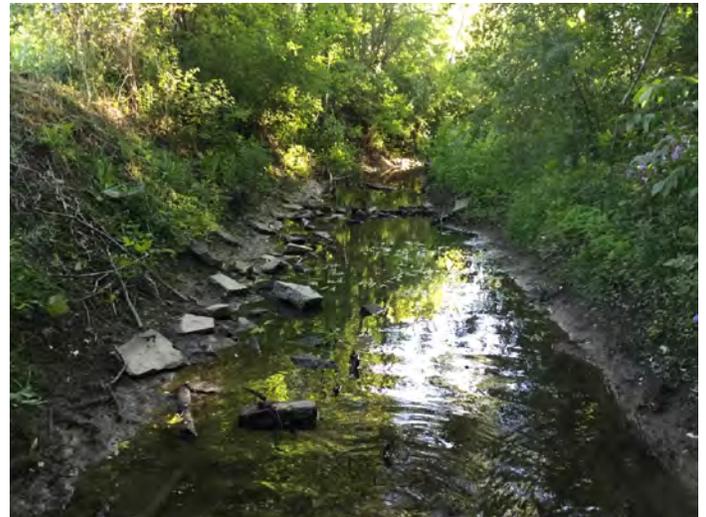
Stones on left side and in center of drain over 100 ft. Also trash scattered.

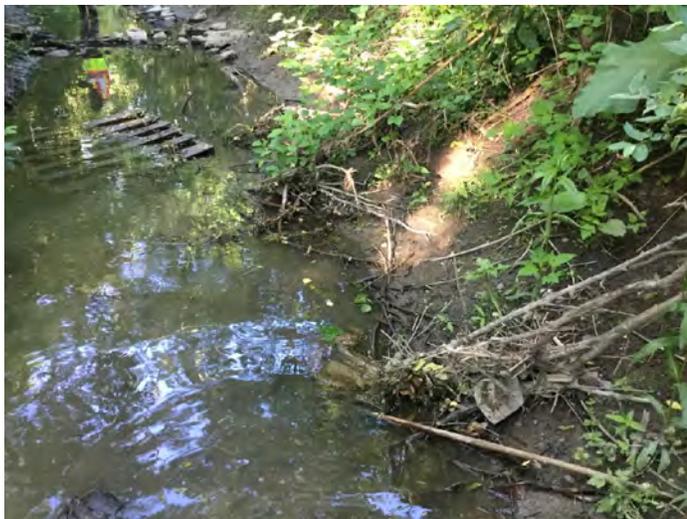
Woody debris on right bank and bottom of drain channel.

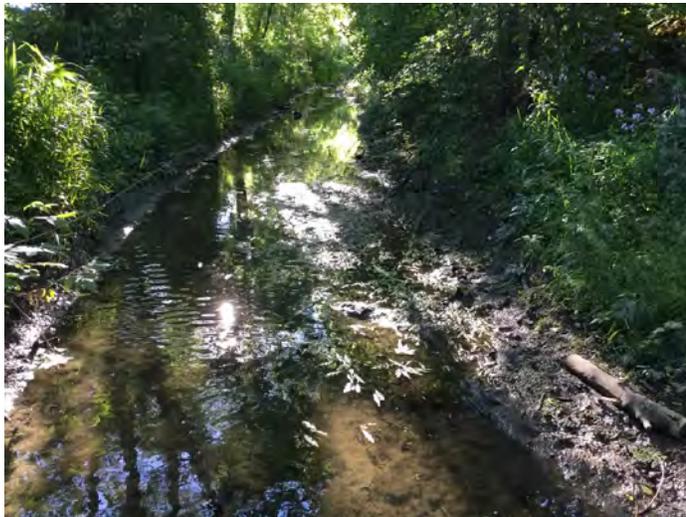
Sediment deposits on right side of drain cutting channel width by 50%.
40 ft long.

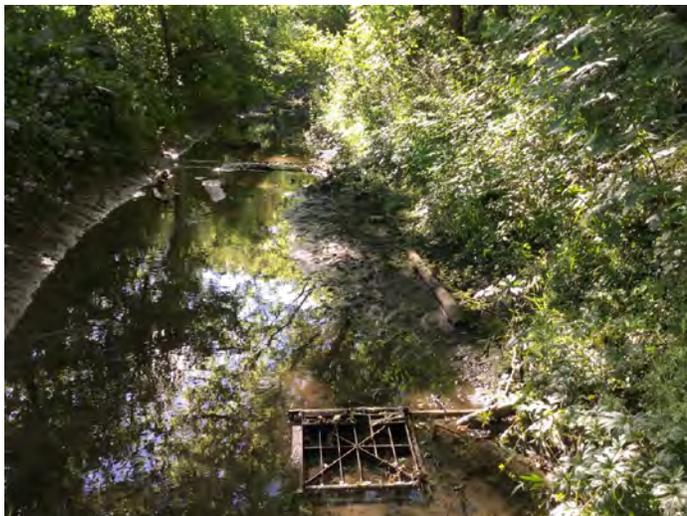
Sediment bar on right side next 30 ft.

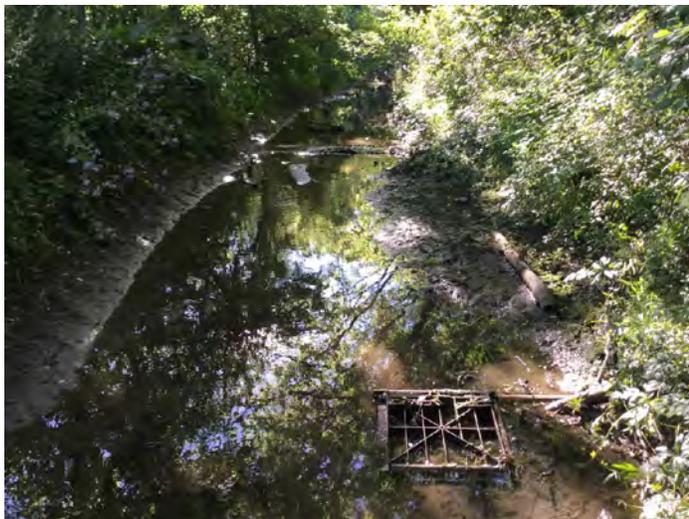
Large pieces of debris next 50 ft.

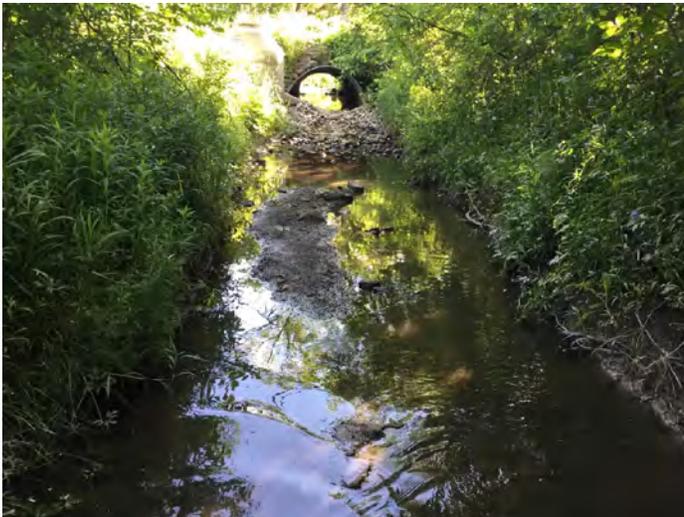
Mid channel sediment bar approx 20 ft long.

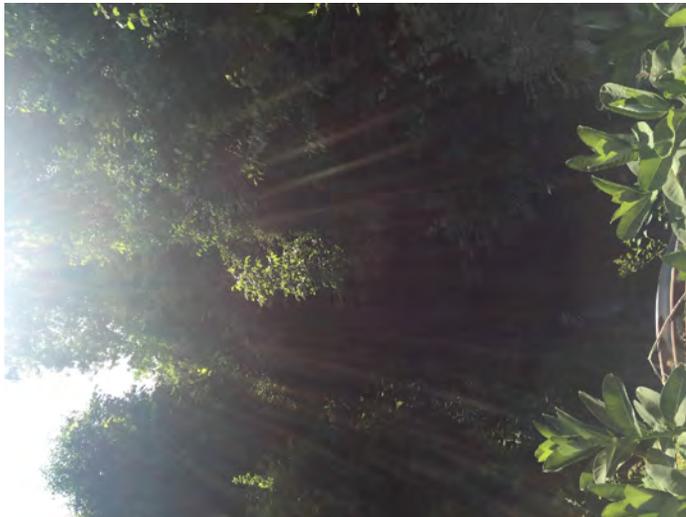
Excessive vegetation along the drain from this location approx 500' upstream to end. Picture facing upstream
