King Street Tile Drain Inspections

Inspection Report for Observation:
Blockage200

CLIENT	Saginaw County Public Works Commissioner

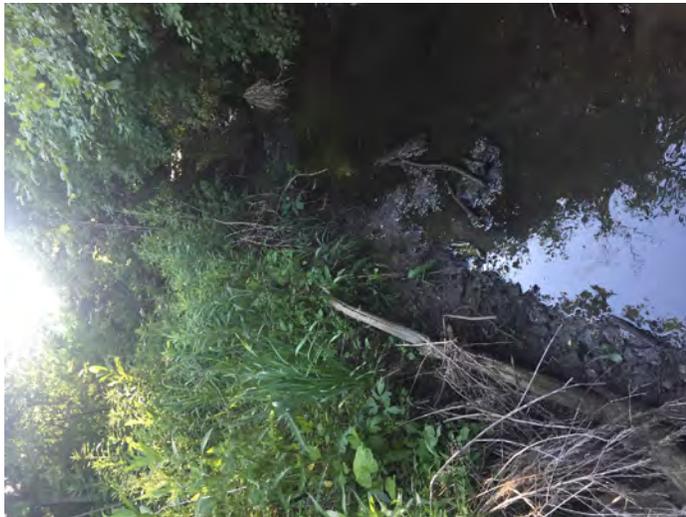
Sediment bar left side of the drain from this location approx 150' upstream to end. Picture facing upstream.

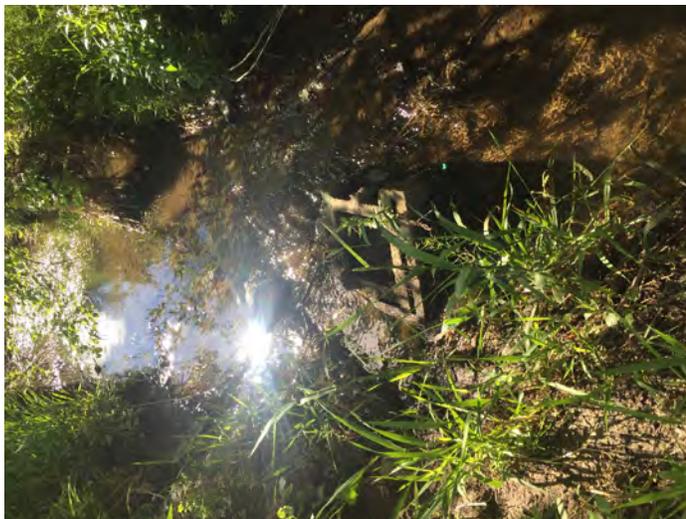
Misc concrete in the drain. Picture facing upstream

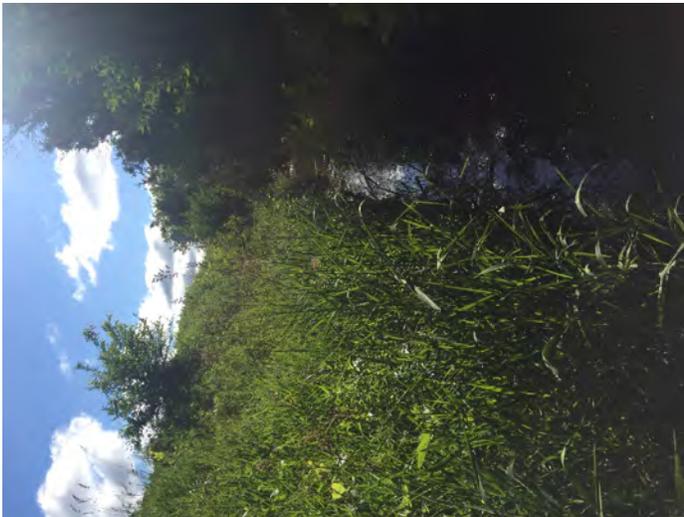
Sediment bar with established vegetation left side of the drain from this location approx 400' upstream to end. Picture facing upstream

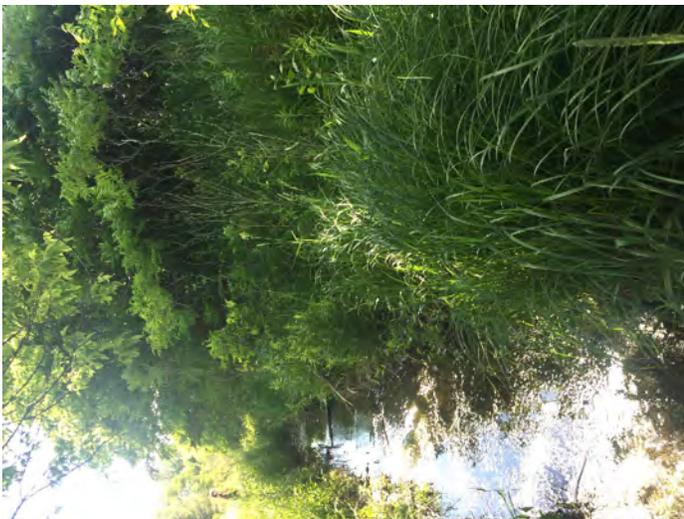
Sediment bar with established vegetation right side of the drain from this location approx 900' upstream to end. Picture facing upstream

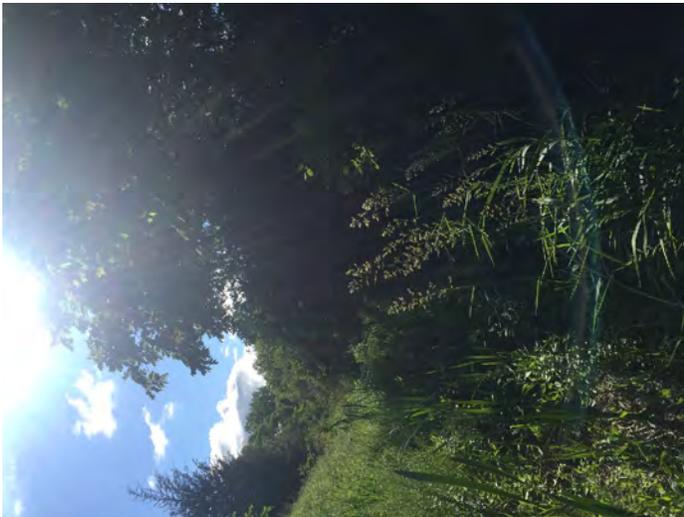
Excessive vegetation right side of the drain from this location approx 900' upstream to end. Picture facing upstream

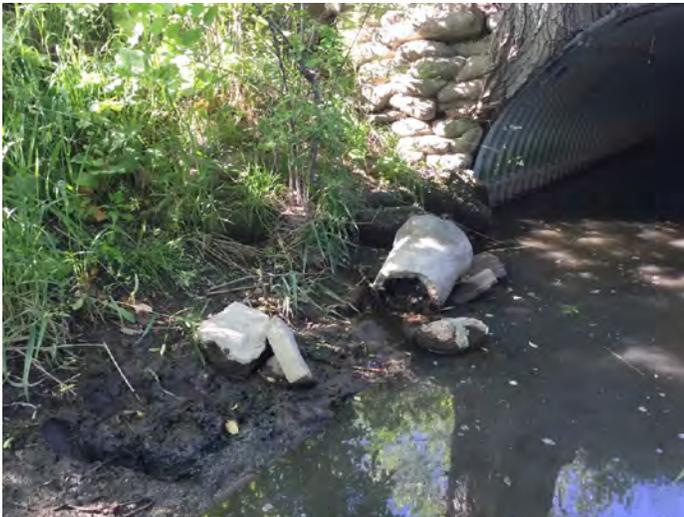
Inspection Report for Observation:
Blockage323

Type: Non-Vegetative Debris

Concrete pipe end section and pieces of clay tile on right side of drain, but no outlets were located. Upstream side of Kansas st culvert.

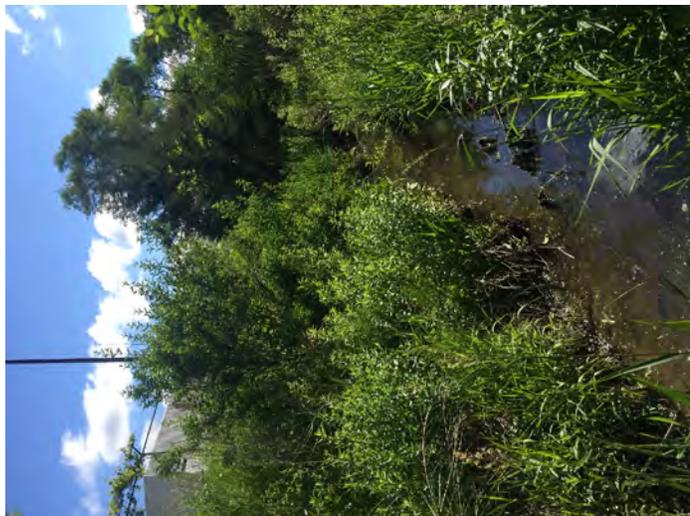
Inspection Report for Observation:
Blockage324

Type: Sediment

Sediment bar with established vegetation left side of the drain from this location approx 700' upstream to end. Picture facing upstream.

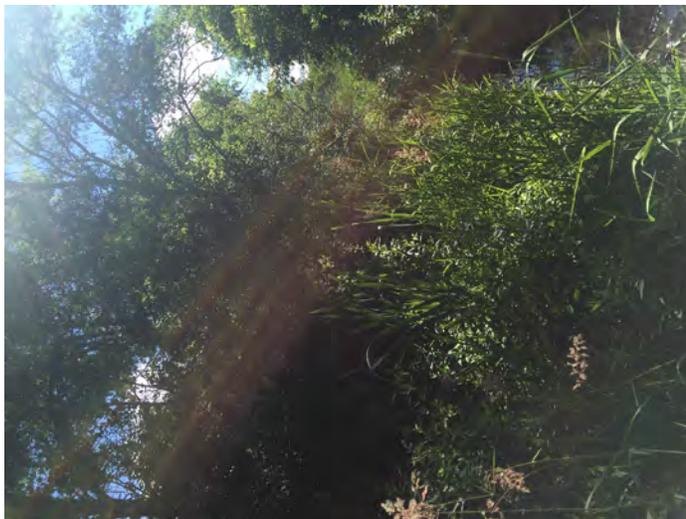
Inspection Report for Observation:
Blockage325

Type: Excessive Vegetation

Excessive vegetation left side of the drain from this location approx 300' upstream to end. Picture facing upstream

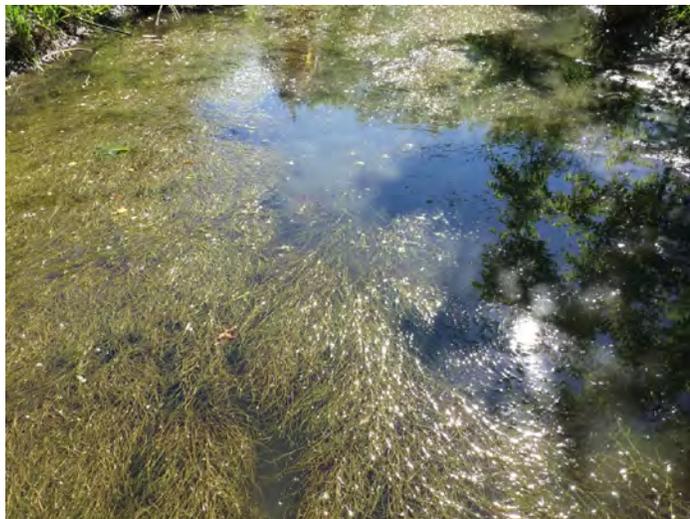
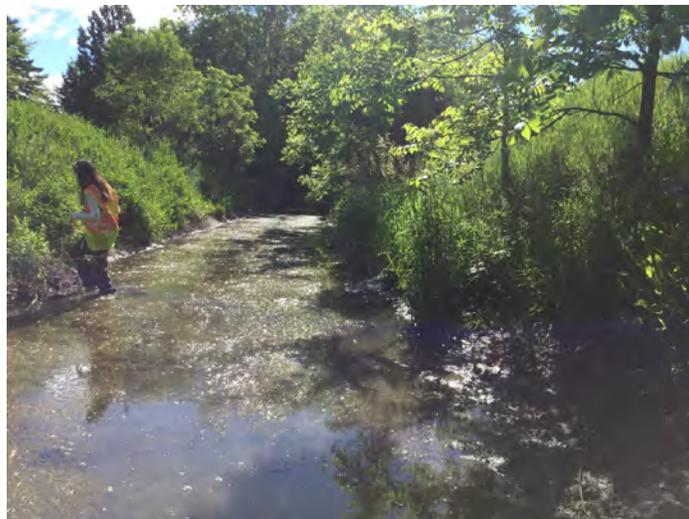
Inspection Report for Observation:
Blockage326

Type: Excessive Vegetation

Heavy grassy growth in bottom of drain channel next 150 ft.

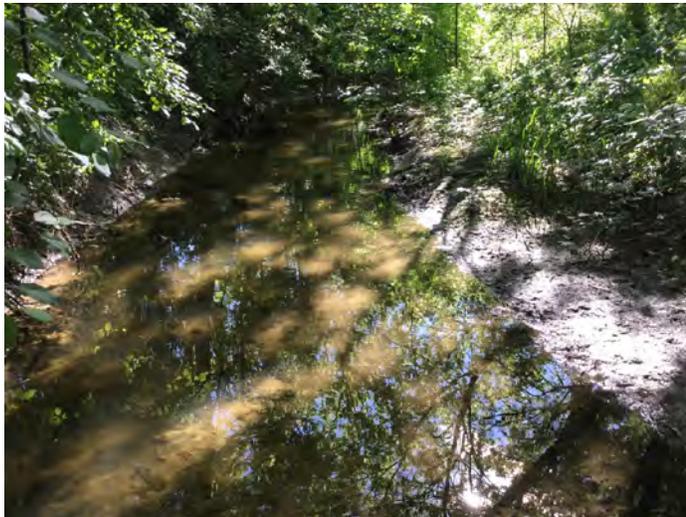
Inspection Report for Observation:
Blockage328

Type: Sediment

Sediment deposits continuous on right side around bend for 100 ft.

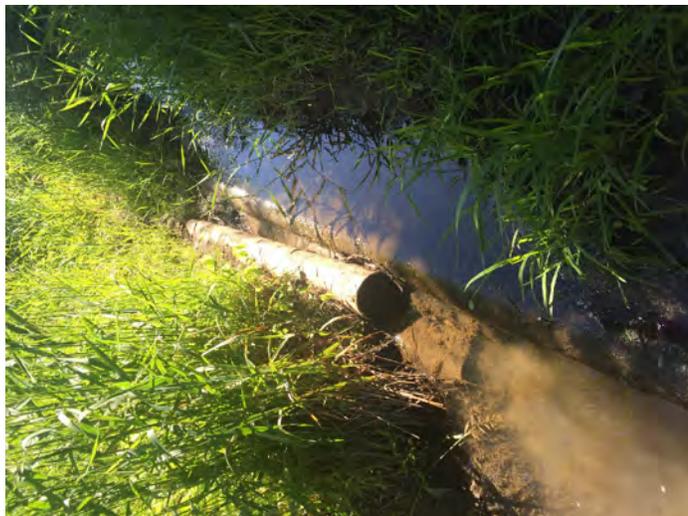
Inspection Report for Observation:
Blockage329

Type: Non-Vegetative Debris

2 6" steel pipes just lying in drain. Picture facing upstream

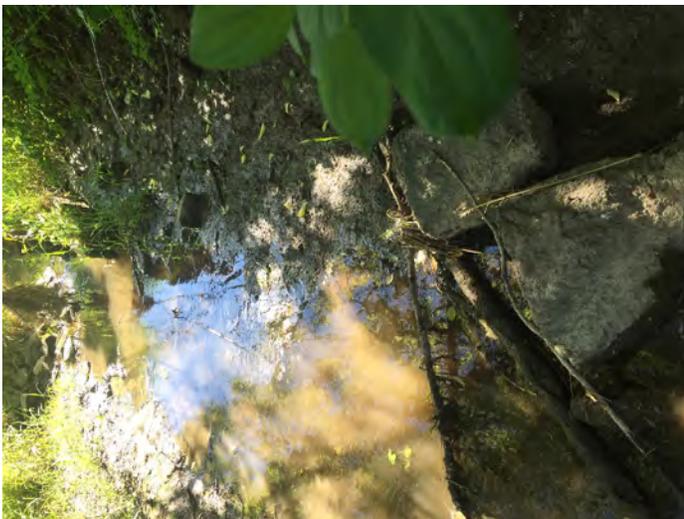
Inspection Report for Observation:
Blockage330

Type: Non-Vegetative Debris

Misc concrete and rr tie in drain. Picture facing upstream

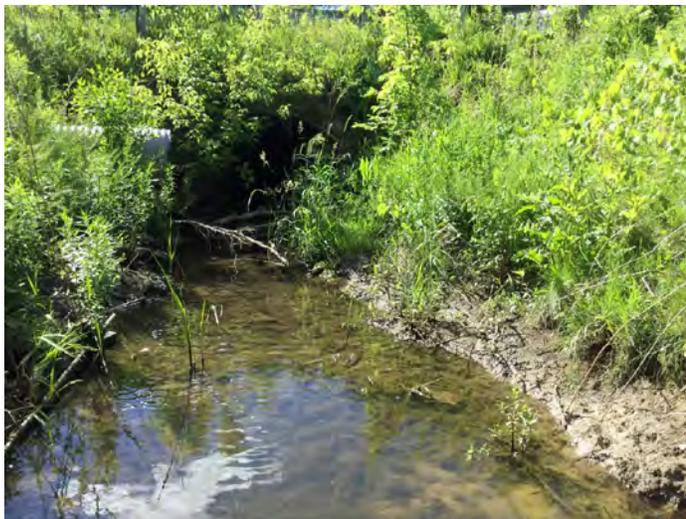
Inspection Report for Observation:
Blockage331

Type: Sediment

Sediment bar on right side with vegetation growing on it. Downstream of Kansas Broadway crossing. Northwest corner of intersection.

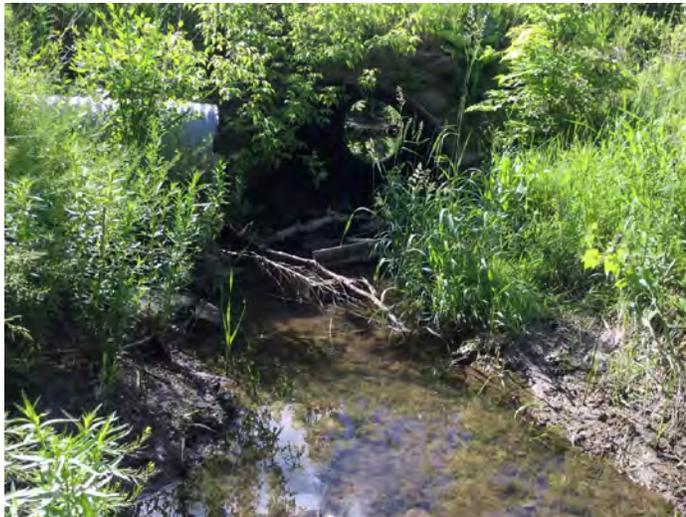
Log jam in center of drain, just downstream of Kansas Broadway crossing. 10 ft. Also with non vegetative debris.

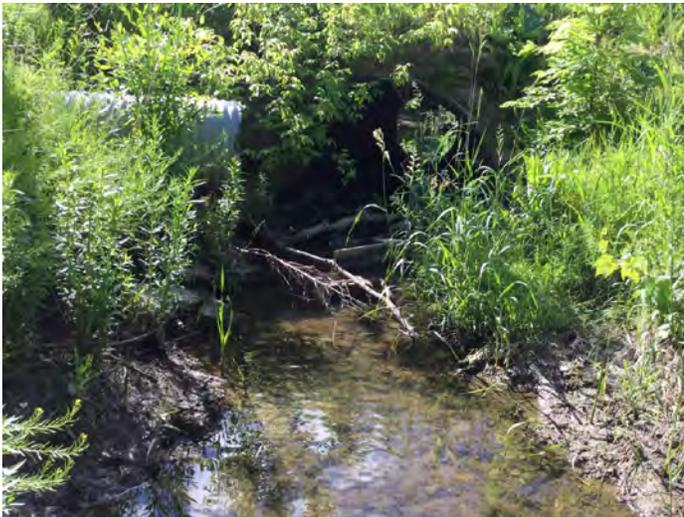
Chunks of concrete mixed in with log jam on downstream side of Kansas Broadway crossing. Might be part of head walls.

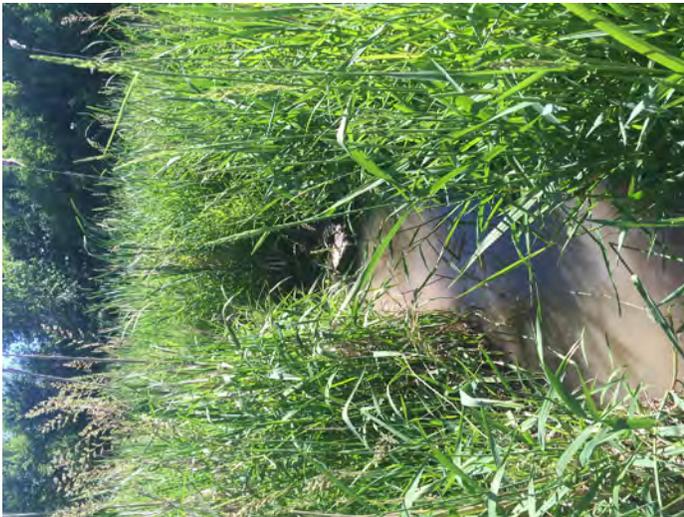
Railroad ties in the drain blocking flow fri this location approx 50 upstream to box culvert . Picture facing upstream

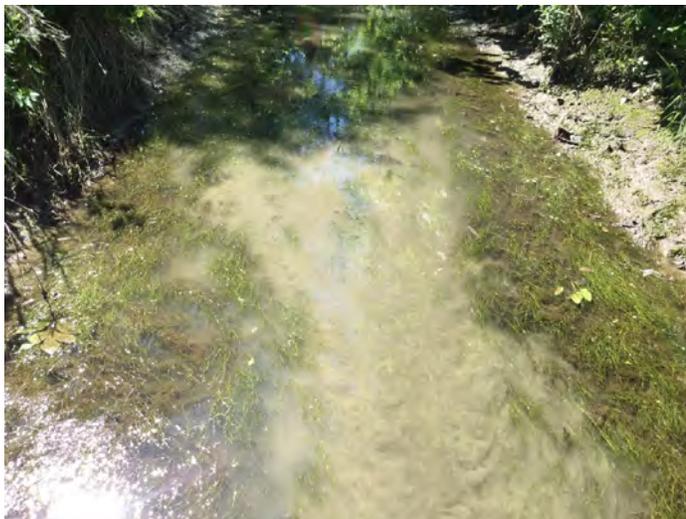
Grassy growth in bottom of drain channel for about 50 ft.

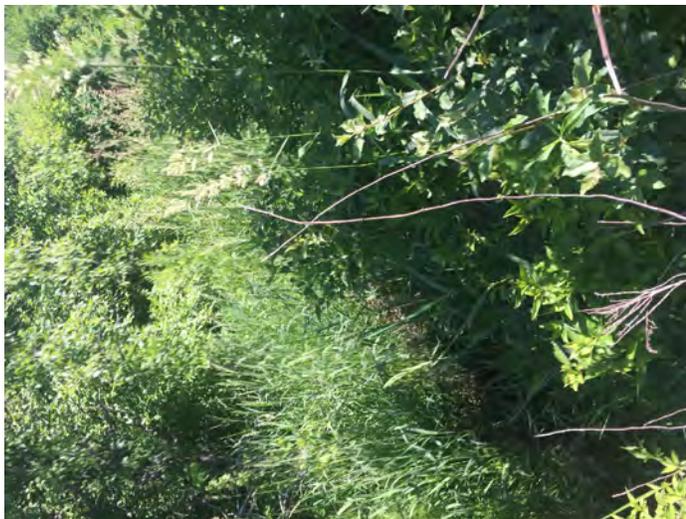
Sediment bars along the drain with established vegetation from this location approx 200'upstream to end. Picture facing upstream

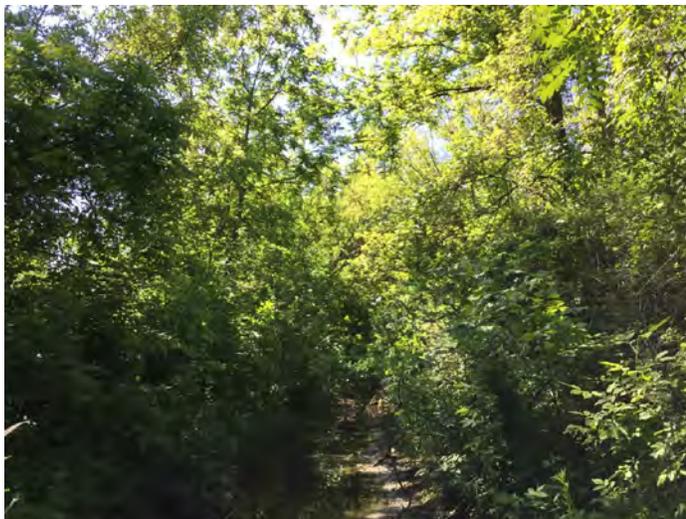
Growth on banks overhanging drain. Next 500 ft.

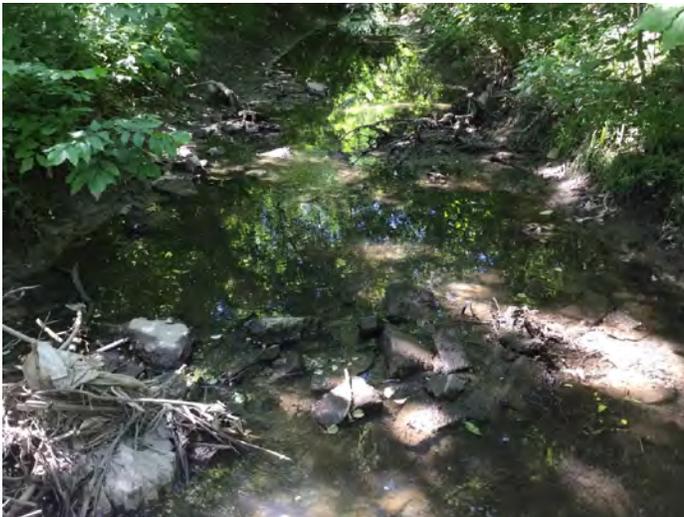
Stones, bricks, and trash in center of drain.

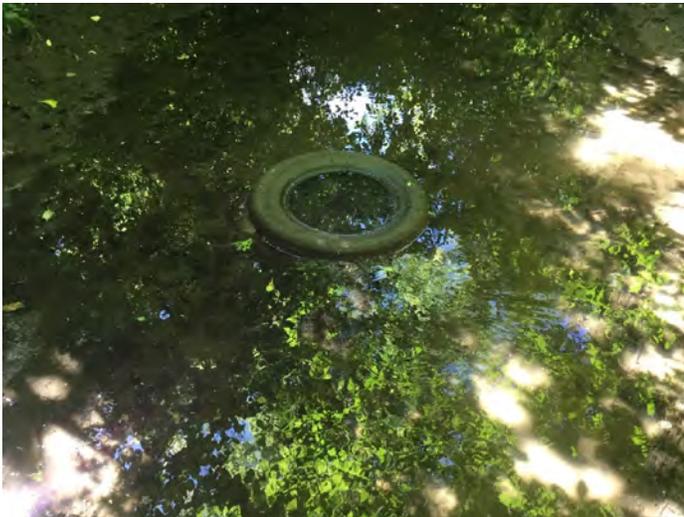
Rubber tire in center of drain.

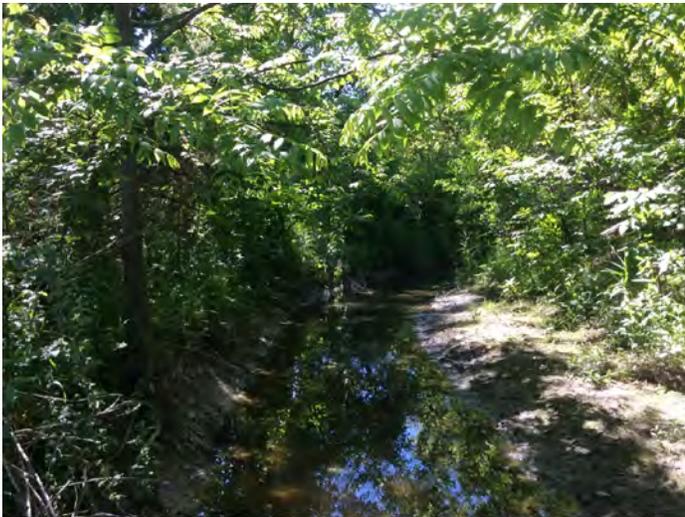
Overhanging vegetation on left side of drain. About 5 ft long. Branch about 7 ft long.

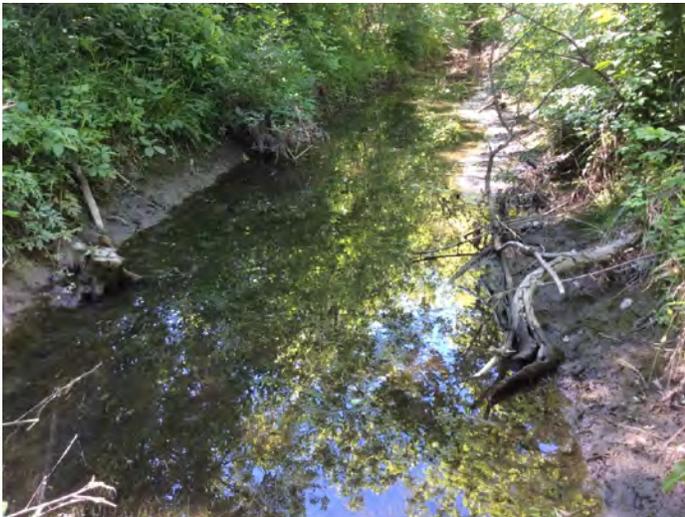
Scattered woody debris on both sides of drain for 50 ft.

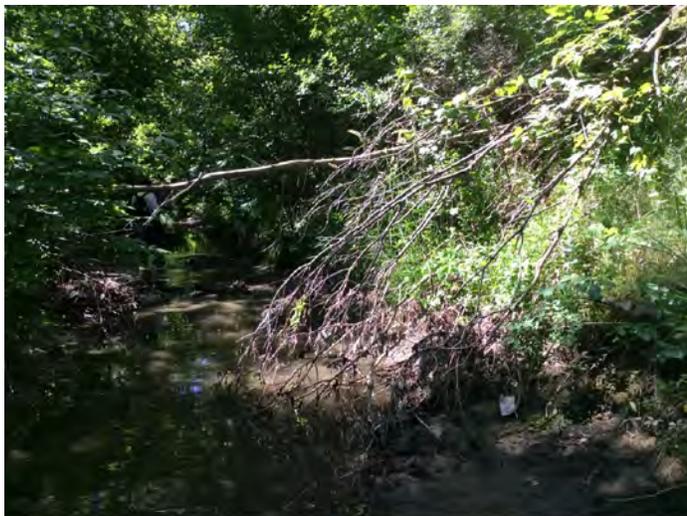
Fallen tree on right side of drain extending across.

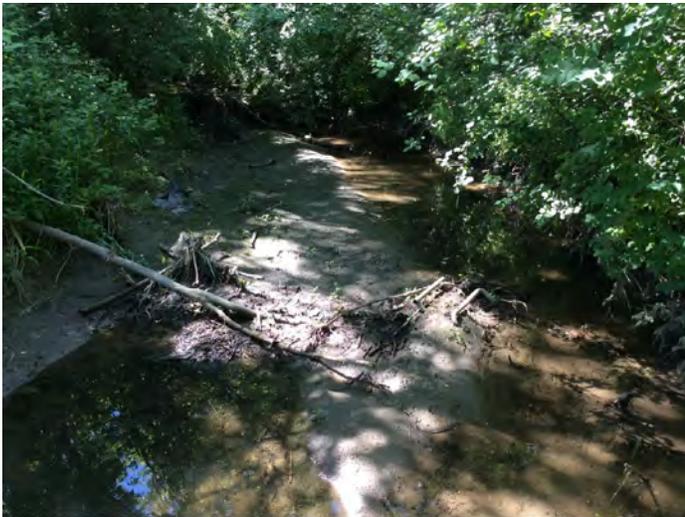
Massive sediment bar on left side of drain extending into center causing major blockage for about 50 ft.

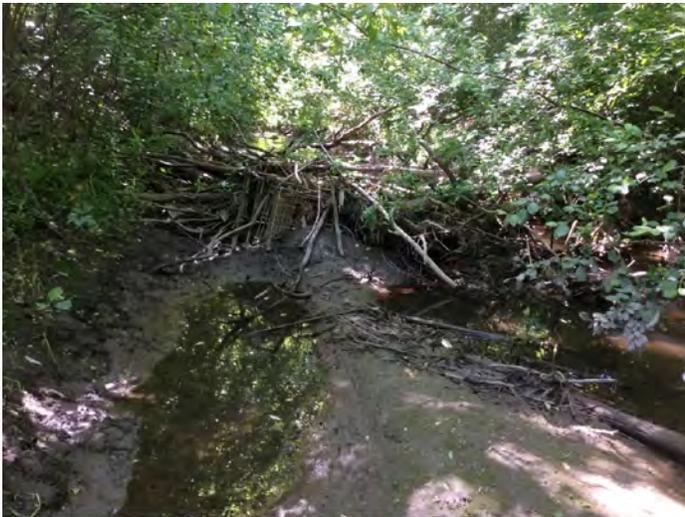
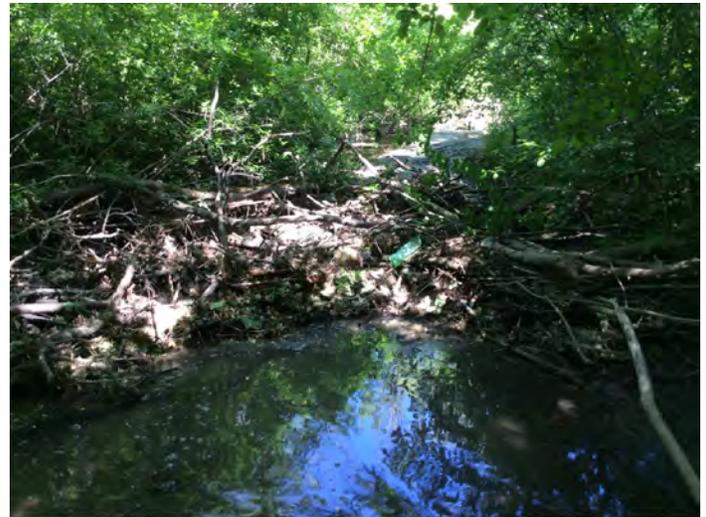
Major log jam with trash. Extending across whole drain for about 10 ft.

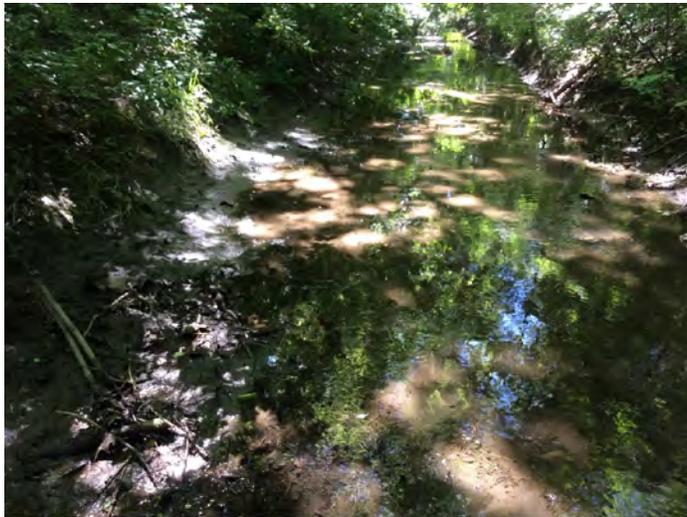
Sediment bars on either side of drain for about 100 ft. Water depth is only inch and a half.

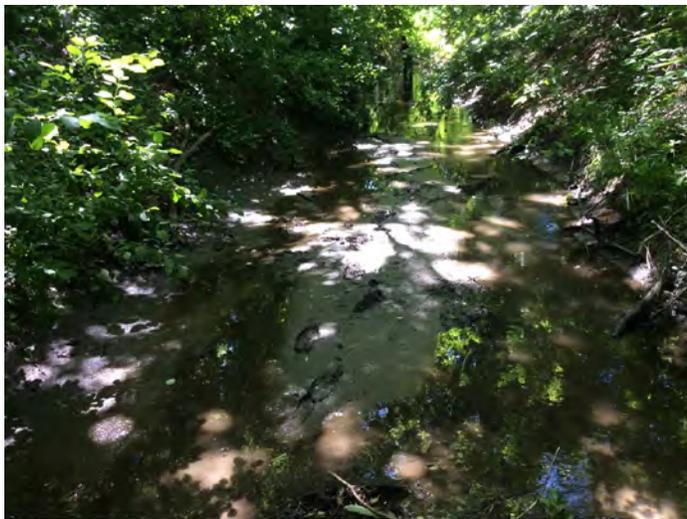
Sediment bar in center of drain because water depth is only an inch.

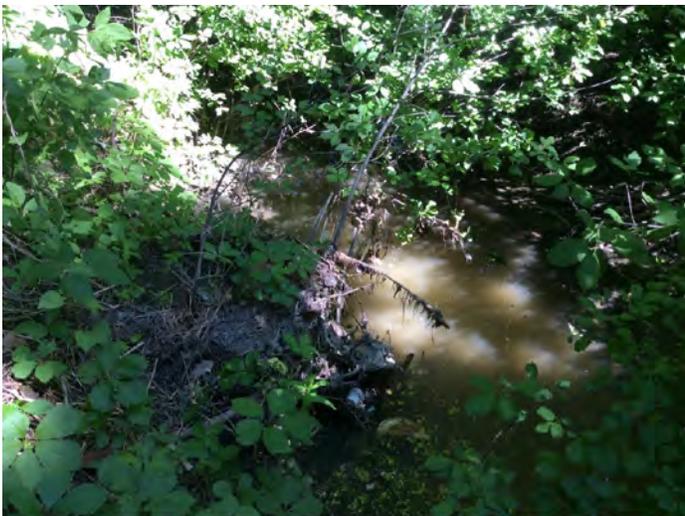
Woody debris on right side of drain for about 4 ft.

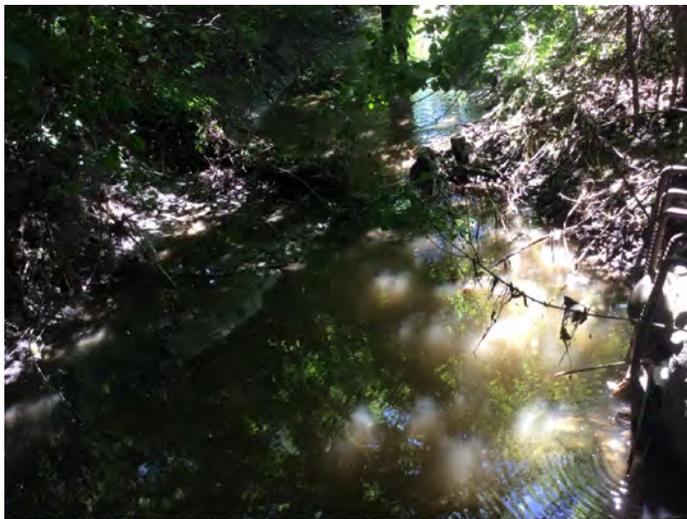
Sediment bar on right side of drain before pipe. Then 10 ft down is sediment bar on left side of drain.

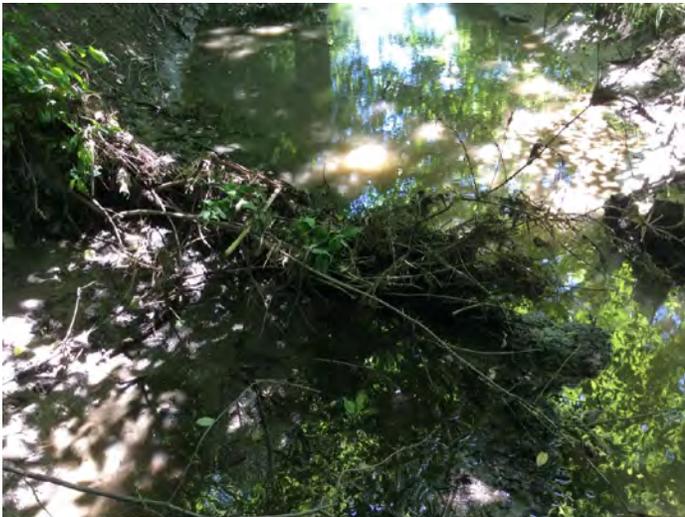
Log jam from fallen tree on left side of drain coming into center and blocking flow. About 5 ft long.

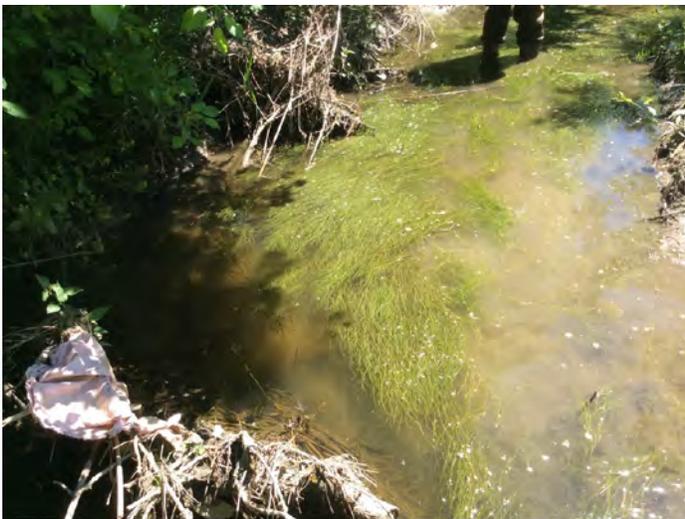
Woody debris on left side of drain for about 20 ft.

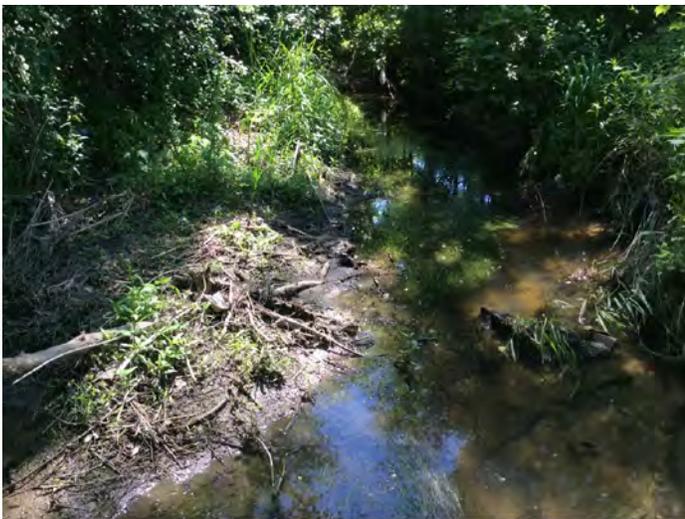
Sediment bar on left side of drain for about 50 ft.

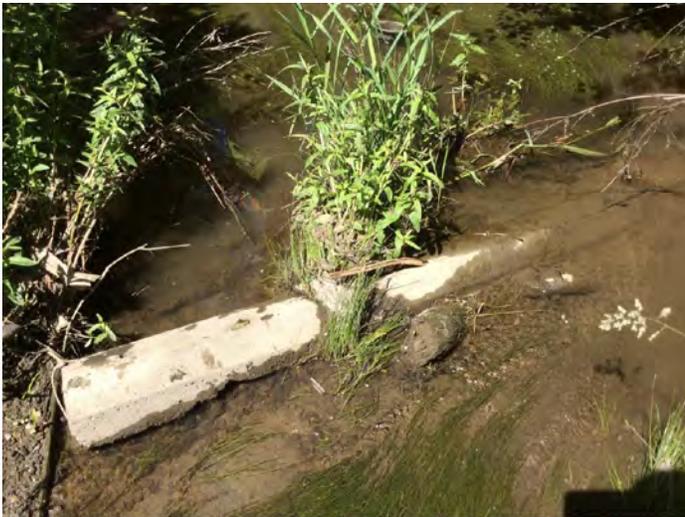
Concrete curb across drain blocking flow and causing riffles.

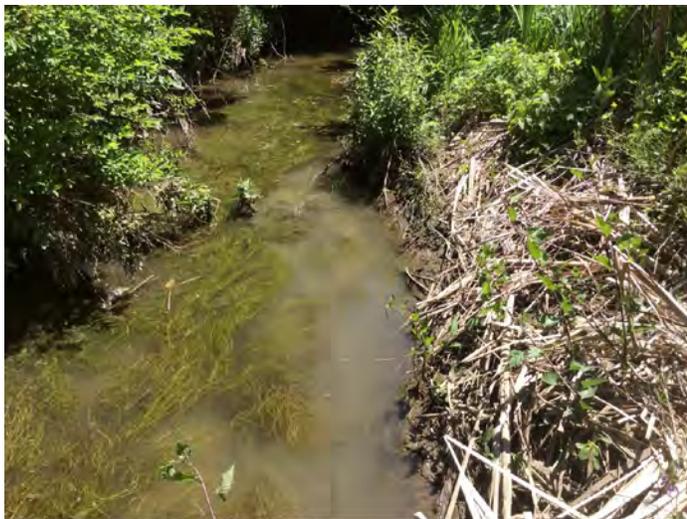
Woody debris on right side of drain on bank for about 10 ft.

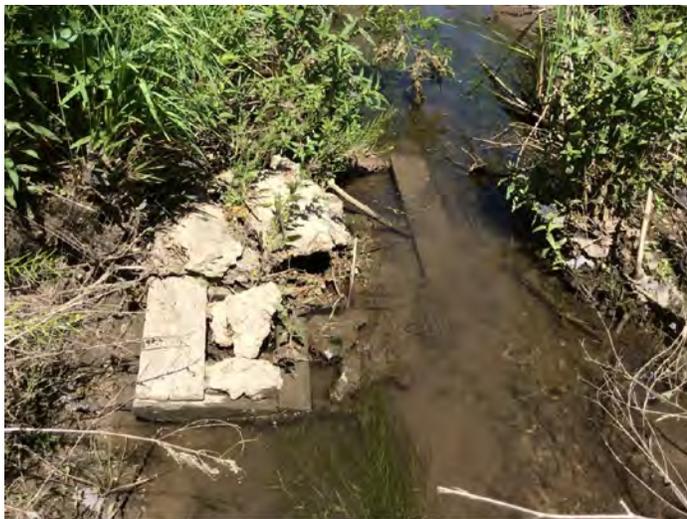
Square block of wood. About 2 ft width. With concrete stones on top.

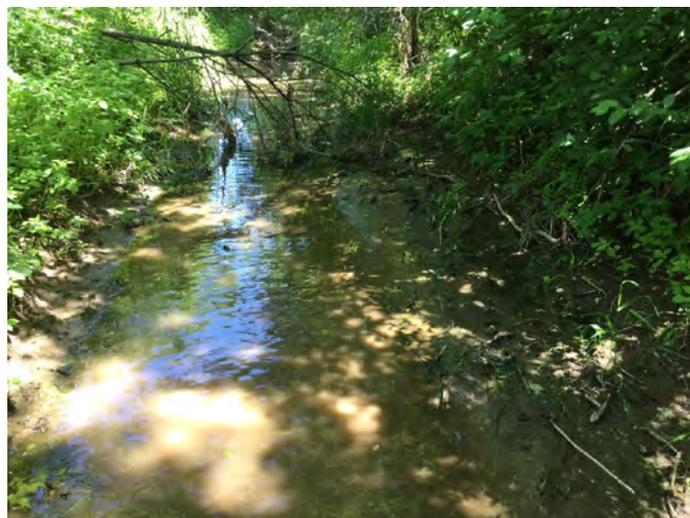
Sediment bars on both sides of drain for about 800 ft.

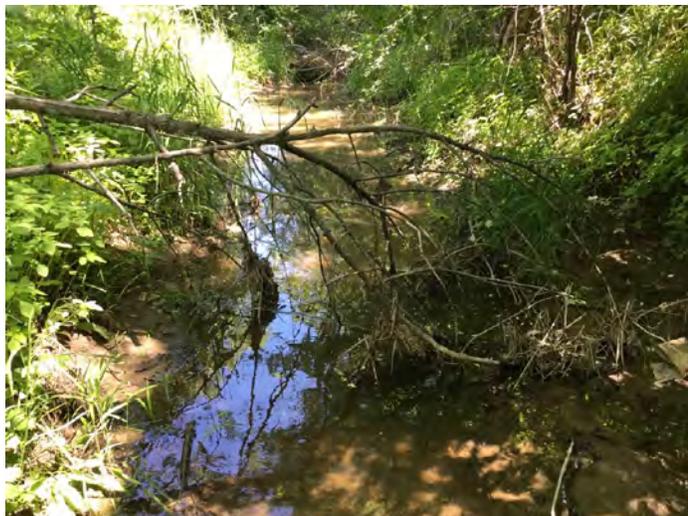
Photo 2

Fallen tree on left side extending into drain. About 7 ft long.

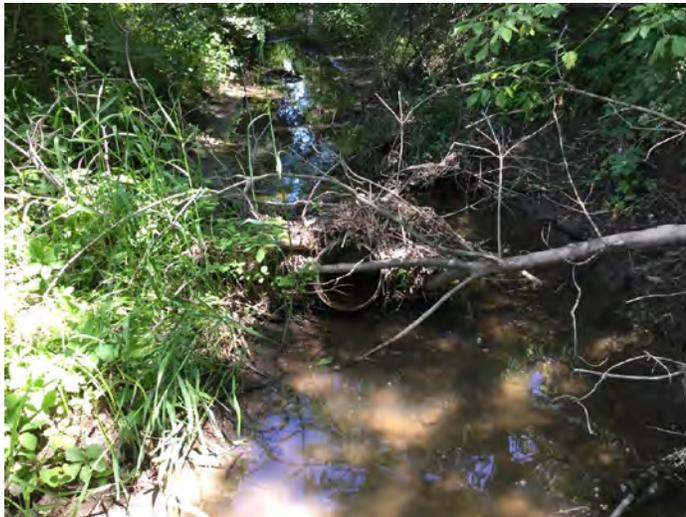
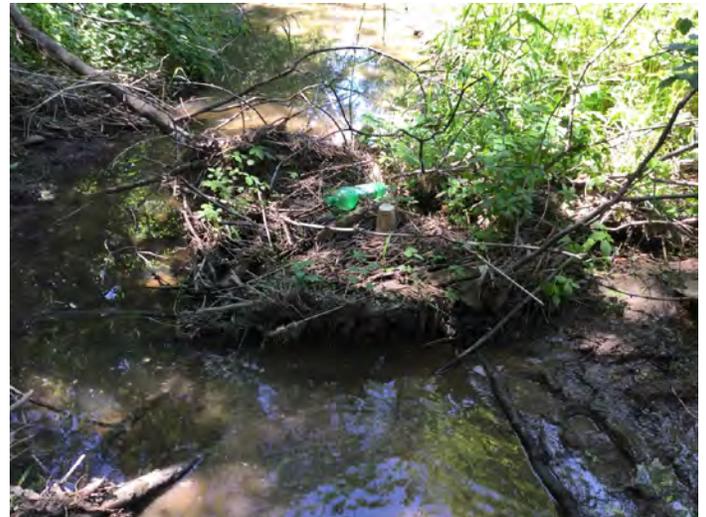
Fallen tree from right side into center of drain. Log jam in surrounding area. Sediment bar on left side of drain connecting too. Trash in jam too. Field tile is 3 ft to the left of jam.

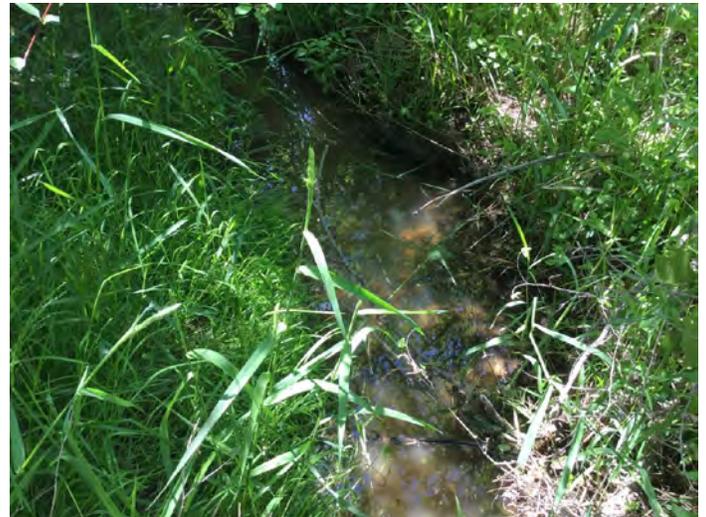
Sediment bars reduce width of drain. 230 ft down reduces width even more. Photo 2 is taken facing downstream 230 ft from where data point starts. Width becomes about 1 foot wide. 100 ft farther down drain width goes back to around 5 ft.

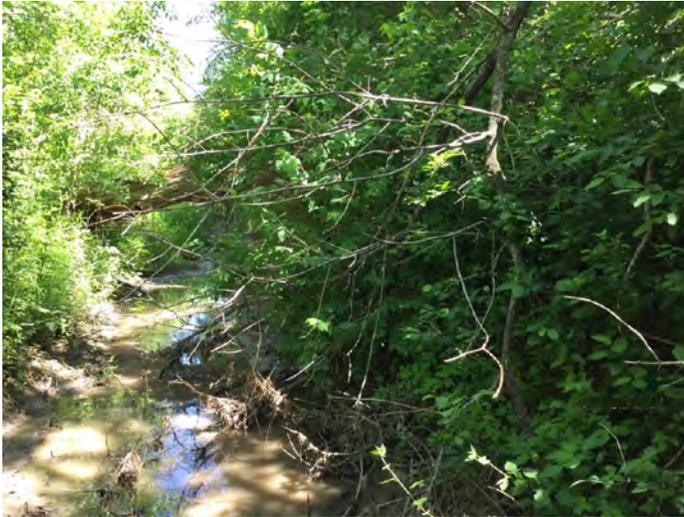
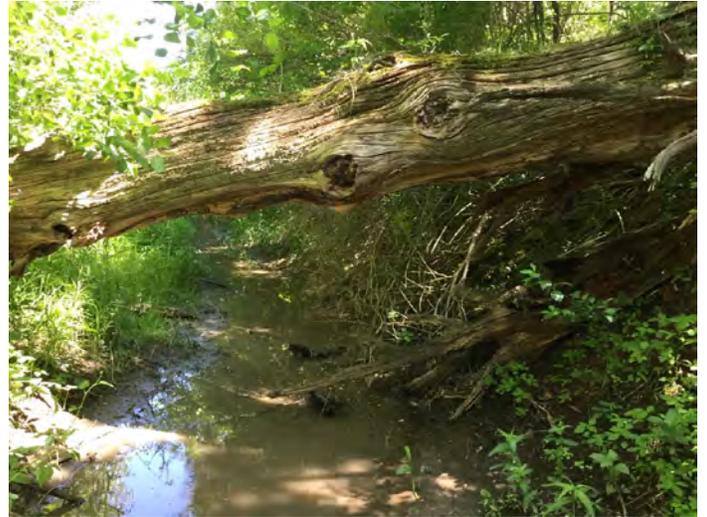
Fallen tree on right side extending into drain. About 20 ft long branch. 15 ft further down drain is huge fallen tree. About 100" diameter. 20 ft long tree.

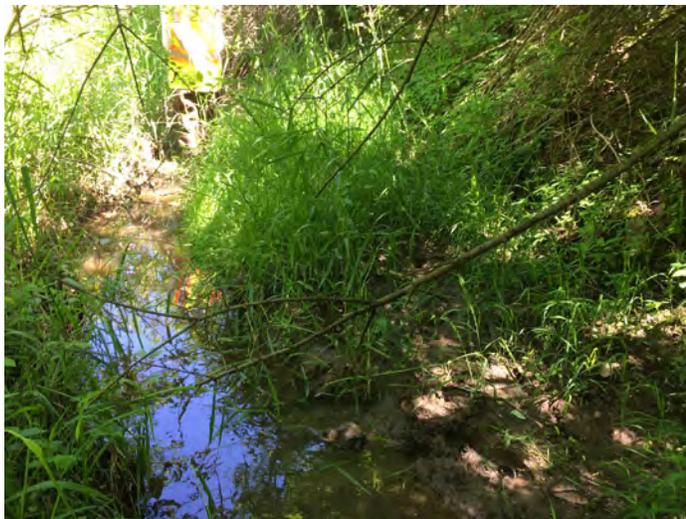
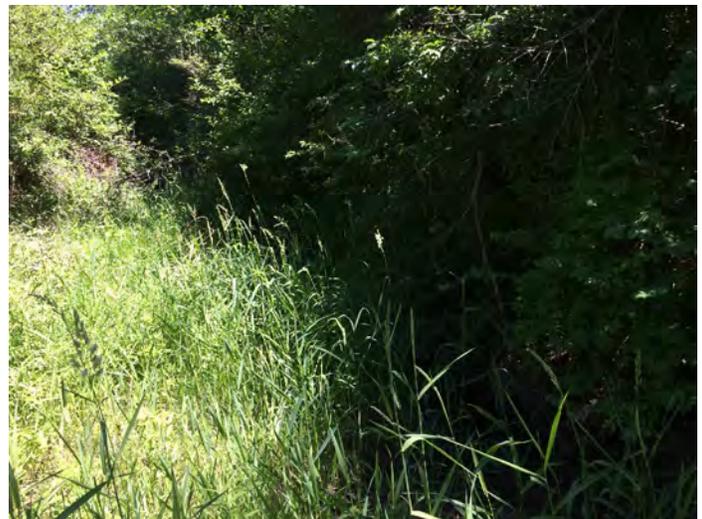
Excessive vegetation growing on sediment bar. Reduces channel width by 75%.

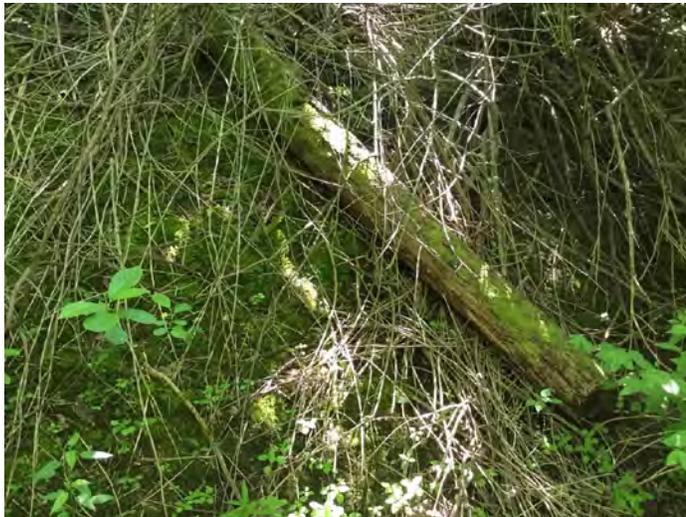
Photo 1

Type: Fallen Tree

About 3 fallen dead trees on right side of drain. About 20 ft long.

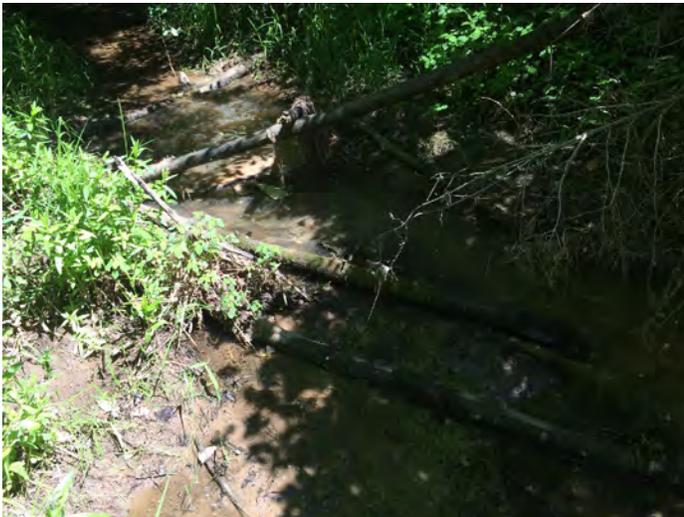
Photo 1

Type: Log Jam

Log jam for 40 ft. Up to 3" diam.

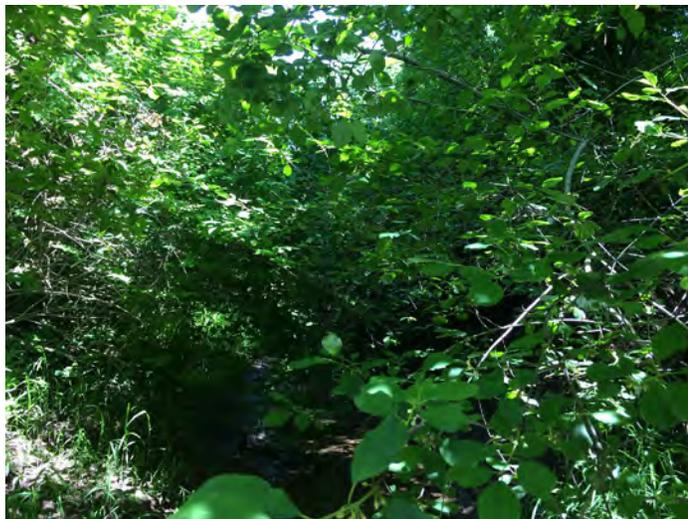
Photo 1

Type: Excessive Vegetation

Growth from banks overhanging drain next 300 ft.

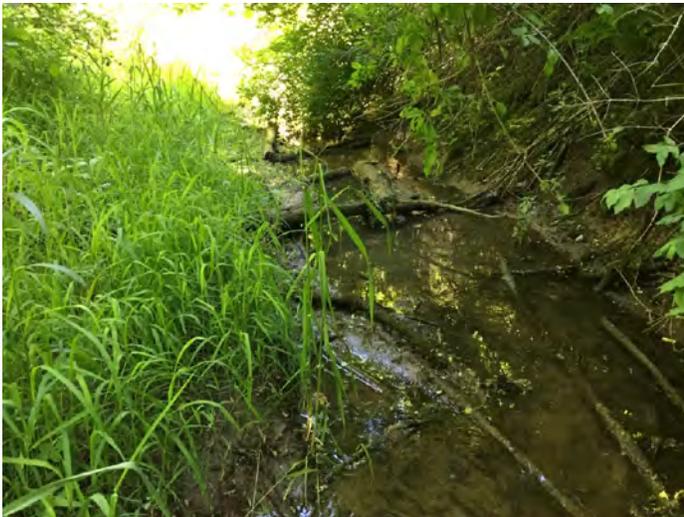
Photo 1

Type: Fallen Tree

Excessive fallen trees in drain for about 50 ft.

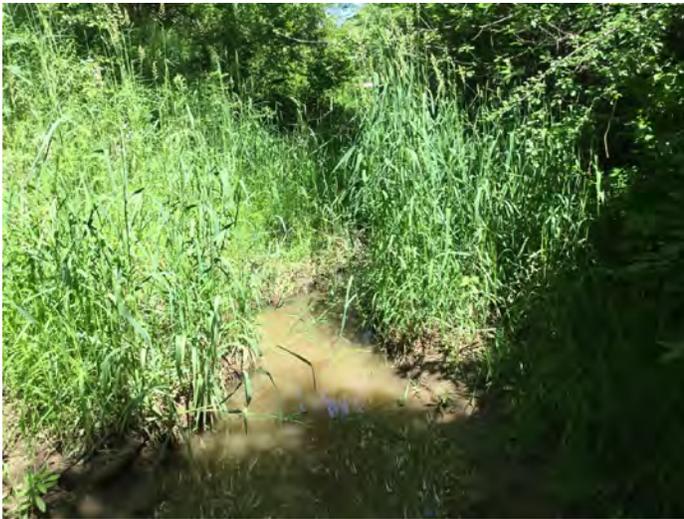
Photo 1

Type: Excessive Vegetation

Excessive vegetation on both sides of drain around smaller drain width for about 250 ft.

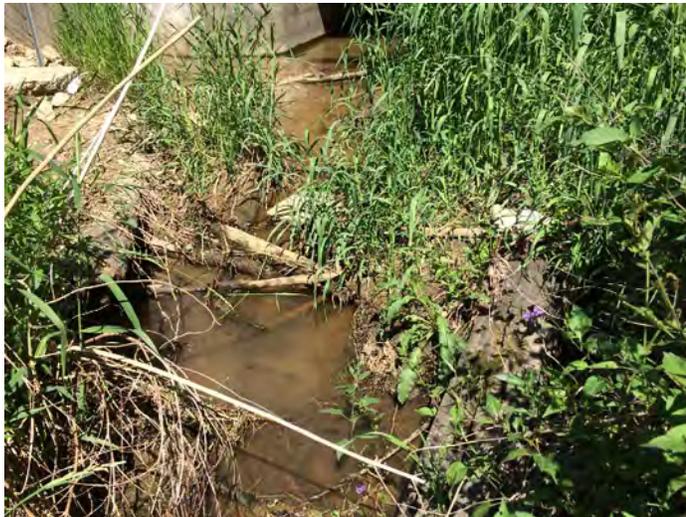
Photo 1

Type: Fallen Tree

Logs 8" diam on either side of drain just downstream of I75 crossing.

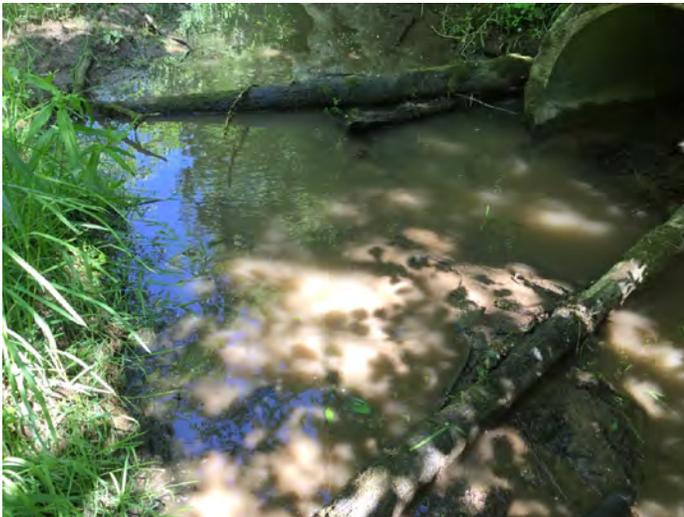
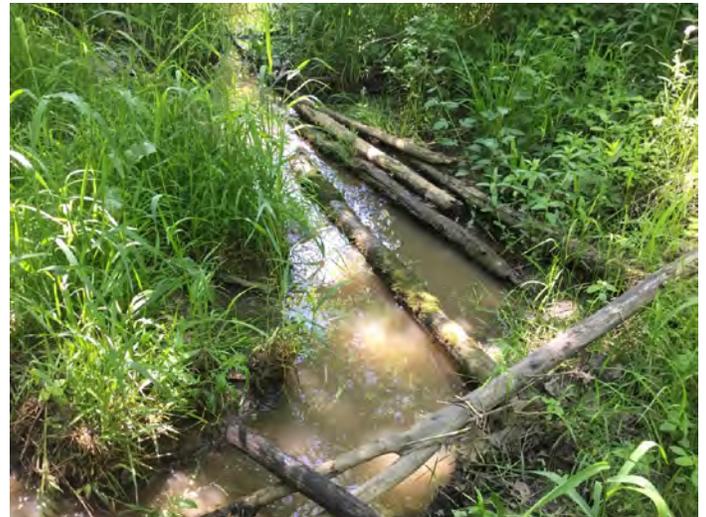
Photo 1

Type: Fallen Tree

Woody debris around surface outlet pipe for about 6 ft. One log protruding out of pipe. 40 ft farther down drain are more logs. Photo 2 facing downstream 40 ft farther than data point. 40 ft farther down drain are more logs on left side.

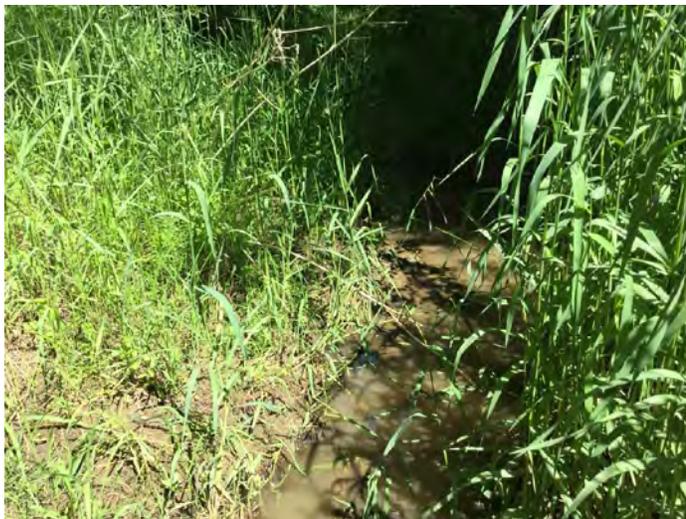
Photo 1

Type: Sediment

Smaller width of channel to about 1 foot wide for 250 ft.

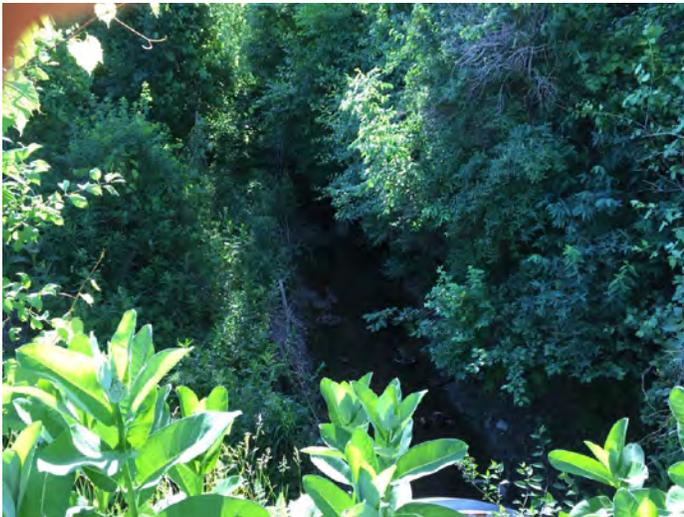
Photo 1

Woody debris on both sides of drain for next 450' to end. Picture facing upstream.

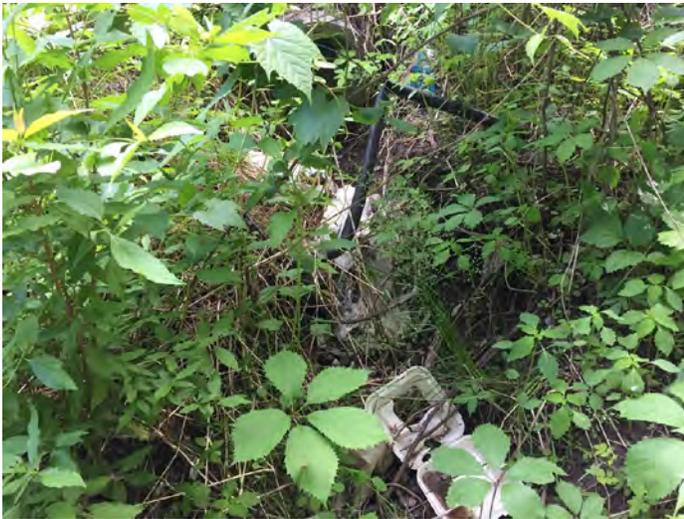
Photo 1

A lot of scattered non-vegetative debris scattered for 5-10' at the mouth of outlet pipe into drain. Picture facing north from drain.

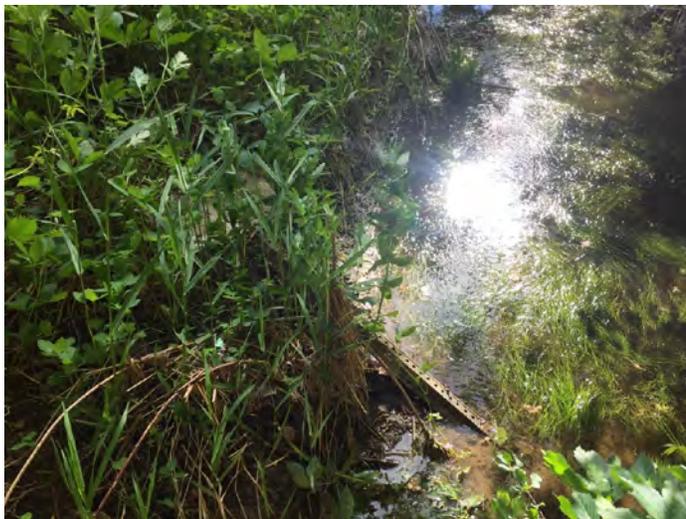
Photo 1

Sign and post in the drain on the left side. Picture facing upstream.

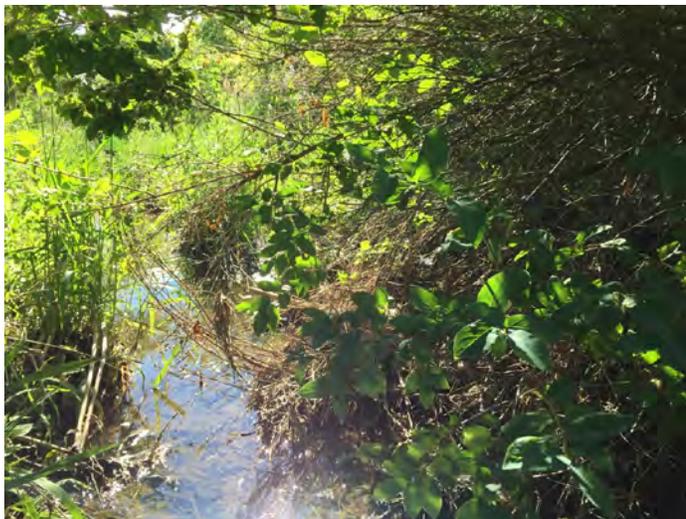
Photo 1

Woody debris blockage for 10' on right side of drain facing upstream.
Picture facing upstream.
