King Street Tile Drain Inspections

Inspection Report for Observation:
Blockage200

CLIENT	Saginaw County Public Works Commissioner

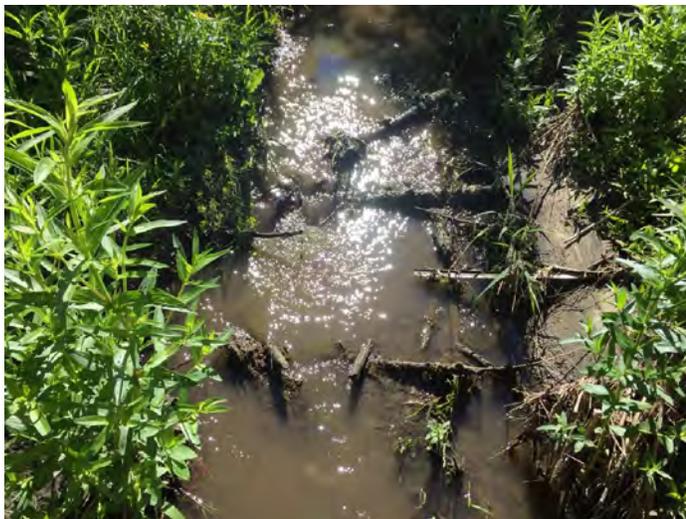
Photo 1

Woody debris for next 5' in center of drain. Picture facing upstream.

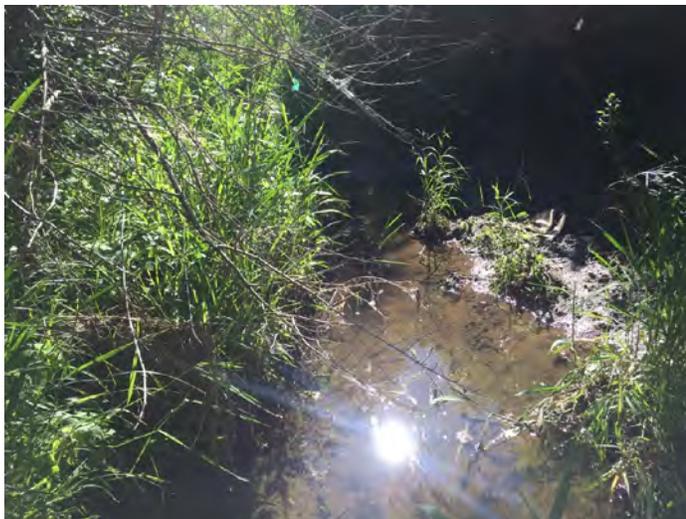
Photo 1

Scattered woody debris throughout both sides of drain for the next 500' to end. Picture facing upstream.

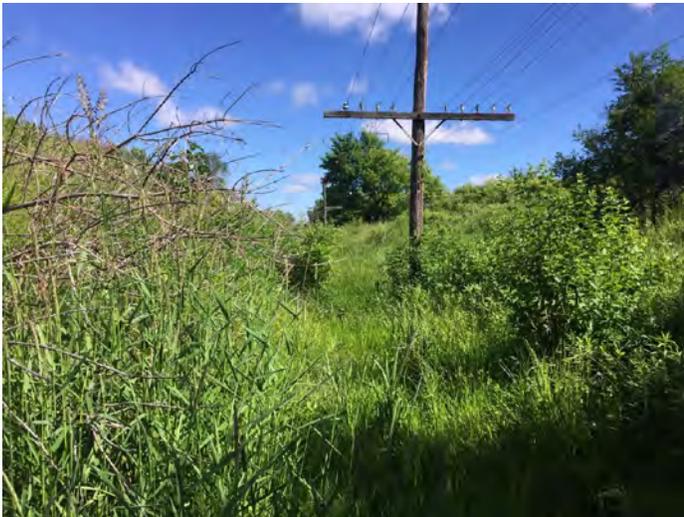
Photo 1

Excessive vegetation on both sides of drain impeding any flow for next 350' to end.

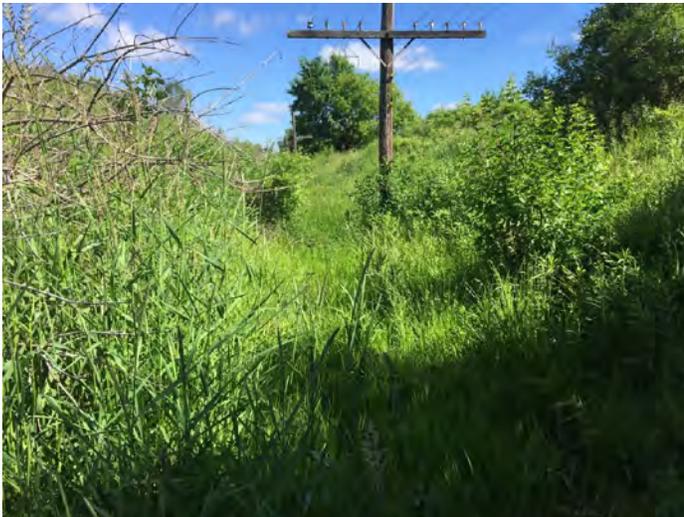
Photo 1

Fallen trees and scattered woody debris for the next 350' on both sides of drain to end. Picture facing upstream.

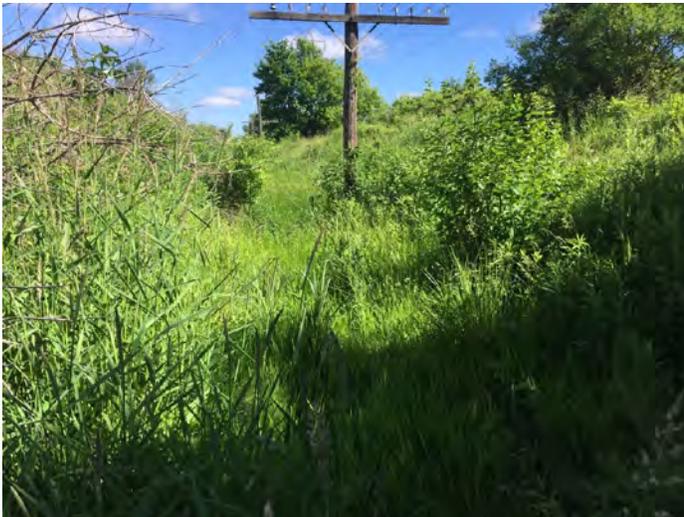
Photo 1

Sediment blockage impeding flow for next 350' to end throughout drain.
Picture facing upstream.

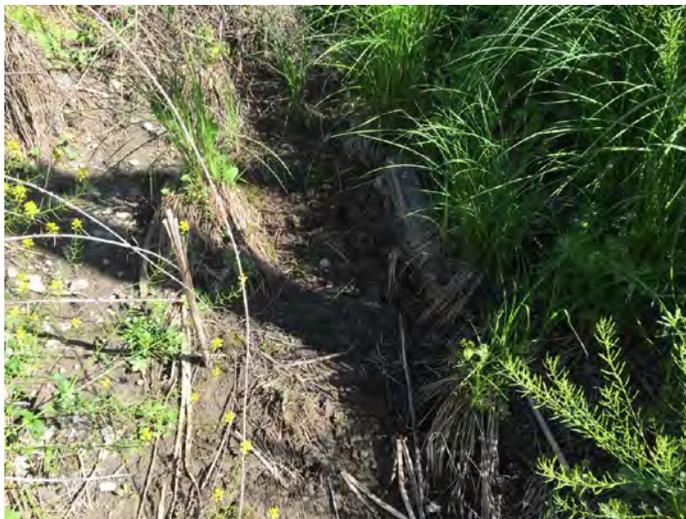
Photo 1

Scattered railroad beams throughout the drain for previous 250' and next 150' throughout abandoned portion of drain. Picture facing upstream.

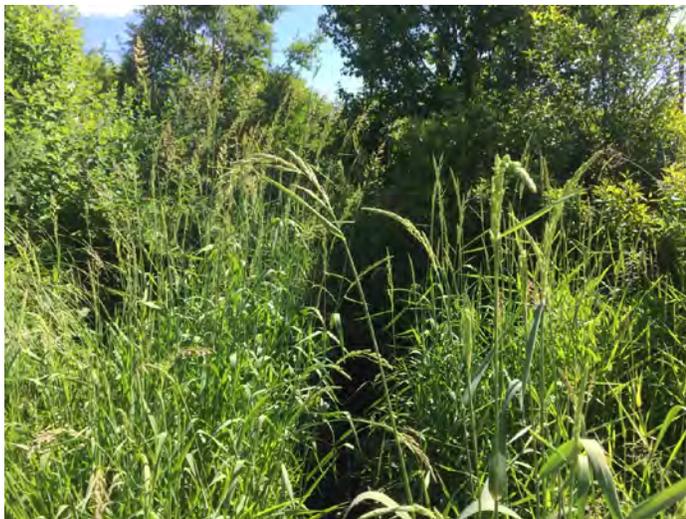
Photo 2

Excessive vegetation on both sides and throughout drain for next 650' to end. Picture facing upstream.

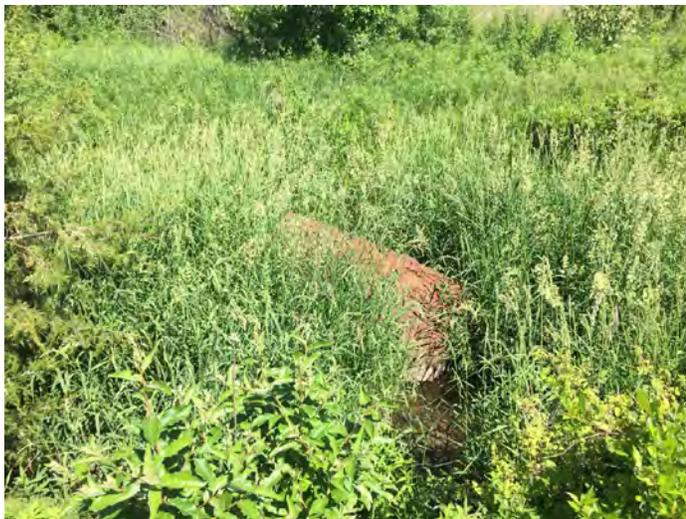
Photo 2

Large 10'x4' piece of metal or CMP laying in the middle of the drain causing a blockage. Picture facing north across the drain.

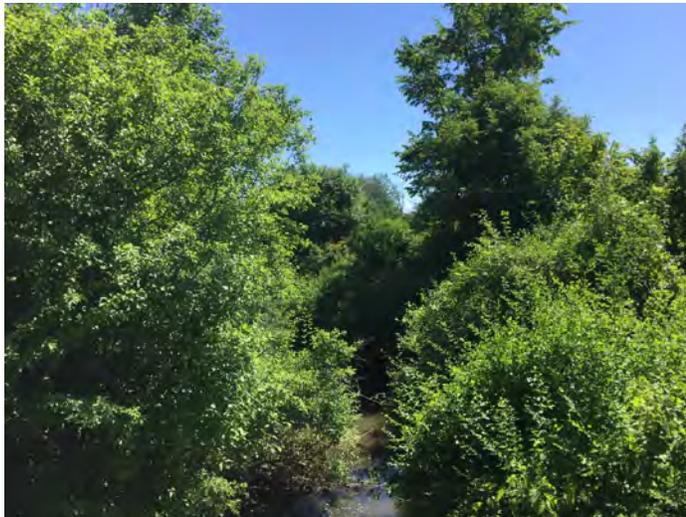
Photo 2

Excessive vegetation on both sides, along and throughout the drain for the next 2000' to the road. Picture facing upstream.

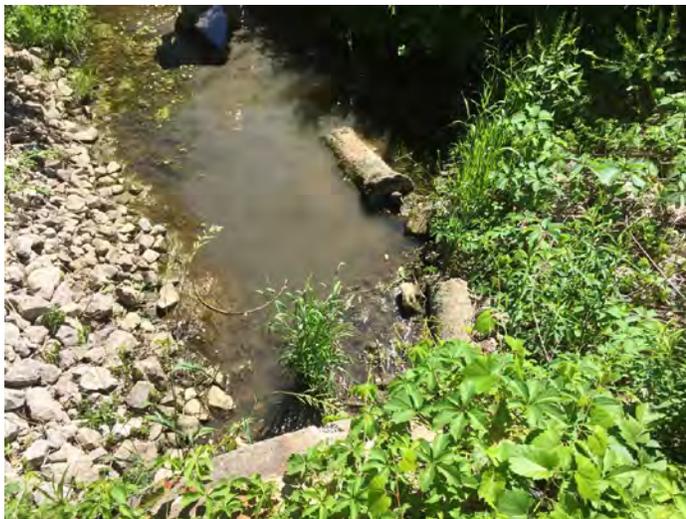
Photo 2

A couple 5' concrete blocks in the drain on the right side. Picture facing upstream

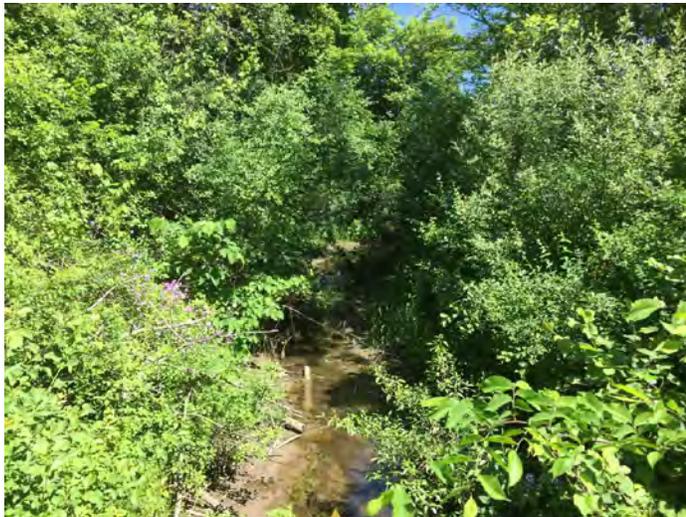
Photo 2

Sediment on both banks of drain for next 850' to road. Picture facing upstream.

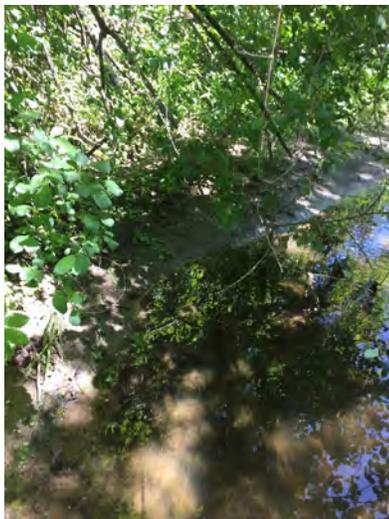
Photo 2

Sediment bar left side of the drain from this location approximately 60' upstream to end. Picture facing upstream

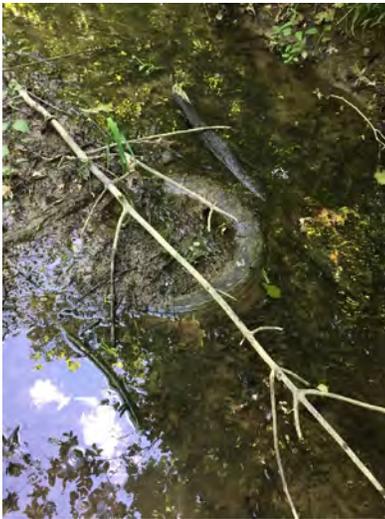
Photo 2

Tire in drain.

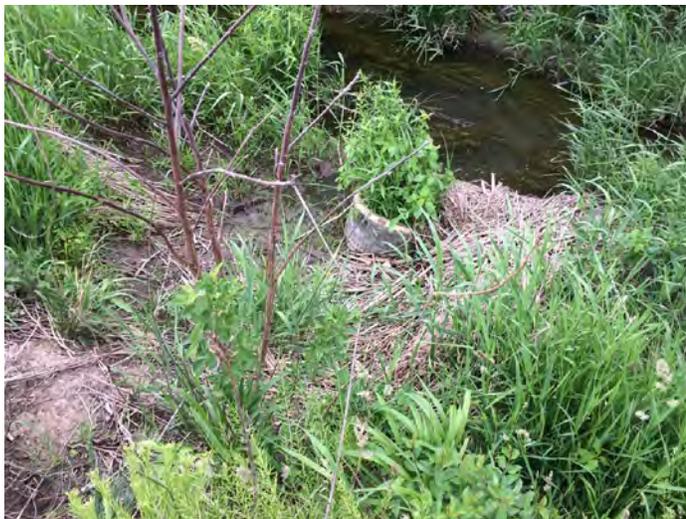
Photo 2

Metal round possible planter on left side of drain.

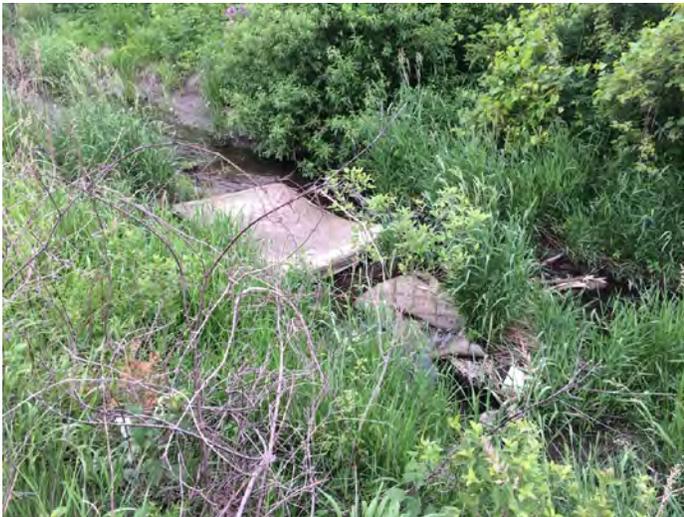
Photo 2

Mattress and box spring debris and crate left of center of drain causing a blockage for 15'.

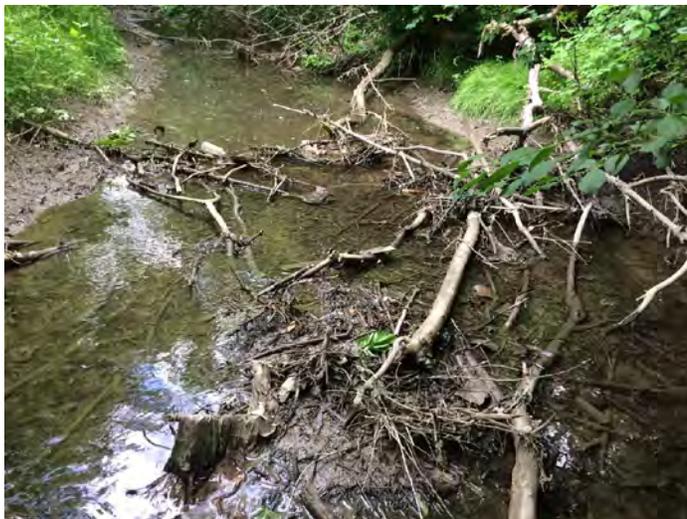
Photo 2

Log jam in center of drain from both sides. About 5 ft of blockage.

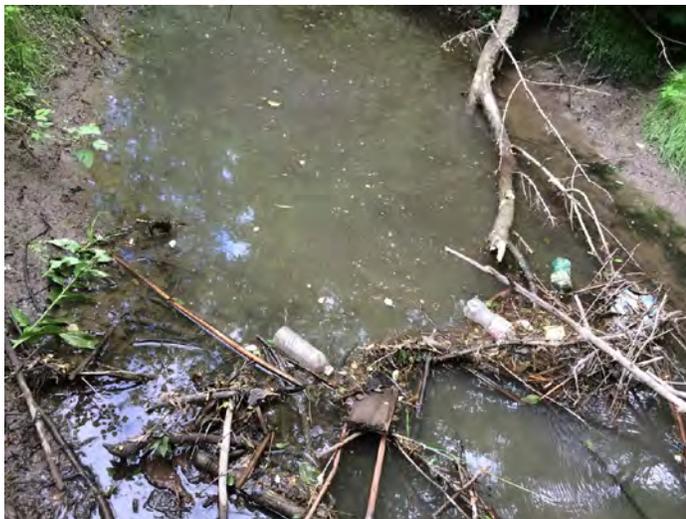
Photo 2

Trash in drain for about 10 ft.

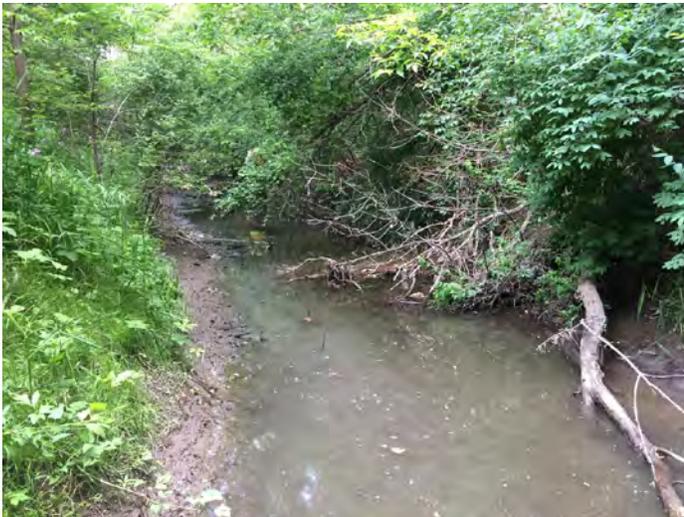
Photo 2

Woody debris on both sides of drain.

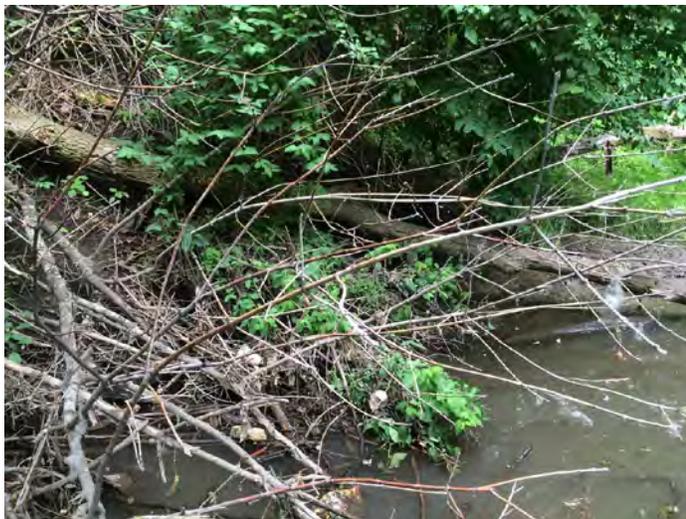
Photo 2

2 fallen trees on right side of drain extending about 3 ft into drain.

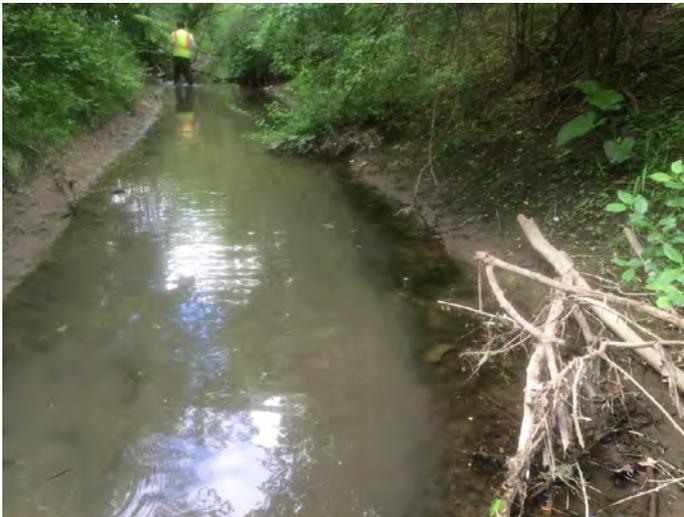
Photo 2

Woody debris on both sides of drain. About 50 ft down.

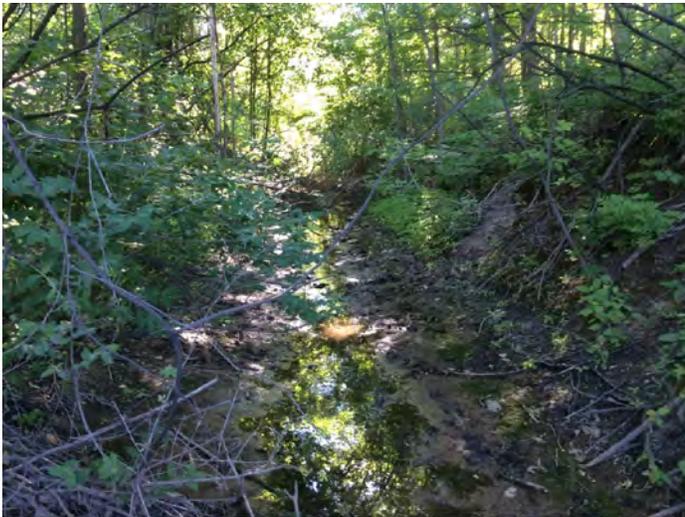
Photo 2

Excessive vegetation on banks over next 500 ft.

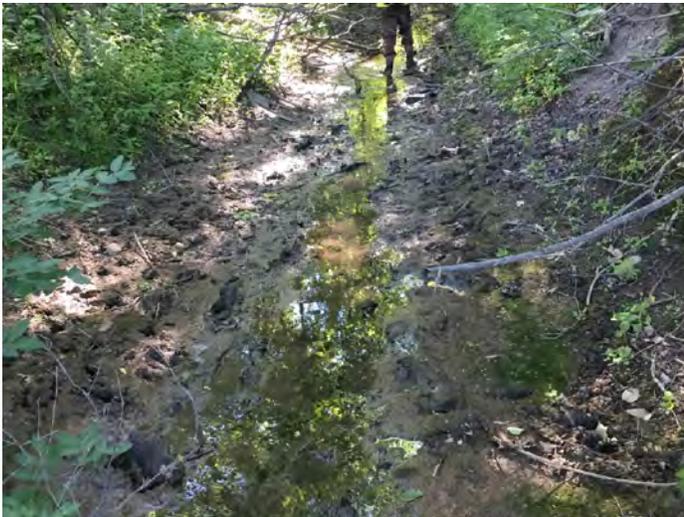
Photo 2

Excessive vegetation on both sides of drain. Barely any water. Depth may be 2 inches deep.

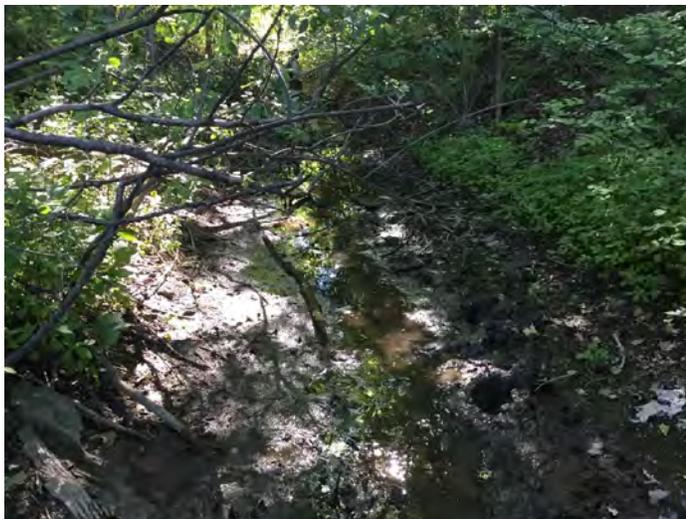
Photo 2

Woody debris on both sides of drain for 500 ft.

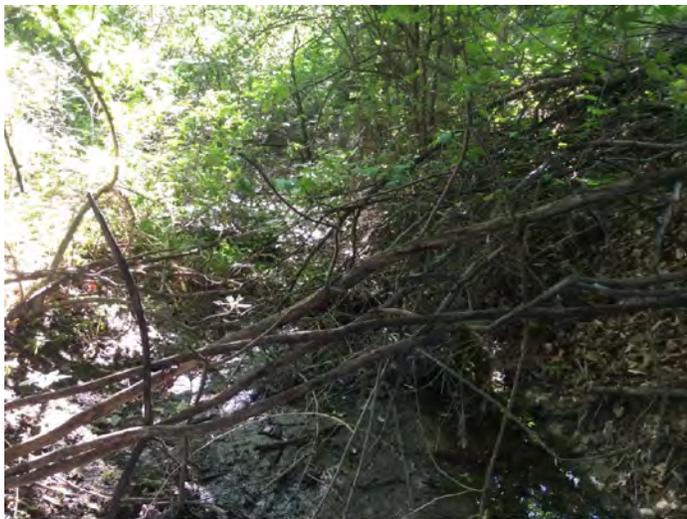
Photo 2

Fallen trees and excessive vegetation are causing blockage in center of drain impeding flow. Next 50 ft.

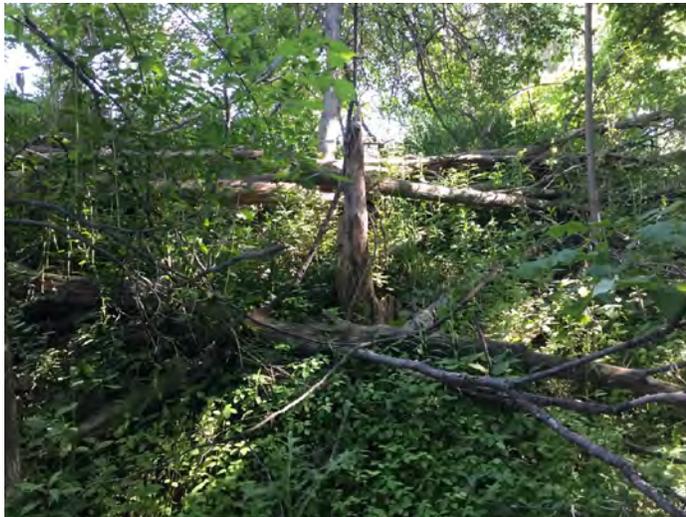
Photo 2

Excessive tree logs on left side of drain on bank. About 20 ft long.

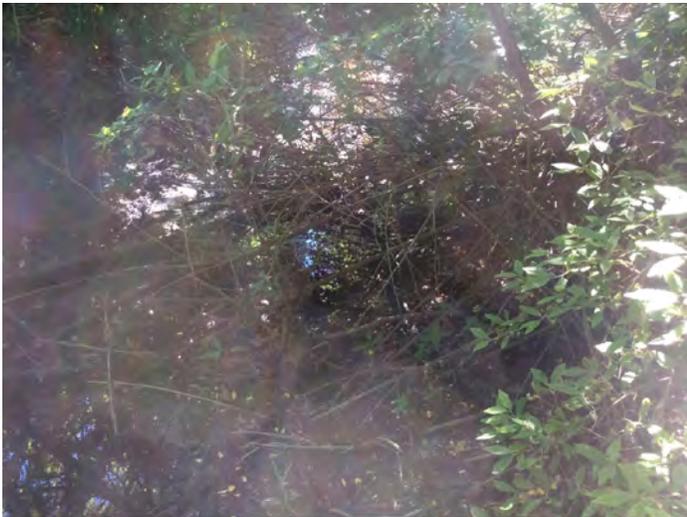
Woody debris and sediment causing blockages drain and impeding flow. Next 10 ft.

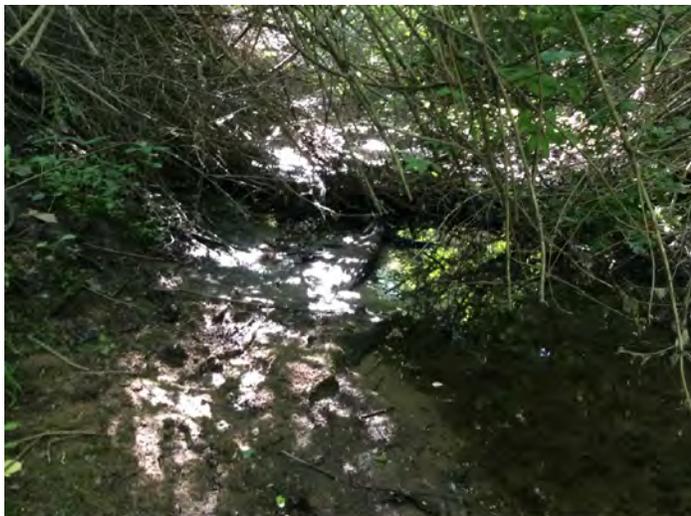
Inspection Report for Observation:
Blockage439

Type: Log Jam

Log jam next 15 ft.

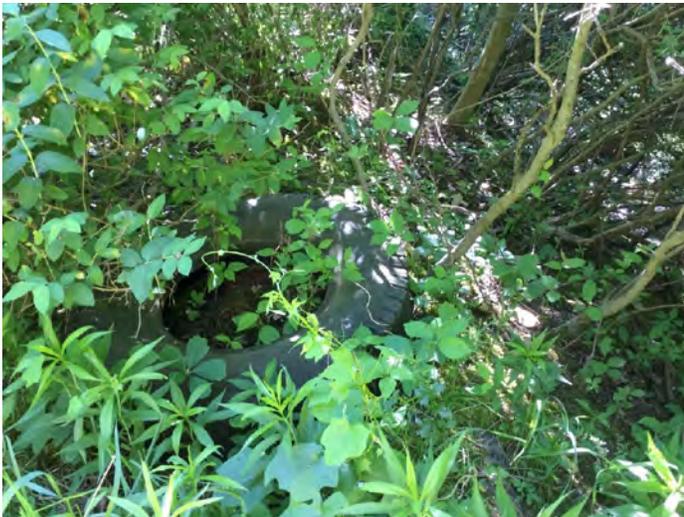
Inspection Report for Observation:
Blockage440

Type: Non-Vegetative Debris

Tire on left side of drain on bank up about 10 ft.

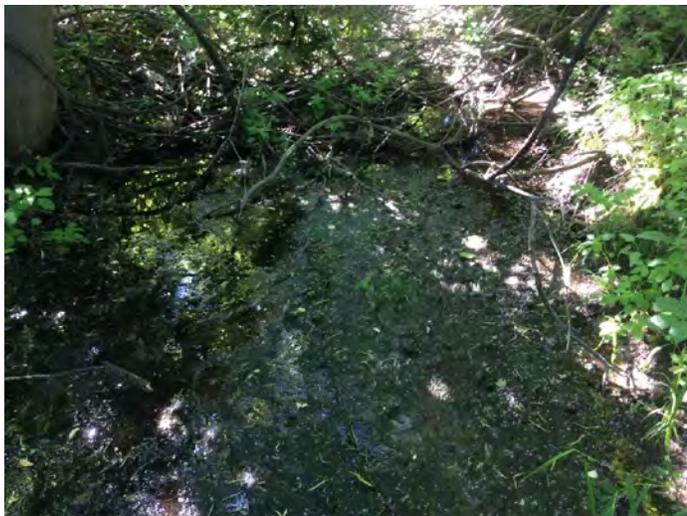
Inspection Report for Observation:
Blockage441

Type: Sediment

Sediment bar downstream of side drain and log jam. Drain is wider here than downstream.

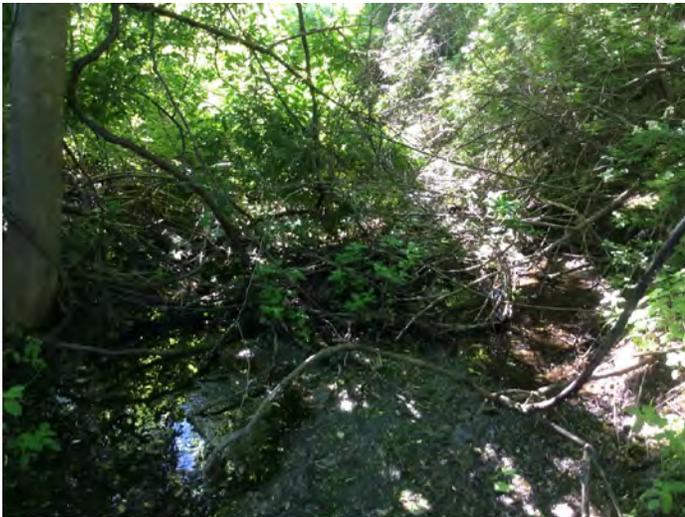
Inspection Report for Observation:
Blockage442

Type: Log Jam

Fallen woody debris and sediment causing log jam and impeding flow. 15 ft.

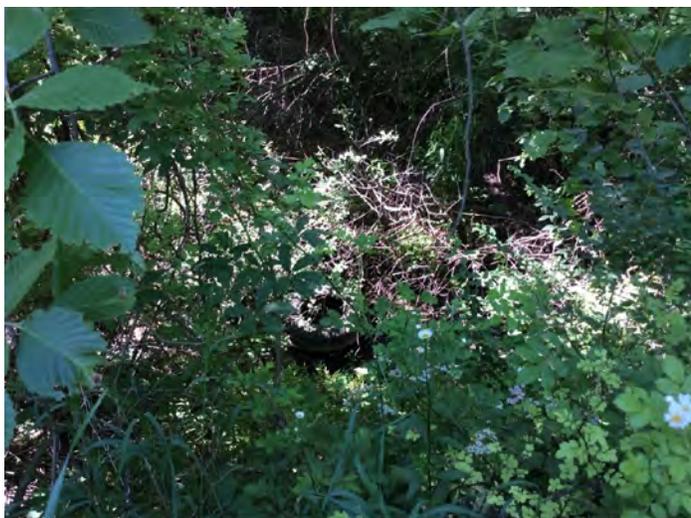
Inspection Report for Observation:
Blockage443

Type: Non-Vegetative Debris

Large tire in center of drain.

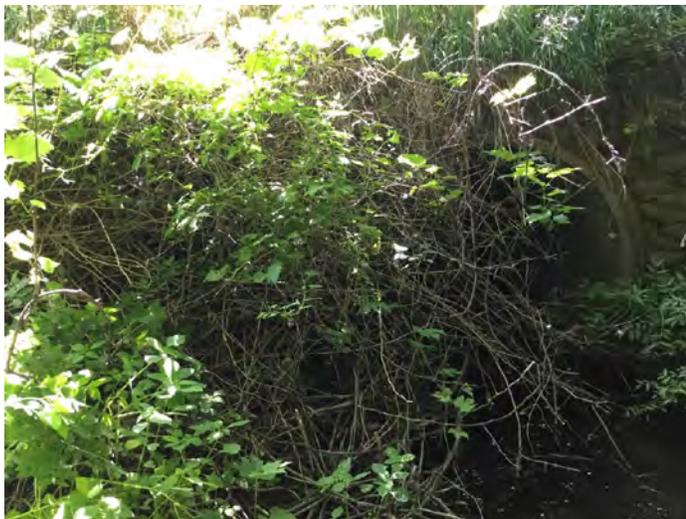
Inspection Report for Observation:
Blockage444

Type: Fallen Tree

Major woody debris on left side of culvert falling over culvert. Also on right side.

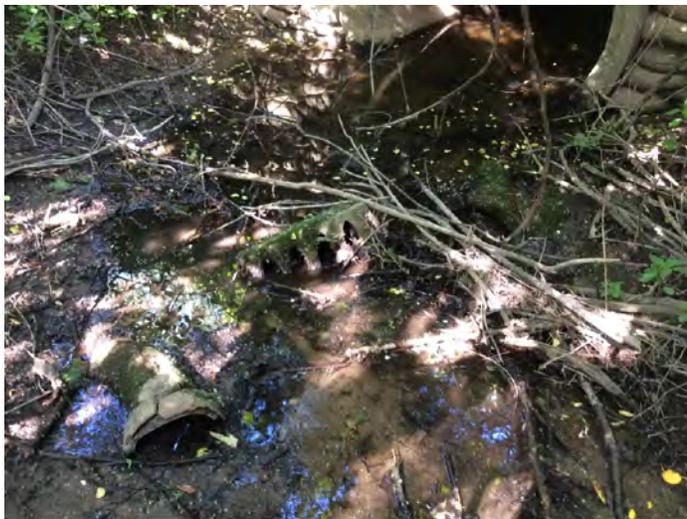
Inspection Report for Observation:
Blockage445

Type: Non-Vegetative Debris

Debris on upstream side of farm crossing.

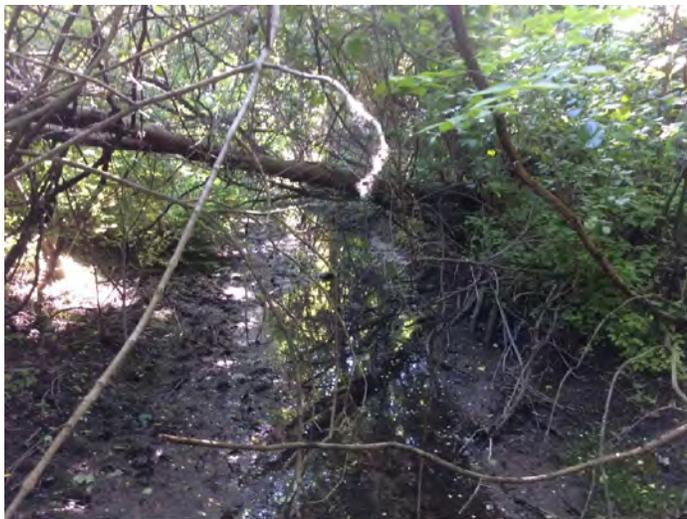
Inspection Report for Observation:
Blockage446

Type: Fallen Tree

8" diam fallen tree on right overhanging drain.

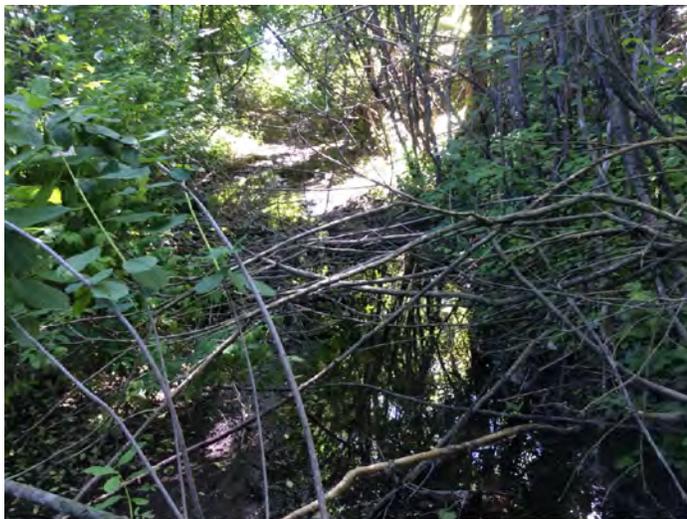
Excessive vegetation grown on both sides of the drain. Small trees growing vertical, and sometimes horizontal overhanging drain. Next 500 ft.

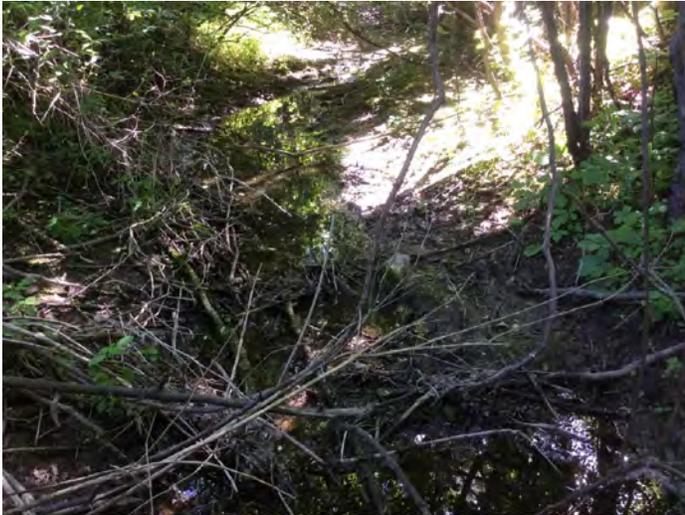
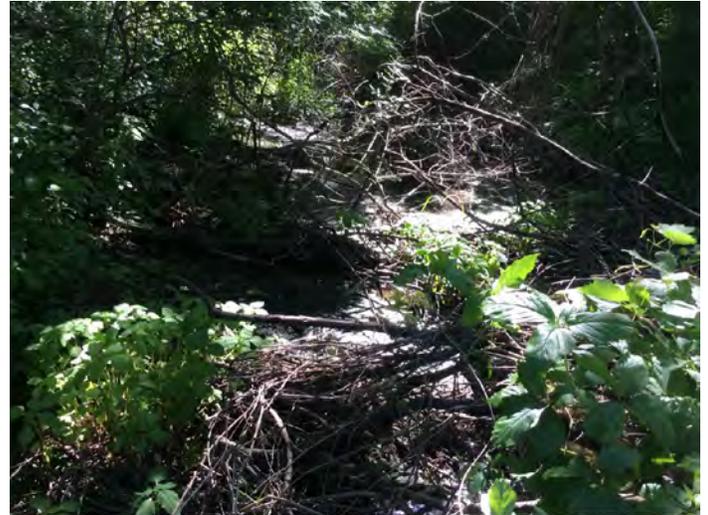
Fallen woody debris, trees, branches next 500 ft. Pretty consistent throughout this stretch.

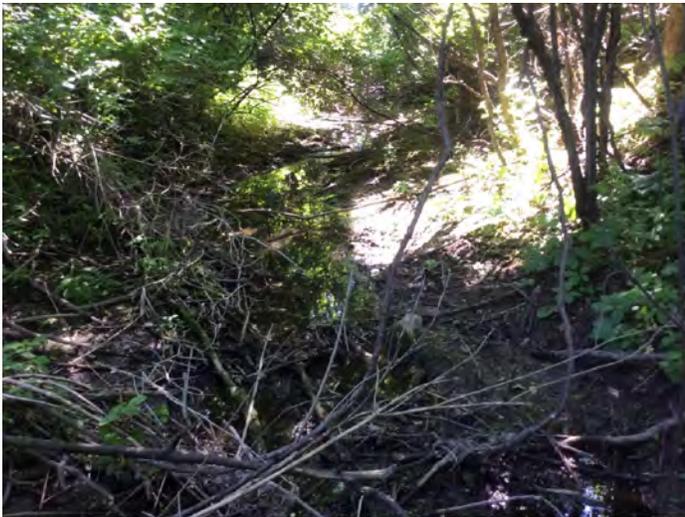
Sediment bars on both sides and center over next 500 ft. Drain channel meanders.

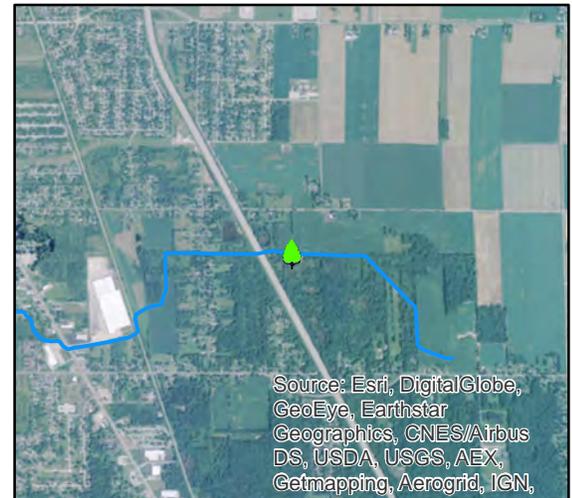
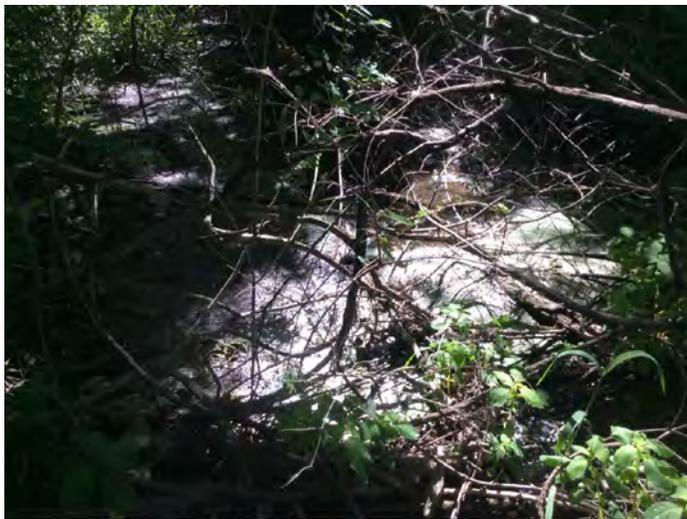
2 logs jams over next 80 ft caused by fallen woody debris.

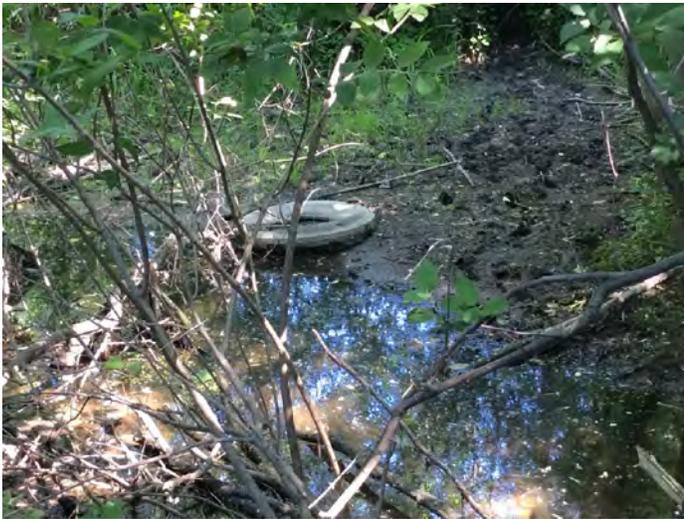
Tire on left side of drain. About 1 ft.

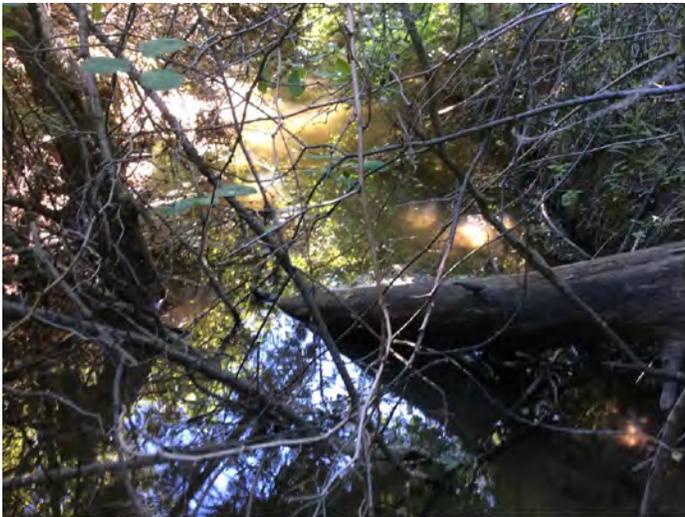
10" diam log in two pieces in center of drain.

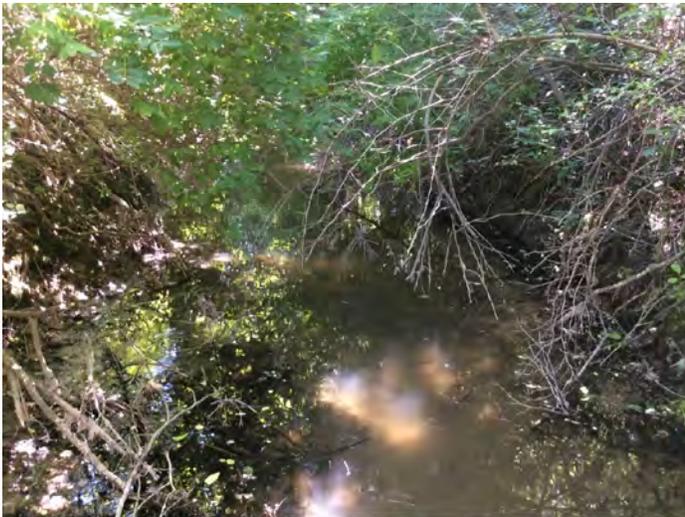
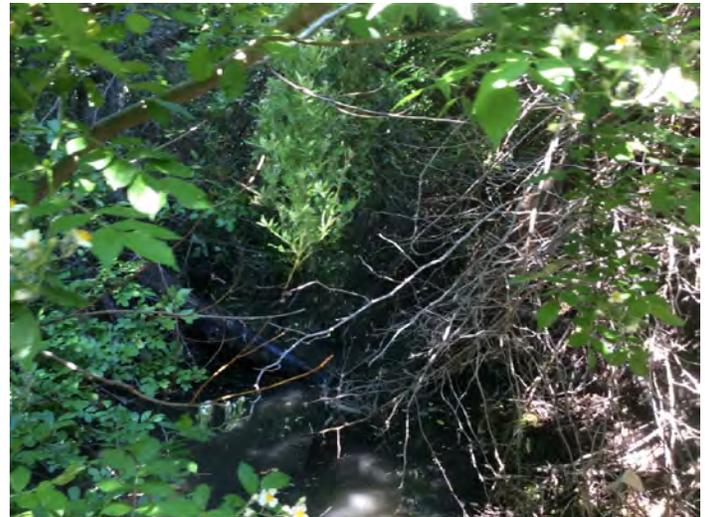
Heavy vegetation growing on both banks. Think vines, small trees. Next 1000 ft to bend.

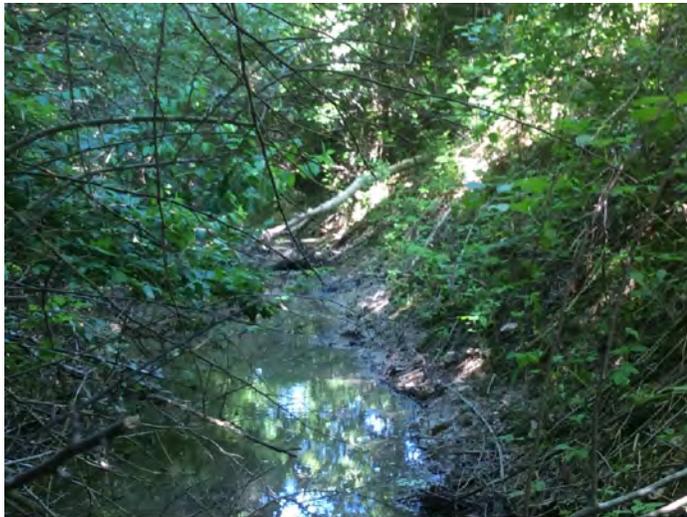
Scattered woody debris including fallen trees, logs, and branches over next 500 ft.

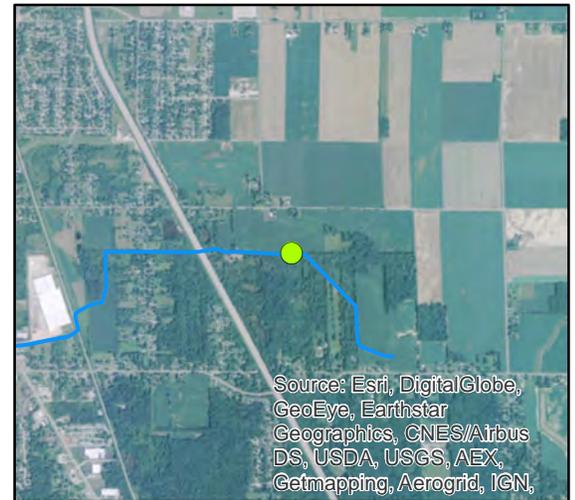
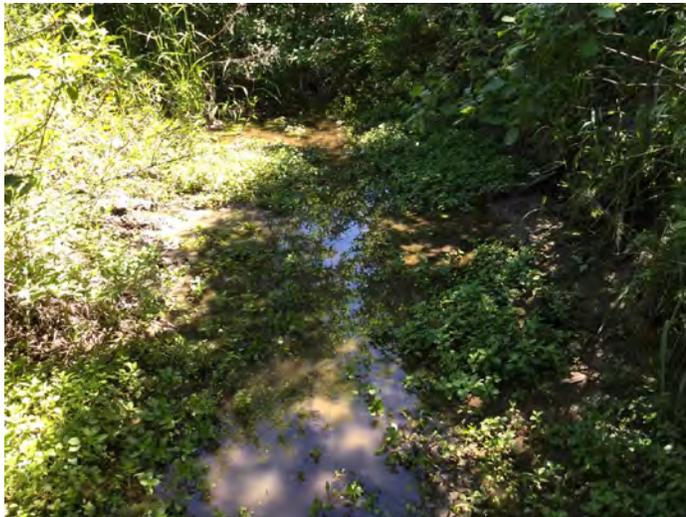
Excessive vegetation growing from bottom of drain on both sides for about 15-20 ft.

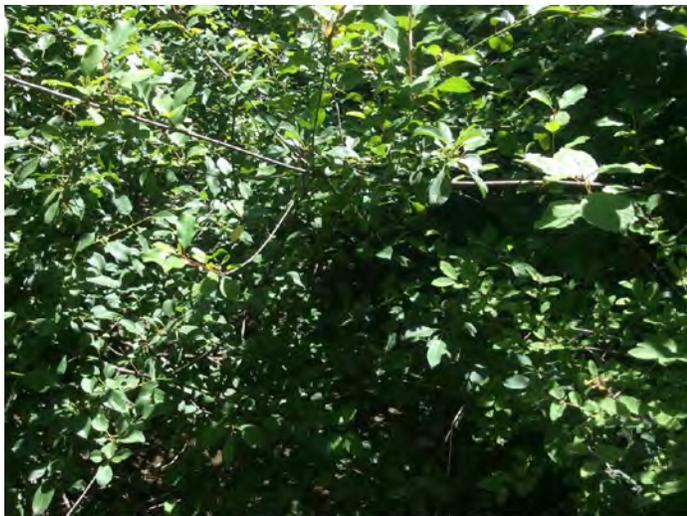
Extremely heavy vegetation on both banks overhanging drain. 250 ft around the bend.

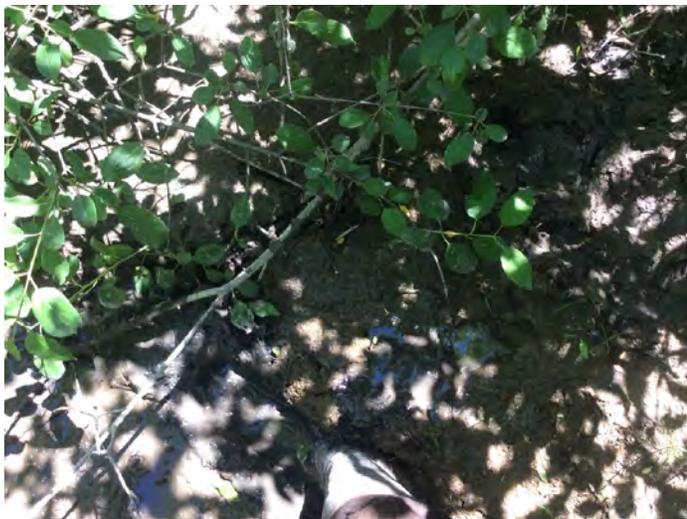
Sediment buildup through drain. Small drain channel. Difficult to see through vegetation. 250 ft around the bend.

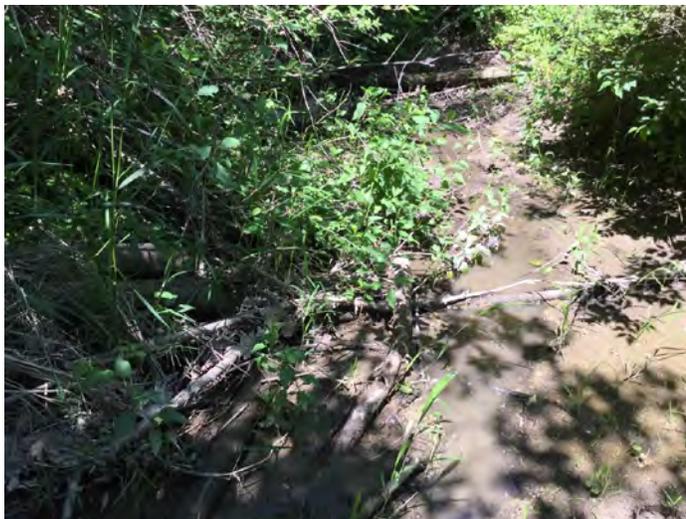
Log jam at bank turn on both sides. Massive sediment around flow meanders. About 10 ft long.

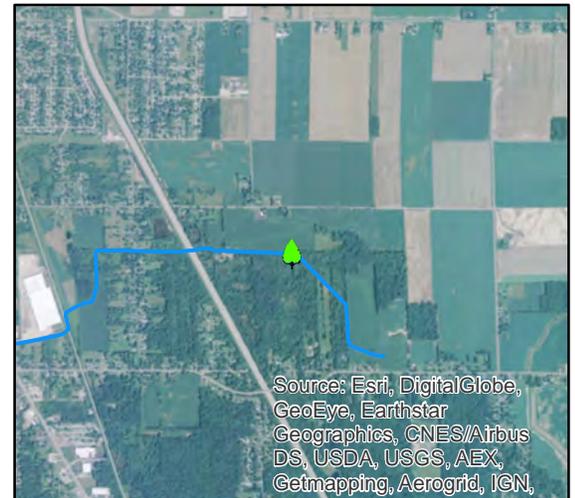
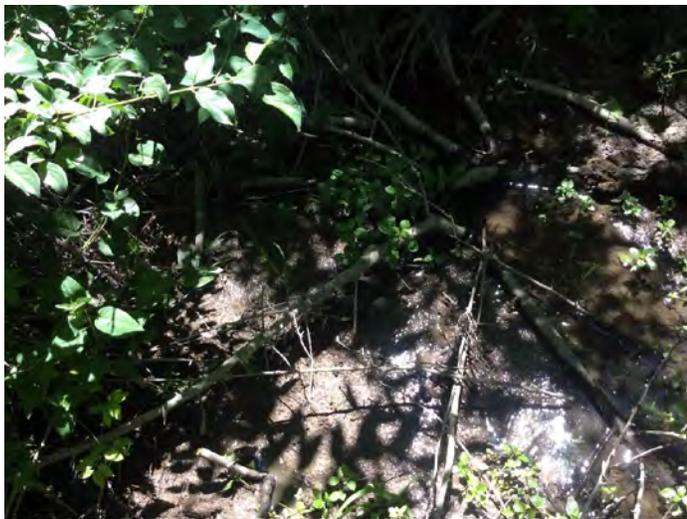
Woody debris scattered next 250 ft around the bend. Low flow due to sediment buildup.

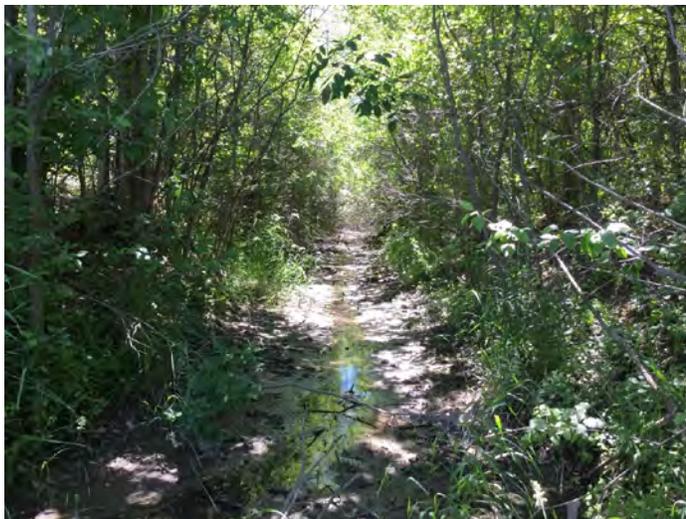
Excessive overhanging vegetation on both sides of drain for about 700 ft.

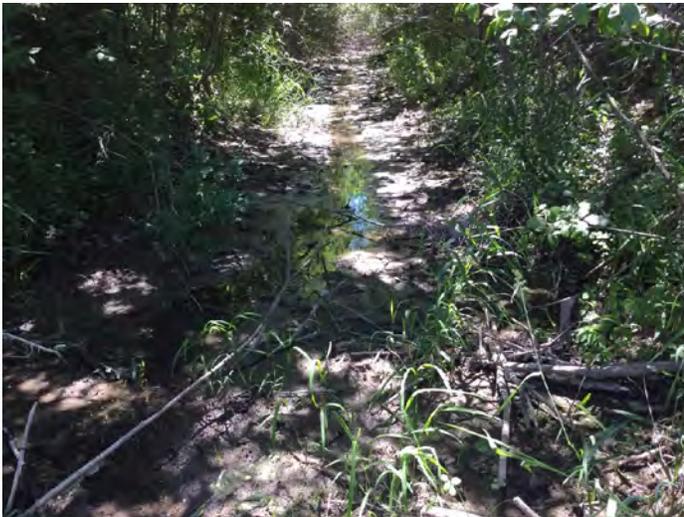
Sediment bars on both sides of drain for about 700 ft. Water depth is only a few inches deep. Loose sediment.

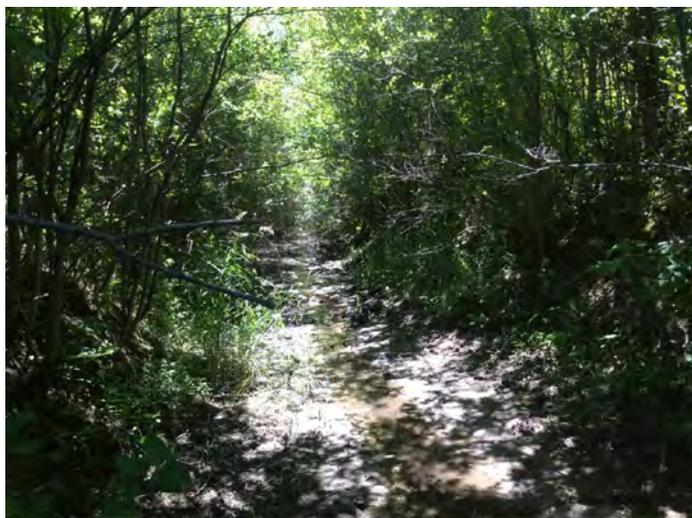
Excessive vegetation growing on both banks next 700.

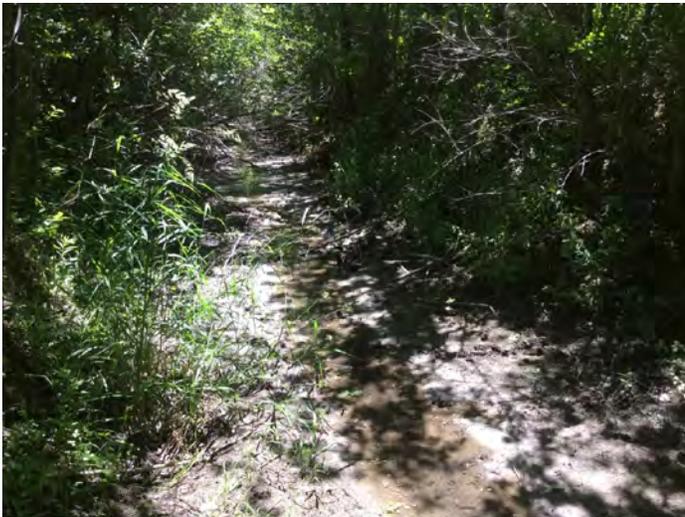
Scattered woody debris over next 700 ft.

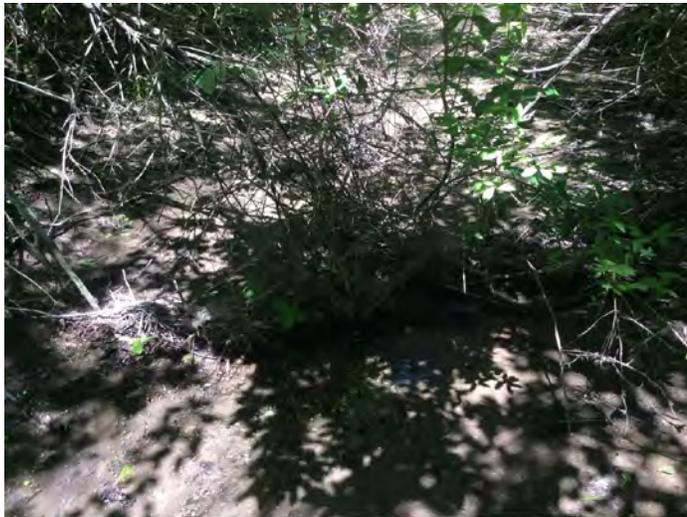
Log jam with woody debris, sediment, and vegetation in center of drain impeding flow.

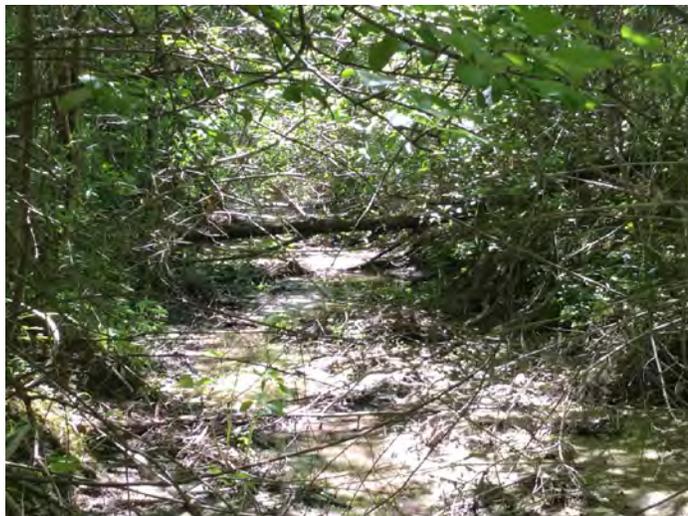
Fallen tree crossing over drain. About 30 ft tree.

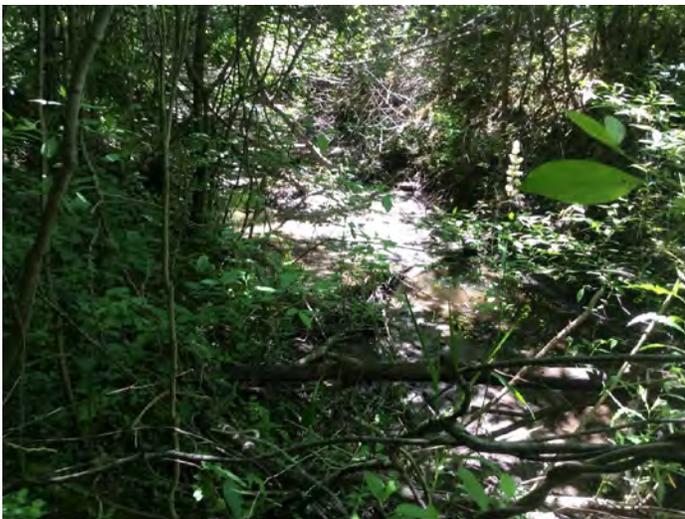
Log jam from fallen trees and other woody debris.

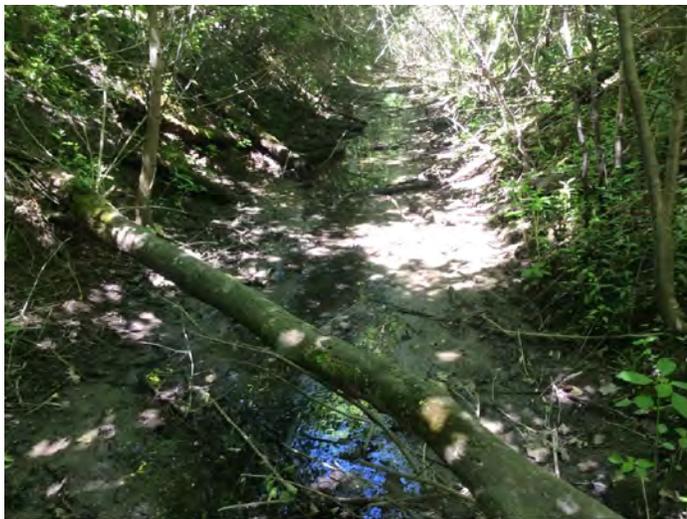
6" diam fallen tree as well as multiple logs in drain.

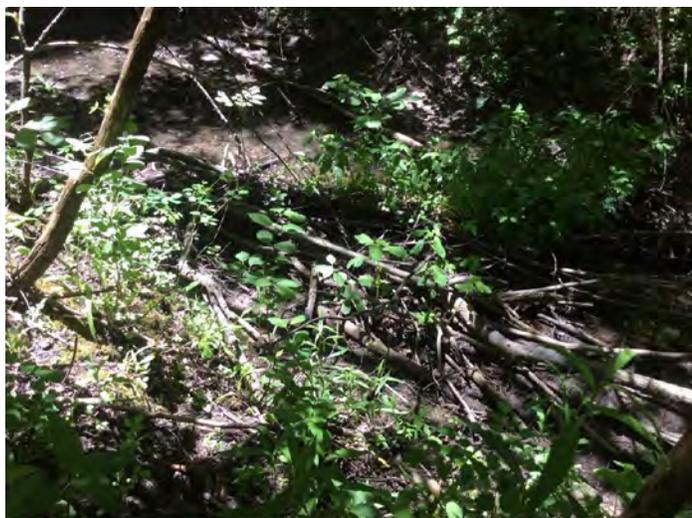
Log jam with fallen branches and sediment in center of drain.

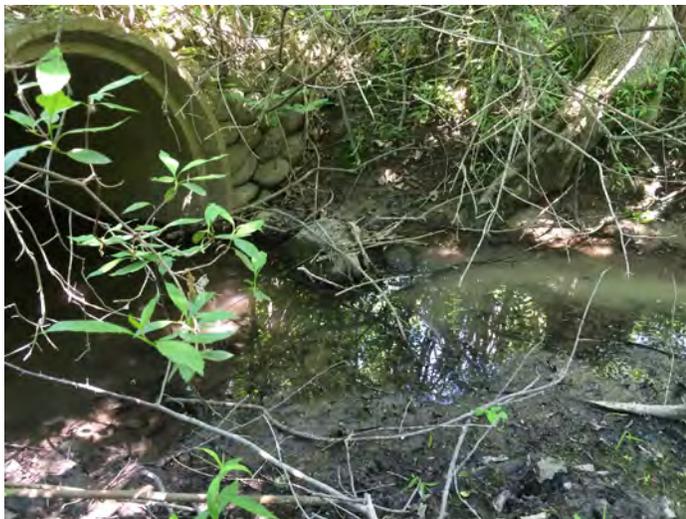
Piece of headwall from upstream side in center of drain. Just upstream of farm crossing.
