King Street Tile Drain Inspections

Inspection Report for Observation:
Blockage200

CLIENT	Saginaw County Public Works Commissioner

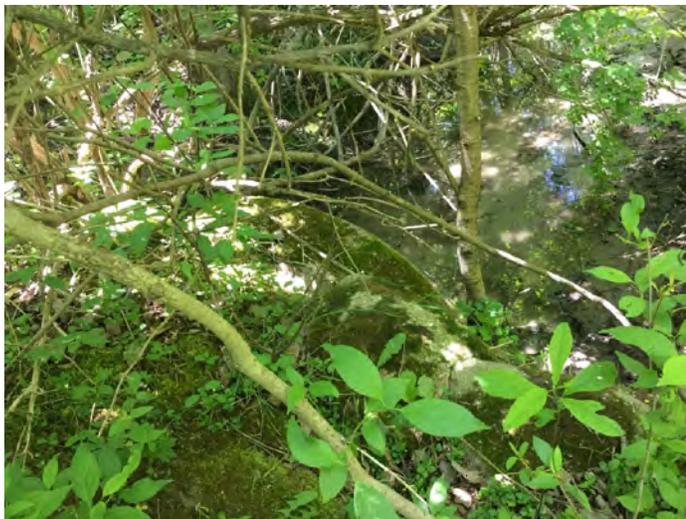
Excessive vegetation growing on farm crossing structure at downstream end.

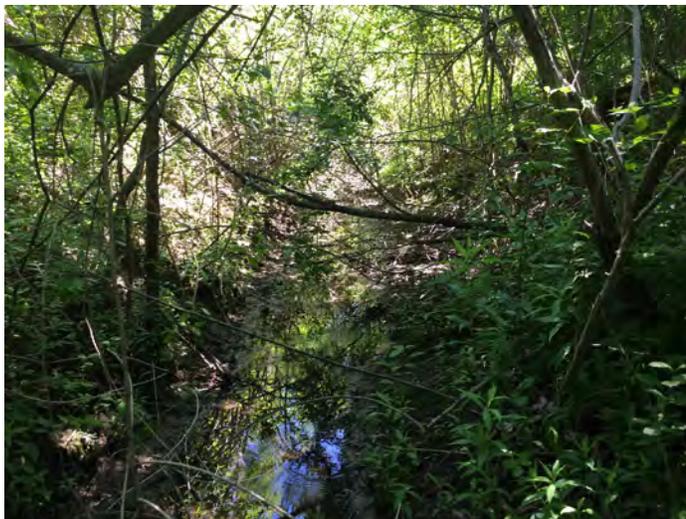
Woody debris including fallen trees, logs, and branches scattered over next 500 ft.

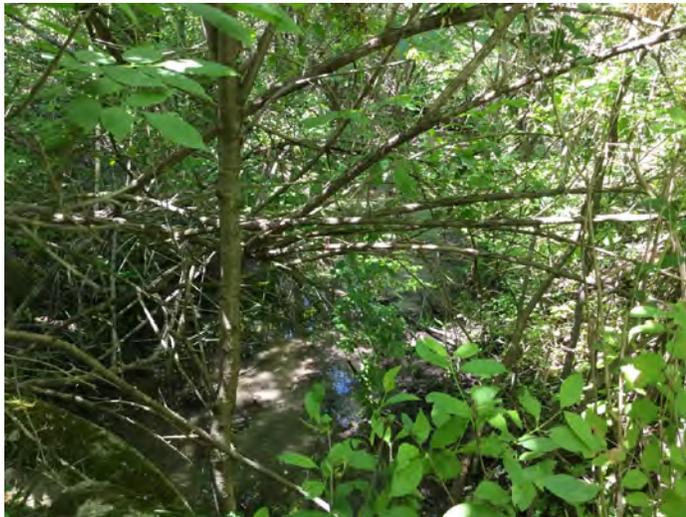
Excessive vegetation around downstream end of farm crossing.

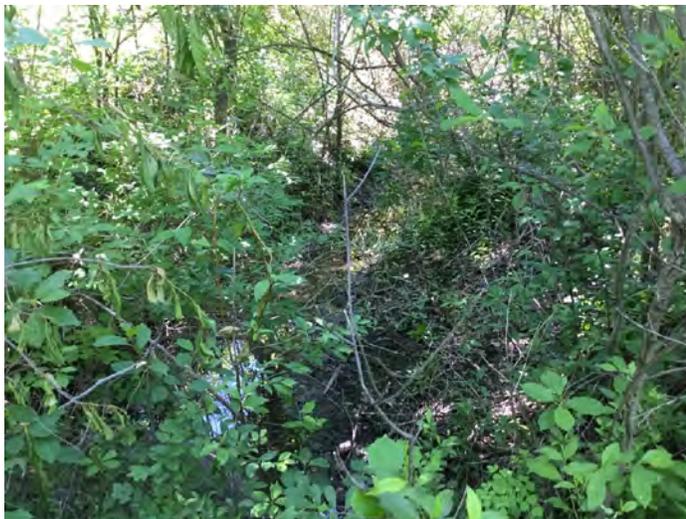
Excessive overhanging vegetation on both sides for 500 ft.

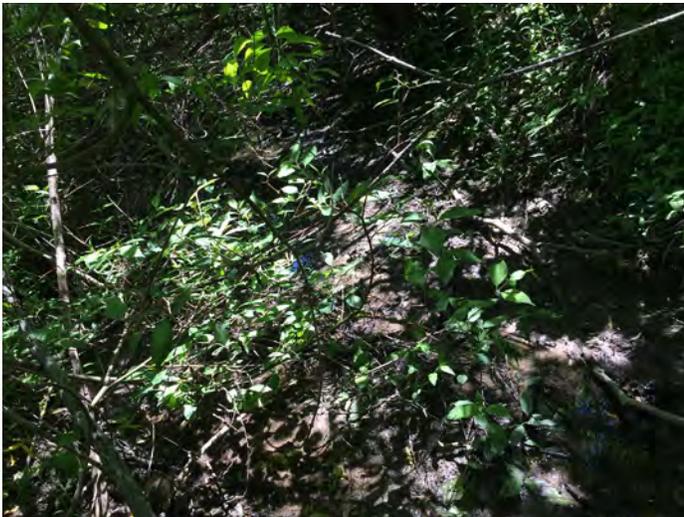
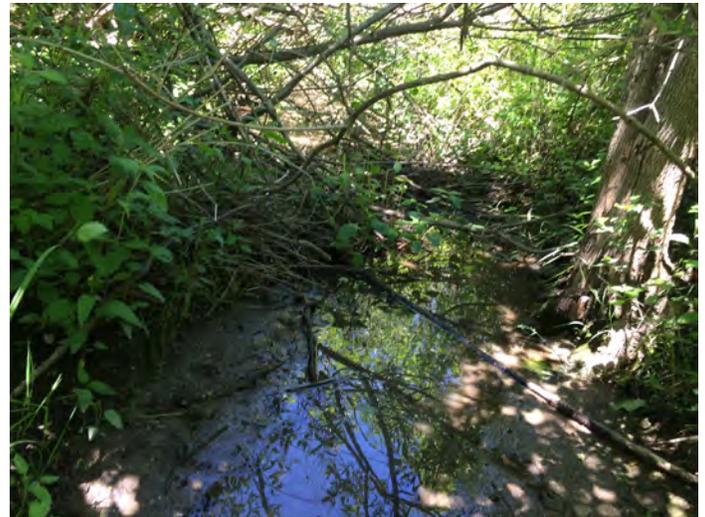
Branches, veg, and sediment causing log jam in this stretch.

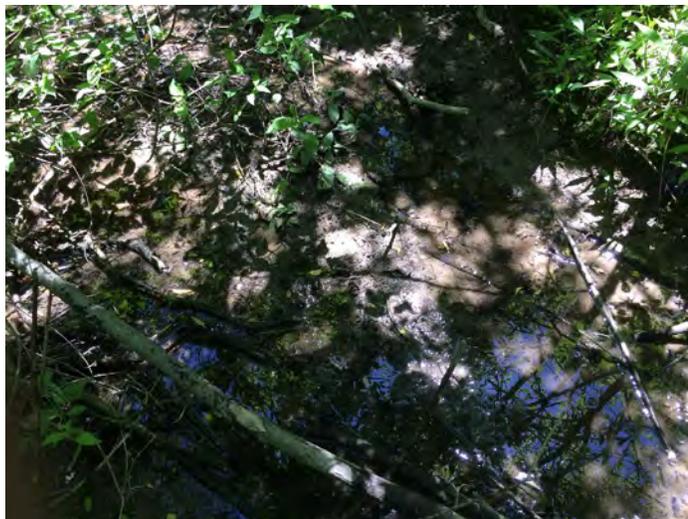
Sediment build up along with woody debris is causing blockage in drain.

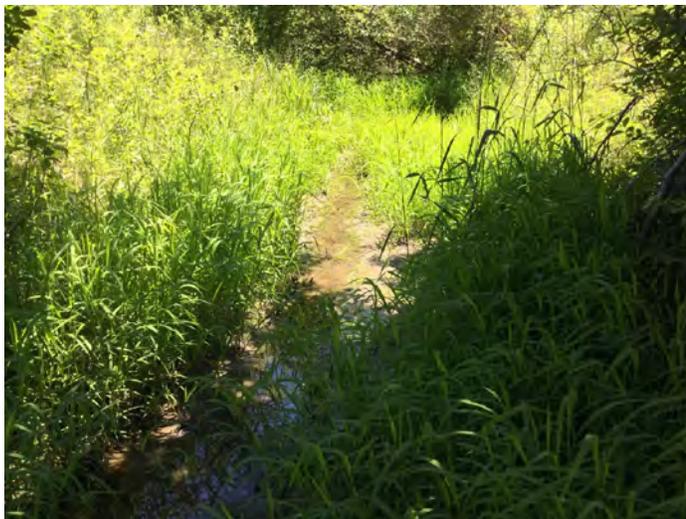
Excessive grass growing on both sides of drain.

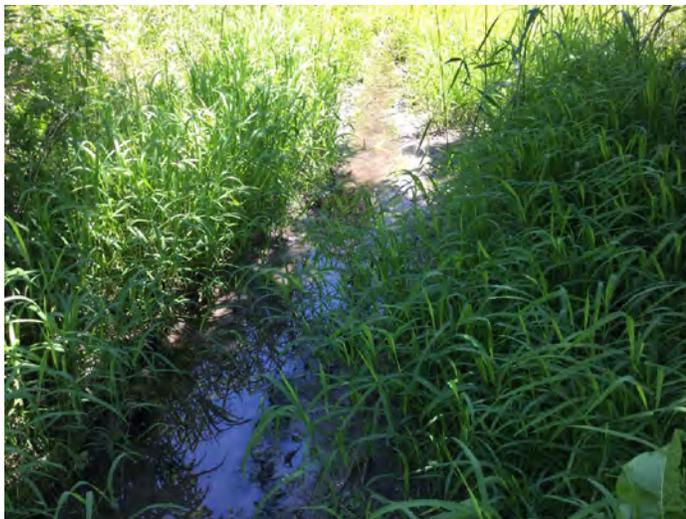
Inspection Report for Observation:
Blockage477

Type: Sediment

Sediment on both sides making width of drain smaller. About 100 ft.

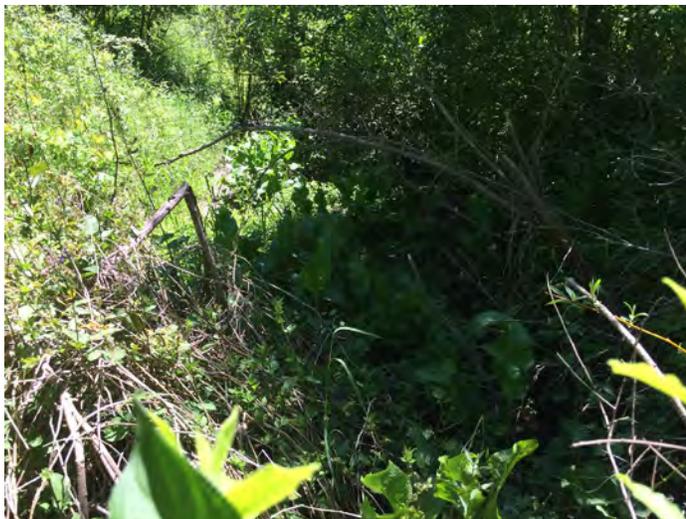
Inspection Report for Observation:
Blockage478

Type: Sediment

Sediment in center of drain with excessive vegetation.

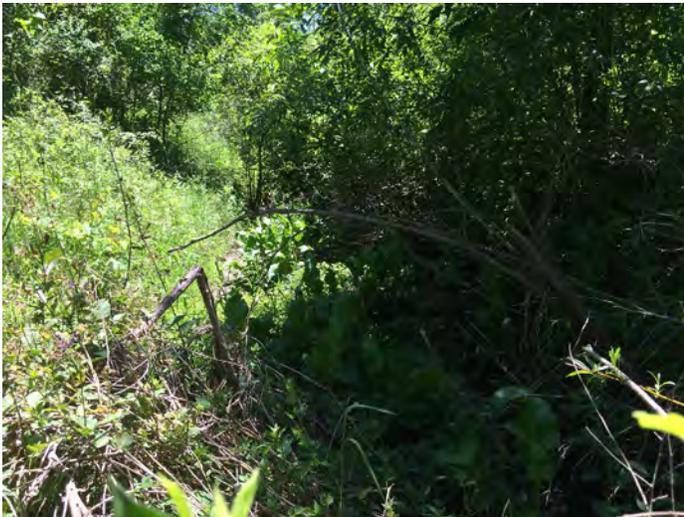
Inspection Report for Observation:
Blockage479

Type: Excessive Vegetation

Excessive vegetation growing on sediment buildup in center of drain.

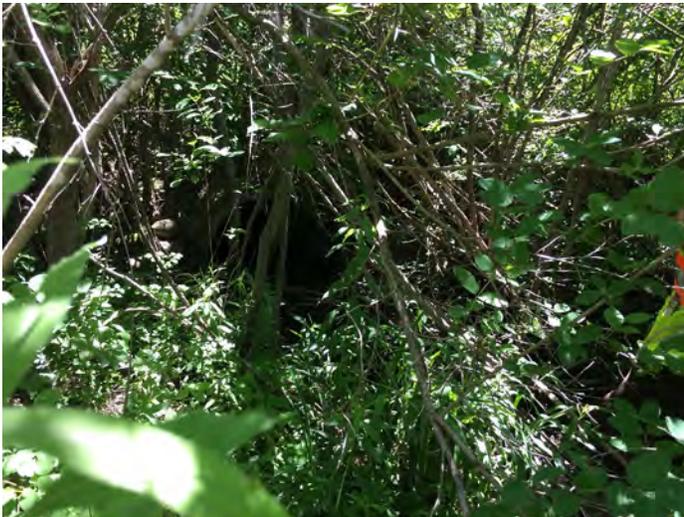
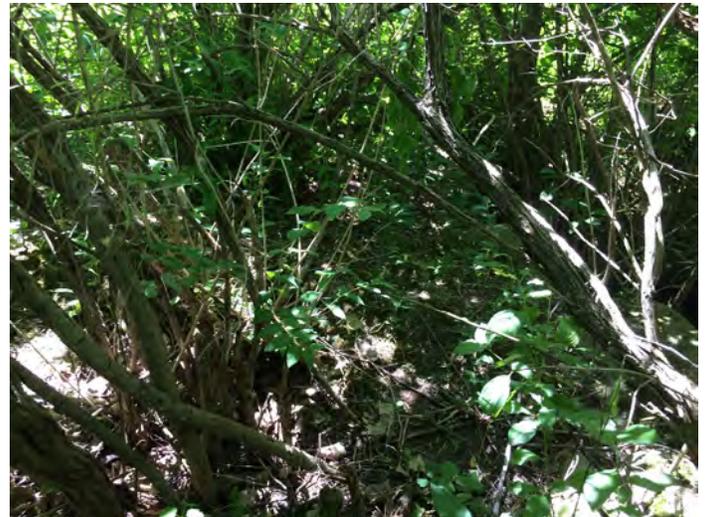
Inspection Report for Observation:
Blockage480

Type: Excessive Vegetation

Excessive vegetation around both upstream and downstream sides of crossing as well on surface.

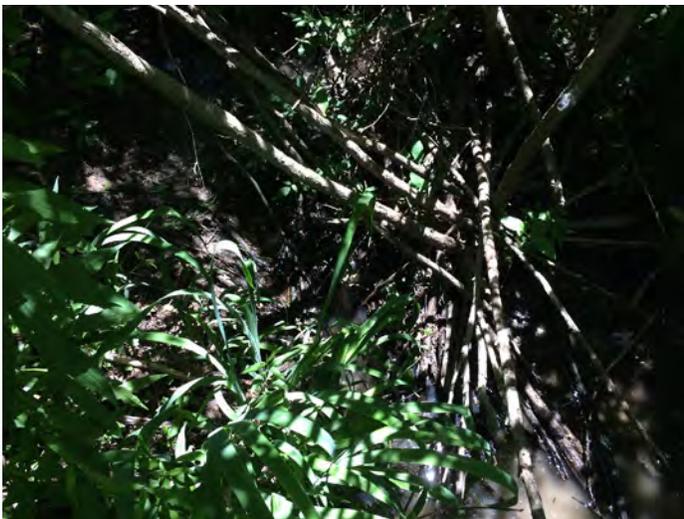
Inspection Report for Observation:
Blockage481

Type: Log Jam

Log jam just downstream of farm crossing impeding flow.

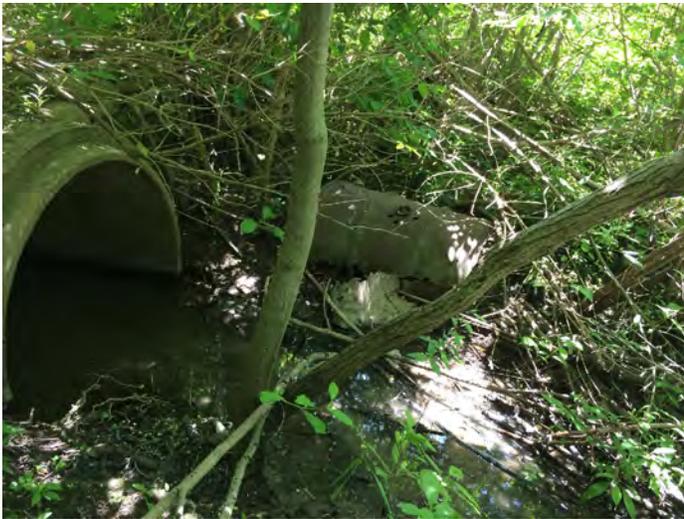
Inspection Report for Observation:
Blockage482

Type: Non-Vegetative Debris

Metal debris. Top of a grill or a metal drum. Just downstream of farm crossing.

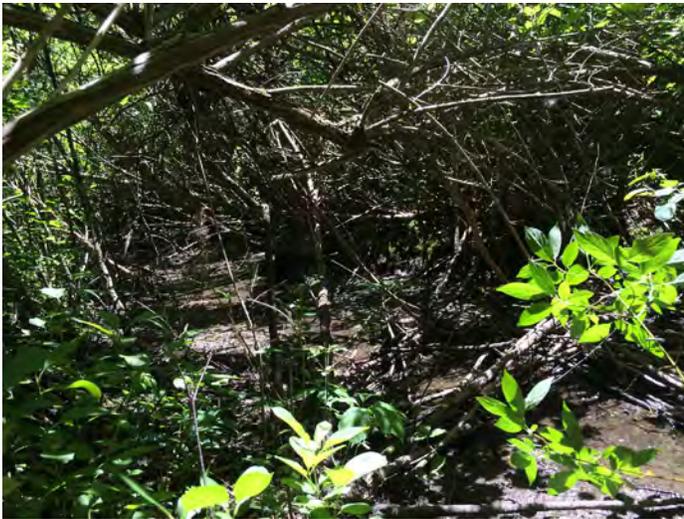
Inspection Report for Observation:
Blockage483

Type: Excessive Vegetation

Extremely heavy excessive vegetation on both banks. Difficult to access. Overhanging drain. Next 400 ft up to bend.

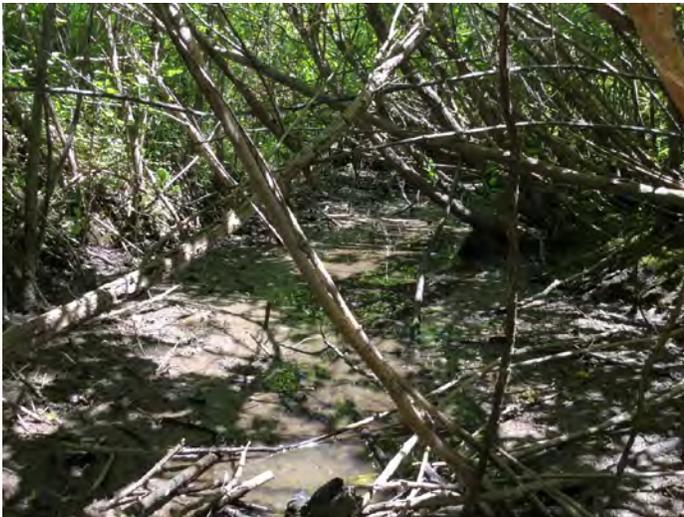
Excessive woody debris on both sides of drain for 400 ft.

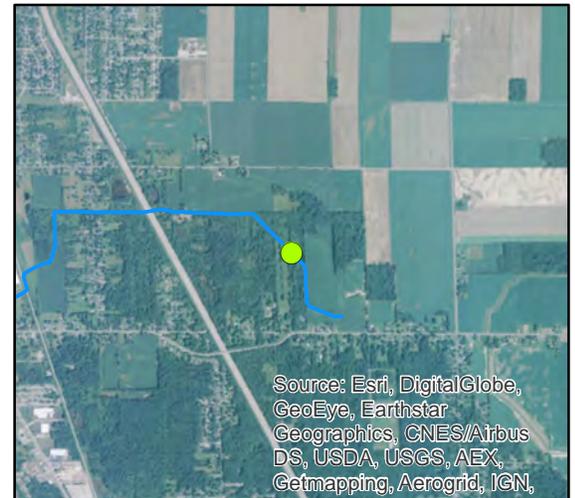
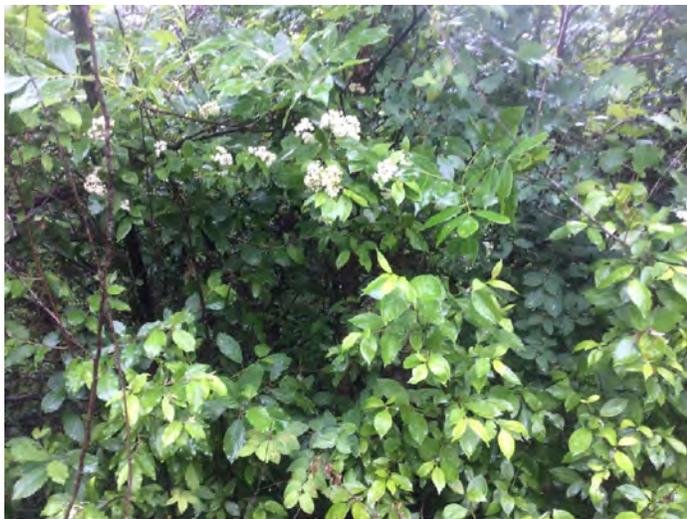
Excessive vegetation along the drain from the location approximately 1200' upstream. Picture facing upstream

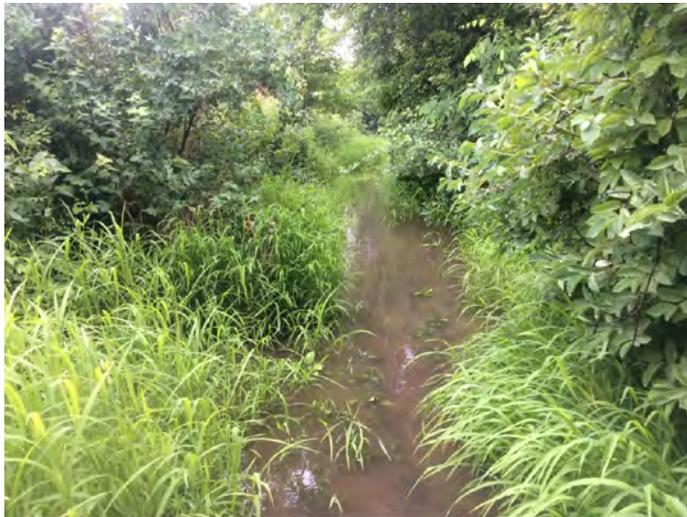
Vegetation and sporadic cattail growing in drain channel from this location approximately 1300' upstream to end. Picture facing upstream.

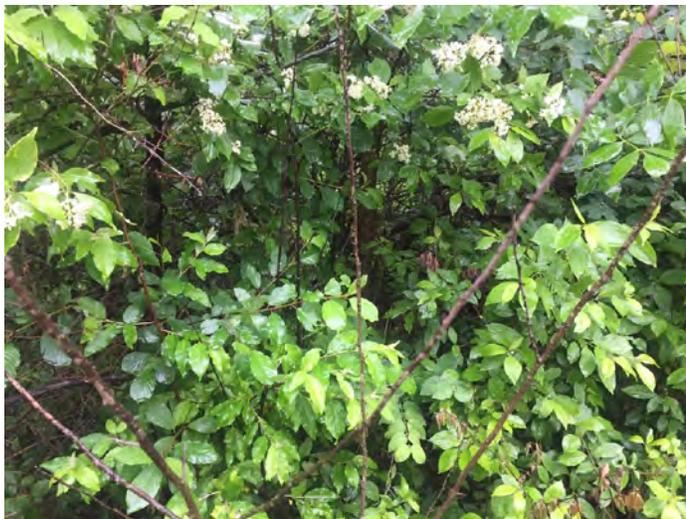
Woody debris on both sides of drain along the drain for next 1200 feet.

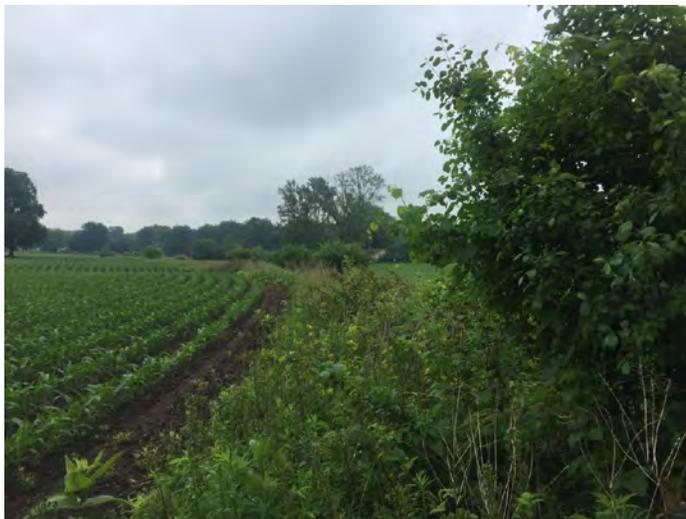
Excessive vegetation growing on both sides of drain for next 700' to end.
Picture facing upstream.

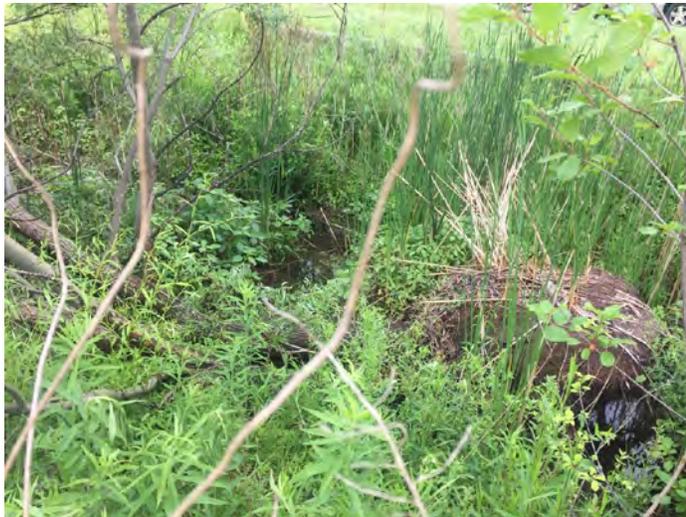
Fallen tree originating from center of drain and falling on left bank is blocking drain for approximately 10'. Picture facing upstream.
